Archaeological Building recording at Trengothal Farm, St Levan, Cornwall

Report No. 11-01

**ARCHAEOLOGICAL BUILDING RECORDING
AT TRENGOTHAL FARM
ST LEVAN, CORNWALL**

**Prepared for
Mr B. Hocking**

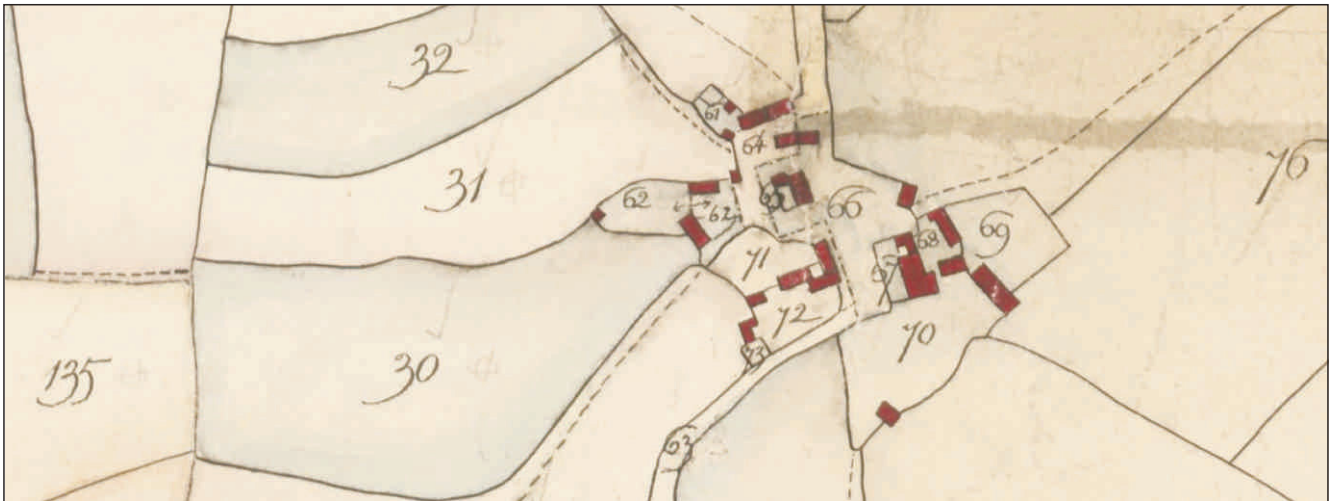
Fig. 2 St Levan Tithe map (1842) (not to scale).

The nature of the earliest building, shown on the 1842 tithe map and extending north from the main farmhouse is unclear. The fact that at least one small recess survived within the north

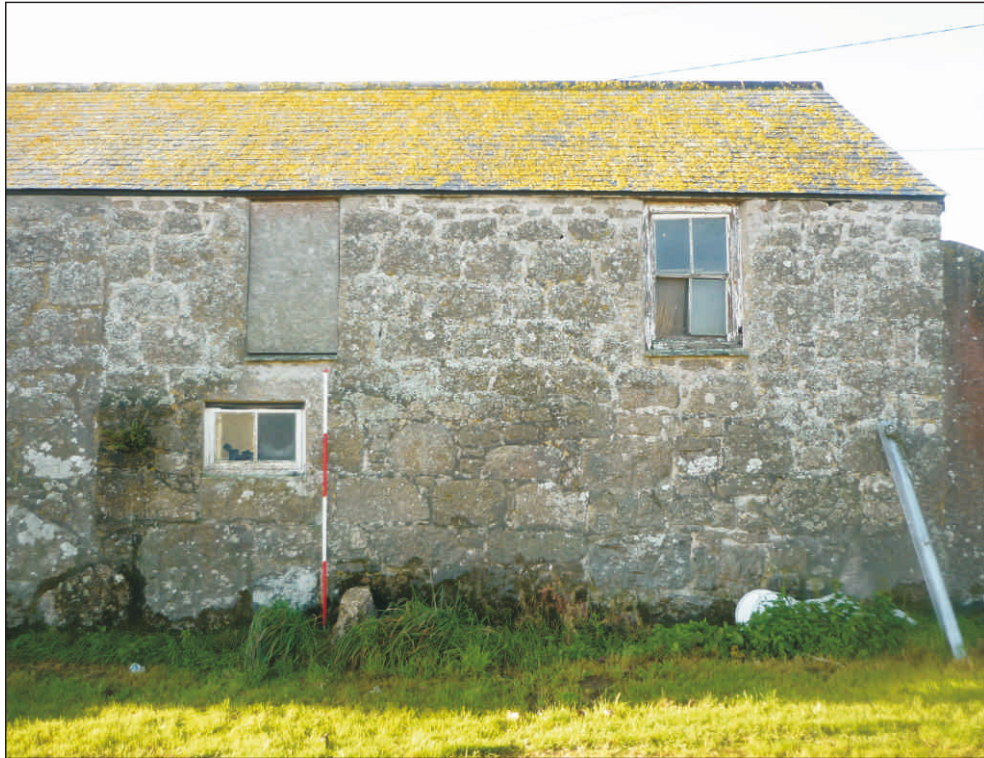
Pl. 1 North elevation, showing break in building fabric with small canted window and late 19th century sash window. 2m scale. Looking south-west.

The lower part of the north elevation is constructed of large roughly dressed granite and granite rubble. A clear building break is visible in the elevation with the line extending eastwards underneath the farmhouse extension. It is probable that these are the remains of a long building shown on the 1842 tithe map (Fig. 2). Along the inside of the northern wall was a cupboard-like recess (Pl. 4). This could have stored medicines, lamps and other small items. The extent of earlier fabric survival in the north-west wall was hidden by a modern extension, while the inside of the wall had been limewashed.

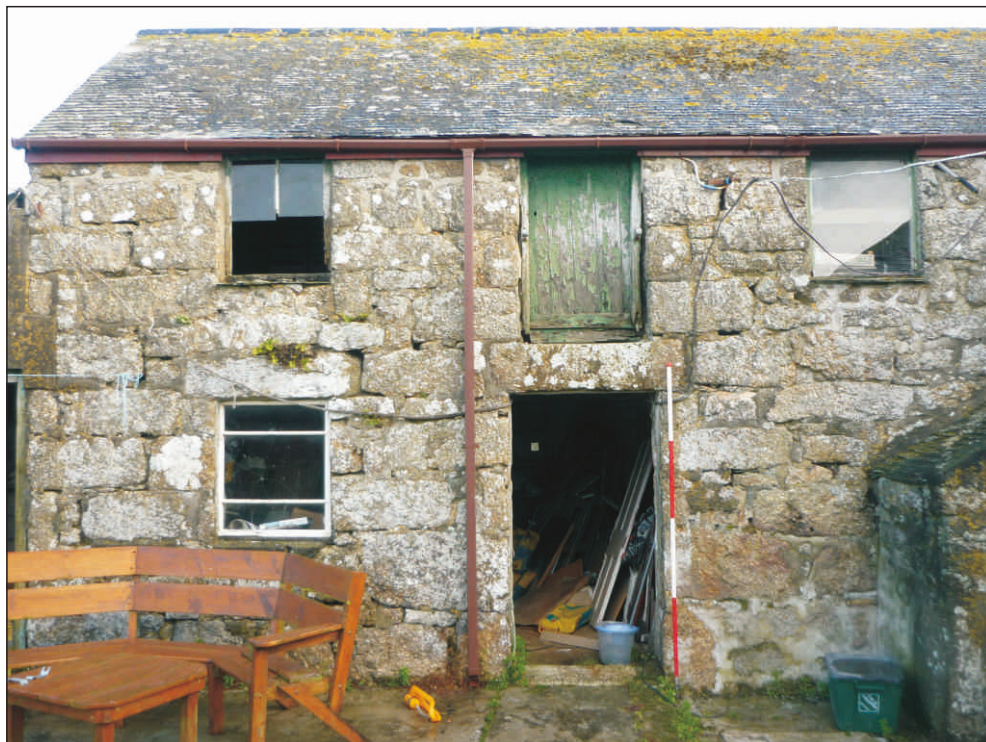
Pl. 2 South elevation, showing the building prior to conversion. 2m scale. Looking north-east.

The south elevation is constructed mostly of fair-faced roughly dressed granite with dressed granite lintels. The centrally-placed door on the ground floor had a substantial dressed granite lintel. Both the frame and door itself had been removed.

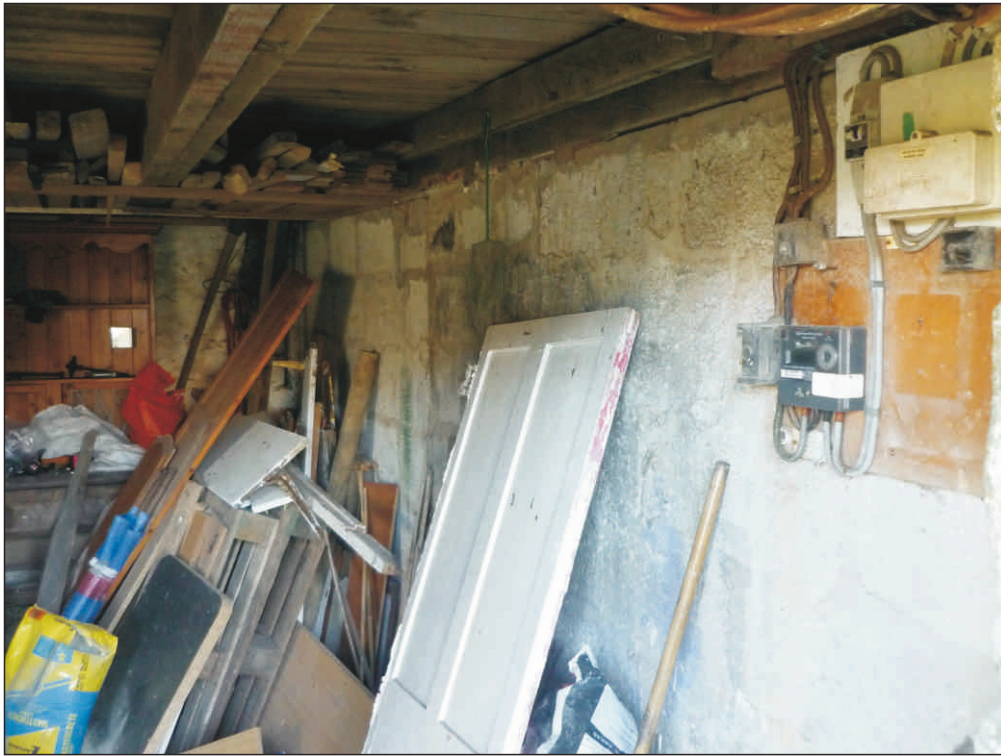
Pl. 3 Ground floor, interior view at south-east end, showing modern block partition. Looking north-east.

The door opened into a large rectangular space. This was divided widthways by a full-height modern block partition immediately to the right of the doorway. The room was lit by a single window in the south wall. This appears to be a replacement and was timber-framed with three lights, a slate sill and a granite lintel above. Apart from this evidence the ground floor showed

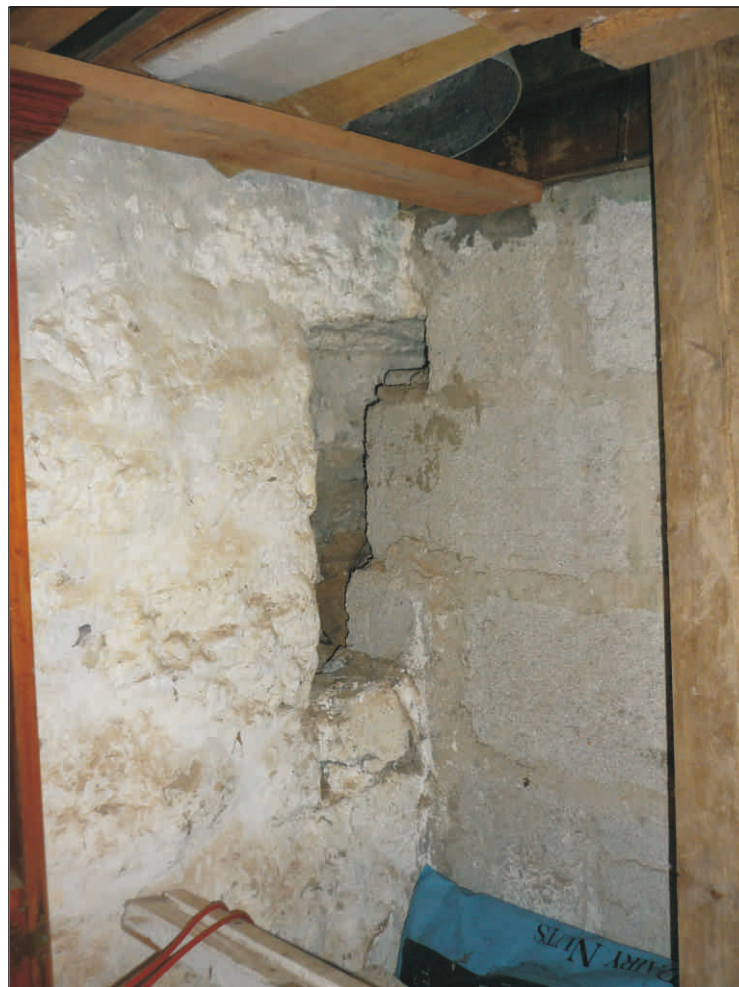
Pl. 4 Ground floor, interior view at south-east end, showing the shelf recess in the north wall. Looking north-east.

wall might suggest that at least part of the building was used to house livestock as they are commonly encountered in feeding passages of cowsheds or stables.

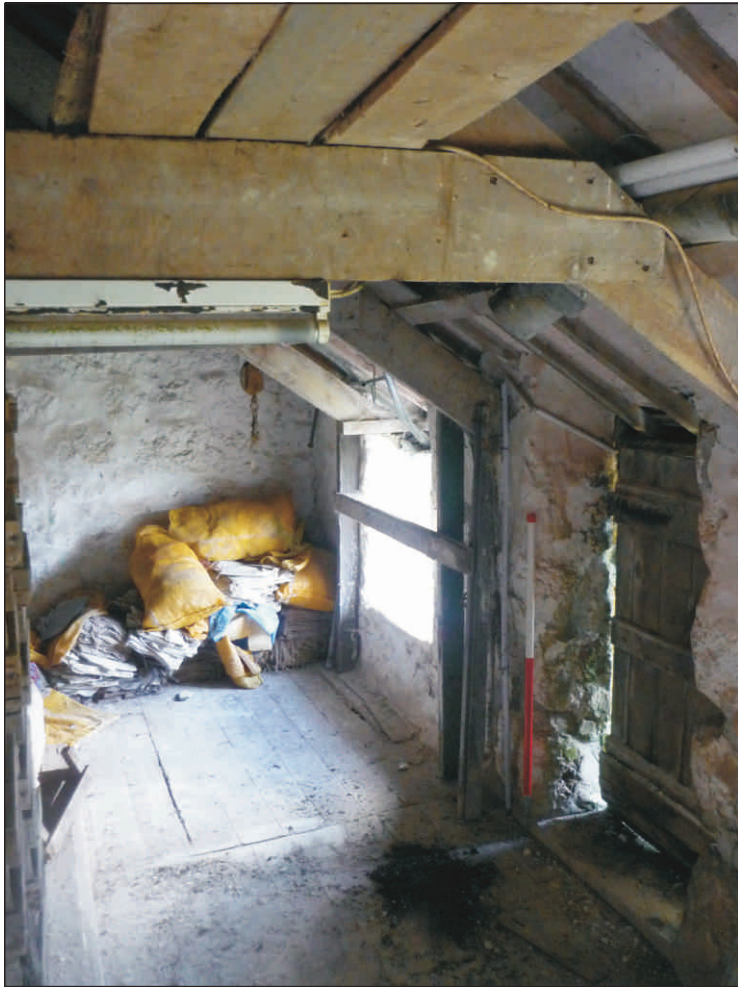
Pl. 5 First Floor, interior view at south-east end. 1m scale. Looking south-east.

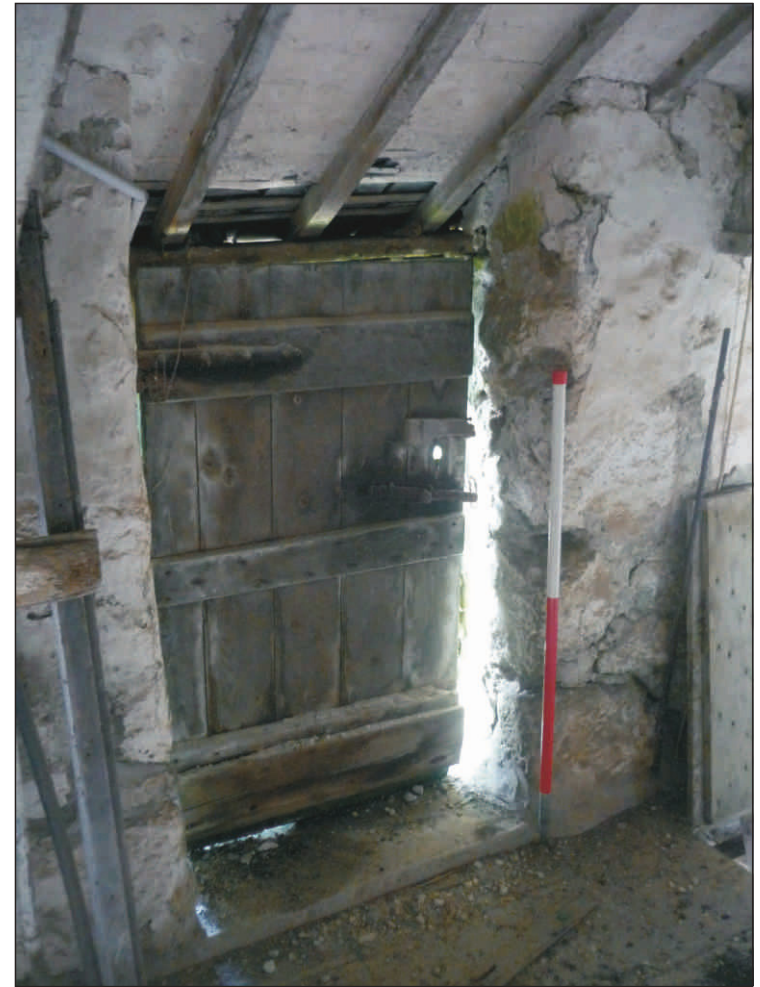
Pl. 6 First floor, interior view showing central loading doorway. 1m scale. Looking south-west.

A centrally-placed doorway was located in the south wall, consisting of a simple wooden frame and battened door. This was a loading doorway and was hung using what are probably the original strap and pintle hinges, the straps being affixed with additional bolts. Although a large number of wooden boxes were being stored on this level it was clear that the original wooden floor had been replaced in modern times, a distinct break being visible in line with the block partition. The remainder of the floor is likely to be late 19th century in date. In the south-east corner a clear building break was visible on the inside of the south wall (Pl. 14), showing it clearly abutting the earlier wall of the farmhouse extension.

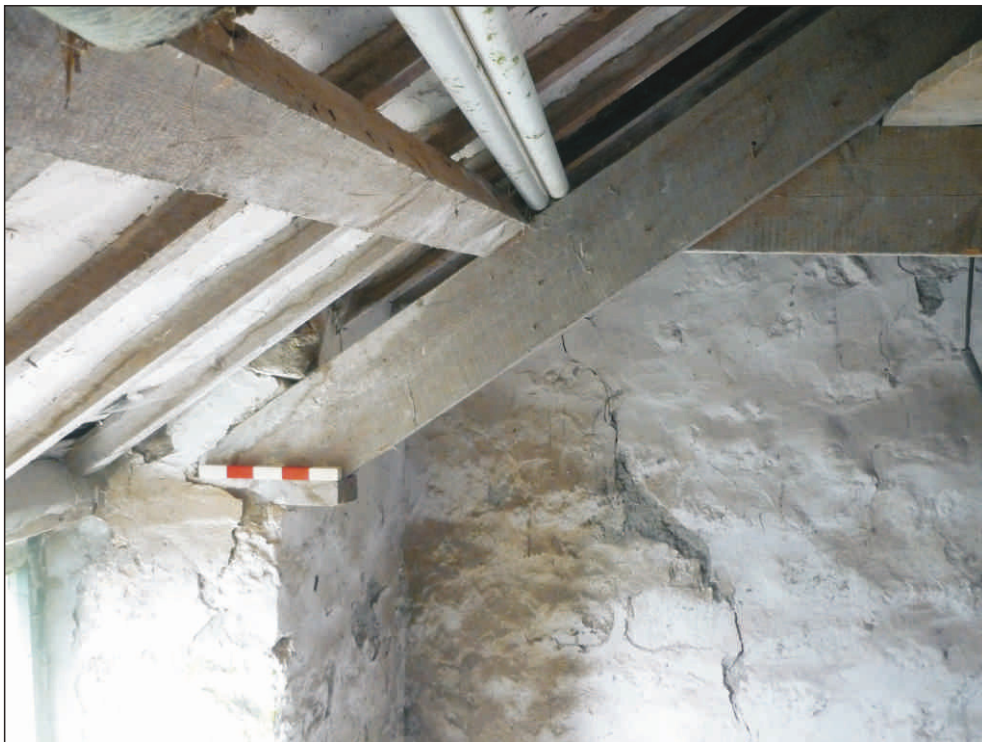
Pl. 7 First floor, interior view at north-west end showing typical sole plate and principal rafter. 0.25m scale. Looking west.

A pitched roof of slates was supported by four simple, collared trusses, half-lapped and bolted just below the apex. The collar pieces were also nailed but not lapped. The ends of the trusses were tied to the wall with sole plates, while the trusses rested on a wall plate. A number of collar pieces contained names and dates. On the second collar were the surnames Prowse and Wallis with the date (?) 1888, while the third collar had the date (?) of 1898.

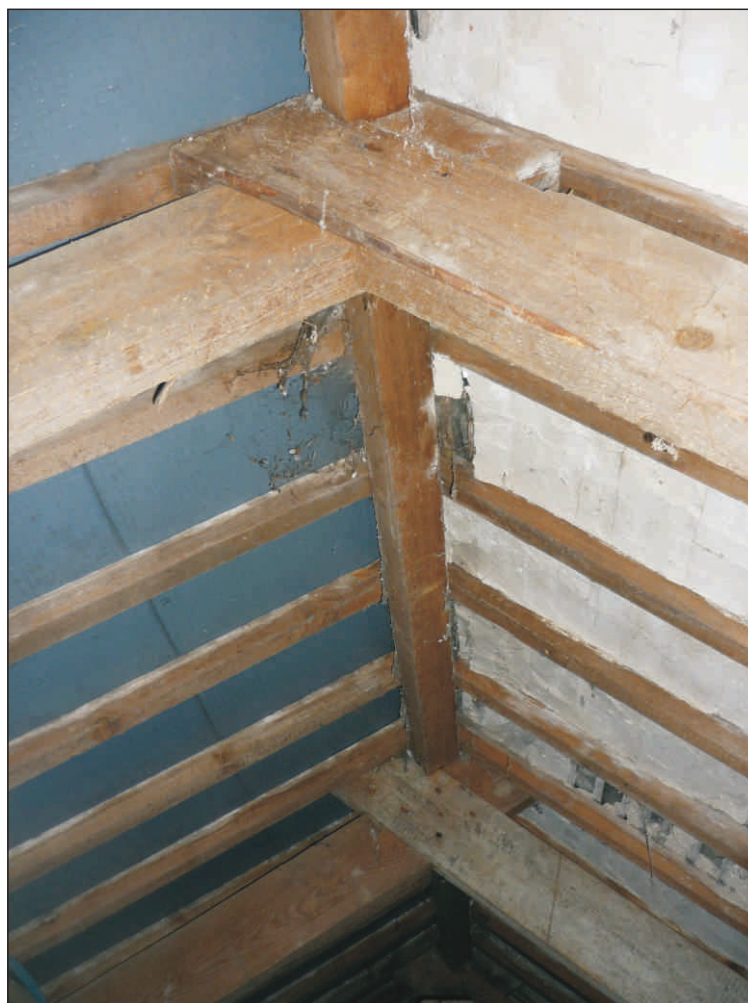
Pl. 8 First floor, interior view showing halved lap joint rafters, with modern roof on left and the late 19th century roof on right. Looking south-east.

The roof consists of original grouted scantle slate roofing on the south side, and modern Spanish slate on the north side. The ridge tiles were also modern. At the west end the gable was sealed by waney-edged weatherboarding, reflecting the modern and original roofing material. The roof of the farmhouse extension and the building ran through, suggesting that the entire roof was relayed following the construction of the later extension.

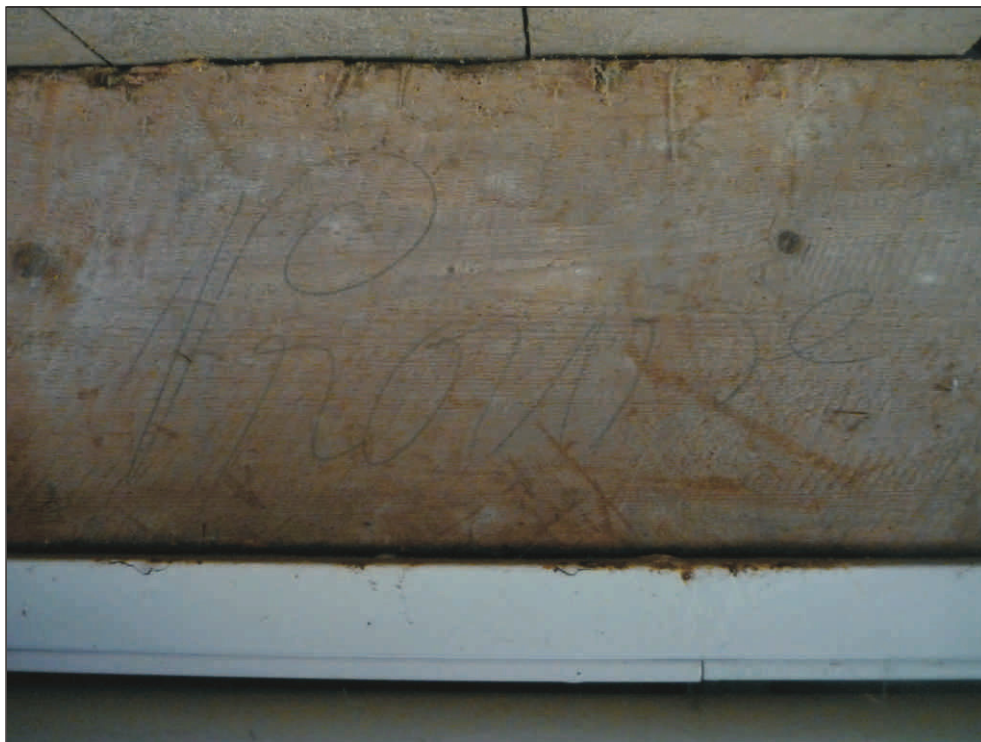
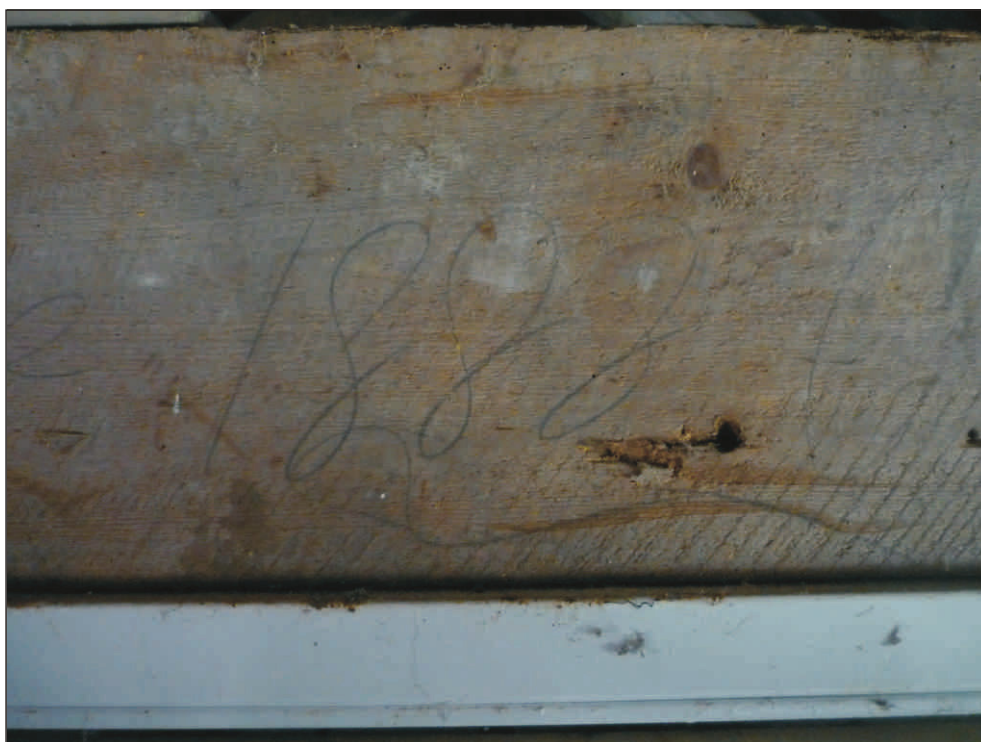
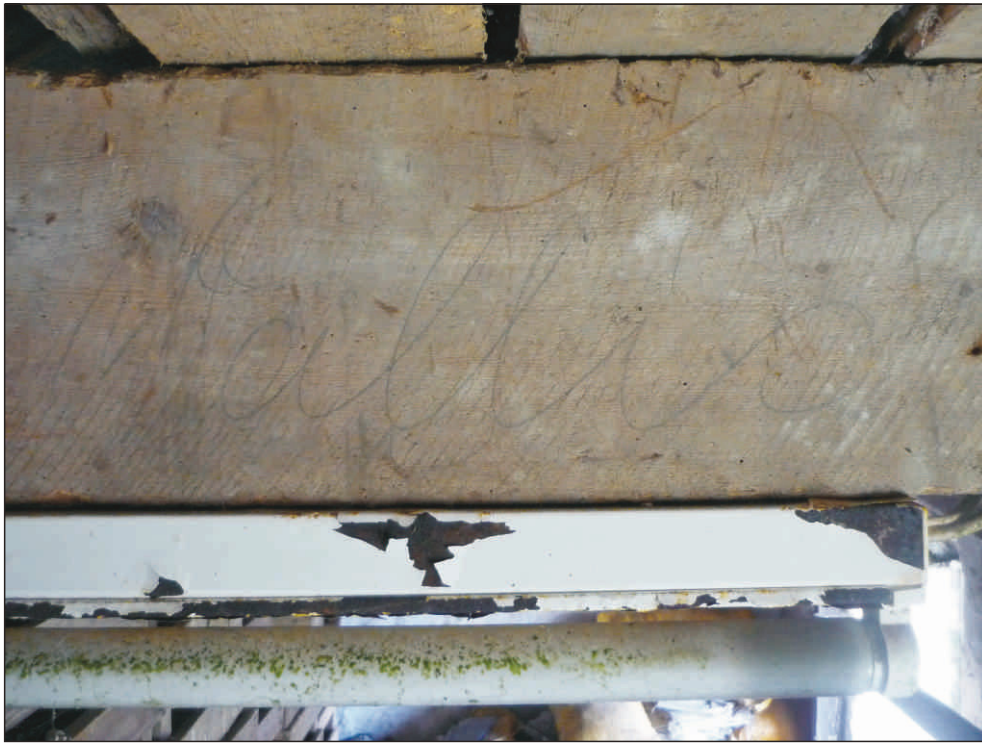
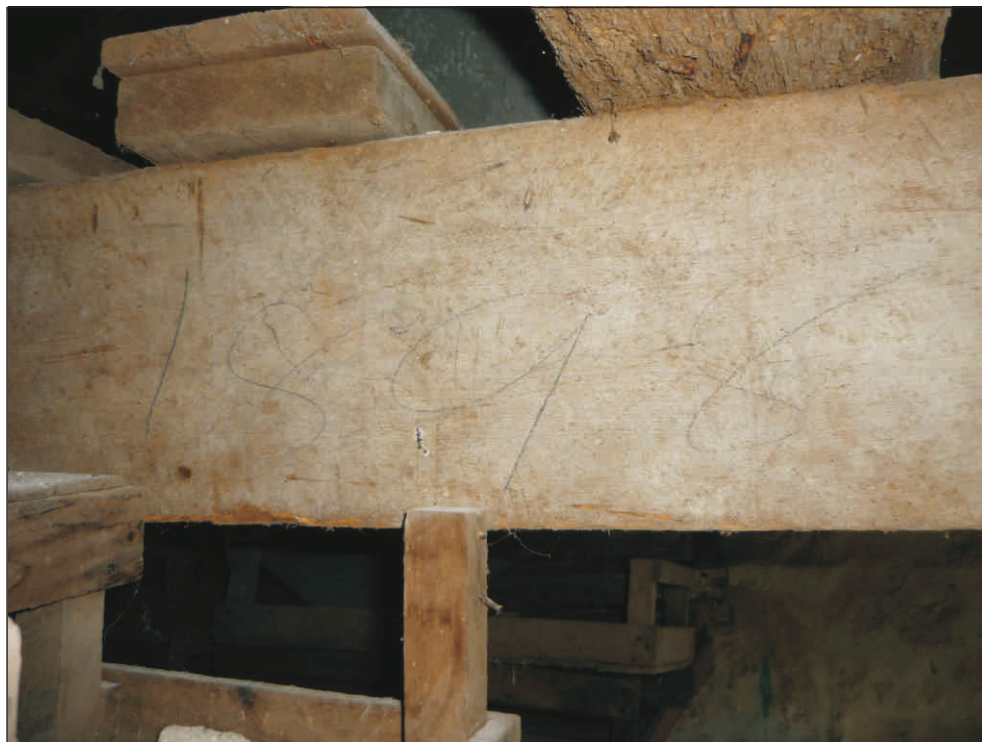
Pl. 9 Roof timbers, interior view showing detail of writing (Prowse?) on applied collar. Looking south-east.

Pl. 10 Roof timbers, interior view showing detail of writing (1888?) on applied collar. Looking south-east.

Pl. 11 Roof timbers, interior view showing detail of writing (Wallis?) on applied collar. Looking south-east.

Pl. 12 Roof timbers, interior view showing detail of writing (1898?) on applied collar. Looking south-east.

By the second half of the 19th century a further building had been attached to the north end of the farmhouse extension. It is unclear whether the dates (?) on the roof trusses indicate a date for the construction of the building. While the first floor has always been used for crop storage, there was little left to suggest the function of the ground floor. Following the expansion of cattle husbandry on the farm in the mid-late 19th century and the construction of a barn, stable and cart shed to the south of the farmhouse, the function of the ground floor may have been for the storage of farm implements.

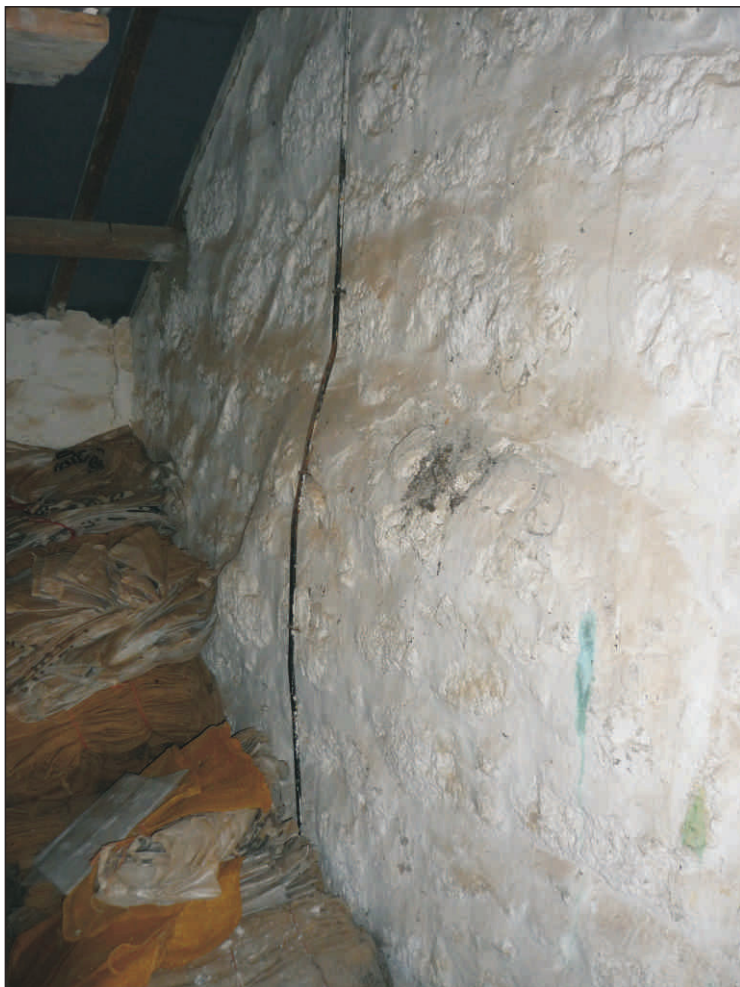
Pl. 13 First floor, interior view at south-east end showing north wall of farmhouse extension with chimney flue. Looking east.

At some stage prior to the 1876-1901 OS map (Fig. 3) the western farmhouse was extended and a wing added. The extension re-used some of the earlier foundations (Fig. 6), although a clear building break in both the southern and northern elevations would suggest that at least some of the earlier building remained standing beyond the farmhouse extension. The north-west wall of the extension was not visible on the ground floor, being hidden behind a modern block wall, while the remains on the first floor suggest that a chimney flue and stack (Pl. 13) was originally located at this end.

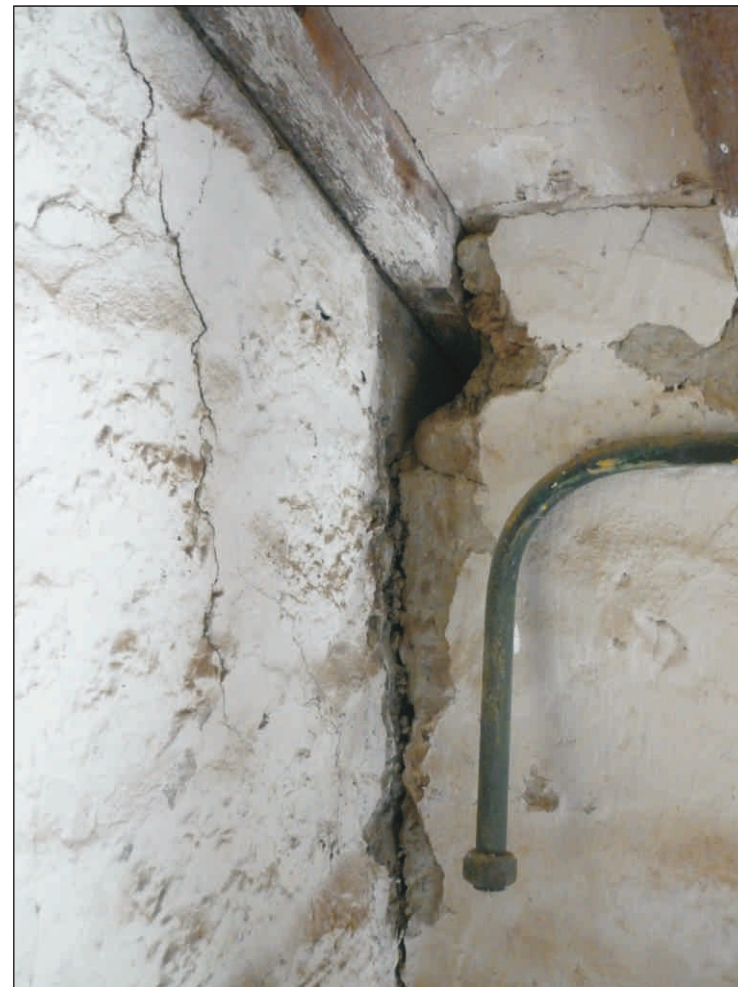
Pl. 14 First floor, interior view at south-east end showing later building fabric abutting north wall of farmhouse extension. Looking south-east.
