**Archaeological excavation at St Michael the
Archangel Church, Trusham,
Devon**

Report No. 14-02

June 2014

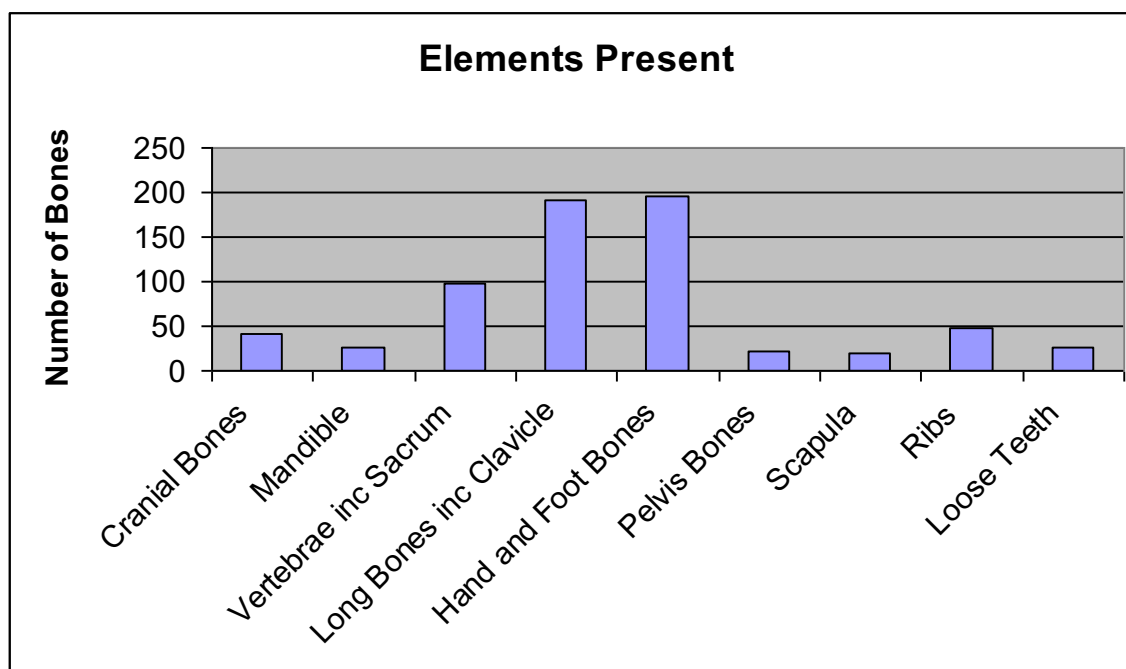
Fig 1. Groups of Elements Present.

Long bones and hand and foot bones make up the vast majority of the assemblage with vertebrae with the third highest count. The lowest group is scapula this is probably due to survival as this element is particularly fragile.

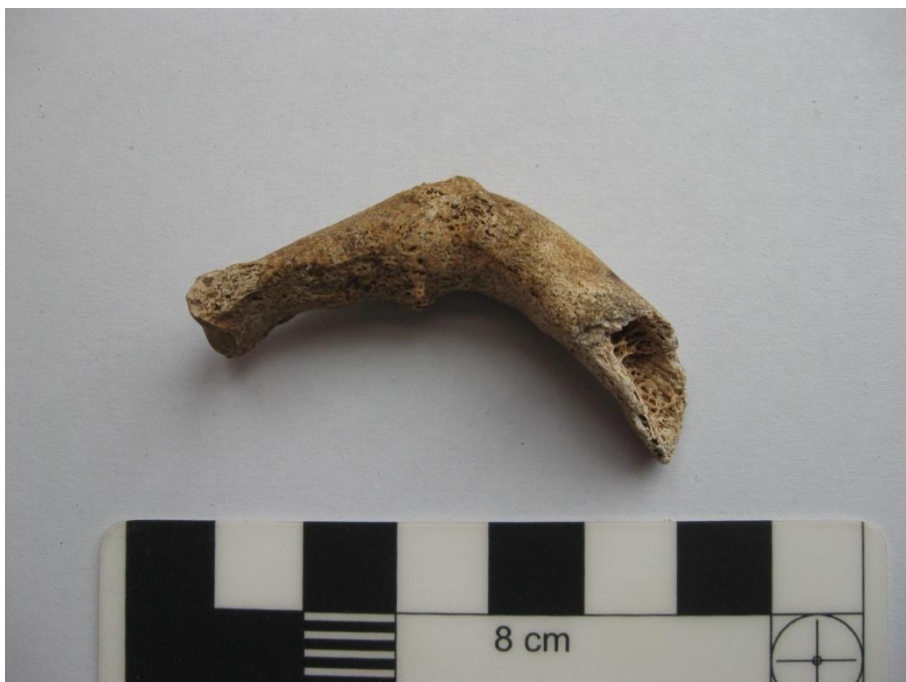
Two hand phalanges were identified as being fused together (plate 1), these are a proximal and an intermediate phalanx. The joint surfaces of both bones have been completely fused, while the metaphyses are unaffected. This was possibly caused by traumatic arthritis (development of arthritis after trauma) or rheumatoid arthritis (an inflammatory disease of the synovial joints and connective tissue, possibly caused by an autoimmune response) (Aufderheide and Rodriguez-Martin, 2005). However it is not possible to determine which as the elements are disarticulated.

Plate 1. Fused proximal and intermediate hand phalanges, possibly caused by fusion after trauma.

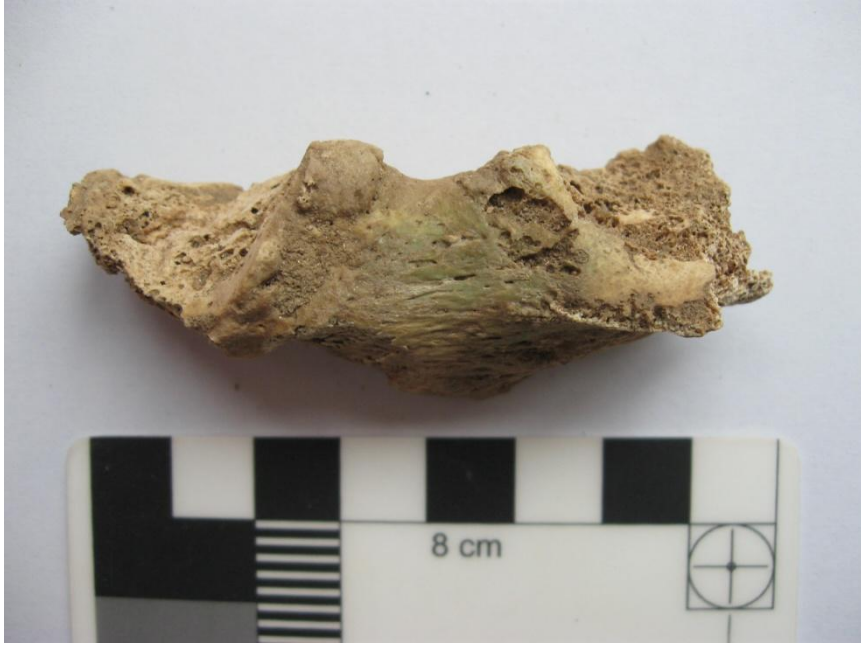
Two of the recorded bones show signs of Osteoarthritis (non-inflammatory neuromechanical condition). This was diagnosed only when eburnation is present (a polishing of the bone, where two bones rub together) and/or at least both pitting and osteophytes are present (extra bone formation near the joint surface, which is the bodies attempt to spread the weight at that joint). In this assemblage a superior portion of a sternum (where it articulates with both clavicles) had severe osteoarthritic changes (plate 2), including extensive pitting, joint remodeling, osteophytic growth and eburnation. One rib also had slight osteoarthritic changes present on the tubercle.

Plate 2. Severe Osteoarthritis of the superior sternum with pitting and eburnation.

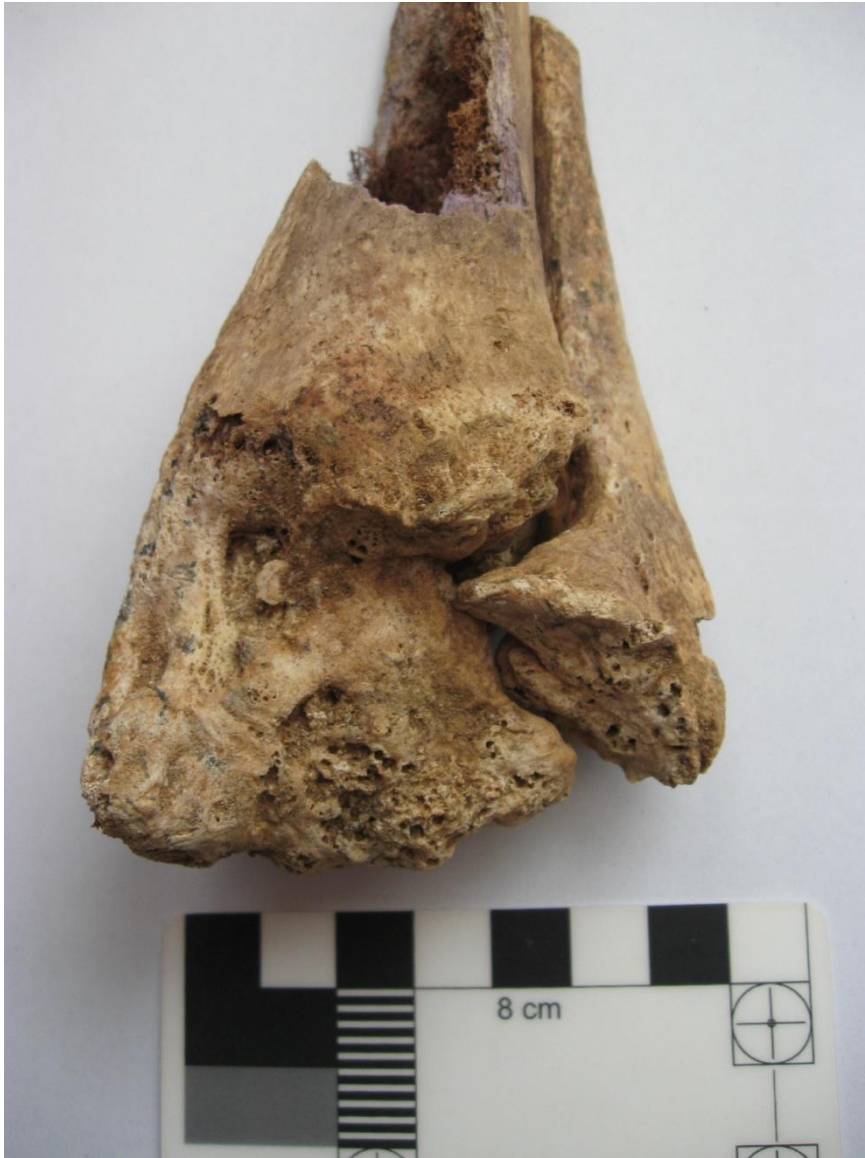
but the joint surface has reshaped substantially and is also pitted. Neither the metaphysis of the tibia or fibula appear to be affected. This fusion of the joint would have affected mobility and appears to have been active at the time of death. This was possibly caused by rheumatoid arthritis or psoriatic arthritis, a systematic disease with unknown cause, with symptoms similar to that of rheumatoid arthritis. (Aufderheide and Rodriguez-Martin, 2005).

Plate 3. Posterior view of a distal tibia and fibula with possible rheumatoid arthritis.

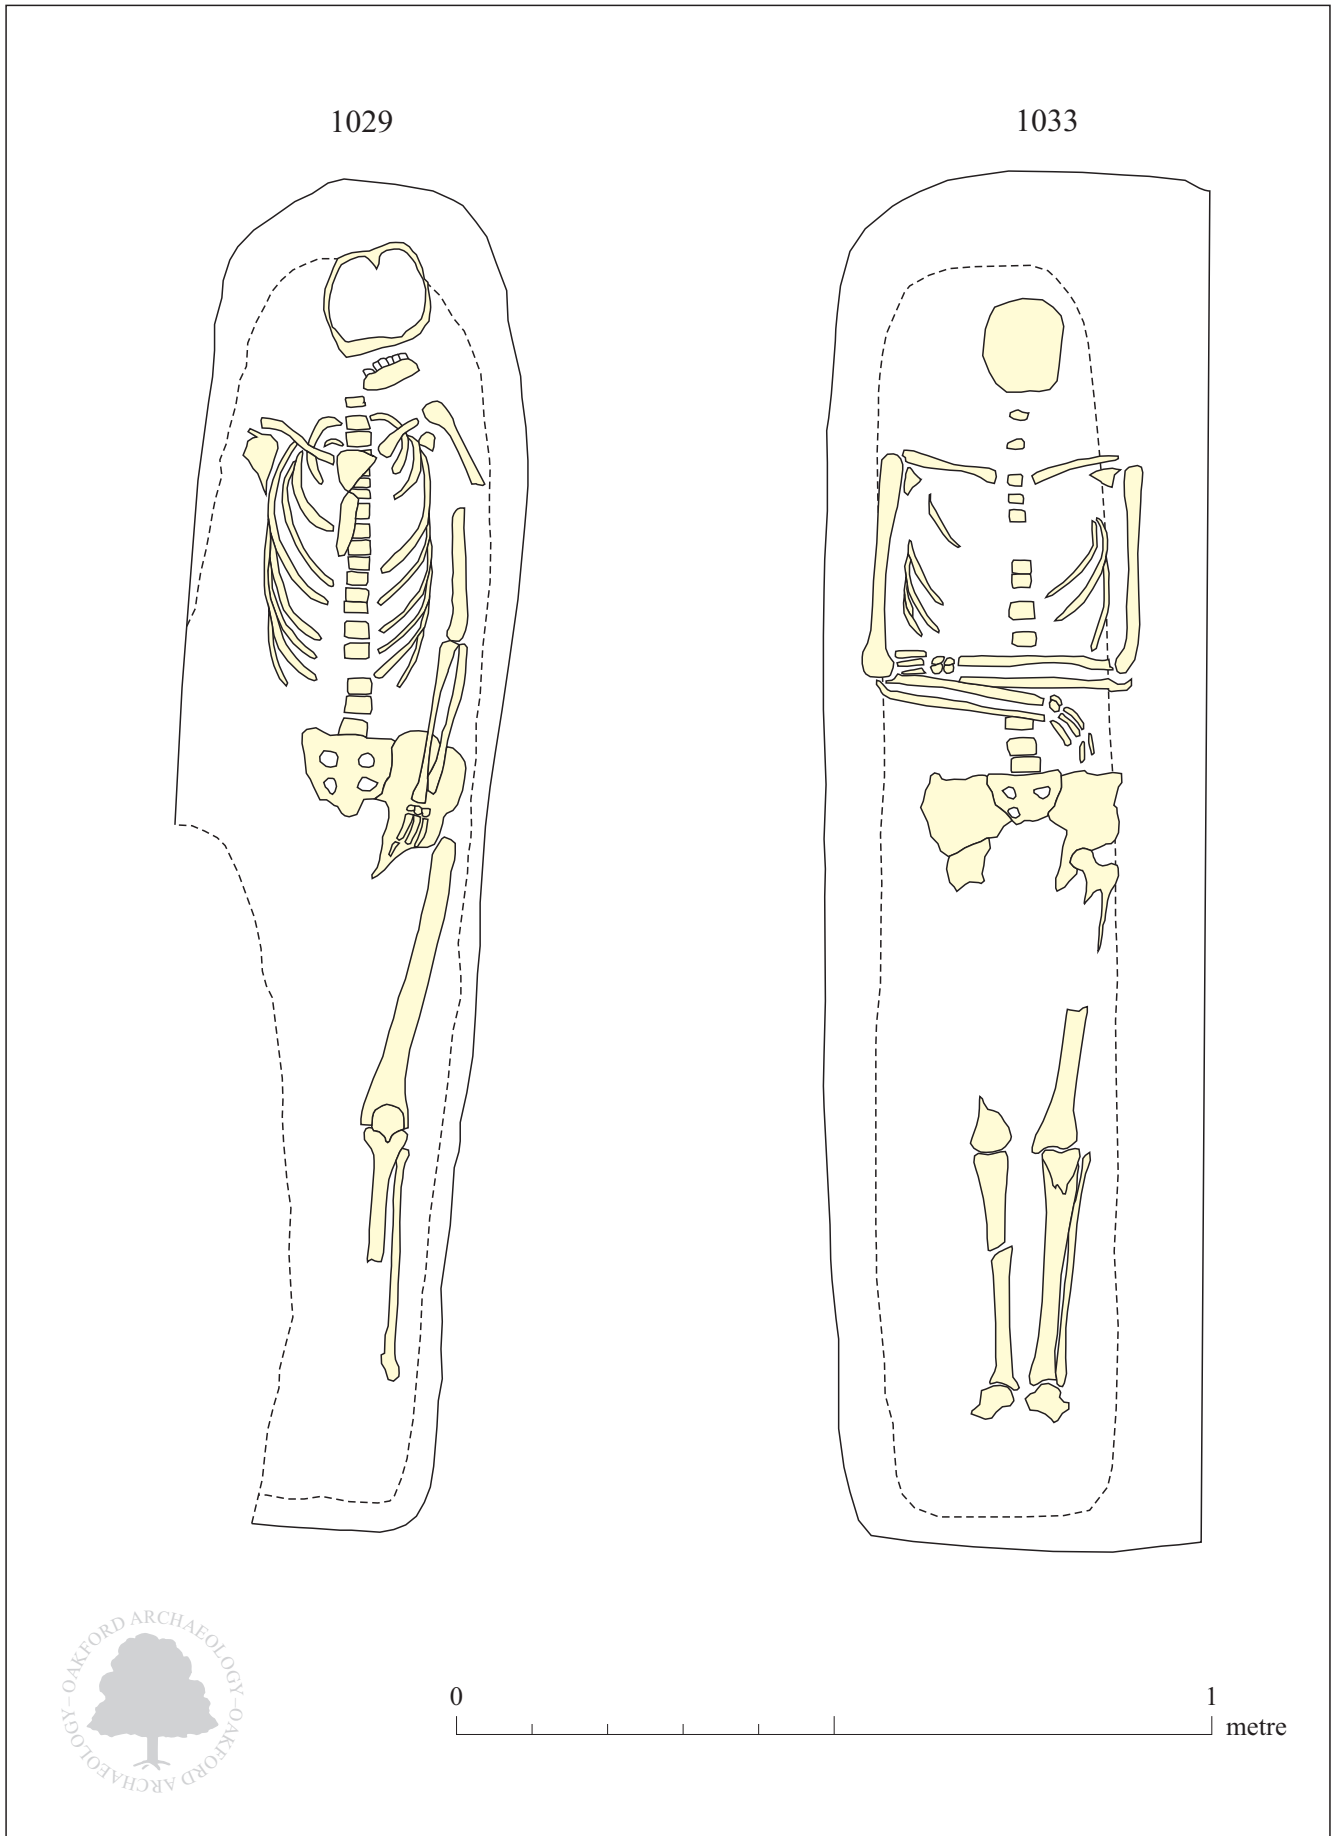
Fig. 5 North aisle: skeletons 1029 and 1033.

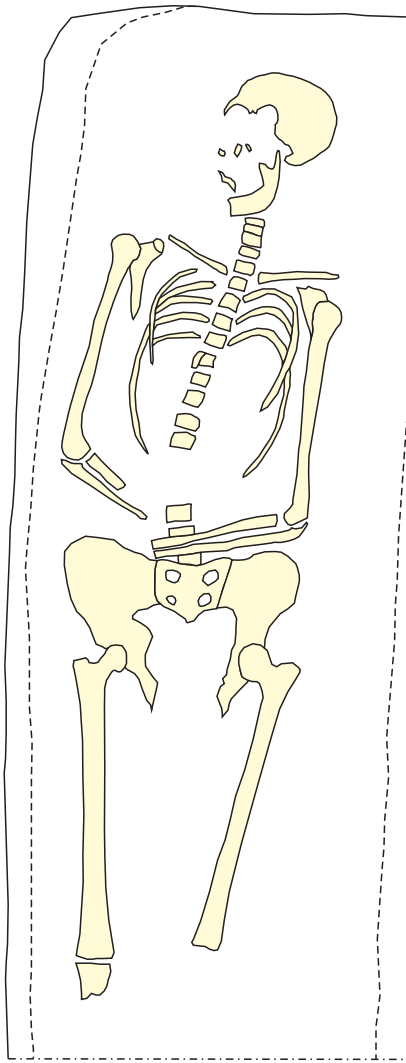
Fig. 6 North aisle: skeletons 1036 and 1039.

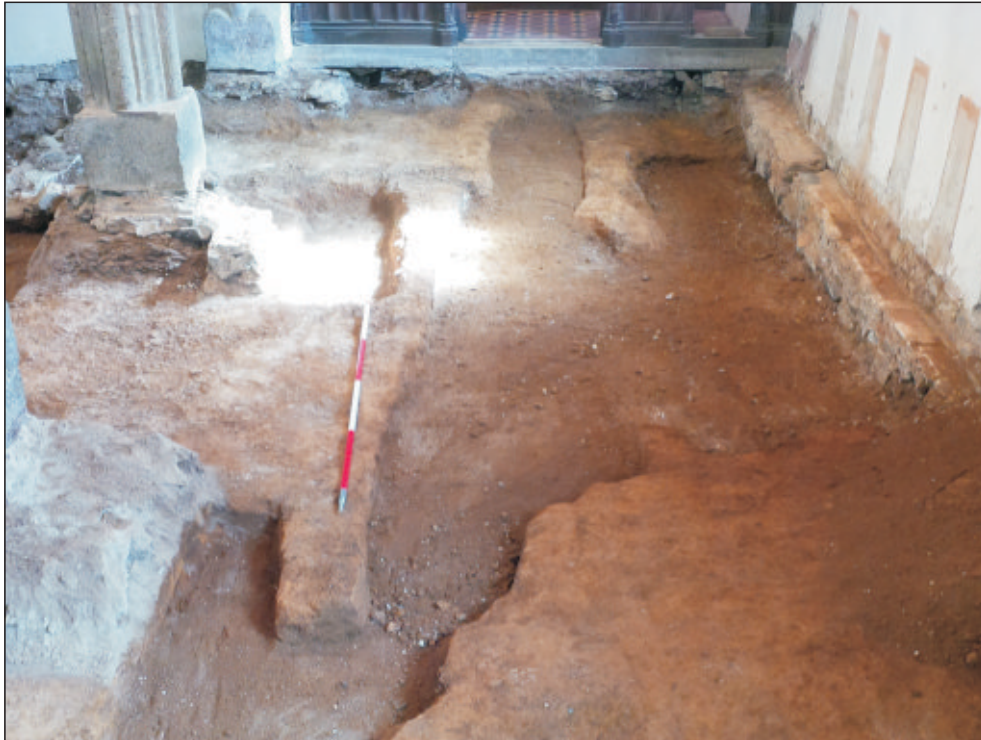
Pl. 1 General view of nave showing extent of burials. 2m scale. Looking east.

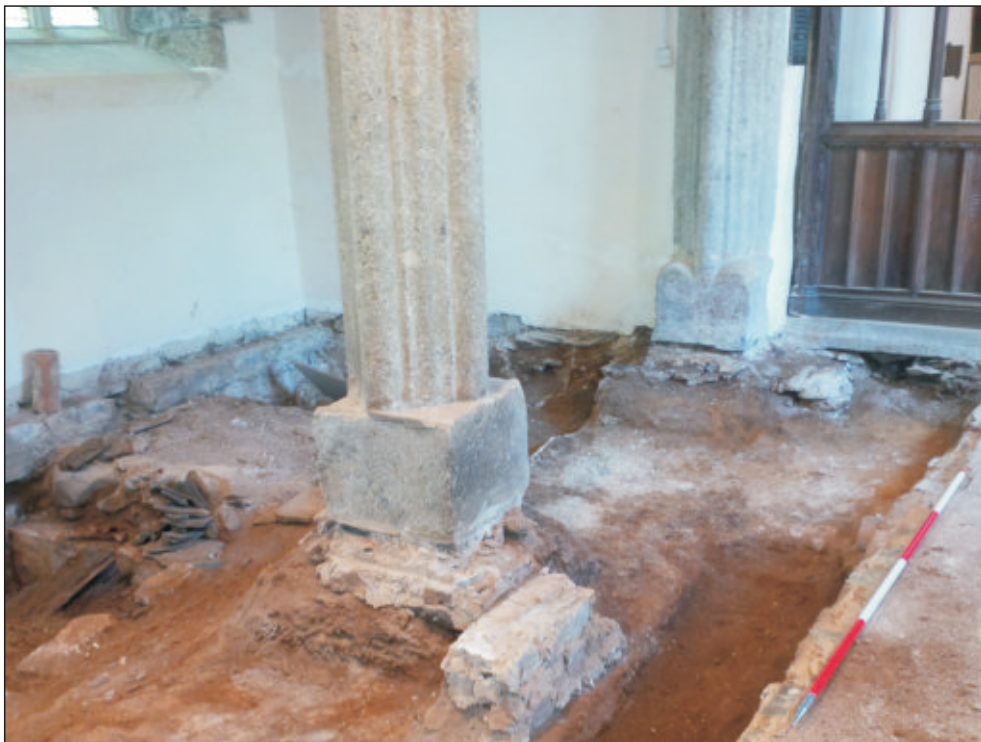
Pl. 2 General view of north aisle and arcade foundations. 2m scale. Looking northeast.

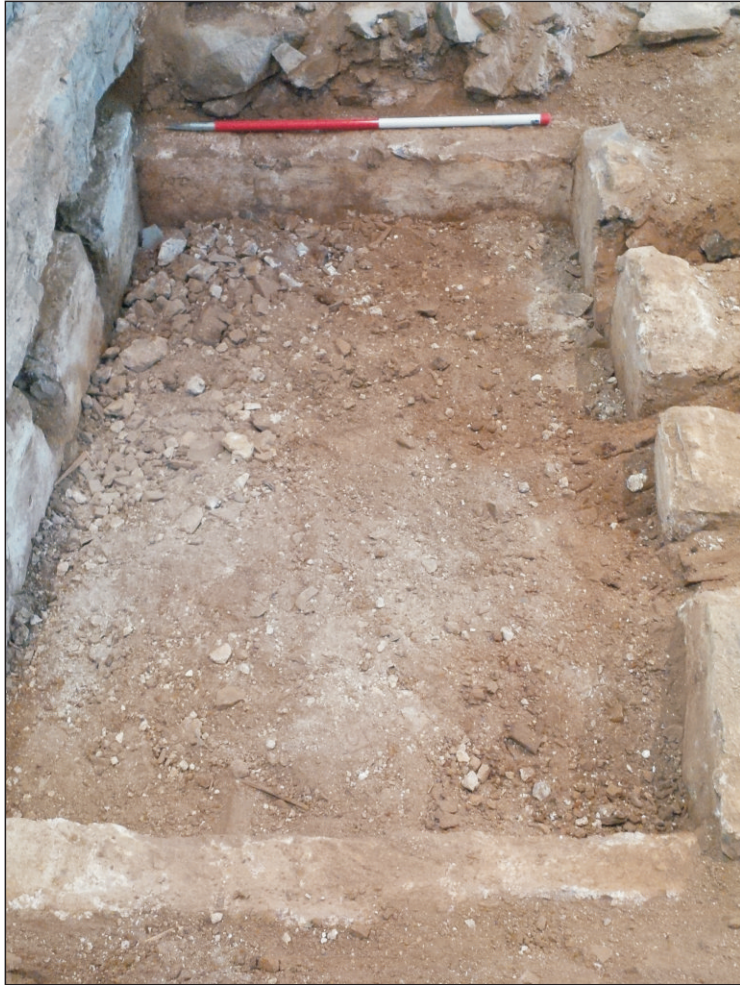
Two stone built subterranean funerary vaults (1046 and 1050) were exposed at the east end of the north aisle. Both vaults were approximately 1.49m deep, and both had been completely filled with loose soil, stones, fragments of hand-made brick, roof slates, mortar and blocks of local stone. This fill was almost certainly spoil excavated from the church floor when the church interior was reordered in the 19th century. The ledger stones were probably removed at this time and no evidence was uncovered for wooden or lead-lined coffins. However, the remains of at least one individual were partly exposed at the bottom of each vault, suggesting that these were not completely cleared and some of the deceased were left *in situ*.

eastern end, and neither vault had access steps leading into the chamber. The eastern vault (1046) had a ragged rear face which indicates that it was once constructed against an earth face; it is now integrated into the wall of vault 1050. The well-constructed coursed stone walls of both vaults had level wall-tops each with a thin lime mortar capping. The western vault (1050) had six large sockets built into the walls tops, three on the each of the long sides. These sockets would have held timbers supporting the ledger stones; fragments of decaying wood were recorded in some of the sockets, and three substantial timbers subsequently collapsed into the filled vault. Partial excavation revealed that both vaults had been lime washed. A small pile of disarticulated human skeletal material was found in the southeast corner of vault 1050: it appears to have been a charnel dump perhaps associated with burials disturbed during the re-ordering of the church in the 19th century. There were no wall plaques above either vault nor were there ledger slabs set in the nave floor above to indentify the occupants or the dates of the vaults.

Pl. 3 North aisle: Vault 1050. 1m scale. Looking east.

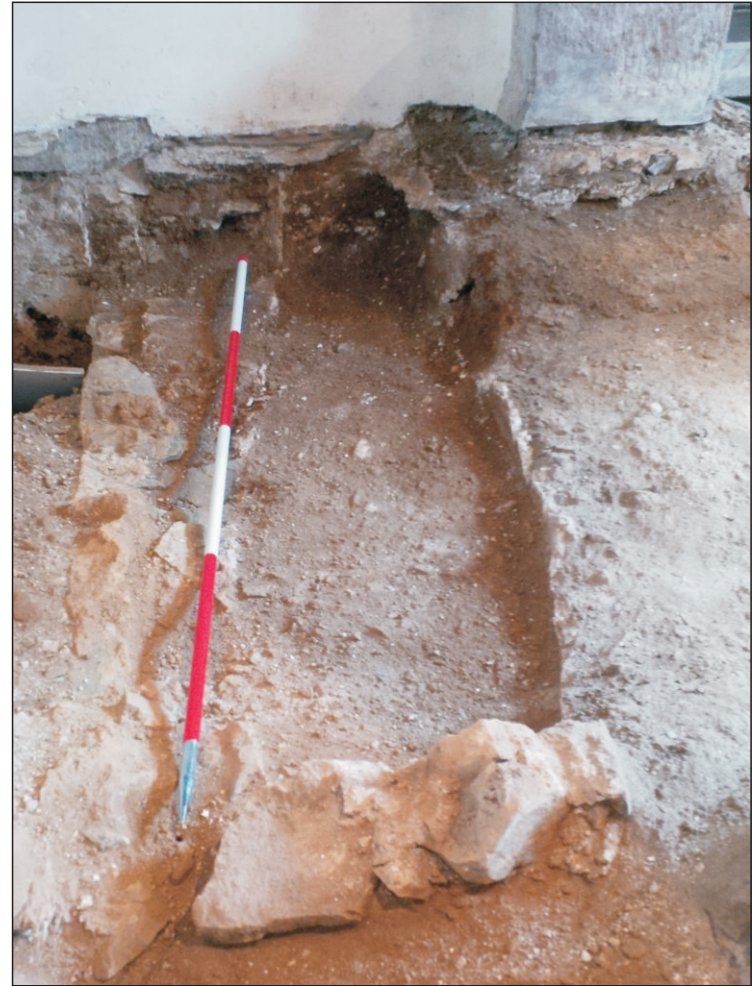
Pl. 4 North aisle: Mortar lined grave 1041. 2m scale. Looking east.

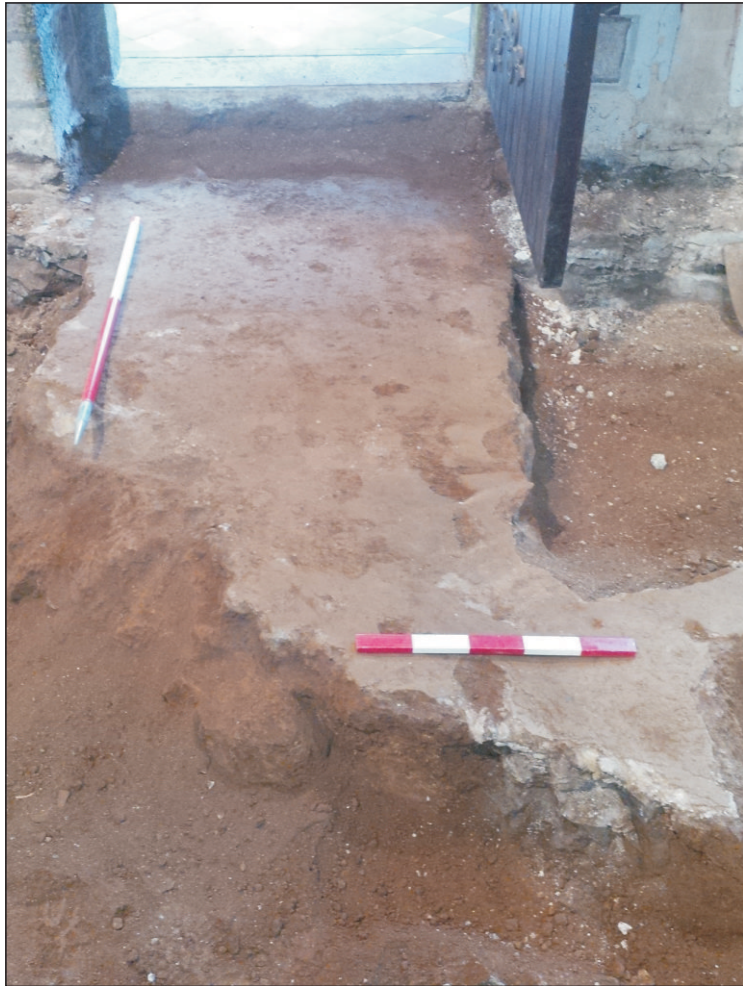
Pl. 9 Nave: General view of earth-floor (1080). 0.5m and 1m scale. Looking south.

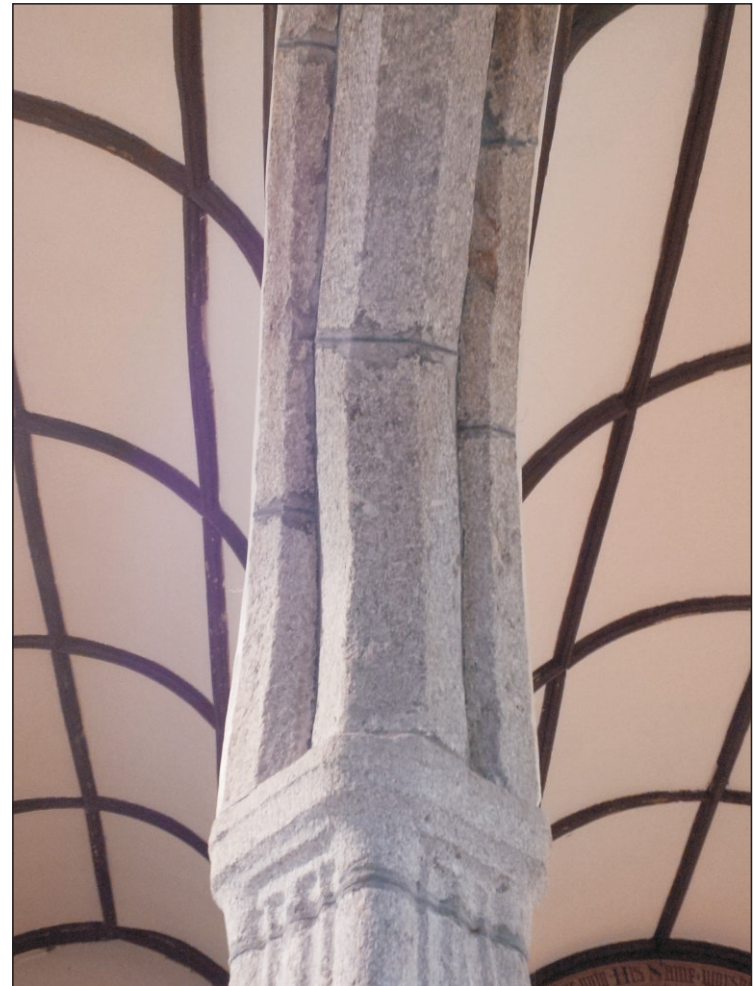
Pl. 10 Arcade: Close-up of west bay arch. Looking east.

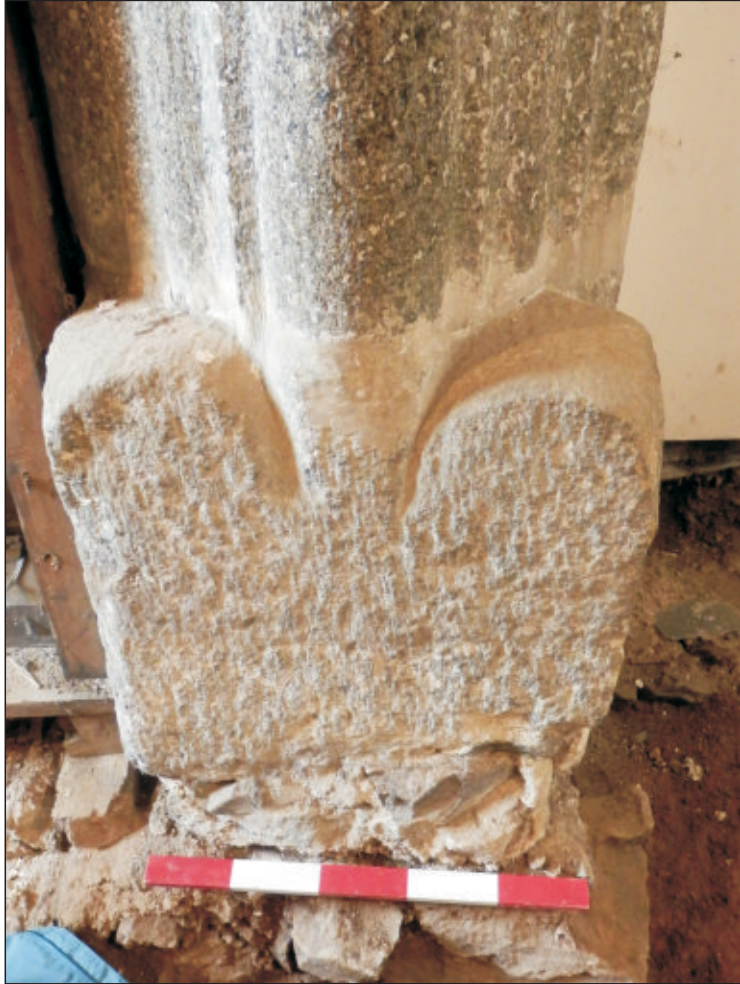
Pl. 11 Arcade: Close-up of western pillar base and foundation. 0.5m scale. Looking west.

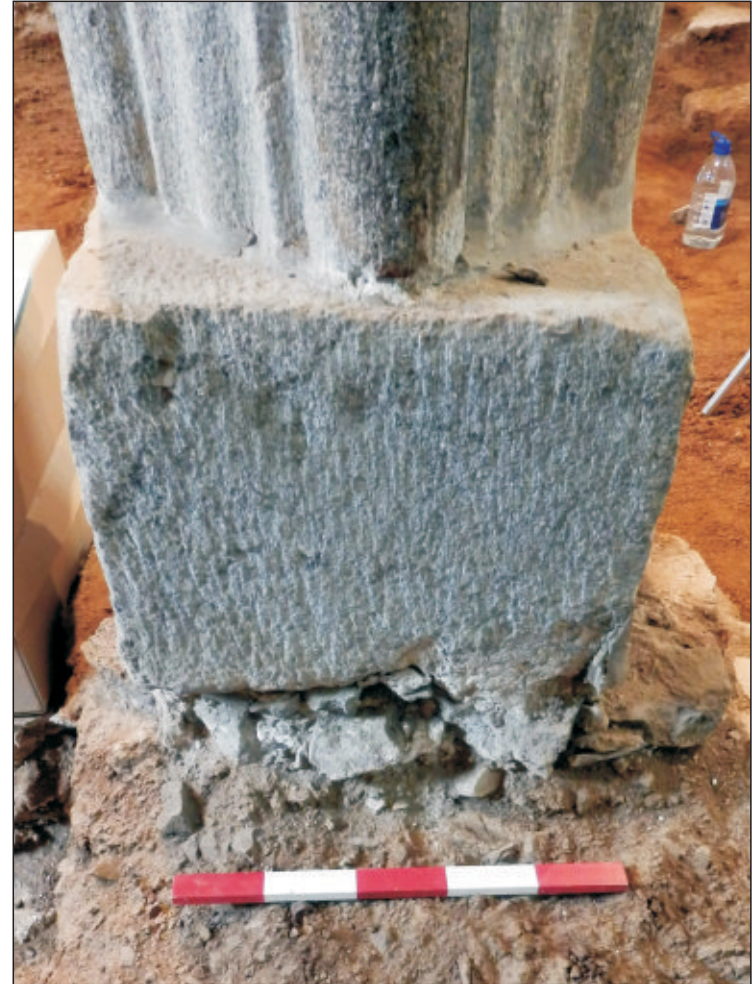
Pl. 12 Arcade: Close-up of central pillar base and foundation. 0.5m scale. Looking west.

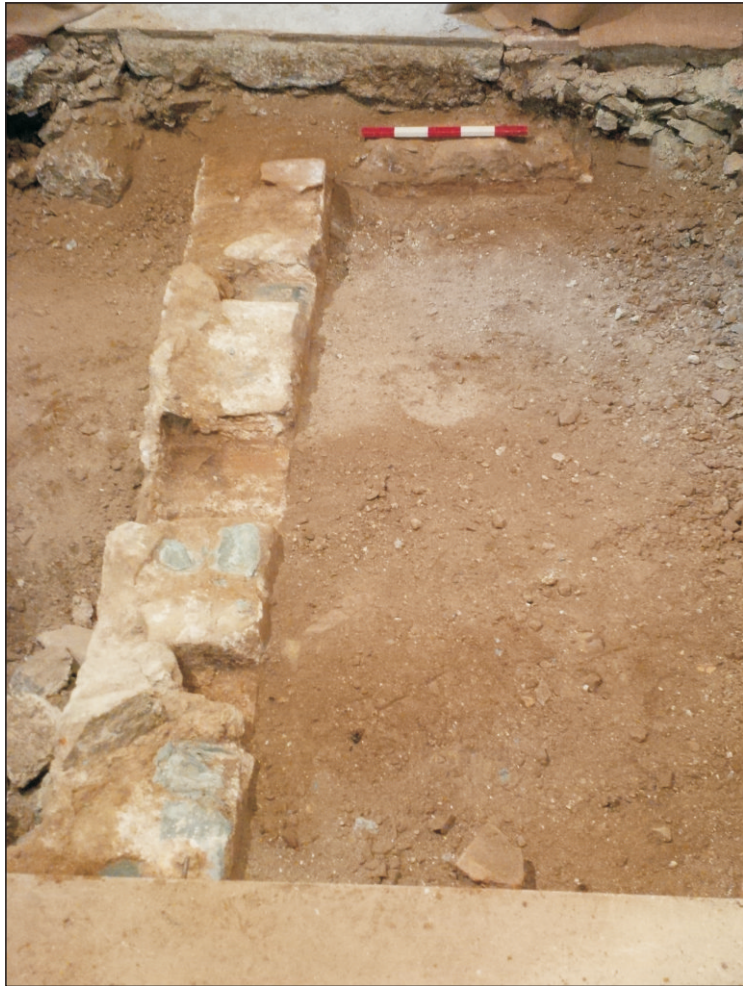
Two stone vaults (1054) occupied the western part of the chancel. The north wall of the northern vault, which lay directly under the north wall of the chancel, had three large sockets built into the top, while the south wall had three corresponding sockets. These sockets would have held timbers supporting the ledger stones. The south vault was similar in size to the northern vault and its south wall lay more or less completely under the south chancel wall. Both vaults were filled with spoil – mostly loose earth and rubble. The vault walls and the internal level were reduced to the new formation level.

Pl. 13 Chancel: Vault 1054. 0.5m scale. Looking east.

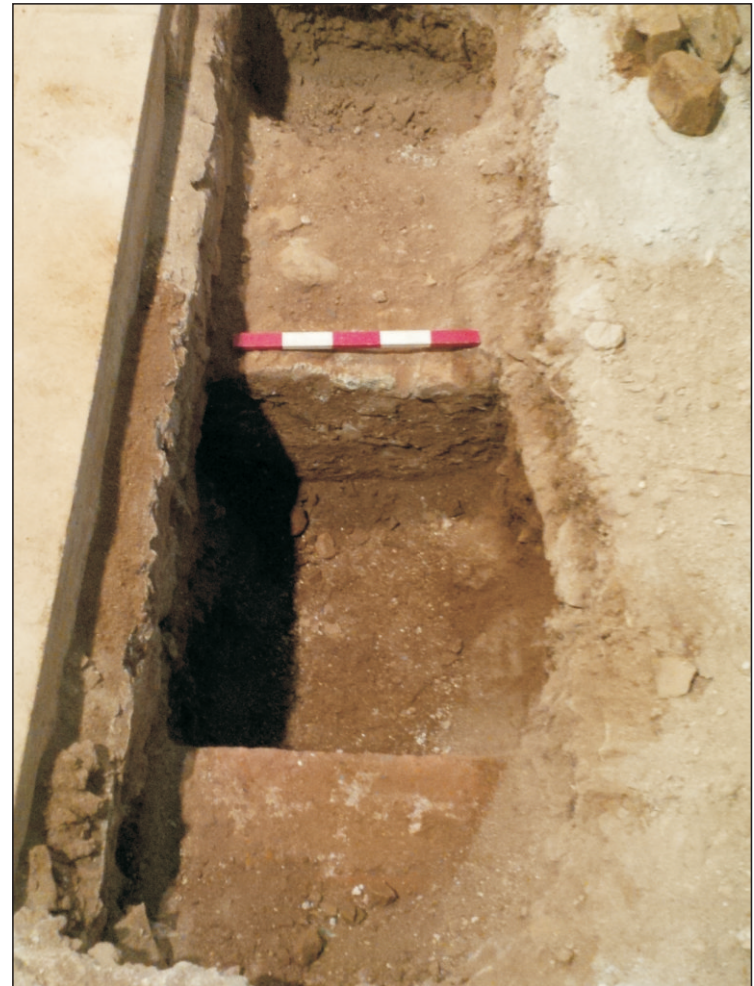
The upper floor was reduced by 0.62m to formation level except at the east end where a single 0.15m high altar step was introduced. Below this floor was a layer of demolition rubble of similar composition to the lower sub floor exposed elsewhere in the church. The reredos and east end side panels were supported by a low wall of poor quality mortared rubble stone. The demolition rubble was cleared from the chancel. The two chancel steps were found to lie across a single earth grave and three vaults. Grave (1059) which lay in the northeast corner of the chancel was cut into natural subsoil and extended out from under the east wall of the chancel. This wall had no foundations. The ledger stone was removed in the 19th century when the interior of the church was reordered, and although the grave was not excavated the stone was most probably sited below the wall monument dated (1593?) which commemorates Hugh Staplehill of Bremell, who died in 1583. It was therefore possible that this was his grave.

Immediately to the south of grave 1059 was a stone-built vault (1057) which occupied the southeast corner of the chancel. It was filled with loose soil and rubble and was subsequently cleared to formation level. The east wall and the south wall of the vault lay directly under the corresponding chancel walls, and all the walls had been rendered with lime wash. A brick wall had been inserted in the vault, most probably to support the new floor when the roof of the vault was removed probably during the 19th century.

Pl. 14 Chancel: Vault 1057 and Grave 1059. 0.5m scale. Looking north.

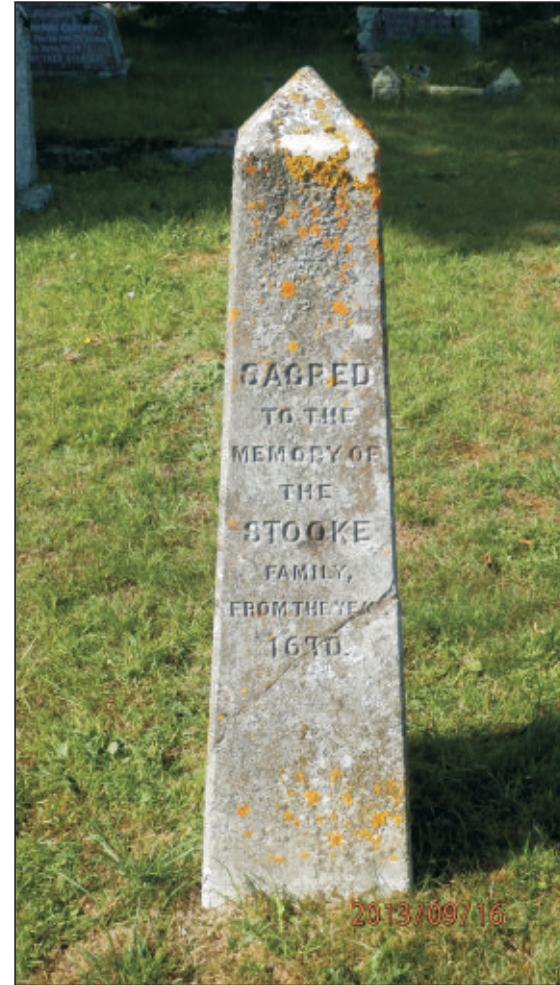
A small limestone obelisk, 1.12m high, is located to the west of the tower. It is inscribed 'Sacred to the memory of the Stooke family from the year 1670' and may mark a vault constructed for the Stooke family in the graveyard. A small chest tomb located near the south door is Grade 2 listed. It has squared, dressed granite sides and a freestone lid which is broken into a number of pieces. It is inscribed to the memory of John James Bullson Bremble and dates to 170[...].

Pl. 20 Stooke family monument in churchyard. Looking west.
