**Archaeological monitoring at Wallon,
Drewsteignton,
Devon**

Report No. 14-06

July 2014

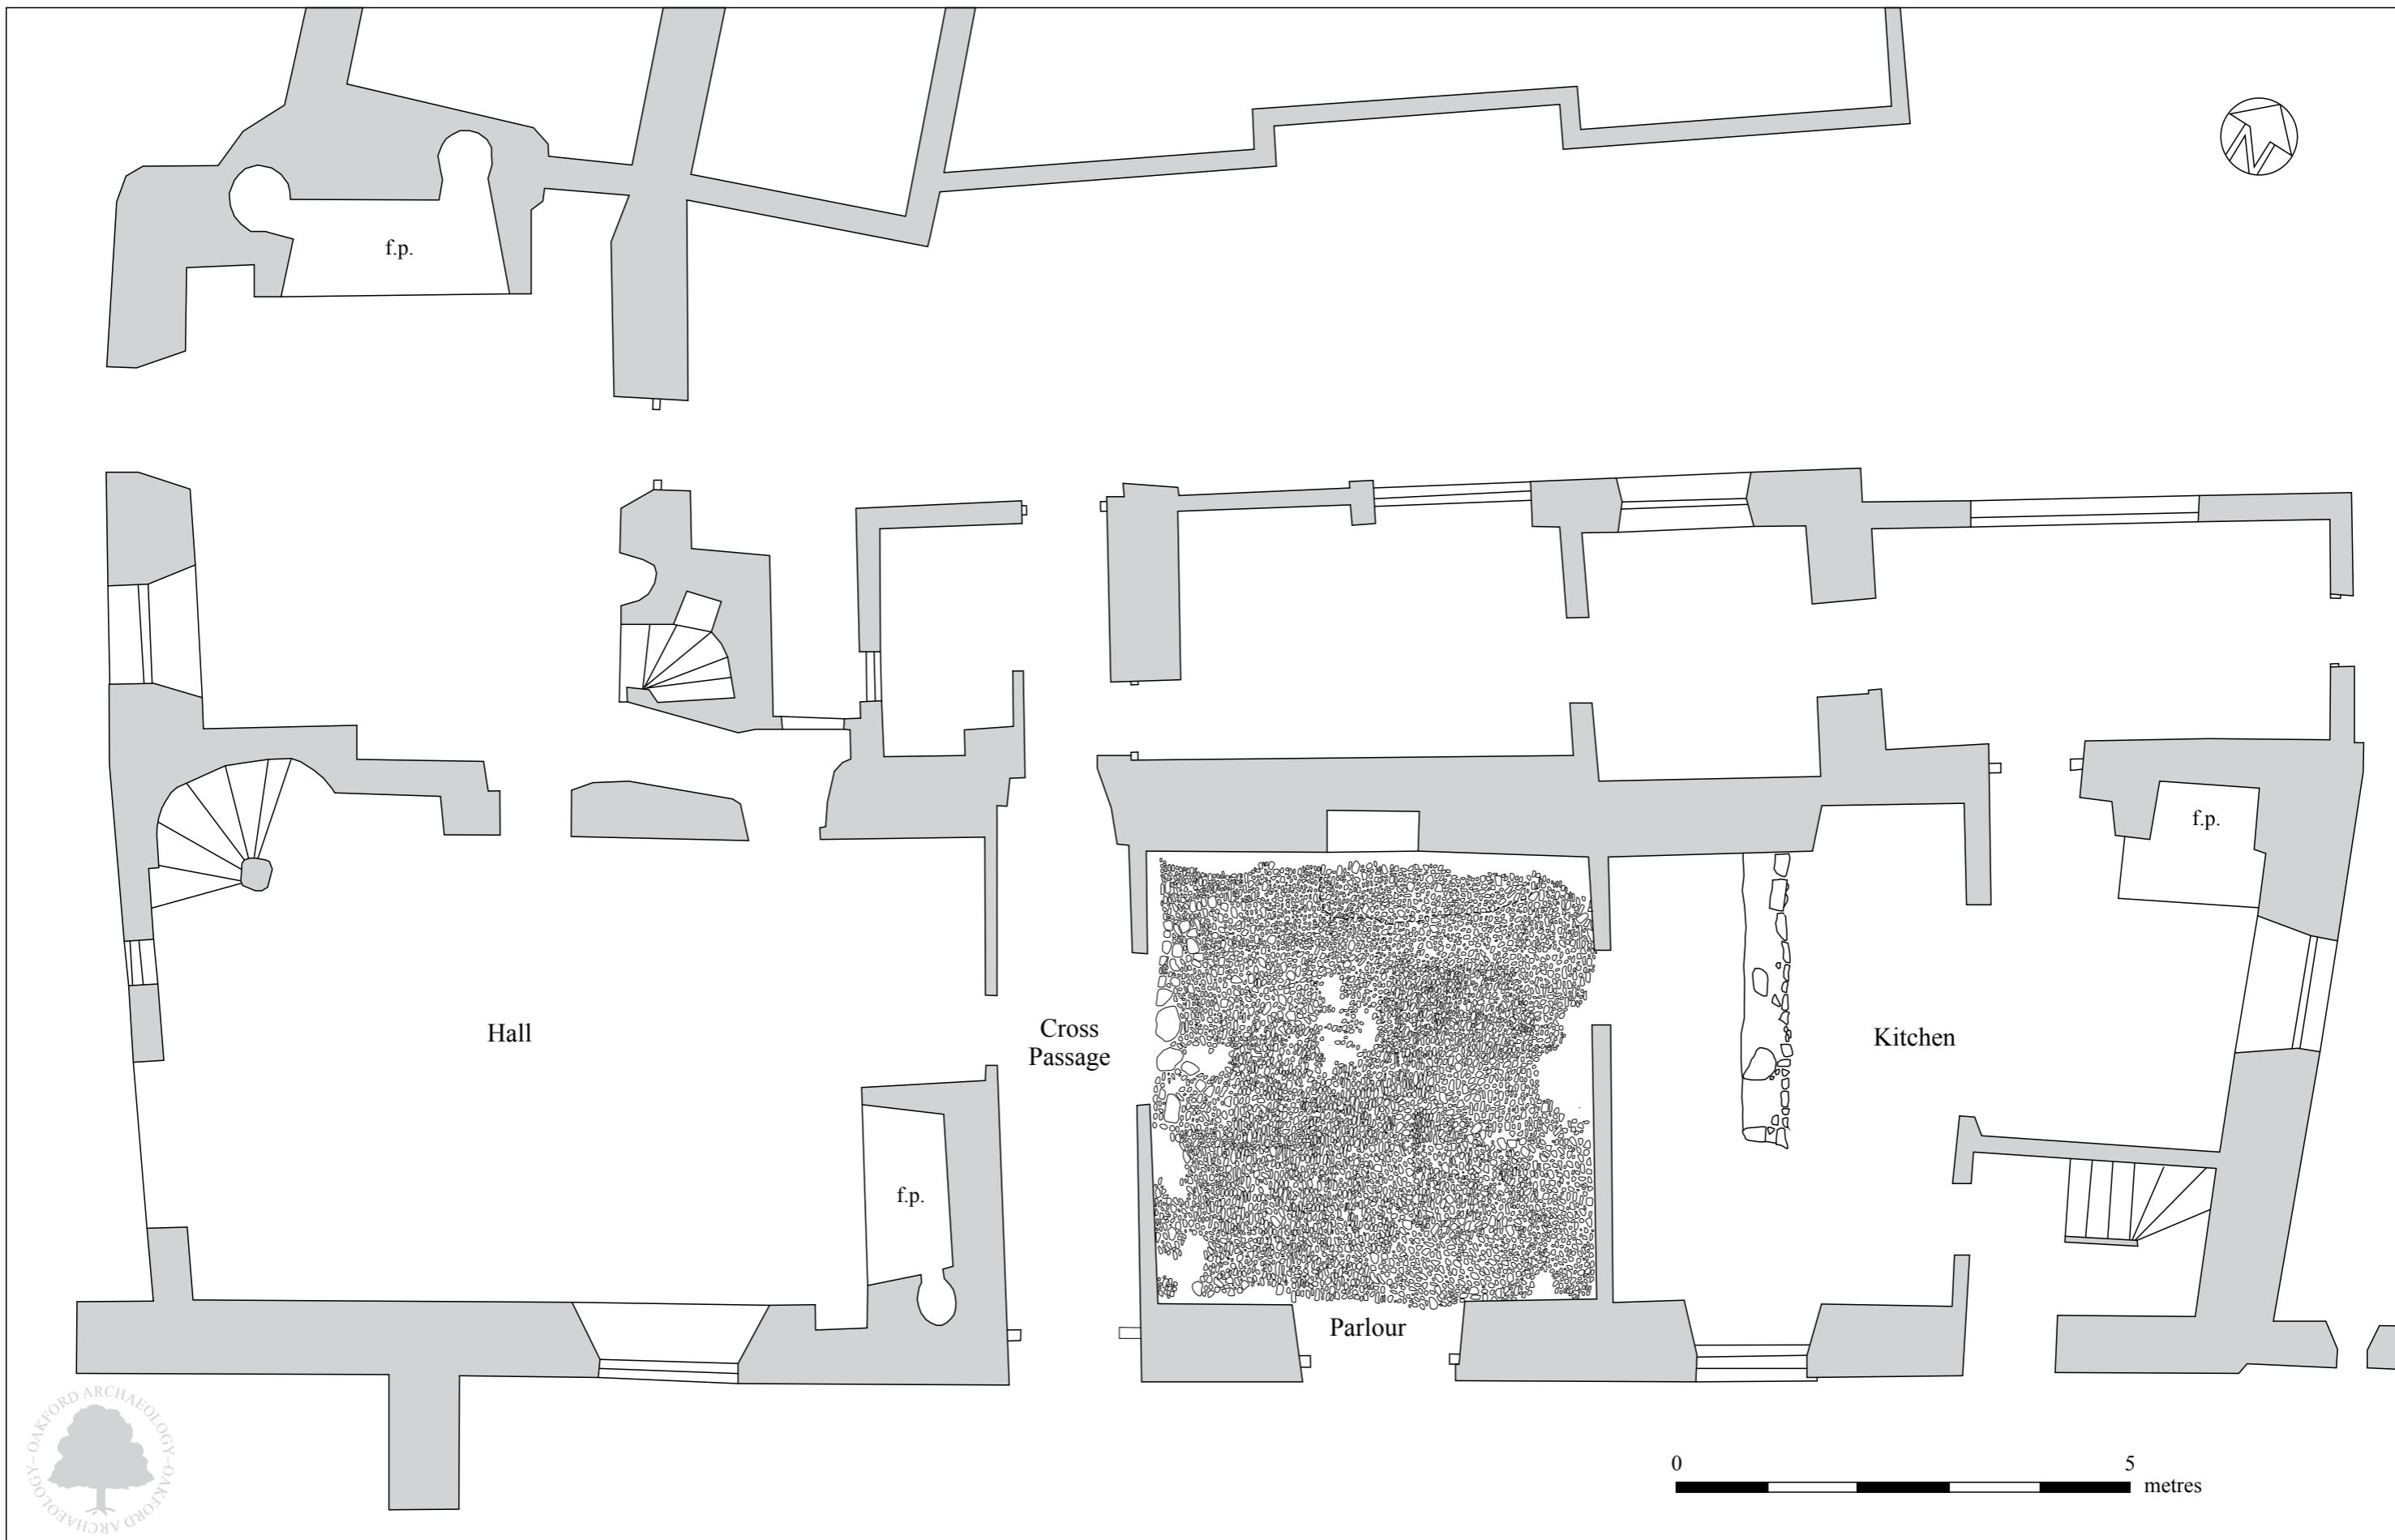
Fig. 5 Plan of Wallon showing location of observations.

The excavation plan (Fig. 5) shows the positions of the cobbled floor and wall revealed within the parlour and kitchen (Pls 1-3). No evidence of earlier flooring survived in the cross-passage and hall due to modern truncation associated with the insertion of concrete floors.

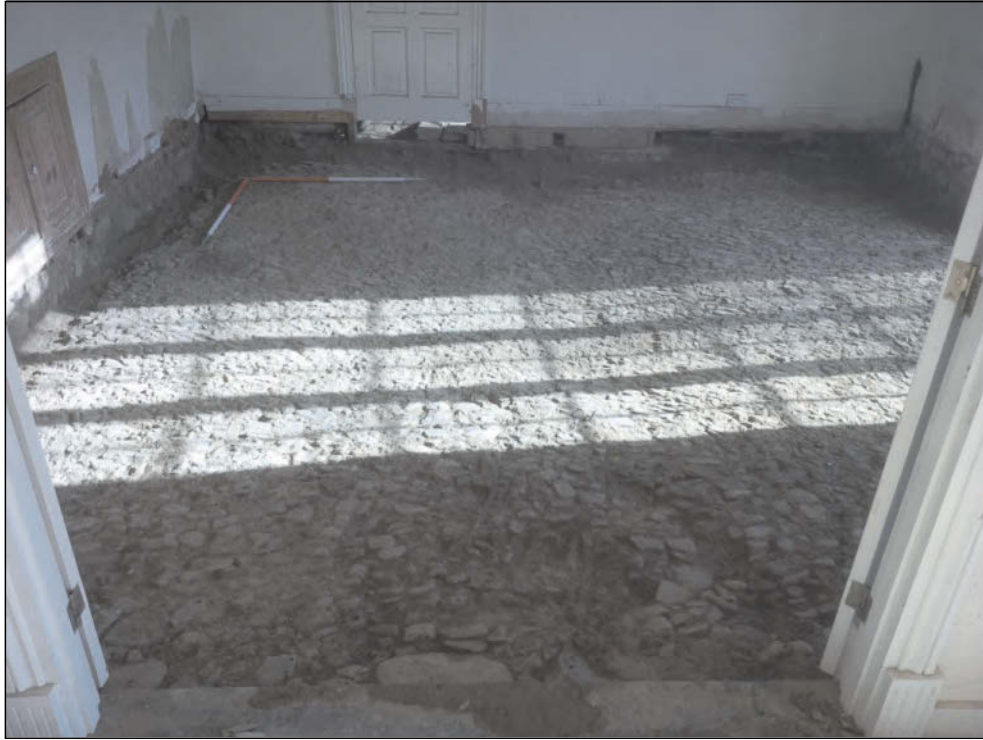
The depth of concrete and sub-base (100) overlying the cobbled floor (101) varied considerably in the parlour, reflecting the gradual northeast-southwest slope. The removal of approximately 0.1-0.2m of concrete and sub-base exposed elements of an earlier cobbled surface in the parlour.

The cobbled surface consisted of small to medium size sub-angular worn limestone fragments on a bed of sand that overlay the natural subsoil. No evidence was found for a drainage gully and the flooring is likely to be part of the early 18th century phase, when the longhouse was extensively refurbished and the original shippon divided into a parlour and a small service kitchen built at the east end.

Pl. 1 General view of cobbled floor (101) in sitting room. 1m and 1m scales. Looking northeast.

Although no evidence of a possible fireplace in the north wall of the sitting room was observed (Keystone 2013) a fine layer of ash (dashed line) covered the cobbled surface immediately in front and to the east of the low cupboard.

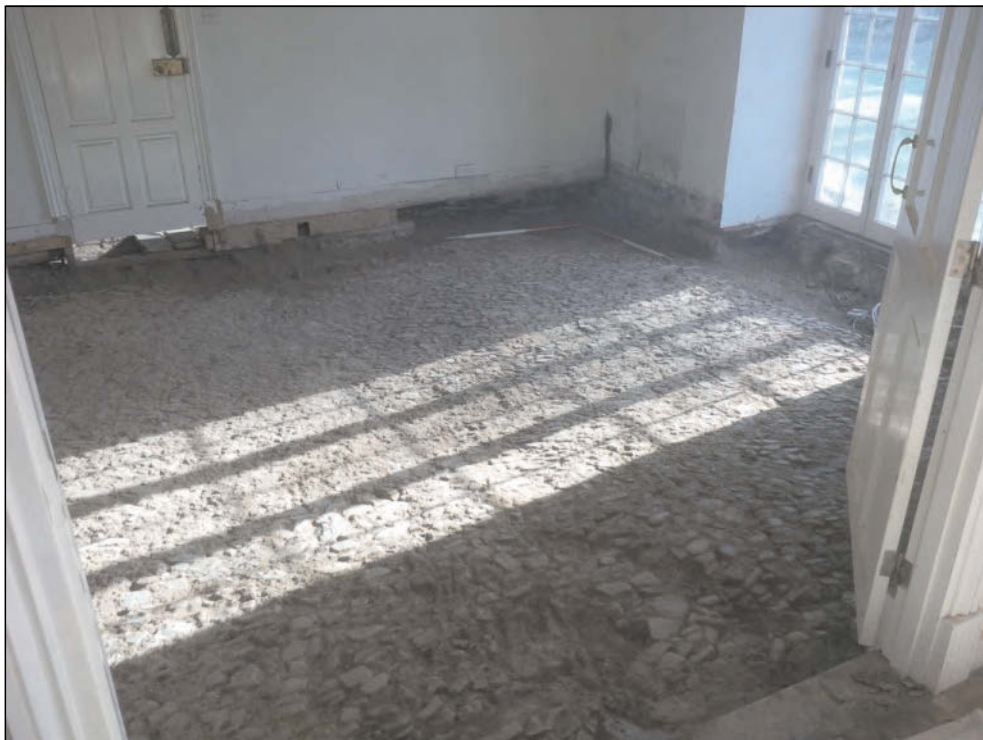
Pl. 2 General view of cobbled floor (101) in sitting room. 1m and 1m scale. Looking east.

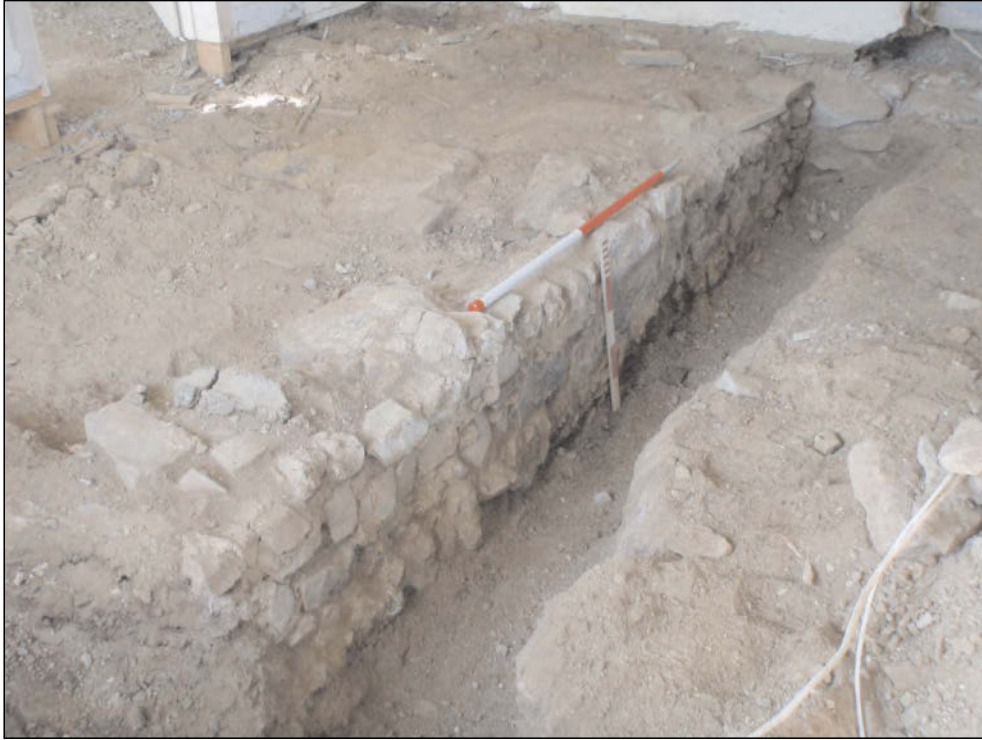
Work in the kitchen uncovered the remains of a northwest-southeast aligned wall foundation (103). This was approximately 3.25m long and 0.5m wide and consisted of limestone rubble, laid in rough courses. The bonding material consisted of crumbling, pale yellow lime mortar. No bricks or re-used building stone were identified. The wall clearly abutted the north wall and therefore represents a later insertion or alteration.

There is little doubt from the position of the wall that it was constructed at the same time as the major early 18th-century refurbishment and extension to Wallon House - the addition of the parlour and service kitchen. The wall was probably designed to support floorboards associated with the substantial suspended floor located in the northeast corner of the service kitchen

Pl. 3 General view of wall (103) in breakfast room. 0.5m and 1m scale.
Looking west.
