## Devon County Council Historic Environment Record

Civil Parish & District:  Gittisham, East Devon	Refer		Number:
<b>Subject:</b> Archaeological monitoring and recording Gittisham, Devon.	; at Kinş	gs Cottage,	Photo attached:
Planning Application no: 14/0762/LBC		Recipient museum n/a	n:
OASIS ID: oakforda1-194639		Museum Accession/a	on no:
Contractor's reference number/code: OA1196		Dates fieldwork u 22/09 and 30/10/2

## **Description of works:**

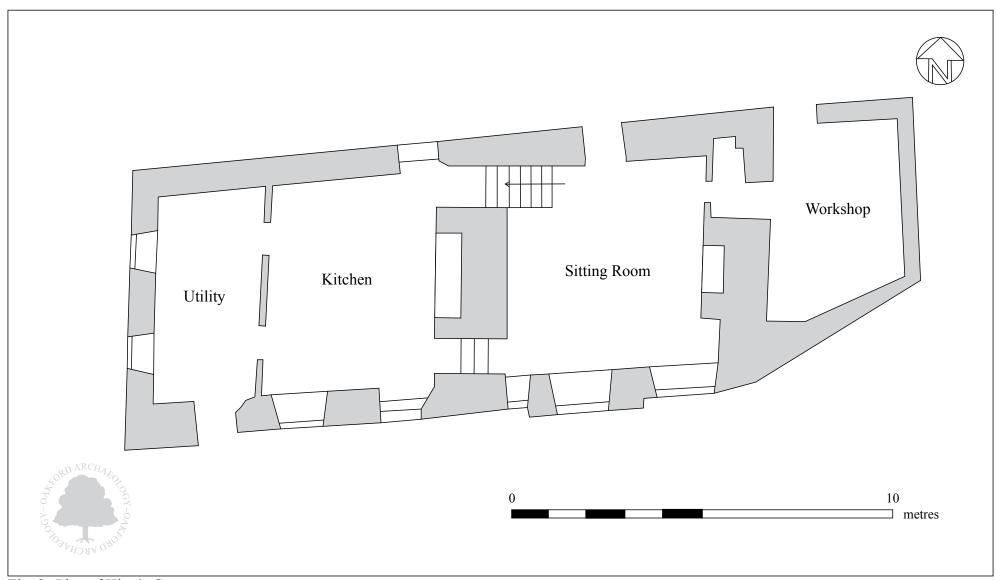
Fig. 2 Plan of King's Cottage.

A watching brief was maintained during works associated with the removal of existing concrete floor surfaces throughout the ground floor (Fig. 2). The initial ground reduction for the new under floor heating extended to a depth of 0.35-0.4m.

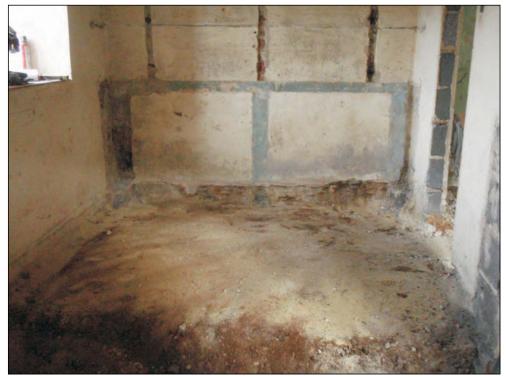
The removal of concrete floors (Pls. 1-3) exposed no deposits, features or dating evidence indicative of archaeological activity. The work uncovered a simple sequence consisting of a 0.05-0.1m thick concrete floor located above natural subsoil. This consisted of a mid reddish-brown clay natural subsoil with frequent shillet inclusions.

Pl. 1 Utility Room showing exposed natural subsoil. Looking north.

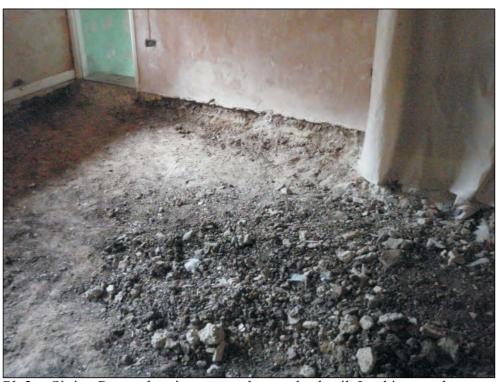
Pl. 2 Sitting Room showing exposed natural subsoil. Looking southwest.

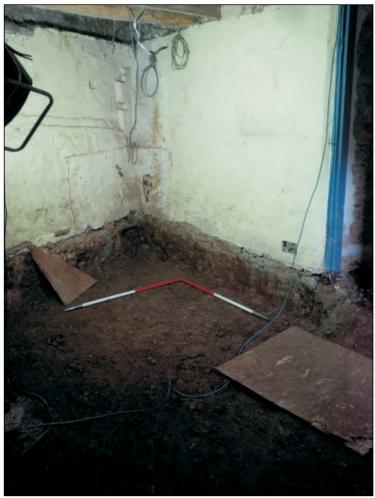
Pl. 3 Workshop showing exposed natural subsoil. Looking southwest.
