**Archaeological monitoring and recording at St
Michael's Church, Alphington,
Devon**

on behalf of
Alphington PCC

Report No. 14-05

November 2014

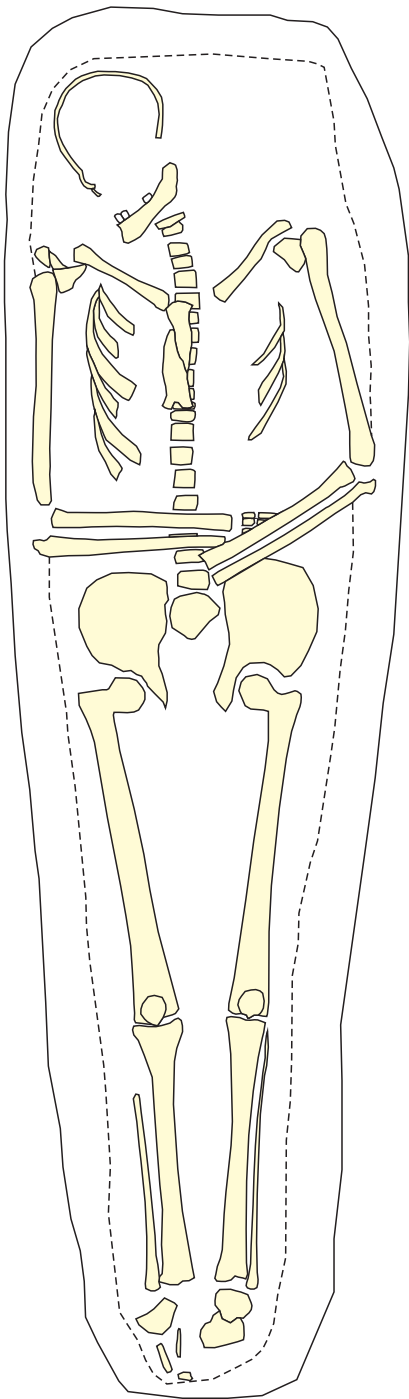
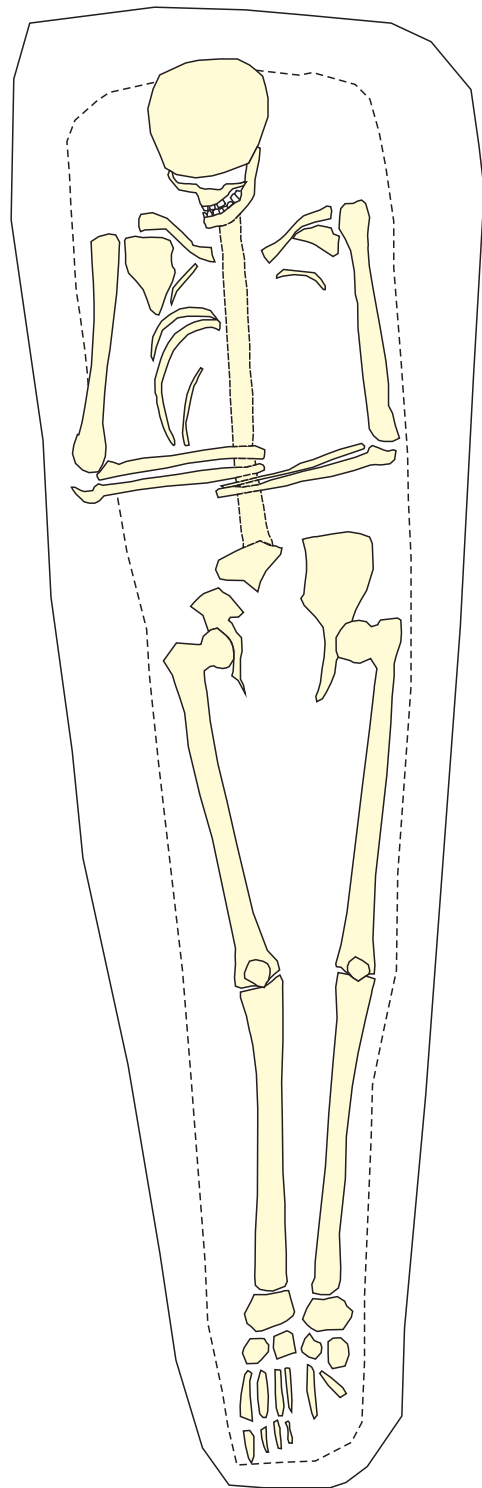
Fig. 8 Annex: skeletons 104 and 107.

Located at the to the south of the tower, Grave 103 measured approximately 1.85m in length and 0.55m in width. This contained a single adult inhumation (skeleton 104). The fill 105 consisted of mid reddish brown silty clay. The grave truncated the top of Grave 106 and no finds were recovered from the excavation. Skeleton 104 was in a good state of preservation, and was 76-100% complete. The individual was a young to mature adult male and was 173.2cm (5 foot 8) in stature. The burial was laid out in an extended and supine position, with the head to the west and the feet to the east, and arms folded over the lower abdomen. No evidence of a coffin survived.

Grave 106 was located immediately to the west and underneath Grave 103, and measured approximately 1.95m in length and 0.6m in width. This contained a single adult inhumation (skeleton 107). No finds were recovered from fill 108. This consisted of mid reddish brown silty clay. The grave was cut grave 109. Skeleton 107 was in a poor state of preservation, and was 51-75% complete. The remains were of an adult female and were 158.8cm (5 foot 3) in stature. The burial was laid out in an extended and supine position, with the head to the west and the feet to the east, and arms folded over the lower abdomen. No evidence of a coffin survived.

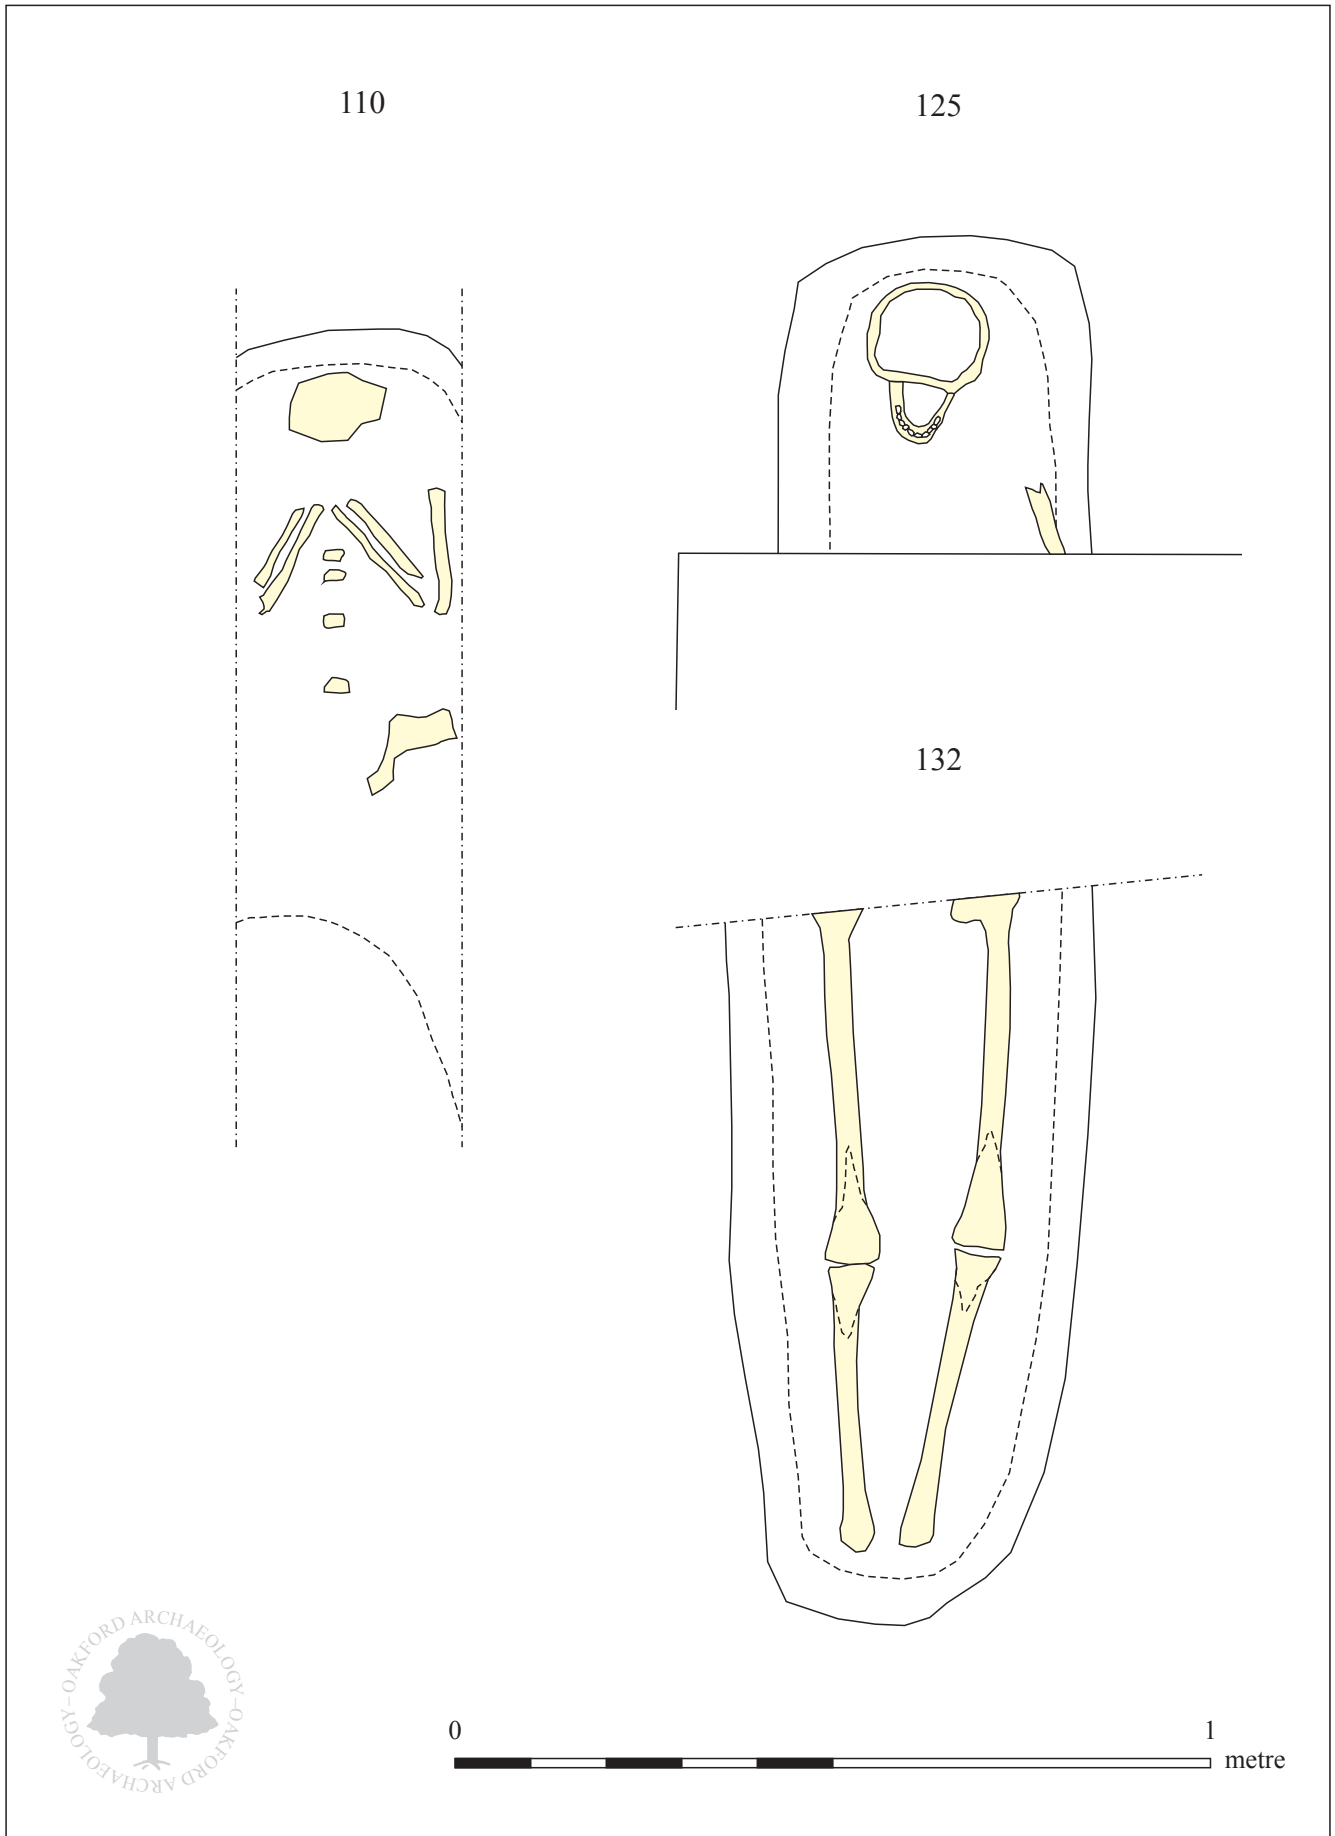
Fig. 9 Annex: skeletons 110, 125 and 132.

Grave 109 was located immediately to the north of Grave 106, and measured approximately 1.05m in length and 0.35m in width. This contained a single adult inhumation (skeleton 110). No finds were recovered from fill 111. This consisted of mid reddish brown silty clay. The grave was cut into the underlying geology. Skeleton 110 was in a poor state of preservation, and was 26-50% complete. The remains were of an adult female. The burial was laid out in an extended and supine position, with the head to the west and the feet to the east, and arms folded over the chest. No evidence of a coffin survived.

Located immediately to the west of the south aisle, Grave 124 measured approximately 0.42m in length and 0.43m in width. This contained a single adult inhumation (skeleton 125), truncated the south aisle. The fill 126 consisted of mid reddish brown silty clay. The grave was cut into the underlying geology and no finds were recovered from the excavation. Skeleton 125 was in a poor state of preservation, and was 0-25% complete. The remains were of an adult. The burial was laid out in an extended and supine position, with the head to the west and the feet to the east. No evidence of a coffin survived.

Grave 131 was located immediately to the south of the tower, and measured approximately 1.01m in length and 0.47m in width. This contained a single adult inhumation (skeleton 132). No finds were recovered from fill 133. This consisted of mid reddish brown silty clay. The grave was cut into the underlying geology and no finds were recovered from the excavation. Skeleton 132 was in a good state of preservation, and was 26-50% complete. The remains were of an adult. The burial was aligned E-W, and was laid out in an extended and supine position. The head of the grave extended beyond the western limit of the excavation. No evidence of a coffin survived.

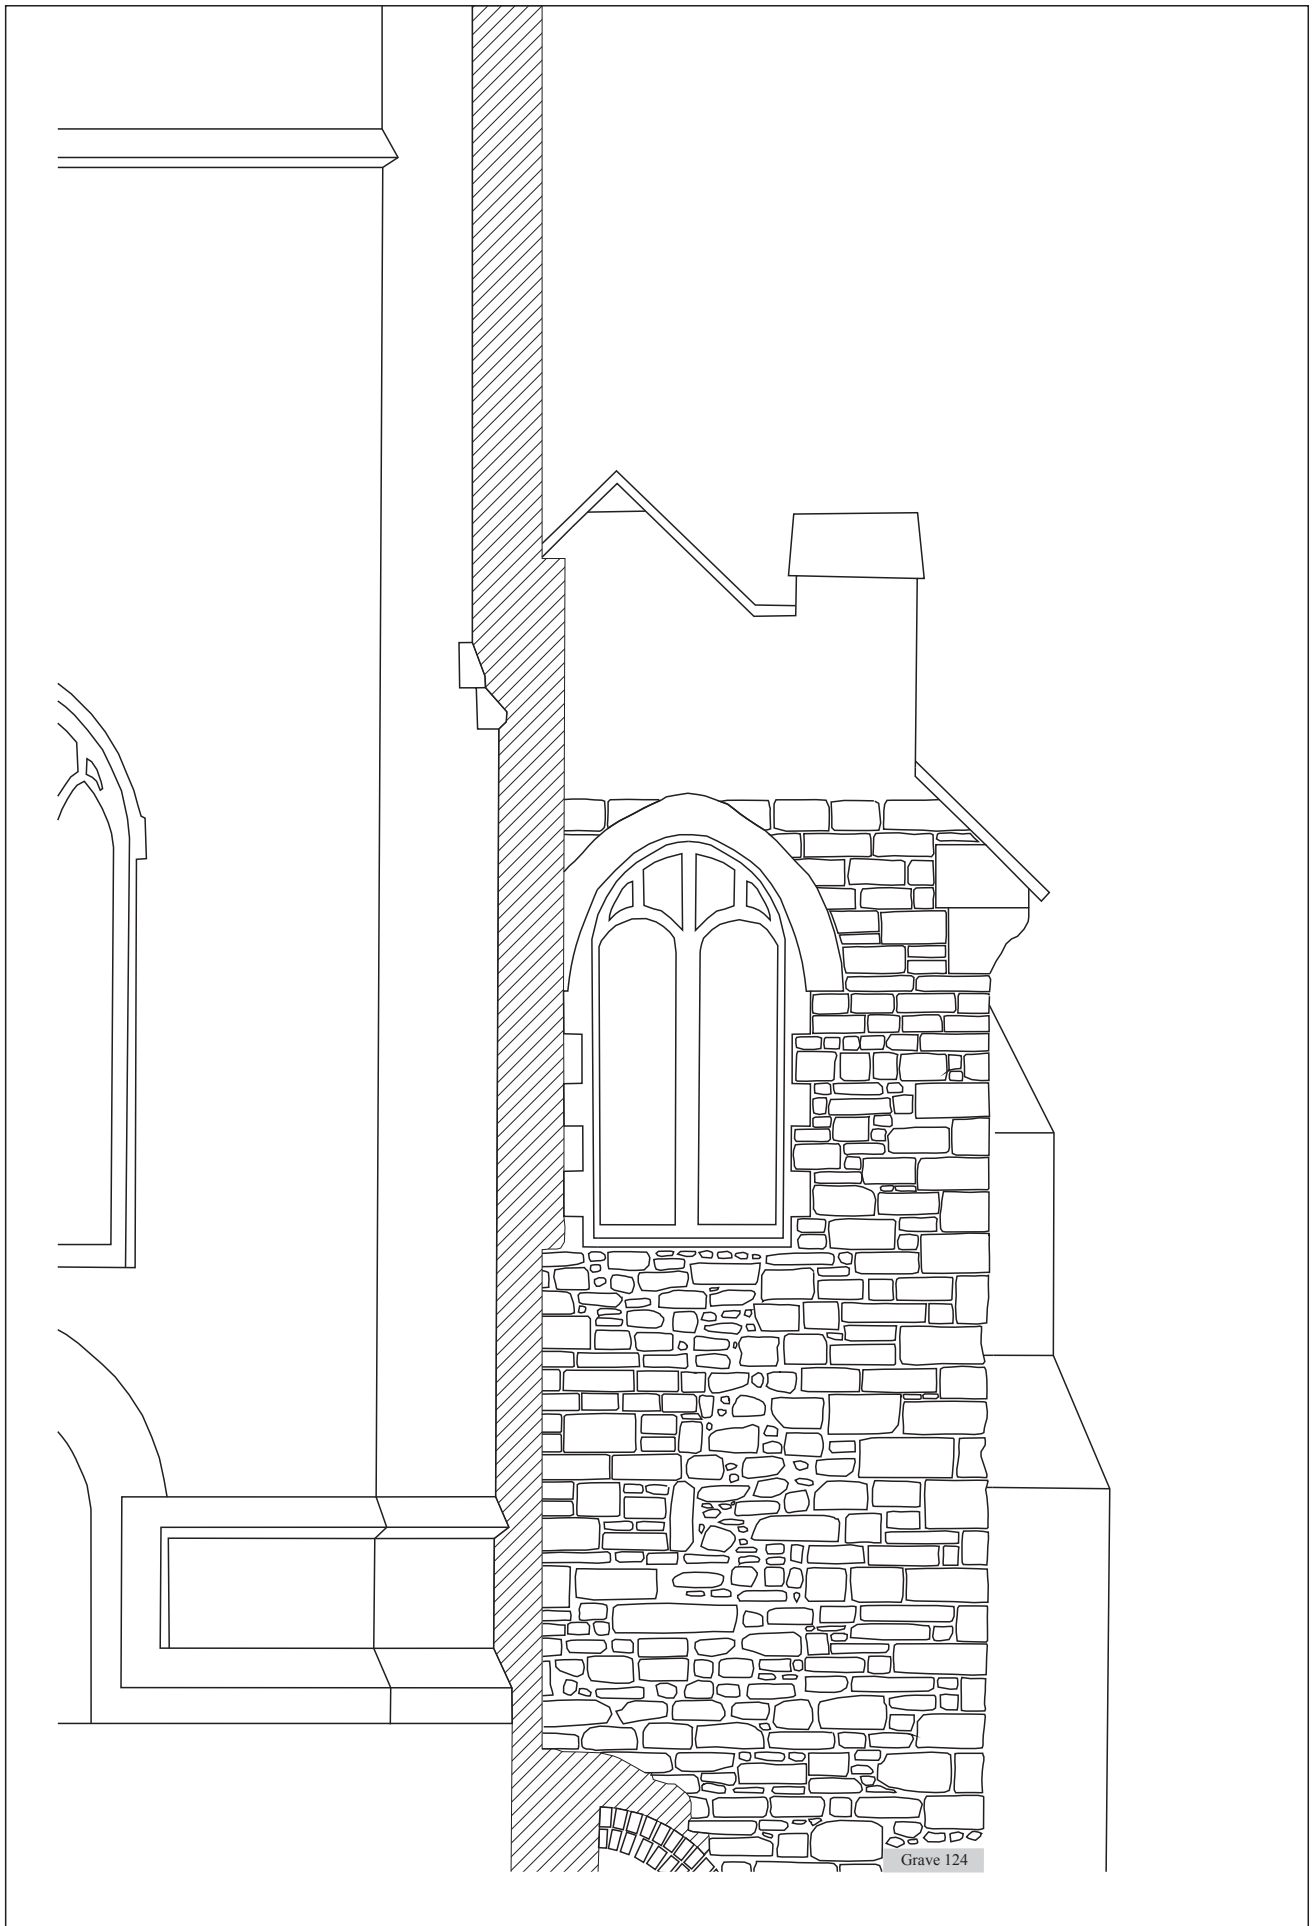
Fig. 10 Elevation of West end South Aisle.

Groundworks for the new two-storey annex involved the removal of an existing 15th century window in the west wall of the north aisle and the insertion of a new doorway underneath. A stretch of 3.2m of facework of the western wall of the south aisle was recorded. The upper part of the west wall was not accessible and although internal render was removed this didn't allow sufficient detail to be visible. Four main facework builds were seen on the external elevation.

An area of mixed rubble forming part of the earlier fabric of the western south aisle wall, consisting largely of roughly squared volcanic trap, with some breccia blocks. The return for the south wall was located 0.4m north from the location of the later wall, suggesting that grave 124 would have butted-up against the exterior of the original southern south aisle wall. It had been re-pointed using a reddish white lime mortar; no areas of original mortar were identified. This build is likely to precede the major re-building of the church in the mid to late 15th.

Roughly dressed breccia (Heavitree stone) and volcanic trap rubble with large stressed breccia quoins. Slate was also used to pack out joints and to level individual blocks. All of the elevation was re-pointed using light reddish white lime mortar with coarse grit, making it impossible to identify areas of primary mortar. Some very large breccia blocks appear in this facework, up to 0.85m x 0.53m. The build is likely to represent the major rebuilding of the church in the mid to late 15th century.

The earlier mixed breccia and trap rubble is cut and replaced by medium and large well-squared closely jointed blocks of breccia laid in 16 horizontal courses associated with the tower. Although the northern edge of the elevation was partially obscured by a down pipe the coursing corresponds to the coursing seen in the tower. This section had been re-pointed with

External brick arch at the base of the wall, also seen on the inside. 19th century flue providing access for cast-iron heating pipes from the boiler house.

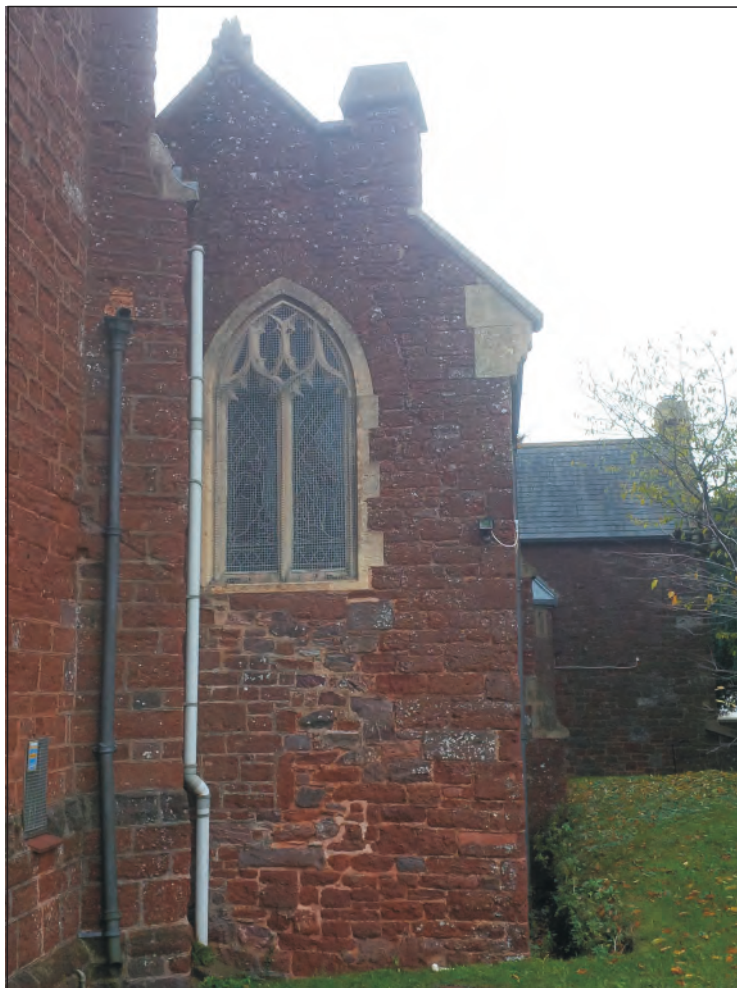
Pl. 2 South Aisle western elevation.
Looking northeast.

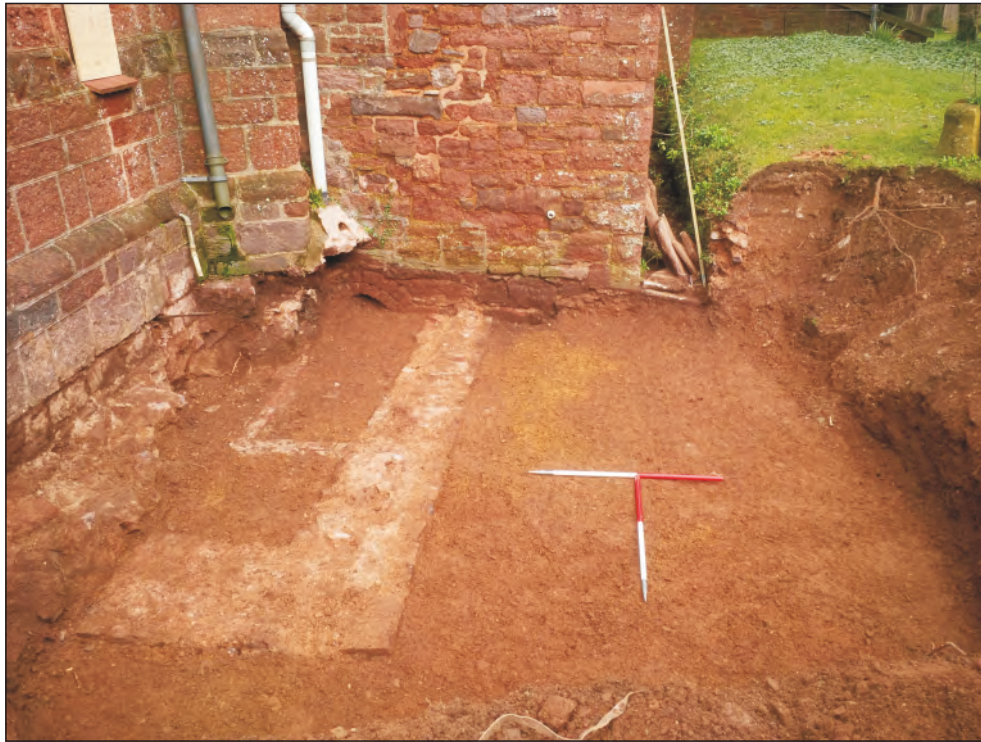
Pl. 3 Annex showing foundation of 19th century boiler house, foundations of tower and burial horizon. 1m and 1m scales. Looking northeast.

A trench measuring 5m x 5m was excavated following the removal of the foundations of the 19th century boiler house. The trench was excavated to the impact level 1.8m below the current graveyard level. The natural geology, a mixture of yellow clay and gravels, was cut by at least 10 approximately west-east orientated graves. The graves were closely packed and there was considerable intercutting of features. Only burials that would be disturbed by drainage works were excavated. A total of five grave cuts containing five skeletons were excavated. Only a single coffin was identified and the lack of clothes fastenings, such as

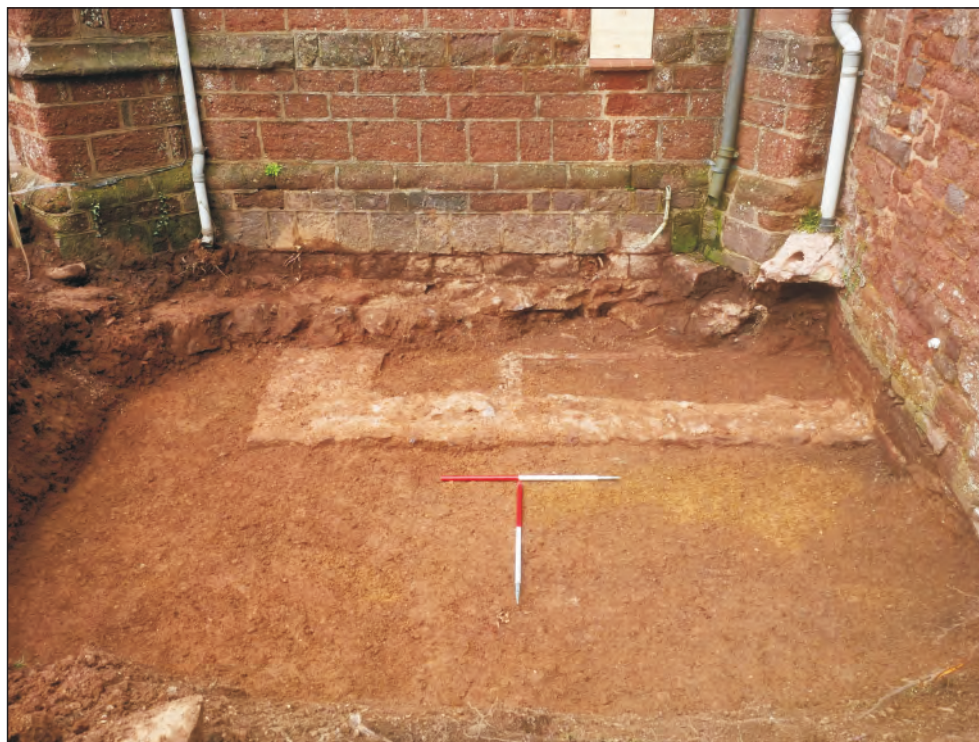
Pl. 4 Annex showing foundation of 19th century boiler house, foundations of tower and burial horizon. 1m and 1m scales. Looking northwest.

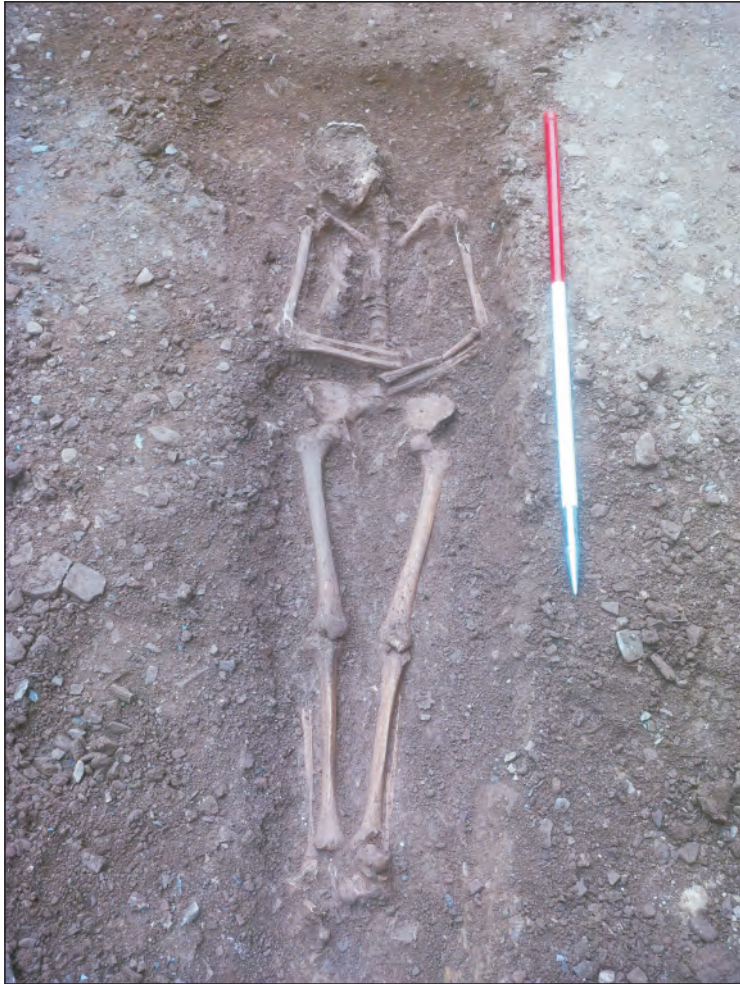
Pl. 5 Annex: Skeleton 104. 1m scale. Looking southwest.

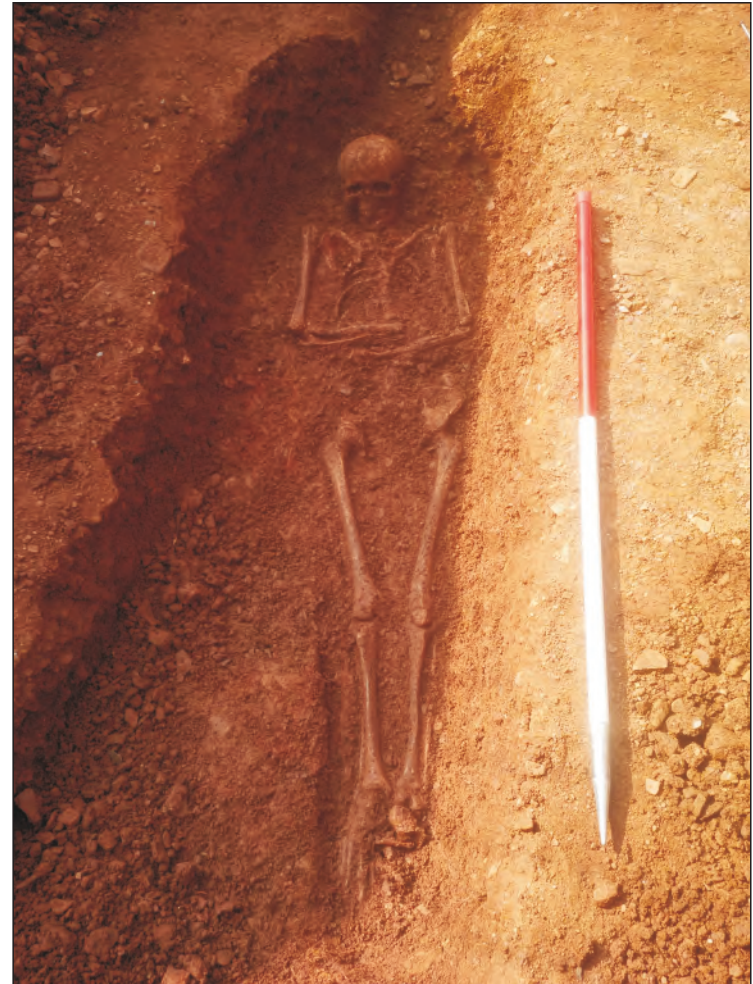
Pl. 6 Annex: Skeleton 107. 1m scale. Looking southwest.

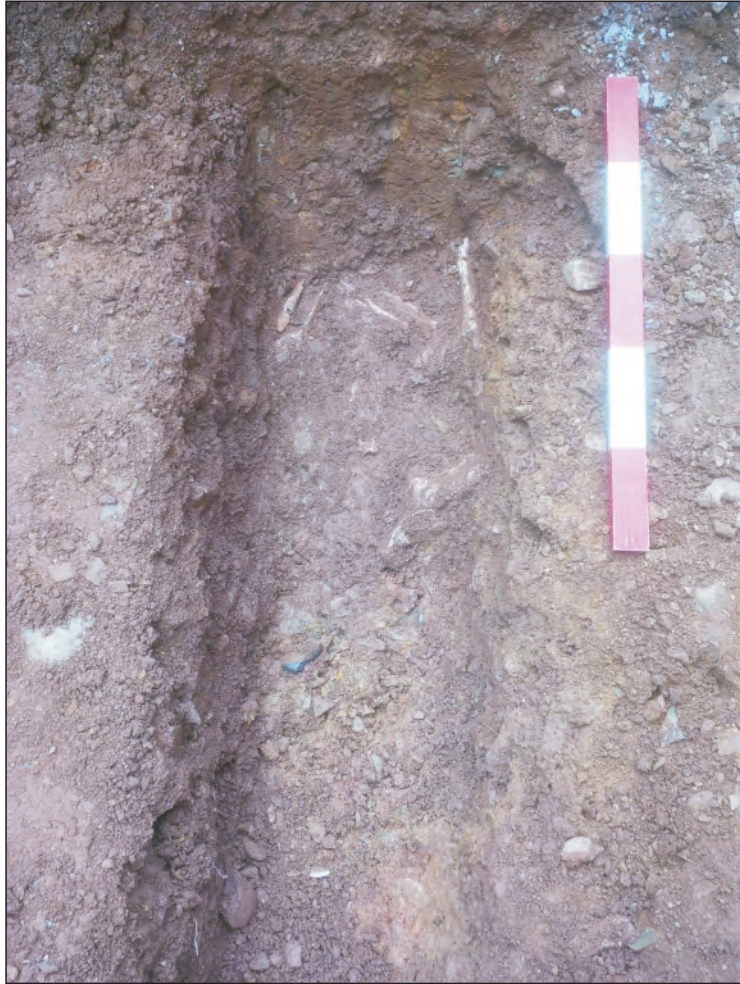
Pl. 7 Annex: Skeleton 110. 0.5m scale. Looking southwest.

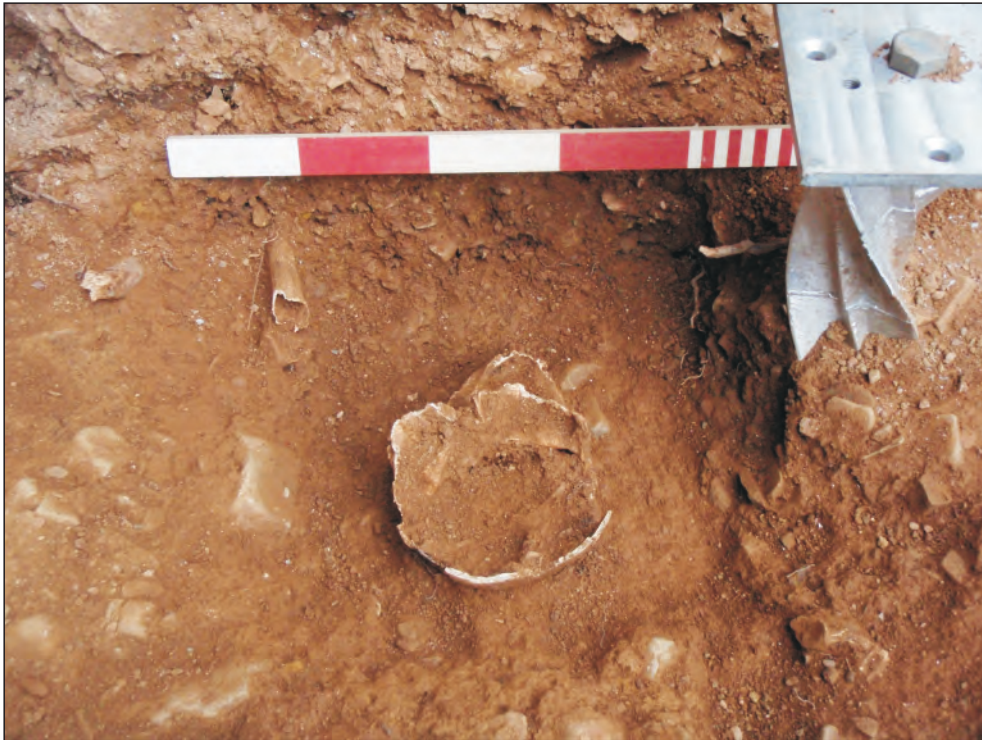
Pl. 8 Annex: Skeleton 125. 0.5m scale. Looking northeast.

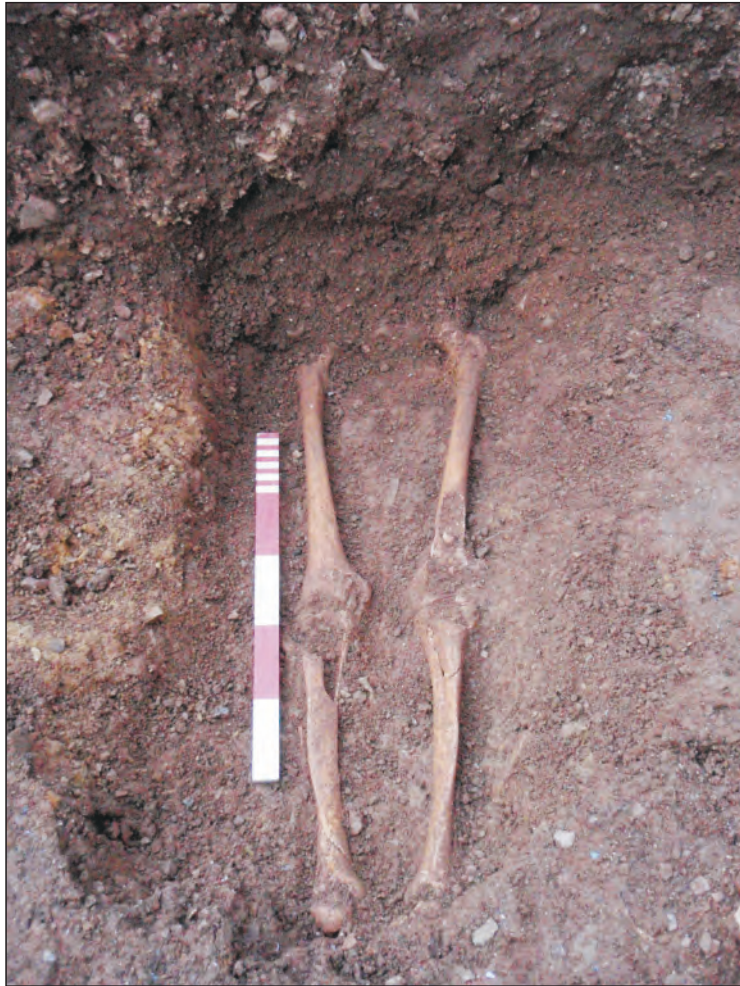
Pl. 9 Annex: Skeleton 132. 0.5m scale. Looking southwest.

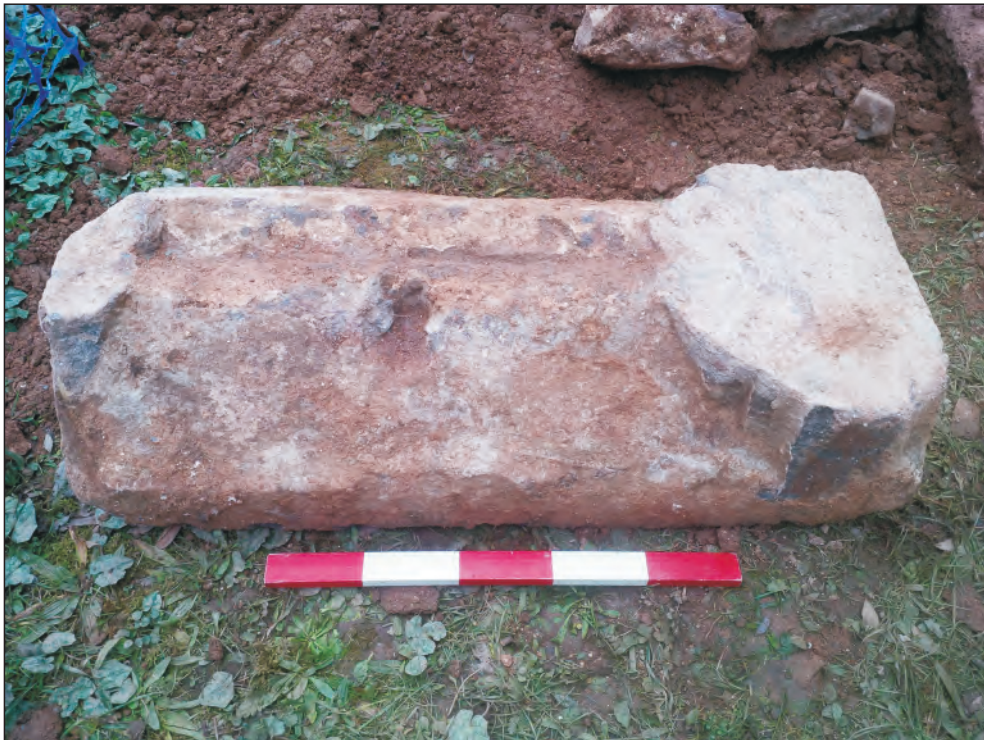
Pl. 10 Close-up medieval window jamb re-used in 19th century boiler house foundations. 0.5m scale.

Monitoring of the demolition of the 19th century boiler house wall foundation (130) recovered two architectural fragments. The window jamb with a flat back illustrated in pl. 10 is probably from the same window as the arch shown on pl. 11 and both were carved from pieces of volcanic trap. The two pieces also throw light on the subsequent history of these windows, suggesting that they may have been part of an earlier phase of windows.

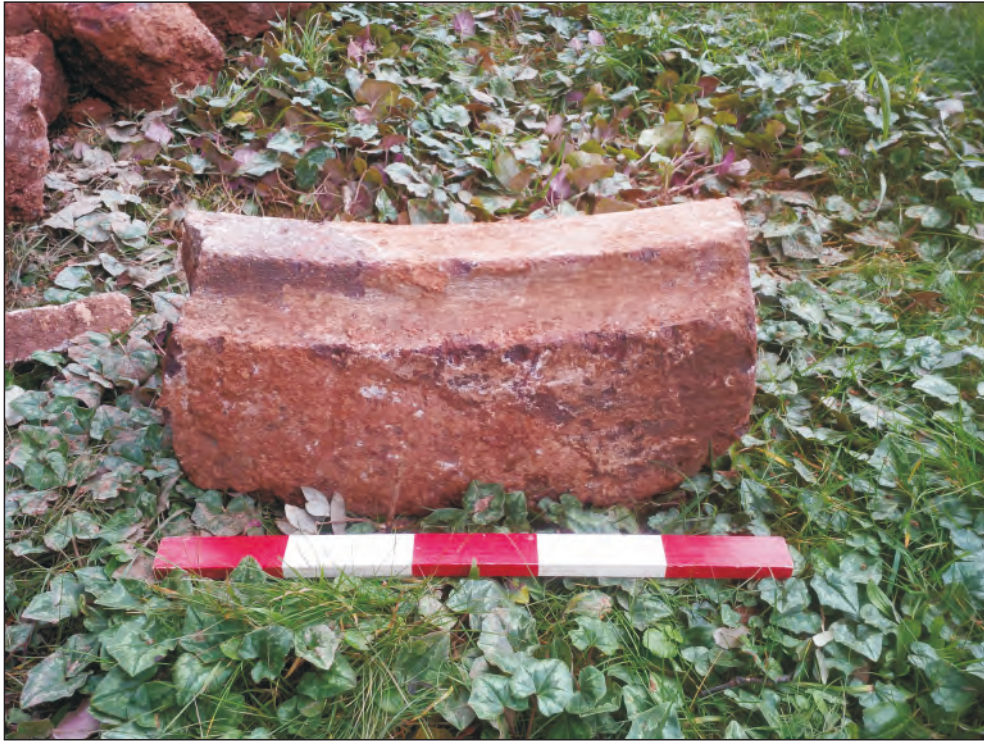
Pl. 11 Close-up of medieval window arch re-used in 19th century boiler house foundations. 0.5m scale.

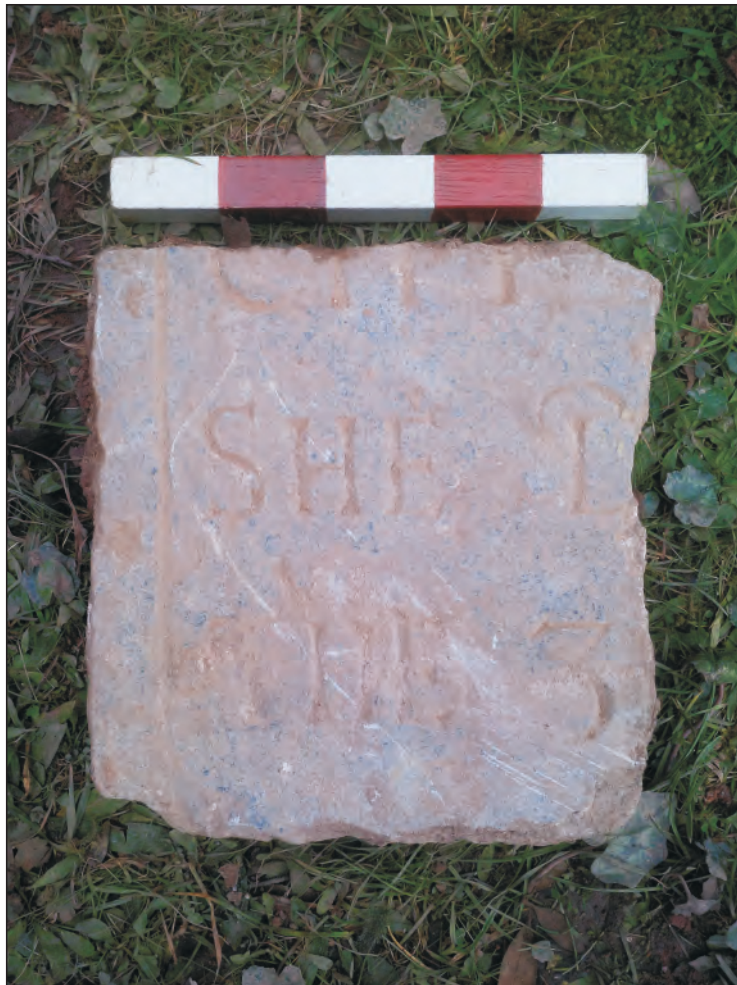
Pl. 12 Grave slab fragment re-used in 19th century boiler house foundations. 0.25m scale.

In addition a single fragment from a probably 19th century gravestone was also recovered from the foundations.

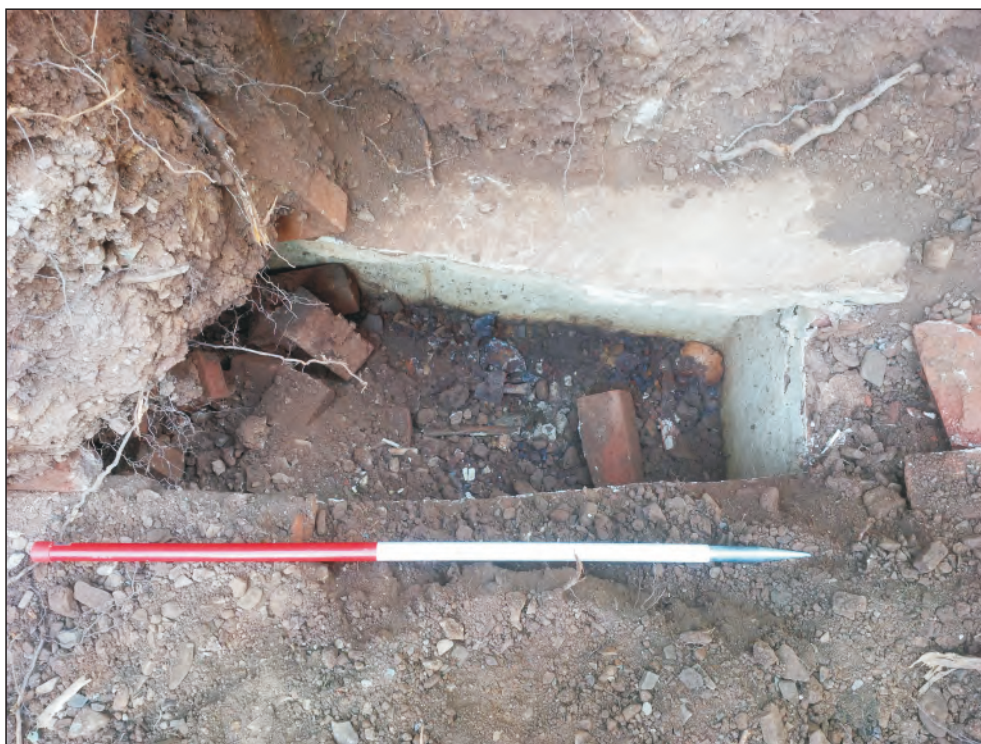
Pl. 13 Close-up of mortar lined grave 220 with Skeleton 221. 1m scale.
Looking north.

The last burial, Grave 220, was built of limewashed brick and located to the west of the tower. It measured 2.23m in length and 0.65m in width and contained a single adult inhumation (skeleton 221). The grave was cut into the underlying charnel soil. The Skeleton 221 was in a good state of preservation, and was 76-100% complete. The remains were of an adult. The burial was laid out in an extended and supine position, with the head to the west and the legs to the east. The head of the grave extended beyond the western limit of the excavation. The skeleton lay within the remnants of a coffin, indicated by the presence of a breastplate. The top of the brick lining was removed and the remains left *in situ*.

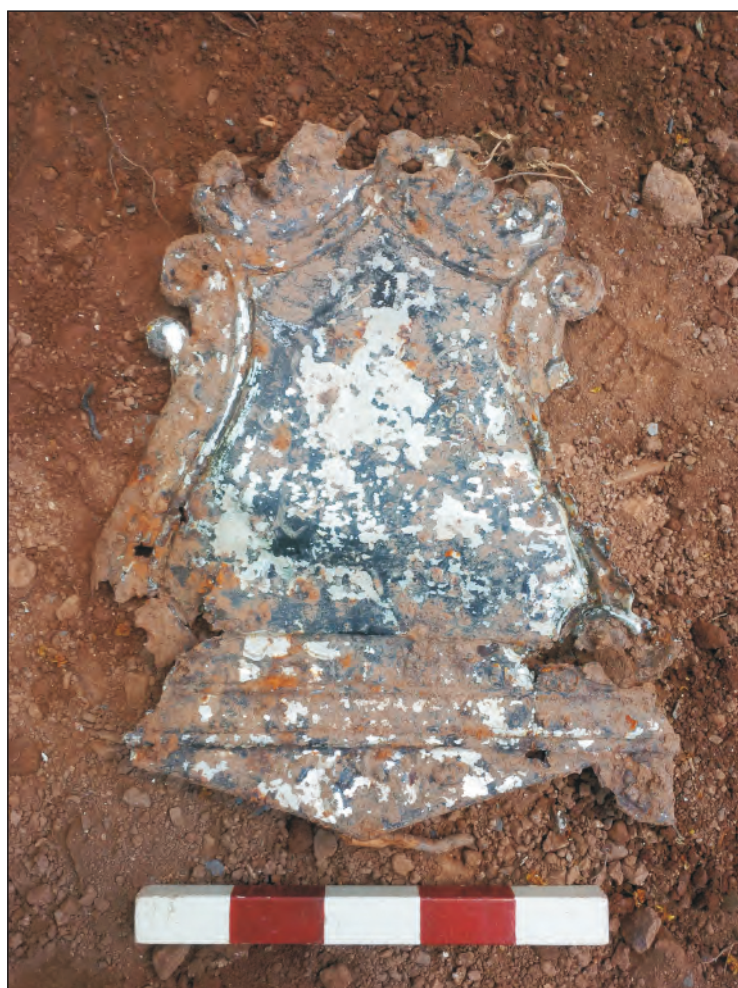
Pl. 14 Close-up of coffin breastplate grave 220. 0.25m scale.

Breastplates are commonly found overlying post-medieval skeletons. These plates, originally attached to the coffin lid identified the deceased, commonly displaying the name, age-at-death and date of death of the deceased. On cheaper iron breastplates the inscription was often painted on in contrasting colours. A single breastplate, consisting of a stamped iron sheet, was identified during the works. Some black paint was present but unfortunately no contrasting paint for lettering was identified.

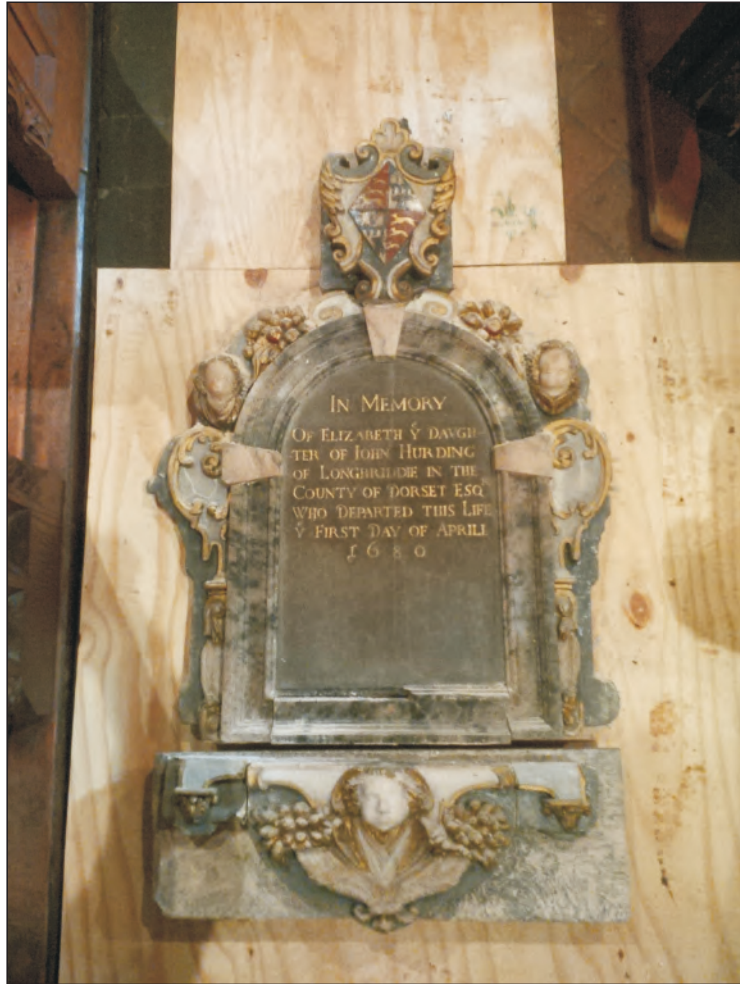
Pl. 19 South Aisle: Hurding monument.

A large multi-coloured stone monument, located on the south wall of the south aisle, was dedicated to Elizabeth Hurding who died in 1680. The monument has a highly decorated apron with a carved cherub's head and flowers. The inscription is on a central rectangular panel surrounded by an ornamental frame with stylised quoins and key stone. The frame is

further decorated with carved flowers and leaves, as well as two cherub's heads, and is surmounted with a coat of arms.

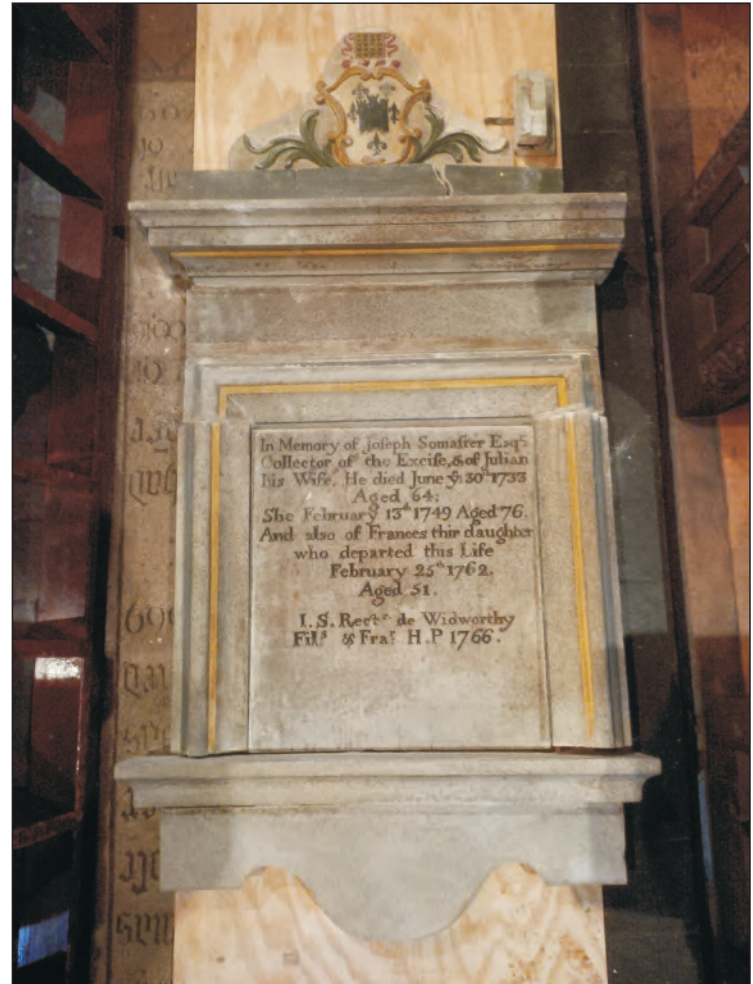
Pl. 20 South Aisle: Somaster monument.

A second monument, located to the east of the previous monument, was dedicated to Joseph Somaster (1733), his wife Julian (1749) and their daughter Frances (1762). It had a plain apron and bottom shelf. The inscription is again on a central rectangular panel surrounded by a simple frame with a single gold band. The monument has a simple upper shelf decorated with a single gold band and flat top surmounted with a coat of arms.

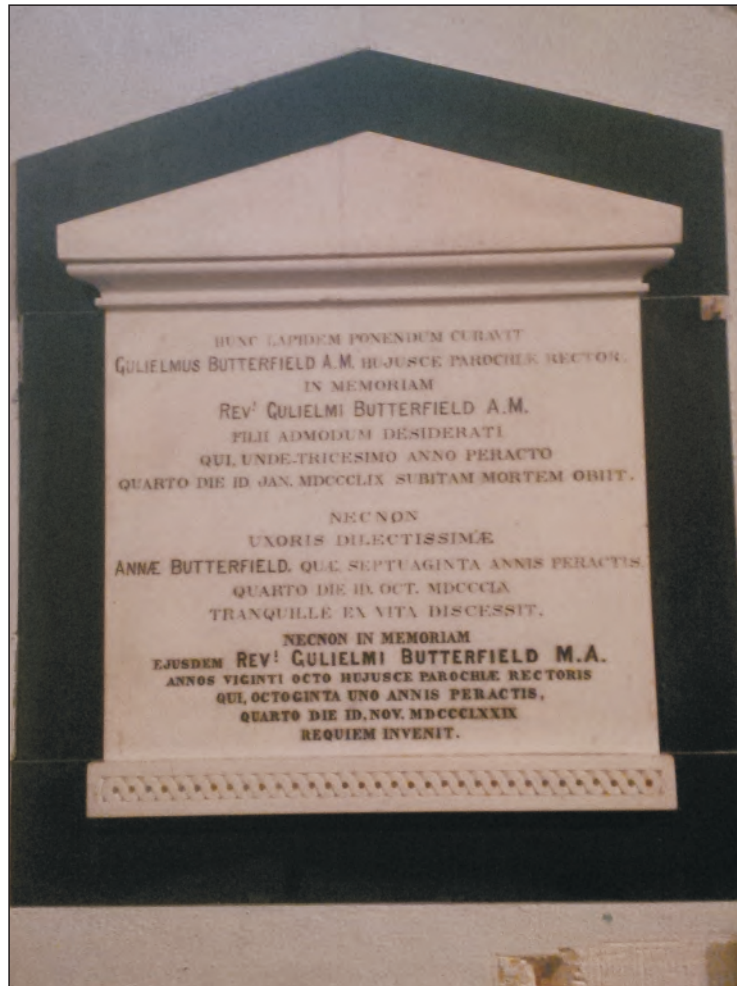
Pl. 21 South Aisle: Butterfield monument.

Two memorial plaques with plain black marble backing were mounted on the west wall of the south aisle. The left one was dedicated to the Revd William Butterfield, who died in 1859, his wife Anne (1850) and their son William (1879). The other plaque was dedicated to Charles Porter died in 1864. Both monuments had a simple pediment.

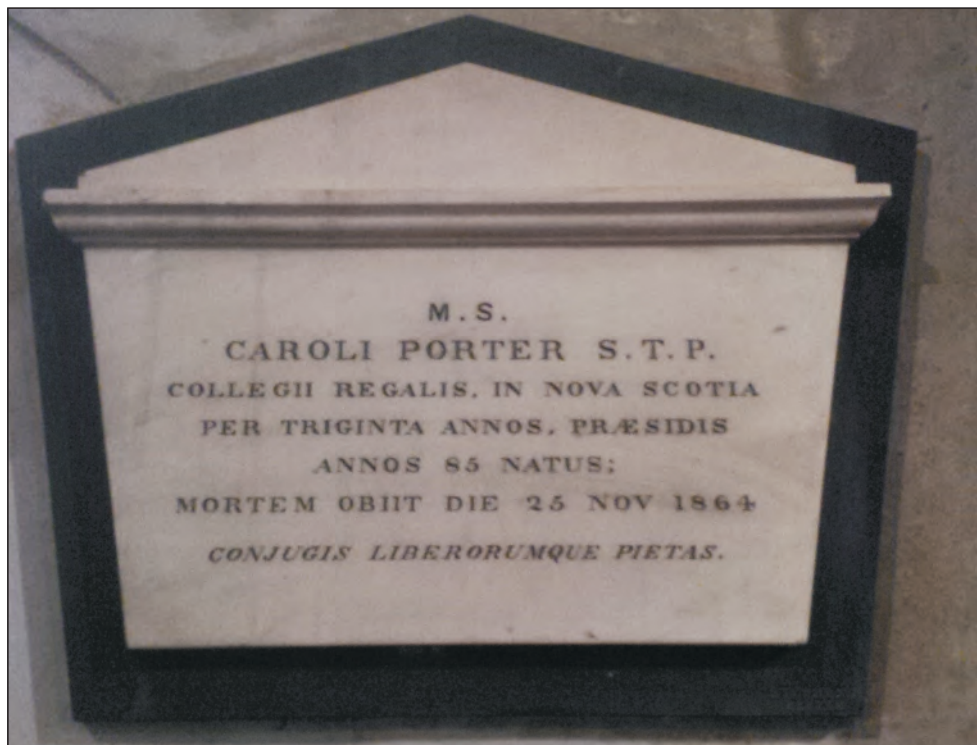
Pl. 22 South Aisle: Porter monument.
