**Historic building recording and archaeological
monitoring and recording at Quay Gardens,
Monmouth Avenue, Topsham**

Report No. 14-07

June 2015

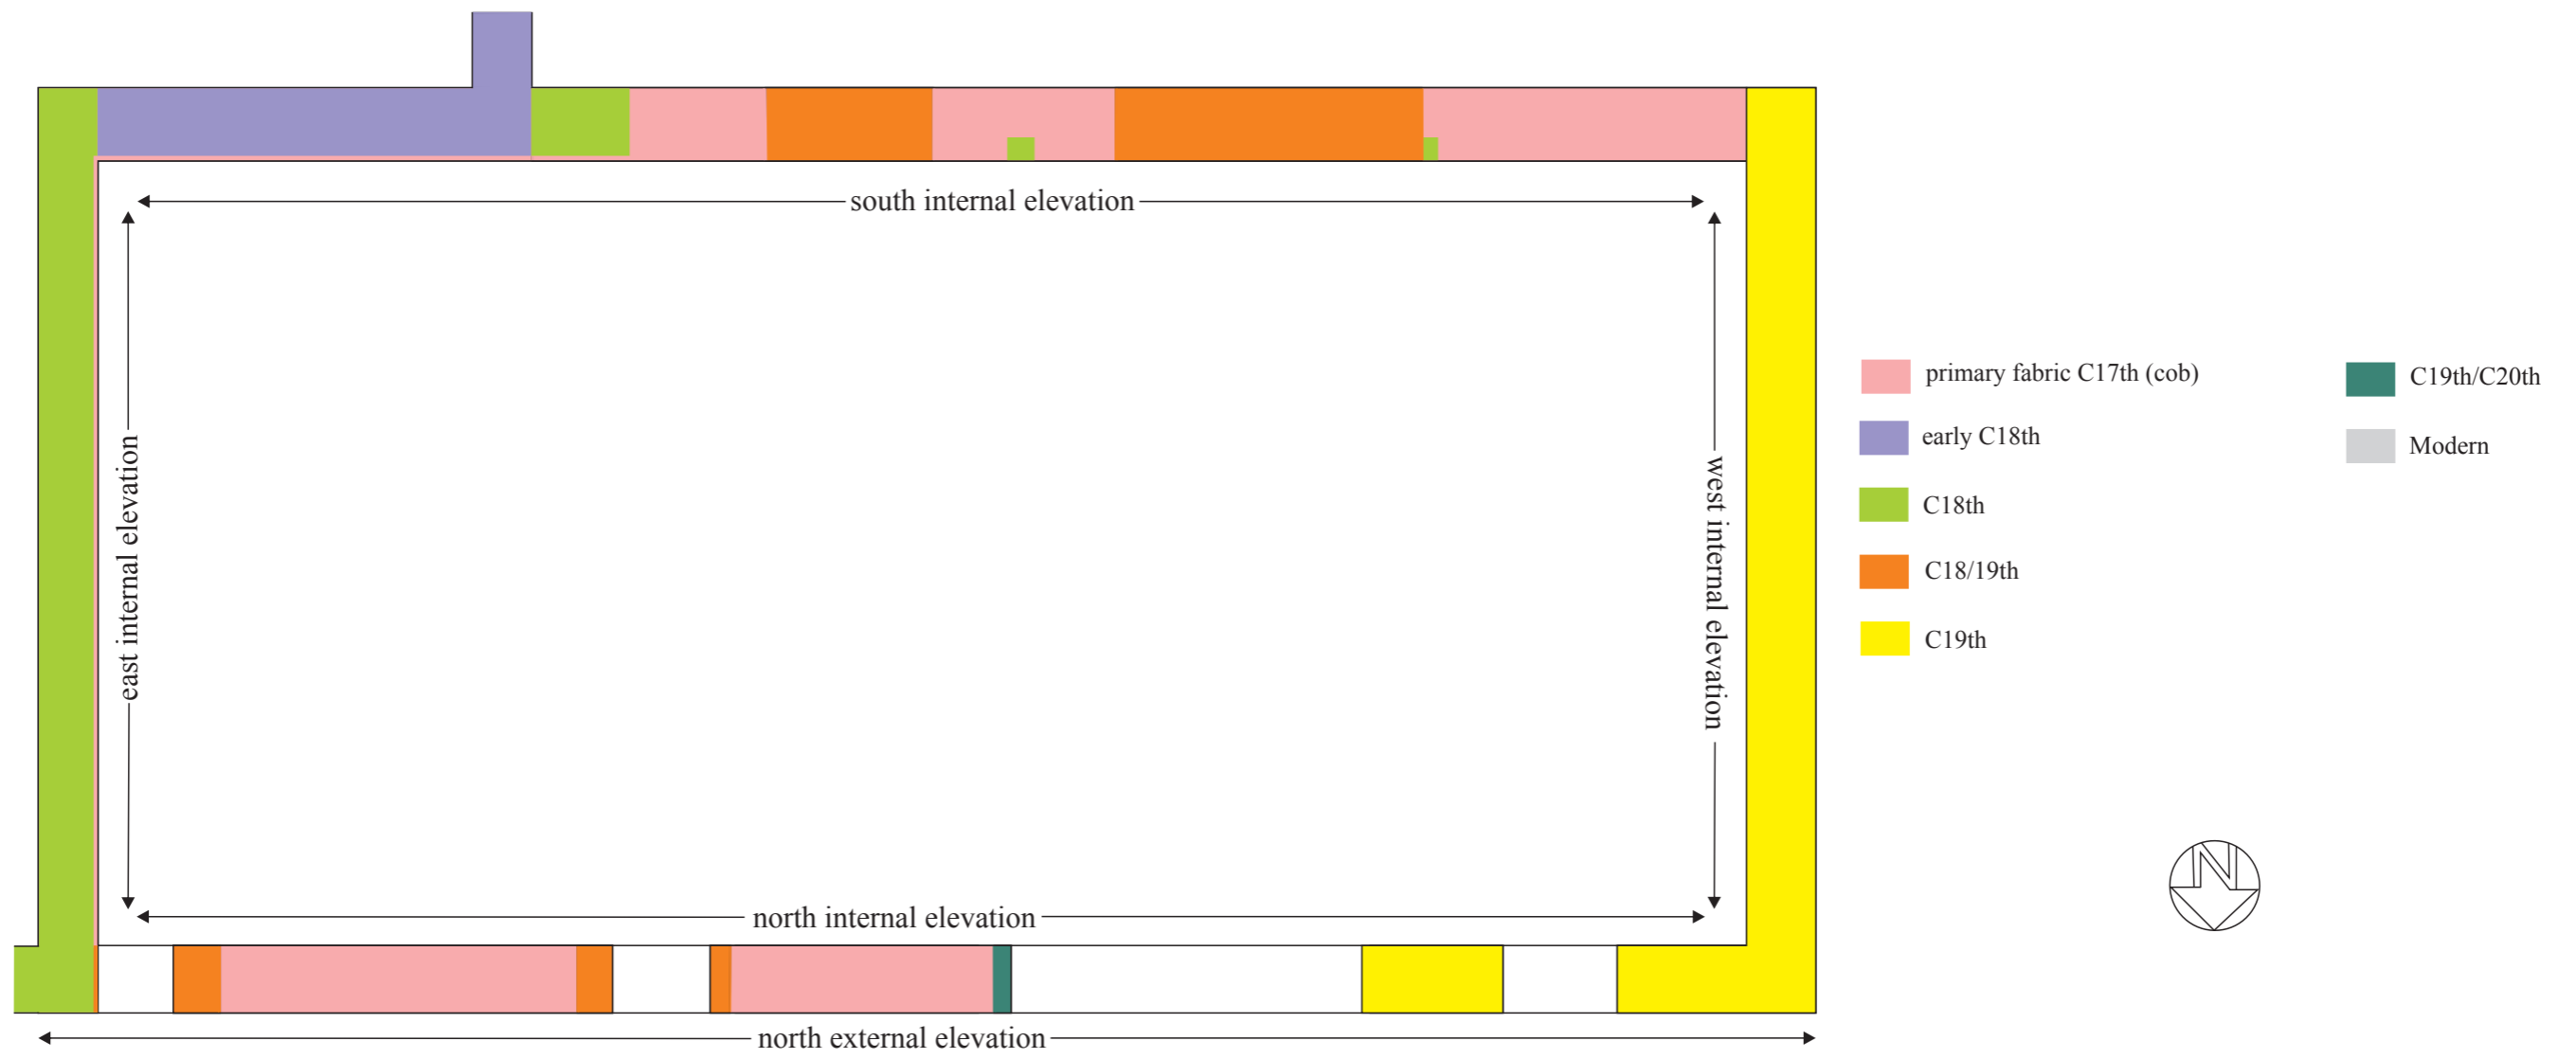
Fig. 6 Plan of barn showing location of observations and suggested phases of development.

The barn (Fig. 6) is a small structure measuring approximately 12m long, and is aligned east/west (Pls. 1-2). Dating to the 17th century, the building is constructed of cob above Heavitree breccia footings. It is situated to the south of the main house. A site visit prior to the refurbishment of the building permitted closer inspection of the historic building fabric of the barn, and allowed the identification of areas that contained original features and areas where these had been replaced. Although the barn has been greatly altered it nevertheless retains features dating from the 17th and 18th centuries.

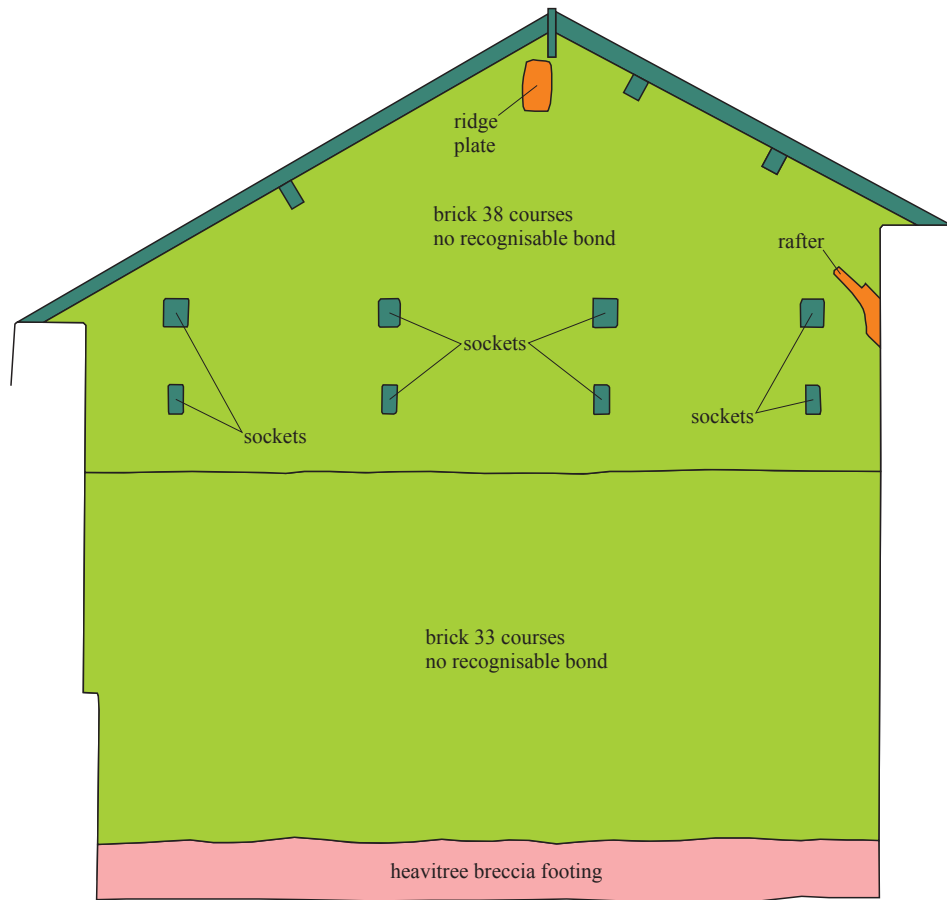
Fig. 10 Hand-measured internal elevation drawing showing features in the east wall.

This elevation (Fig. 10, Pl. 17) presents a unified appearance, being built of 71 courses of 18th century brick with no recognisable bond over Heavitree breccia footings. The brick is likely to represent the construction of the rear range of the neighbouring property. Surviving within the masonry are elements of the 18th century roof arrangement, including the ridge plate and a rafter, suggesting that the roof was slightly lower than it is today.

Two rows of four roughly rectangular sockets remain, possibly representing surviving elements of a loft space.

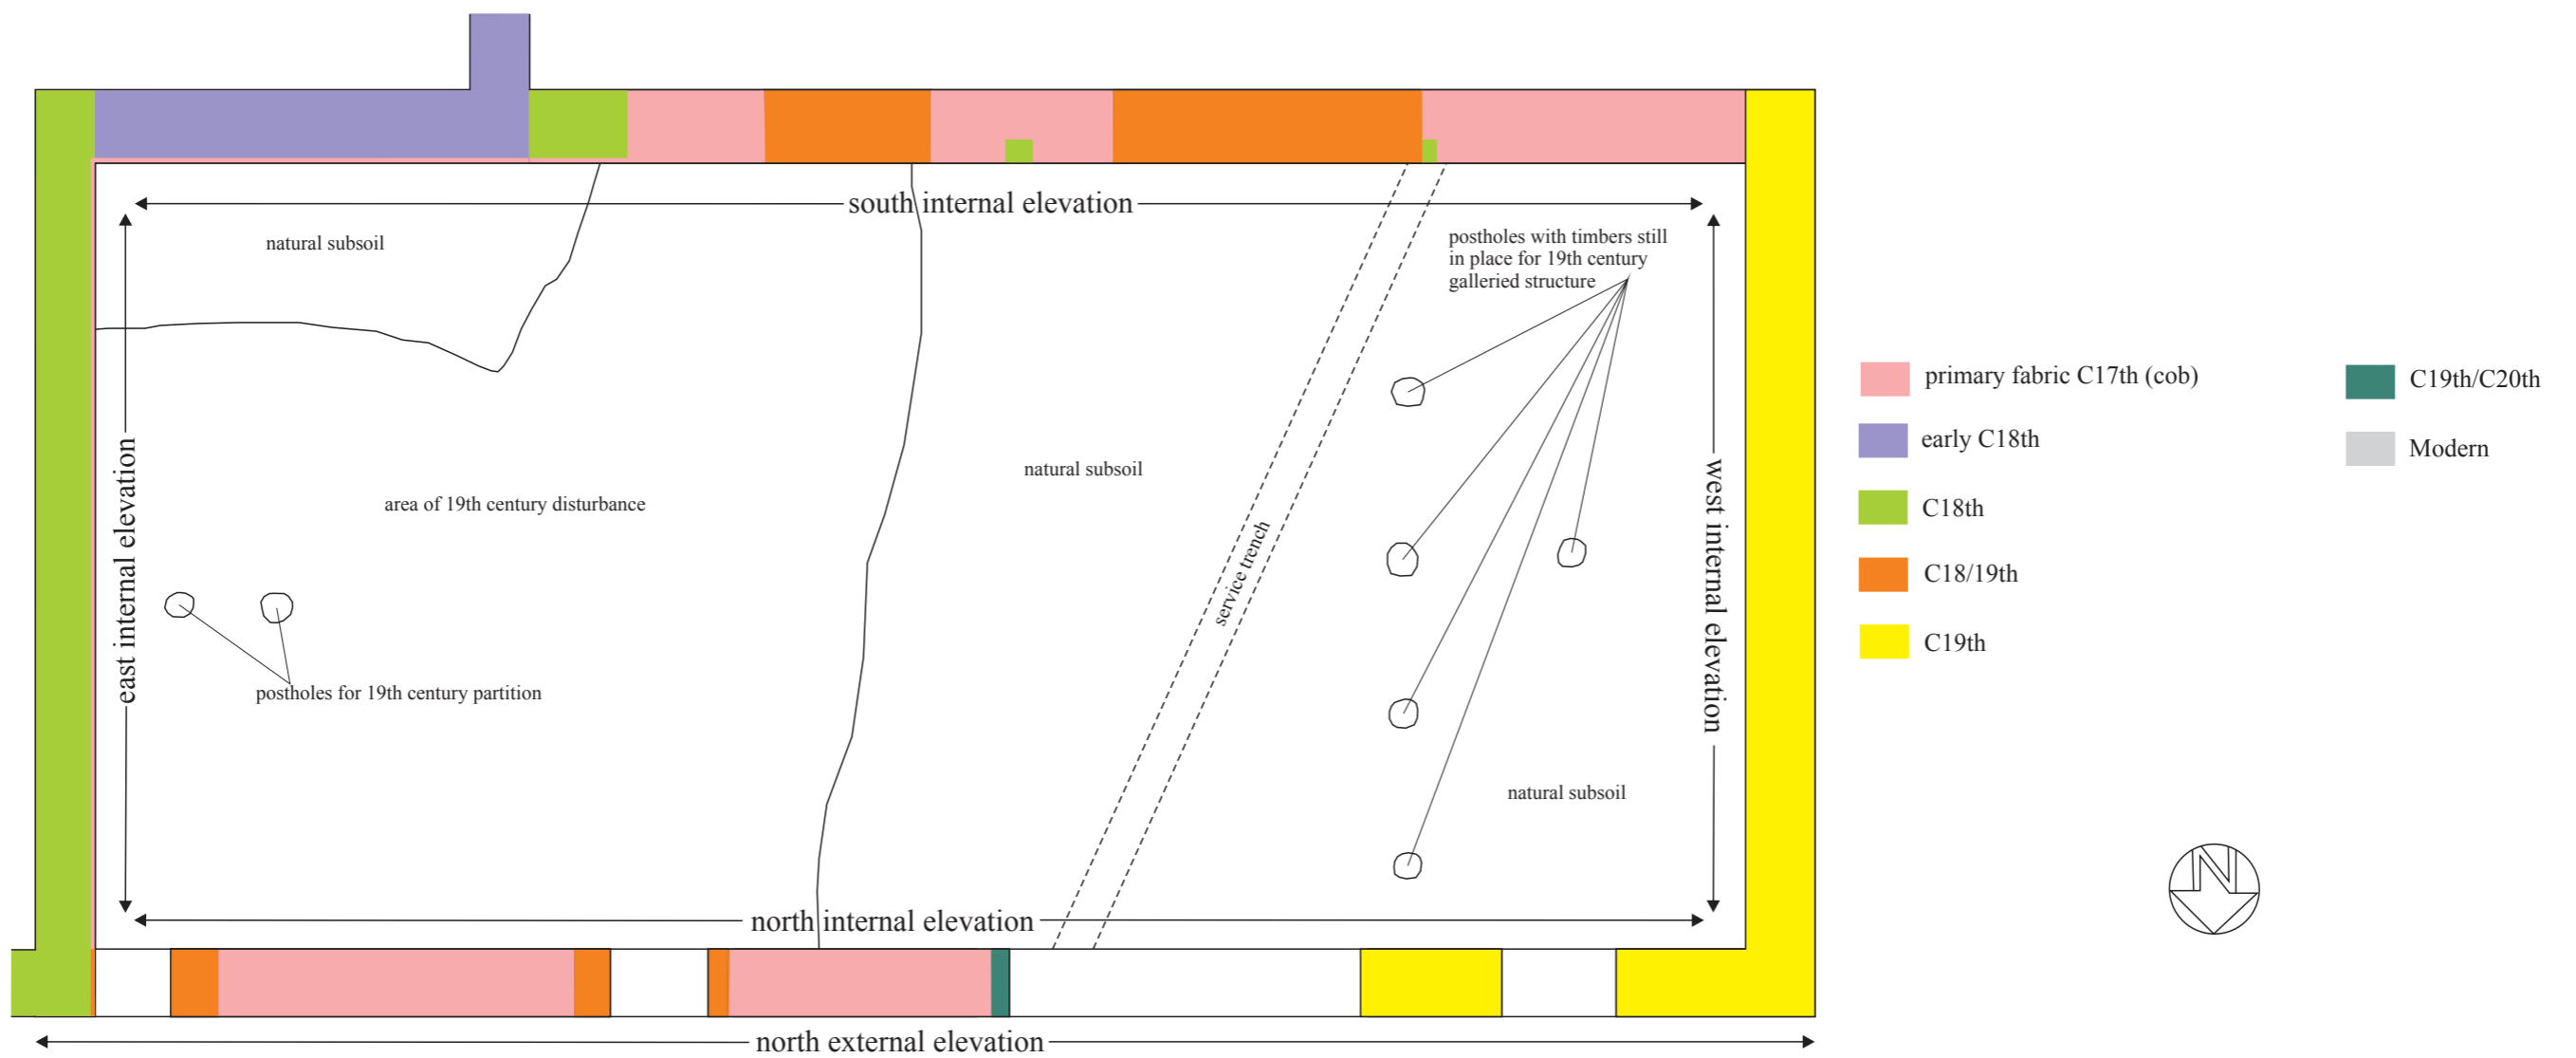
Fig. 12 Plan of barn showing location of watching brief observations and suggested phases of development.

The watching brief (Fig. 12) was maintained during subsequent trenching on site (September 2014). This included the internal floor reduction and excavation of a service trench between the existing house and the front of the barn.

The reduction of the internal ground level was monitored and the reduced area was excavated to a depth of approximately 0.5m deep. Underneath the existing cobbled floor the groundworks revealed large areas of 19th century disturbance in the central and eastern parts of the barn. This contained frequent slate and coal fragments, as well as 19th century blue-and-white transfer ware. Truncating this disturbance were two postholes, located central to the eastern elevation and possibly the remains of a 19th or 20th century partition.

At the western end of the barn five postholes, with the timbers still *in-situ*, likely represent the remains of a galleried structure, dating to the 19th-20th century.

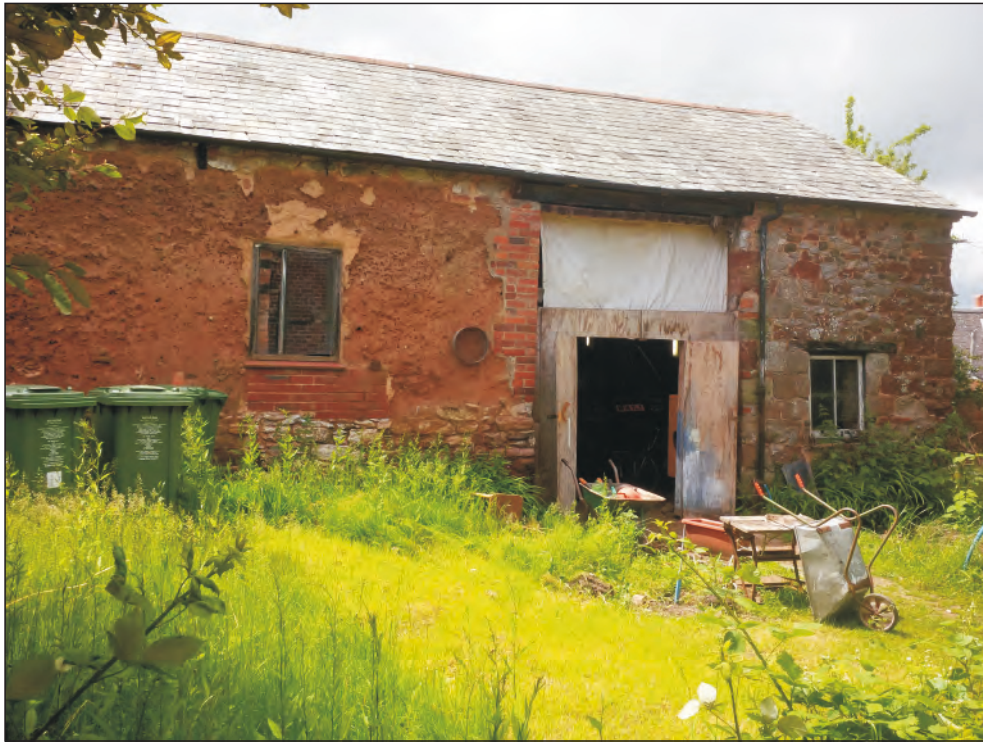
Pl. 3 General view of north elevation showing extensive 19th century rebuilding of west end (right).

The western end of the building has been rebuilt in limestone rubble and 19th century bricks with breccia quoins bonded with a sandy light-brown mortar containing lime flecks. This represents the rebuilding of the western wall, possibly as a result of structural failure. A simple 19th century reused 2-light sash window with timber lintel had been built into the wall.

This was formerly one of the two gabled elevations of the barn. It has been severely altered and no early fabric remains. The main elevation (Pls. 3-4) has been rebuilt with 19th century brick, roughly squared sandstone blocks, small limestone rubble and breccia quoins, while the gable has been built-up with timber panels, infilled with 19th century bricks, and may represent a further phase of rebuilding.

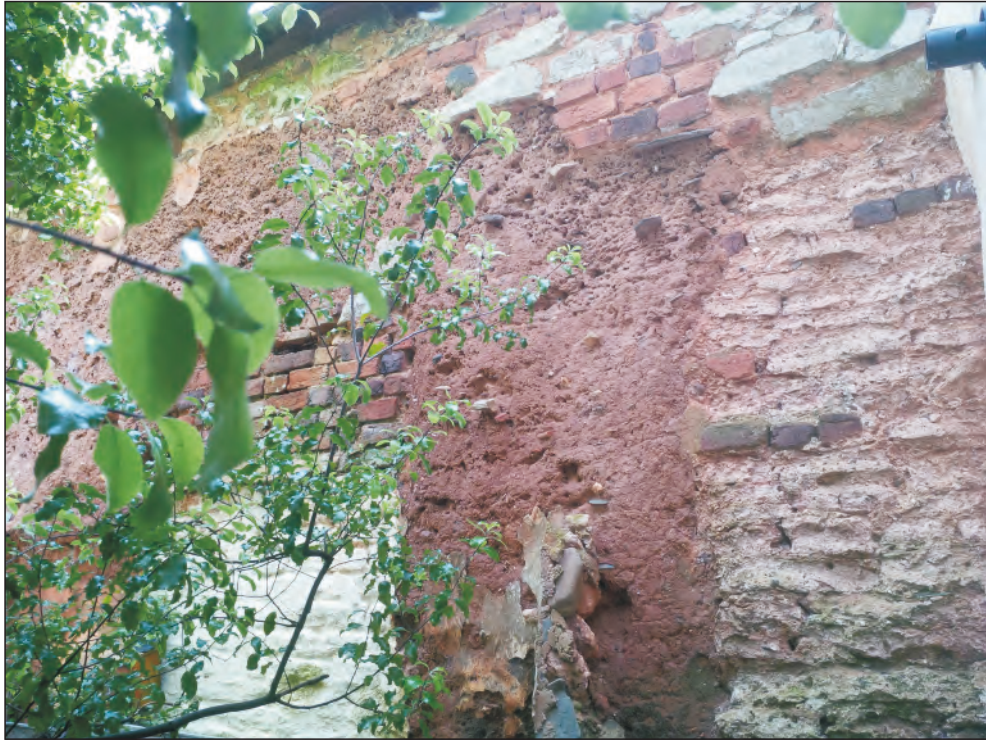
Pl. 9 Detail of south elevation.

The south elevation (Pls 9-10) is almost entirely concealed by foliage and, in part, by modern buildings on this side of the barn. The wall is largely cob-built, with traces of 19th century brick and limestone rubble patching. At the centre of the elevation is a later opening, blocked with late 18th-early 19th century brick. A further opening in the west part of the wall has also been blocked using grey limestone rubble, and probably represents a later doorway. A shallow buttress, composed of limestone rubble, forms part of the later blocking. This elevation was not recorded in any detail during the current works.

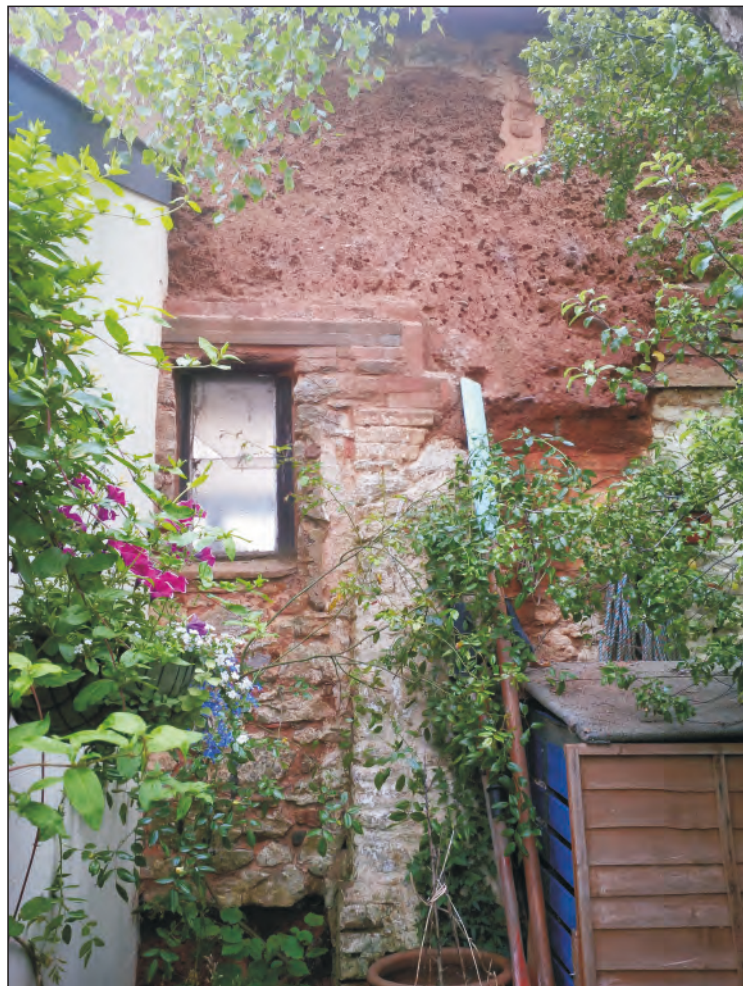
Pl. 10 Detail of south elevation showing blocked doorway.

The large doorway located towards the western end of the elevation has been blocked with grey limestone rubble and occasional volcanic trap fragments set in a soft orange pink lime mortar. The simple wooden lintel is directly surmounted by the original cob fabric, suggesting that the doorway is part of the primary construction of the barn. It is possible that the doorway may have served as a winnowing door.

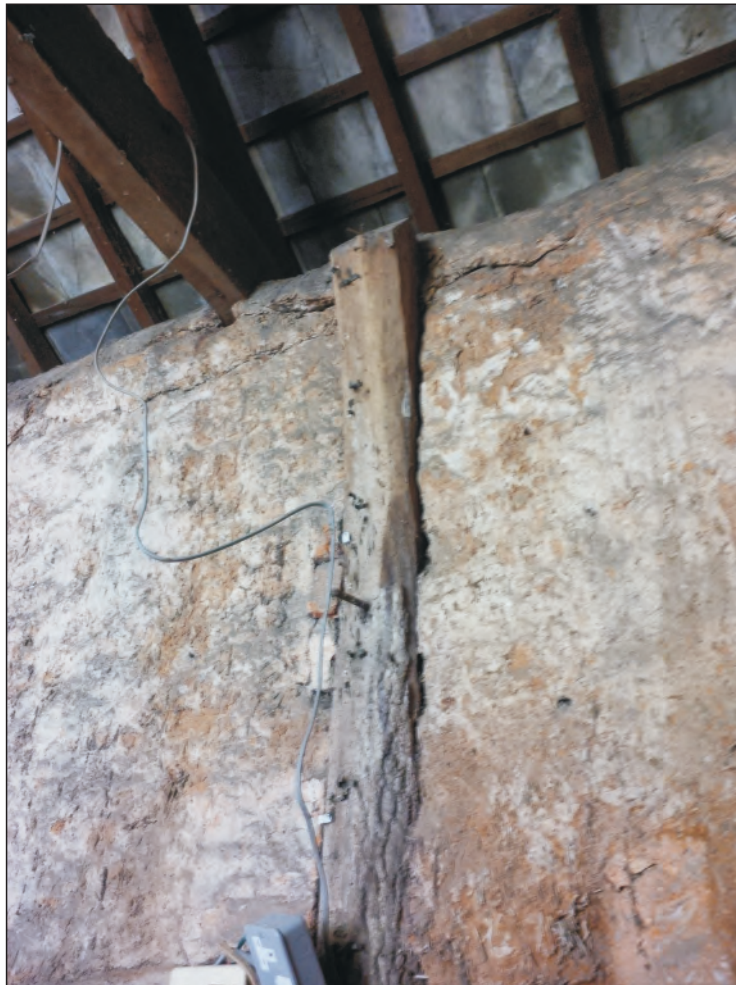
Pl. 12 Detail of in-situ sawn-off cruck in south elevation.

The elevation (Fig. 9, Pls. 12-16) is of richly-coloured brown cob above Heavitree breccia footings and contains signs of blocked openings suggesting ground-floor windows and a doorway. The elevation exposed a further two redundant cruck chases now infilled with small waterworn pebbles set in light grey lime mortar. A single jointed cruck post survived buried in the cob wall immediately to the west of the blocked doorway. This had been sawn off at

eaves level prior to the construction of the later roof, providing a small glimpse of the original roof arrangement.

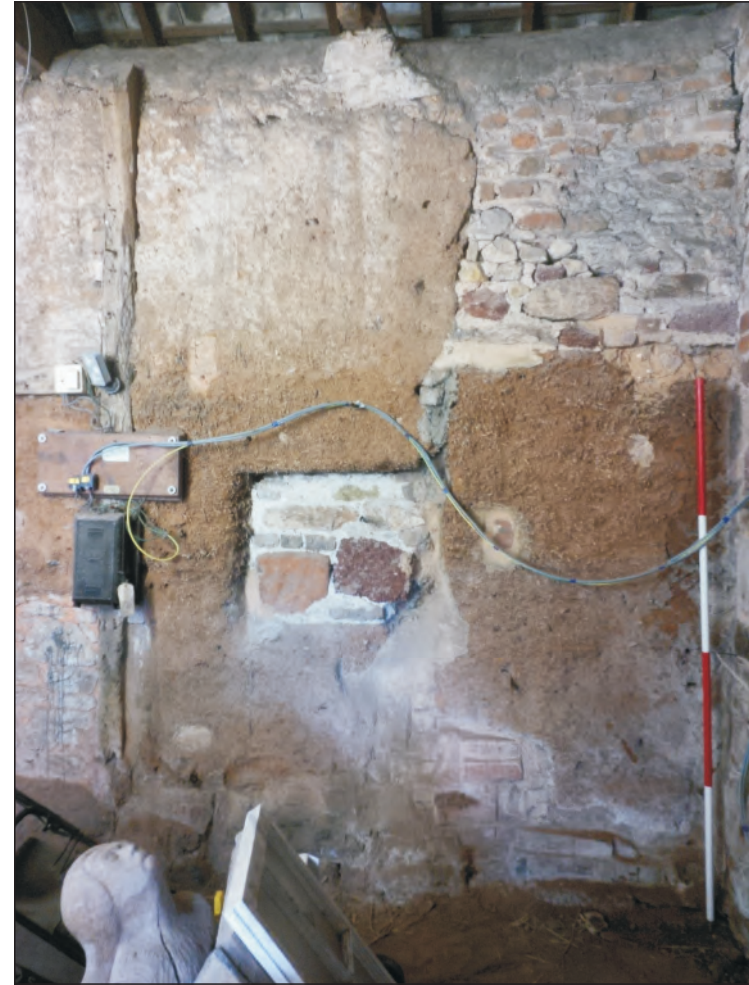
Pl. 14 Detail of south elevation showing blocked opening.

At the centre of the south elevation is a later opening blocked with late 18th or early 19th century brick and a simple wooden lintel. The packing above the lintel would suggest that the window is a later insertion into the primary cob fabric. A small splayed opening, blocked with limestone, sandstone and breccia rubble, at the western end of the elevation may also be a later addition.

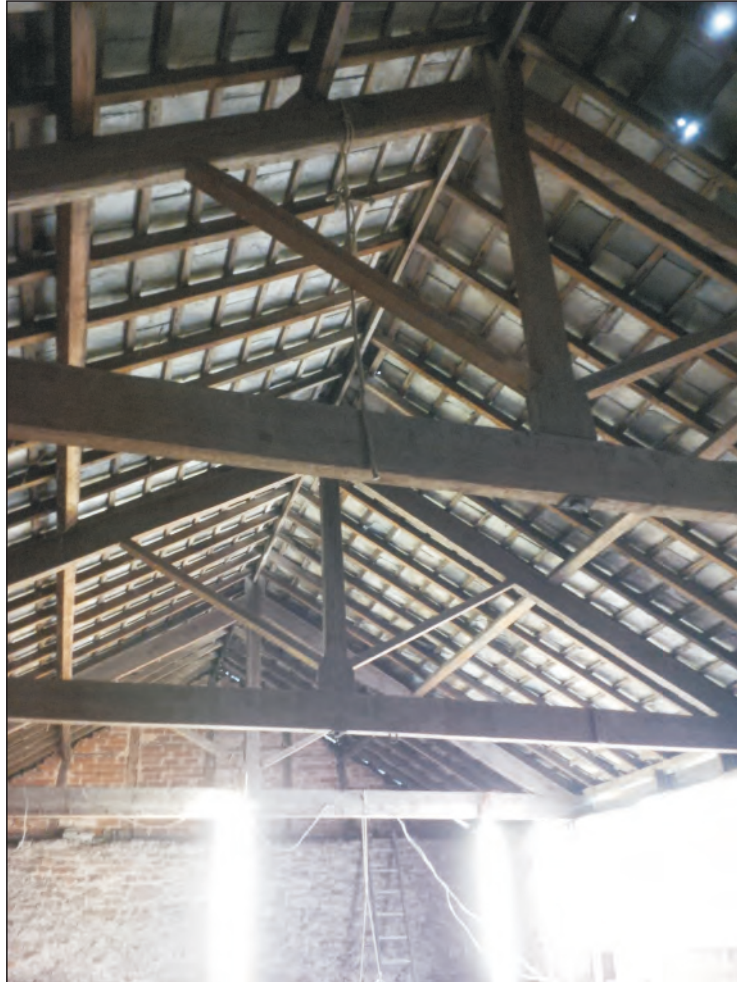
Pl. 21 Detail of 19th century roof arrangement.

The roof structure (Pl. 21) over the barn is gabled at either end and slated. The roof consists of three king post trusses, with a single level of cleated purlins on each side. These trusses divide the roof space into 4 roughly equal bays, each approximately 3m wide. The feet of the main trusses at the eaves rest on the top of the cob of the north and south walls. The common rafters continue to a ridge plate. To compensate for the additional height at the eastern end of the south elevation six rafters, including three augmented rafters were added to the roof. This is likely to be a 19th or early 20th century rebuilding of an earlier roof.

The current king post truss roof over the barn is a 19th century arrangement, set into the rebuilt west end of the barn.
