**OAKFORD
ARCHAEOLOGY**

**Archaeological monitoring and recording at St
Mary's Church, Ottery St Mary,
Devon**

Report No. 16-07

February 2016

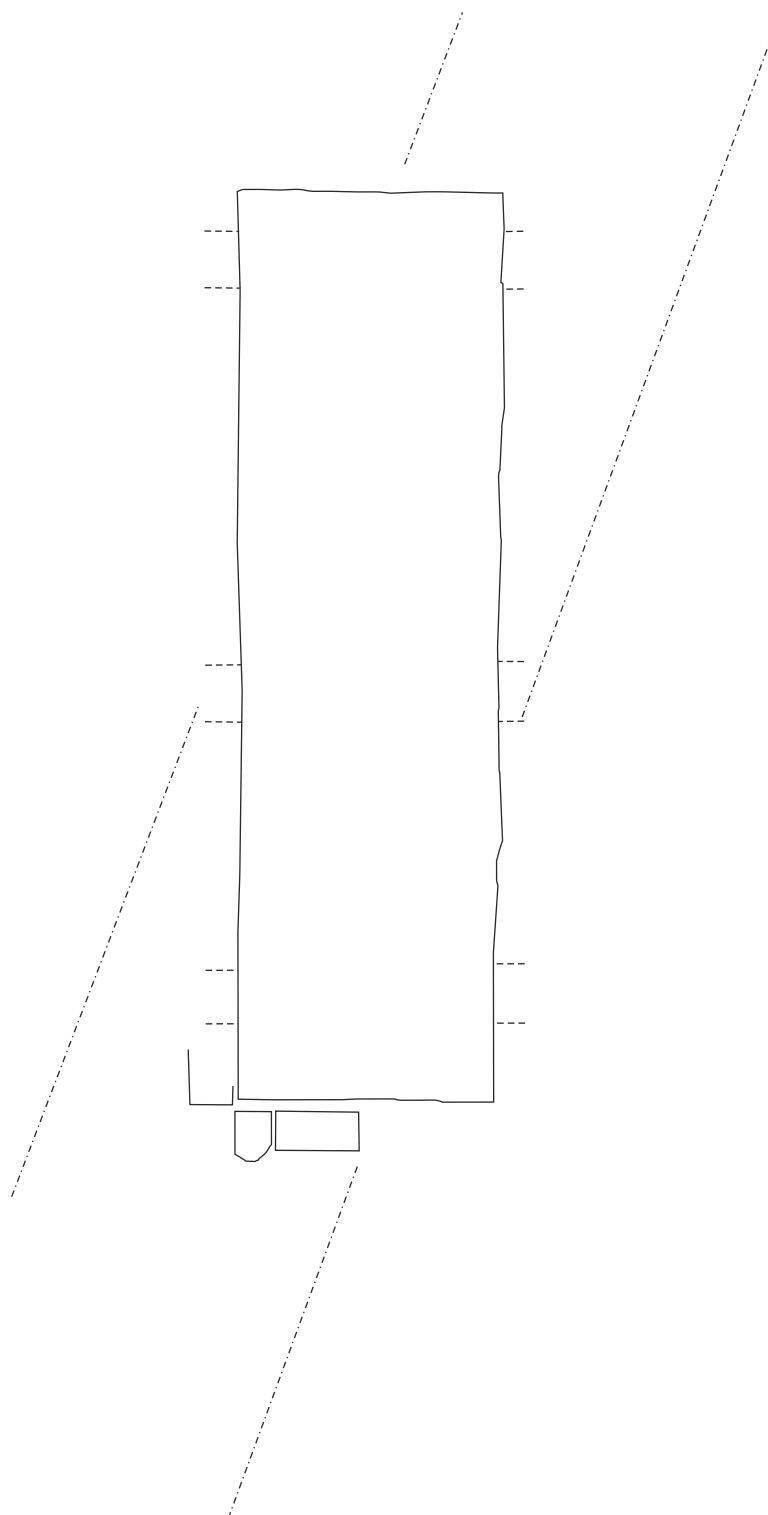
Fig. 5 Brick vault 112.

Grave 112, was built of lime washed brick and located to the north of the choir vestry. It measured 2.7m in length and 0.85m in width and contained a single adult inhumation (skeleton 113). The grave was cut into the underlying charnel soil. The Skeleton (113) was in a good state of preservation, and was 76-100% complete. The remains were of an adult. The burial was laid out in an extended and supine position, with the head to the west and the legs to the east. The edges of the brick lined shaft extended beyond the limits of the excavation. The skeleton lay within the remnants of a coffin. The top of the brick lining was removed and the remains left *in situ*.

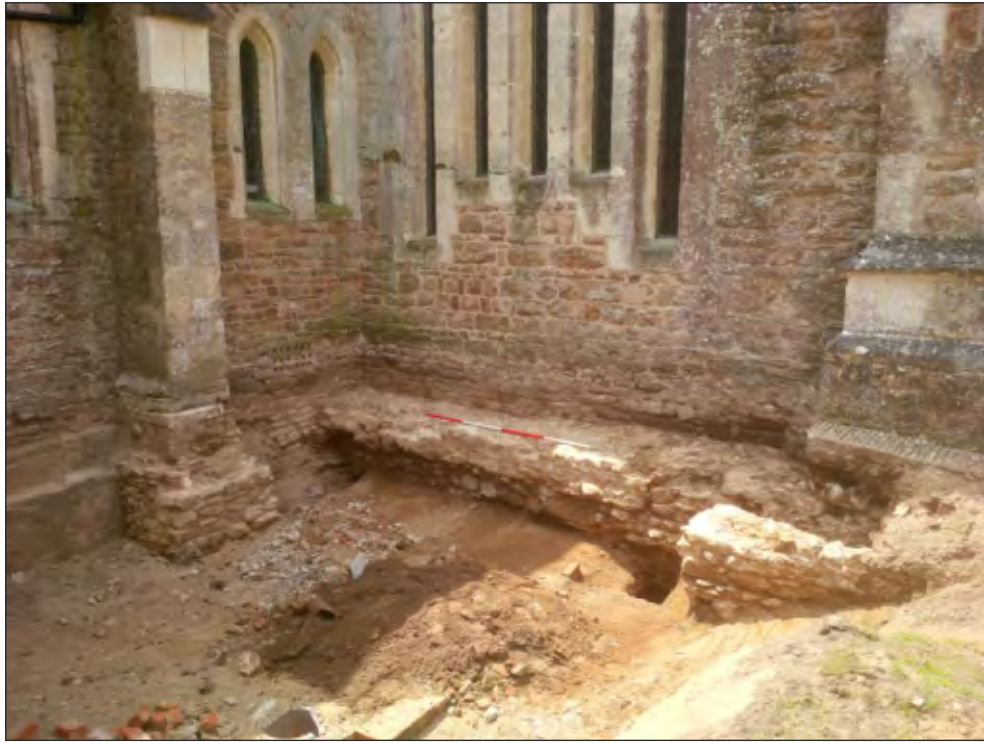
Pl. 1 General view of the tower foundation. 2m scale. Looking southwest.

The excavations exposed the foundations of the north tower, measuring approximately 5.3m long, 1m wide and 0.7m thick, and its relationship with the north choir aisle wall. Inspection of the junction showed that the tower is later – a point evident at their foundations. The footing of the north tower are later, with the masonry of the tower butting up to the north wall of the choir aisle. Moreover, at the facework level none of the coursing corresponds to the coursing seen in the choir aisle wall. Composed of Otter conglomerate and rubble bonded with light yellowish white lime mortar the foundation was trench built. The main facework consisted of roughly dressed Otter conglomerate and smaller rubble. All of the elevation was re-pointed using light pinkish white lime mortar with coarse grit, making it impossible to identify areas of primary mortar. The build represents the rebuilding of the church in the mid-14th century.

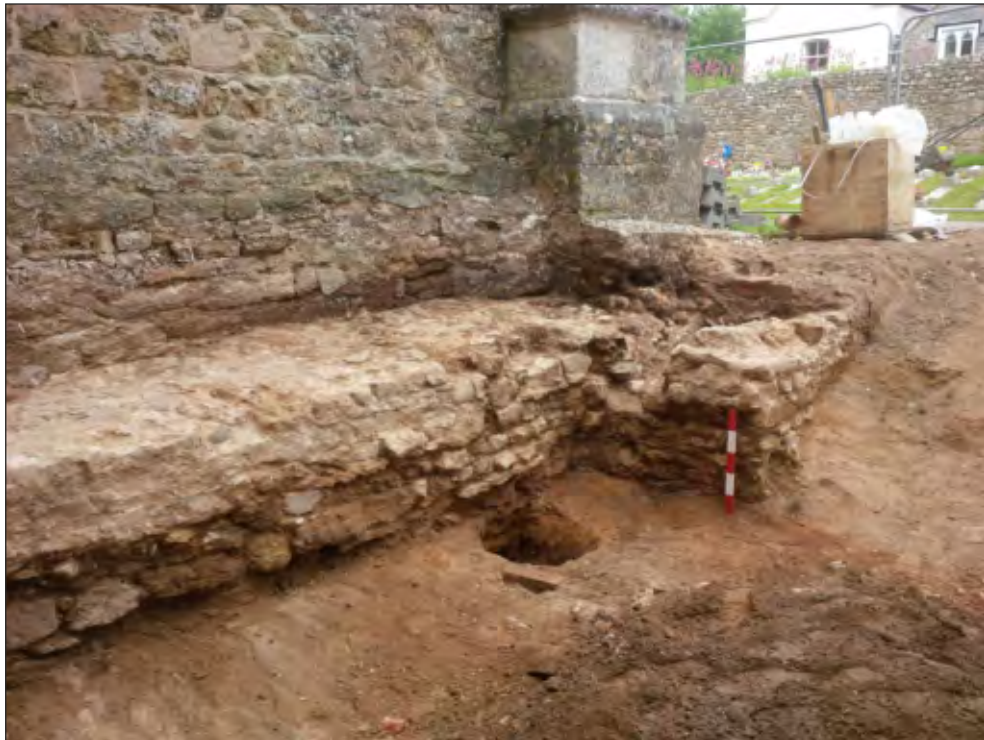
Pl. 2 Close-up of the tower foundation. 0.5m scale. Looking northwest.

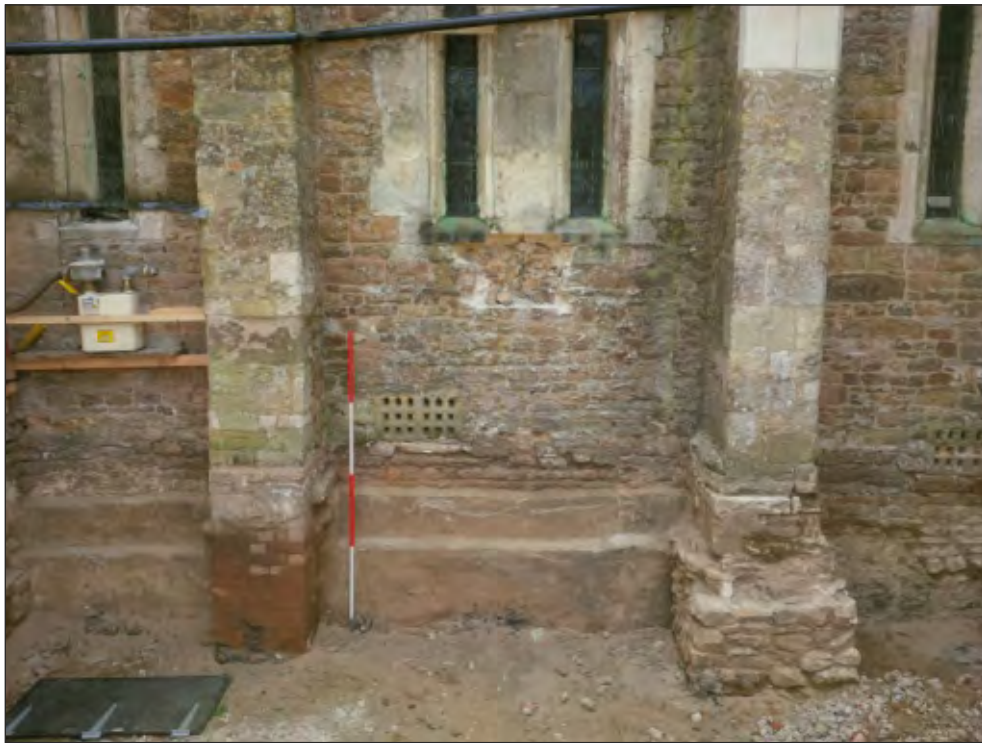
Pl. 3 General view of the choir aisle wall and later buttresses showing level of 19th century underpinning (left). 2m scale. Looking south.

Both the buttresses against the choir aisle wall and the buttress against the choir vestry wall are later additions. Of the two buttresses against the choir aisle wall only the foundations of the western buttress survived. This was composed of a 0.7m high foundation consisting of Otter conglomerate and Beer stone rubble bonded with light yellowish white lime mortar. Above this was a smaller plinth, approximately 0.3m high composed of roughly squared Beer stone, Salcombe stone and Otter conglomerate. The facework of the buttress consisted of a Beer and Salcombe ashlar front, with Otter conglomerate at the rear. Inspection of the junction with the choir aisle wall showed that the buttress is a later addition.

The foundation of the eastern buttress had been removed in the 19th century and subsequently underpinned with bricks, while the choir vestry buttress foundation was covered in mortar making detailed recording impossible. Inspection of the junction with the choir vestry wall foundation showed that the buttress is a later addition.

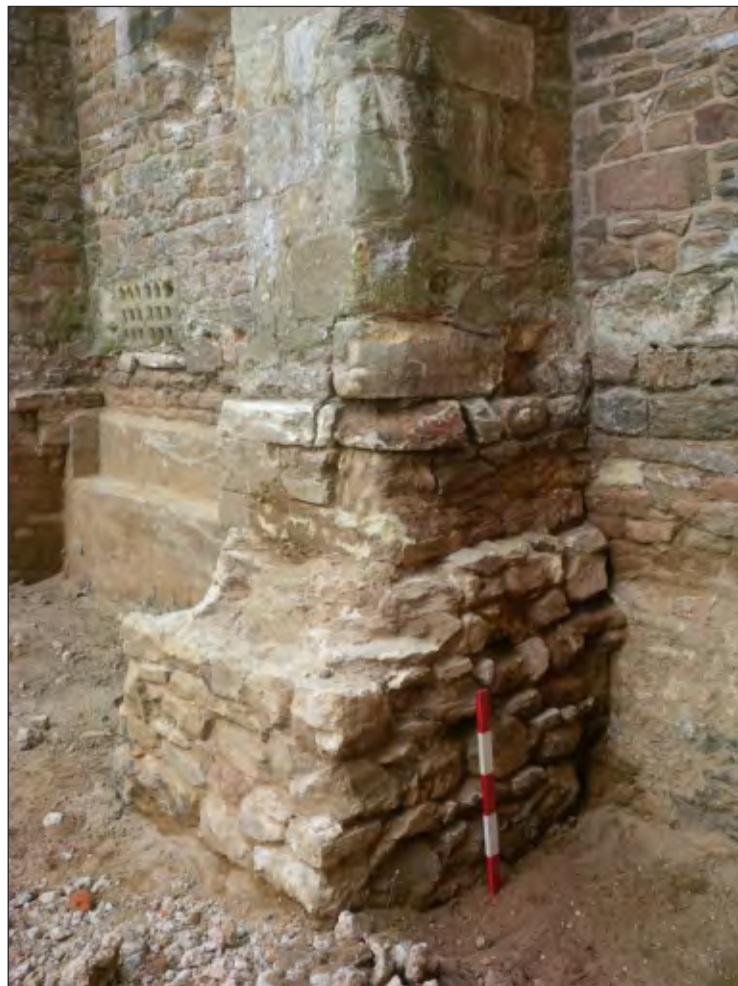
Pl. 4 Close-up of buttress showing buttress foundation butting-up against choir aisle wall. 0.5m scale. Looking southeast.

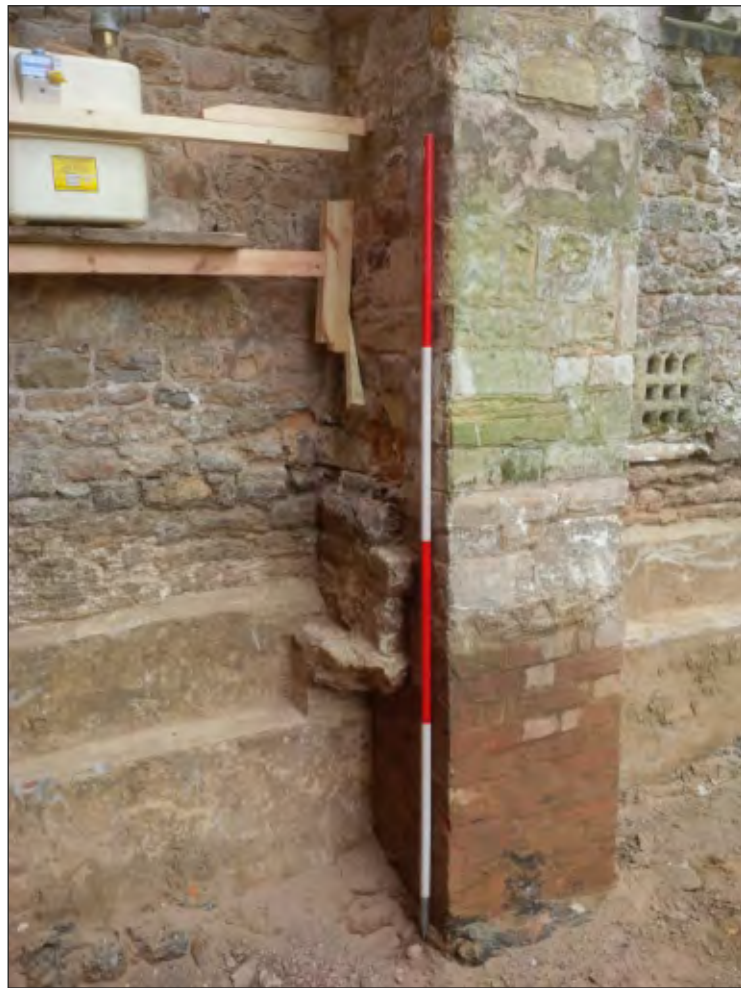
Pl. 5 Close-up of buttress showing 19th century rebuilding and underpinning. 2m scale. Looking southwest.

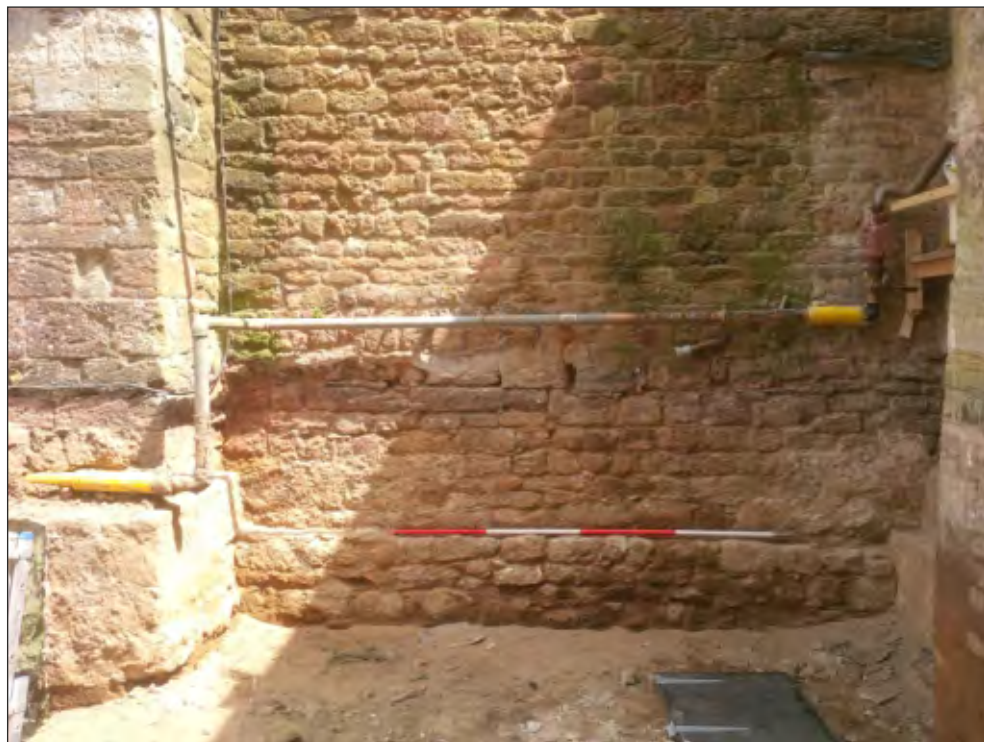
Pl. 6 General view of choir vestry foundations. 2m scale. Looking east.

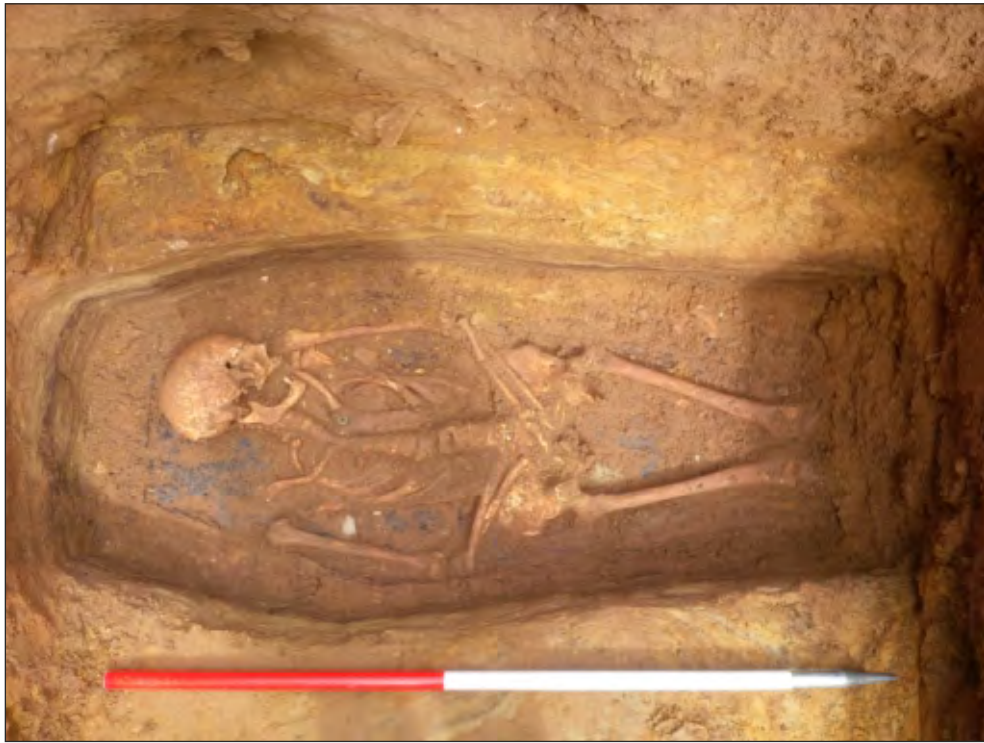
Pl. 7 Close-up of Skeleton 110 showing surviving coffin imprint. 1m scale. Looking north.

The natural geology was cut by a single approximately west-east orientated grave. This was the only grave affected by the drainage works and was excavated in accordance with a Ministry of Justice licence. The remains of a coffin was identified underneath the skeleton and the presence of a single button, might suggests that the dead had been laid out clothed within the coffin. No earlier archaeological deposits were found below the grave.

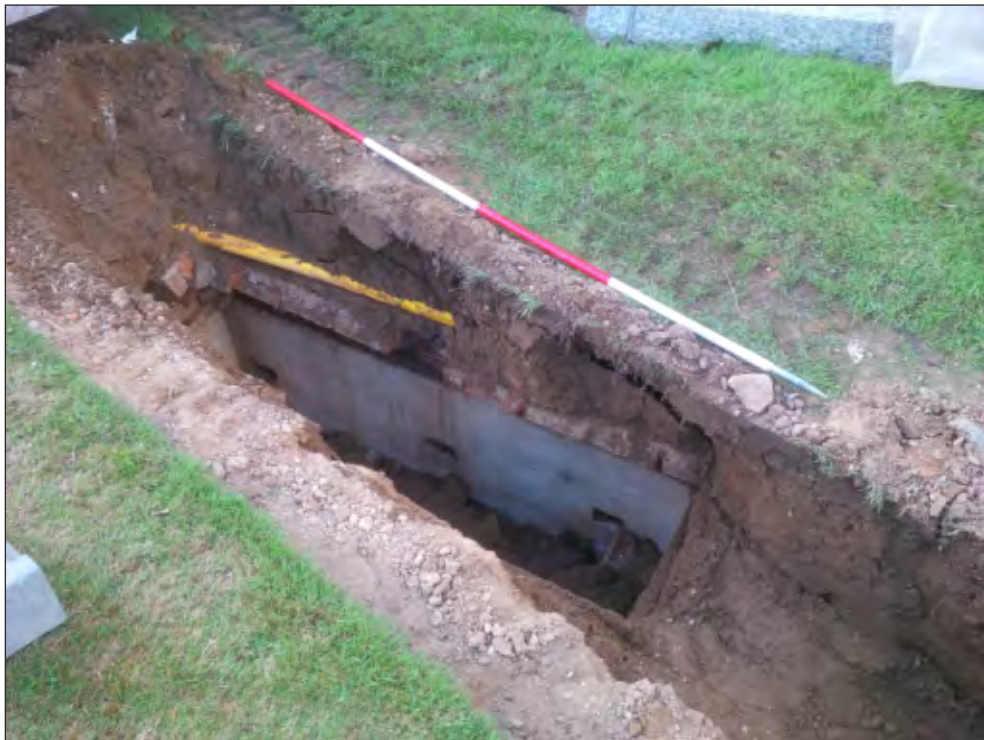
Pl. 8 General view of brick vault 112 showing sockets. 2m scale. Looking southeast.
