**Historic building recording and monitoring and
recording at Higher Uppacott, Poundsgate,
Devon**

on behalf of
Dartmoor National Park Authority

Report No. 16-02

August 2016

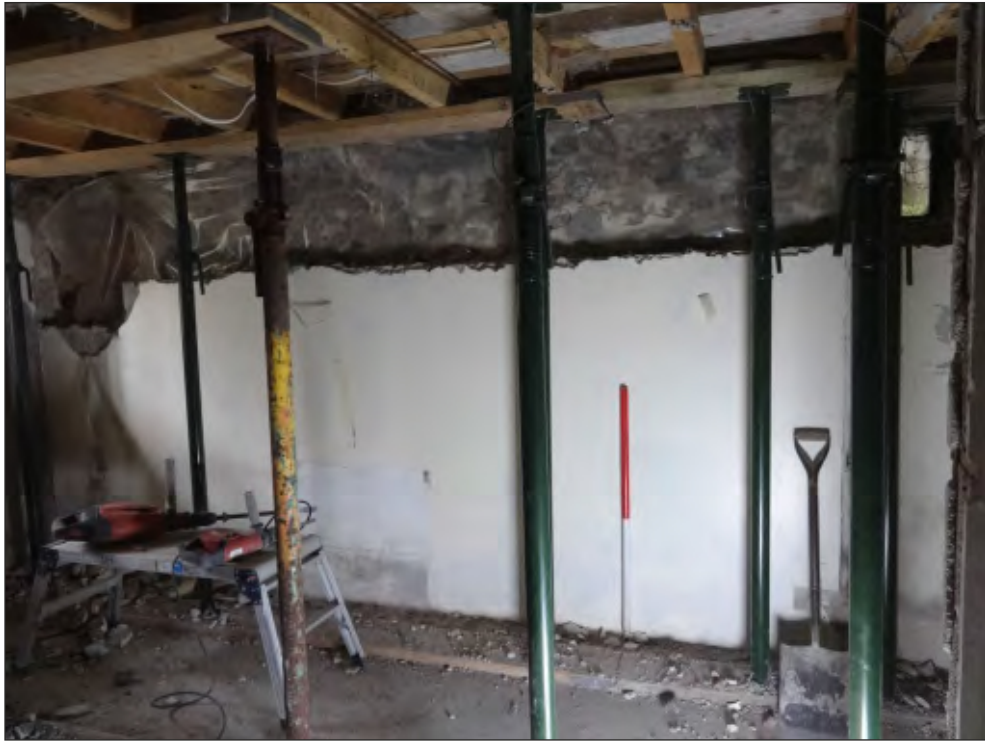
Pl. 1 Demolition works in the inner room, showing the tanking of the north wall behind the modern walling. 1m scale. Looking southeast.

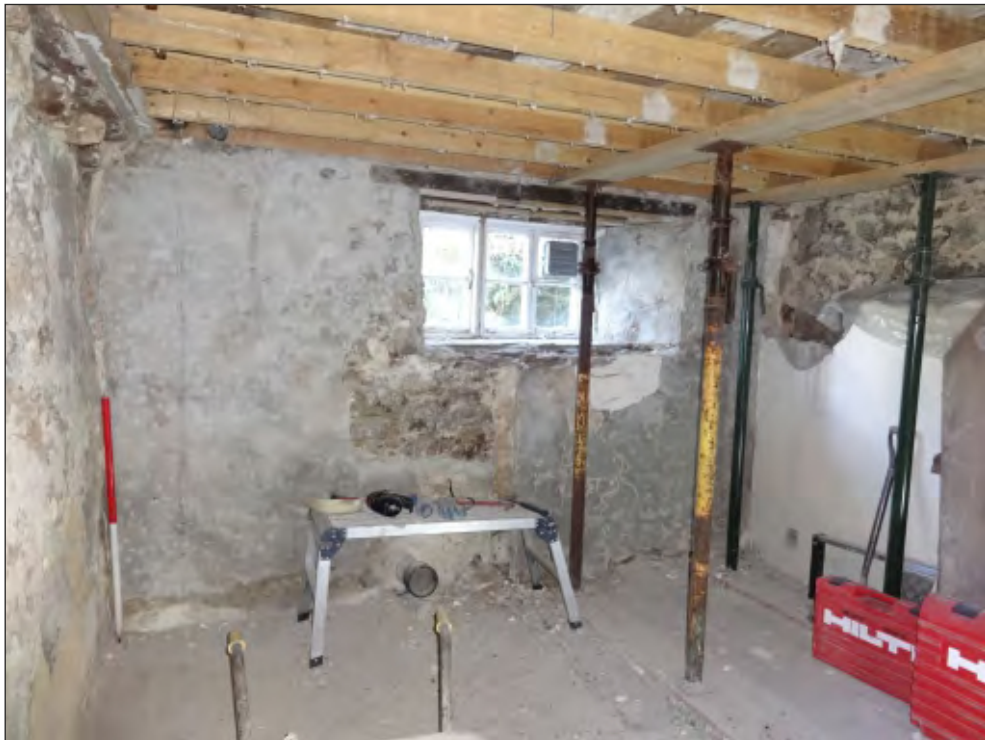
Pl. 2 The inner room after stripping, showing the absence of any sockets for an earlier floor level. 1m scale. Looking west.

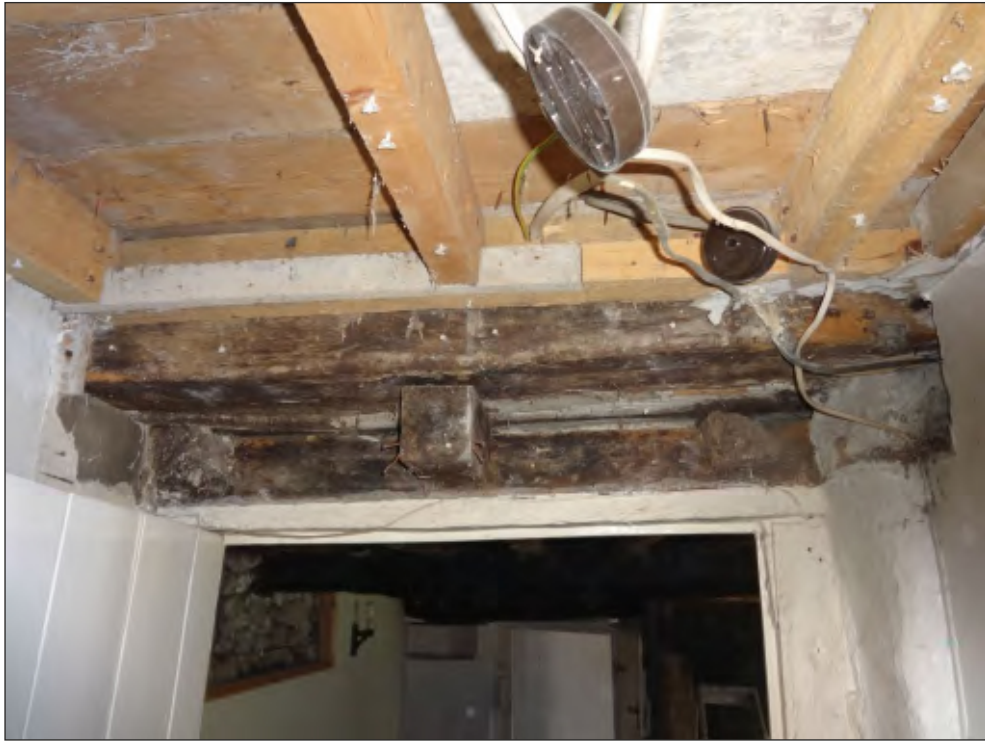
Most unusually, each alternate joist projects over the wall top beyond the north face of the dividing wall, to form a shallow jetty projecting to the north, supporting the first-floor timber partition between the hall chamber and inner room chamber (Pl. 5). This partition is supported on a horizontal jetty bresummer resting on the ends of each alternate joist. The jetty projects out not into the hall, as is usually found in Devonshire farm houses, but rather into the inner room. Furthermore, the jettying of the hall chamber over the inner room, rather than the inner room over the hall, demonstrates that the flooring over of the hall must pre-date the insertion of any first-floor structure in the inner room, which must have been open to the roof long after the hall was storeyed.

Pl. 3 Detail of the jetty over the doorway from the inner room to the hall, showing alternating long and short joists beneath the jetty. Looking south.

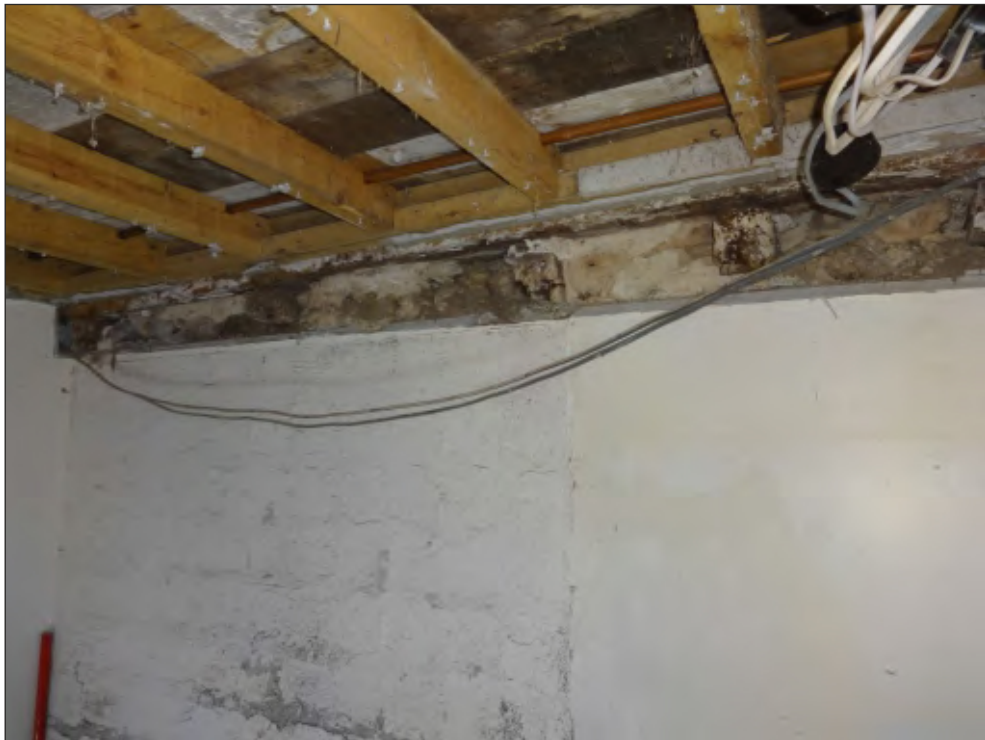
Pl. 4 Detail of the construction of the jetty showing the longer ends of alternate joists beneath the jetty towards the inner room. Looking southeast.

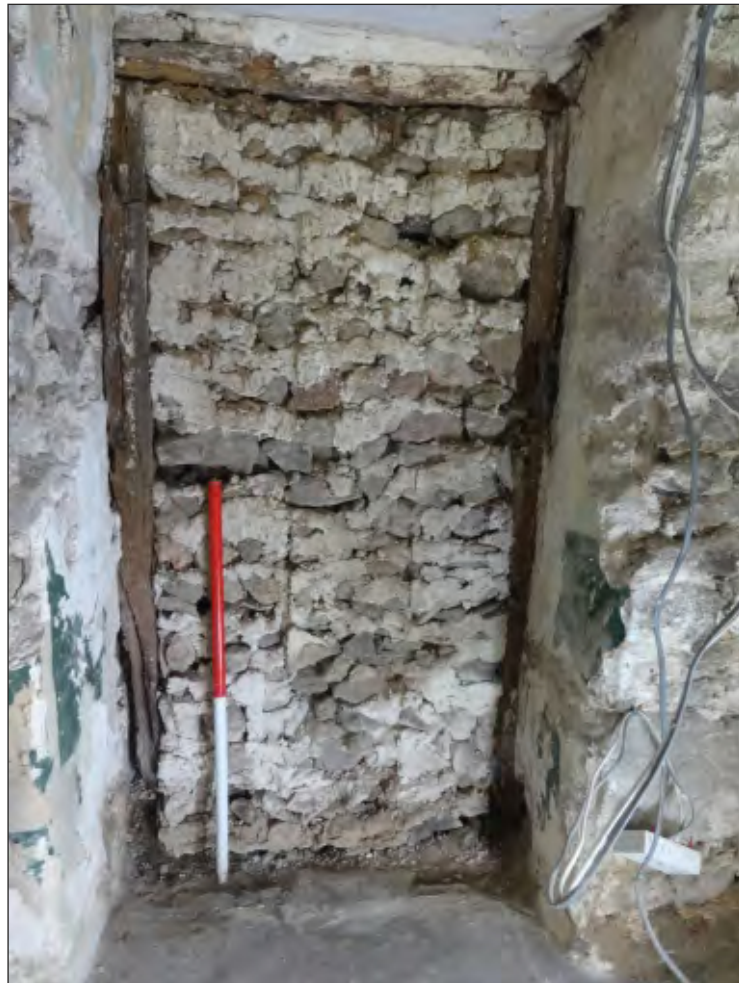
Pl. 6 Detail of the blocked main doorway to the hall, showing the imprint of a 16th- or 17th-century door with applied vertical fillets. 1m scale. Looking east.

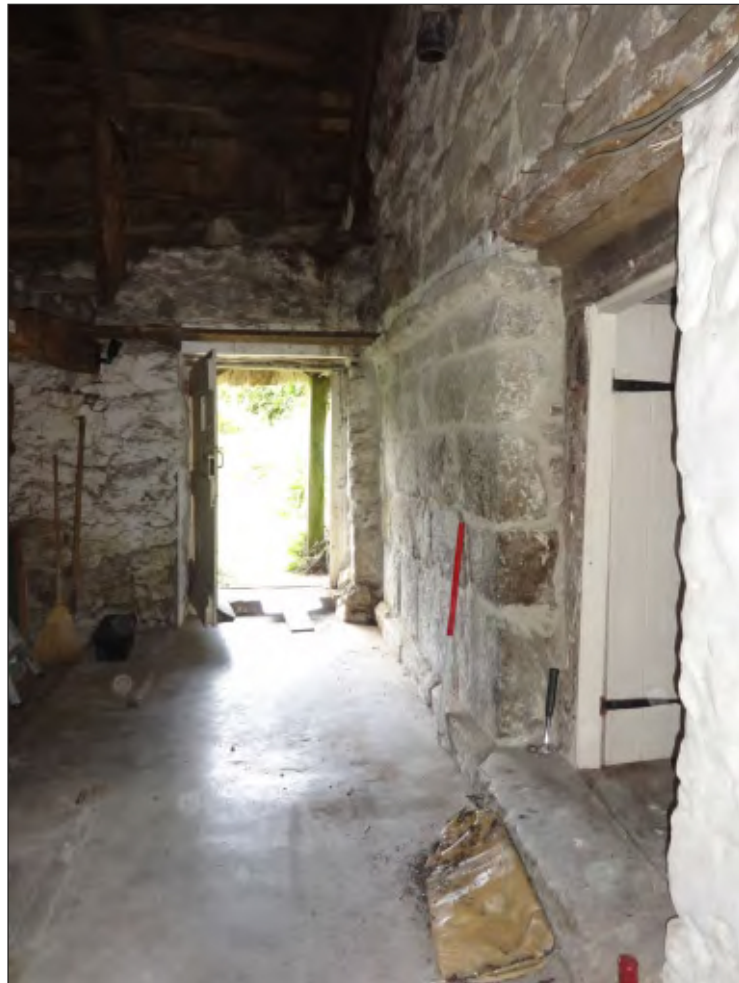
Pl. 8 View of the cross passage following the demolition of the modern partition, showing the granite ashlar of the inserted chimney. 1m scale. Looking west.

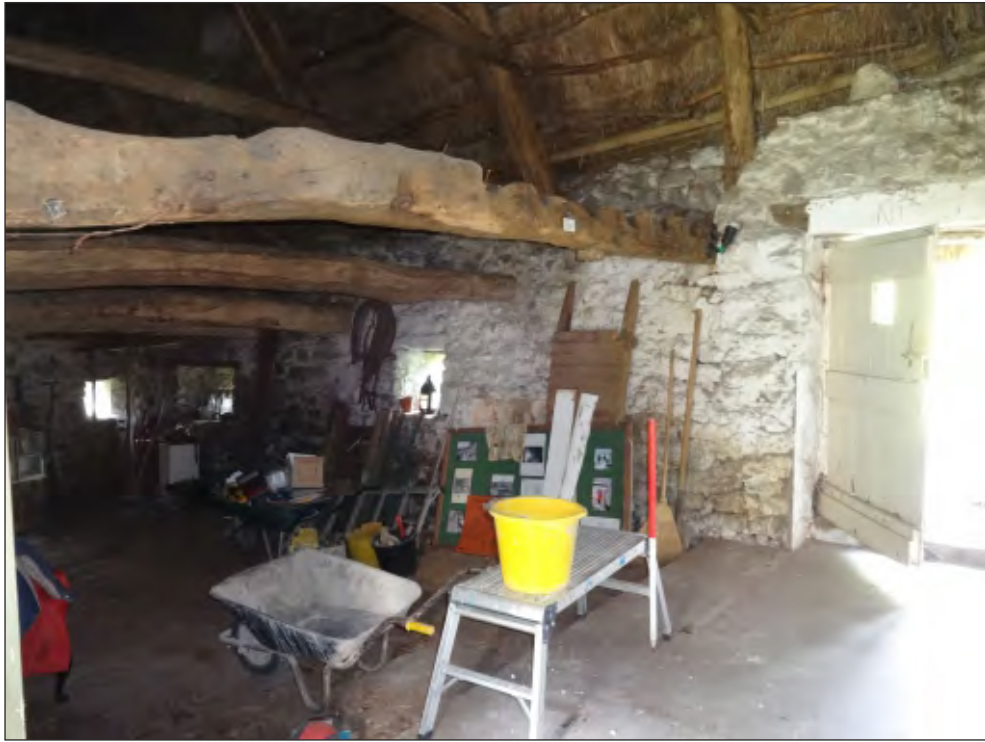
Pl. 11 View of the cross passage showing sockets for the beams supporting a sleeping platform over its western part. 1m scale. Looking southwest.

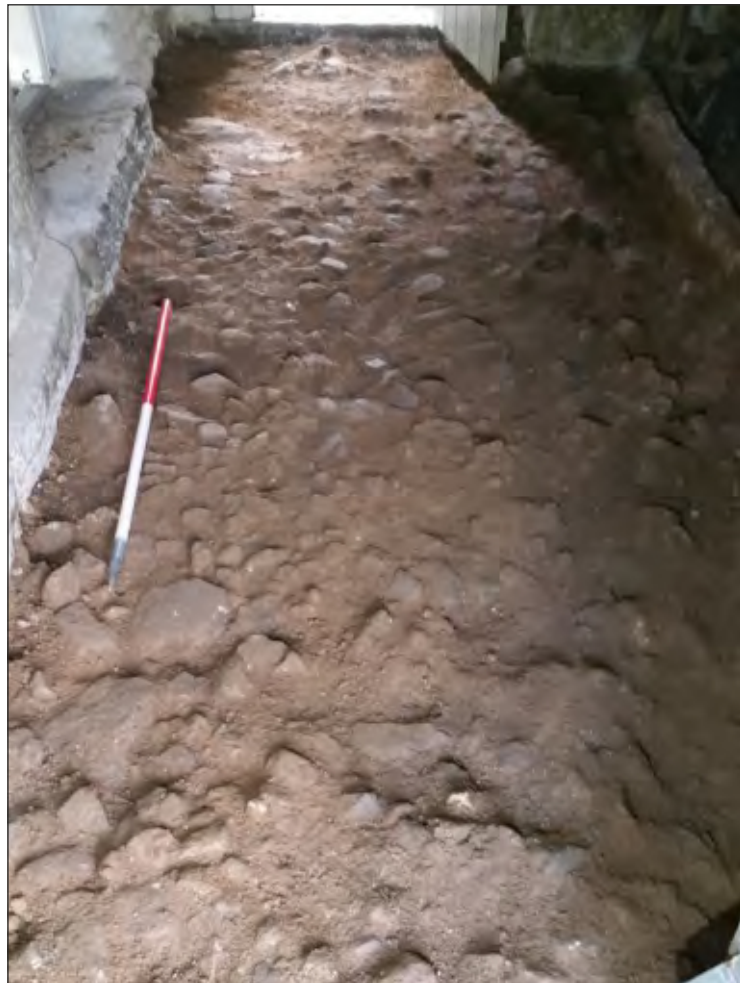
Pl. 12 General view of rough cobbled surface in cross-passage. 1m scale. Looking east.

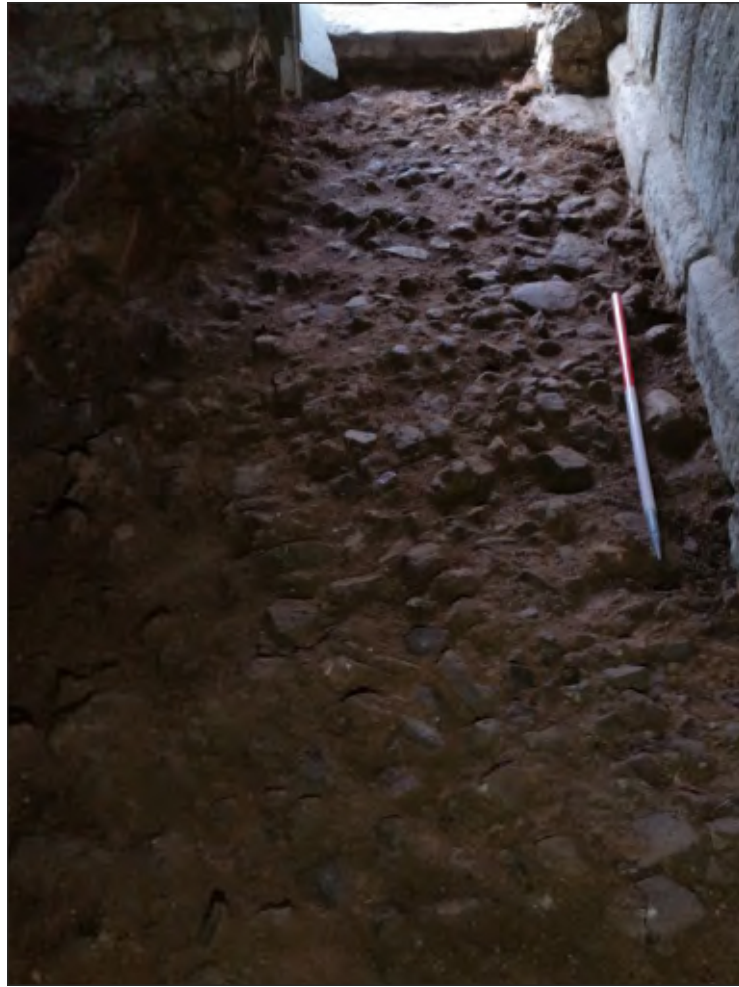
Pl. 13 General view of rough cobbled surface in cross-passage. 1m scale. Looking west.

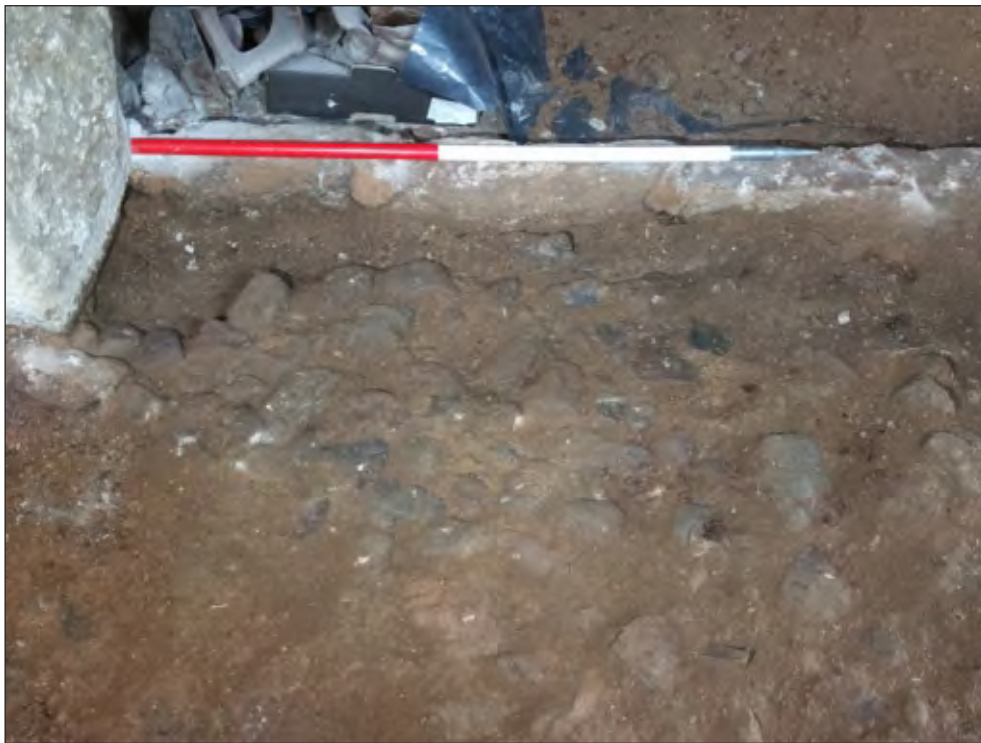
Pl. 14 Close-up of tightly packed cobbles behind eastern cross-passage door. 1m scale. Looking southeast.

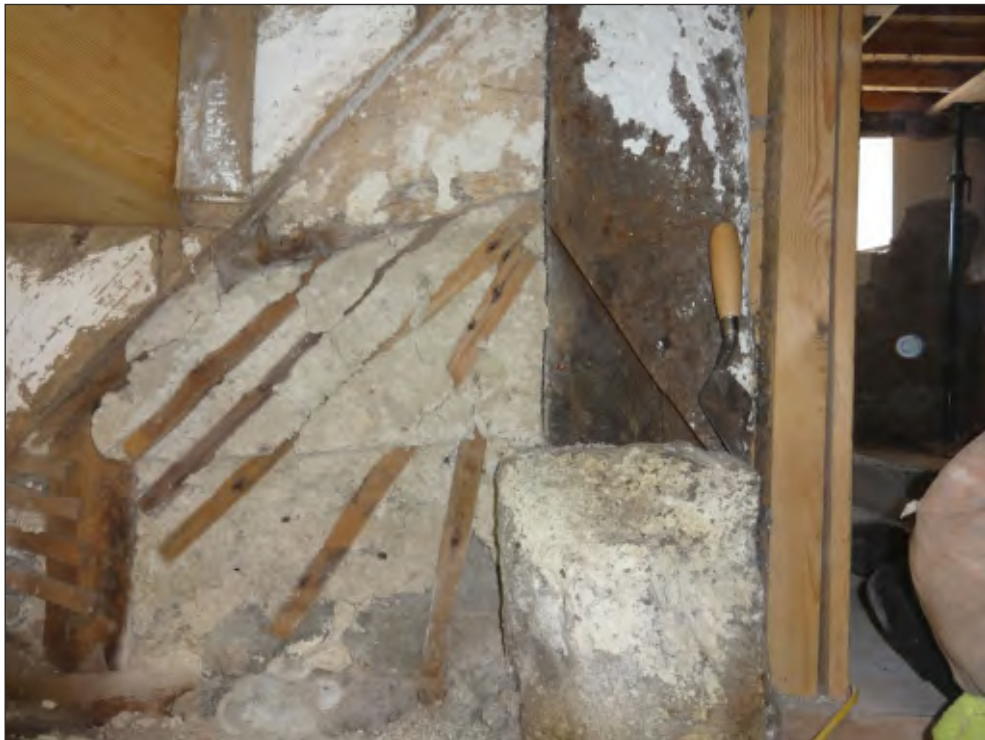
Pl.16 Detail of the area beneath the staircase, showing the diagonal socket and the stone plinth and post. the trowel is added for scale. Looking west.

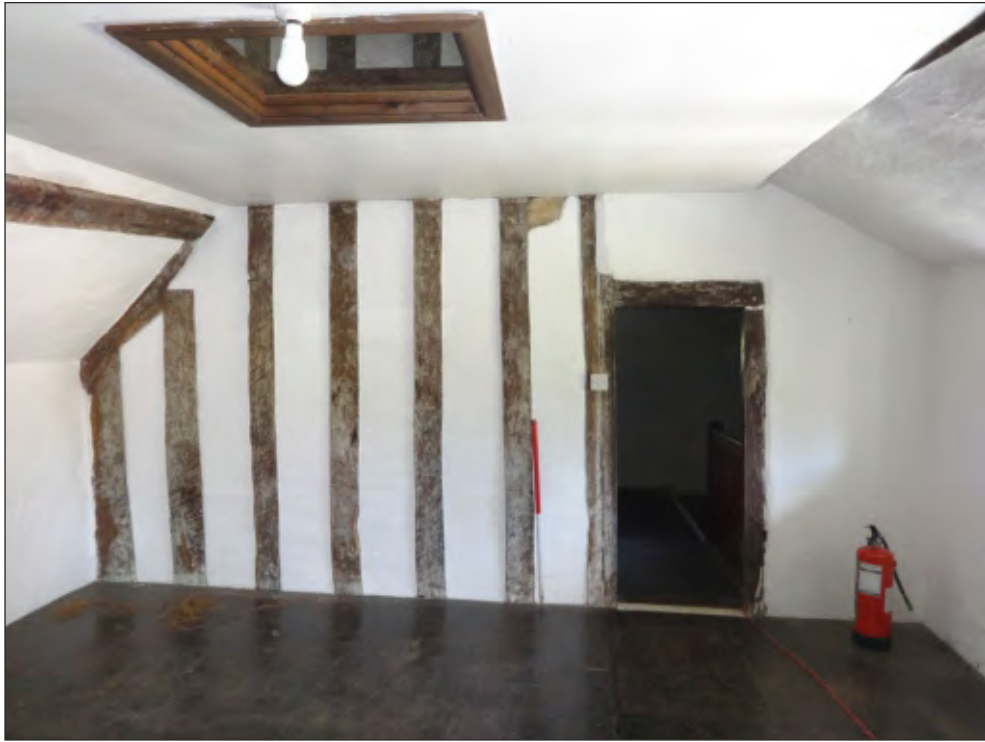
Pl. 17 View of the hall chamber showing the stud partition separating the room from the upper part of the inner room. 1m scale. Looking north.

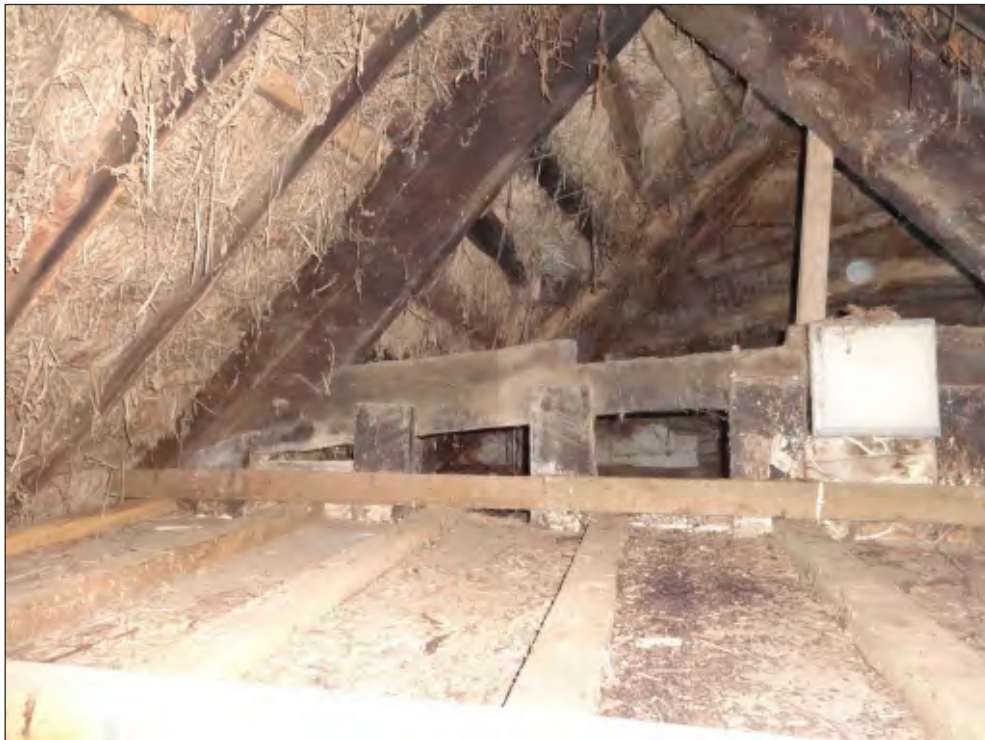
Pl. 18 View of the roof space above the hall chamber, looking north, showing smoke blackening on the inner face of the partition.

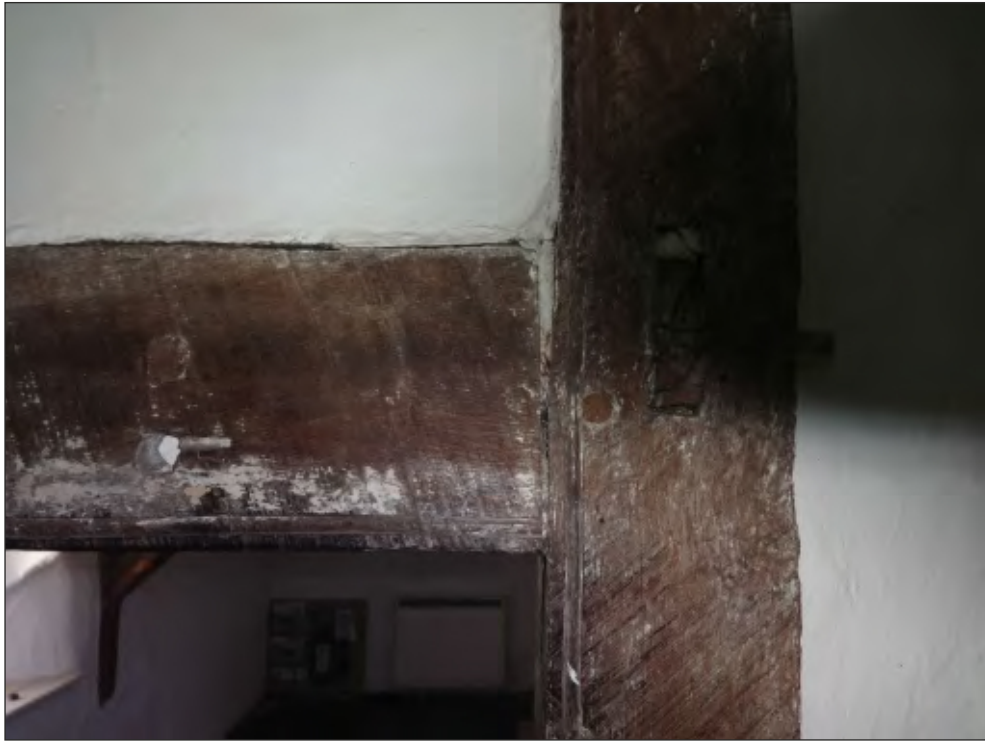
Pl. 19 Detail of the doorway to the hall chamber, seen from the north, showing the scratch mouldings and the tenon of the head beam of the spere.

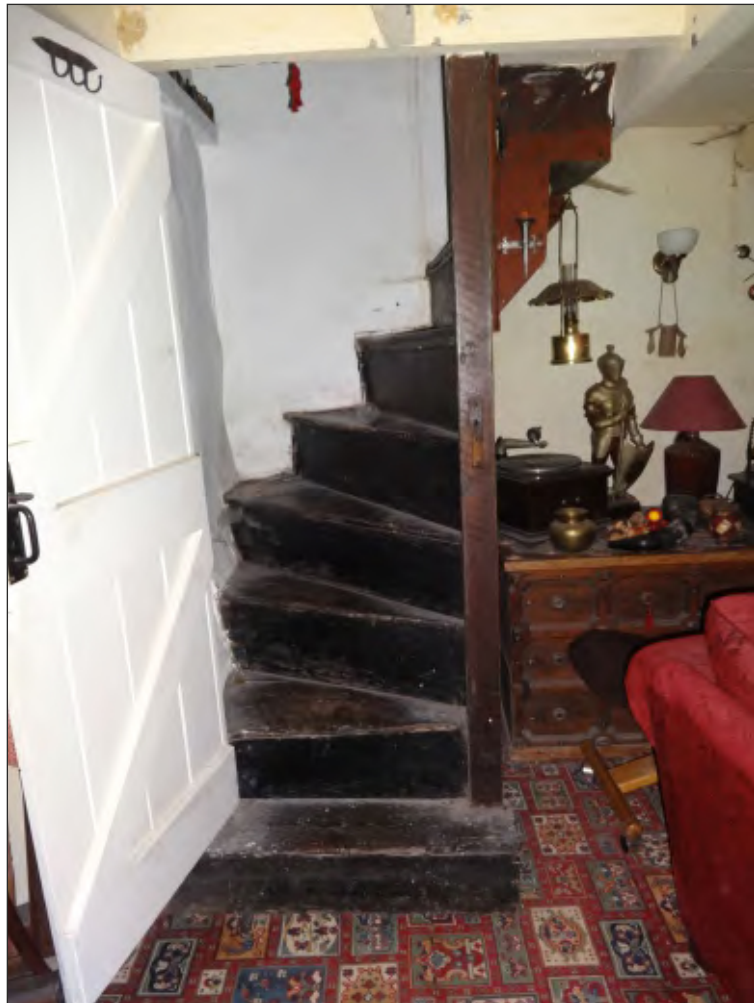
Pl. 20 View of the 19th-century staircase in the parlour wing, showing a timber newel within a confined space. S similar structure may have risen within the inner room. Looking north.

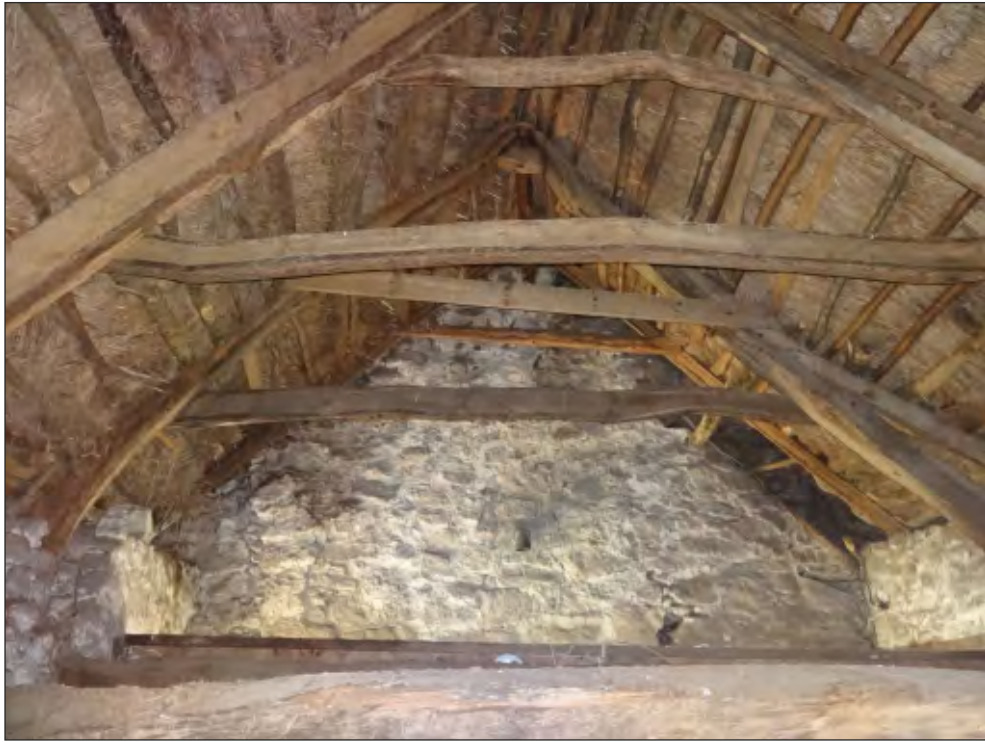
The earliest part of the present roof has been identified by Keystone as the smoke-blackened true-cruck truss with a yoke for a square-set ridge, lying immediately south of the cross passage, which Keystone have dated on stylistic grounds to the early 14th century (Pl. 21). This is the only truss which survives of the original roof; however, this truss, part of the ridge and a single smoke-blackened purlin extending from its northern face, are sufficient to fix the original height and pitch of the roof. The rest of the roof of the shippon has been replaced, probably in the 18th or early 19th centuries, with simpler 'A'-frame trusses resting on rebuilt stone walls.

Pl. 21 View of the early 14th-century truss at the north end of the shippon.

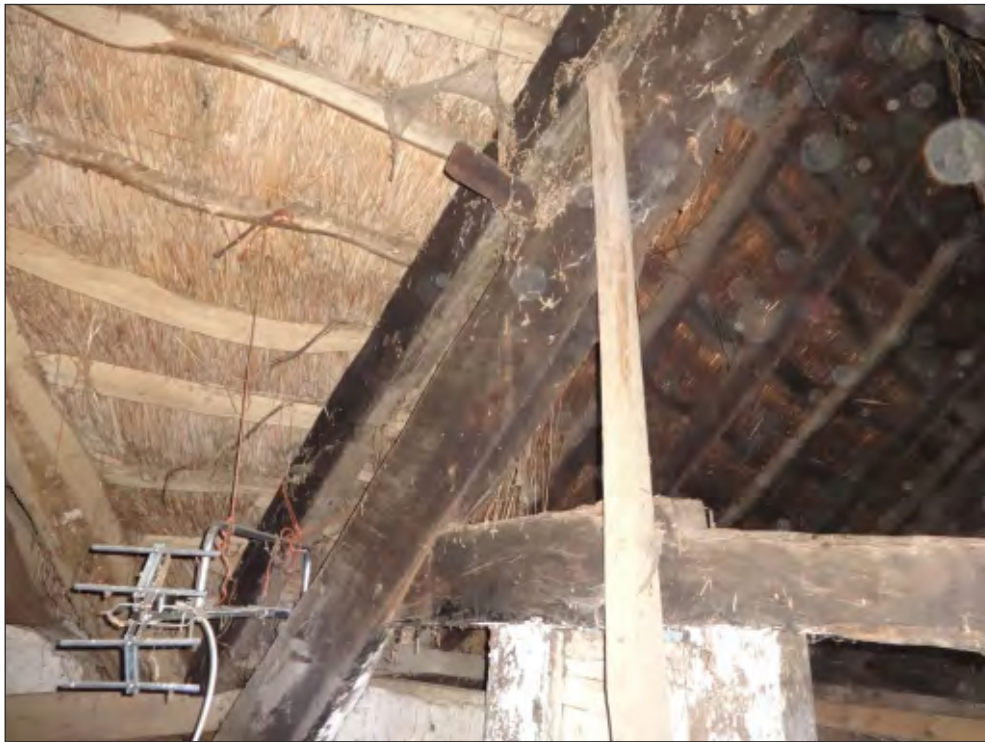
The roof over the hall chamber is also a replacement, rising to a higher level than the earlier roof, and with distinctive carpentry features which suggest a mid-17th-century date (Pl. 22). This roof, as has been argued above, appears to be contemporary with the flooring over of the hall to create the hall chamber, but probably post-dates the addition of the hall chimney, which may have been built through the original 14th-century roof structure, in an open and unfloored volume. This is suggested by the relieving arch over the lintel of the fireplace, which is cut across by the beams of the existing first-floor structure, and also by the stone cross wall alongside the chimney, when seen from the shippon, which seems to reflect the original, rather than the later profile of the roof.

There are clear signs that the roof was again altered while the inner room was still unfloored, and while an open hearth was still in use in this area. Overlying the eastern principal of the truss incorporating the partition is an extra principal rafter raised above the earlier truss (Pl. 23). This appears to have been added to ease the transition of the roof with that over the parlour wing. This alteration may have involved the replacement of most of the rafters on the east side of the roof. The additional principal rafter is also smoke blackened, which demonstrates that the inner room was still open to the roof, and heated by an open hearth, at the time the parlour wing was added.

Pl. 22 Detail of the additional rafter added over the eastern principal of the earlier 17th-century truss (looking south-east), showing smoke blackening to both timbers.

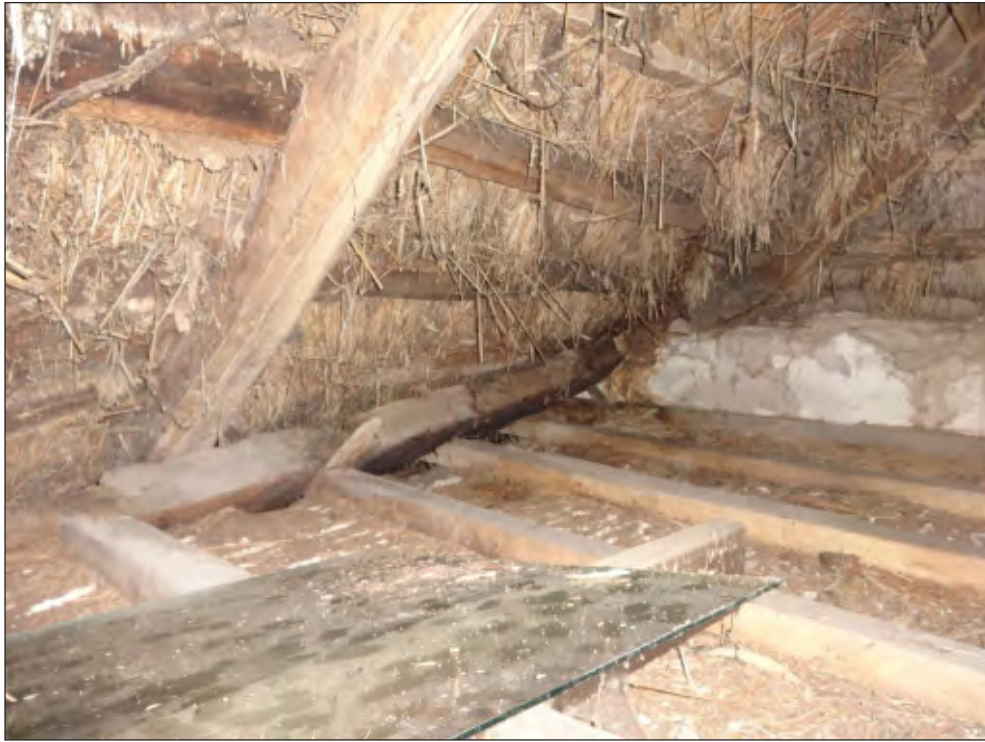
The roof over the inner room has largely been replaced, probably in the 19th century. The reason for this alteration is not known but may be connected with the insertion of a floor over the inner room, or the raising of the roof over the parlour wing to a slightly shallower pitch, perhaps in order to improve headroom in the parlour chamber. The replacement roof over the north end of the house is not smoke blackened, but it does incorporate smoke blackened timbers, either reused in this position or, in the case of one surviving, heavily sooted purlin, surviving from the secondary roof over this part of the house.

Pl. 23 The northern end of the roof, looking north, showing a smoke blackened purlin over the inner room.

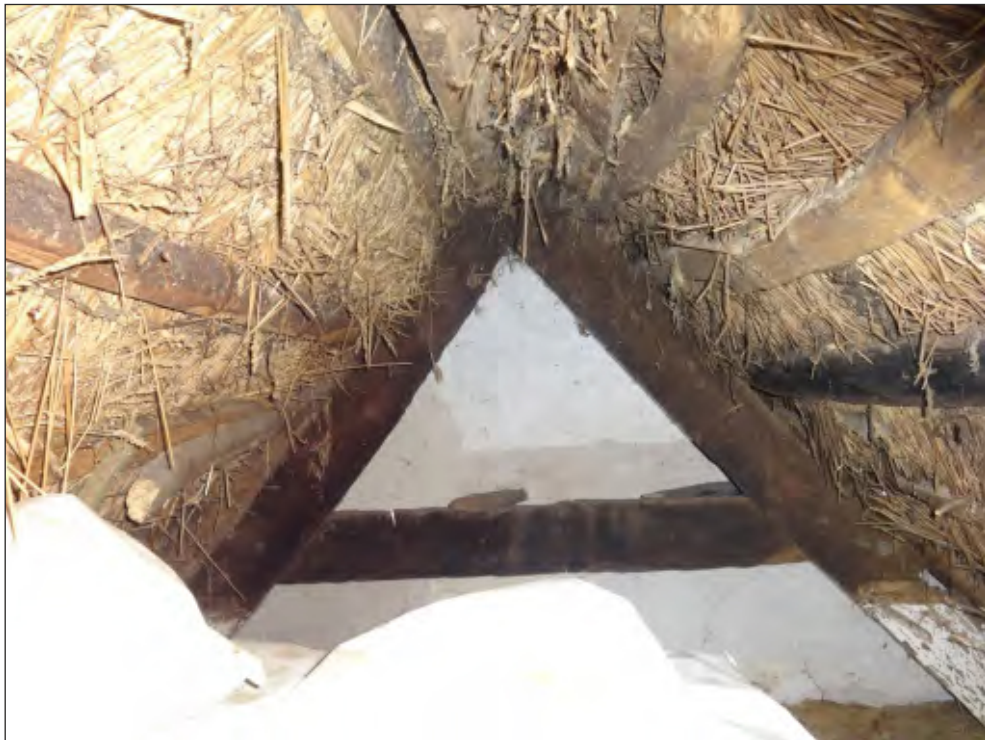
The roof over the parlour chamber was briefly inspected and proved to be supported by an 'A'-frame truss with a plain, straight collar linking the two principal rafters (Pl. 24). This truss was of superior carpentry to the replacement trusses over the north end of the house and is certainly earlier. The roof structure had clearly been ceiled just below collar level since the lower parts of the principals were whitewashed but, above this, the truss was also smoke blackened. As the parlour wing has two storeys, both heated by apparently contemporary fireplaces, it is unlikely that the smoke blackening originated from an open hearth within this wing, rather that the apex of the roof must, like the hall chamber, have been linked to the open volume of the inner room chamber by a void area in the partition between them. This confirms that the inner room, rather than an open hearth in the hall, is likely to be the source of the smoke blackening throughout the whole of the northern part of the house.

Pl. 24 View of the roof over the parlour wing, looking east, showing smoke blackened trusses of probable 17th-century date.
