**Historic building appraisal at Fenacre Farm,
Burlescombe, Devon**

Report No. 15-10

December 2015

OAKFORD ARCHAEOLOGY

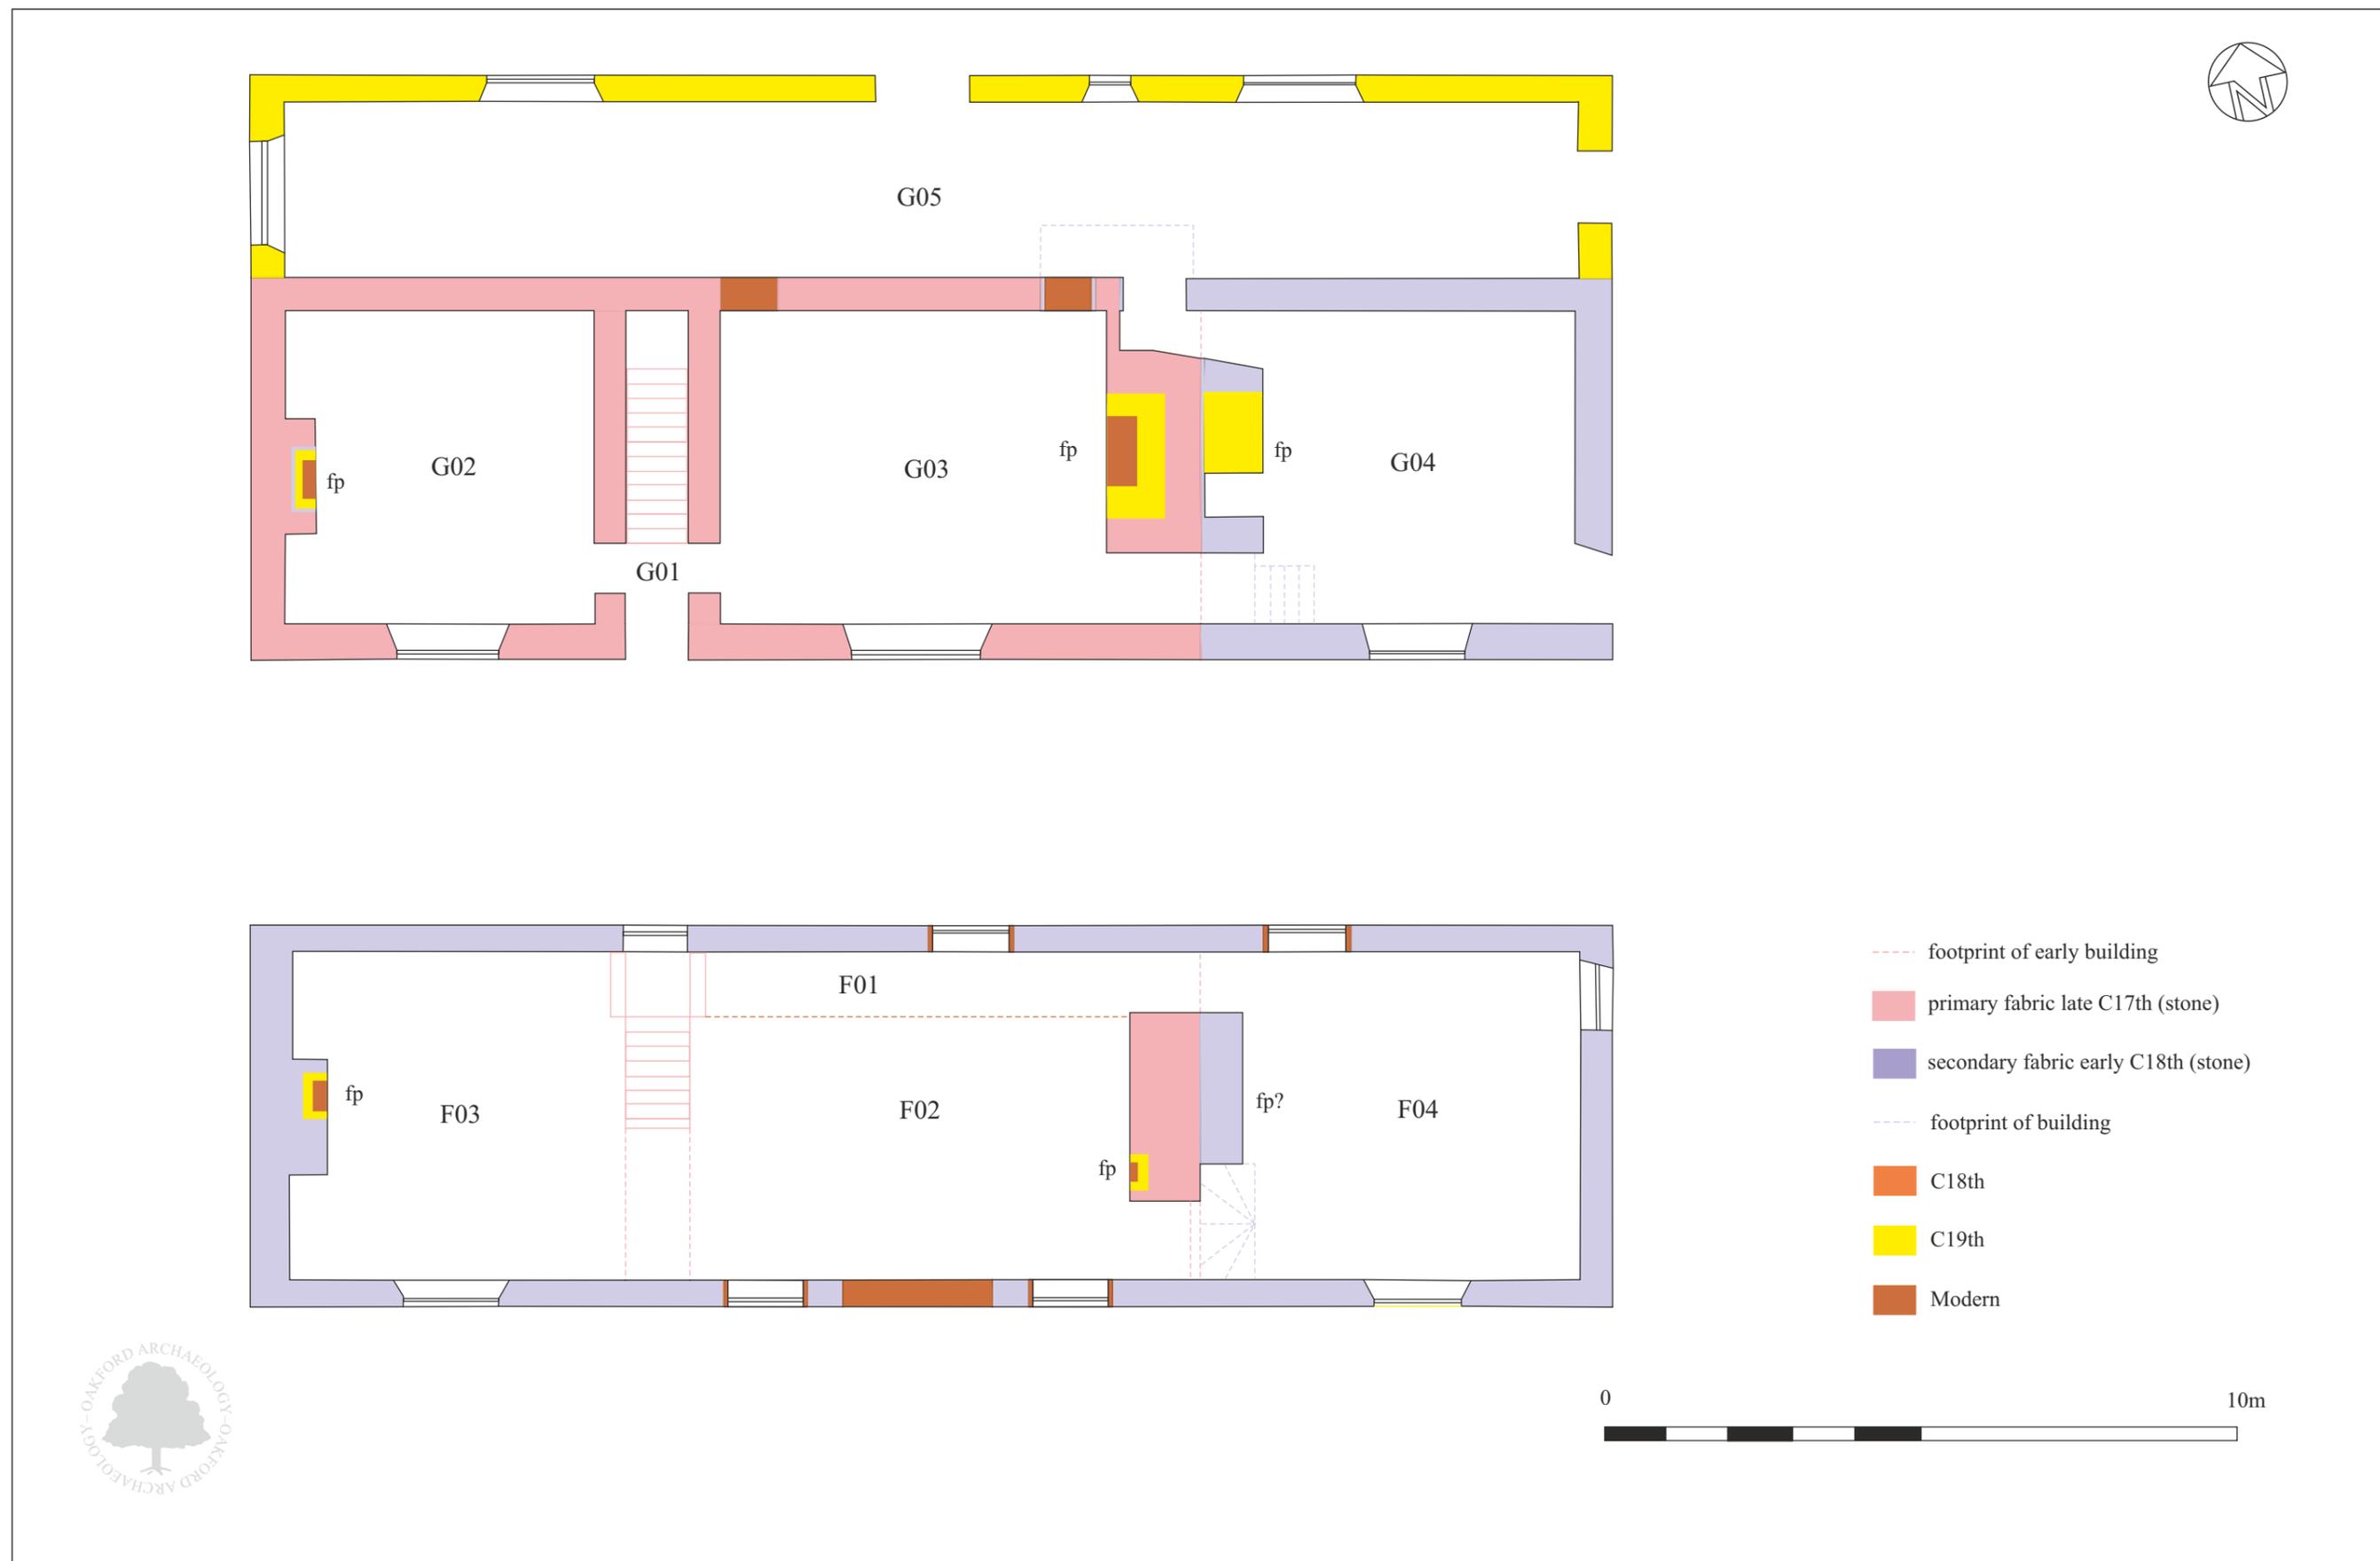
Fig. 8 Plan of ground and first floor showing location of observations and suggested phases of development.

The ground floor (Fig. 8, Pls. 3-4).

The interior of the main range had been severely altered by the time of the visit to form a large open plan room. These alterations included the complete removal of the internal partitions defining the original rooms, which has unfortunately resulted in the loss of the historic plan of the building. Some traces of the original interior arrangement remained in the form of wall scars allowing a reconstruction of the original layout.

The most likely reconstruction of the original plan form of the ground floor of the early house had two large rooms. The rooms would have been separated by a lobby and stone wall partitions (G01) flanking the staircase.

The western ground-floor room (G02) may have functioned as a service room within the original house; it was heated by a large stone fireplace in the west gable wall. This would originally have had a large timber lintel supported by the surviving stone jambs concealed within the plaster, although this had been replaced with a brick lintel in the 19th century. The large opening was successively reduced in size between the 18th-19th centuries before being finally blocked-up during the modern period.

The room to the east of the lobby (G03) probably represents the original ‘hall’, the main room of the house. This contained a large painted plaster-decorated fireplace in the north-eastern wall, part of the primary construction of the building, which displayed fragmentary false ashlar on the rear face and on the internal faces of the jambs (Fig. 10, Pls. 5-6). The design represented on the jambs and on the rear face – false ashlar - is a common pattern found in combination with other designs, at Gotham, Tiverton, at Nos 44-6 Magdalen Street and 21 The Mint, Exeter, at Honiton Barton, South Molton and at Chivelhayes, Clyst Hydon (Adams 2015), although these 17th century examples are generally more ornate. The decoration on the fireplace jambs and rear therefore fits well into the kind of ‘faux’ architectural painted decoration popular at this period. Such painted schemes have been found at No. 41-42 High Street, Exeter, including the jamb of the parlour fireplace which was painted red with white lines in imitation of brickwork (Thorp 2015). This kind of ornamentation is also used on walls where these are sometimes painted as panelling, studwork or as woven hangings (John Thorp *pers. comm.*). The Fenacre House example is likely to belong to the period after 1660-1690 and represents a late development of the sgraffito fireplace tradition (Richard Parker *pers. comm.*). It is unclear if the decoration is part of the primary construction of the building and unfortunately at the time of the visit the timber lintel had been removed making it impossible to date the fireplace more closely by analysing any surviving decoration and thereby refining the date of the primary fabric of the main range and the painted plaster decoration. Two small doorways in the north wall lead to room G05.

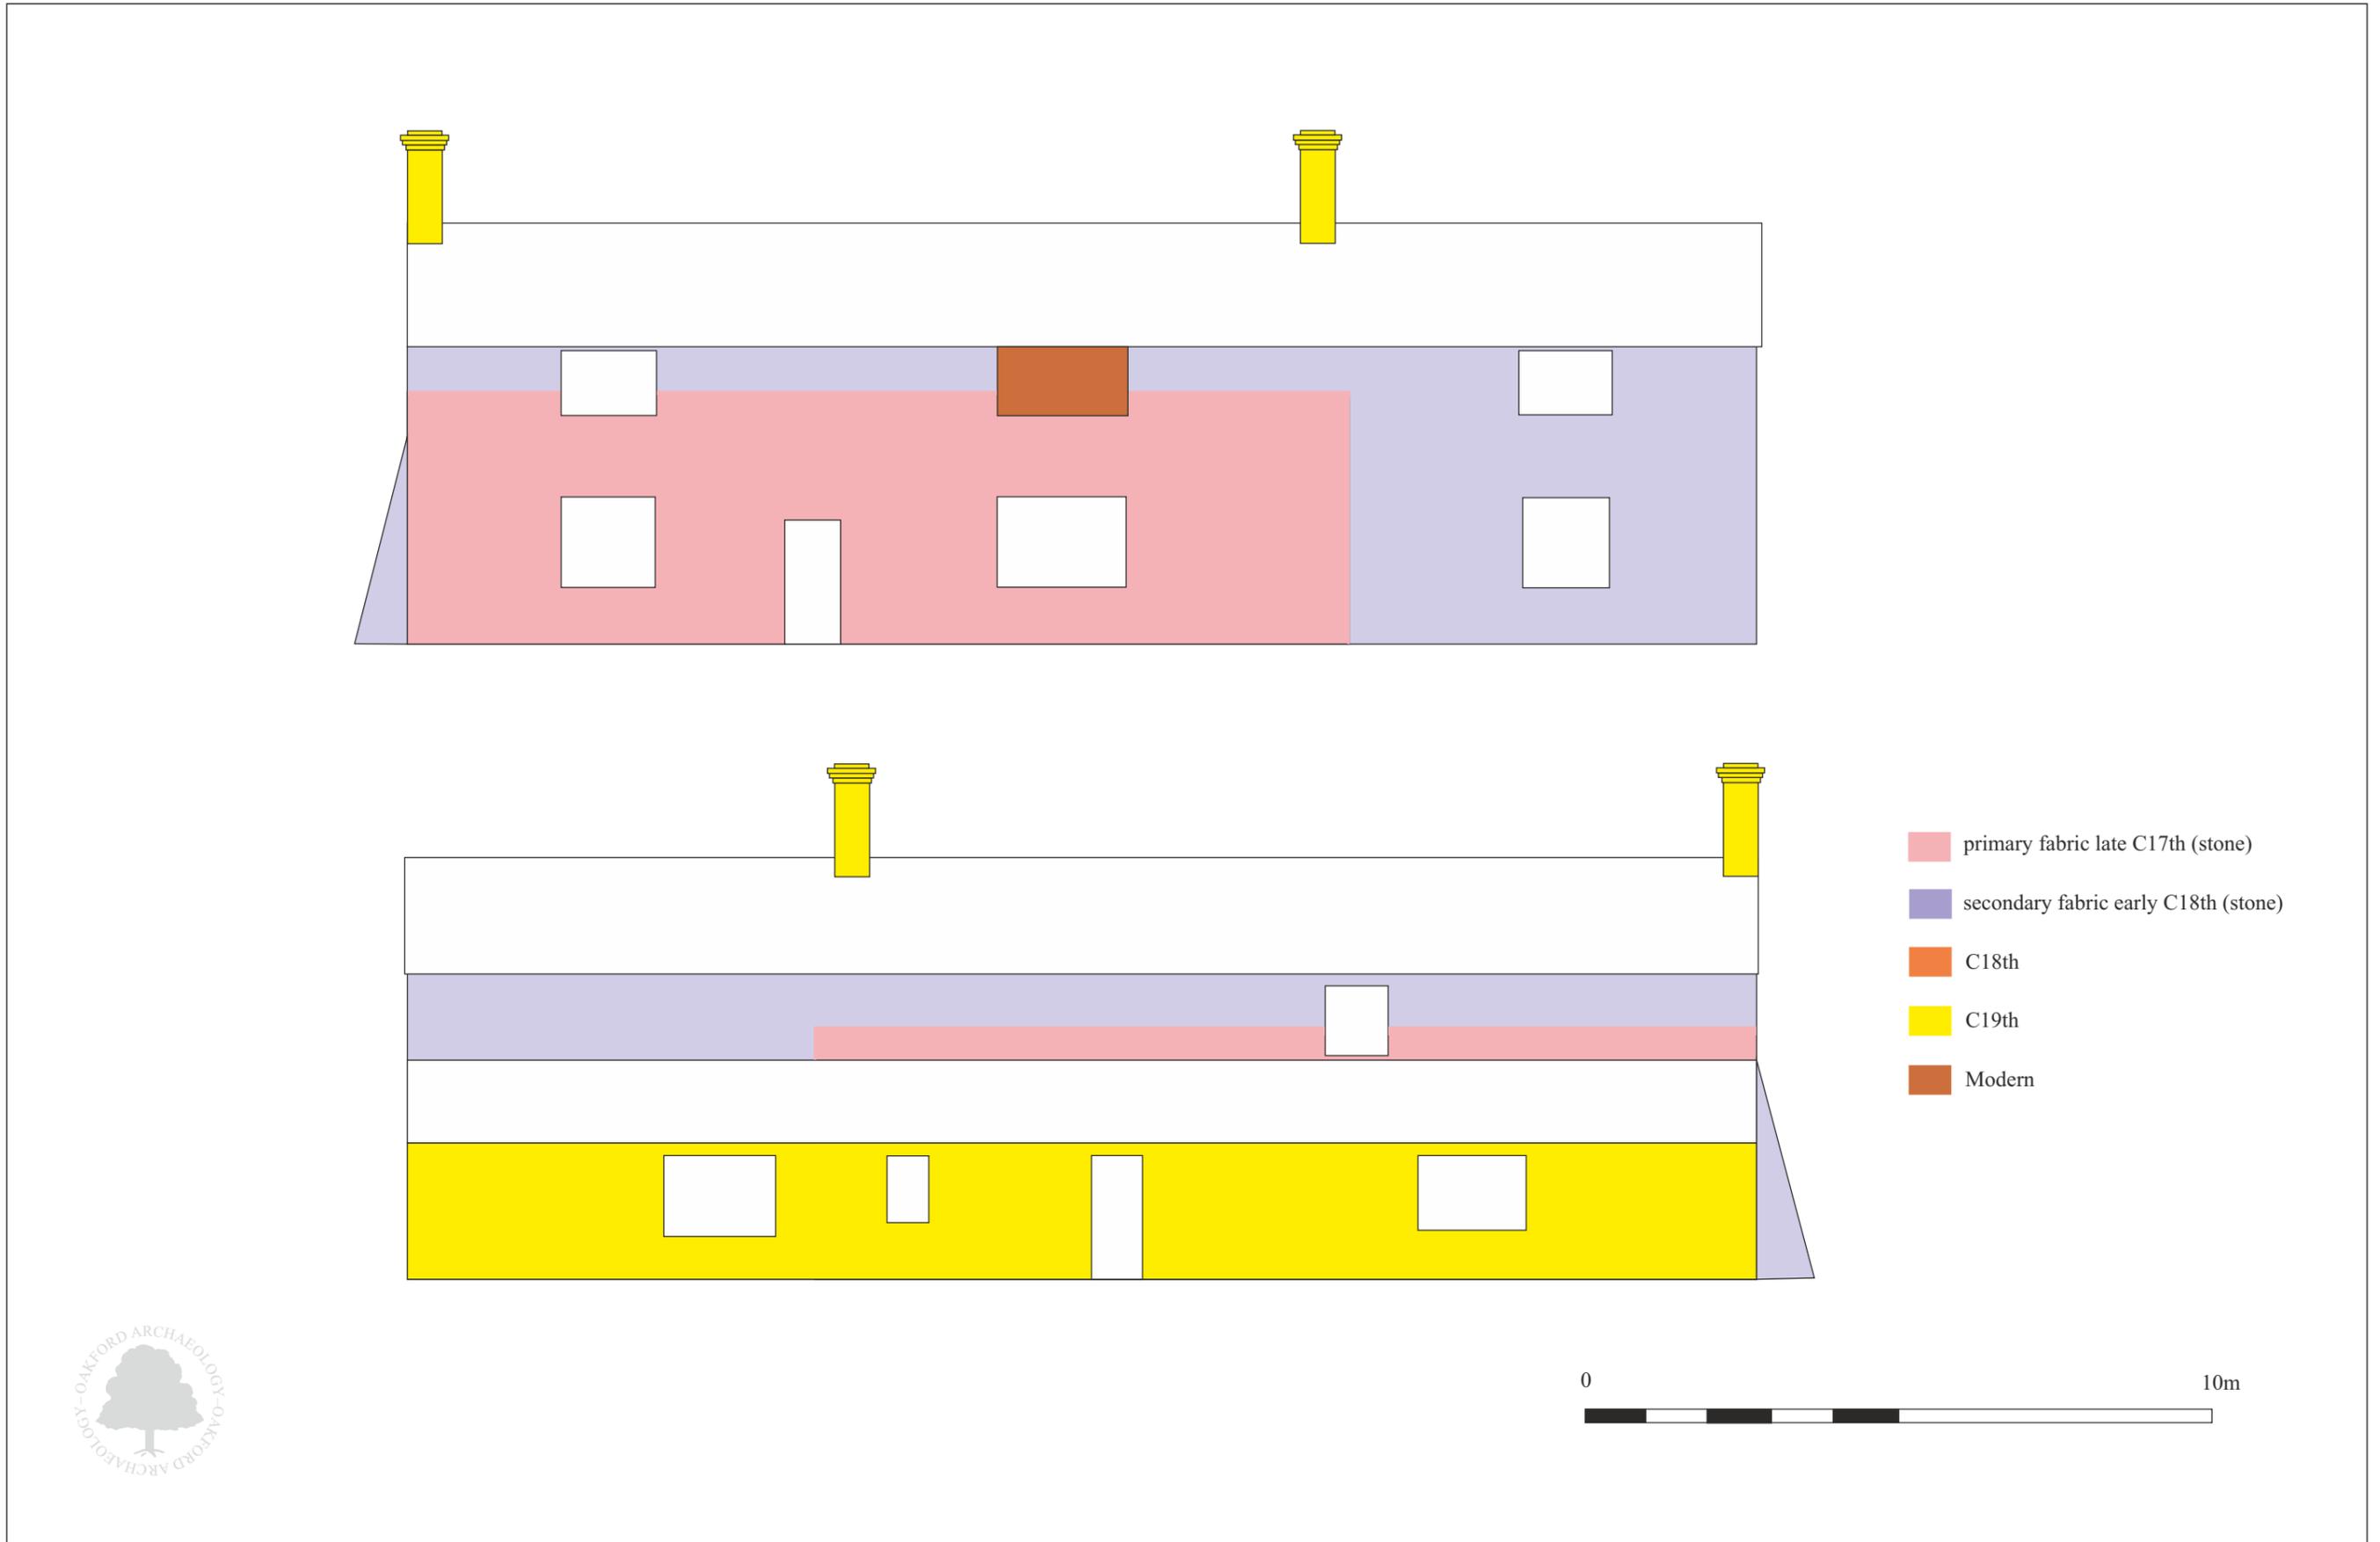
Fig. 8 Elevation of main farmhouse showing location of observations and suggested phases of development.

The house is a two-storey structure, constructed of coursed stone rubble covered with painted render. The original core of the house is a rectangular range, aligned north east-south west, and crowned with chimney stacks on each of its gables (Figs. 8-9, pls. 1-2). A two-storey extension projects from the east end of the original building, along the yard, and represents an early extension to the house, possibly dating to the early 18th century. To the north of the main range a single storey extension in the form of a lean-to or outshut was added in the 19th century.

The south-west elevation of the house is its principal façade, presenting a two-storey elevation to the yard under a steeply-pitched slate roof. The ground floor is entered through a door to the left of the elevation which would originally have opened onto a small lobby, providing access on either hand to the hall and a further room on the ground floor and to the stair leading up to the first floor. Light is provided by a single window to the left of the doorway, and a single larger window to the right. The main part of the elevation is constructed of stone rubble, while a building break is visible from halfway up the first floor windows, suggesting that the roof line has at some period been raised above its original level. There are two windows on the first floor mirroring the arrangement below. The steeply-pitched roof is gabled to the north-east and south-west.

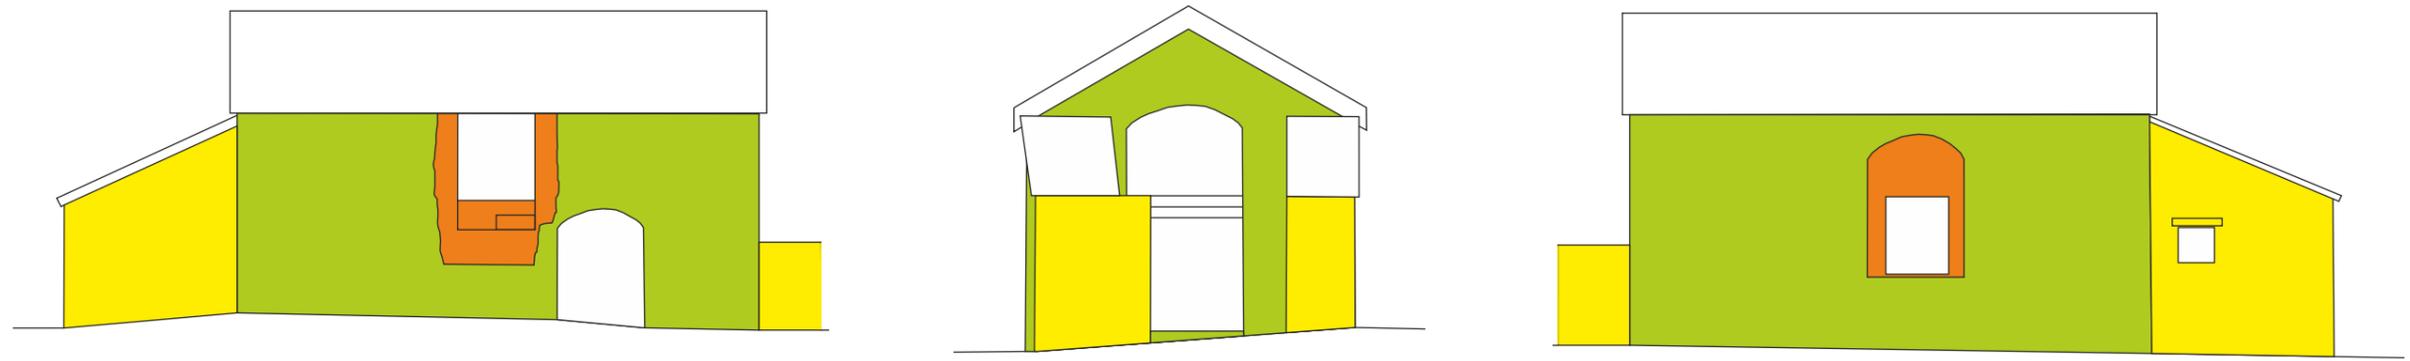
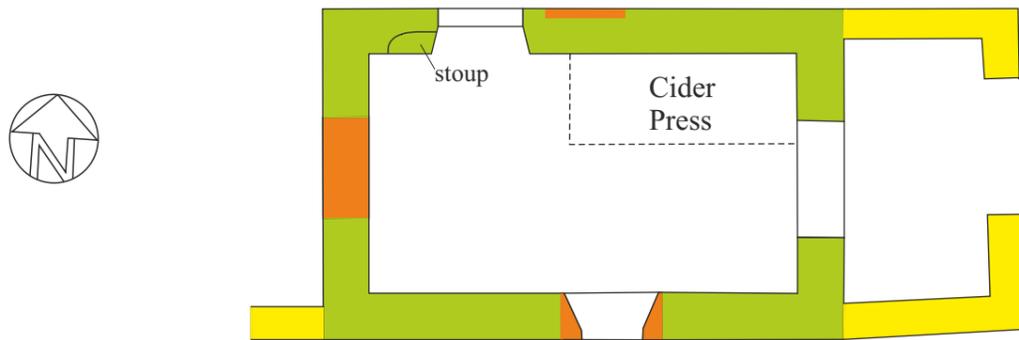
Fig. 11 Plan and elevations of chapel showing location of observations and suggested phases of development.

The ground floor (Fig. 11)

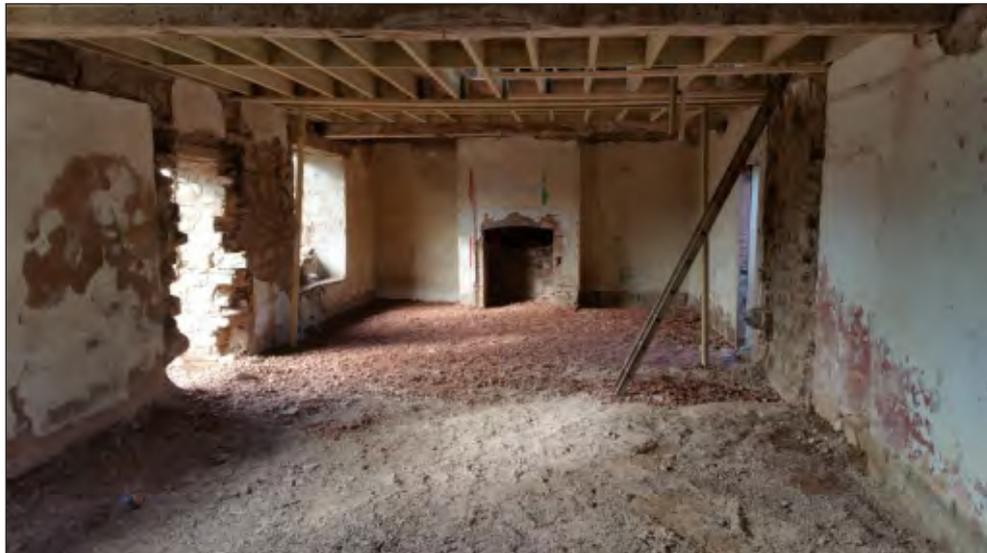
Pl. 3 General view towards room G02 after removal of solid cross walls. 2m scale. Looking west.

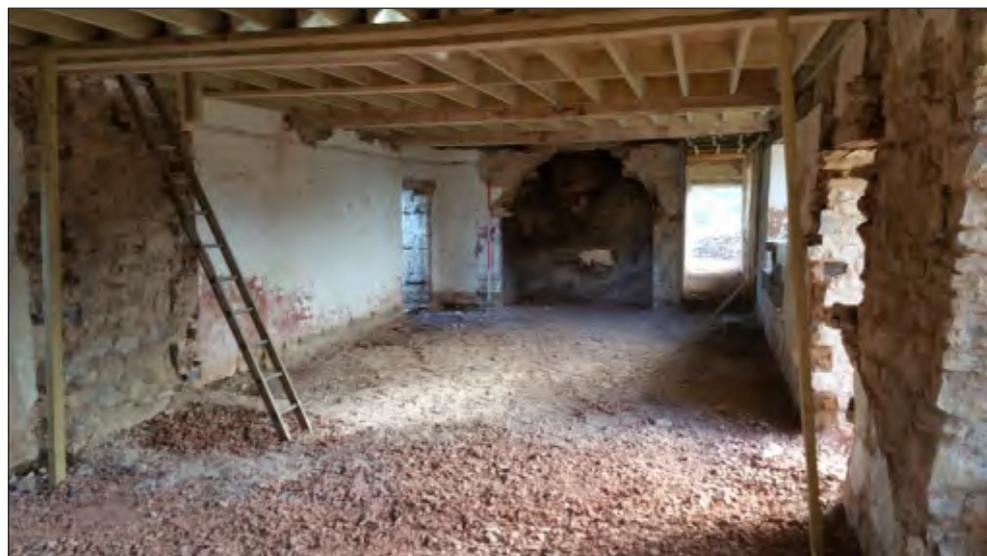
Pl. 4 General view towards room G03 after removal of solid cross walls showing fireplace with sgraffito decoration. 2m scale. Looking east.

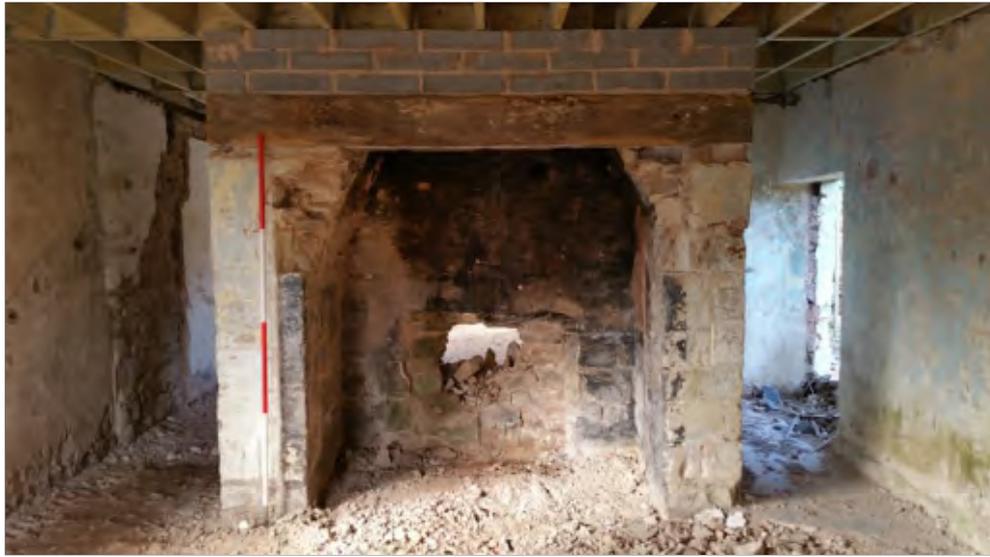
Room G04 was the main kitchen within the new service wing and contained a large, early 18th-century stone fireplace built against the rear of the existing fireplace in room G03. The original oak lintel had been removed and the large opening was successively reduced in size between the 18th-19th centuries before being finally blocked-up in the modern period. The room was originally lit by a single window in the south elevation, while a doorway, partly knocked through the primary fabric in the north elevation, would have provided access to a service corridor along the north side of the main house.

Pl. 7 Close-up of fireplace in room G04. 2m scale. Looking west.

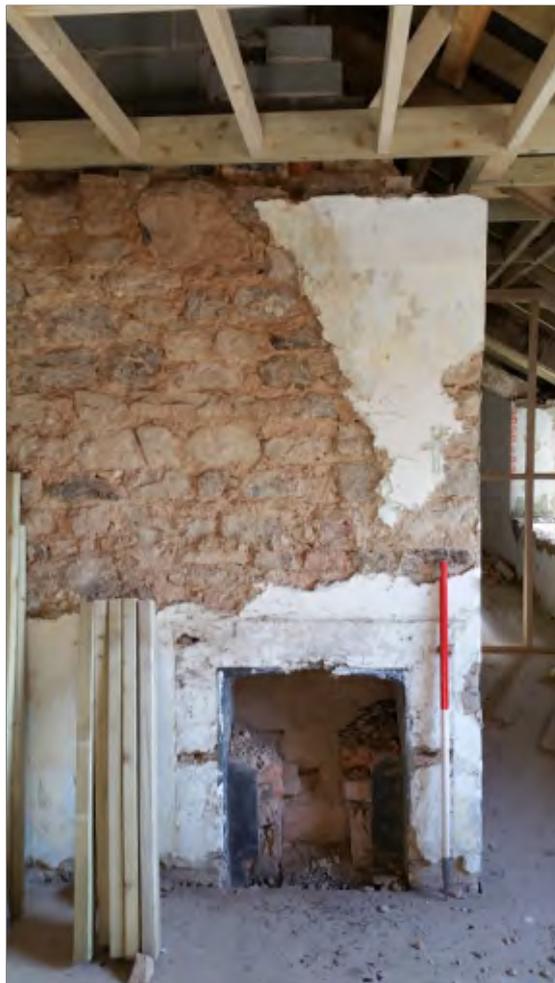
The staircase opened onto a modern landing (F01) which provided access to the large room above the hall (F02), reflecting the layout of the ground-floor rooms below. Surprisingly in a house of this period, the room was originally unheated; a small fireplace was inserted into the existing hall fireplace stack rising through the chamber at a later date. Evidence for laths on the lower trusses suggests that the room was not open to the roof but instead had a primary ceiling. A small room (F02) was located immediately to the west of the stair. The room was lit by a single window in the south elevation and contained a small fireplace in the west gable. This was also a later addition and had been blocked-up in the 20th century. Both fireplaces would originally have contained small cast-iron fireplaces and grates.

Pl. 8 Close-up of later fireplace room F02. 1m scale. Looking east.

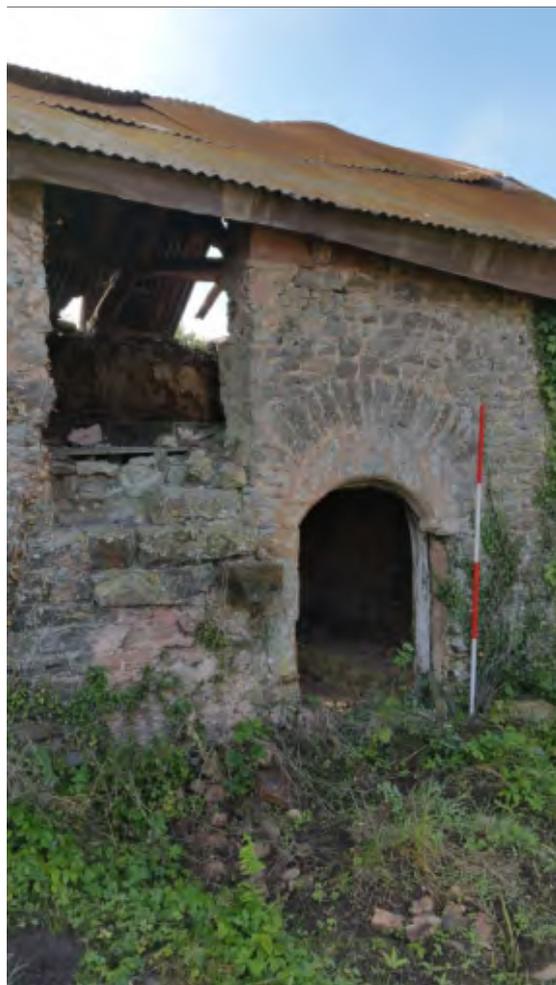
Pl. 10 Close-up of C15th chapel entrance and C18th first floor stair and doorway. 2m scale. Looking southwest.

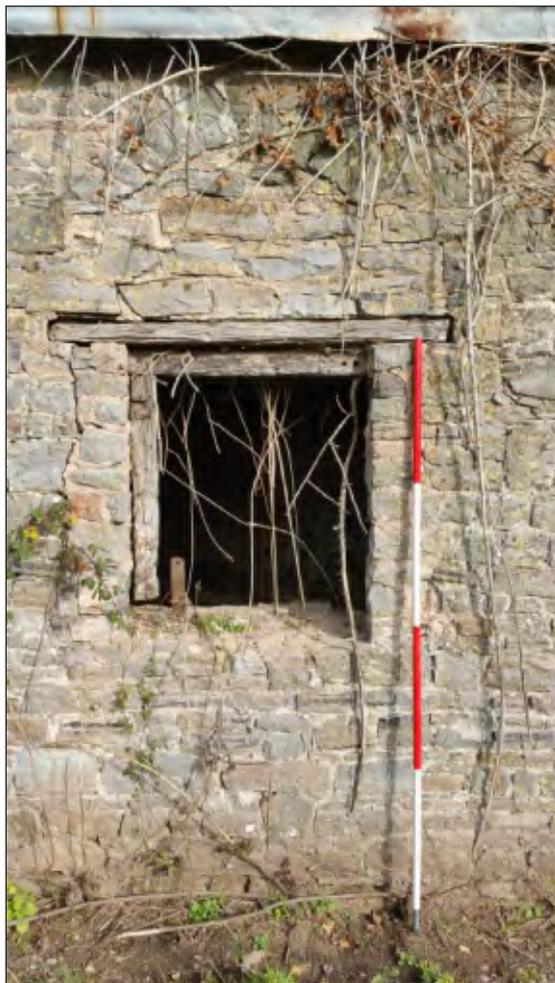
Pl. 12 Close-up of south window showing arch and C18th blocking. 2m scale. Looking north.

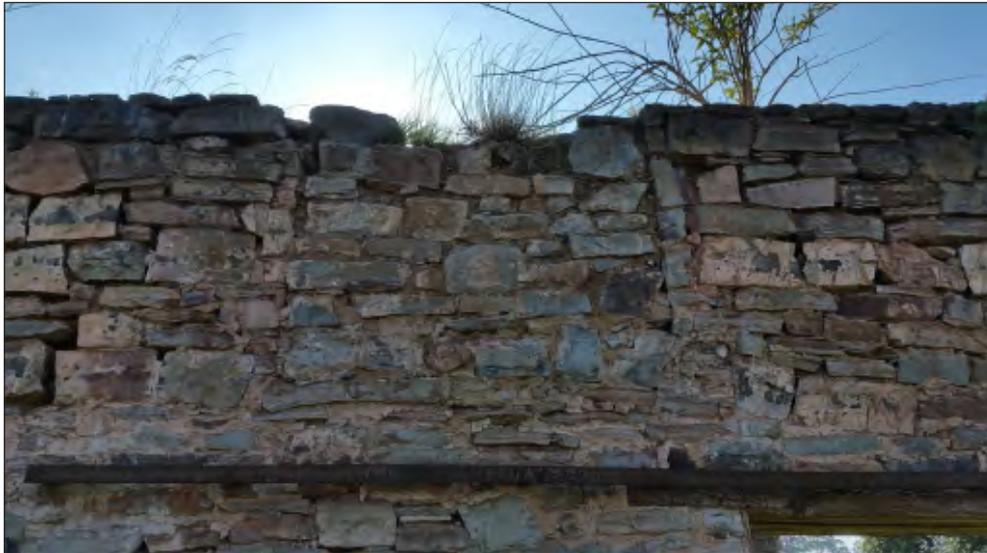
Pl. 22 Close-up showing blocked doorway to hayloft. Looking south.
