## Archaeological monitoring and recording at St Andrew's Church, Ashburton, Devon

*on behalf of*  
**Ashburton PCC**

**Report No. 16-04**

**June 2016**

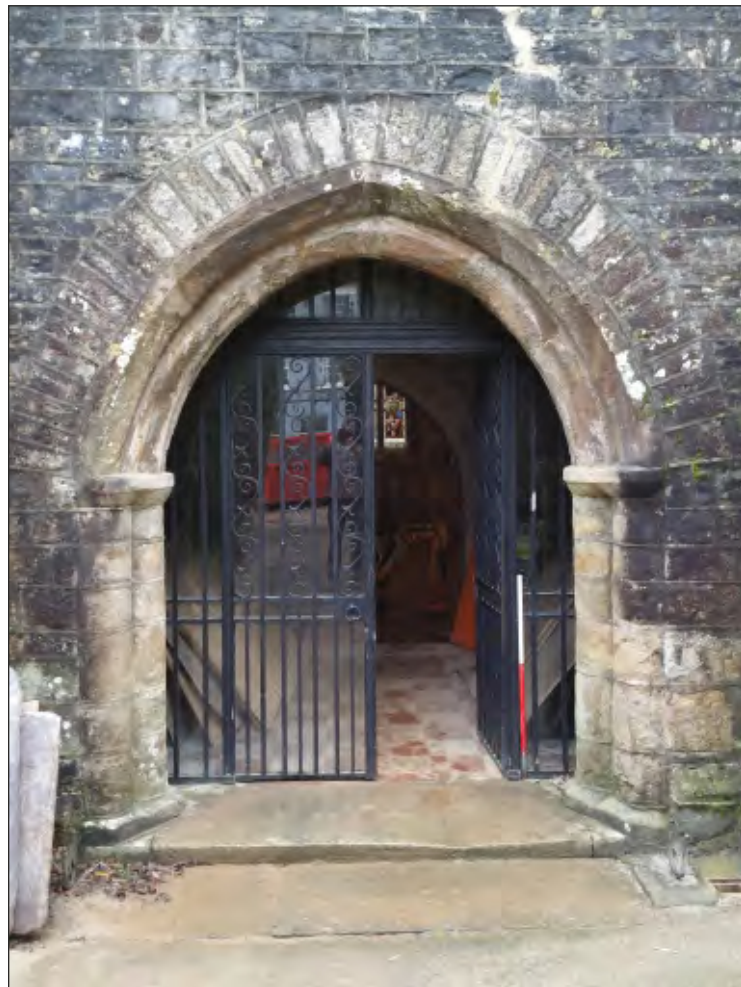
Fig. 2 Close-up of north porch with possible re-used mid-14th century arch. 2m scale. Looking south.

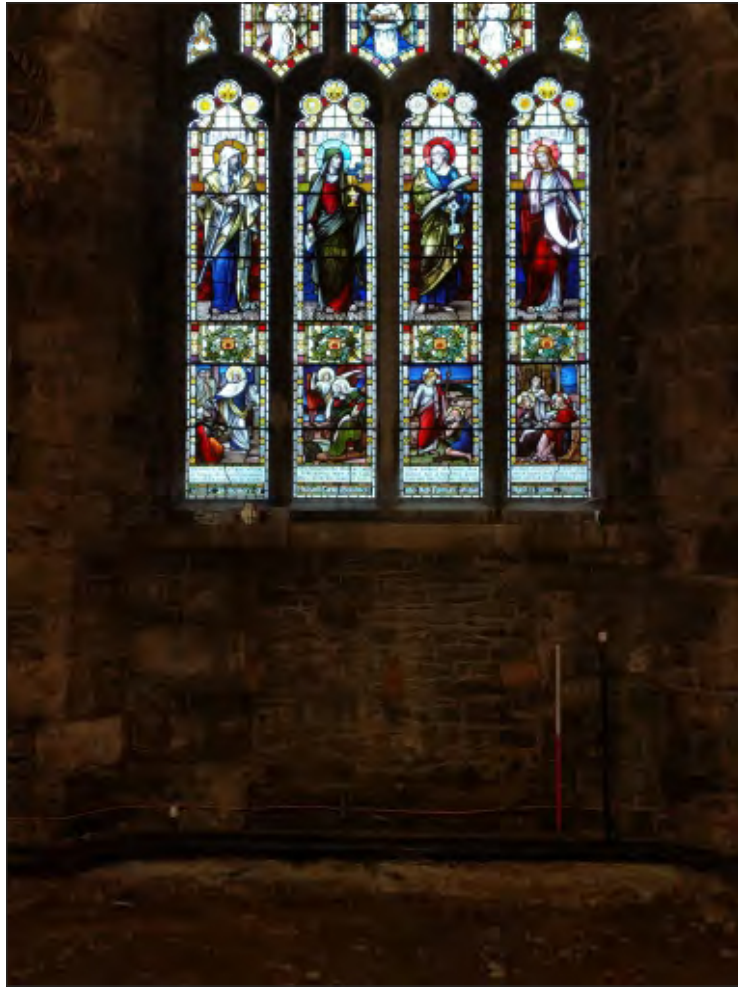
Fig. 4 Close-up showing blocked south doorway and later enlarged window. 1m scale. Looking south.

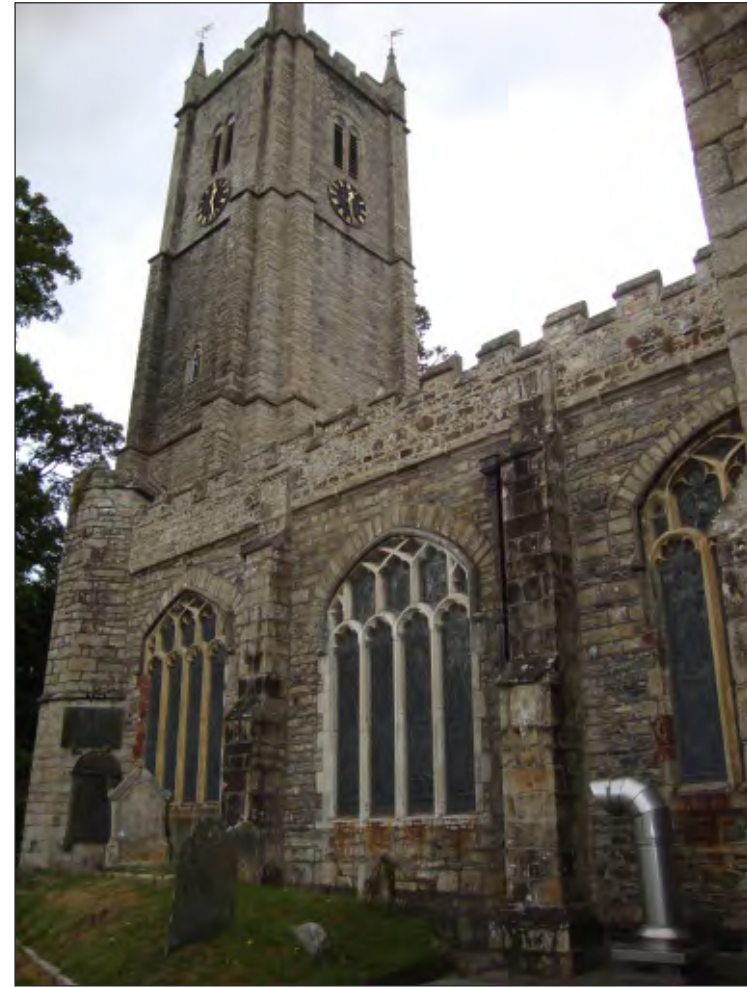
Fig. 5 General view of south aisle wall showing blocked doorway and later enlarged window. Looking northwest.

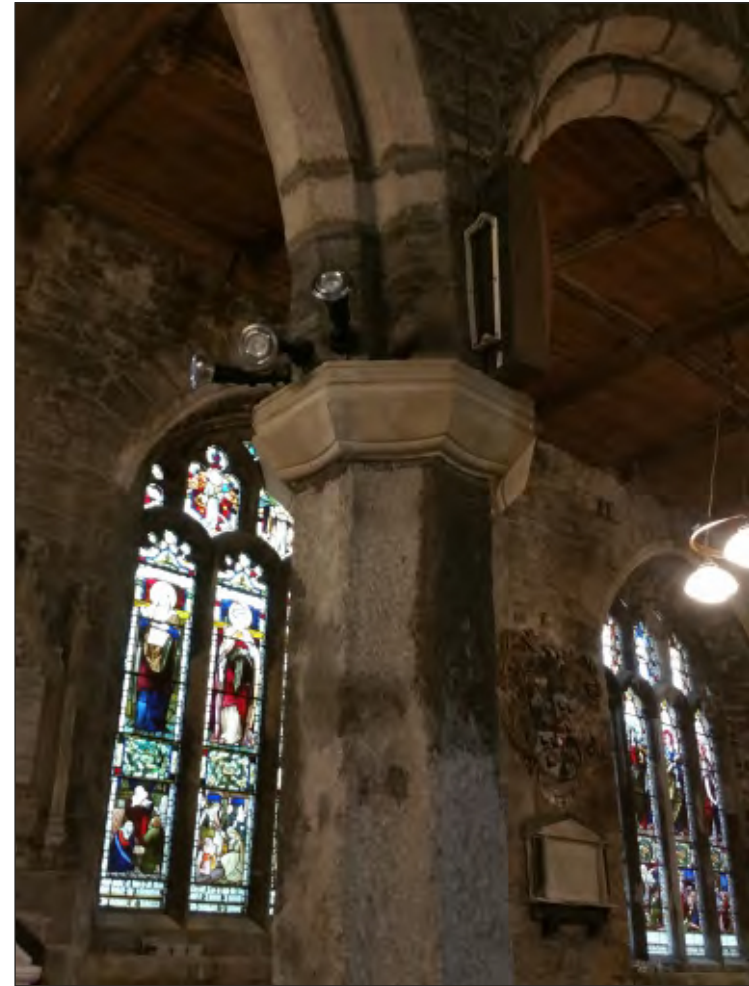
Fig. 11 Close-up of south crossing pier showing volcanic material at base of arch rather than granite highlighting the possible position of early 15th century rood screen. Looking southwest.

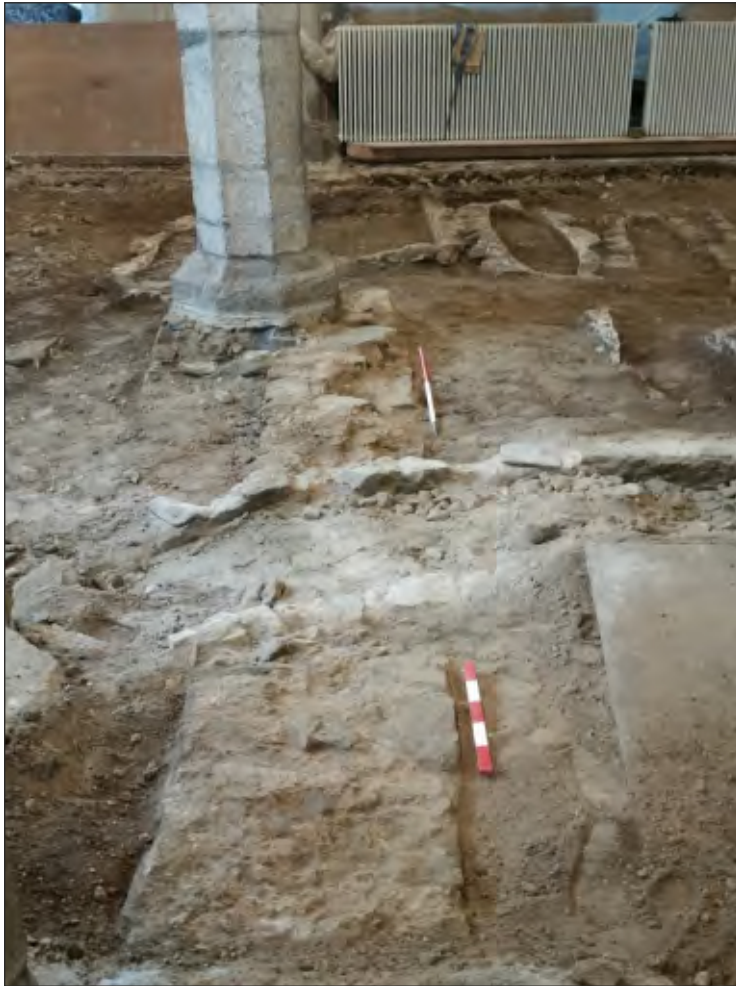
Fig. 21 General view of 12th century wall. 0.5m and 1m scale. Looking east.

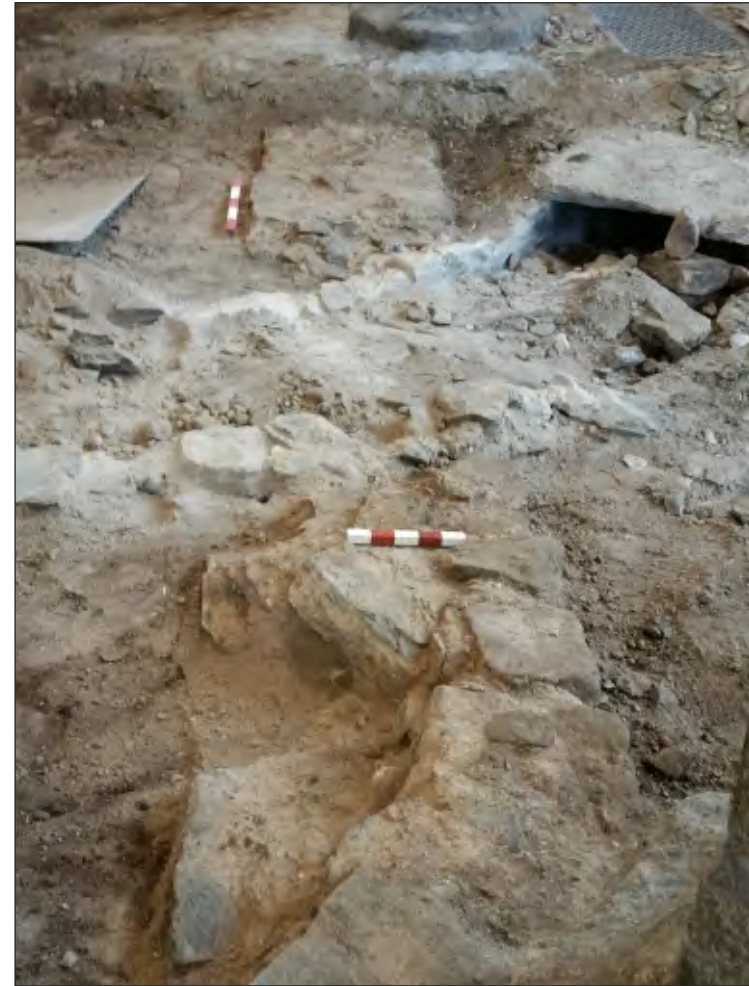
Fig. 22 Close-up showing 19th century heating duct truncating 12th century wall. 0.25m and 0.5m scale. Looking west.

As the re-ordering of the church in 1883 included the re-flooring of the whole church it is likely that the under-floor heating system was built at that time. It comprised an external boiler house located at the angle of the south aisle and south transept. The warm air was conducted through a large duct to floor grilles in the north and south aisles. Remains of the system were uncovered by the excavations and found to have been built with stone walls and stone and slate capping above the heating ducts. A series of cast-iron pipes were subsequently inserted into the duct to serve the large radiators positioned throughout the church.

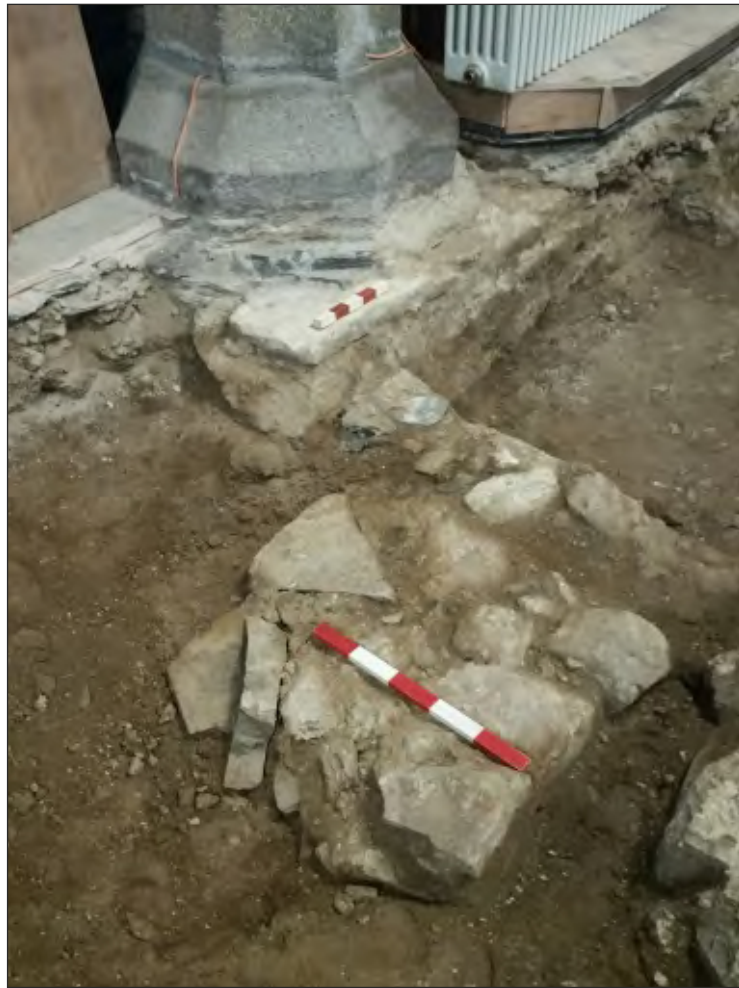
Fig. 23 General view of 12th century wall fragment.  
0.25m and 0.5m scale. Looking southeast.

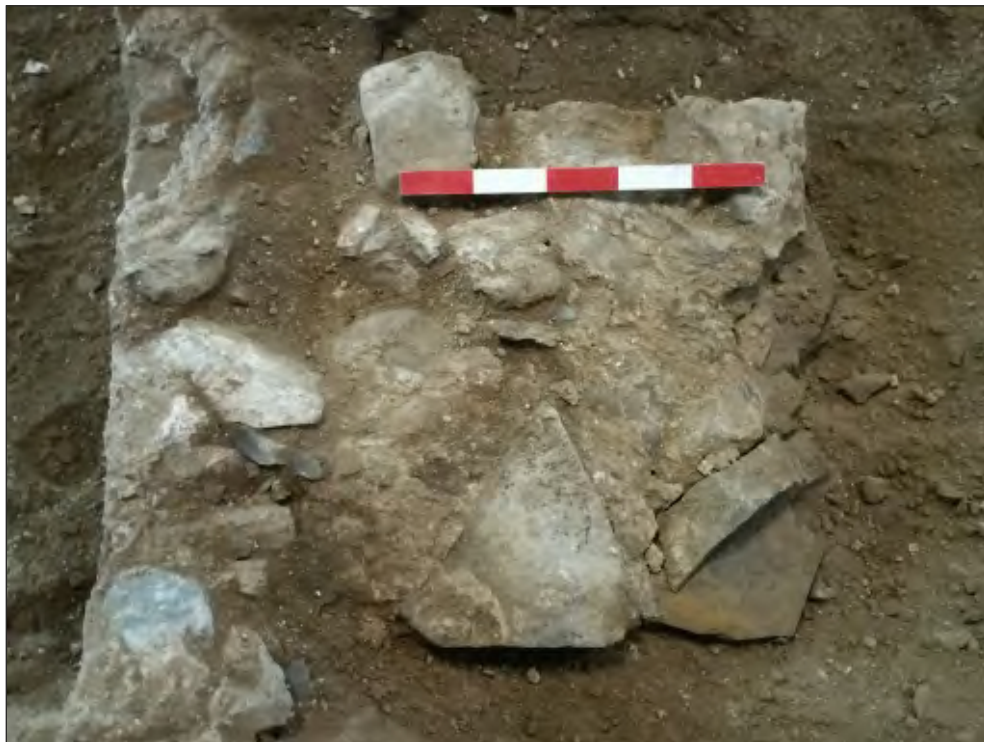
Fig. 24 Close-up of 12th century wall fragment. 0.5m scale. Looking west.

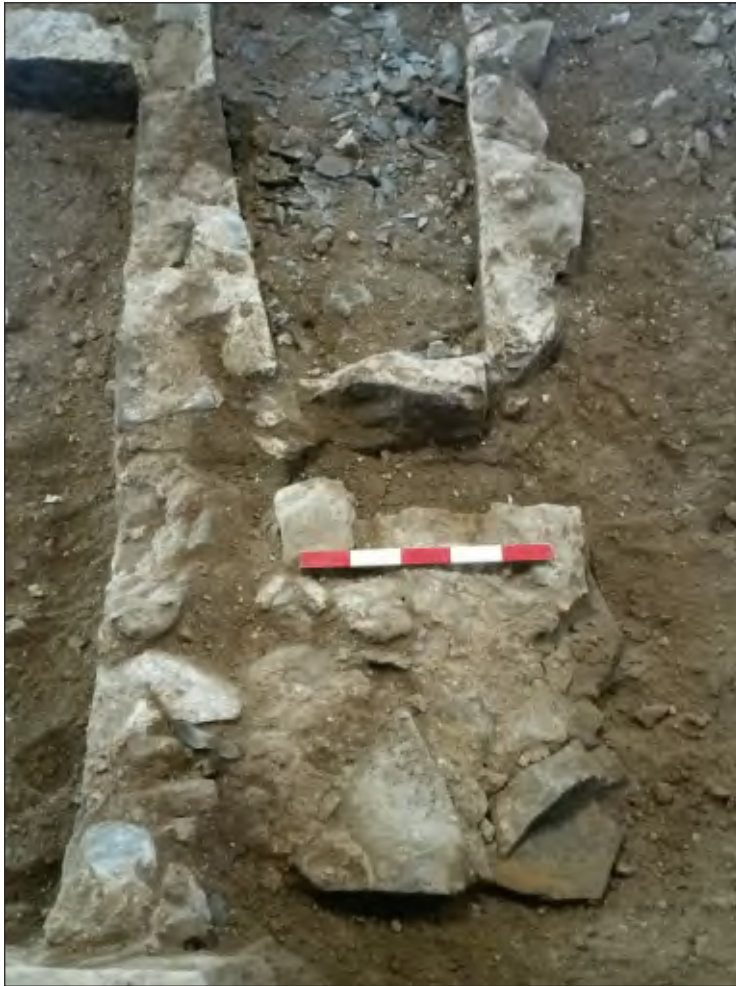
Fig. 25 General view of 12th century wall fragment. 0.5m scale. Looking west.

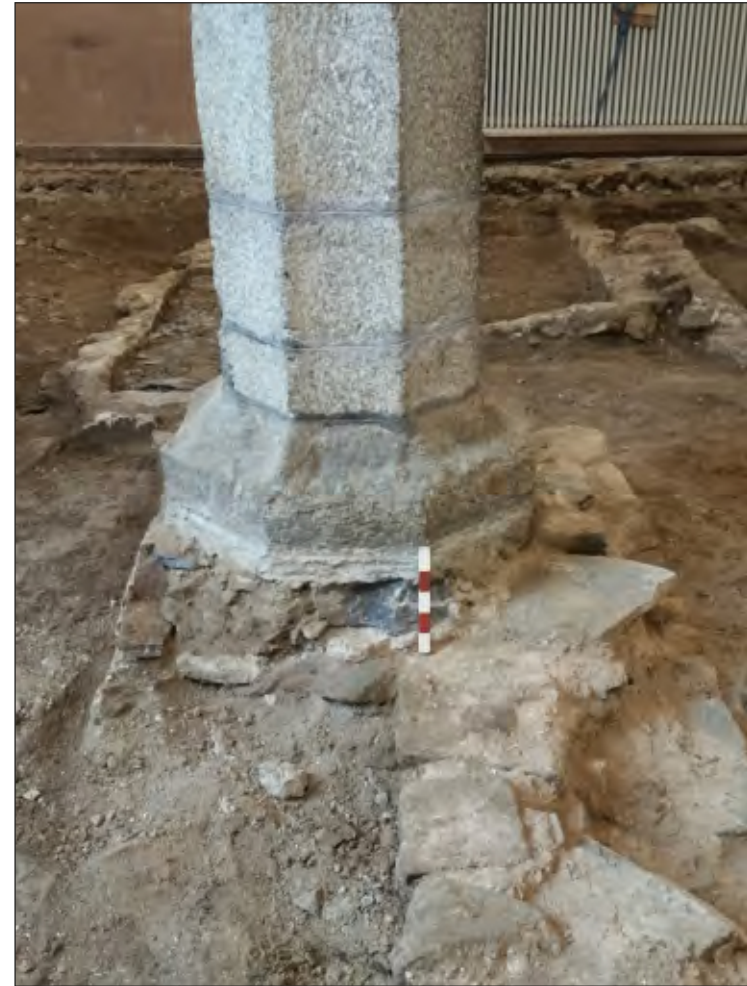
Fig. 26 Close-up showing 12th century wall overlain by early 15th century pier base. 0.25m scale. Looking east.

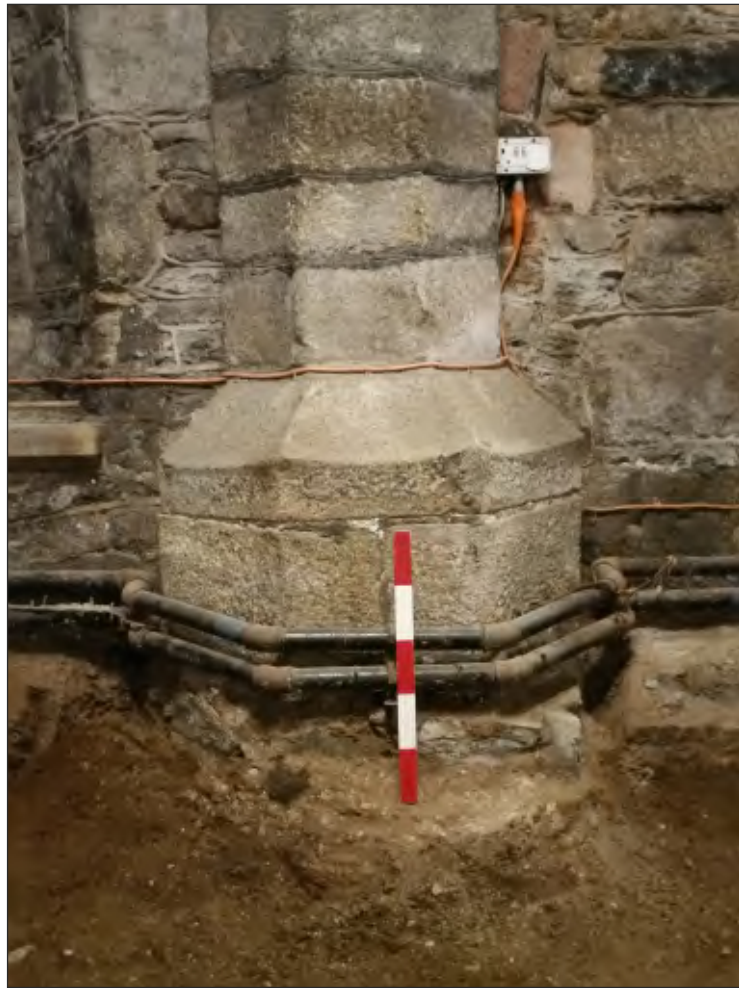
Fig. 28 Close-up showing early 15th century pier base truncating probable 13th century foundations. 0.5m scale. Looking west.

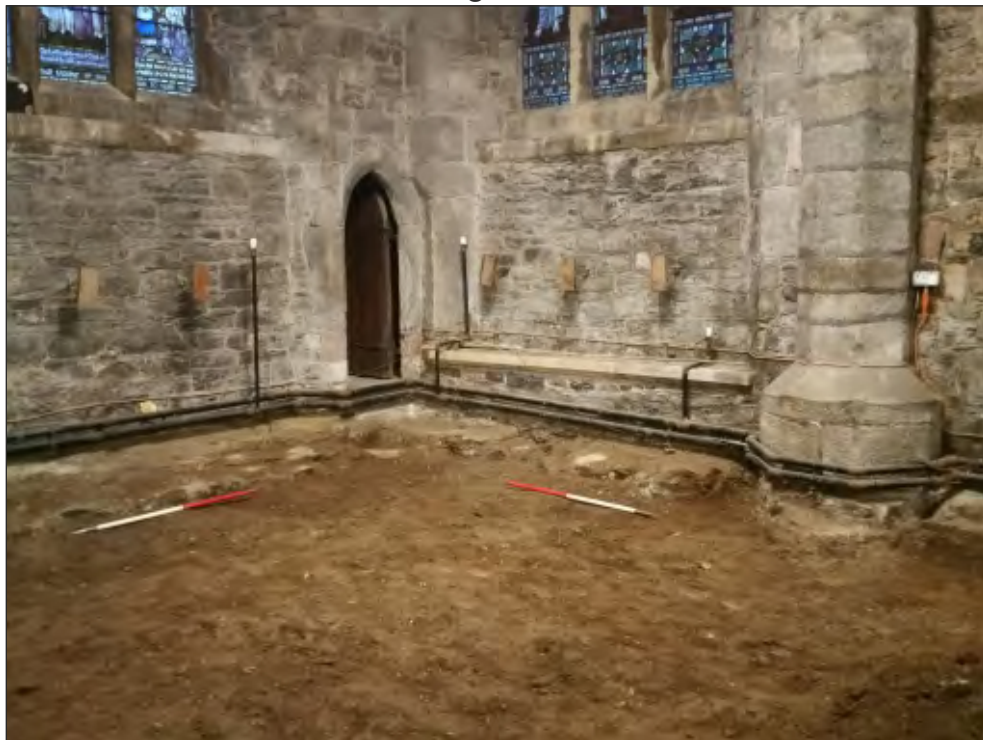
Fig. 29 General view of 13th century foundations. 1m scales. Looking southwest.

Further foundations (105-109) to the west and south are associated with the addition of a south aisle and re-building of the west front. The foundations are built largely of local limestone rubble set in compact reddish brown clay and lime mortar. The south wall of the later church partially incorporates these earlier foundations.

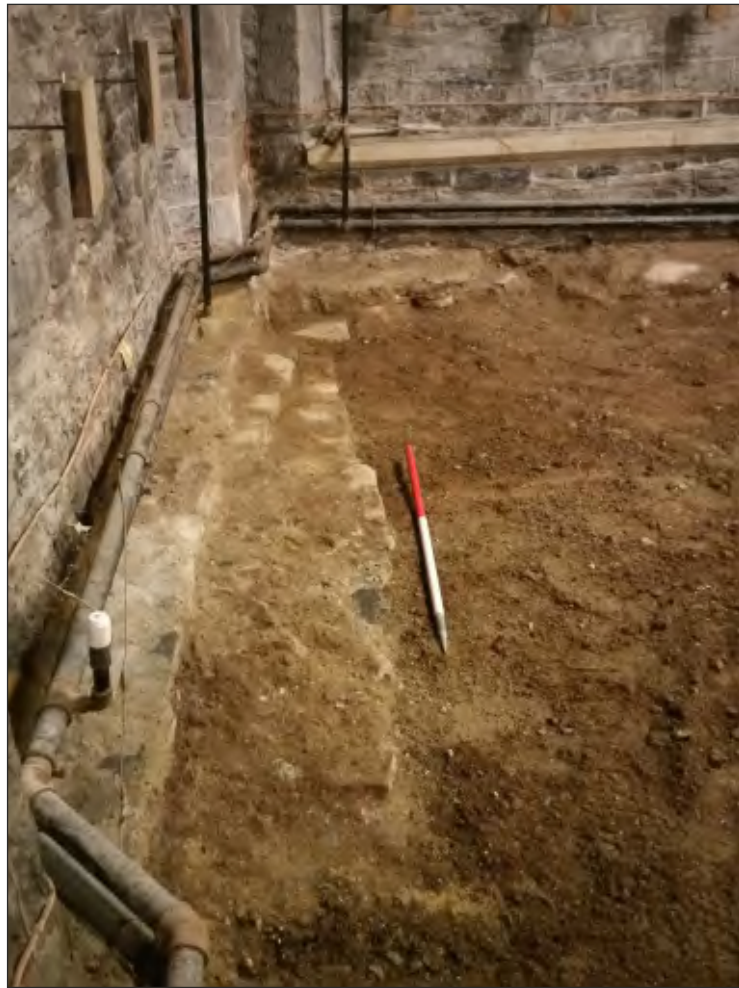
Fig. 30 Close-up of 13th century foundations partly overlain by early 15th century church. 1m scale. Looking west.

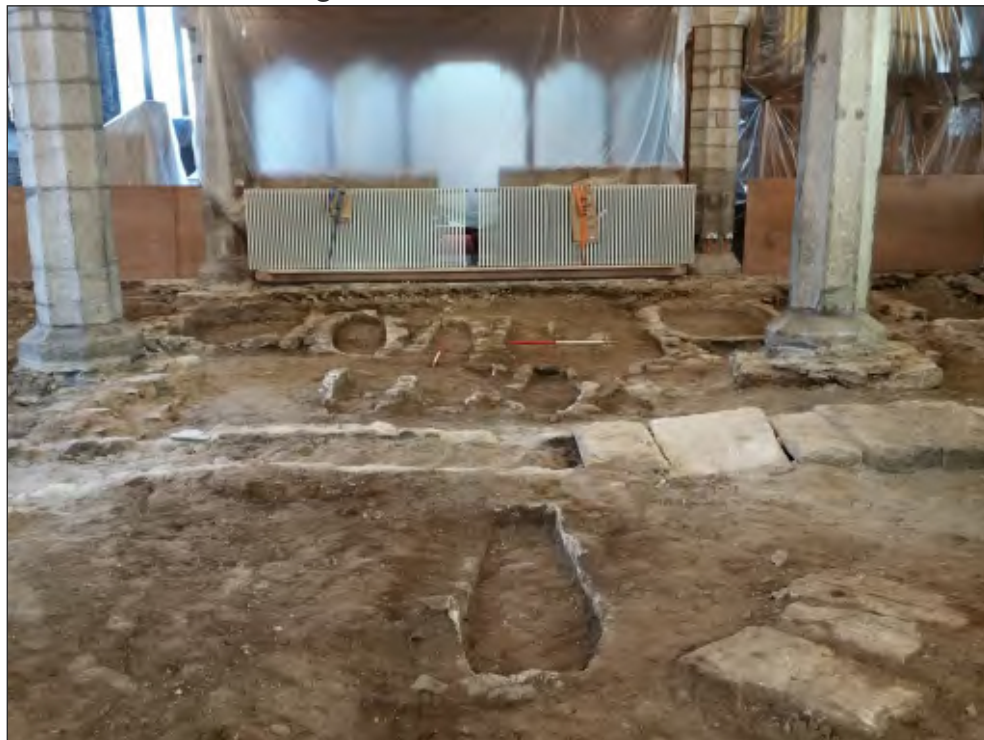
Fig. 31 General view of nave showing stone lined burials and Victorian heating duct (foreground). 1m scale. Looking east.

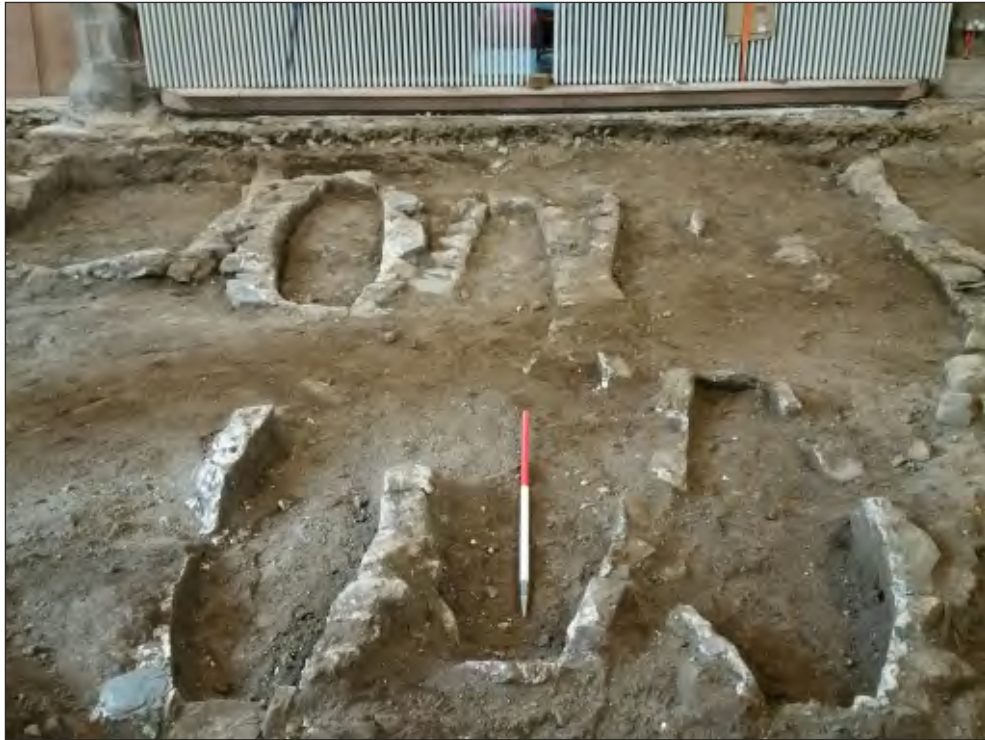
Fig. 32 Close-up of stone-lined graves. 1m scale. Looking east.

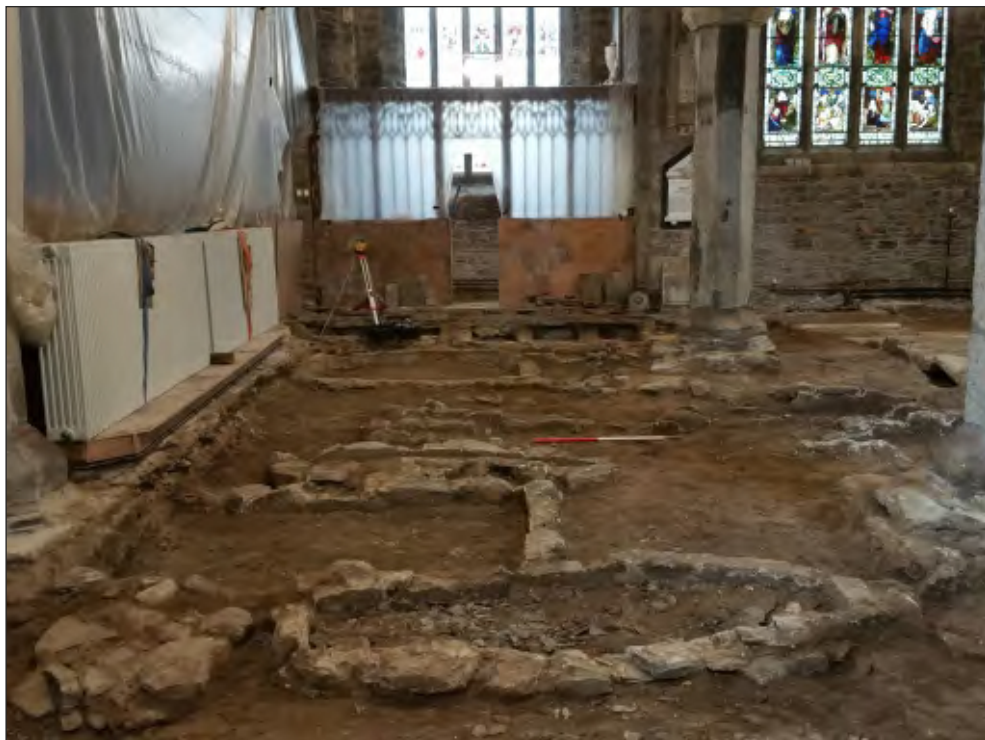
Fig. 33 General view of stone-lined graves and vaults. 1m scale. Looking south.

A number of burials had been interred within stone-and-brick chambers (139-143). These date from the late 17<sup>th</sup>-18<sup>th</sup> centuries, although none of these had access steps leading into the chamber. The bricks are hand-made local bricks dating from this period. The condition of the burials inside was not investigated as part of the works programme. All had been completely filled with loose soil, stones, fragments of hand-made brick, roof slates, mortar and blocks of local stone. The graves were presumably infilled prior to the re-flooring of the church in 1776. The ledger stones were probably removed at this time, while the wall plaques were subsequently moved in the late 19<sup>th</sup> century, making it impossible to identify the occupants or the precise dates of the burial chambers and stone-lined graves.

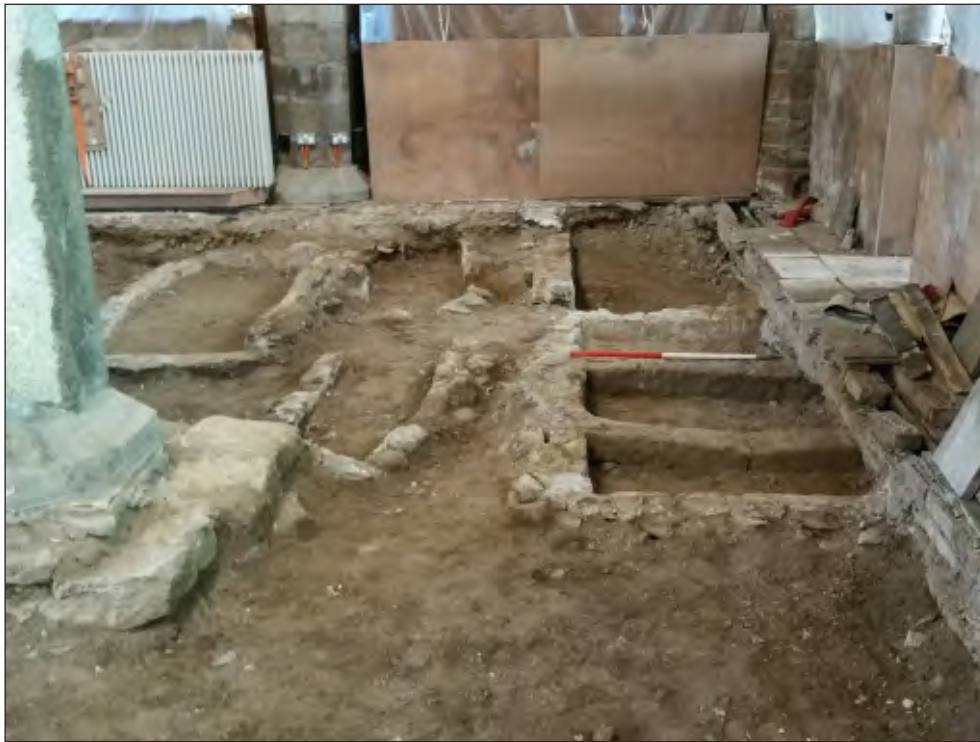
Fig. 34 General view of stone-lined graves and vaults. 1m scale. Looking east.

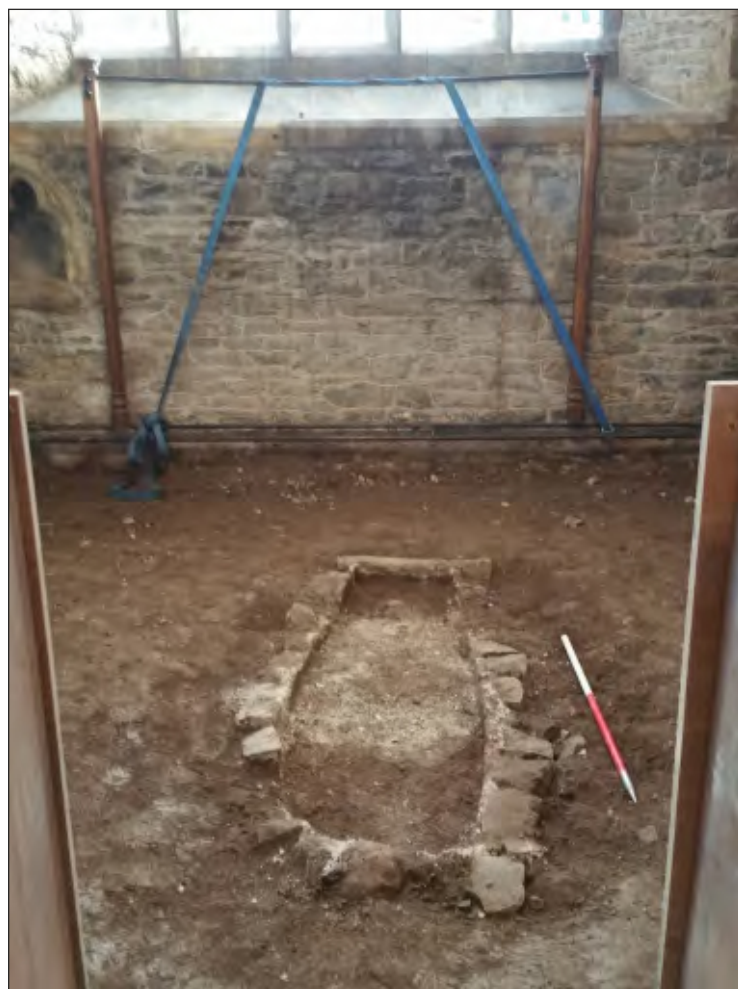
Fig. 35 General view of stone-lined grave in south transept. 1m scale. Looking south.

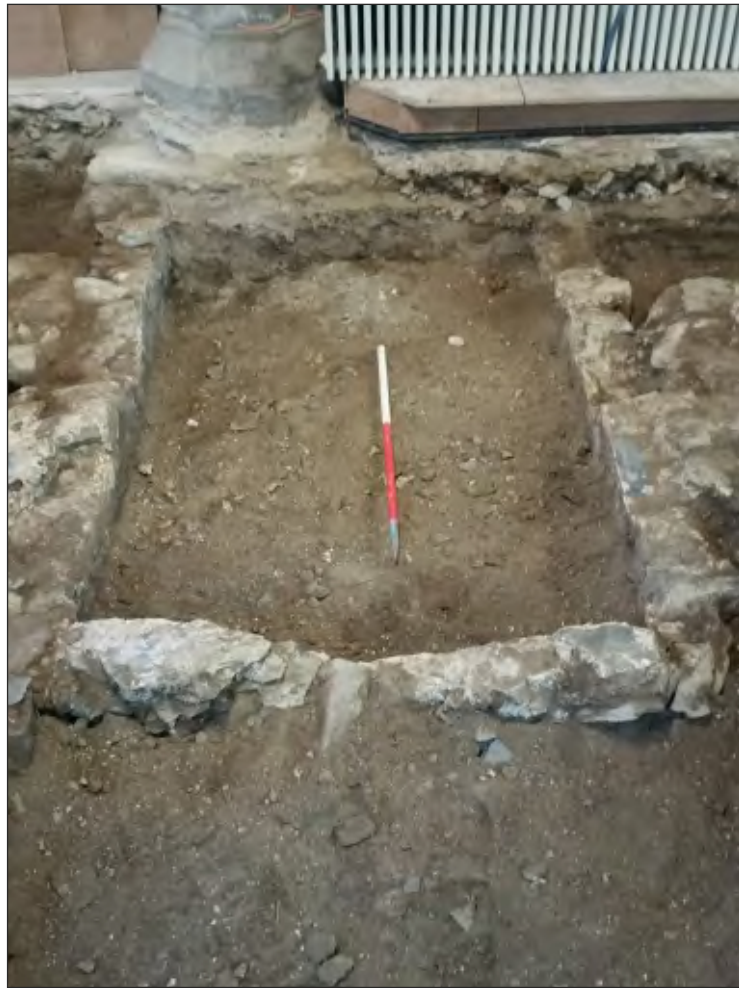
Fig. 36 Close-up of stone-lined vault under crossing. 1m scale. Looking east.

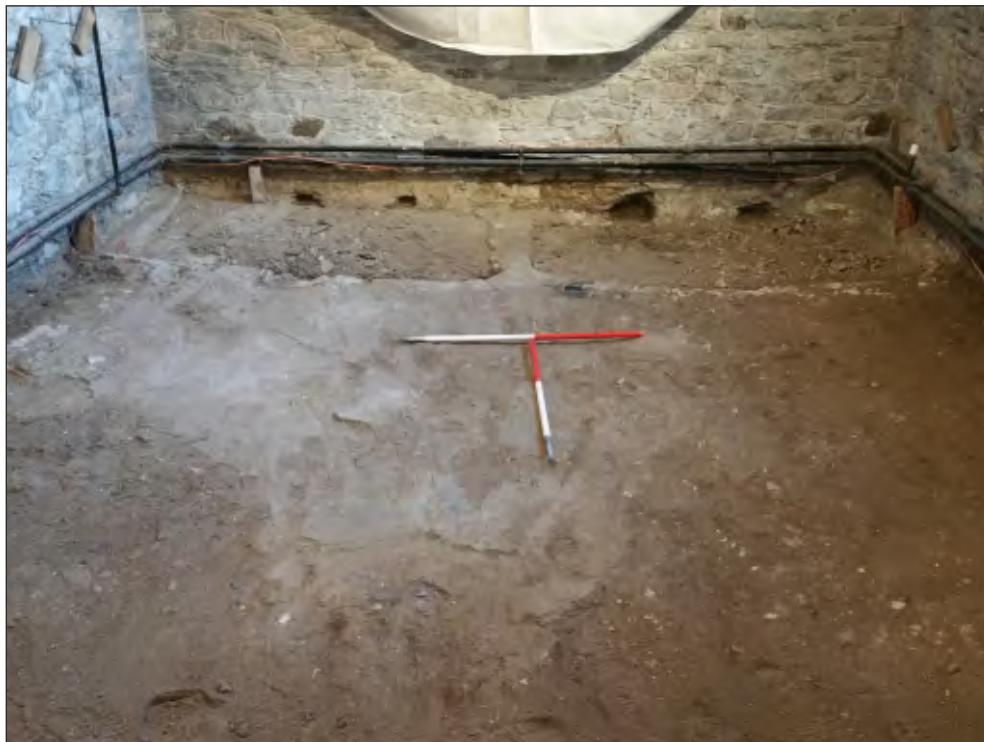
Fig. 37 General view of north transept showing late 18th century floor make-up. 1m scales. Looking north.

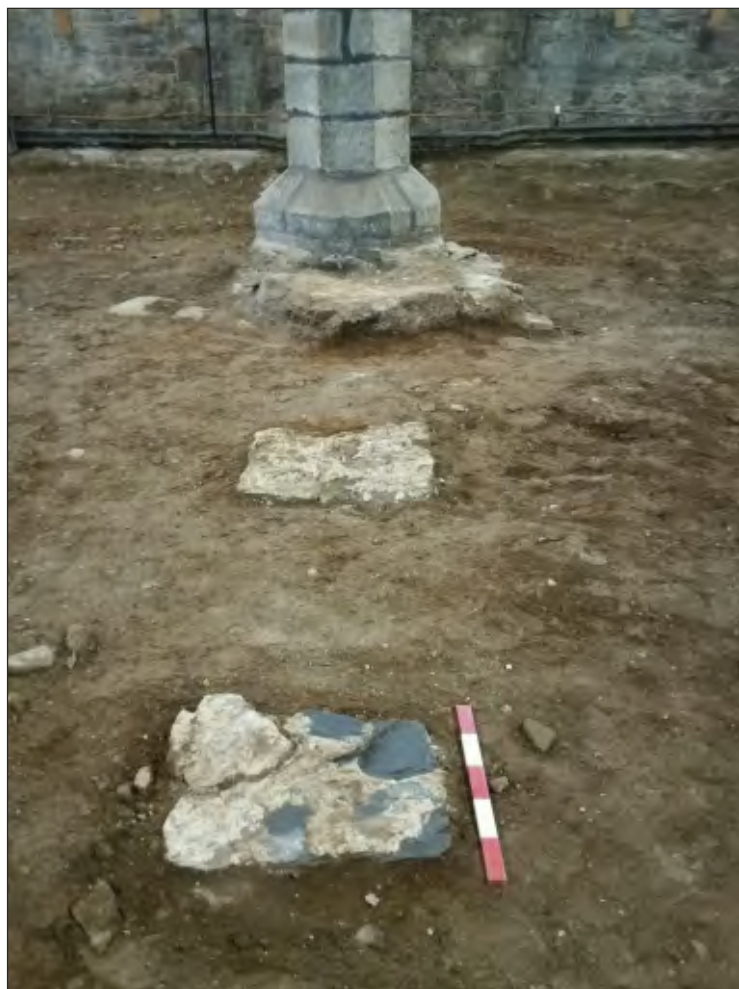
Fig. 38 General view of western gallery footings. 0.5m scale. Looking south.

While the western gallery and its two foundation pads (144 and 145) were added in 1718 further works were undertaken in 1776. This included the removal of the south porch and the blocking of the opening, the addition of north and south galleries and the re-flooring of the entire church. A small area of floor make-up material consisting of a thick layer of lime mortar, measuring 4.9m long and 4.85m wide, and located in the north transept survived the later Victorian re-ordering. A large quantity of early post-medieval window glass was recovered lying immediately above this deposit, suggesting that the medieval glass had already been at least partly removed sometime prior to the Victorian period.

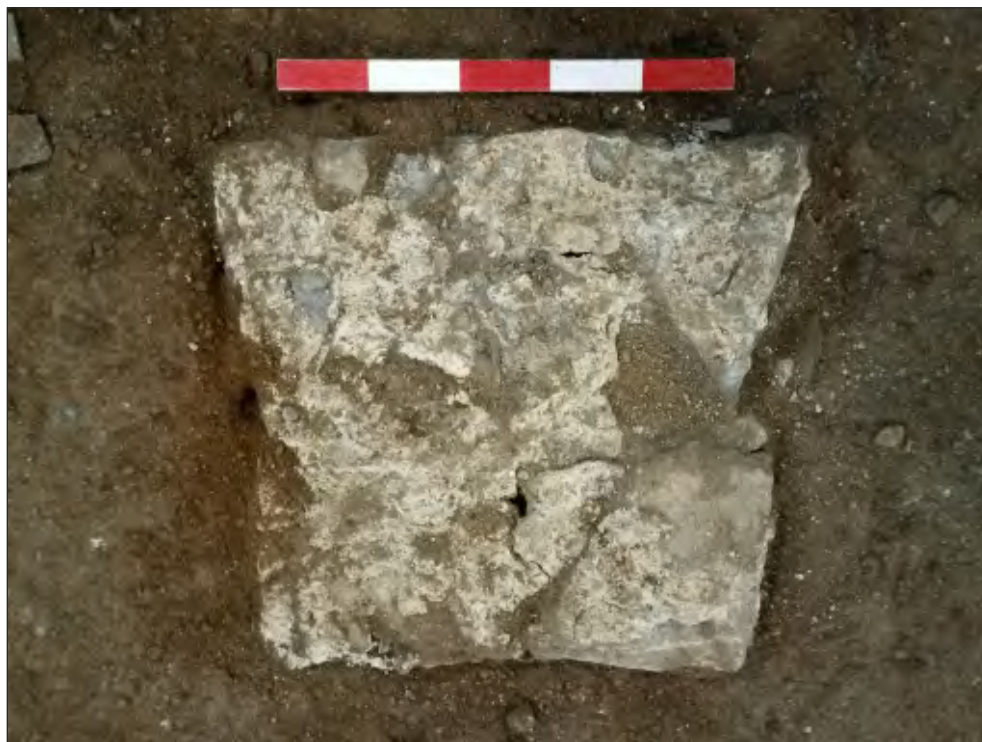
Fig. 39 Close-up of western gallery footing. 0.5m scale. Looking west.

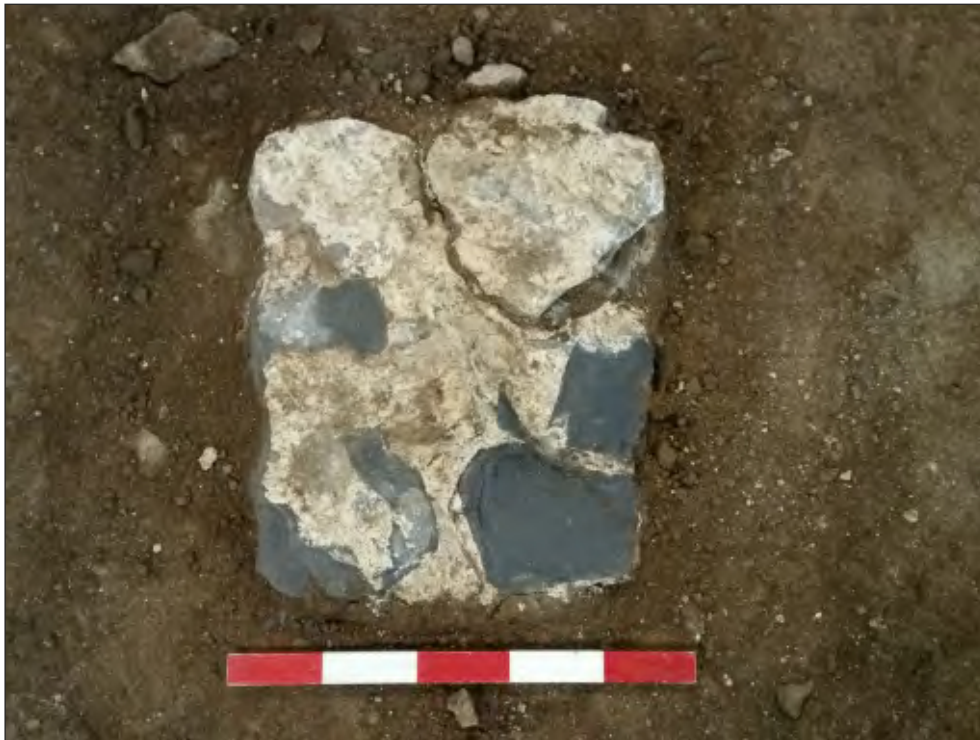
Fig. 40 Close-up of western gallery footing. 0.5m scale. Looking west.

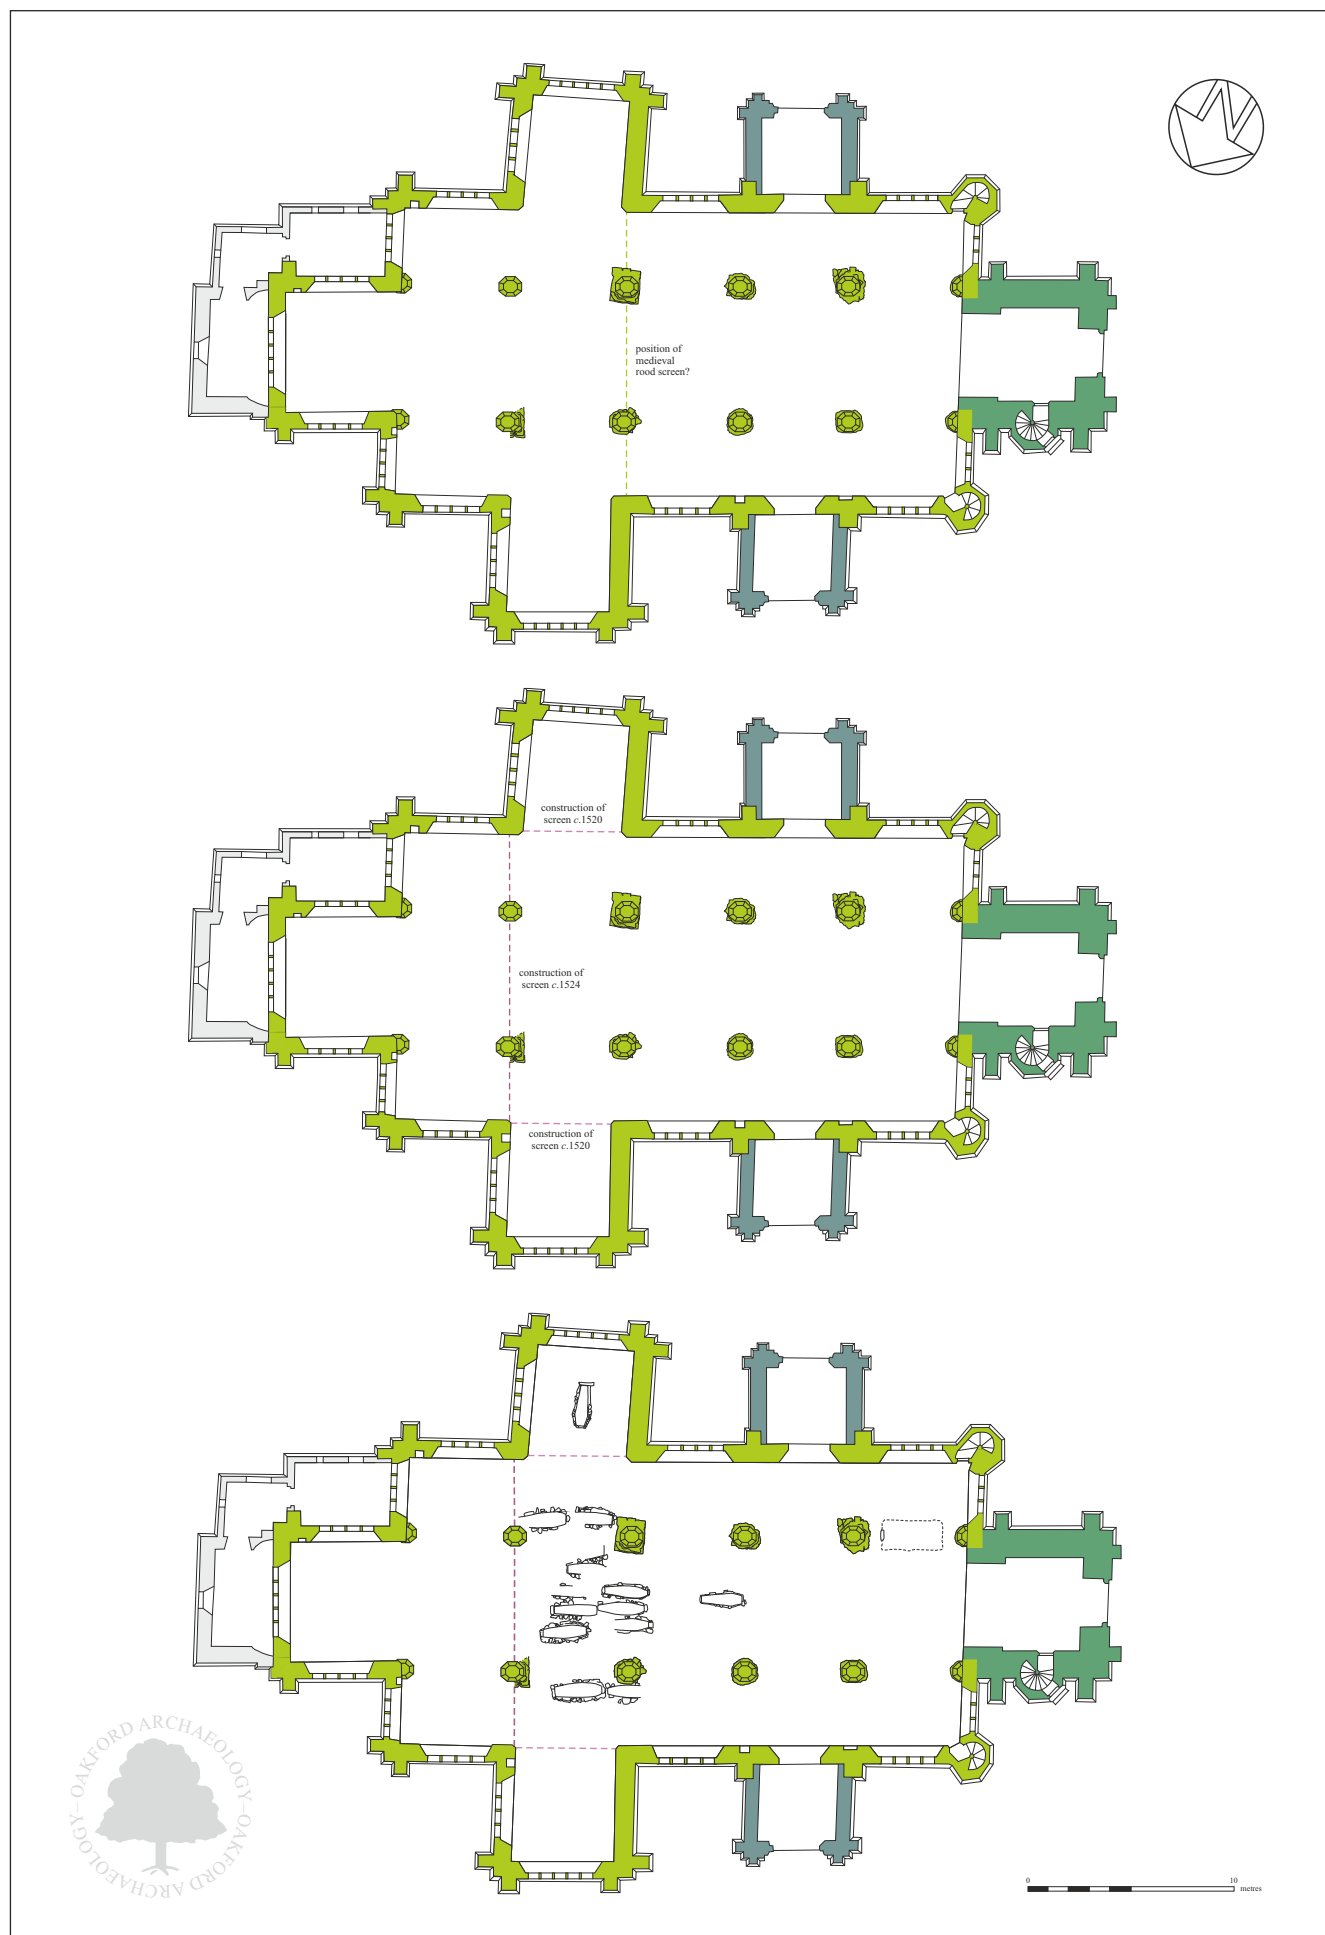
Fig. 42 Phase plans showing development of church: early 15th century (top), early-mid 16th century (middle), late 16th-18th century graves (bottom).
