## Archaeological monitoring and recording at St Andrew's Church, Ashburton, Devon

*on behalf of*  
**Ashburton PCC**

**Report No. 16-04**

**June 2016**

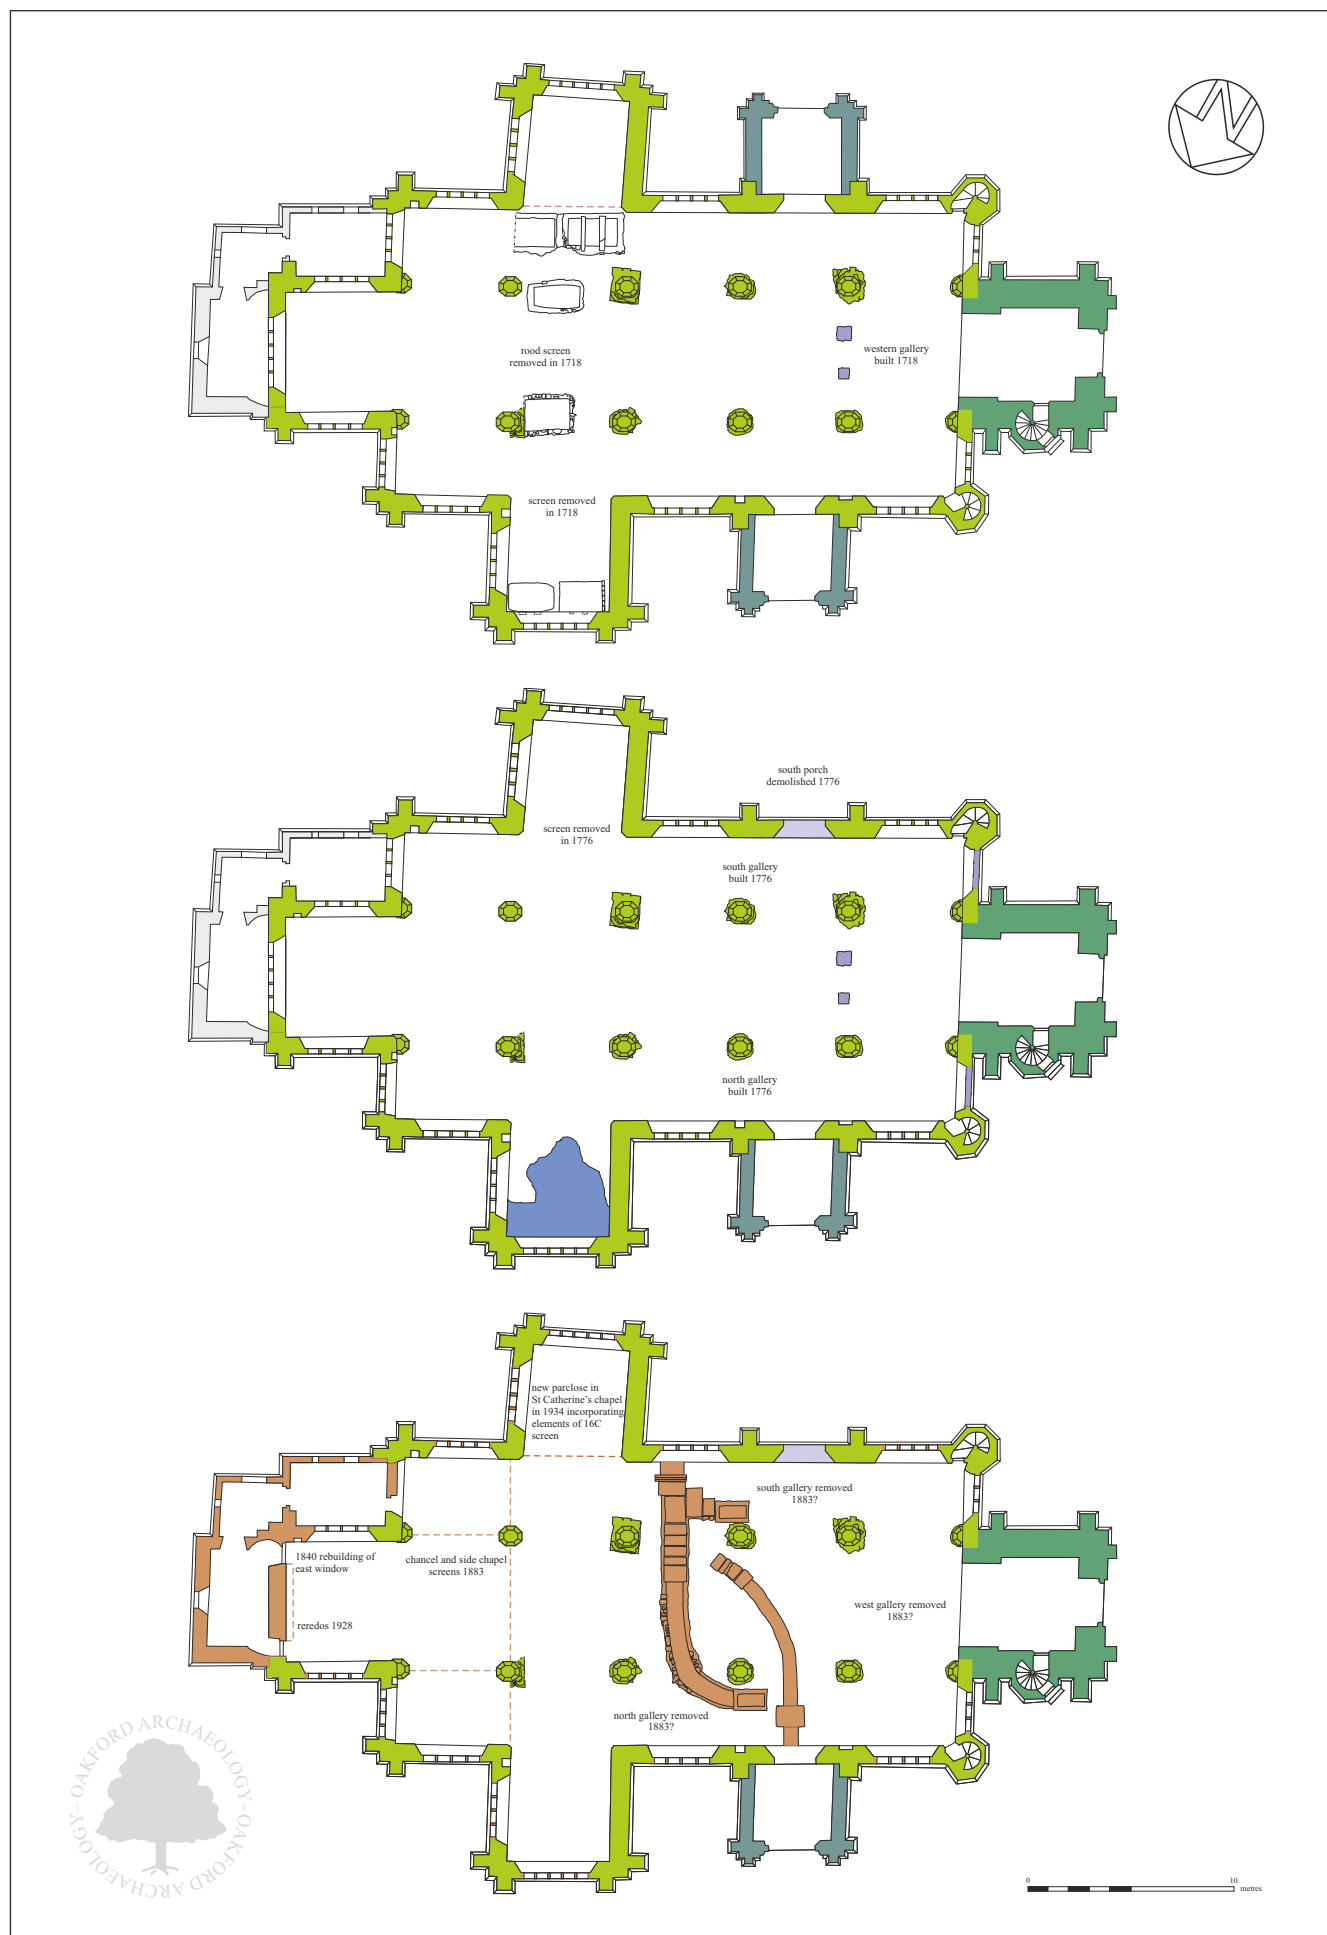
Fig. 43 Phase plans showing development of church: 1718 (top), 1776, (middle), 19th and 20th century (bottom).
