**OAKFORD
ARCHAEOLOGY**

Archaeological monitoring and recording at Milton Abbey, Milton Abbas, Dorset

Report No. 17-06

December 2017

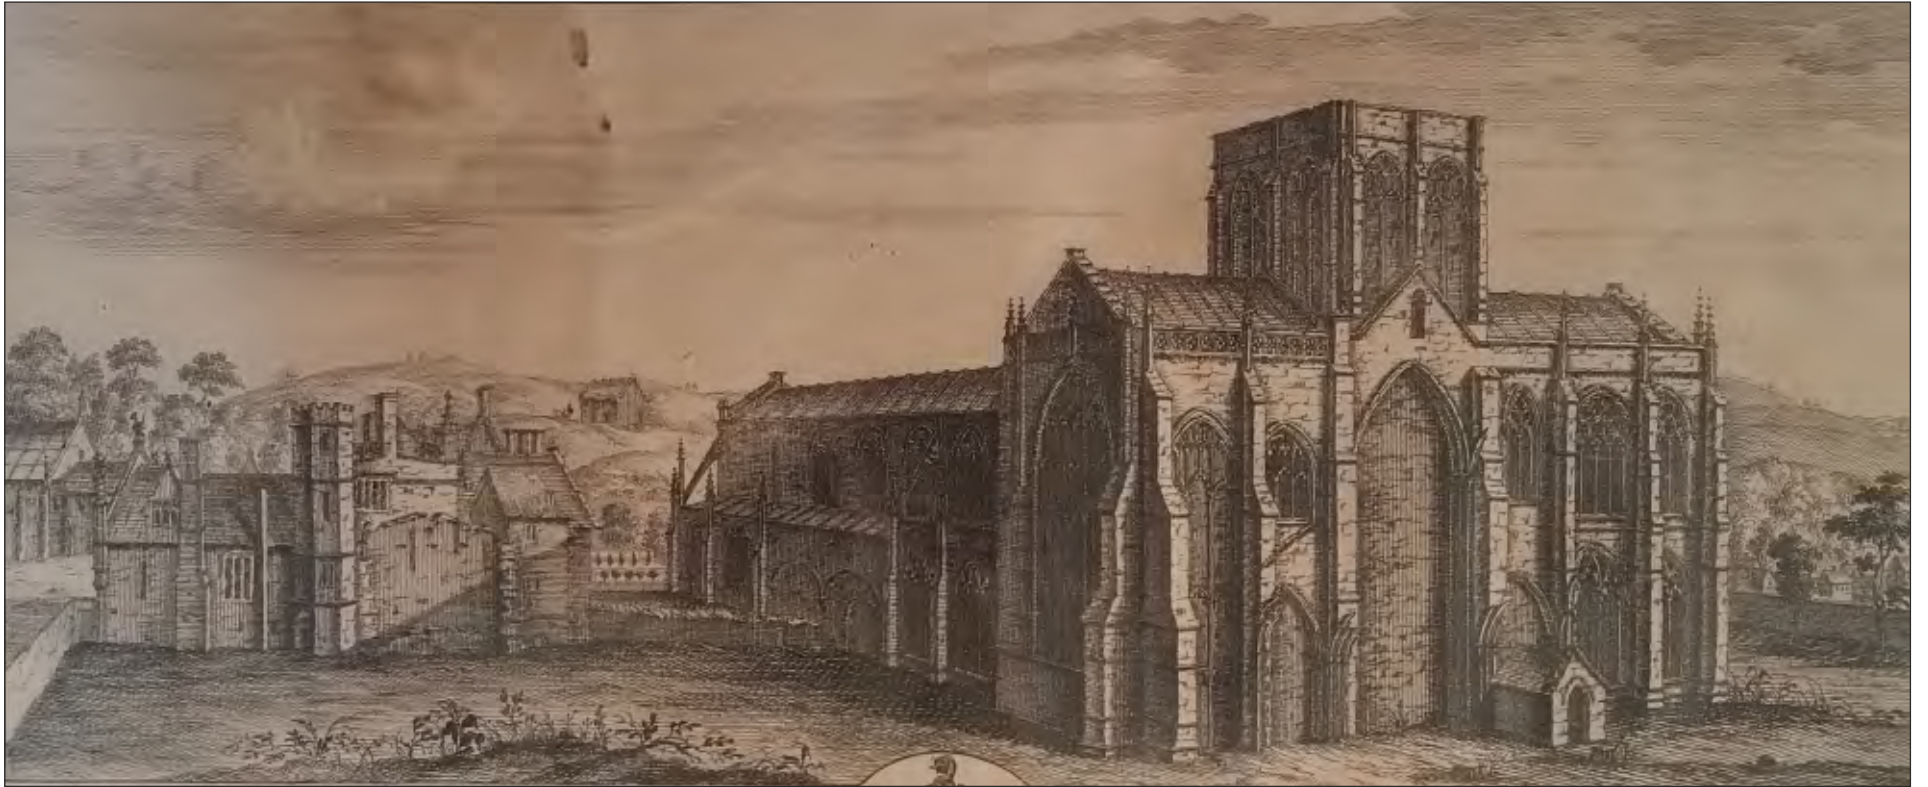
Fig. 3 Detail from 1733 engraving showing Milton Abbey (right), the monastic ranges partially demolished and converted by Sir John Tregonwell (left), the Tithe barn (far left) and St Catherine's Chapel (background).

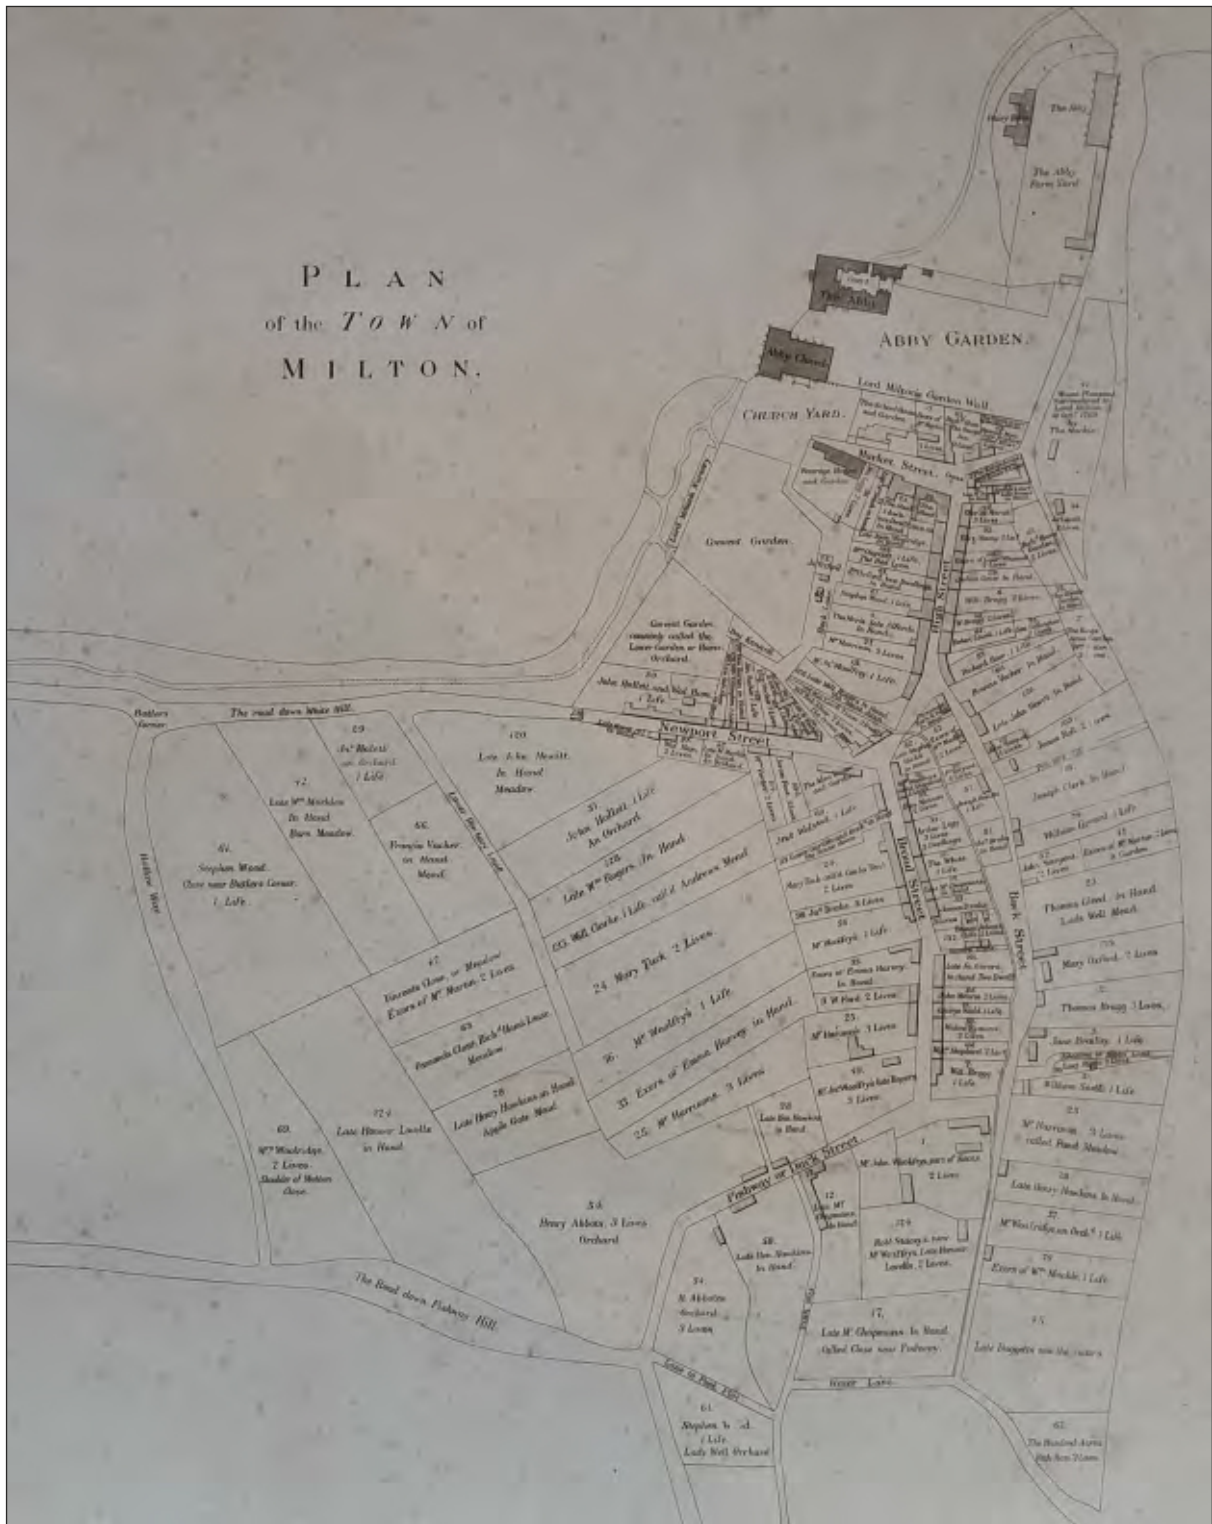
Fig. 4 Detail from an 18th century plan of the town of Milton showing the Abbey and converted monastic ranges to the north.

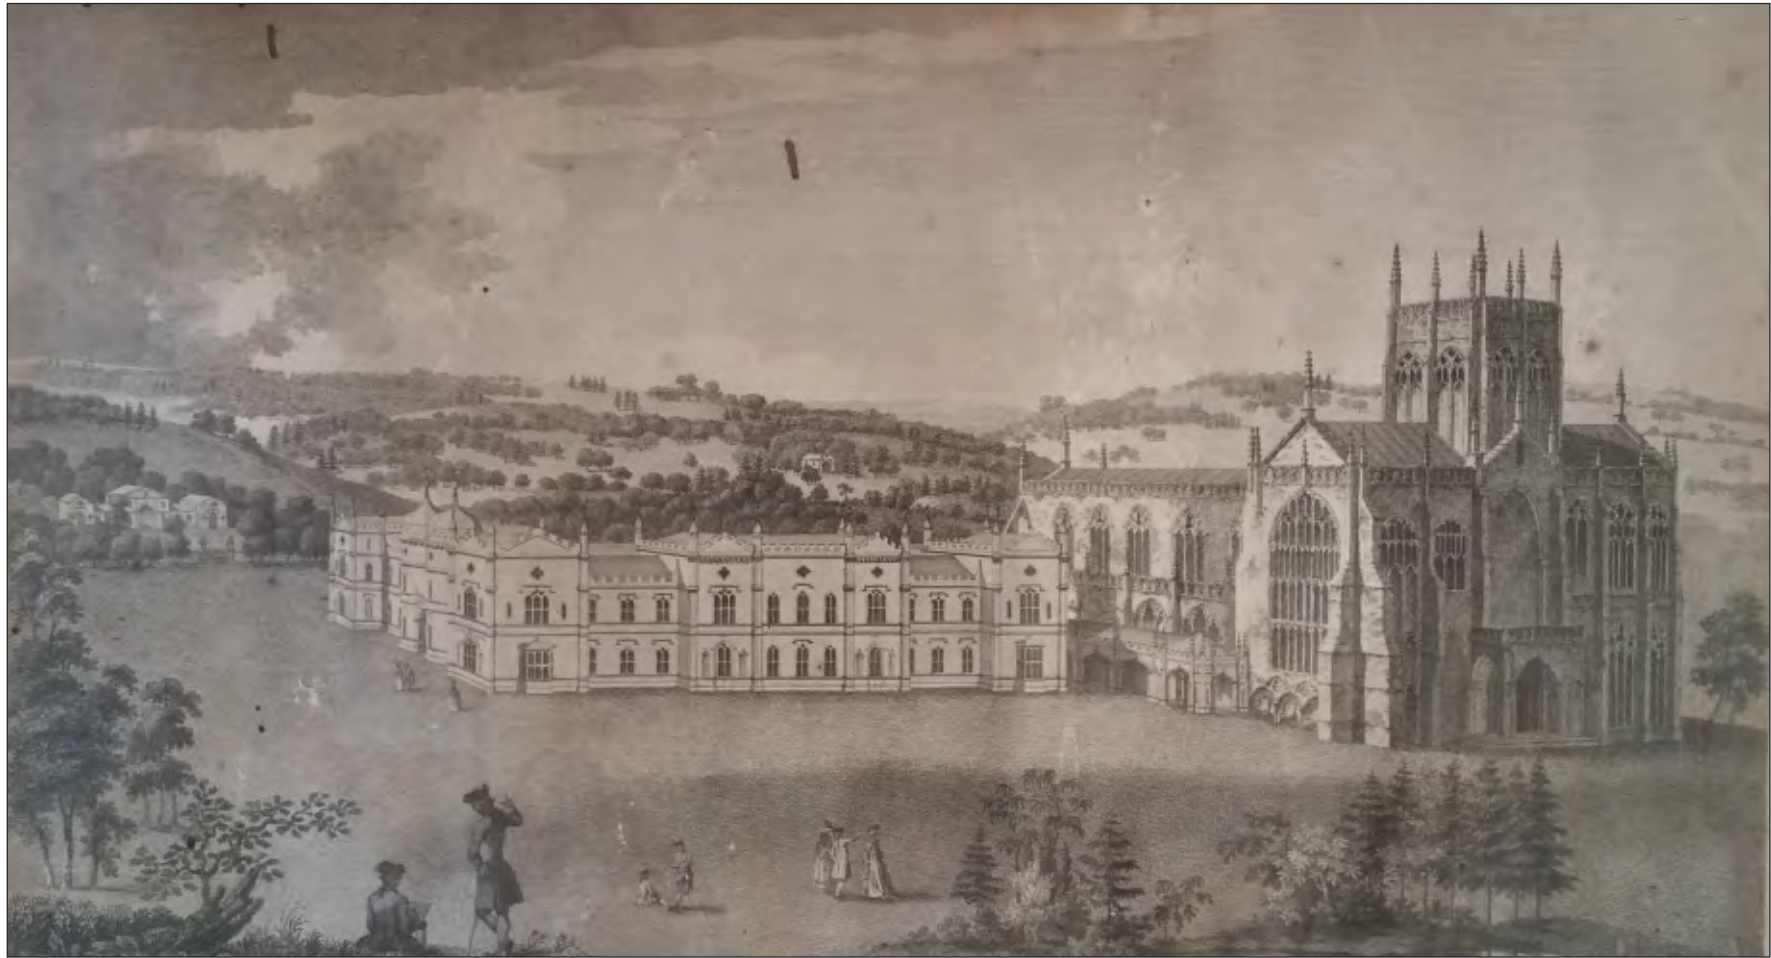
Fig. 6 Detail from a late 18th century engraving showing Milton Abbey after the restoration by James Wyatt (right), Milton Abbey House built for Joseph Damer (left), the new stable block (far left) and St Catherine's Chapel (background).

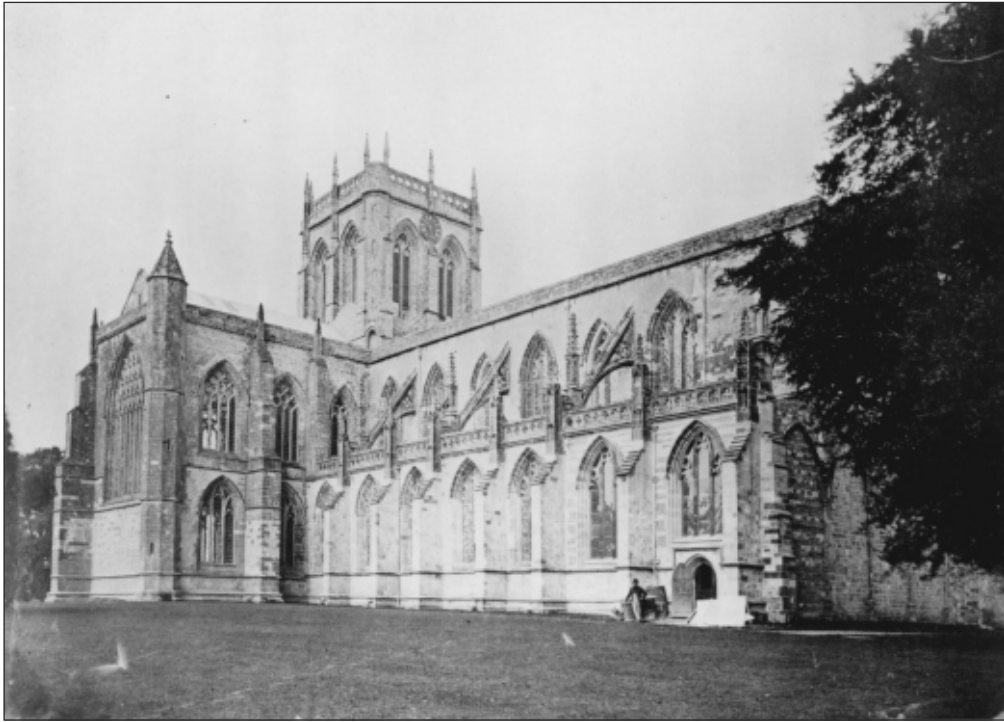
Fig. 7 Photograph of Milton Abbey taken in 1865 during George Gilbert Scott's restoration of the church. Looking northwest.

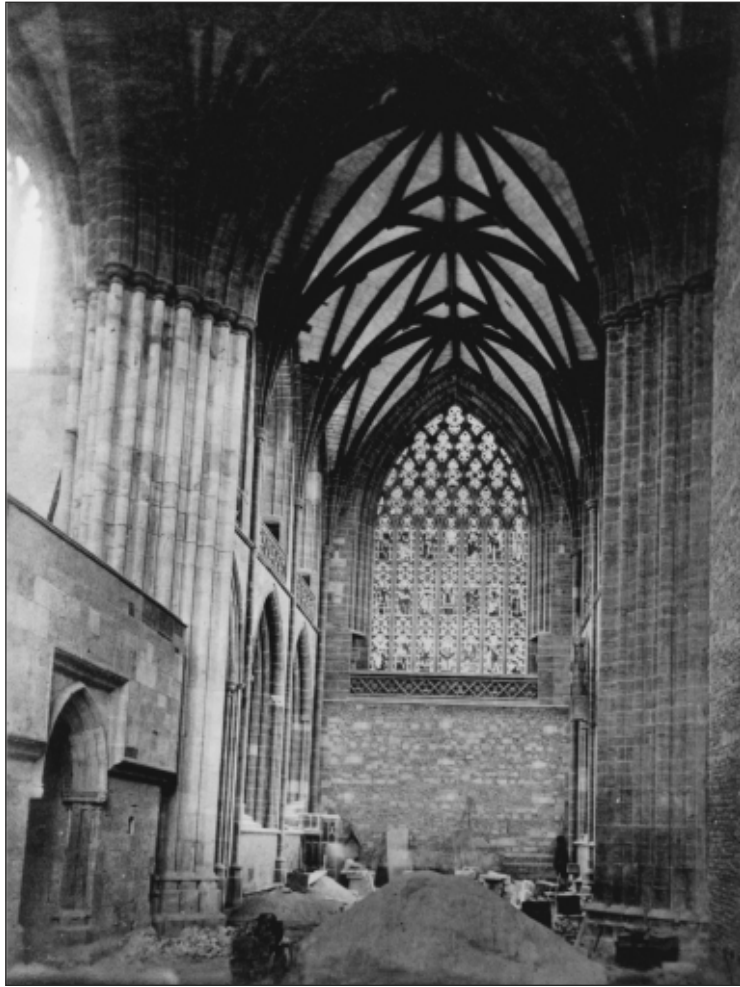
Fig. 8 Photograph of the crossing and south transept taken in 1865 during George Gilbert Scott's restoration of the church. Looking south.

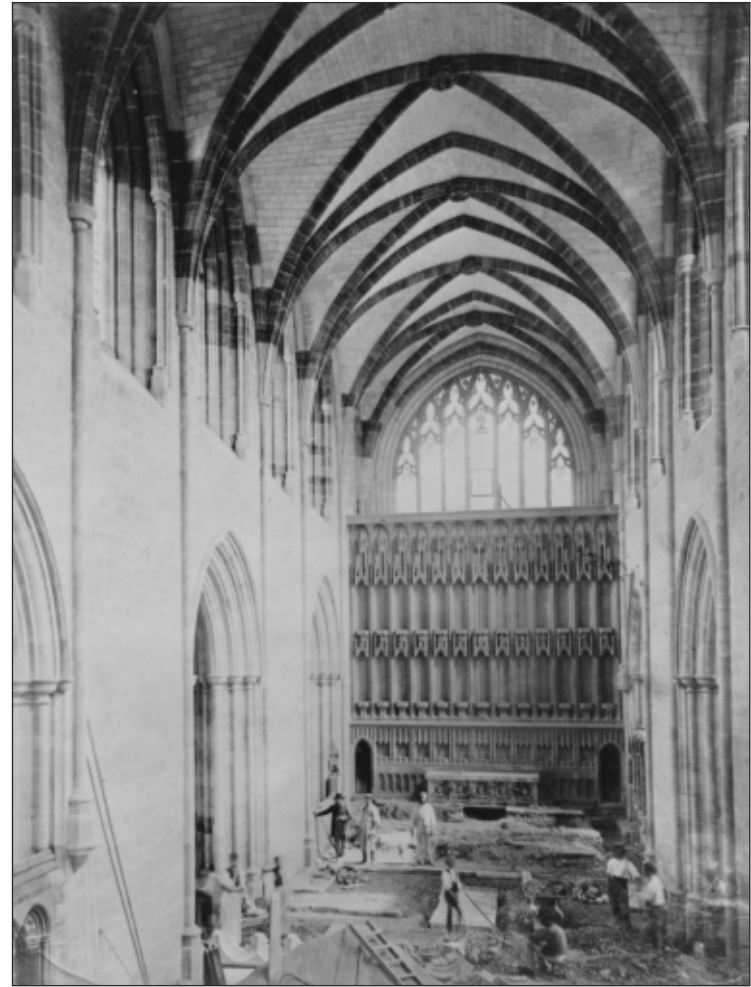
Fig. 9 Photograph of the choir and chancel taken in 1865 during George Gilbert Scott's restoration of the church. Looking east.

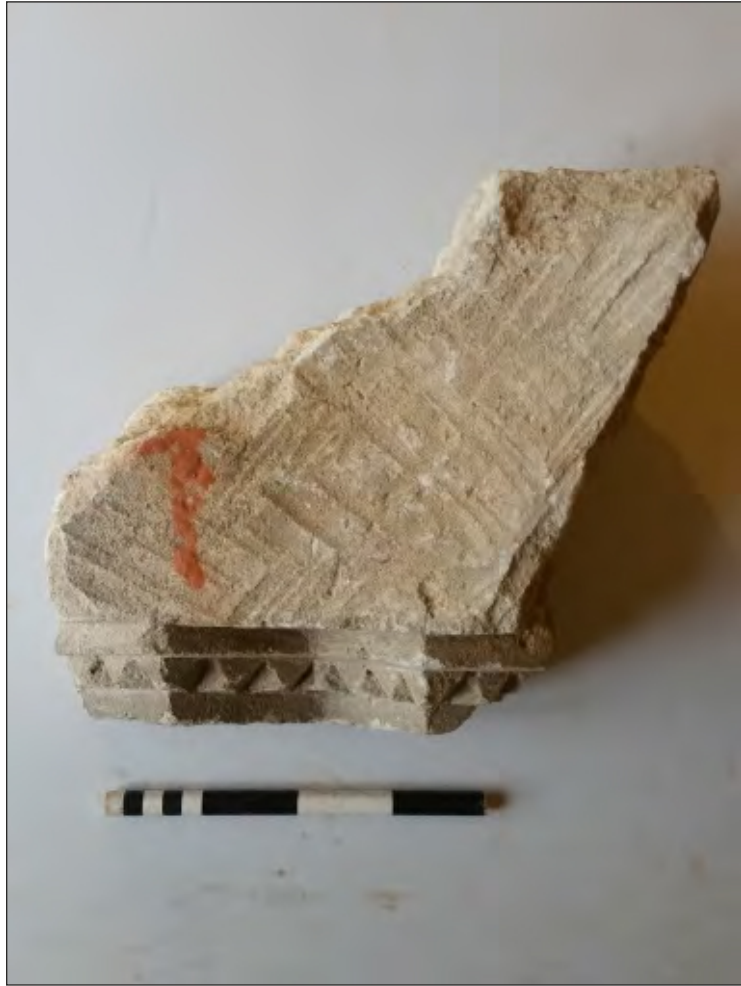
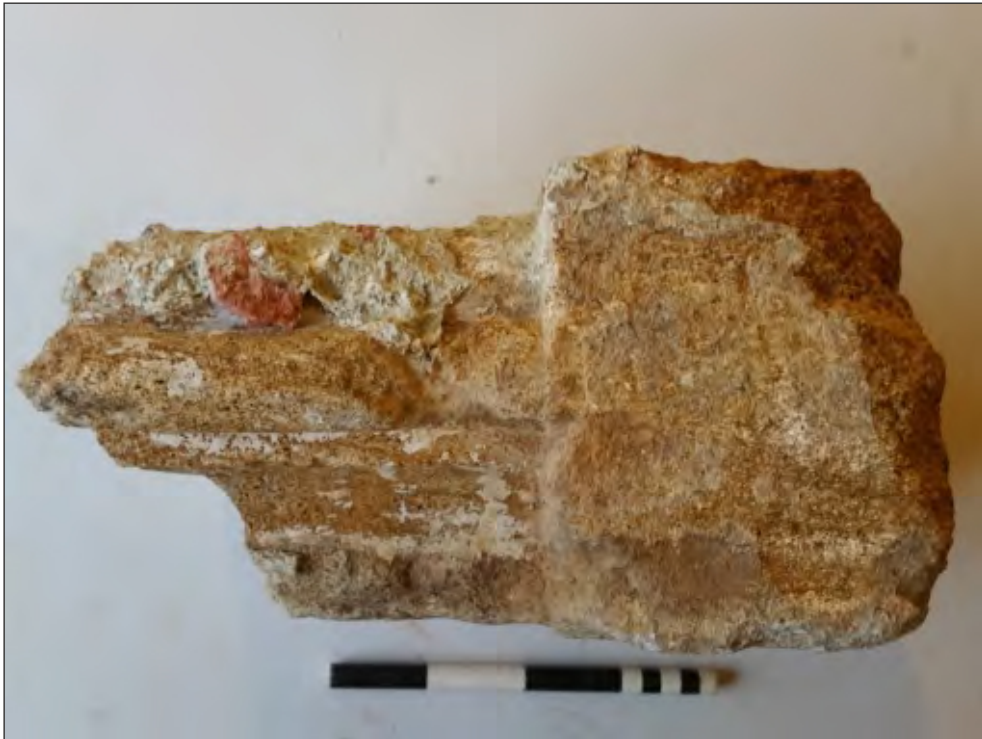
Fig. 21 Oolitic limestone with chevron decoration (above) and Ham stone corner moulding (below).

1. Portland stone, chamfered base of capital with shallow moulding
2. Oolitic limestone with chevron decoration, possibly part of the cloister, late 12th-13th Century (Fig. 21).

11. Ham hill, corner moulding, perpendicular, late medieval (Fig. 21).
12. Ham hill, roll moulding, late medieval.

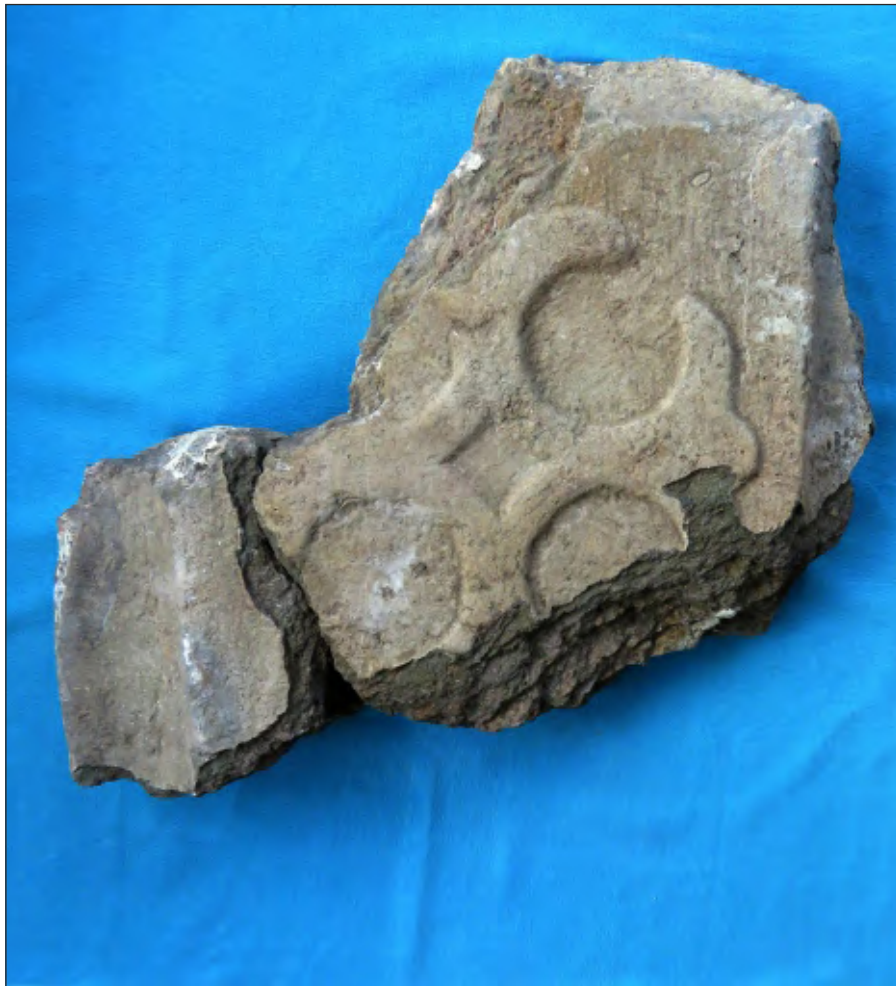
The larger piece has approximate overall dimensions of 39 x 44cm and is currently about 6.5 cm thick. However, Purbeck marble is strongly bedded so it appears to have split along a bedding plane, leading to some loss of thickness. Carved in low relief on the face, is most of the head of a cross and two sides retain parts of the hollow chamfered margin. These meet at the top right corner of the slab at less than 90°, confirming that the slab was tapered. In fact, with the smaller piece in place, it can be appreciated that the slab had quite a strong taper (see Fig. 22). All the edges are broken and a large patch of white mortar adheres to the underside, which is from its re-use for structural purposes. Only the cross itself seems to have been polished (including its voided centre), as worn tooling marks are visible over the whole of the surviving surface, including the chamfer. Despite the wear, a point chisel seems to have been used and the pattern of marks across the open areas is aligned with the axis of the slab. This changes to more of a fan pattern inside the rounded areas between the cross-head's terminals, showing how the carver has worked between them, to meet the edges at an angle. As is normal on Purbeck slabs, all of the relief edges have been worked to a slight chamfer rather than being square cut. On the edges of the slab, the direction of tooling is along the hollow chamfer. The smaller piece is approximately 23 x 19cm overall and is also about 6.5cm thick. As can be seen in Fig. 22 it is from the left side of the slab and it is valuable in providing a profile of the edge moulding, which includes the whole of the hollow chamfer and the vertical outer edge. Using the width of the hollow chamfer and the distance from the centre line (established from the cross head) to the top corner, the width of the slab at the head end can be estimated as about 59cm. This is consistent with what would be expected for a full-size coffin lid approaching 2m in length.

Fig. 22 Purbeck cross slab pieces reassembled (above) and Purbeck cross slab categories (below).

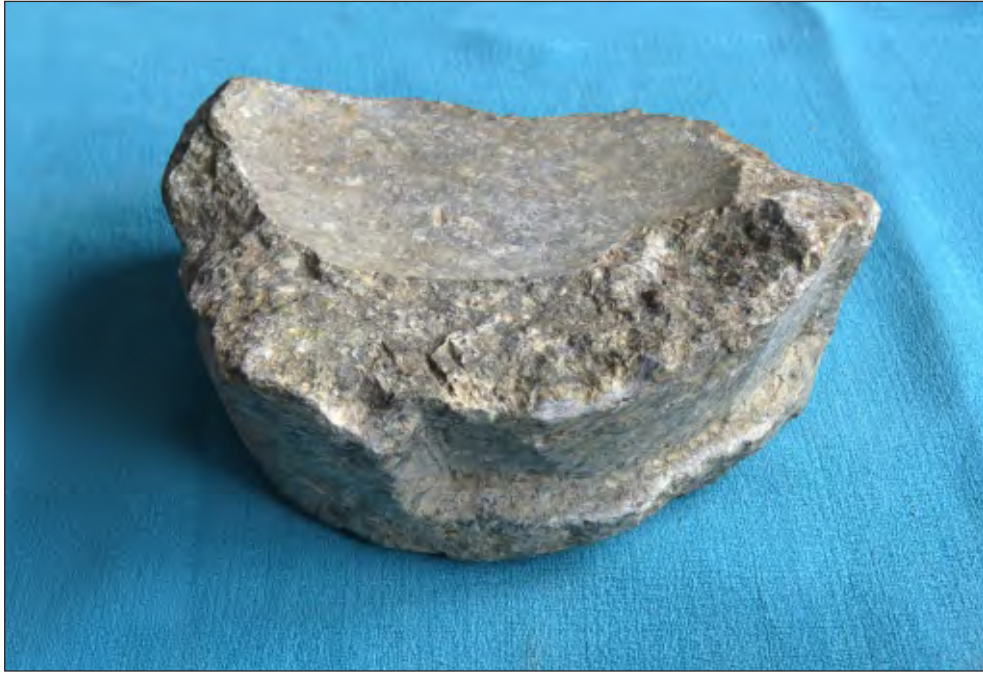
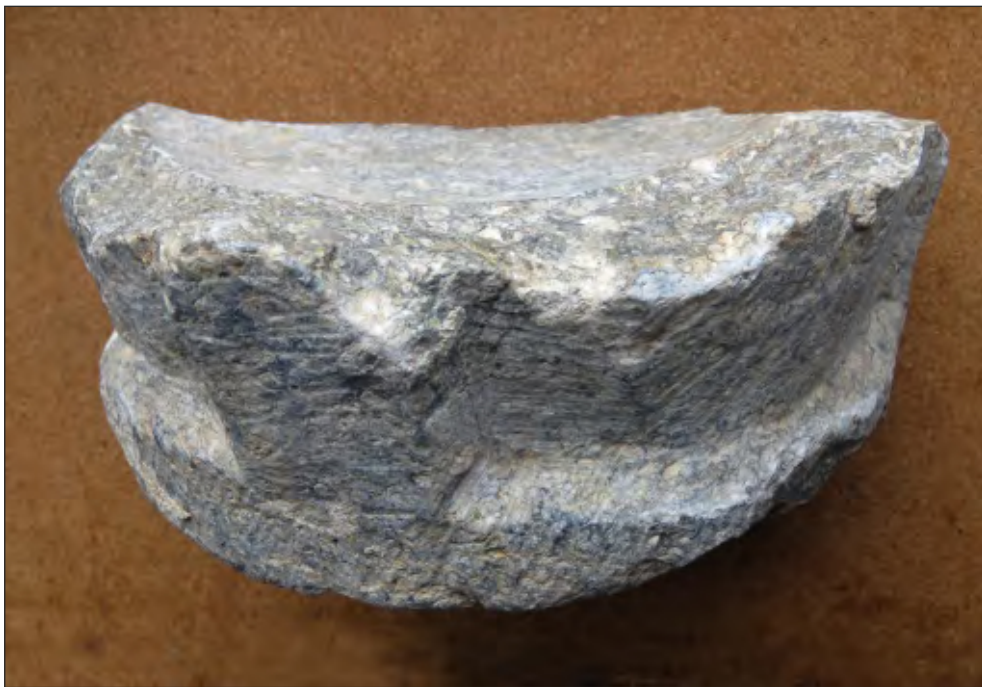
Fig. 25 Mortar fragment (above) and dressing and faceting (below).

The mortar fragment (Fig. 25) is substantial and comprises approximately half the base of the vessel with its foot ring and parts of three out of the four corner ribs. The base diameter is

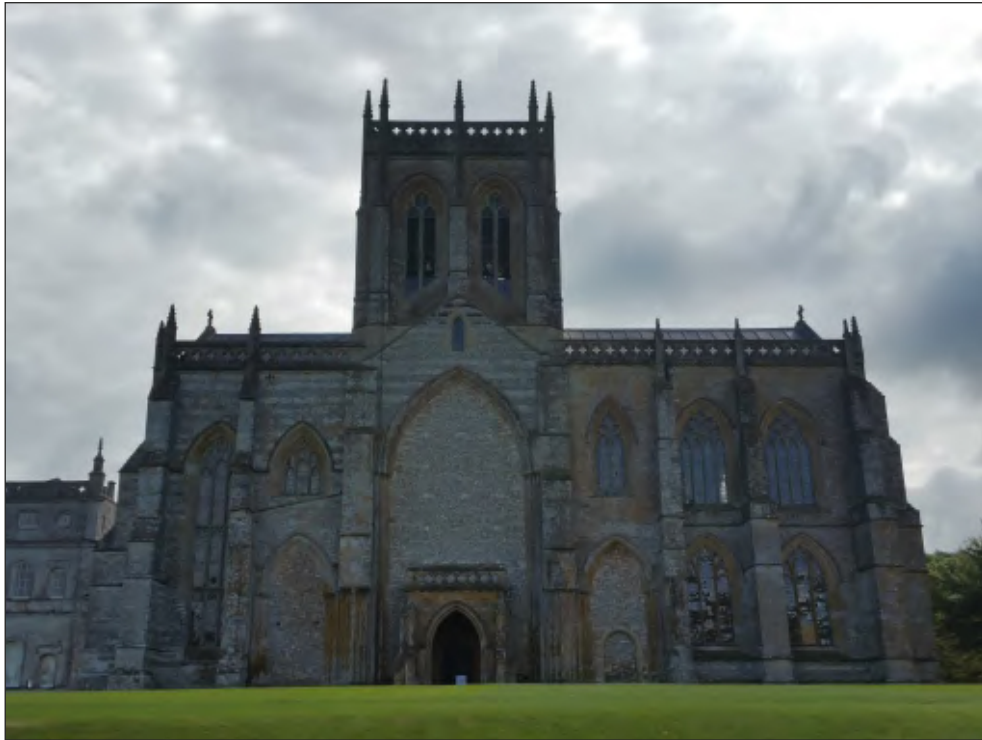
Pl. 1 General view of transepts and crossing with tower above showing location of unfinished nave. Looking east.

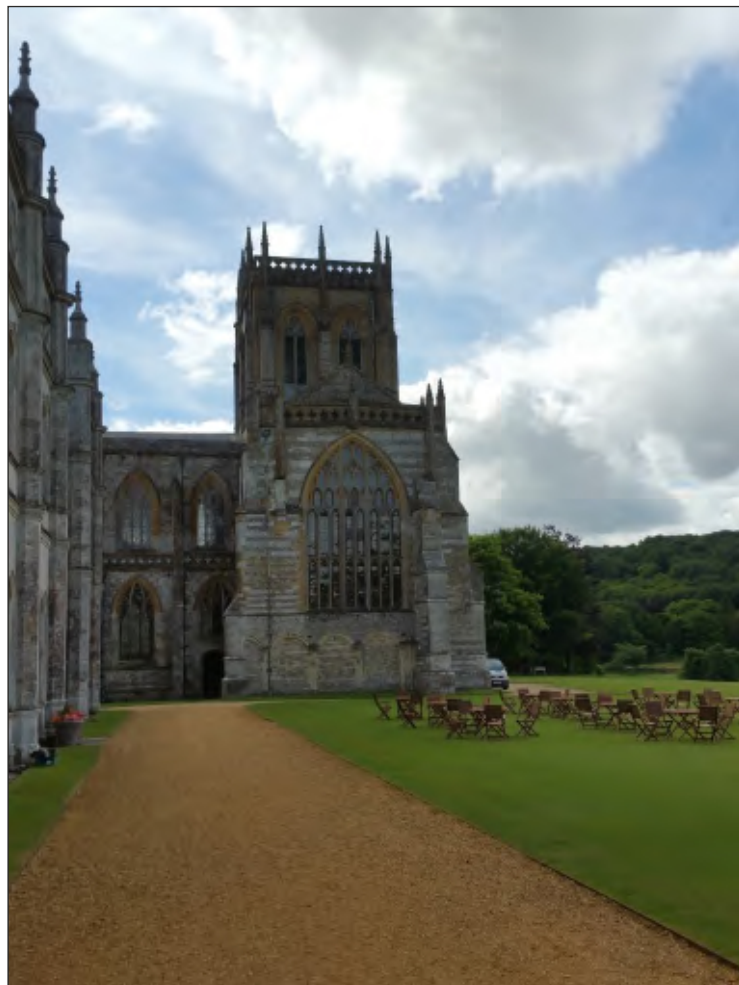
Pl. 2 General view of north transept with crossing tower behind. Looking south.

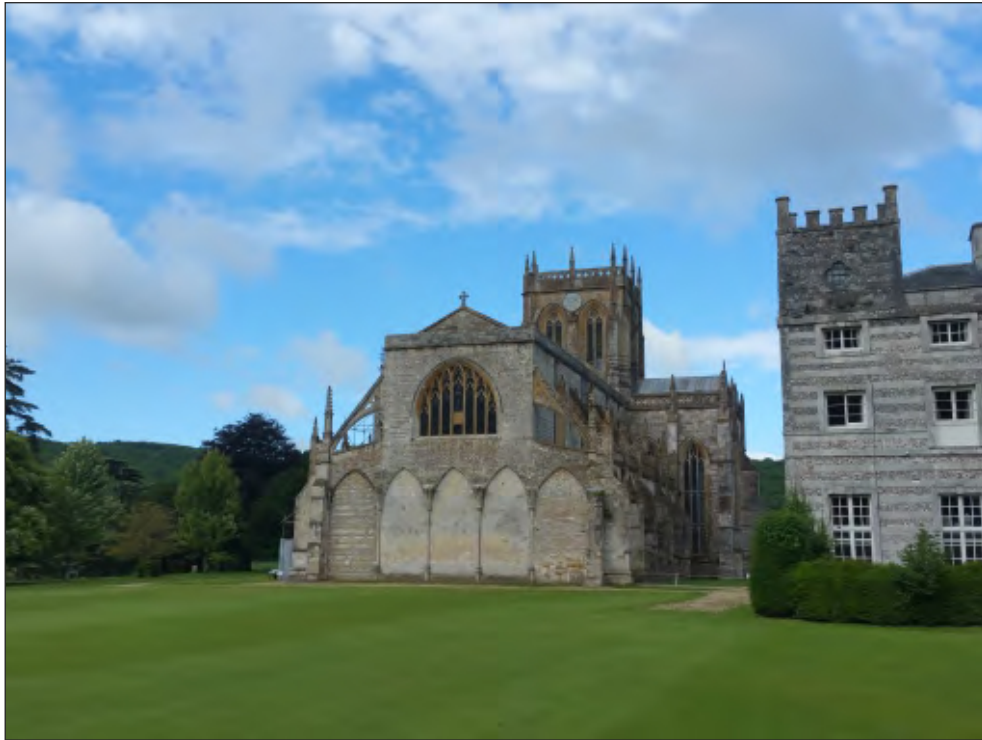
Pl. 3 General view of east end showing location of demolished Lady Chapel. Looking southwest.

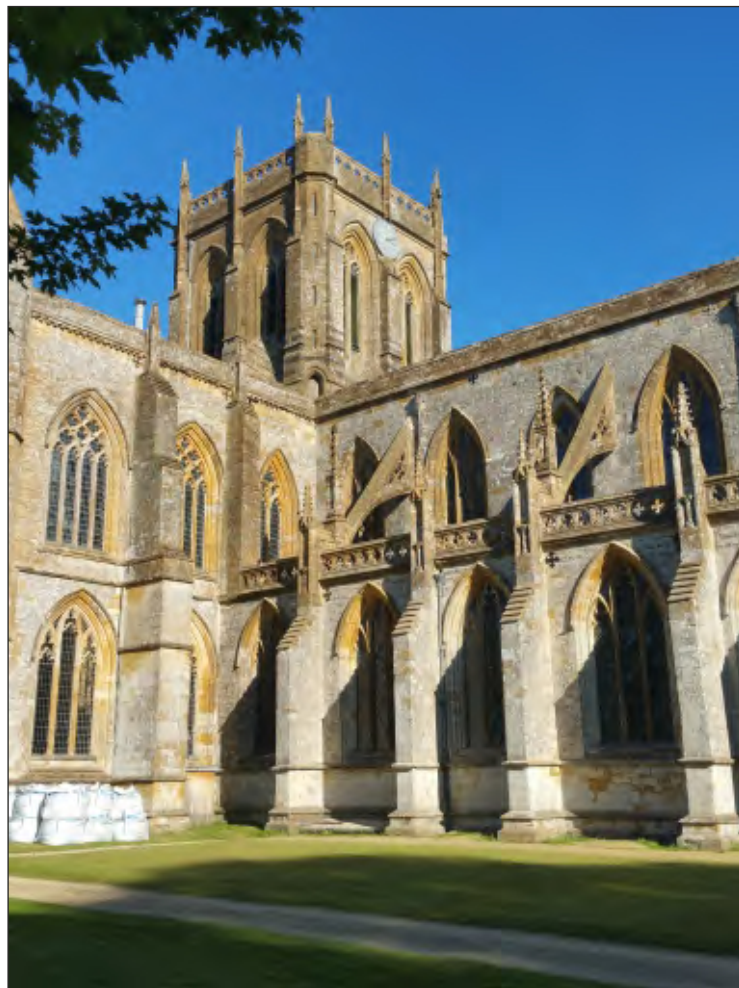
Pl. 4 General view of south transept, crossing with tower above and south choir wall. Looking northwest.

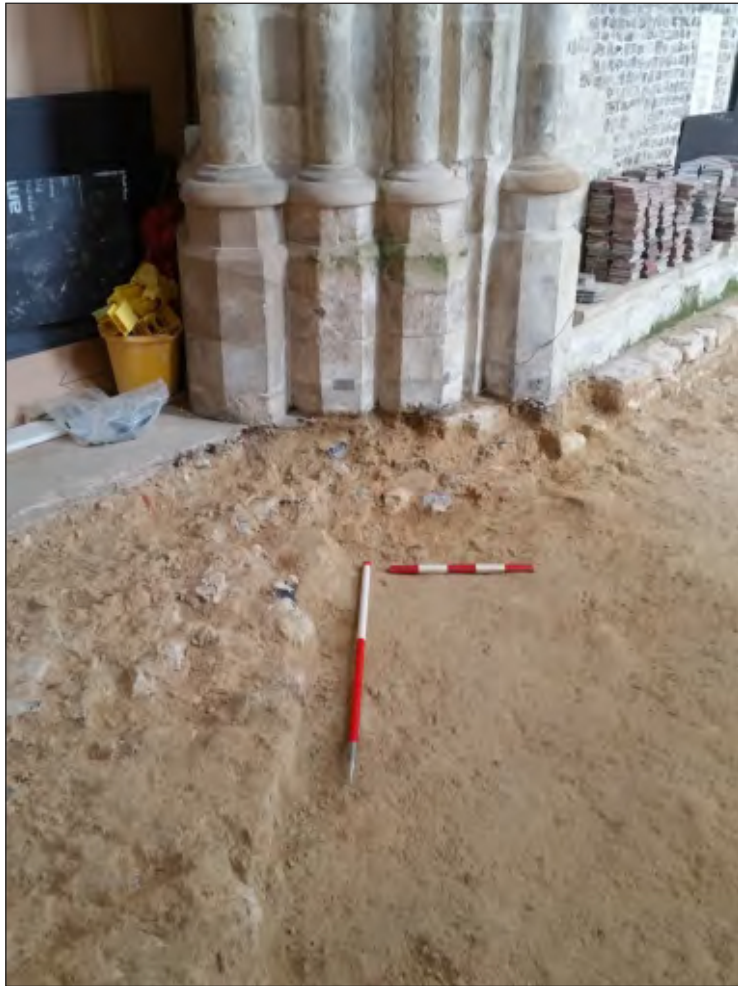
The foundation of the southeast tower pier (1006) consisted of Chilmark rubble and flint nodules bonded with very light yellowish white lime mortar. This was identical to the foundation of the northeast transept pier (1008), suggesting the two were built at the same time. However, the foundation of the east wall (1010) consisted of Chilmark rubble bonded with light to mid-orange yellow lime mortar. This was heavily truncated by at least three stone lined graves. Two graves (1025 and 1026) consisted of fragmentary remains while the third (1027) was uncovered in the southeast corner of the transept. Built of roughly squared chalk blocks the grave measured 2.25m long and 0.85m wide.

Pl. 5 General view of southeast crossing pier foundation (1006) and eastern transept pier foundation (1008). 0.5m and 1m scales. Looking southeast

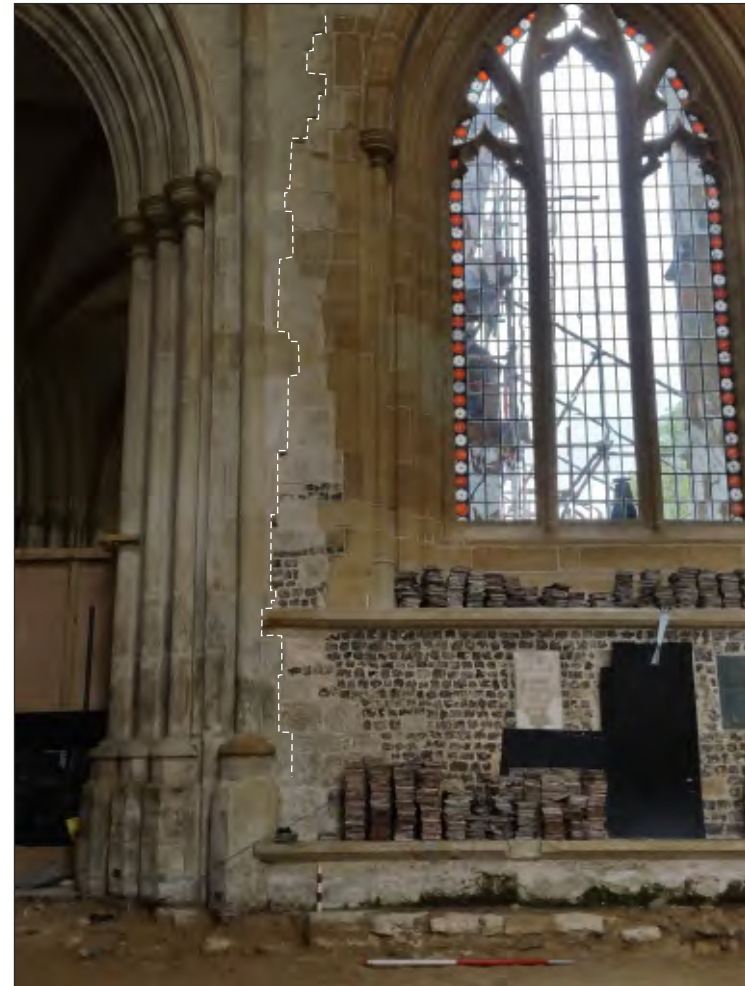
The eastern wall of the transept was built next. The foundations were different to the crossing and south aisle foundations. Although heavily truncated by later burial activity this interpretation is supported by a clear building break running the full height of the eastern elevation. Finally, the south wall, west wall and western crossing were built probably sometime in the 15th century. It is unclear if this coincides with the work undertaken by abbot William Middleton on the north transept and the walkway and vaulting of the south transept.

Pl. 6 General view of building break in eastern elevation of south transept (white) and coinciding with change in foundations. 0.25m and 1m scales. Looking east.

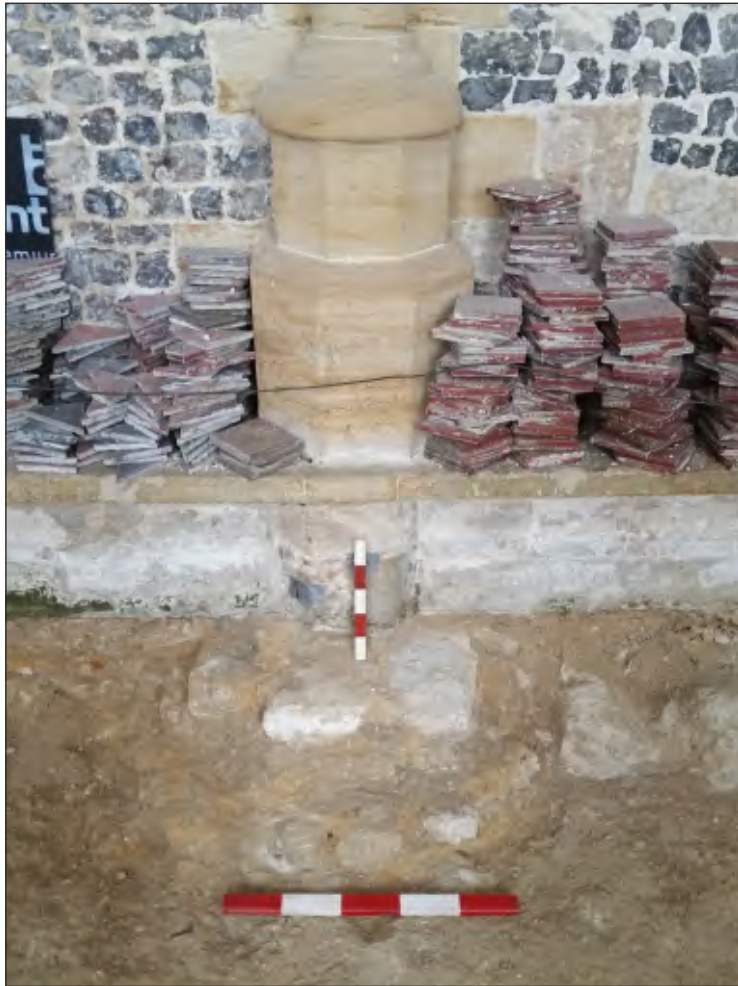
Pl. 7 Close-up showing stone rubble and clay foundations (1010) of east elevation south transept. 0.25m and 0.5m scales. Looking east.

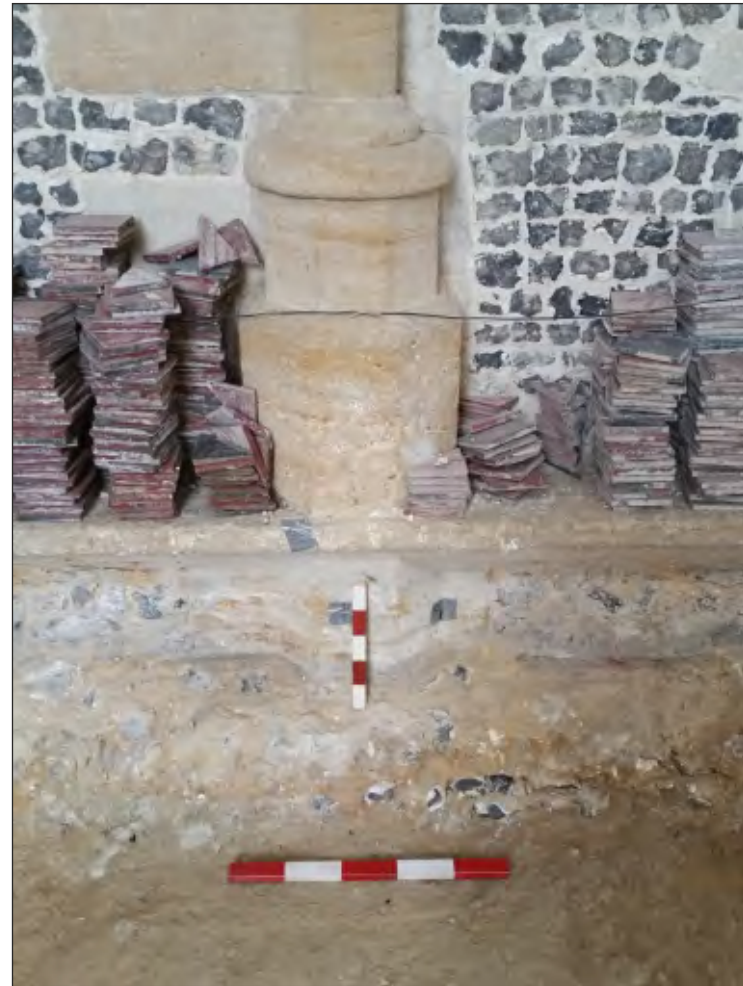
The southern (1014) and western (1016) foundations of the south transept were identical. Consisting largely of flint nodules with rare Chilmark rubble they were bonded with mid orange yellow lime mortar. Both foundations were largely intact, projecting approximately 0.4m beyond the line of the walls. The foundations of the southwest tower pier (1020) and the northwest transept pier (1018) were identical to these, suggesting that they are contemporary. The blocking of the south nave aisle opening was supported on the same foundations. However, following the construction of the new west porch the doorway was blocked in 1865. The small foundation (1023), 1.7m long and at least 0.3m wide, consisted of flint nodules and Chilmark rubble bonded with a light creamy white lime mortar.

Pl. 8 Close-up showing flint and clay foundations (1016) of west elevation south transept. 0.25m and 0.5m scales. Looking west.

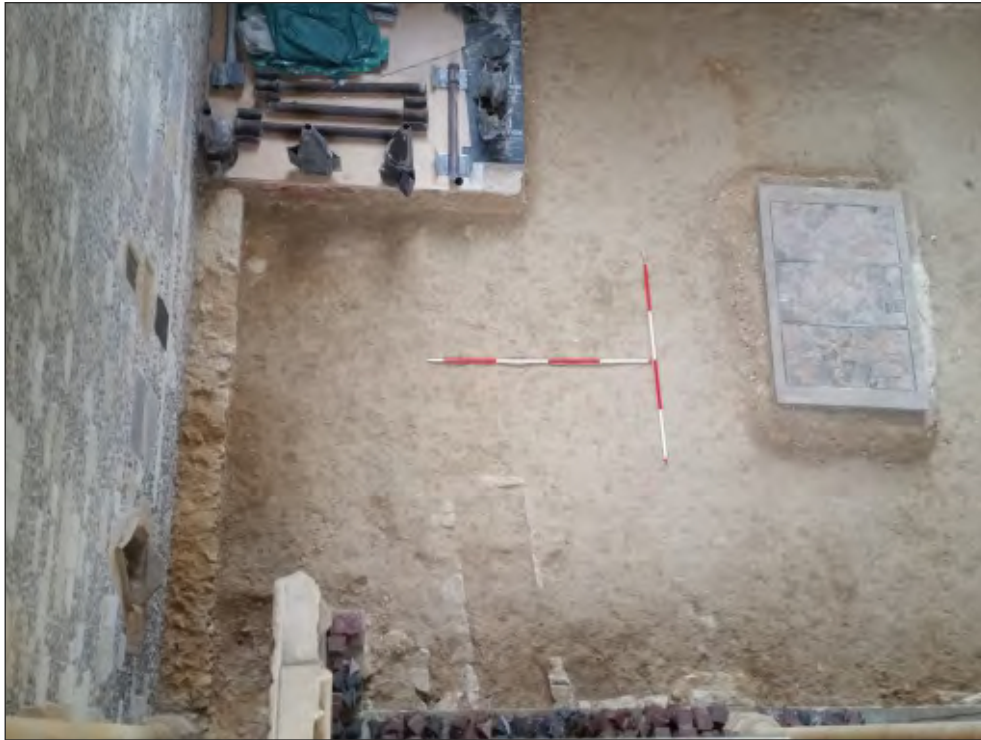
Pl. 9 General view of south transept showing flint and clay foundation (1014) of south elevation and stone lined grave (1027). 2m scales.

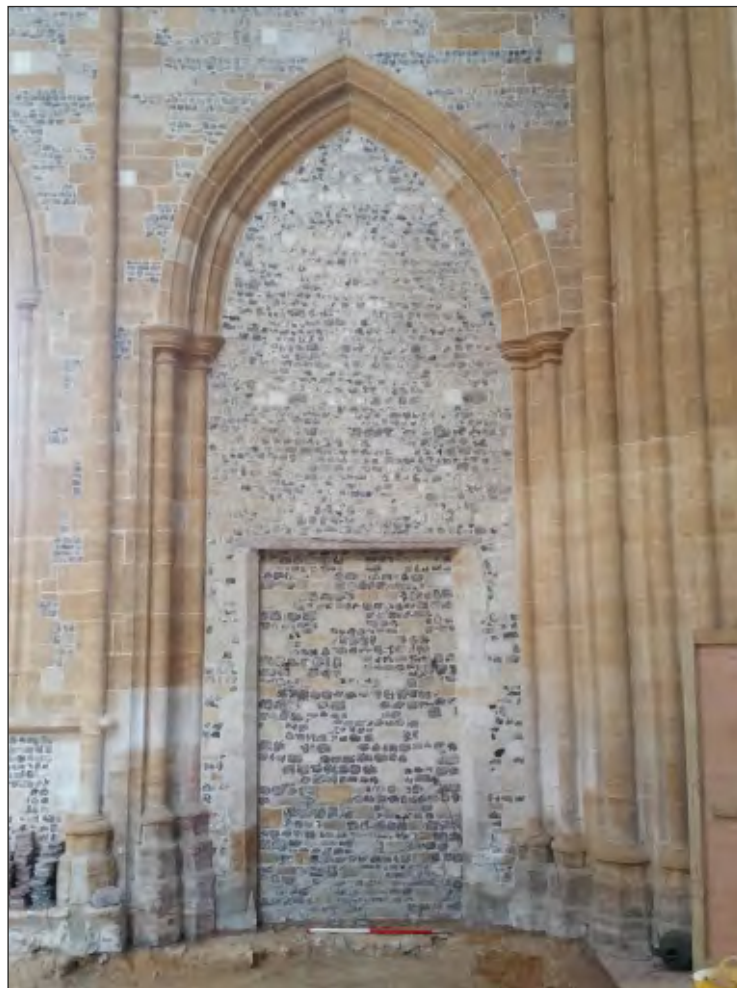
Pl. 10 General view of south nave aisle opening showing pier foundations (1018) and 1020) and foundation (1023) of door blocking (1024).

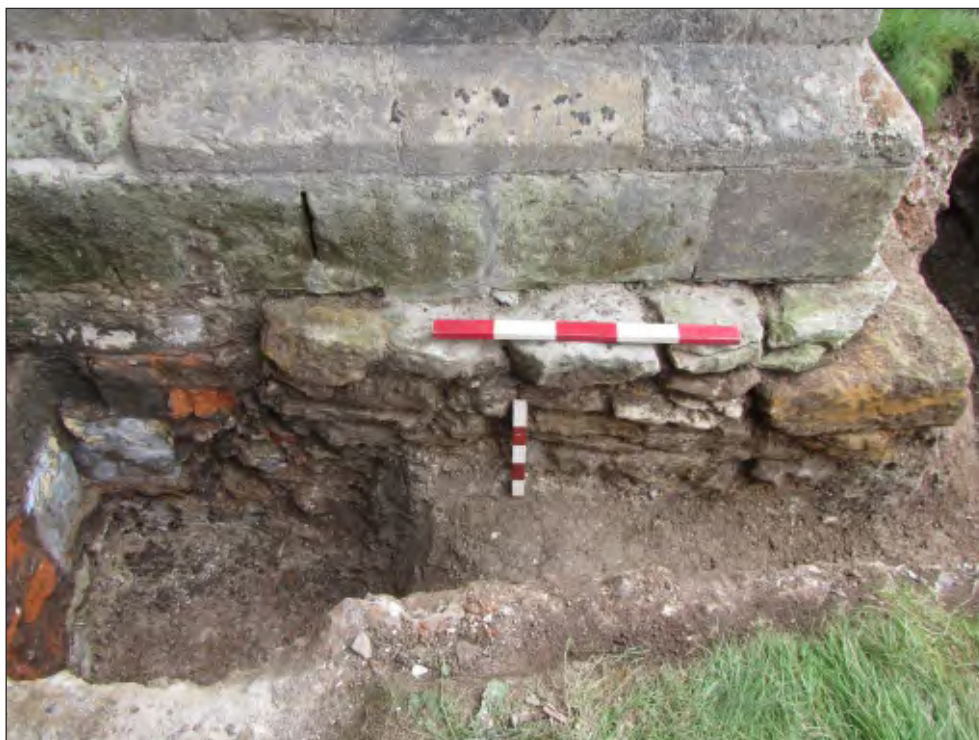
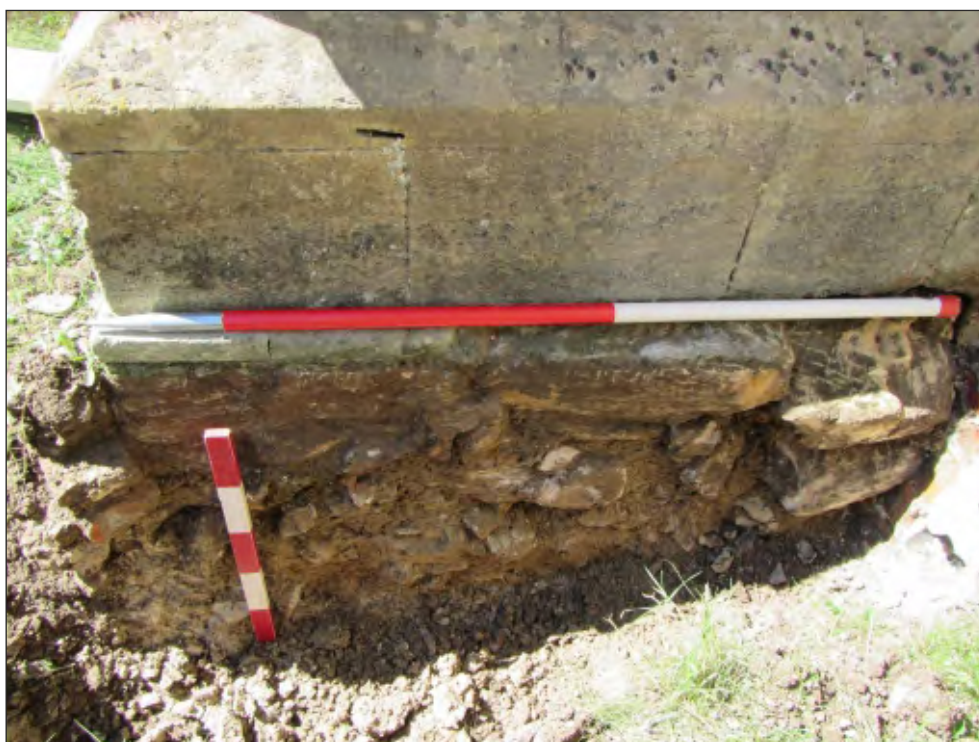
Close examination of the four buttress foundations exposed during the works revealed that unlike the buttresses on the north side, which had been underpinned sometime in the 18th or early 19th century, these all retained their original medieval foundations. Furthermore, no evidence for the south porch was uncovered during the work.

Pl. 11 Close-up of medieval foundation of buttress on south elevation.
0.25m and 0.5m scales. Looking east.

Pl. 12 Close-up of medieval foundation of buttress on south elevation.
0.5m and 1m scales. Looking west.
