**OAKFORD
ARCHAEOLOGY**

Archaeological monitoring and recording at Milton Abbey, Milton Abbas, Dorset

Report No. 17-06

December 2017

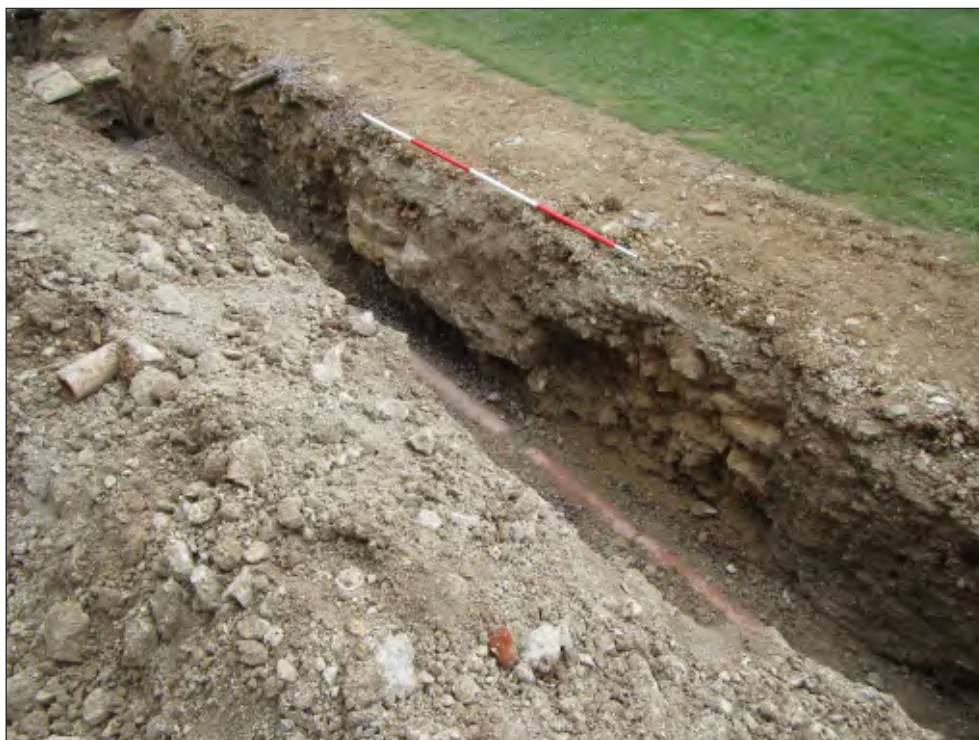
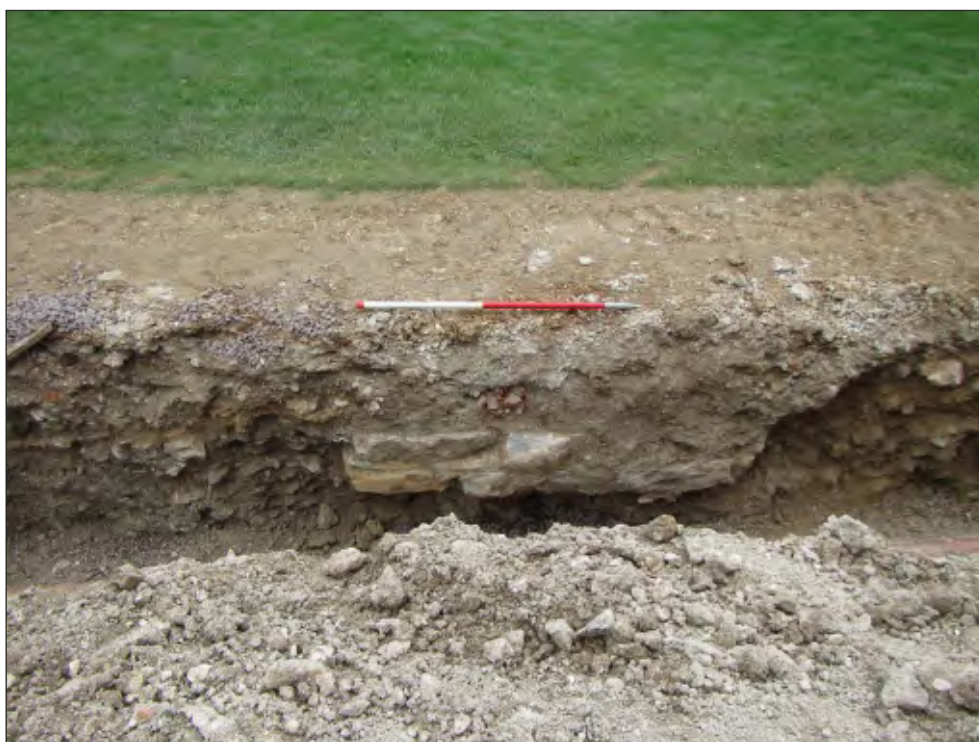
Immediately to the north were the remains of the north wall (2014), buttress (2015) and foundation (2013) of the northern chancel chapel. These were cut into the underlying chalk to a depth of at least 1.4m below current ground level. The foundation (2013) consisted largely of flint nodules with the occasional Chilmark rubble bonded with light yellowish white lime mortar. The main north wall consisted of a rubble core, consisting of flint nodules with occasional Chilmark rubble bonded with light yellowish white lime mortar, and roughly squared Chilmark facework along the southern face. Sharing the same foundation were the remains of a buttress (2015). This consisted of two courses of masonry, containing roughly

squared blocks of Ham stone, Purbeck and Chilmark. Extending approximately 1.77m beyond the edge of the north wall the foundations extend for a further 0.58m suggesting that the buttress has been heavily robbed at the north end.

Pl. 13 General view of foundation (2013), main wall (2014) and buttress foundation (2015). 2m scale. Looking northeast.

Pl. 14 Close-up showing foundation (2013), main wall (2014) and buttress foundation (2015). 1m scale. Looking east.

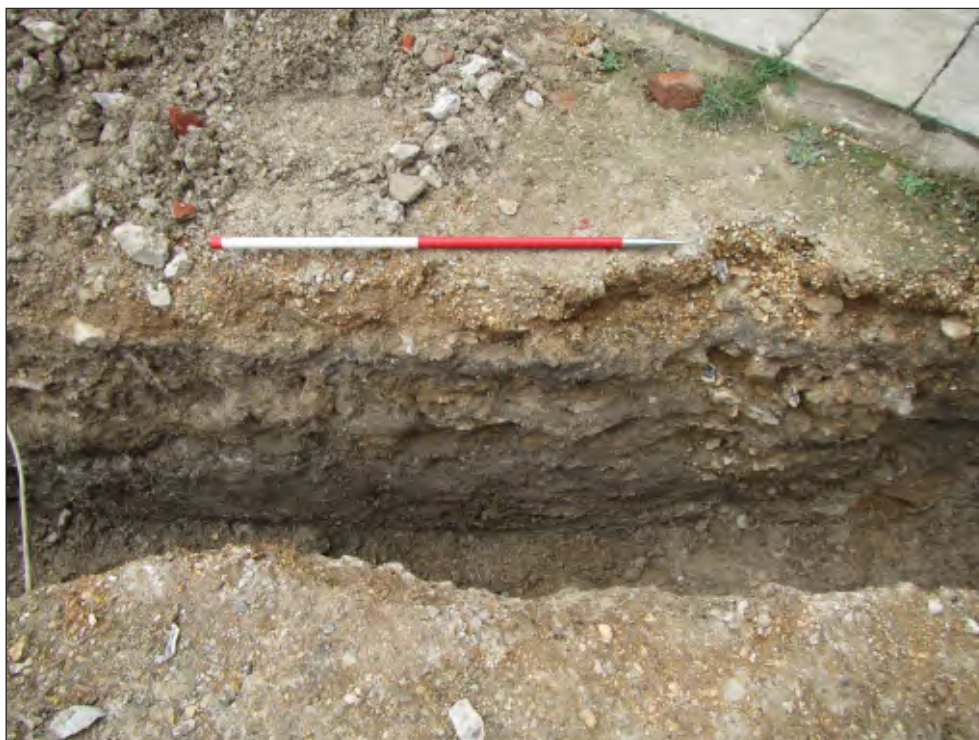
Pl. 15 General view of extensive construction and/or demolition deposits (2003-2009). 1m scale. Looking west.

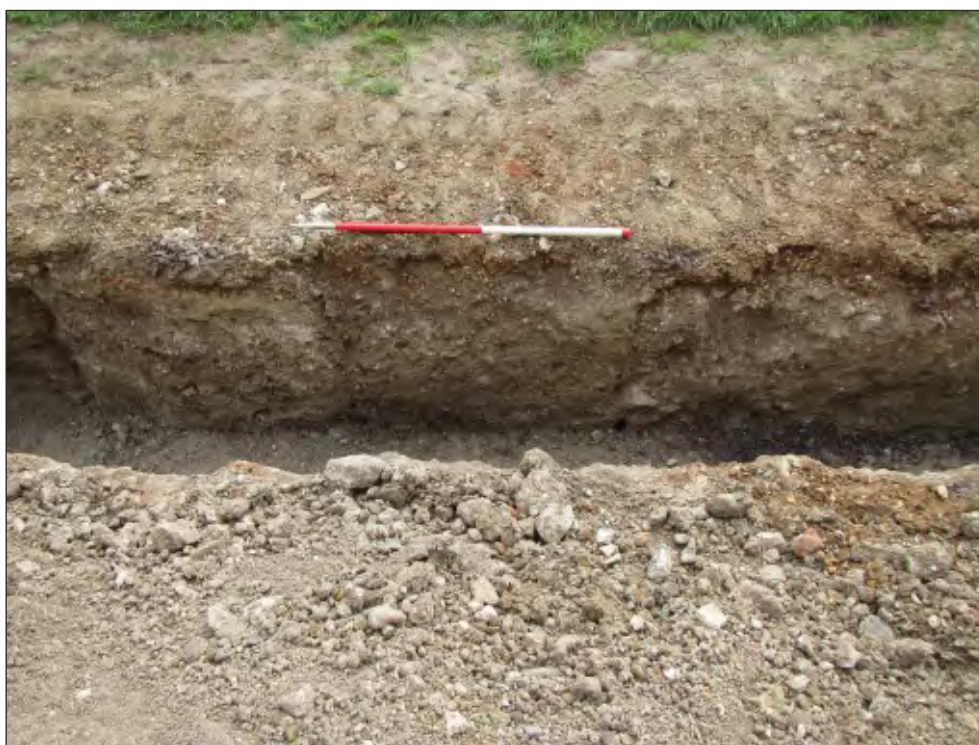
Pl. 16 General view of the robber trench [2040]. 1m scale. Looking east.

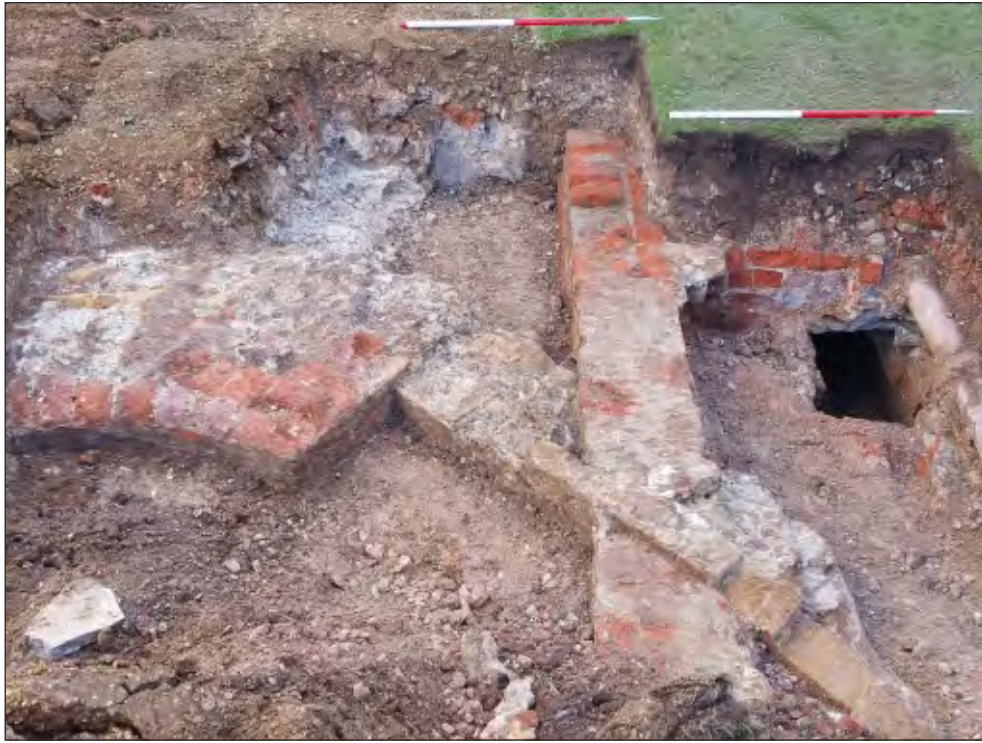
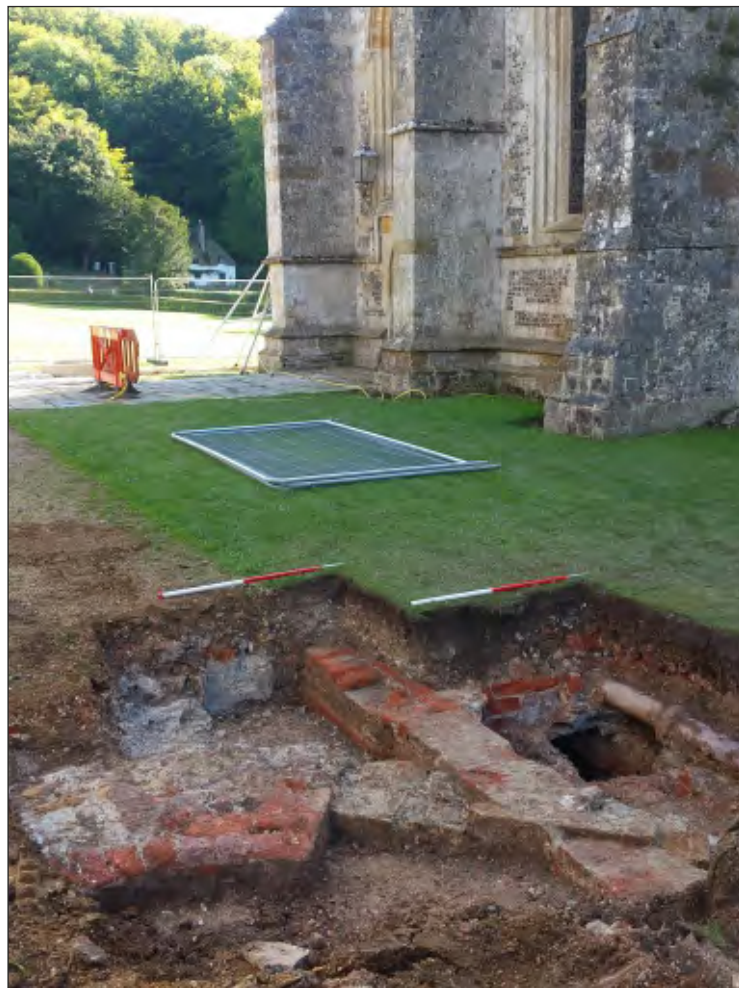
Butting up against and partially overlying this were the remains of an E-W aligned brick wall. Consisting of five courses of mid-to-late 19th century brick and c. 0.34m wide this is likely the foundation of the conservatory shown in this location on the 1888 Ordnance Survey map.

Pl. 17 Close-up of late 17th- 18th century wall (2052) and late 19th century conservatory wall (2055). 1m scales. Looking east.

Pl. 18 General view of late 17th- 18th century wall (2052) and late 19th century conservatory wall (2055). 1m scales. Looking east.

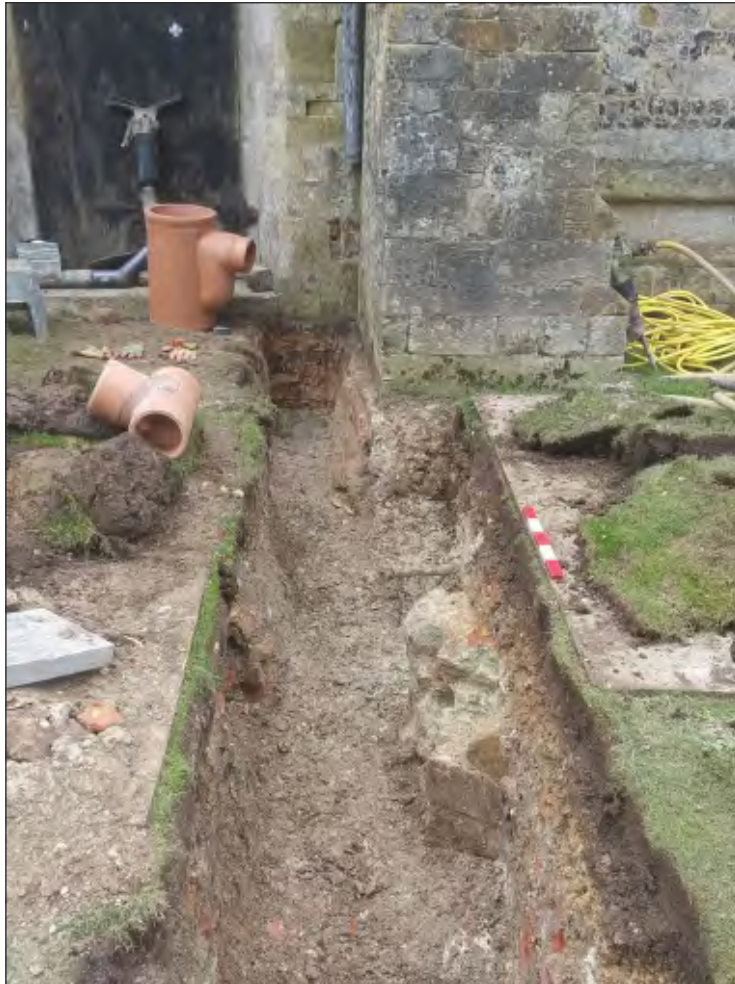
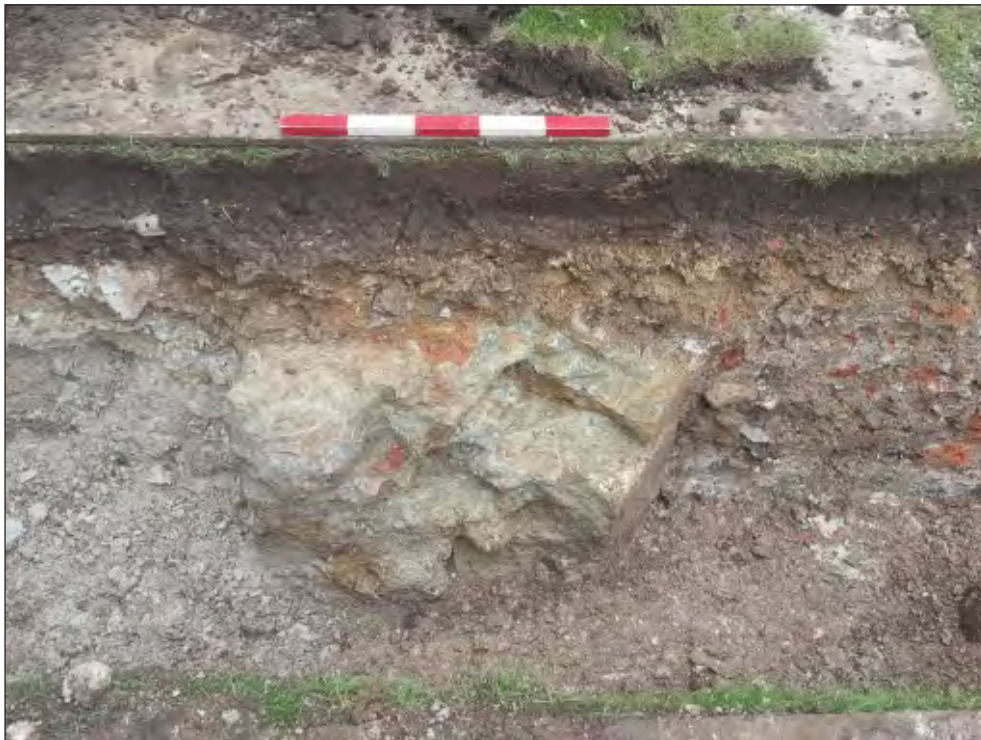
Pl. 19 General view of late 16th-mid 18th century wall foundation (2066). 0.5m scale. Looking south.

Pl. 20 Close-up of late 16th-mid 18th century wall foundation (2066). 0.5m scale. Looking west.

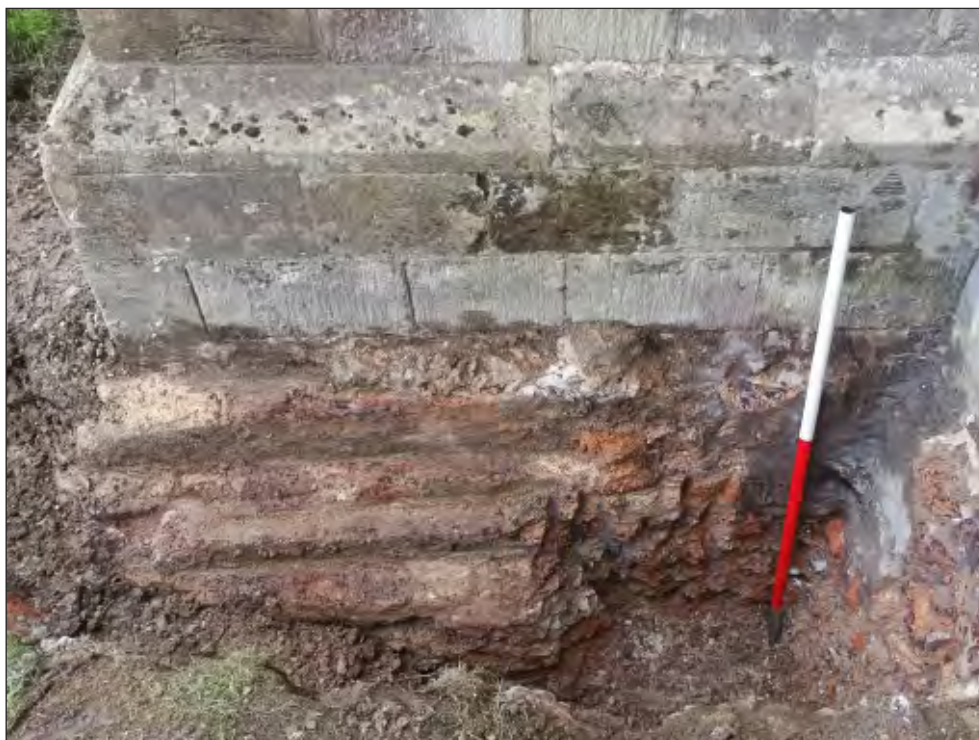
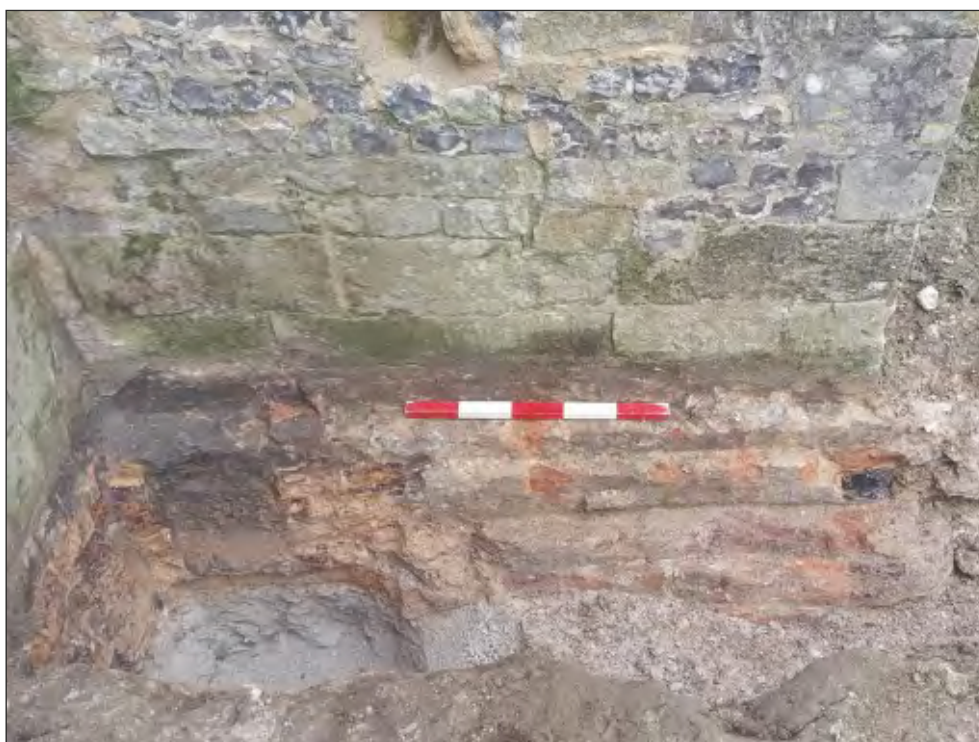
Finally, close examination of the four buttress foundations exposed during the works revealed that unlike the buttresses on the south side, which retained their original medieval foundations, these had all been underpinned with brick. A good context for this might be Wyatt's restoration of the abbey church in the late 18th century.

Pl. 21 Close-up of post-medieval underpinning of buttress on north elevation. 1m scale. Looking east.

Pl. 22 Close-up of post-medieval brick underpinning of buttress on north elevation. 1m scale. Looking west.

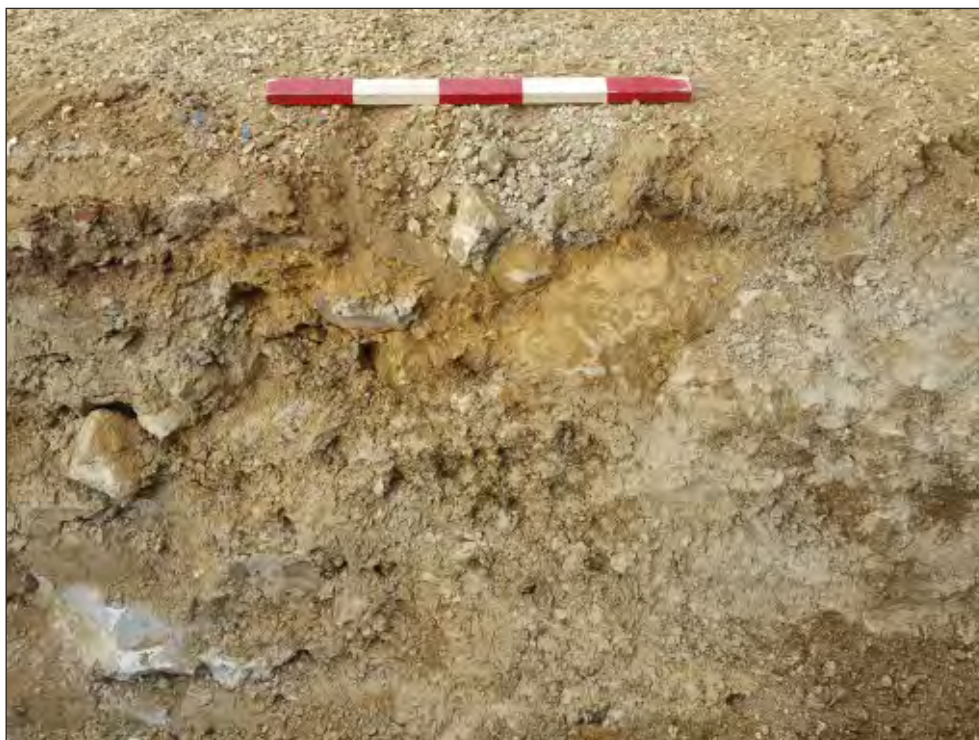
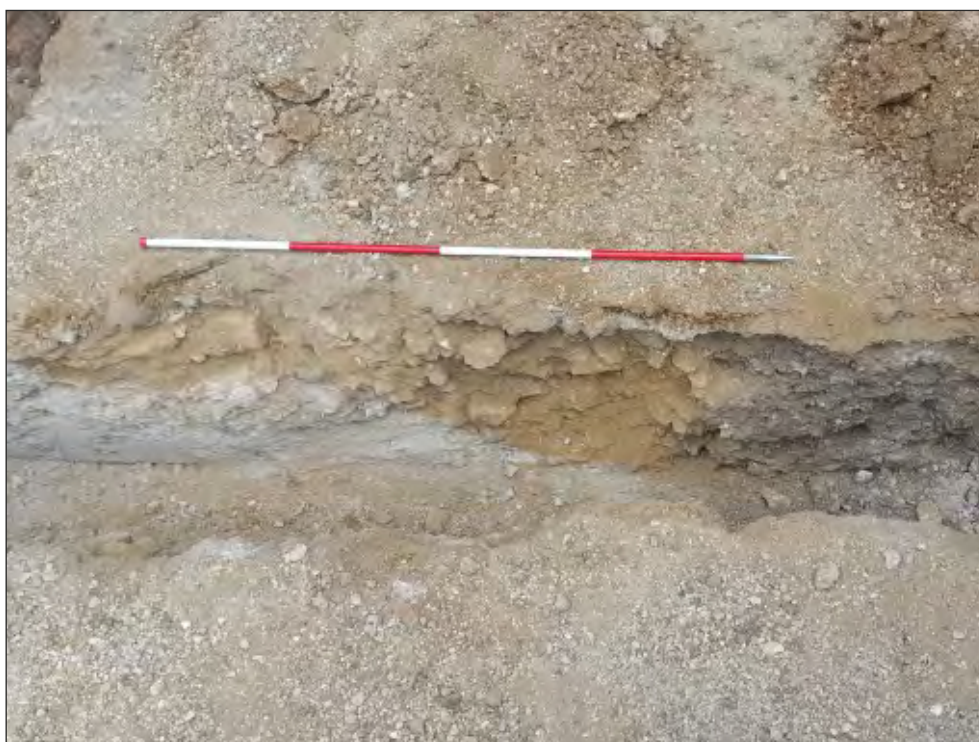
Finally, monitoring of the drainage trench to the west of Milton Abbey exposed the foundations of the first pair of pier bases at the eastern end of the nave. The excavations cut through the southern tip of the northern pier base foundation (2093). This consisted of Chilmark rubble bonded with mid yellow lime mortar. The southern pier base (2106), consisting of Chilmark rubble bonded with mid yellow lime mortar, was approximately 2.3m long and 0.88m thick. Excavations in 1955-7 by the RCHME had exposed parts of the north nave wall but had failed to identify any other elements of the nave. The identification of the two pier base foundations suggests that the nave had been at least partially set out to the level of the first arcade by the time of the dissolution. No evidence was found of the southern nave wall.

Pl. 23 Close-up of northern nave pier foundation (2099). 0.5m scale.
Looking north.

Pl. 24 General view of southern nave pier foundation (2106). 2m scale.
Looking east.

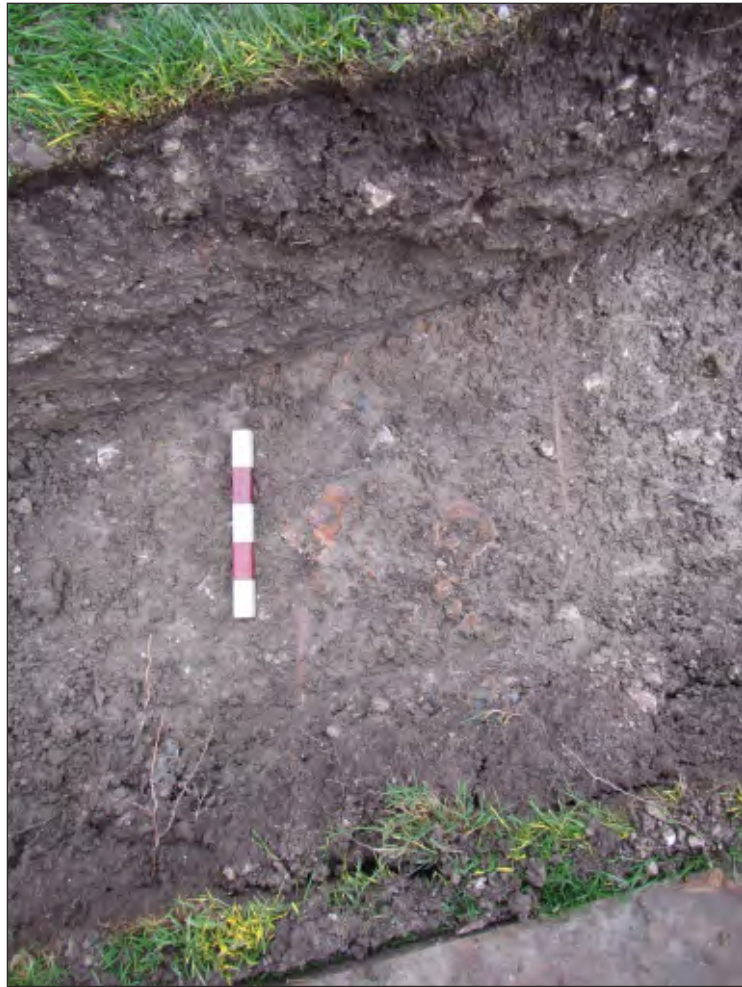
Pl. 25 General view of skeletons (2084) and (2087).
0.25m scale. Looking west.

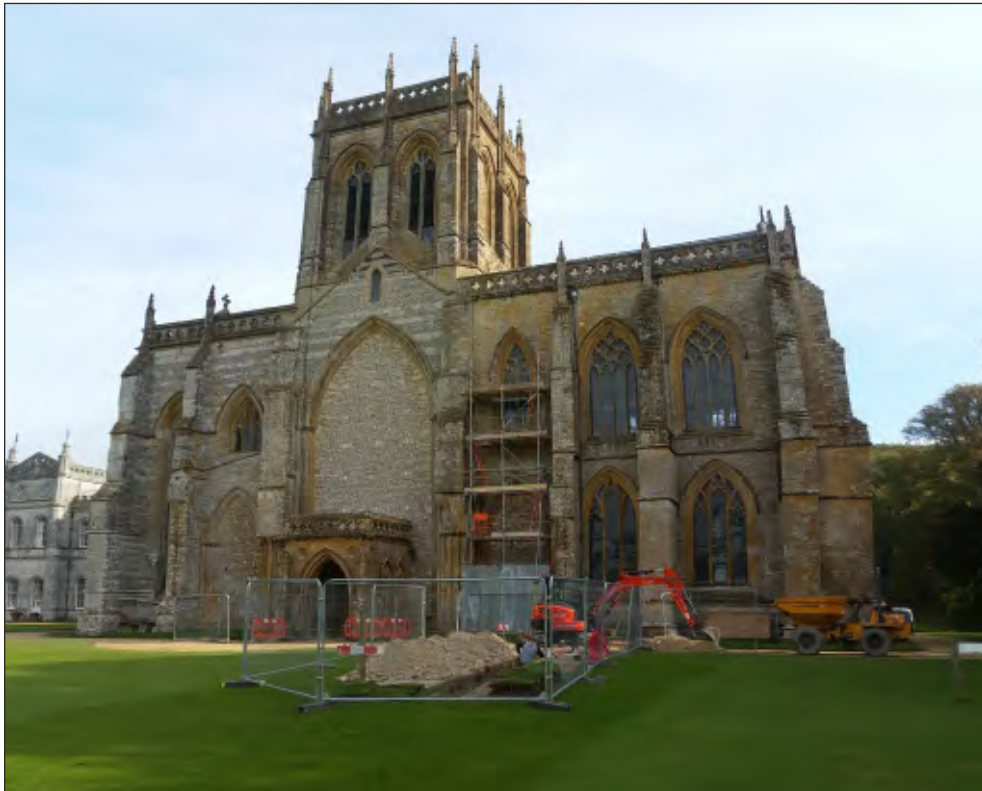
Pl. 26 General view of excavations on west side of Milton Abbey. Looking east.

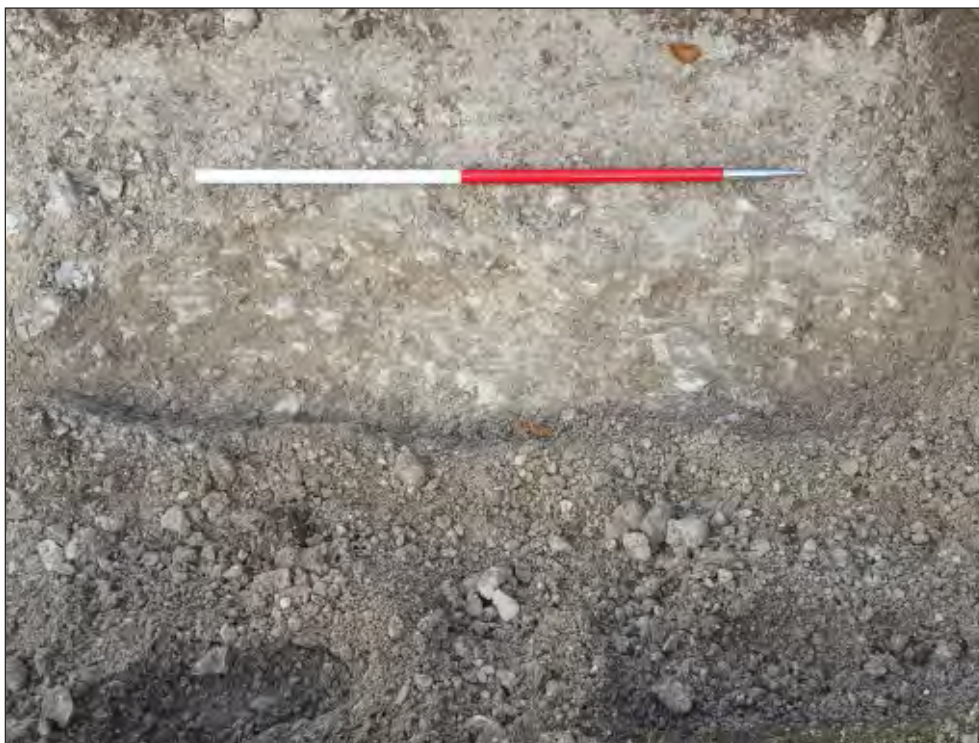
Pl. 27 General view of shallow grave (2123). 1m scale. Looking north.
