**Historic building recording at The Dutch House,
No. 40 The Strand, Topsham, Devon**

Report No. 17-11

August 2017

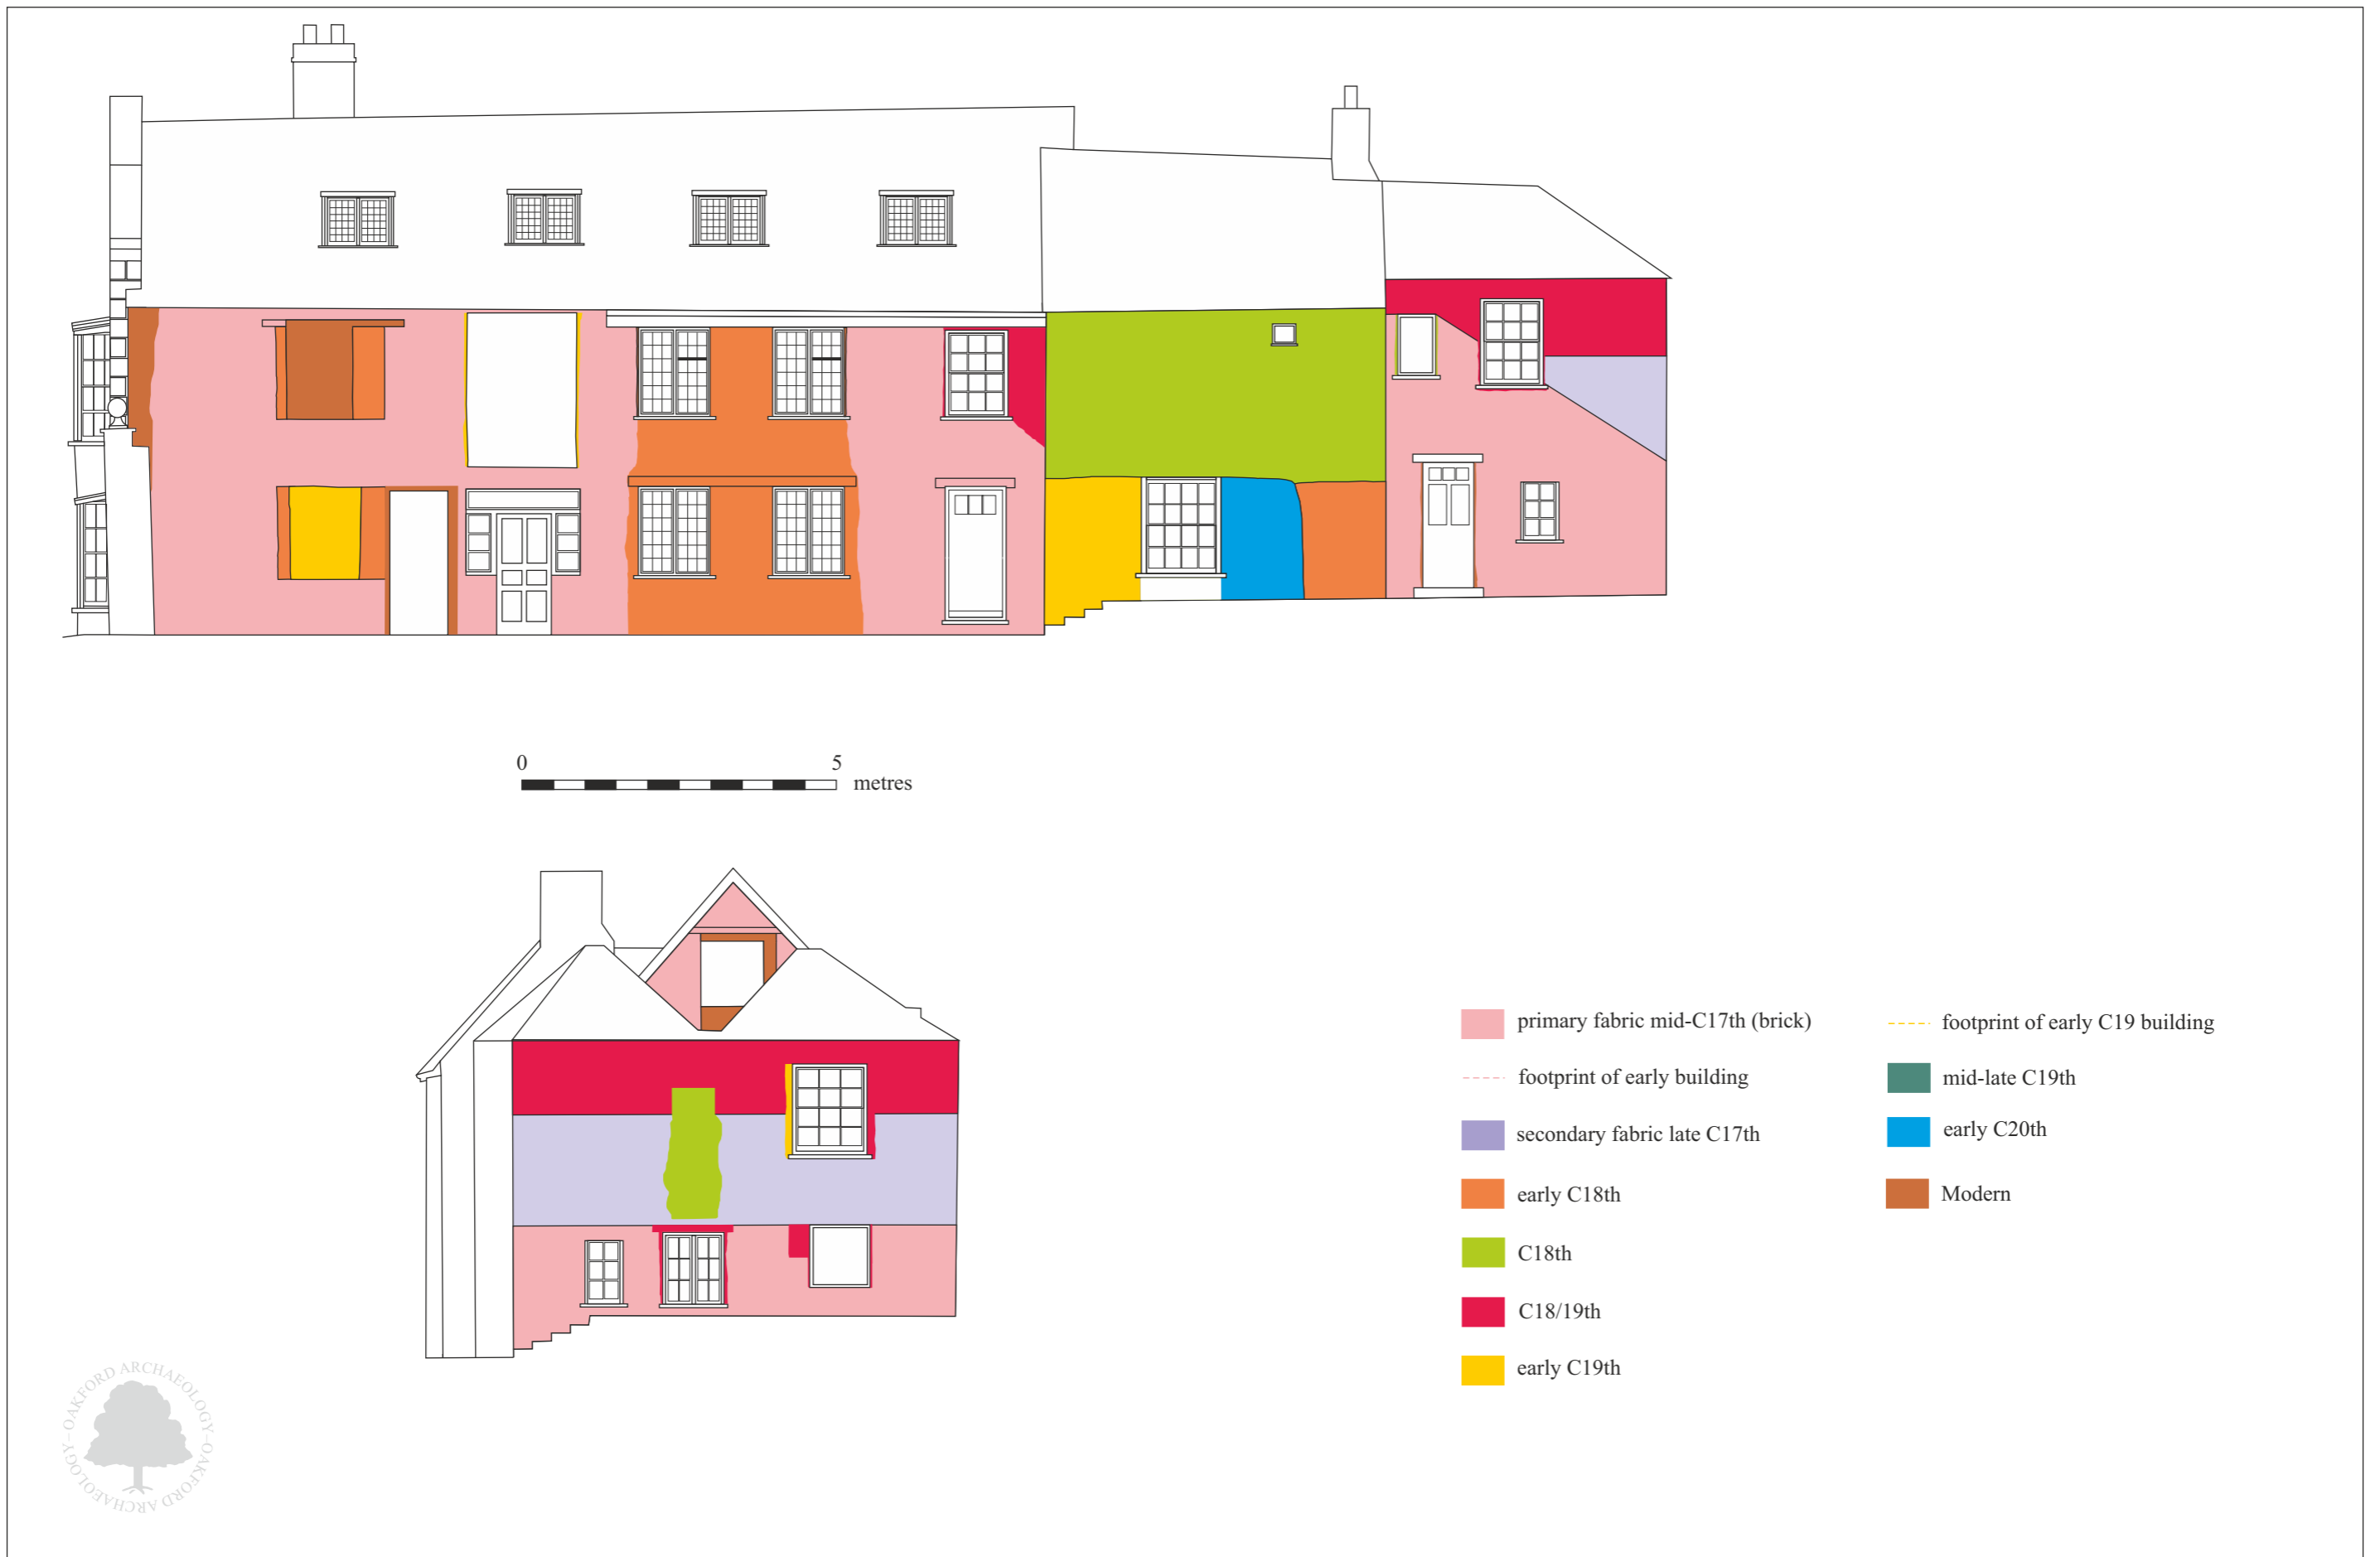
Fig. 15 South (top) and east (bottom) elevations showing location of observations during renovation work and suggested phases of development.

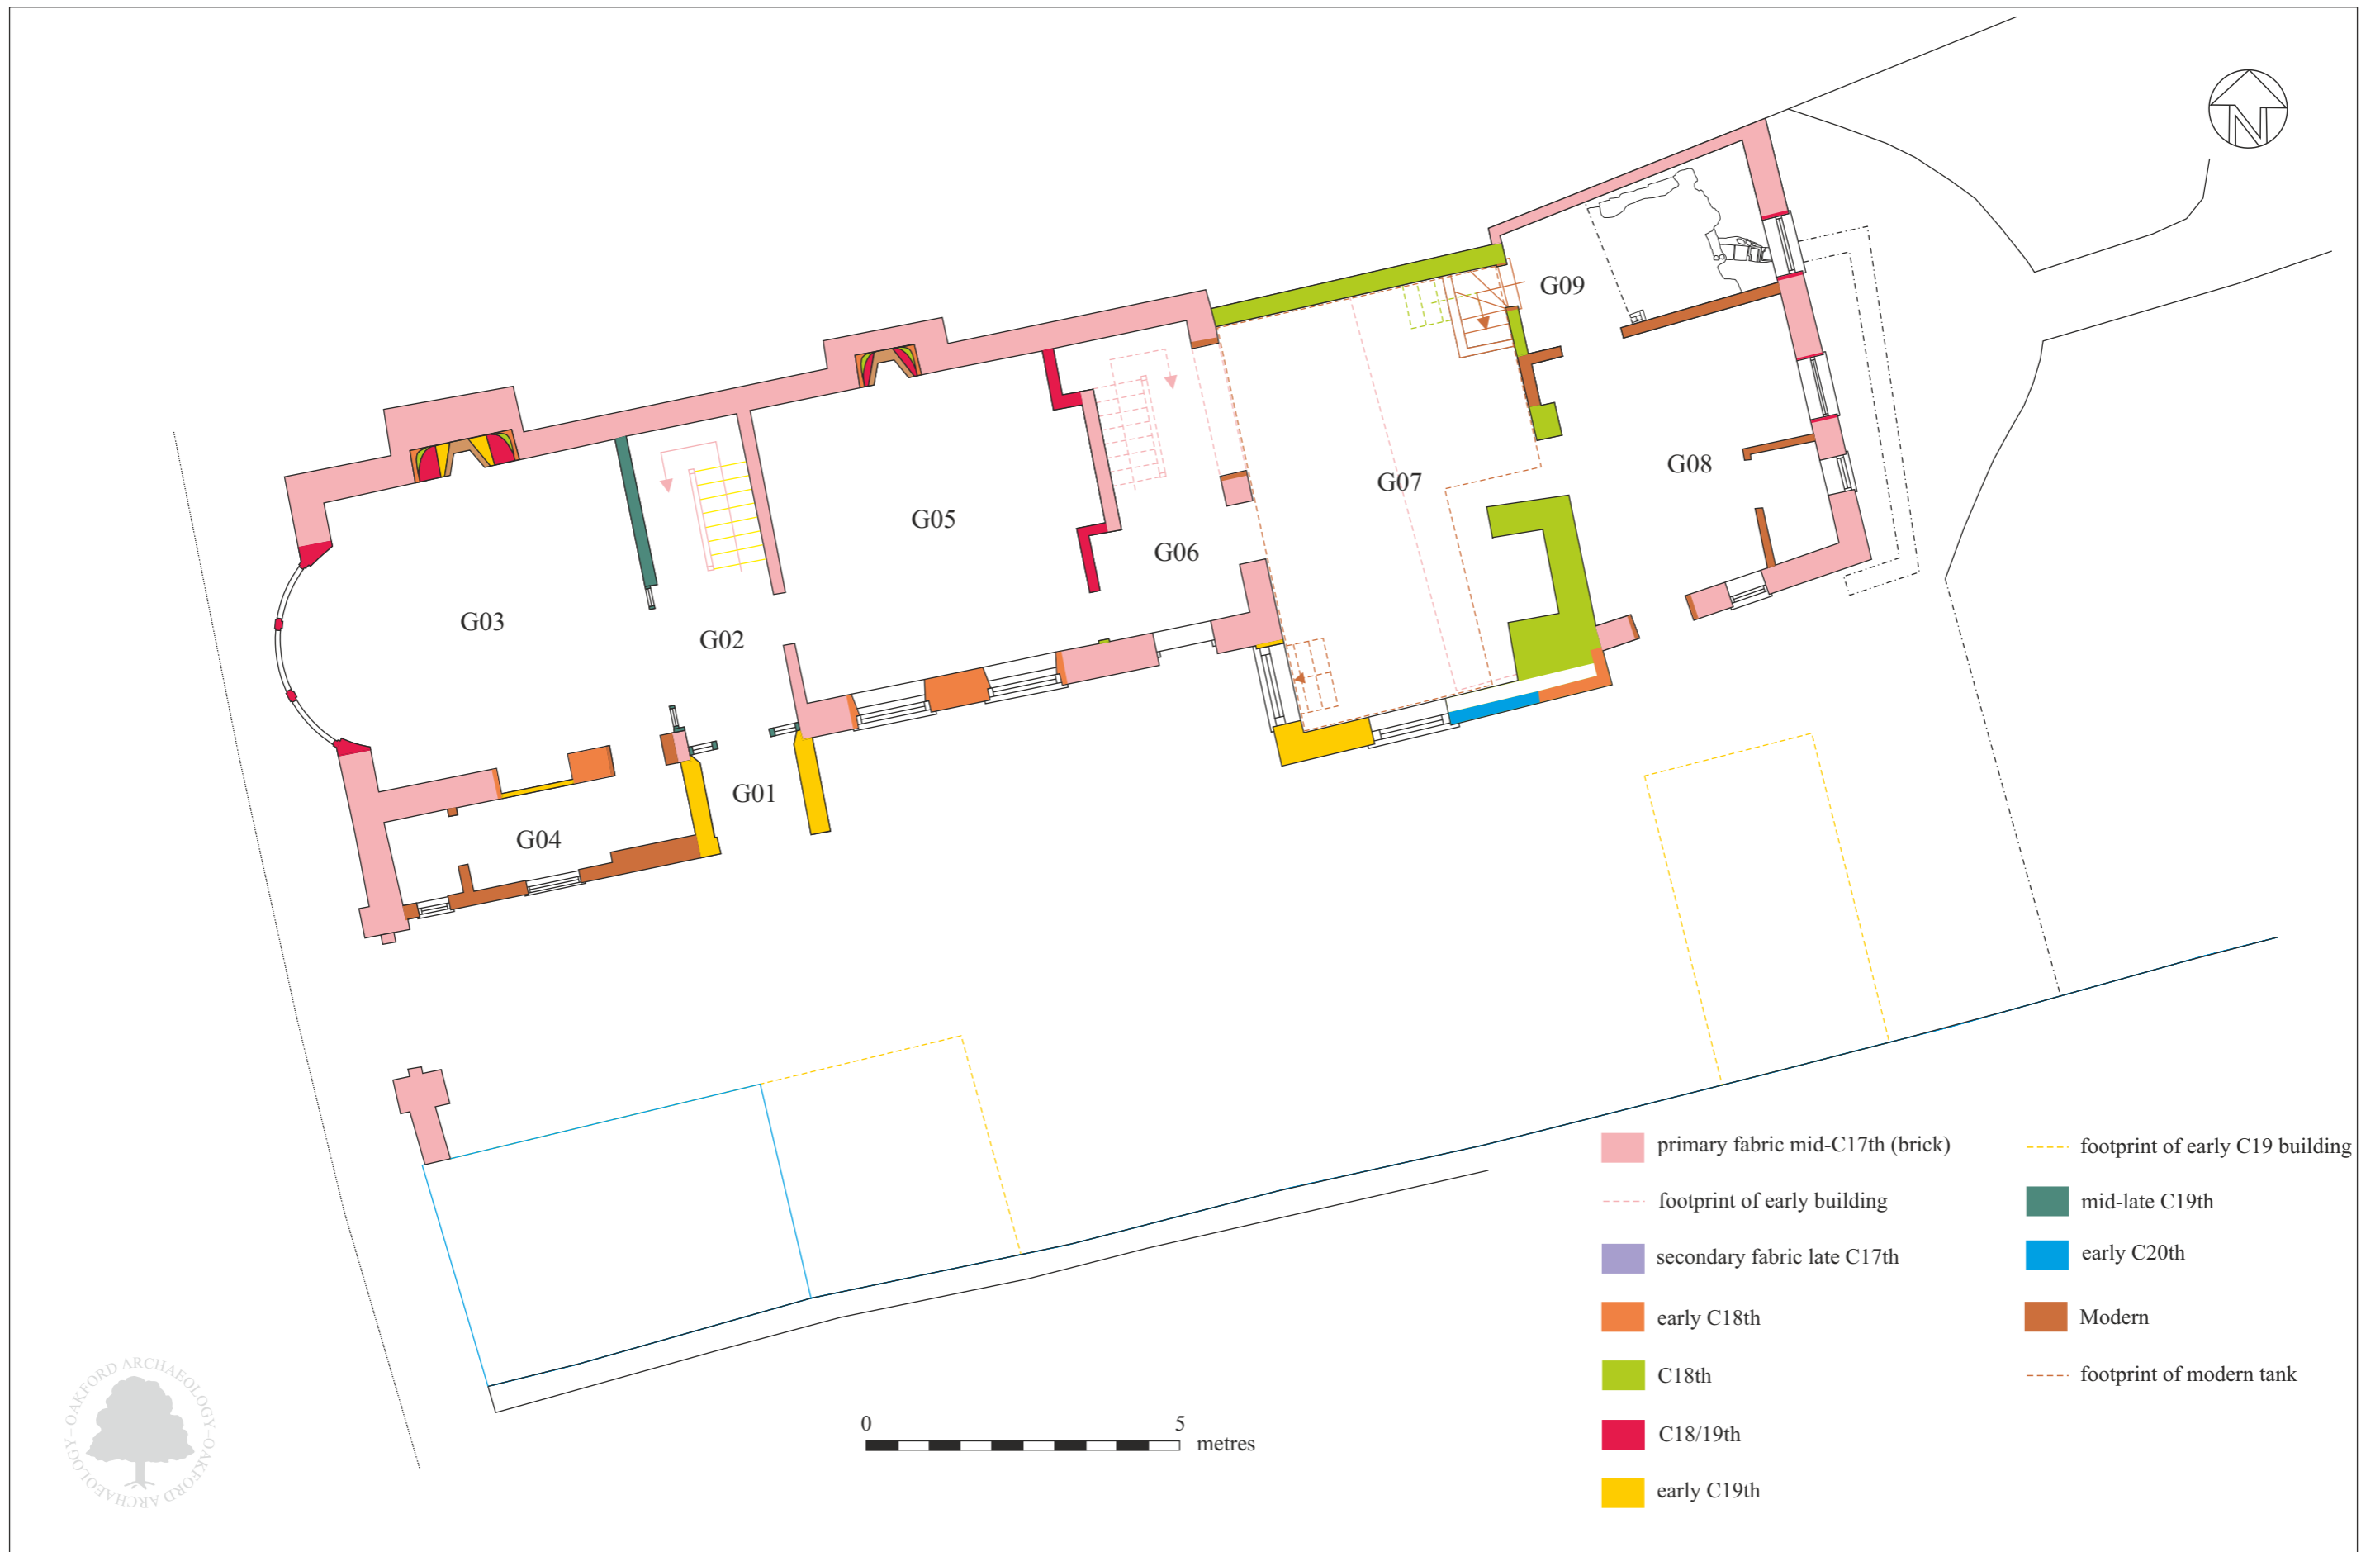
Fig. 16 Plan of ground floor showing location of observations during renovation work and suggested phases of development.

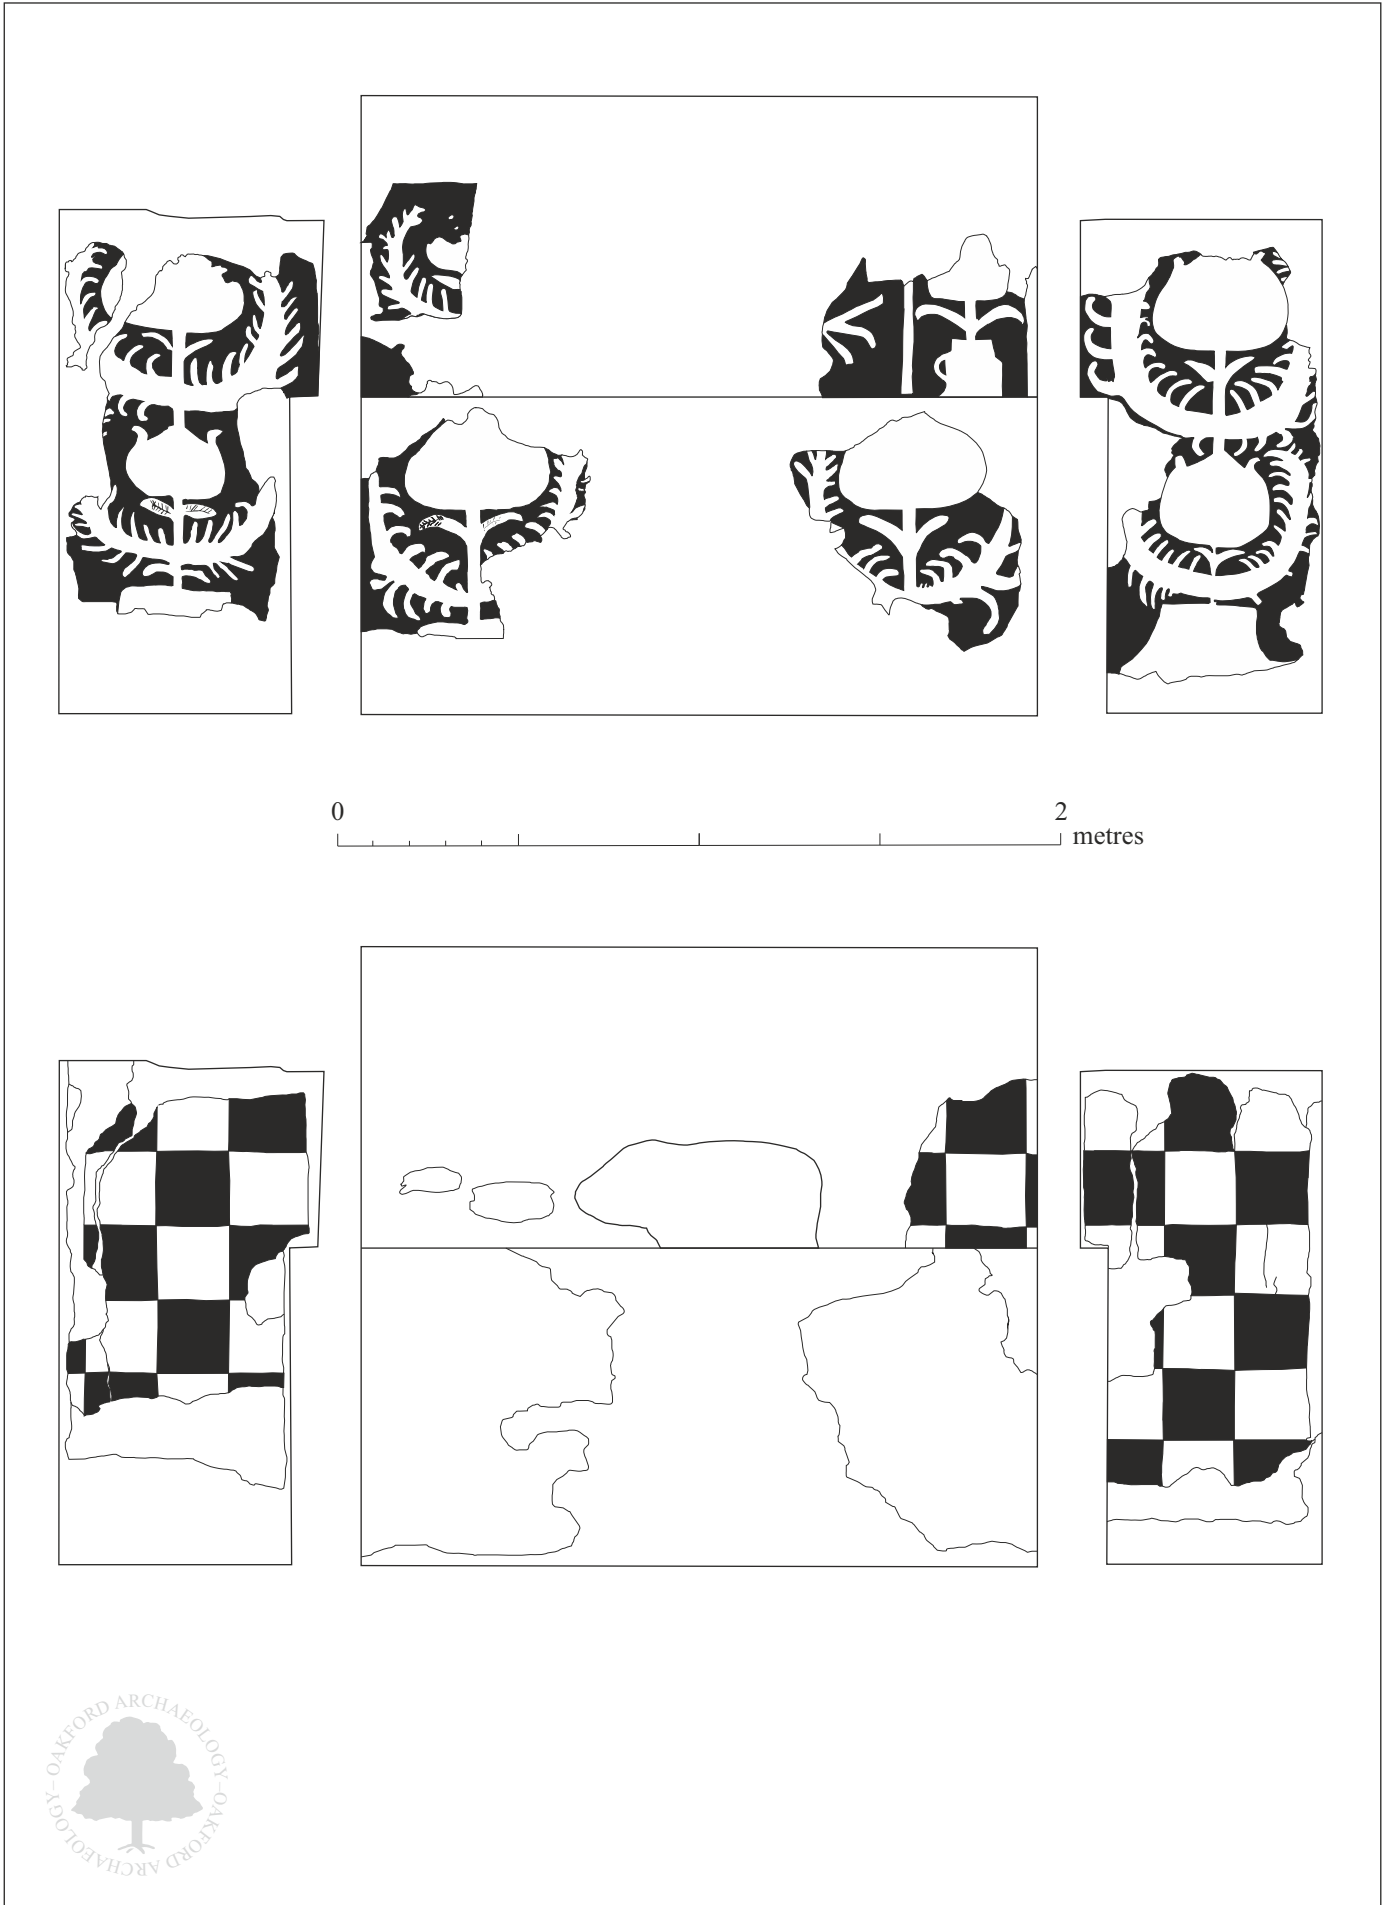
Fig. 17 Ground-floor Room G03, painted plaster decorated fireplace with floral design (top) and plain black-and-white chequerboard decoration (below).

later scheme, consisting of simple black-and-white chequerboard (Fig. 17, pl. 13-14), may have been painted over an earlier scheme that was too fragmentary to recover (Torquil McNeilage *pers. comm.*). Although attempts by Ruth and Torquil McNeilage to conserve the painted chequerboard decoration failed due to the inherently fragile nature of the scheme after three centuries of damp and the very close proximity of the later brick blocking, this revealed an earlier floral scheme surviving extensively on the internal faces of the jambs and the rear of the fireplace (Fig. 17, pl. 15-16). Closely associated with sgraffito-decoration, painted plaster decorative schemes are generally thought to be later in date. The decoration on the fireplace jambs and rear fits well into the kind of painted decoration popular at this period. The later chequerboard scheme is a common pattern found at Billany, Dartington and West Moore, South Brent. This was also sometime found in combination with other patterns, including floral ones, as at Middle Moor, Sowton and with stripes, as at 44–6 Magdalen Street, Exeter. This example is likely to belong to the period 1660-1720 with the fourth quarter of the 17th century perhaps being the most likely date for its installation. Freehand decorations are much less common.

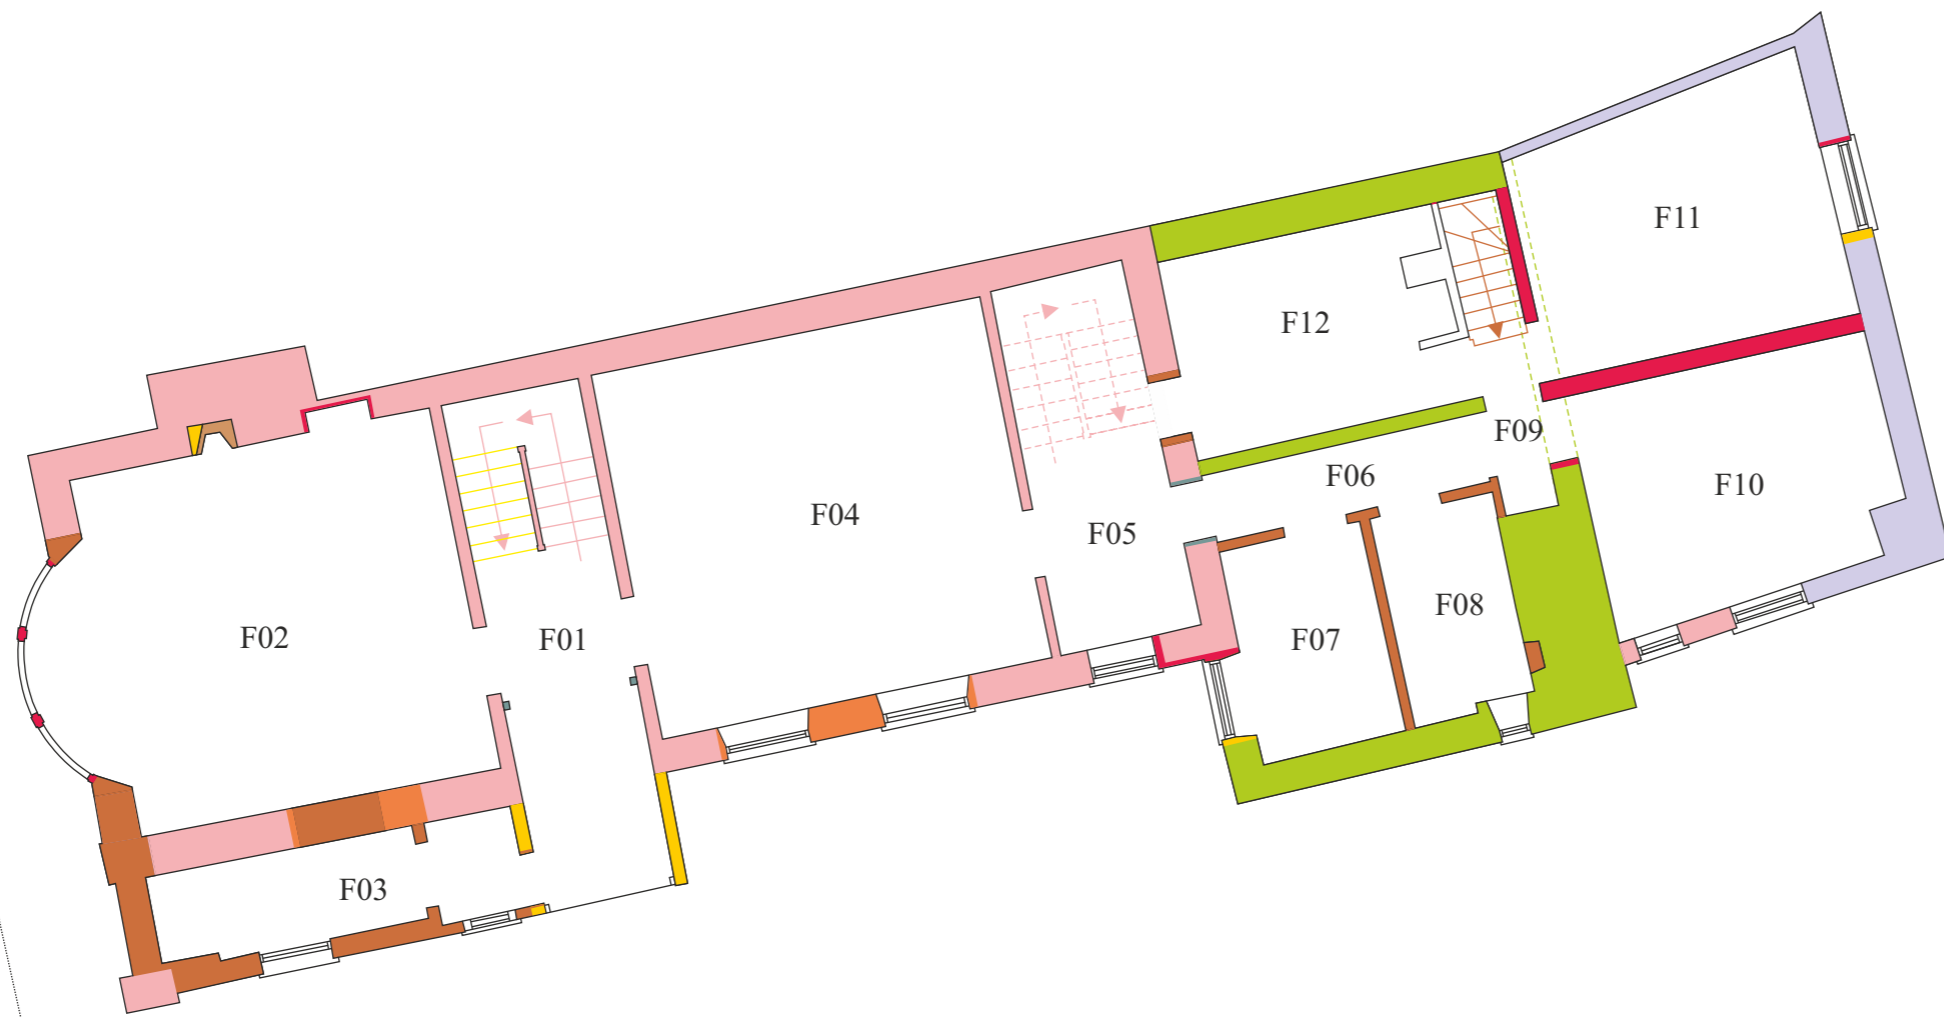
Fig. 19 Plan of first floor showing location of observations during renovation work and suggested phases of development.

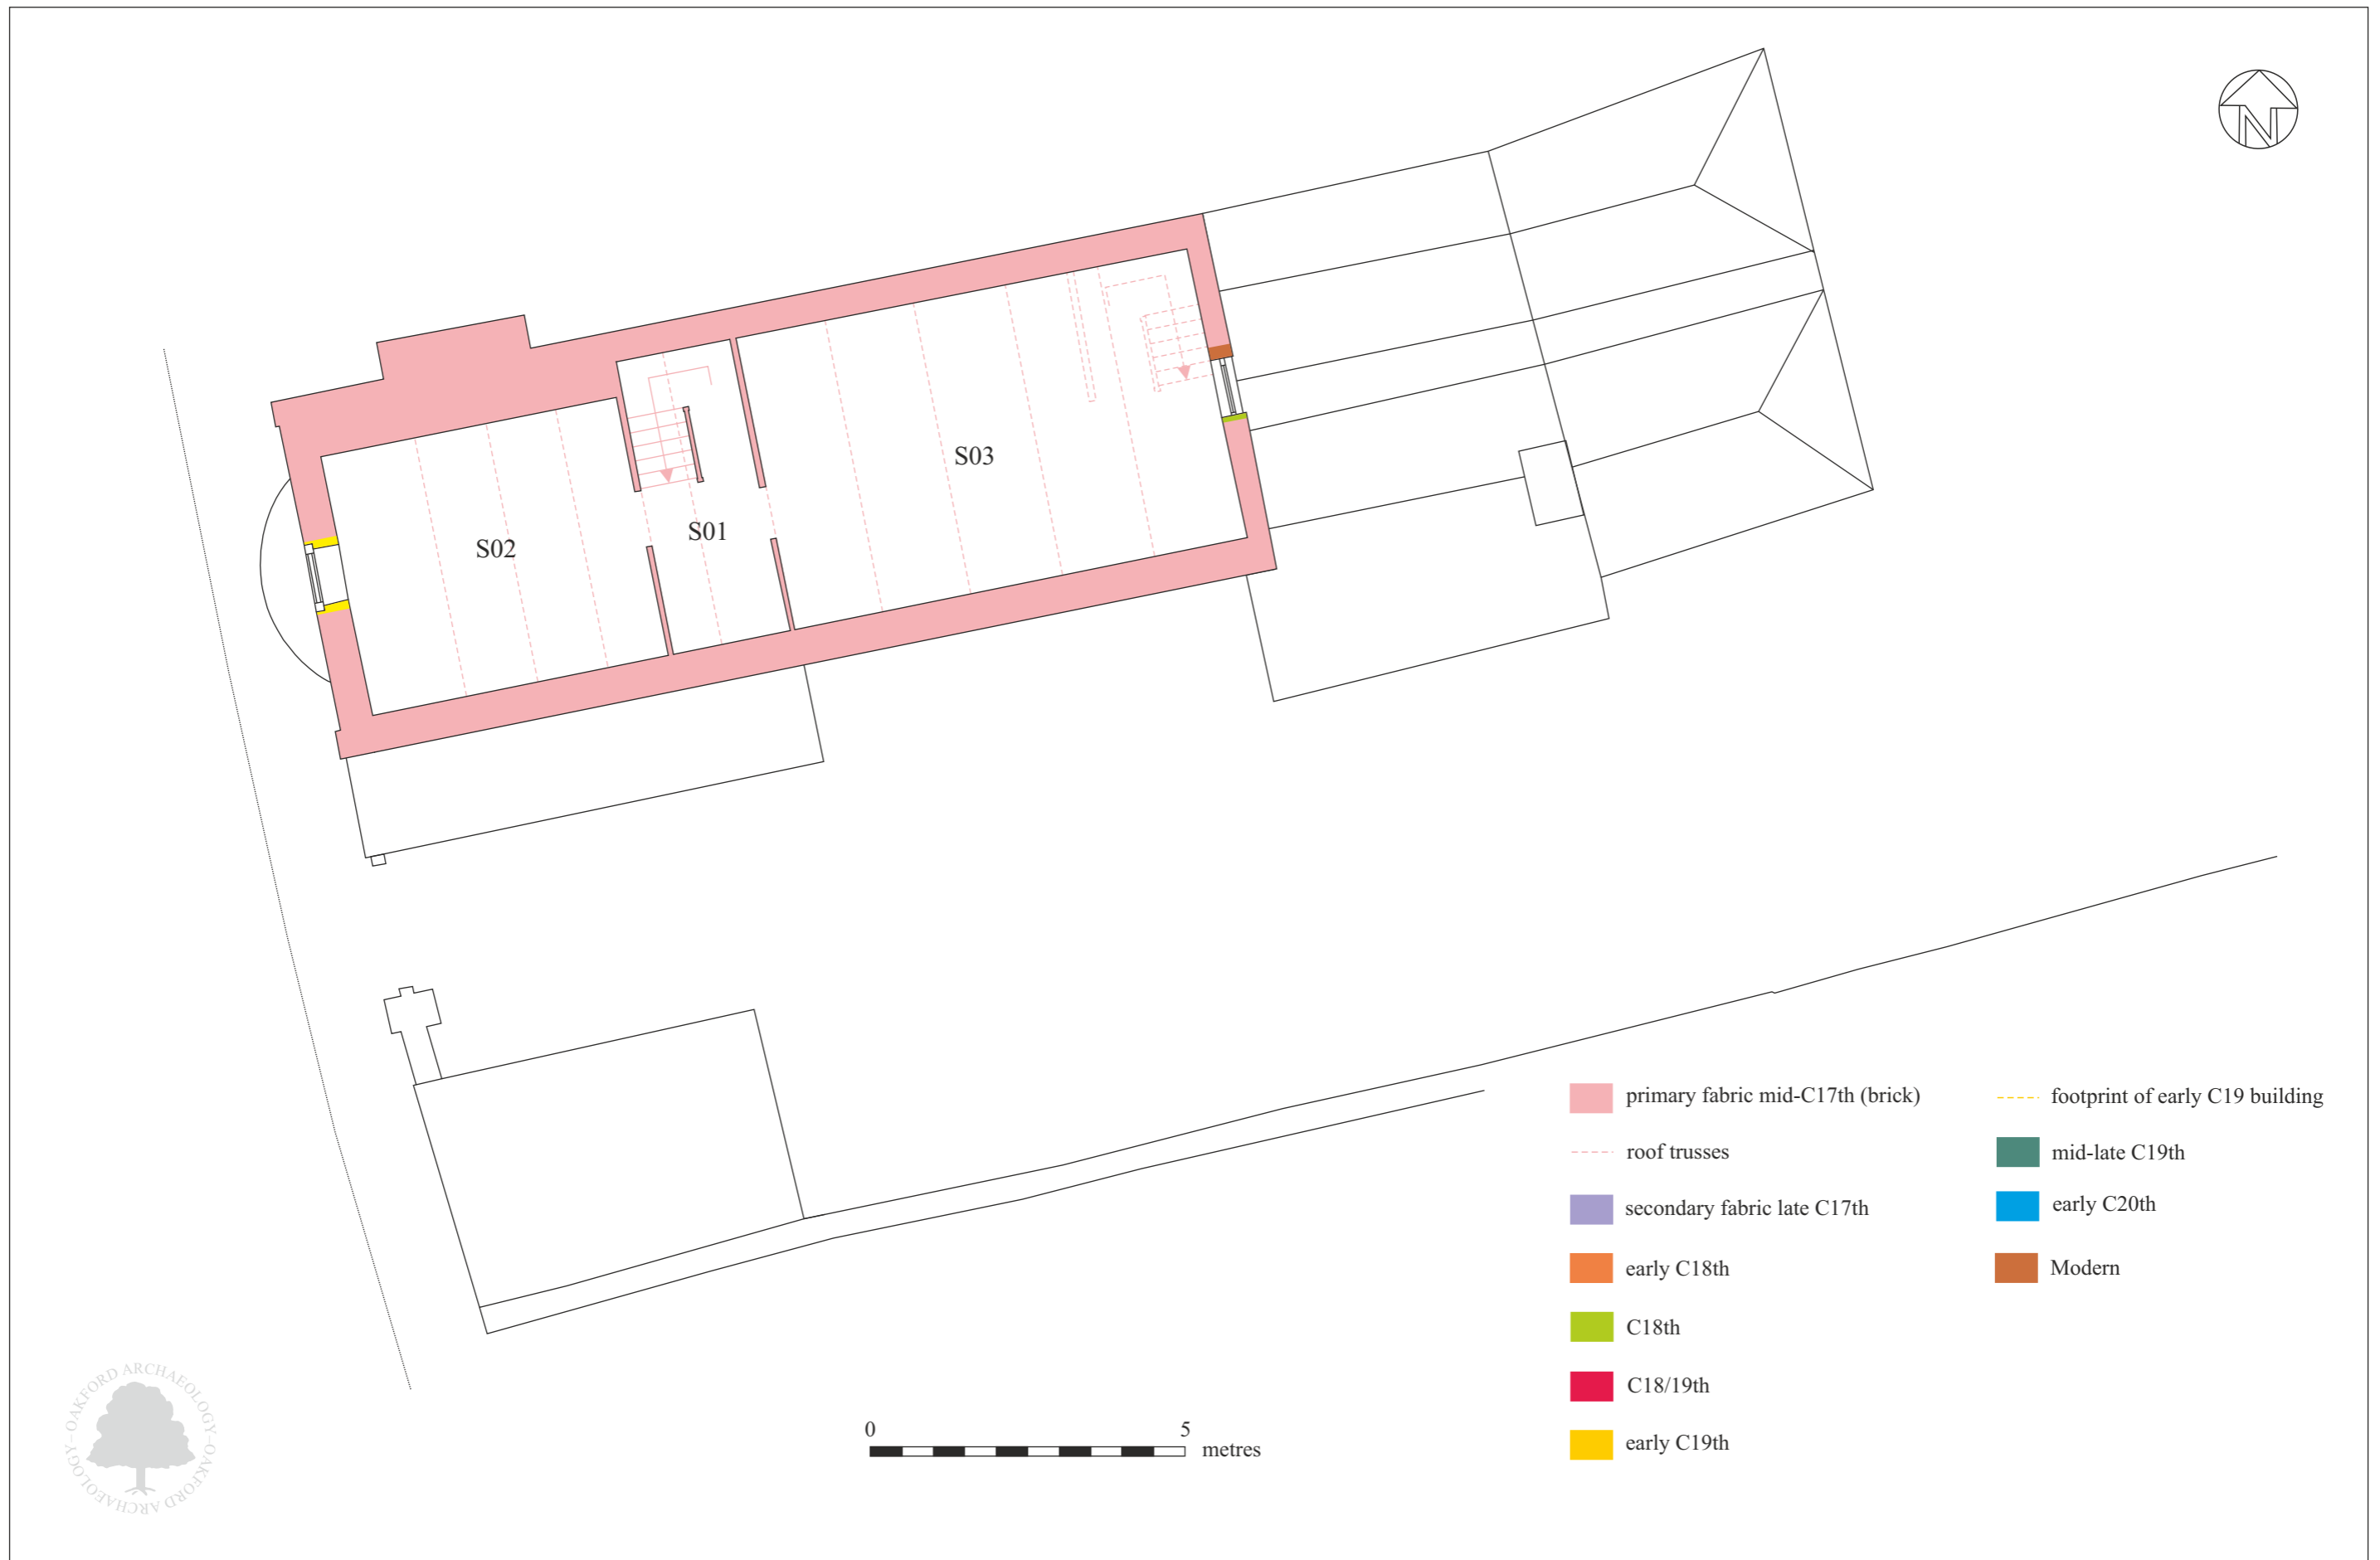
Fig. 20 Plan of the attic storey showing location of observations during renovation work and suggested phases of development.

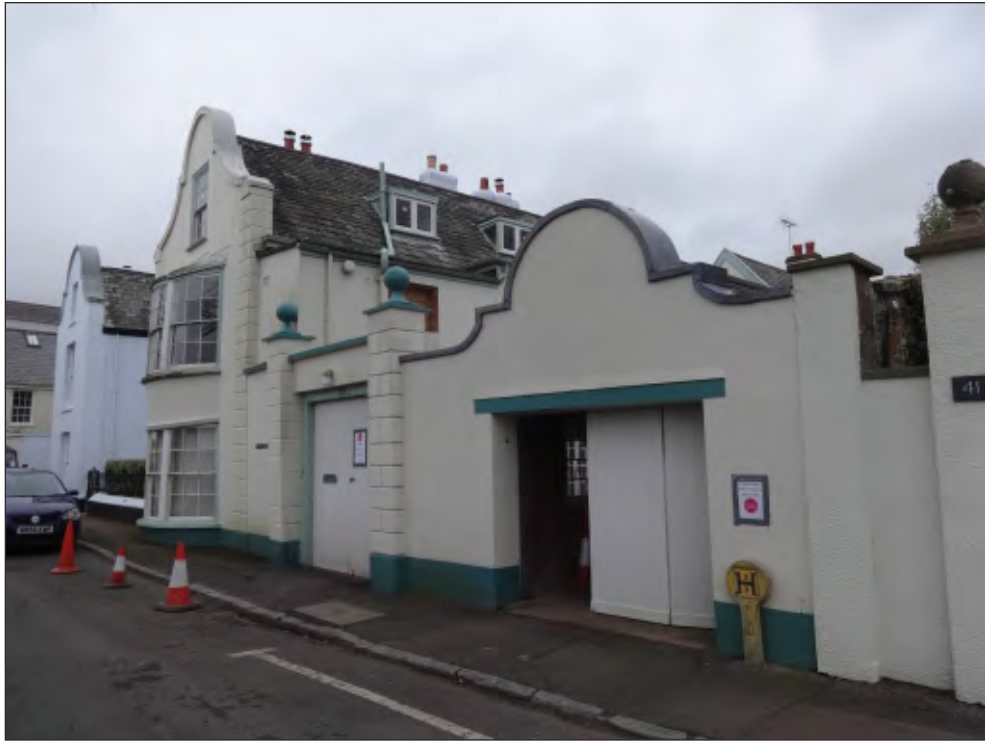
Pl. 1 Side view of No 40 The Strand showing 'Dutch' gable and gateway piers. Looking northeast.

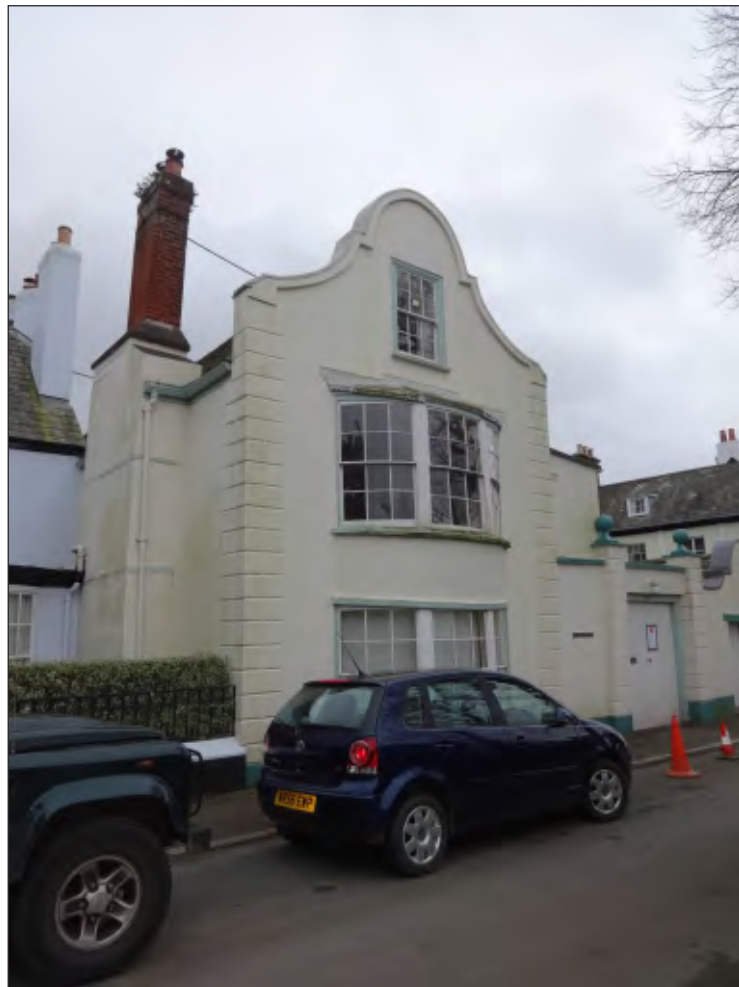
Pl. 2 General view of the street frontage showing late Georgian bow window and 19th century window above. Looking southeast.

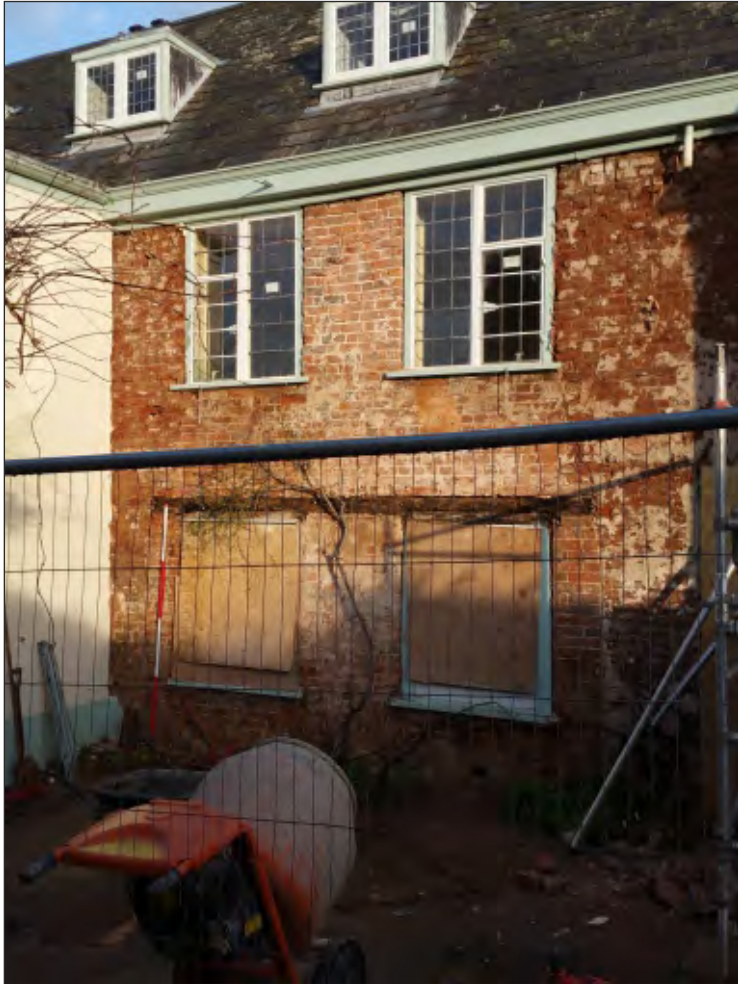
Pl. 3 General view of main house showing early 18th century alterations to the window openings. 2m scale. Looking northwest.

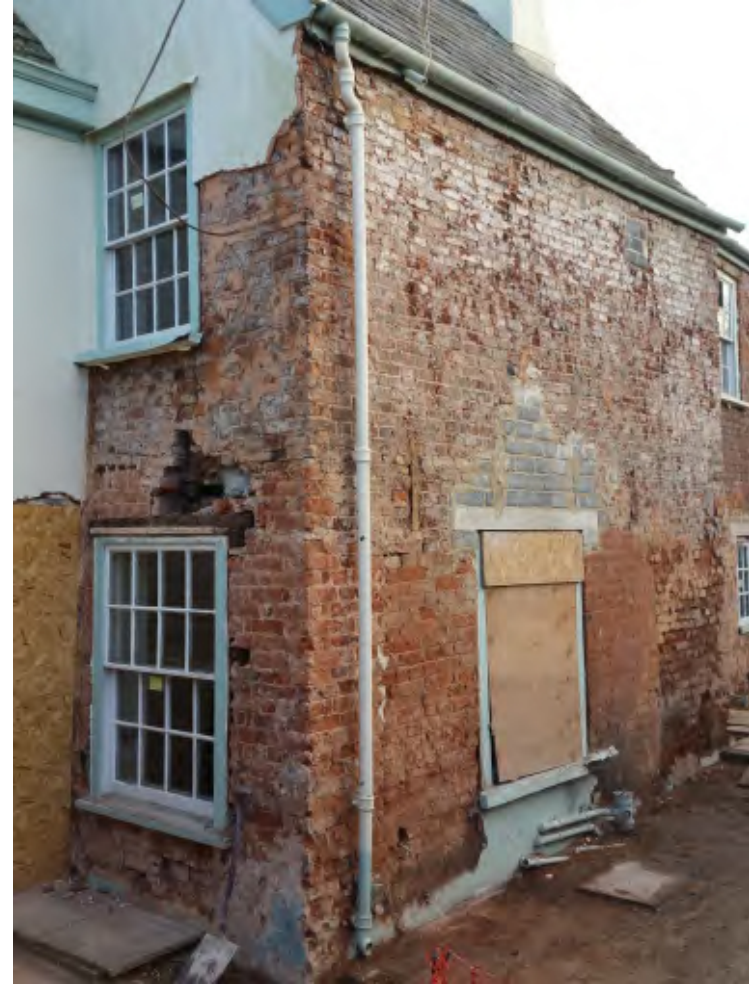
Pl. 4 General view of Kitchen block showing 18th and 19th century alterations to the window openings. Looking northeast.

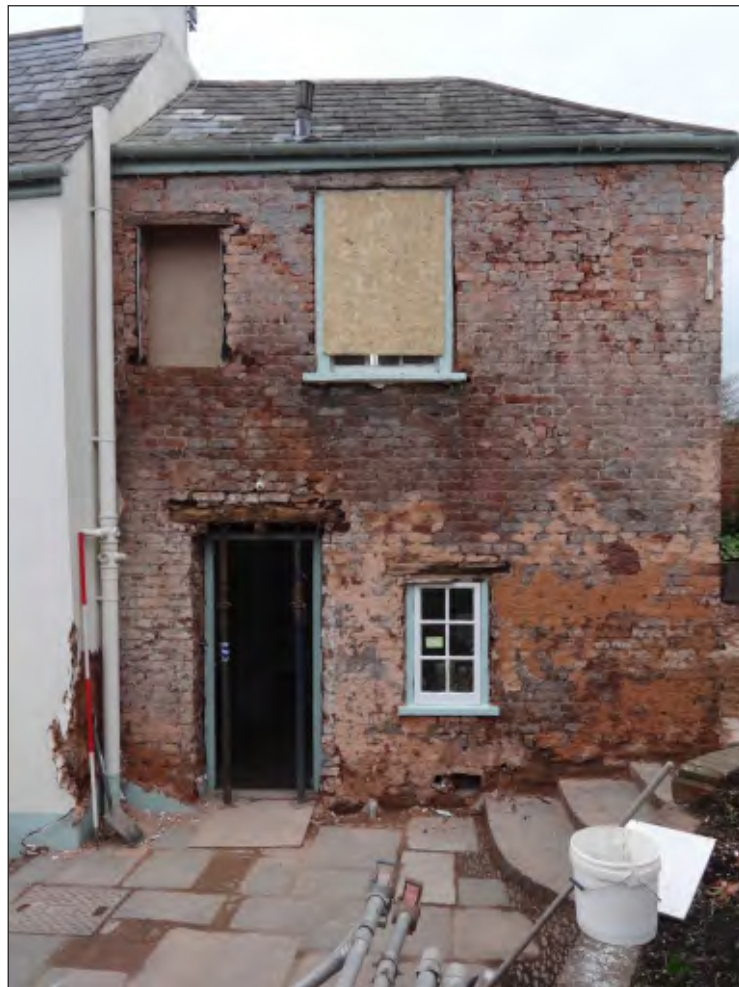
Pl. 6 General view of rear building after removal of render showing early sloping roof line and 18th-20th century alterations to the window openings and doorways. 2m scale. Looking north.

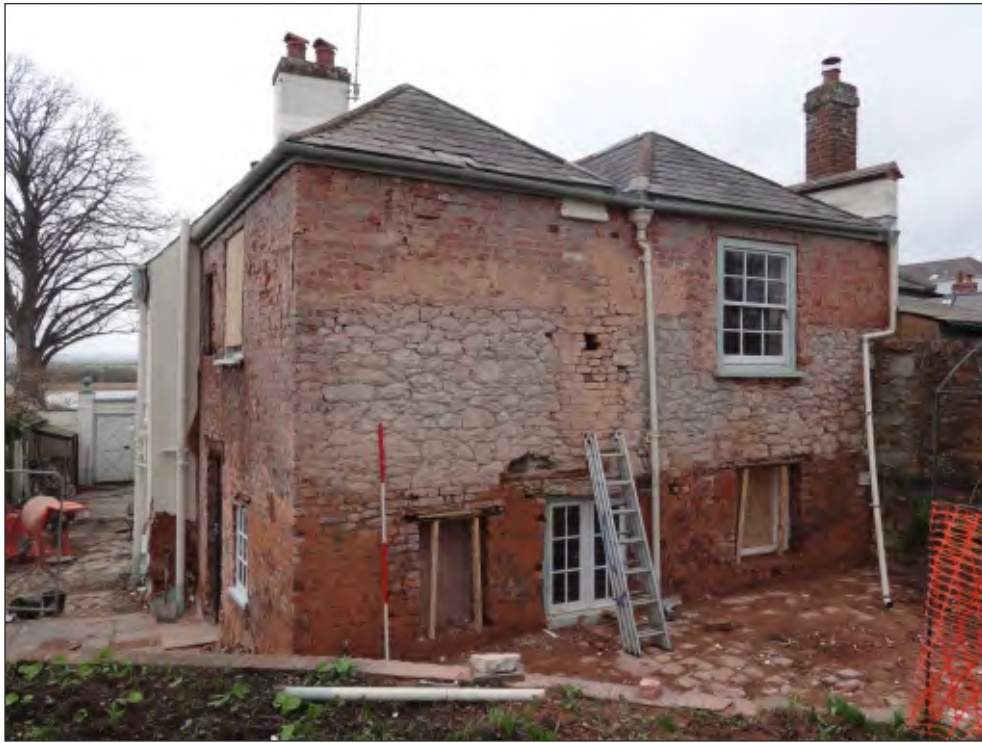
Pl. 7 General view of rear building showing successive raising of rear elevation, the remains of a chimney stack and 18th and 19th century alterations to the window openings. 2m scale. Looking northwest.

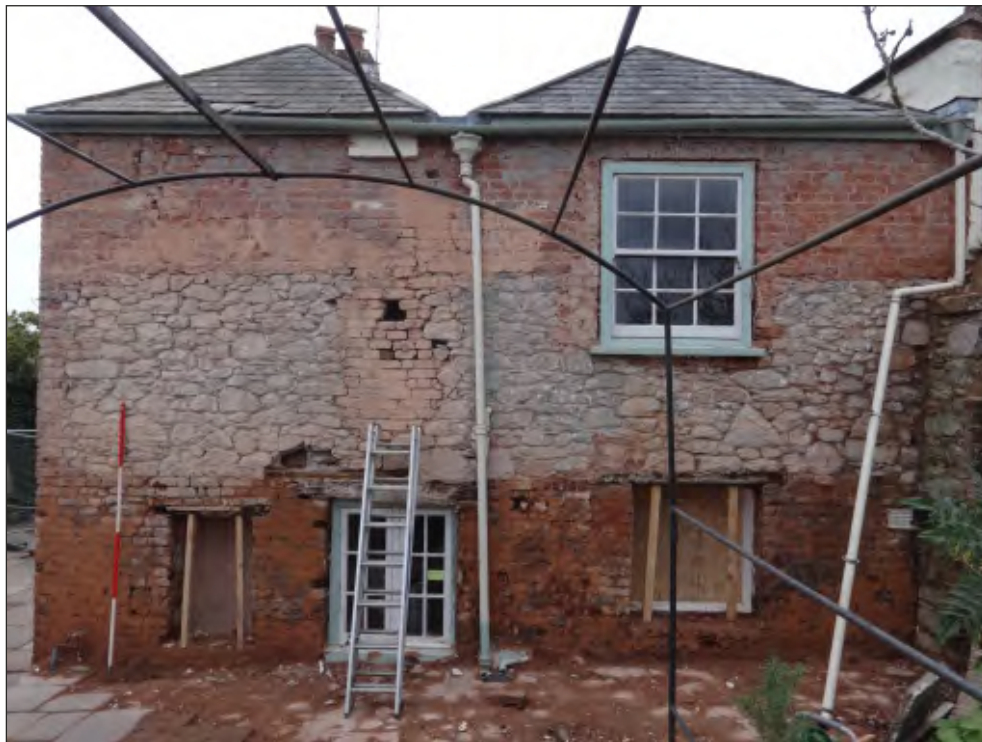
Pl. 8 General view of rear building showing successive raising of rear elevation, the remains of a chimney stack and 18th and 19th century alterations to the window openings. 2m scale. Looking northwest.

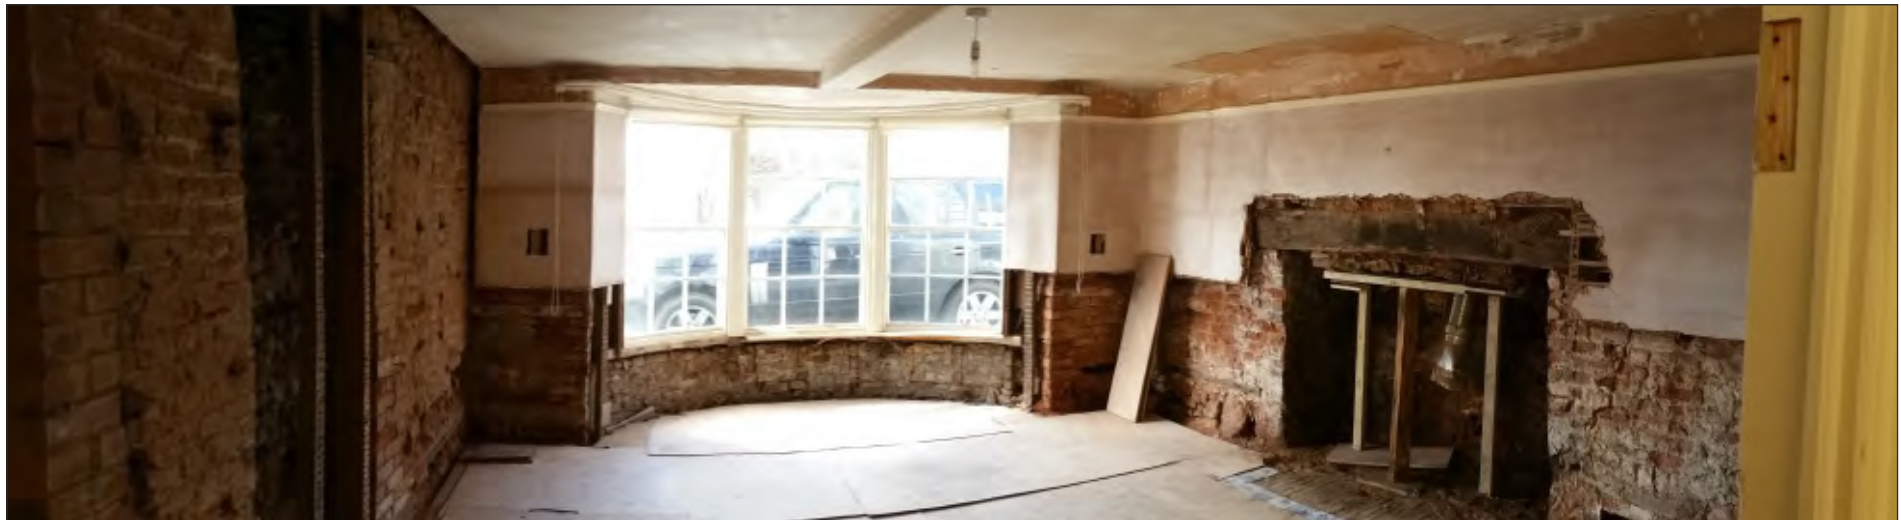
Pl. 9 General view of ground-floor room G03 showing remains of altered window opening (left), late Georgian bow window (center) and original fireplace (right). Looking west.
