**Historic building recording at The Dutch House,
No. 40 The Strand, Topsham, Devon**

Report No. 17-11

August 2017

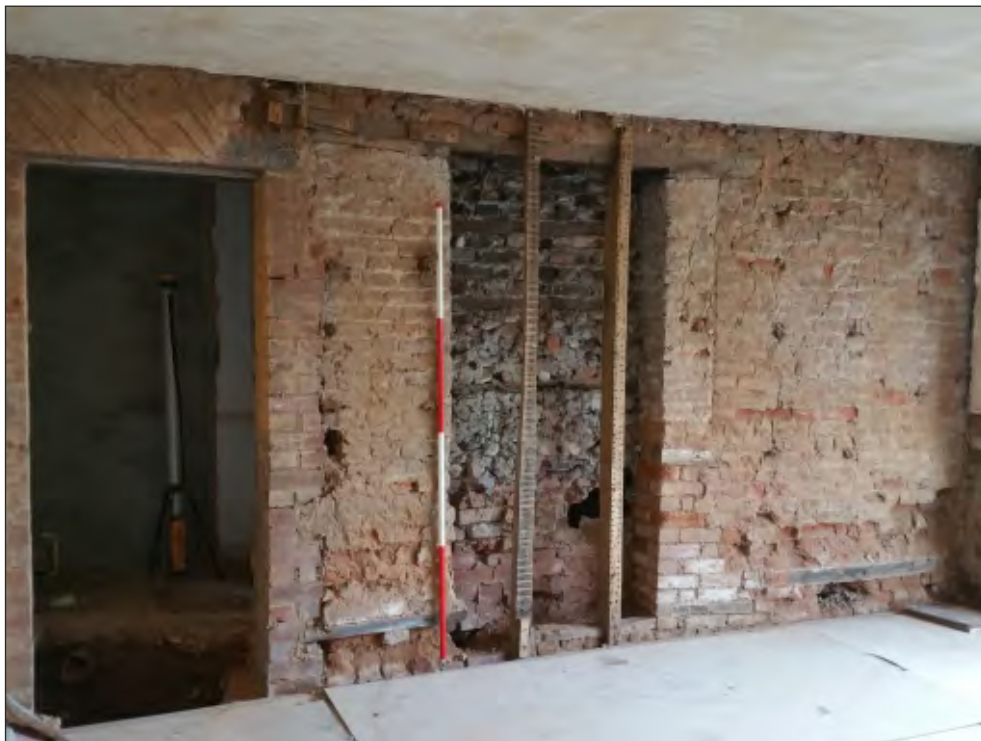
Plate 10

General view of south elevation ground-floor room G03 showing early window arrangement with early 18th century alteration of the original opening and late 18th or early 19th century conversion to cupboard. 2m scale. Looking southwest.

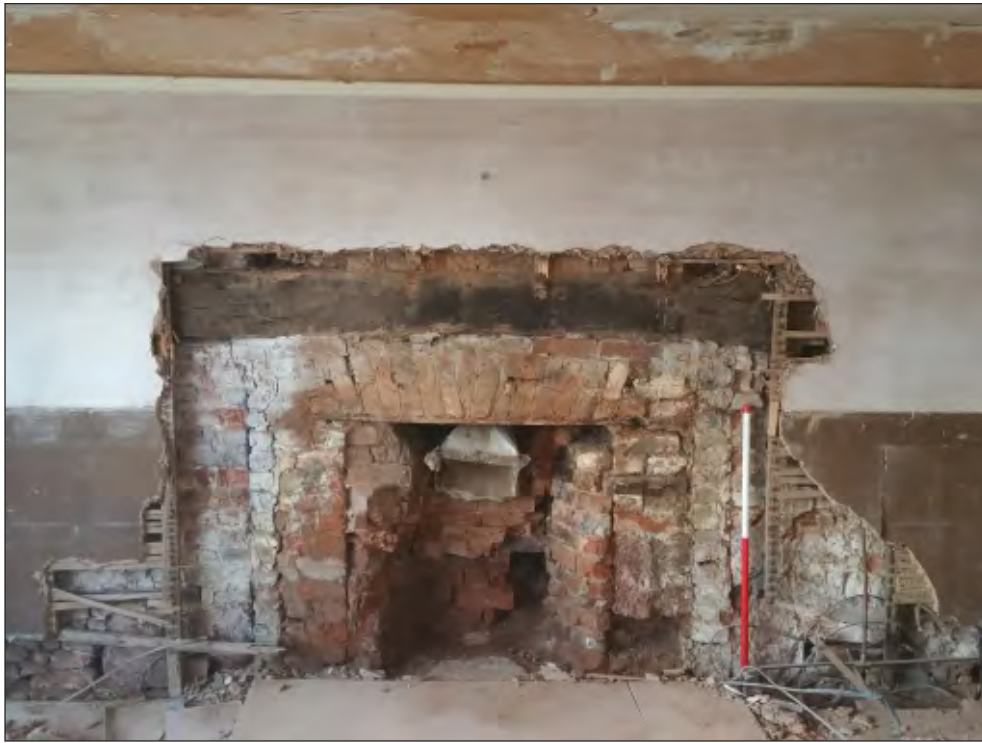
Pl. 11 General view of 19th century fireplace remains. 1m scale. Looking northwest.

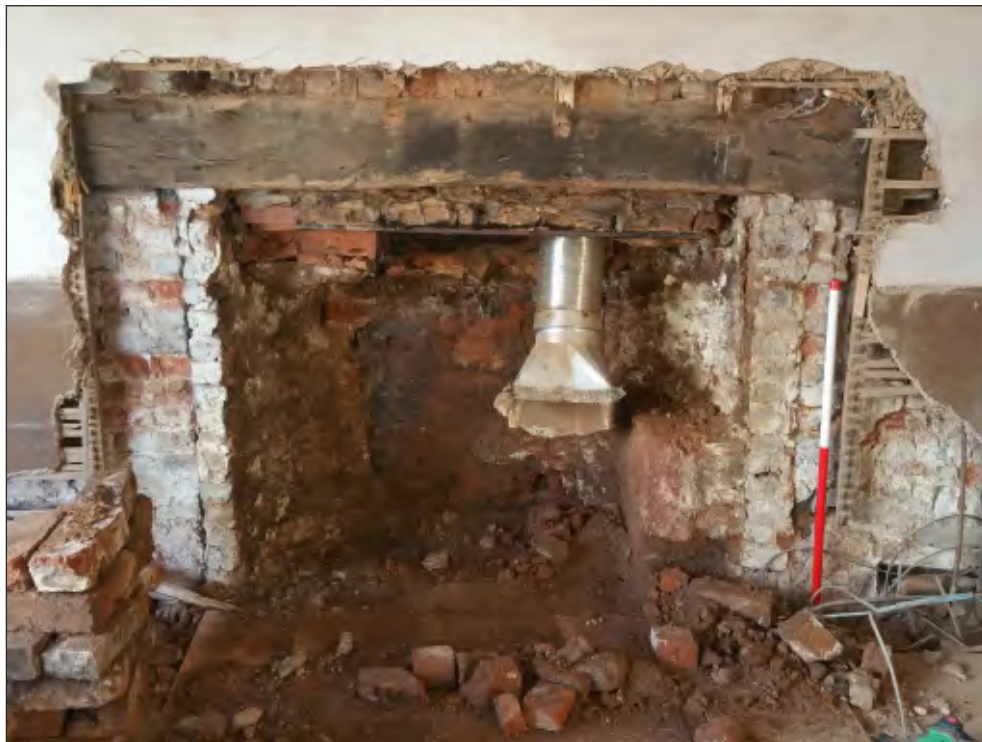
Pl. 12 General view of late 17th or early 18th century 'Dutch' style fireplace with curved sides and back. 1m scale. Looking northwest.

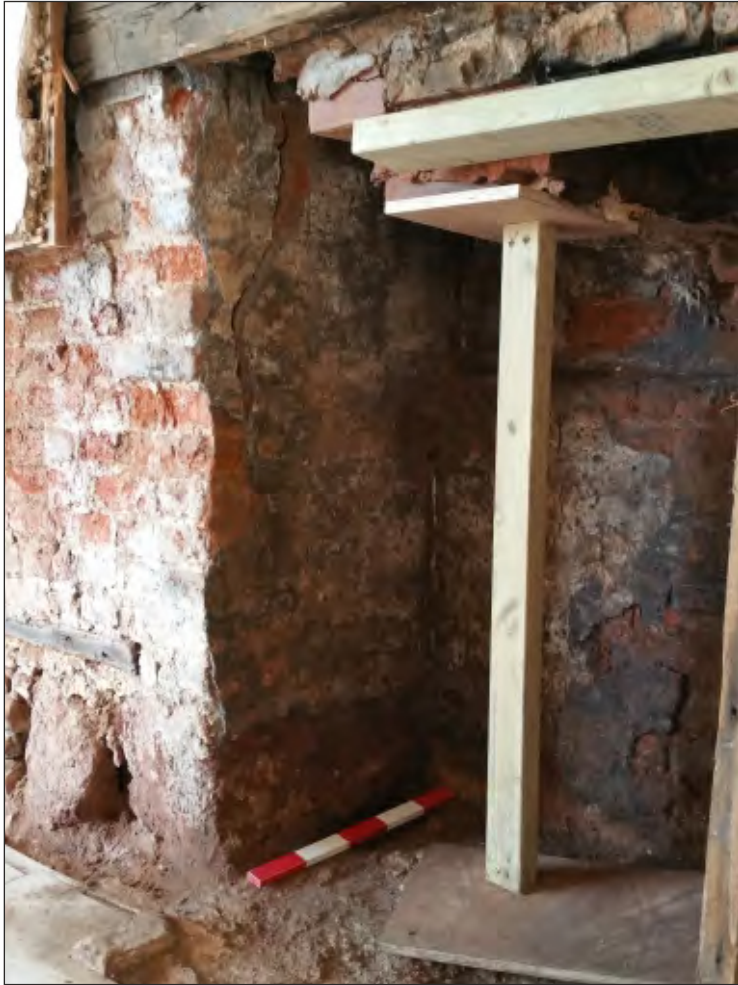
Pl. 13 Close-up of western jamb of fireplace showing black-and-white chequerboard painted plaster decoration. 0.5m scale. Looking northwest.

later scheme, consisting of simple black-and-white chequerboard (Fig. 17, pl. 13-14), may have been painted over an earlier scheme that was too fragmentary to recover (Torquil McNeilage *pers. comm.*). Although attempts by Ruth and Torquil McNeilage to conserve the painted chequerboard decoration failed due to the inherently fragile nature of the scheme after three centuries of damp and the very close proximity of the later brick blocking, this revealed an earlier floral scheme surviving extensively on the internal faces of the jambs and the rear of the fireplace (Fig. 17, pl. 15-16). Closely associated with sgraffito-decoration, painted plaster decorative schemes are generally thought to be later in date. The decoration on the fireplace jambs and rear fits well into the kind of painted decoration popular at this period. The later chequerboard scheme is a common pattern found at Billany, Dartington and West Moore, South Brent. This was also sometime found in combination with other patterns, including floral ones, as at Middle Moor, Sowton and with stripes, as at 44–6 Magdalen Street, Exeter. This example is likely to belong to the period 1660-1720 with the fourth quarter of the 17th century perhaps being the most likely date for its installation. Freehand decorations are much less common.

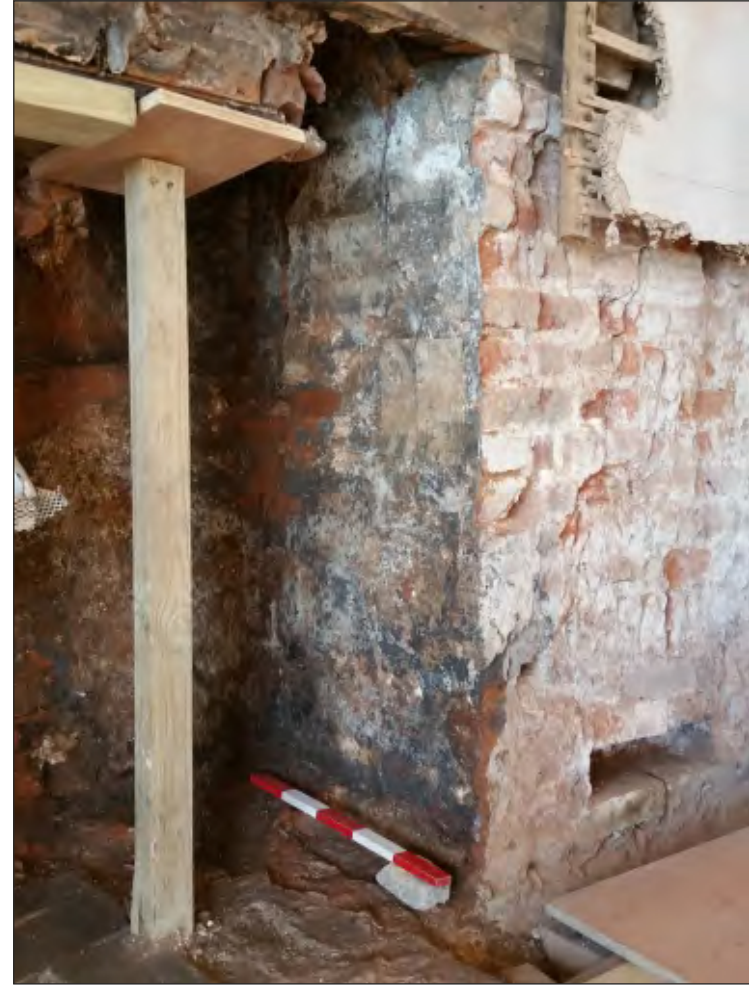
Pl. 14 Close-up of eastern jamb of fireplace showing black-and-white chequerboard painted plaster decoration. 0.5m scale. Looking north.

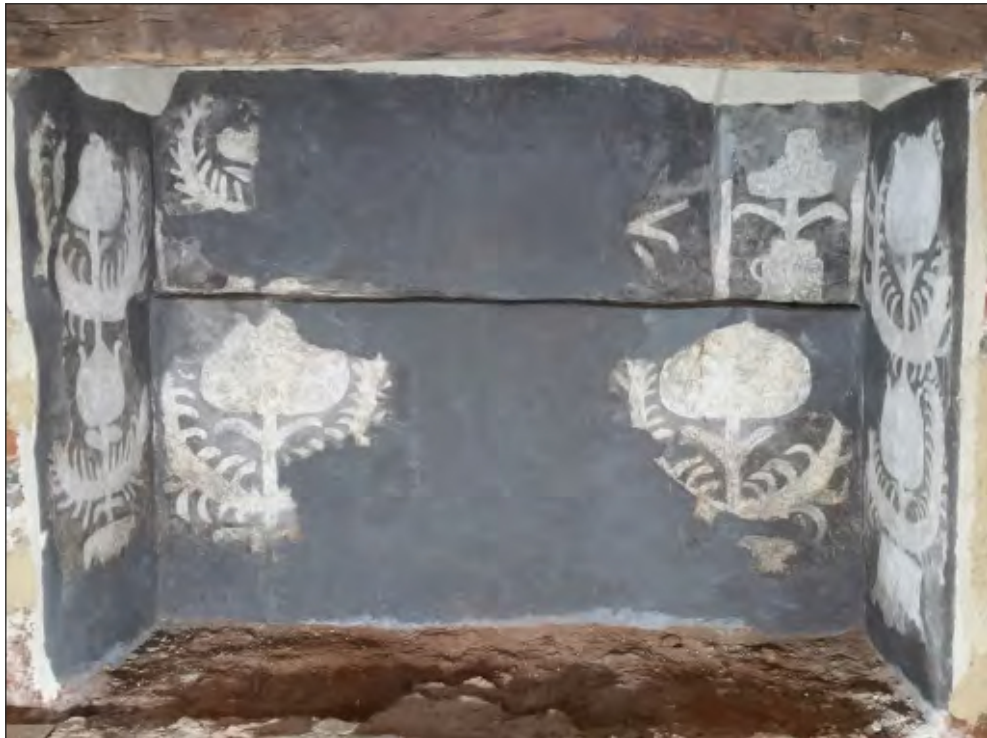
Pl. 16 General view of the painted plaster floral design on jambs and rear of fireplace. Looking northwest.

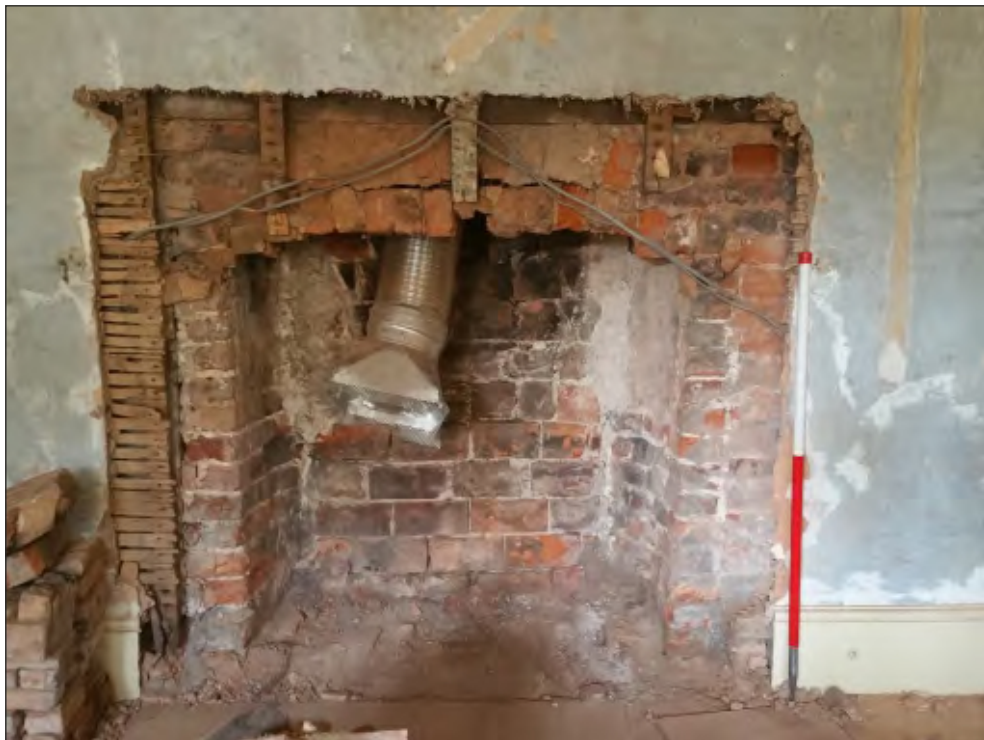
Pl. 18 General view of late 18th or early 19th century fireplace in ground-floor room G05 following removal of modern fireplace. 1m scale.
Looking northwest.

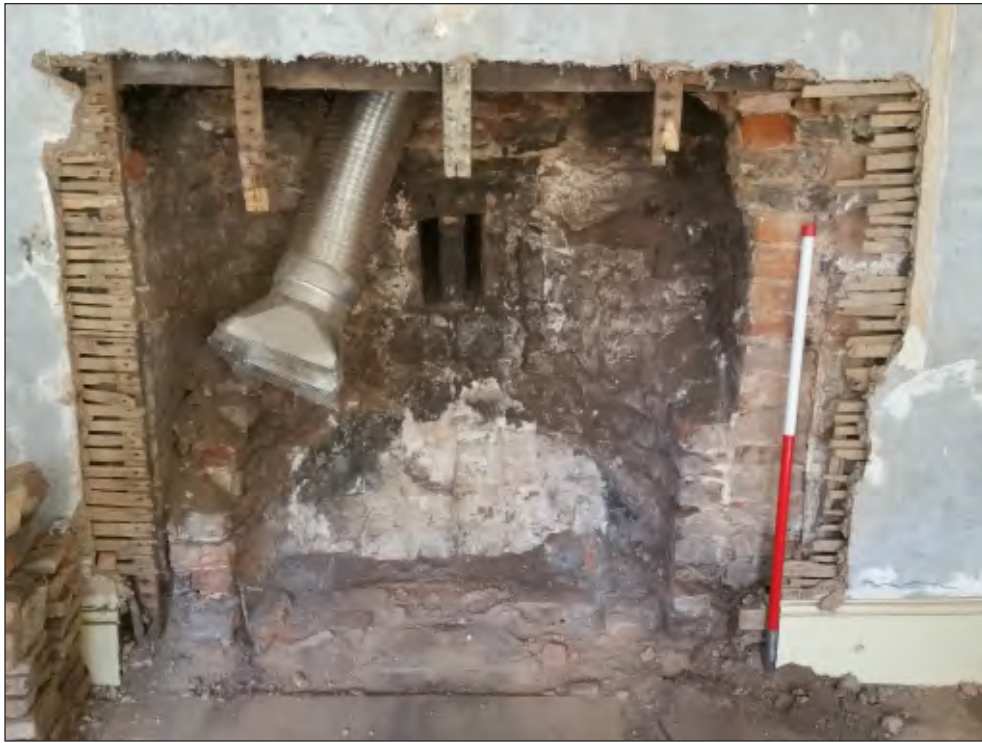
Pl. 19 General view of mid-to-late 18th century 'Dutch' style fireplace with curved sides and rear. 1m scale. Looking northwest.

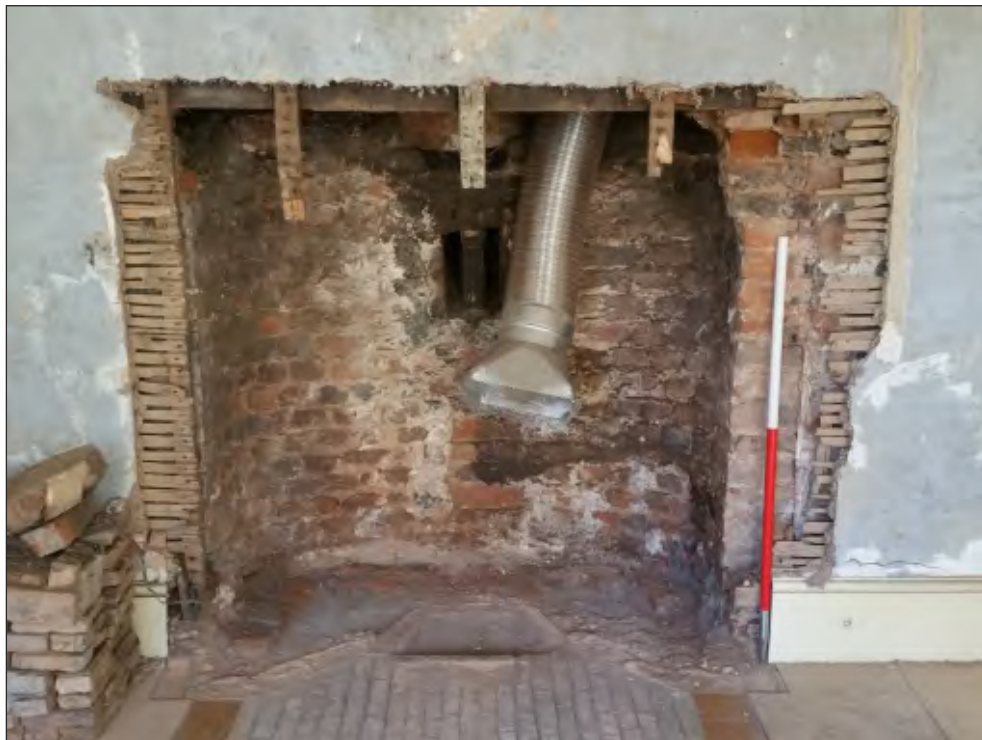
Pl. 20 General view of early-to-mid 18th century 'Dutch' style fireplace with curved sides and rear. 1m scale. Looking northwest.

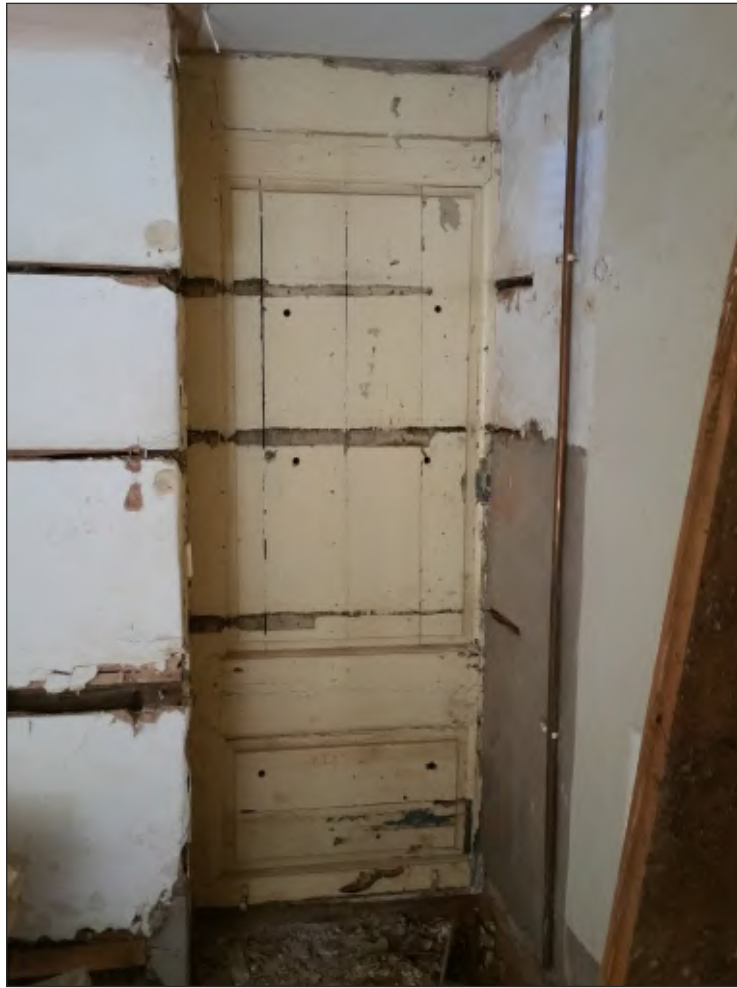
Pl. 21 17th-century panelling re-used in alcove in ground-floor room G06. Looking west.

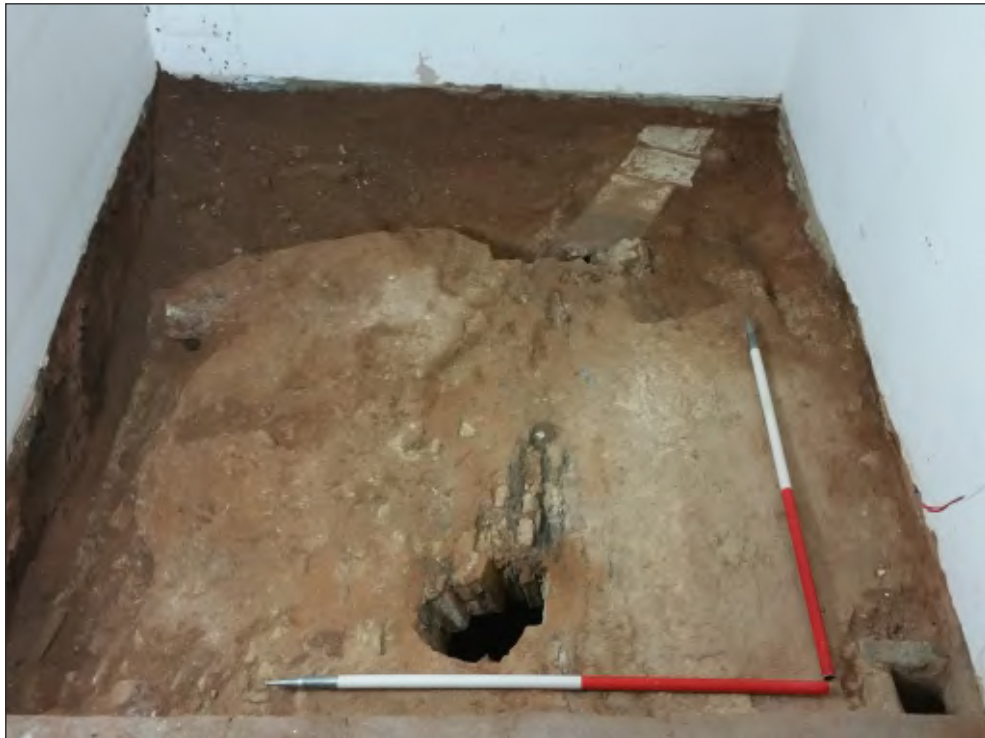
Pl. 22 Cistern and drain (top right) uncovered during work in ground-floor room G09. 1m scales. Looking northeast.

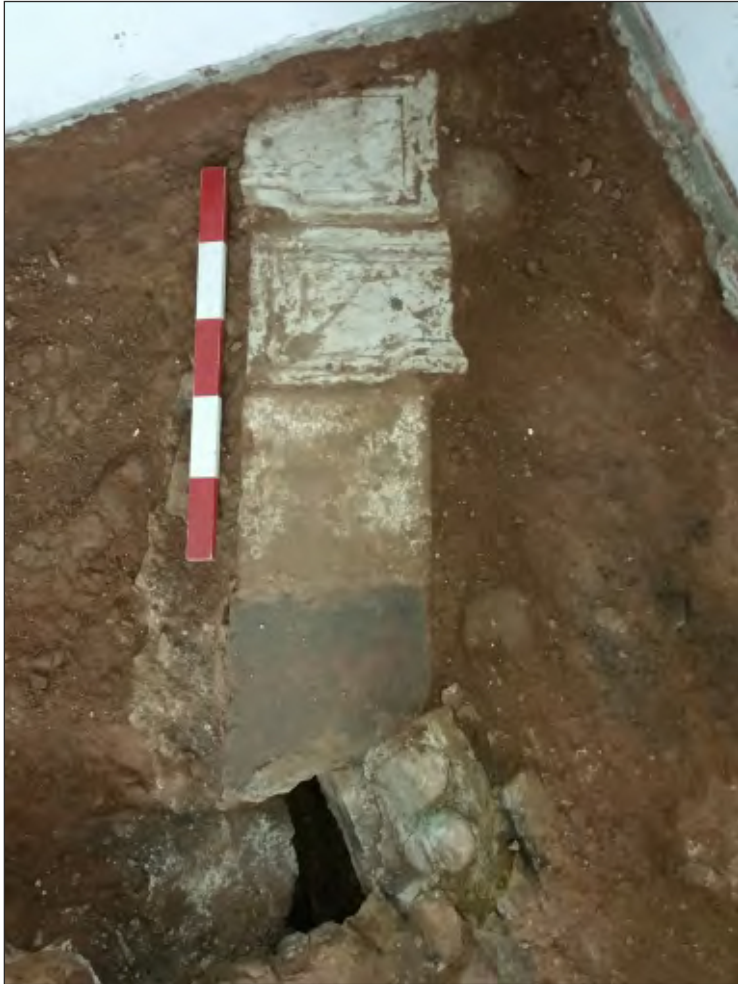
Pl. 23 Close-up of drain showing fireplace surround fragments used in the construction of the cover. 0.5m scale. Looking east.

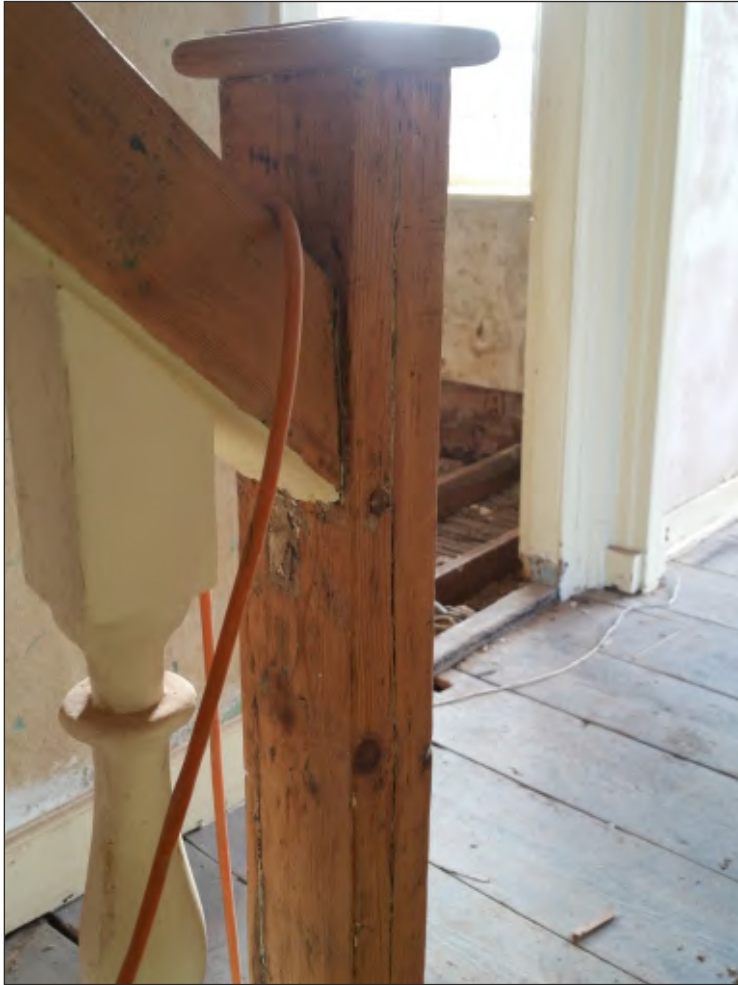
Pl. 25 Close-up of stair construction showing earlier socket and peg hole. Looking southeast.

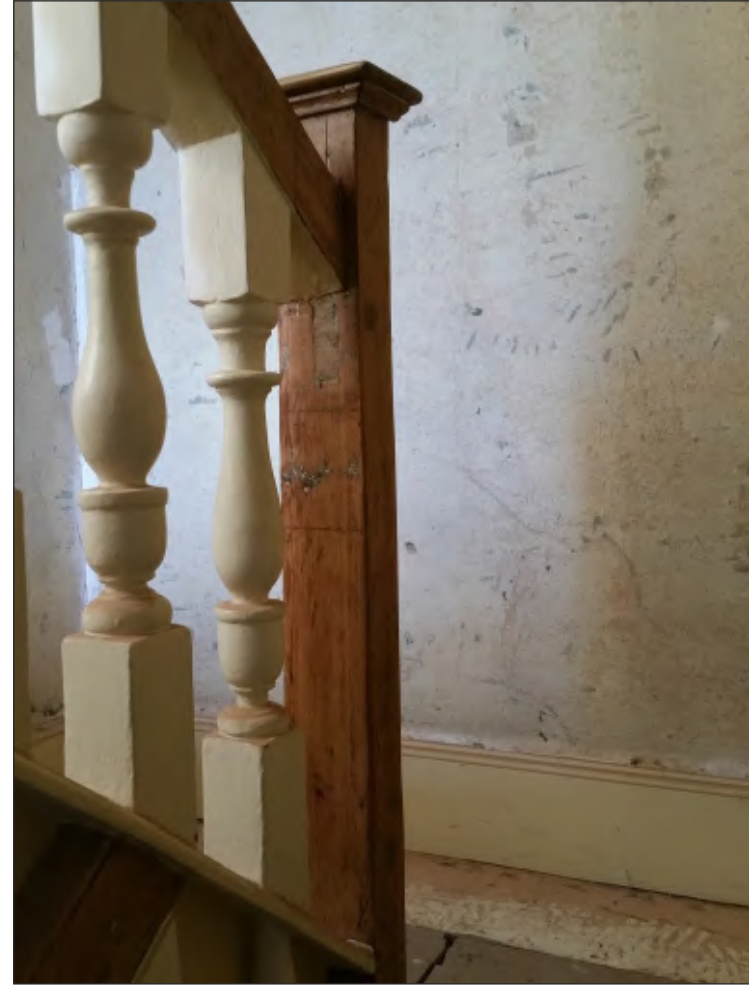
Pl. 26 Close-up of stair construction showing not only the earlier socket and peg hole, but also the inscribed carpenter's marks denoting the intended junction with the lower bannister. Looking southeast.

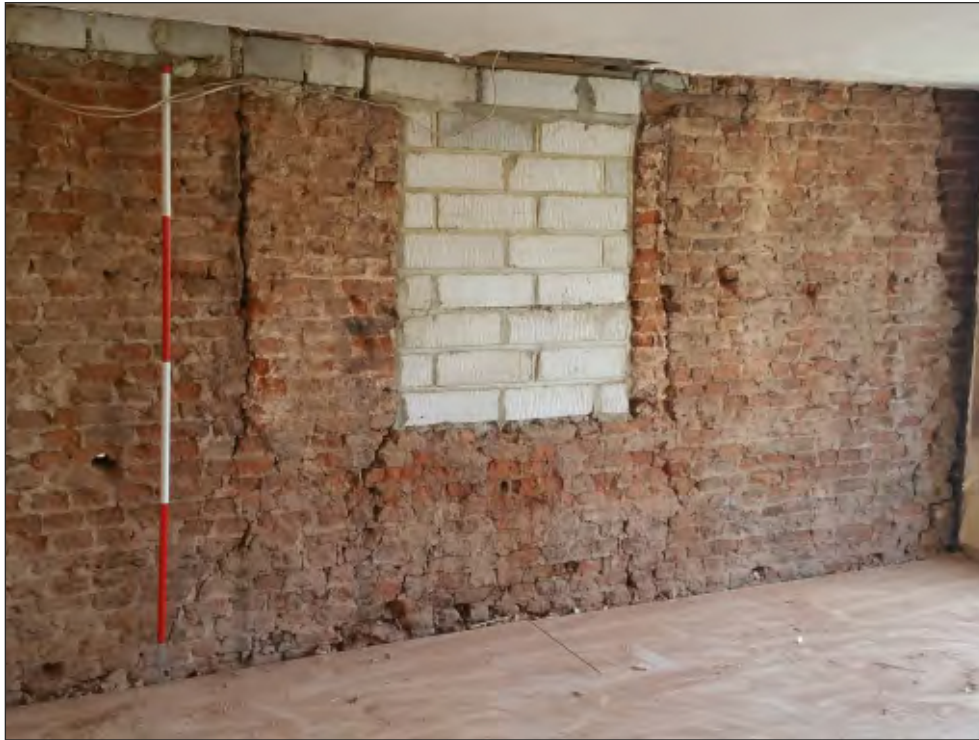
Plate 27 General view of south elevation first-floor room F02 showing early window arrangement with early 18th century alteration of the original opening and modern blocking. 2m scale. Looking southwest.

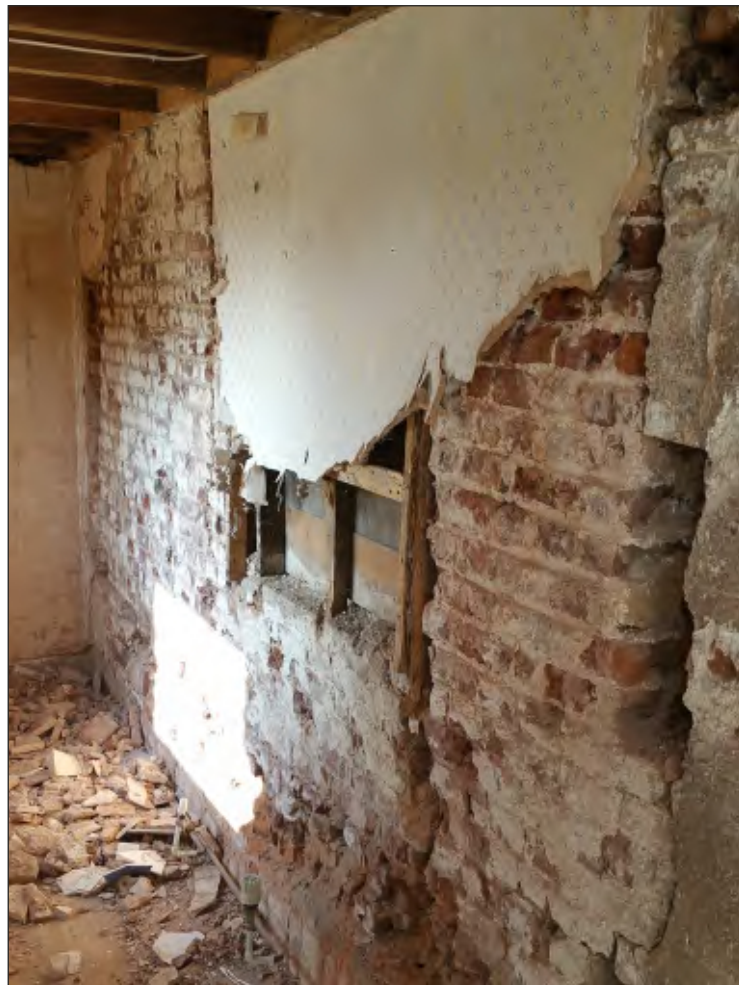
Plate 28 General view of main house elevation showing early window arrangement with early 18th century alteration of the original opening and modern blocking. 2m scale. Looking southwest.

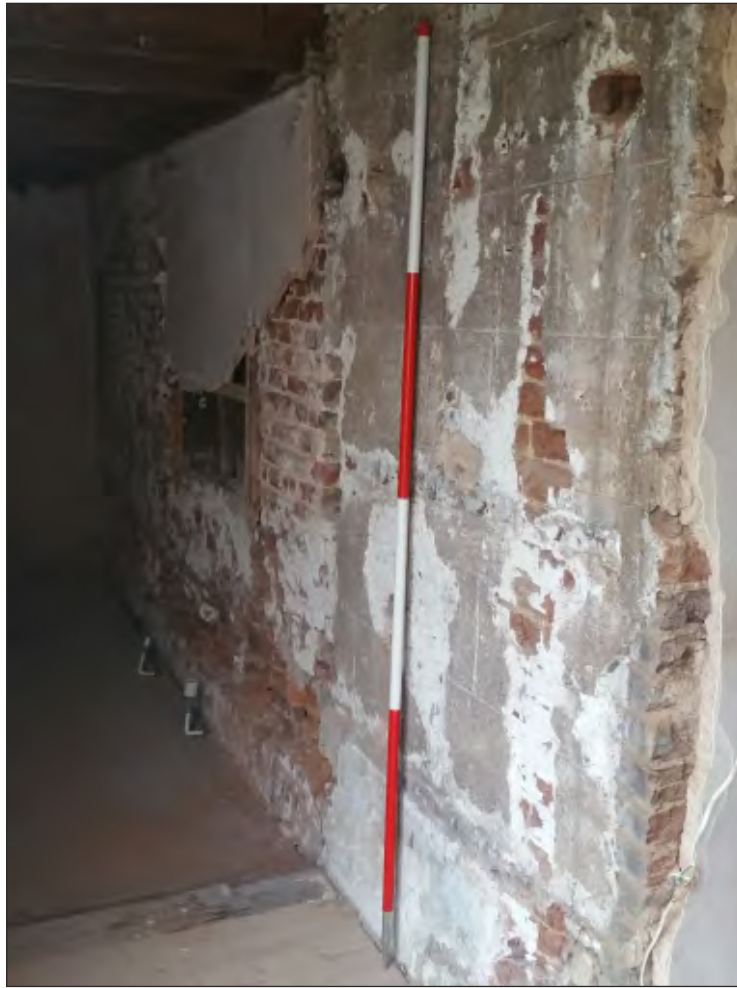
Pl. 29 Small area of surviving 19th century external render with incised ashlar lines. 2m scale. Looking northwest.

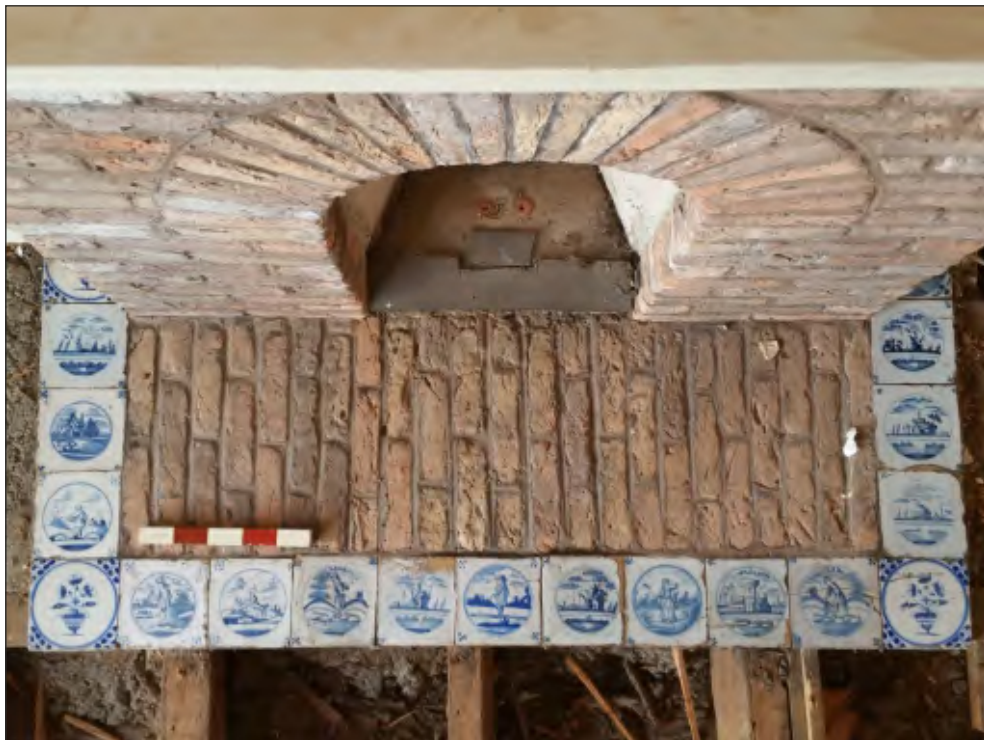
Pl. 30 Close-up of Delft tiles on modern hearth surround first-floor room F02. 0.25m scale. Looking northwest.

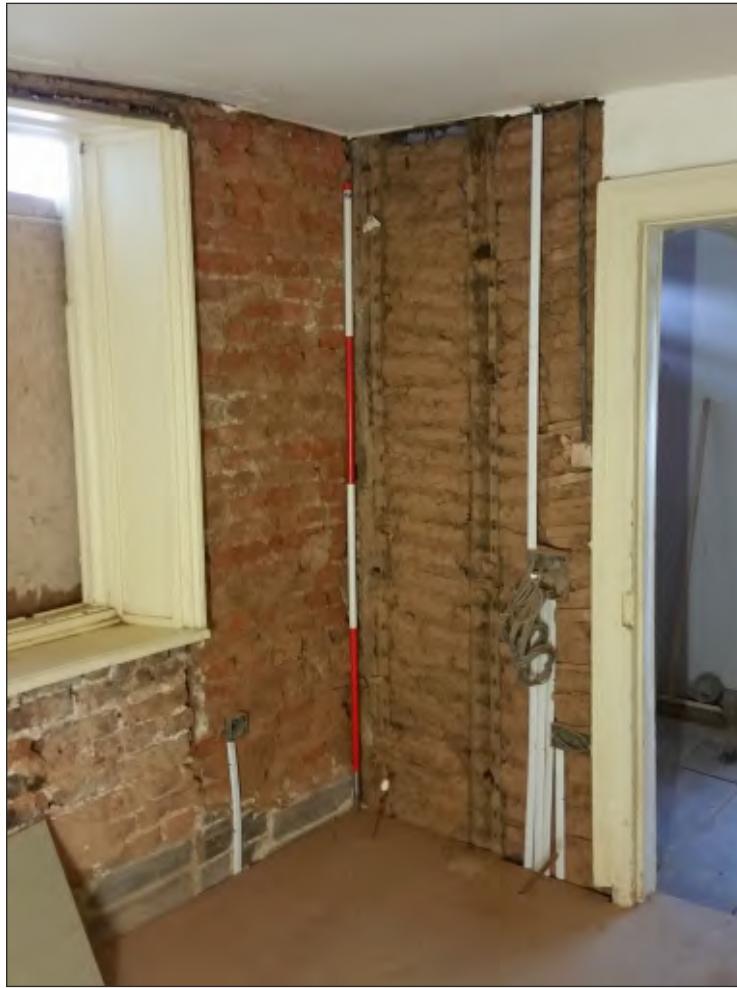
Pl. 31 General view of primary cob partition in first-floor room F04. 2m scale. Looking southwest.

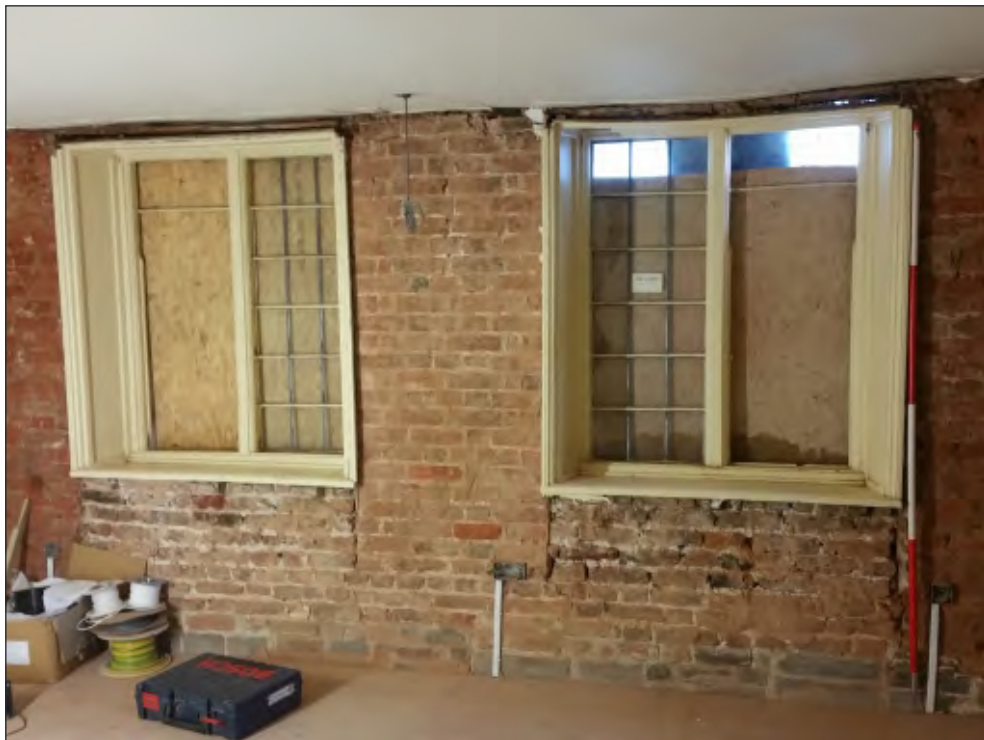
Pl. 32 General view of south elevation first-floor room F04 showing early 18th century alterations to the window openings and blocked-up window seats underneath. 2m scale. Looking southeast.

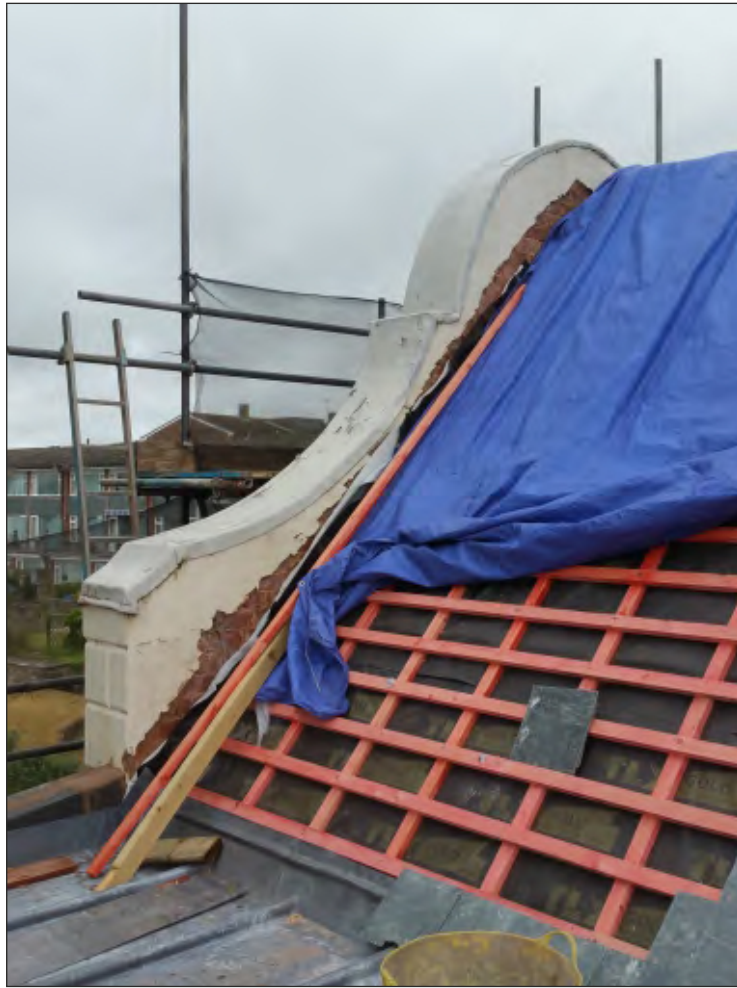
Pl. 35 Close-up of rear of 'Dutch' gable showing substantial modern rebuilding. Looking northwest.

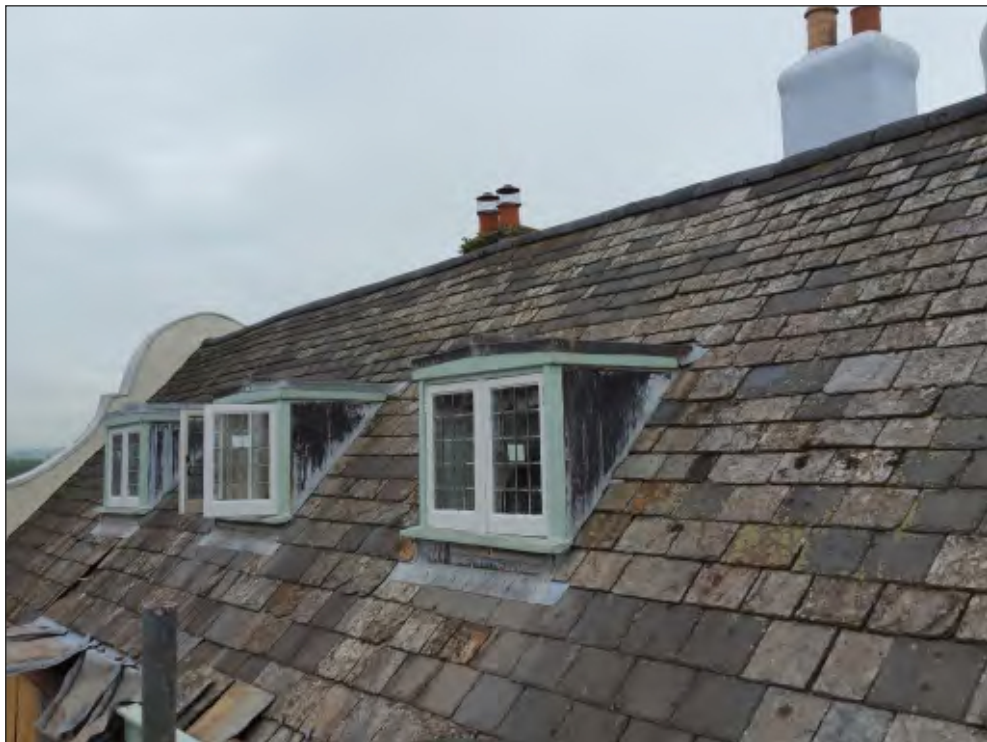
Pl. 36 General view of roof showing dormer windows and decreasing size of slates. Looking northwest.
