Historic building recording at Abbotsham, Brushford, Devon

Report No. 17-14

October 2017

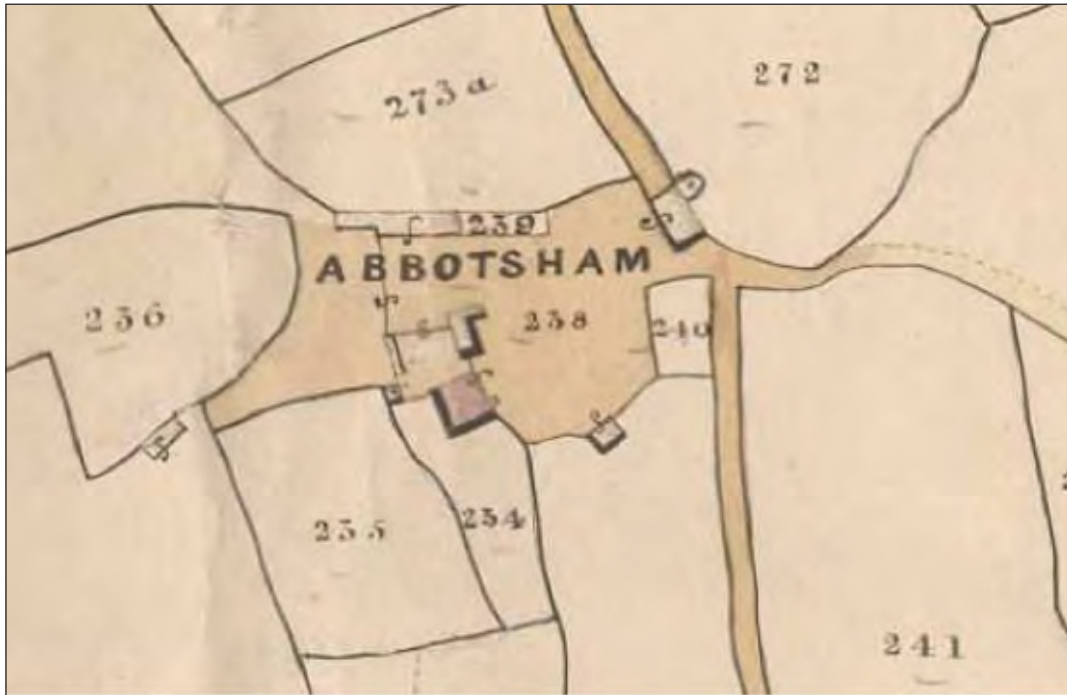
Fig. 2 Detail from the 1843 Brushford tithe map.

The Brushford Tithe Map and Apportionment of 1843 lists Abbotsham as a "Dwelling House and Homestead." The owner was William Luxton Esq, and the occupier was William Luxton who also owned and occupied Batelease, another farm. The tithe map (Fig. 2) clearly shows the main house with its outshuts and a projecting structure on the east side. To the north are several large barns clustered around a large farmyard. The farm consisted of c. 200 acres at this time, together with its large farmhouse and farmyard, representing quite a large and prosperous farming establishment.

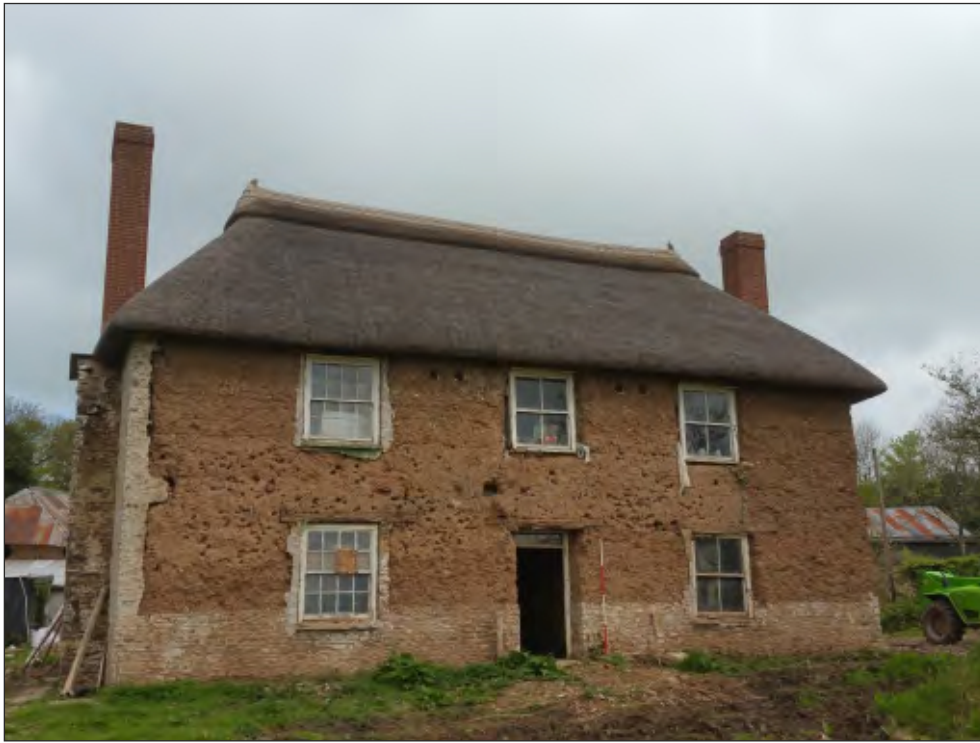
Pl. 1 General view of south elevation showing central doorway and symmetrical facade. 2m scale. Looking northeast.

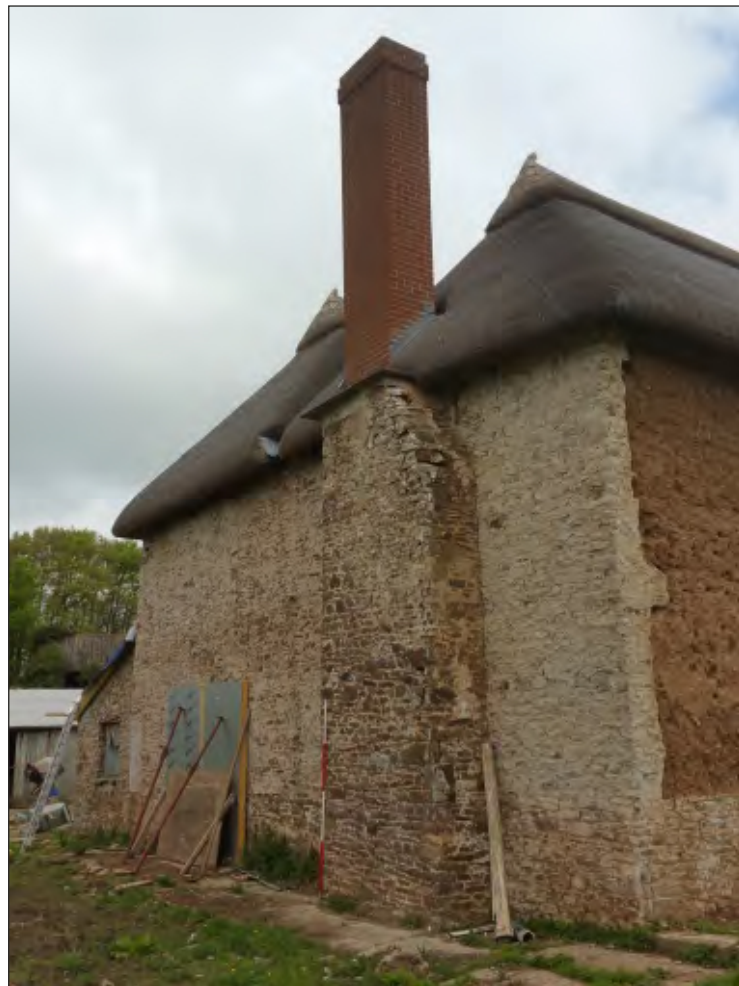
Pl. 2 General view of western elevation showing chimneystack. 2m scale. Looking northeast.

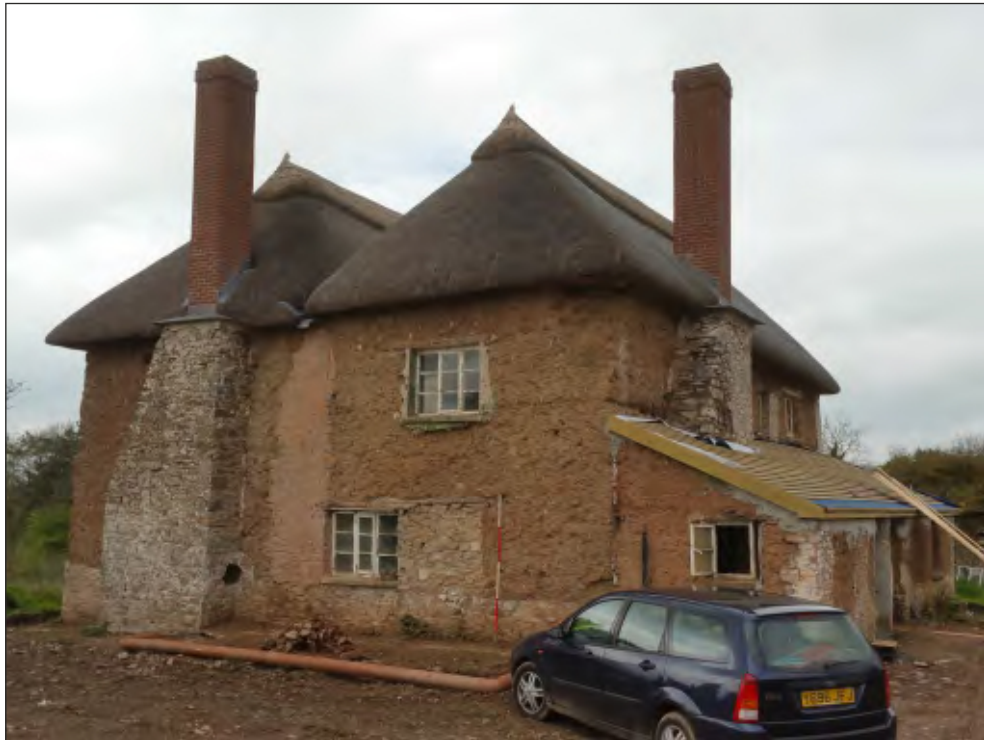
The removal of external render on the east elevation (pl. 3) confirmed the absence of an earlier building phase and revealed the symmetry of the original window arrangement. The ground-floor opening was blocked in the late 19th century and a new opening created immediately to the south. This re-used the earlier window, although both are replacements of earlier windows.

Pl. 3 General view of east elevation showing window arrangement and early 19th century outshuts. 2m scale. Looking west.

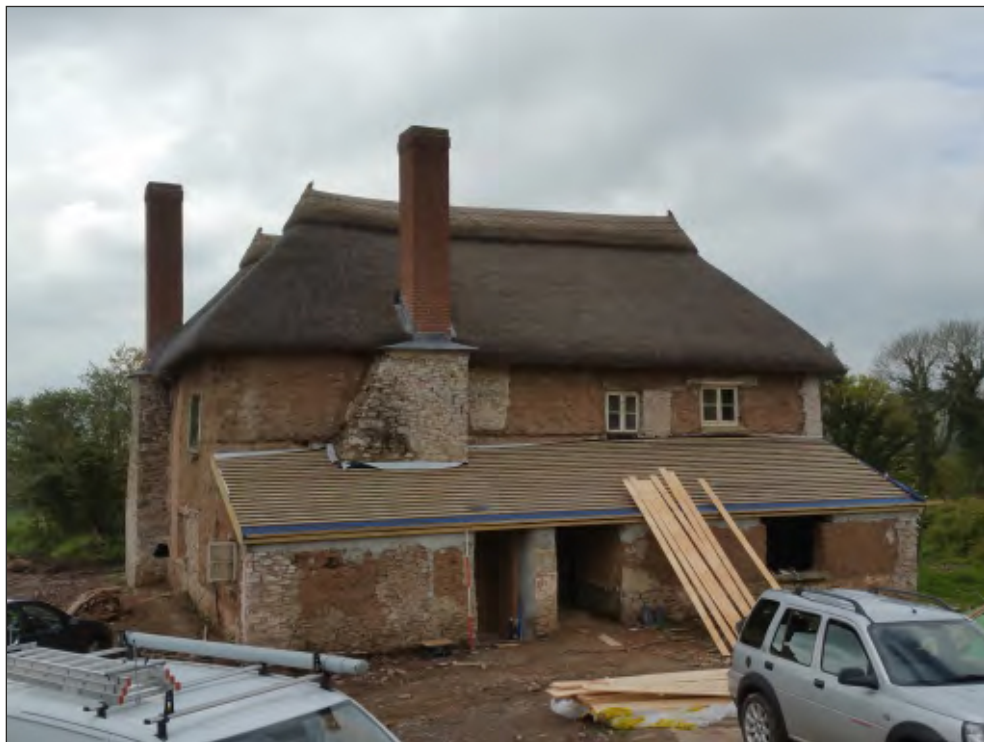
Pl. 4 General view of north elevation showing original chimneystack and early 19th century outshuts. 2m scale. Looking southwest.

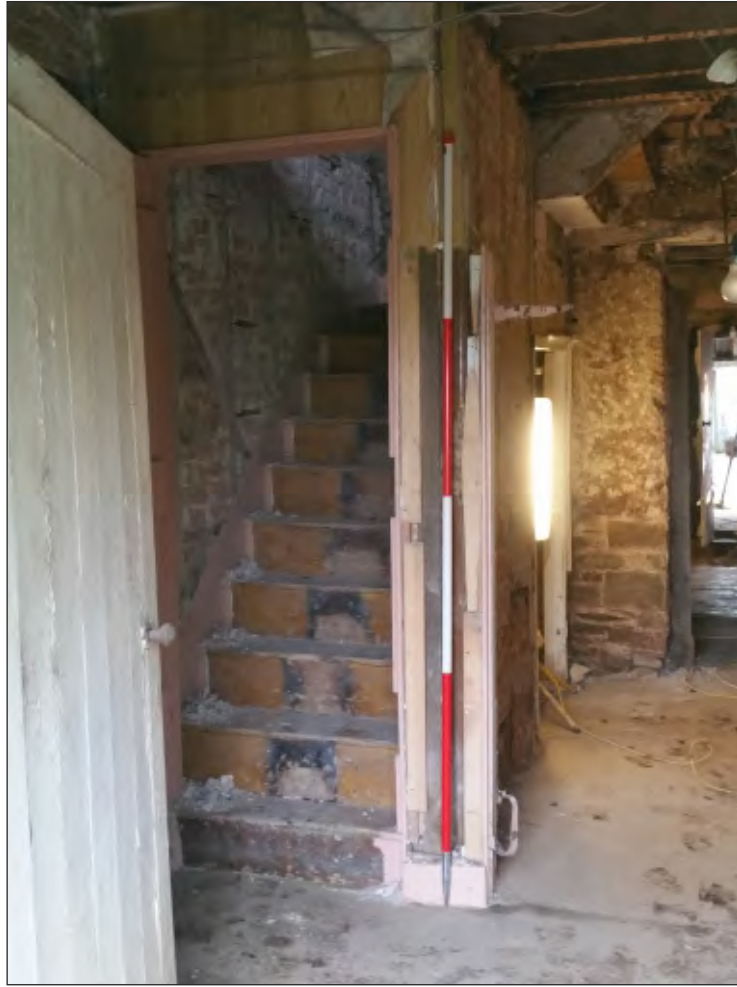
Pl. 5 General view of entrance hall G01 showing original through passage and main stair. 2m scale. Looking north.

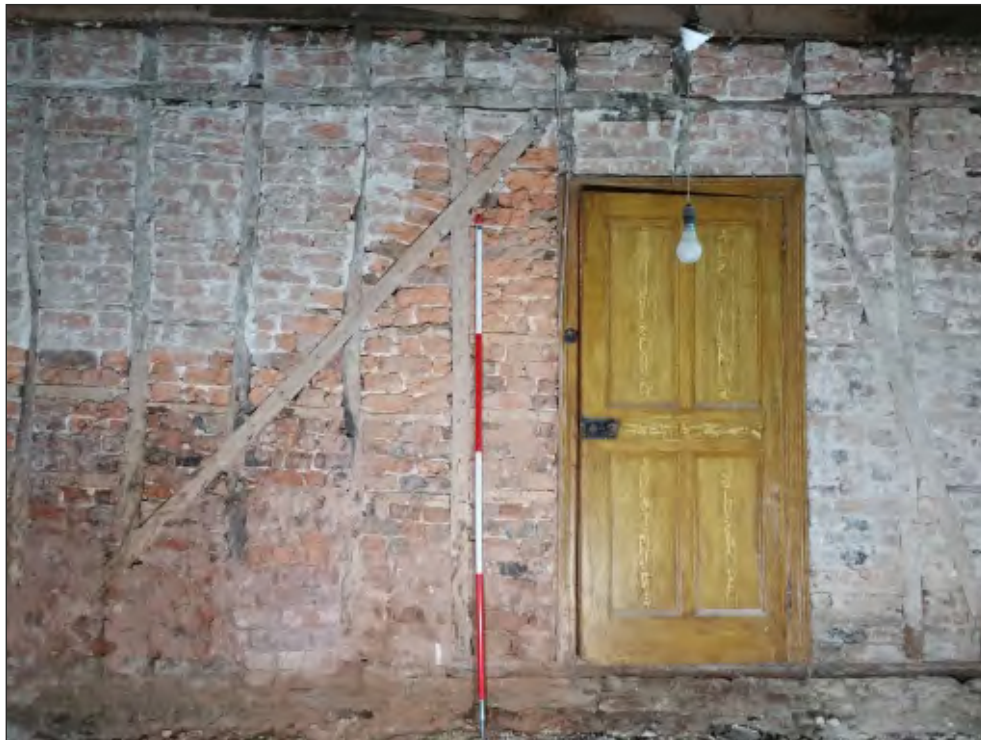
To the west of the lobby is a timber partition with brick infill running the full width of the front range (pl. 6). This is constructed of squared timber, diagonal bracing and brick nogging, and covered with lath and plaster. This partition probably dates from the early 18th century, with the brick replacing the original cob infill. The door to room G02 has a plain 19th-century door frame with a four-panelled door. The ground-floor parlour (G02) to the west of the partition was lit by a single sash window in the south elevation. This is a 19th century replacement of an earlier window. No blocked doorway or window openings were identified within the cross wall dividing the front and rear ranges.

Pl. 6 General view of east elevation ground-floor room G02 showing early 18th century partition with later brick infill and doorway. 2m scale. Looking east.

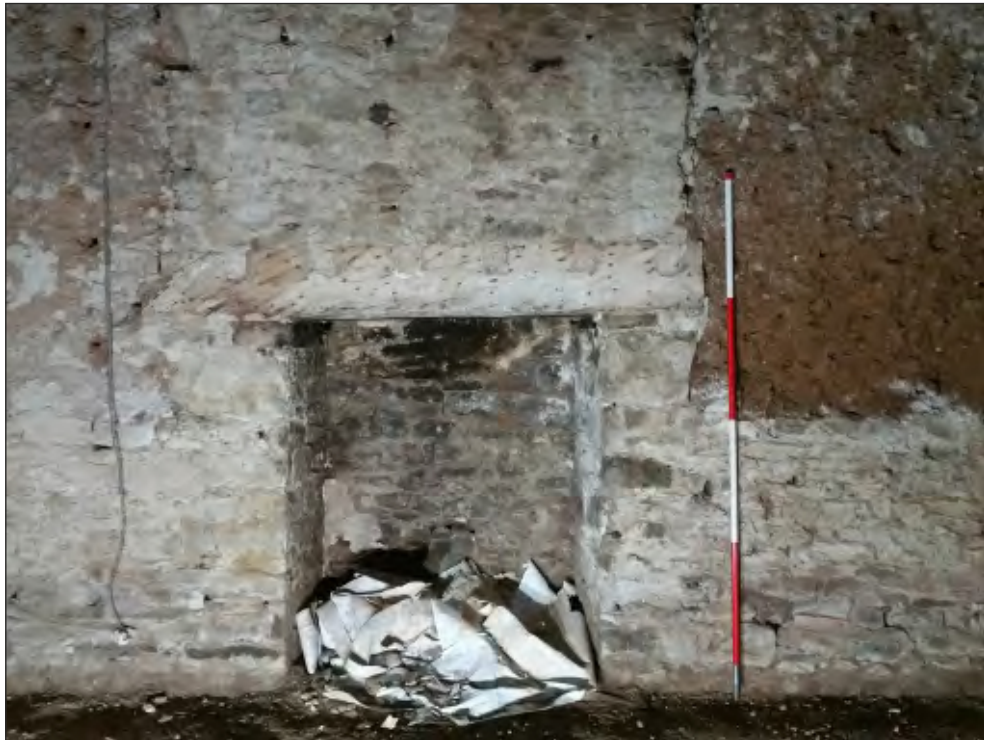
Pl. 7 General view of west elevation ground-floor room G02 showing fireplace with re-used lintel. 2m scale. Looking west.

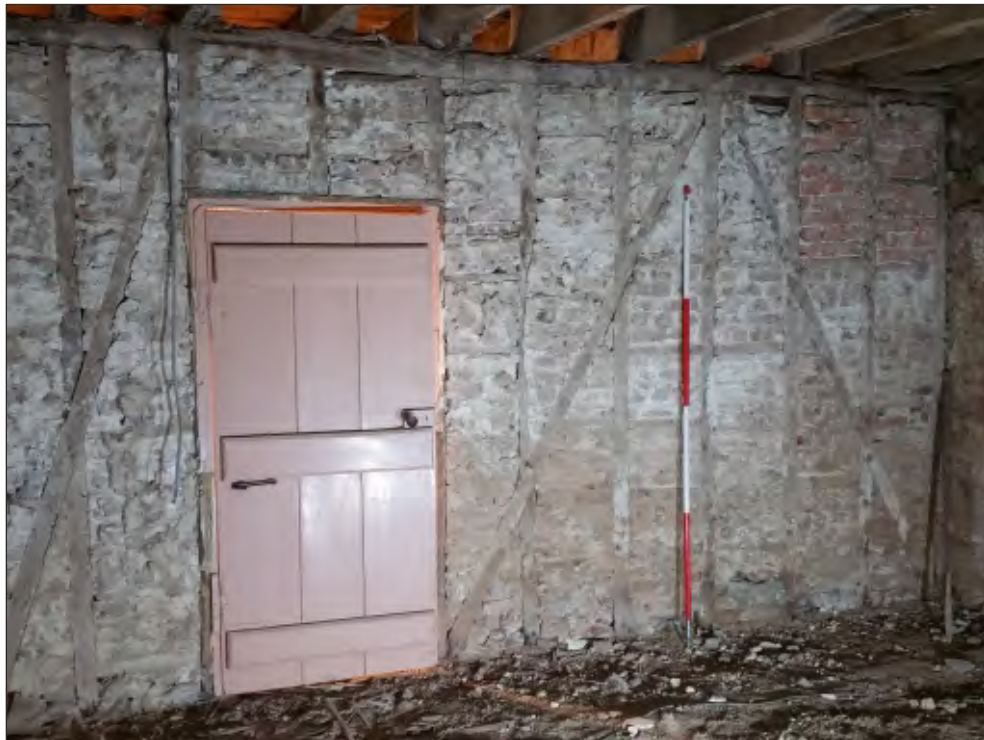
Pl. 8 General view of west elevation room G03 showing early 18th century partition and doorway with later brick infill. 2m scale. Looking west.

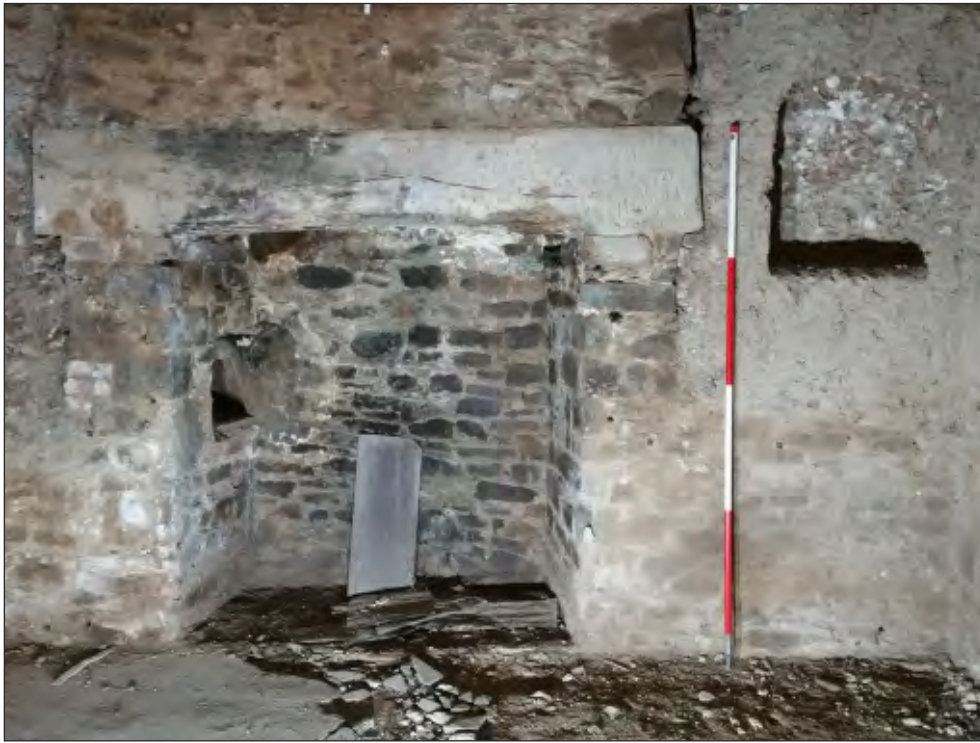
Pl. 9 General view of east elevation ground-floor room G03 showing fireplace with re-used lintel, inserted cloam oven and high-level cupboard. 2m scale. Looking east

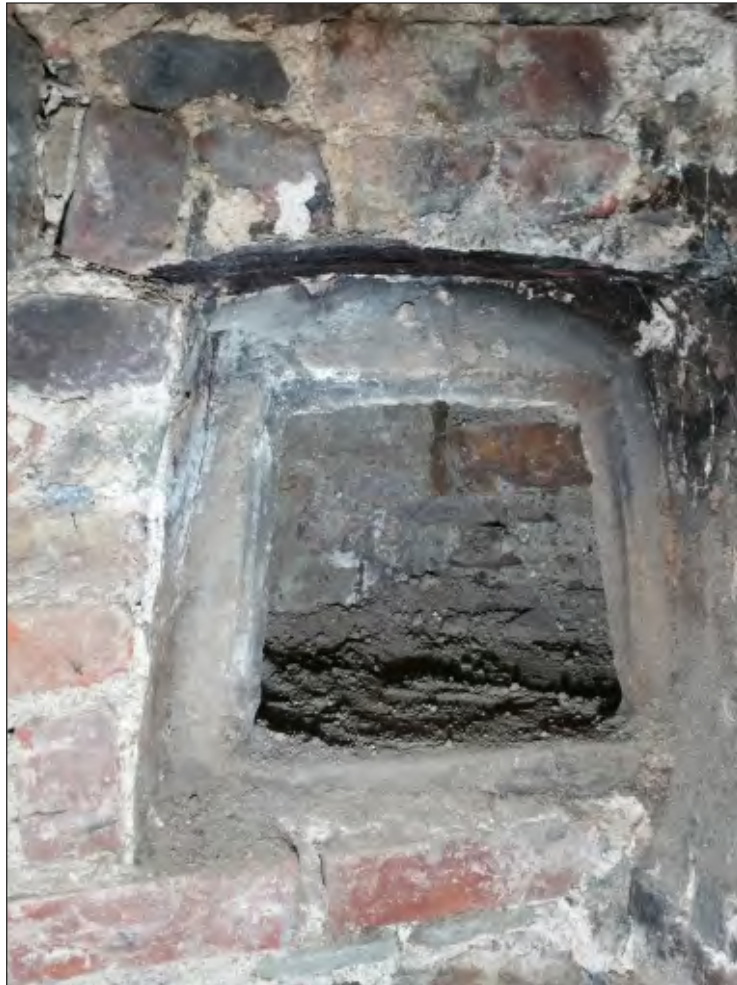
Pl. 10 Close-up view of cloam oven showing truncation at rear. Looking northeast.

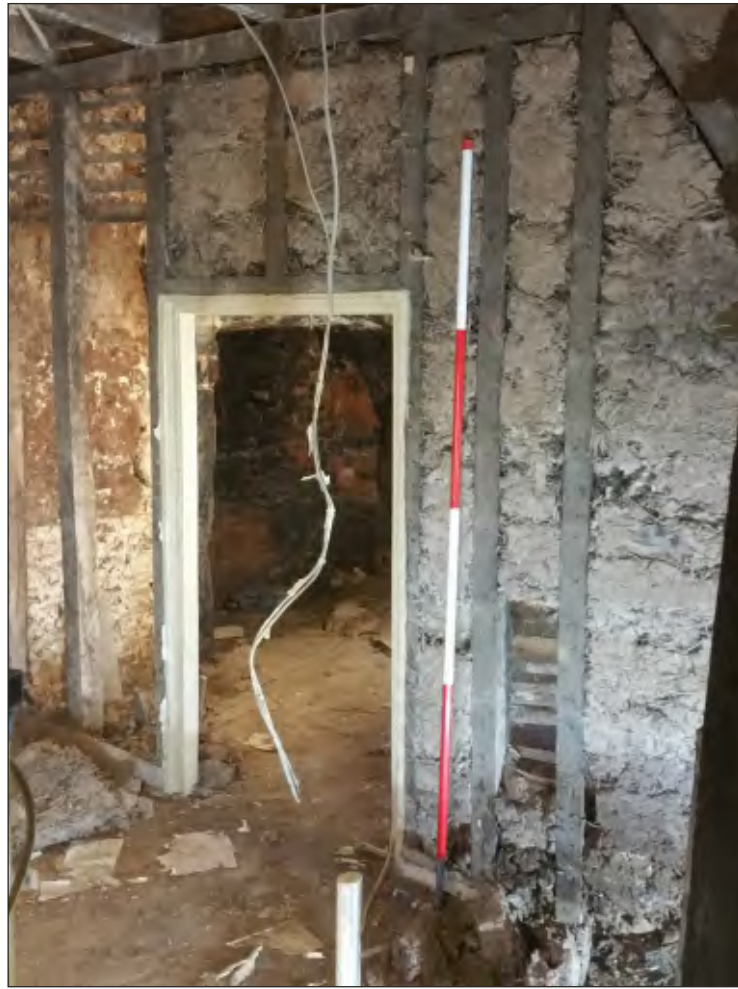
Pl. 11 General view of west elevation ground-floor room G06 showing doorway in cob-infilled partition with corridor G04. 2m scale. Looking southwest.

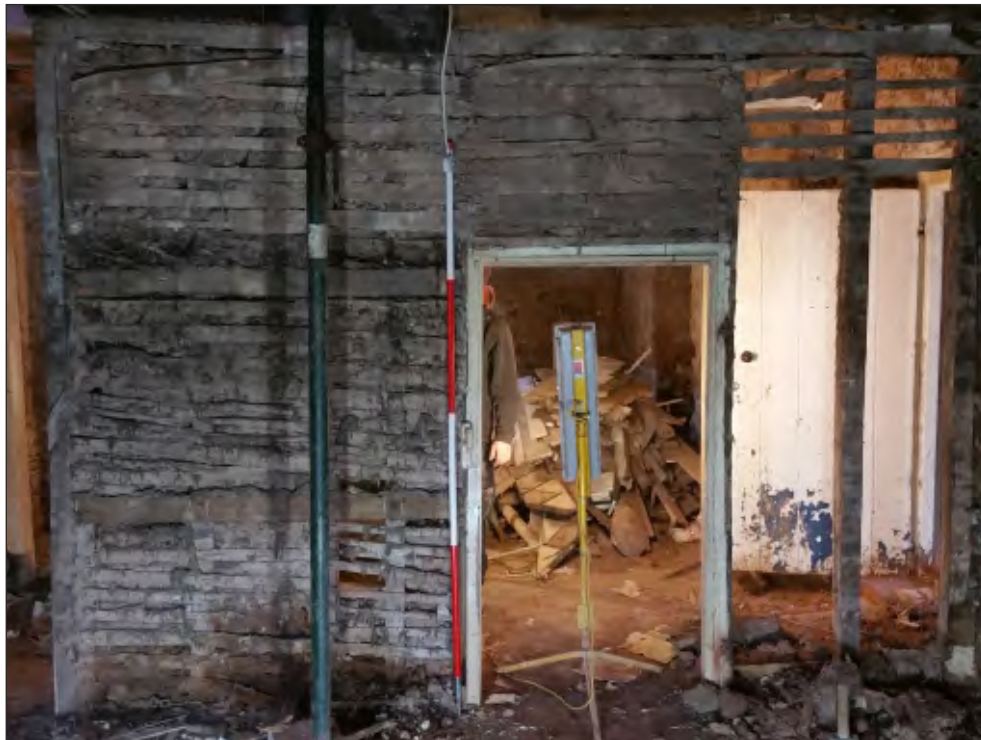
Pl. 12 General view of west elevation ground-floor room G06 showing doorway in cob-infilled partition with corridor G04. 2m scale. Looking west.

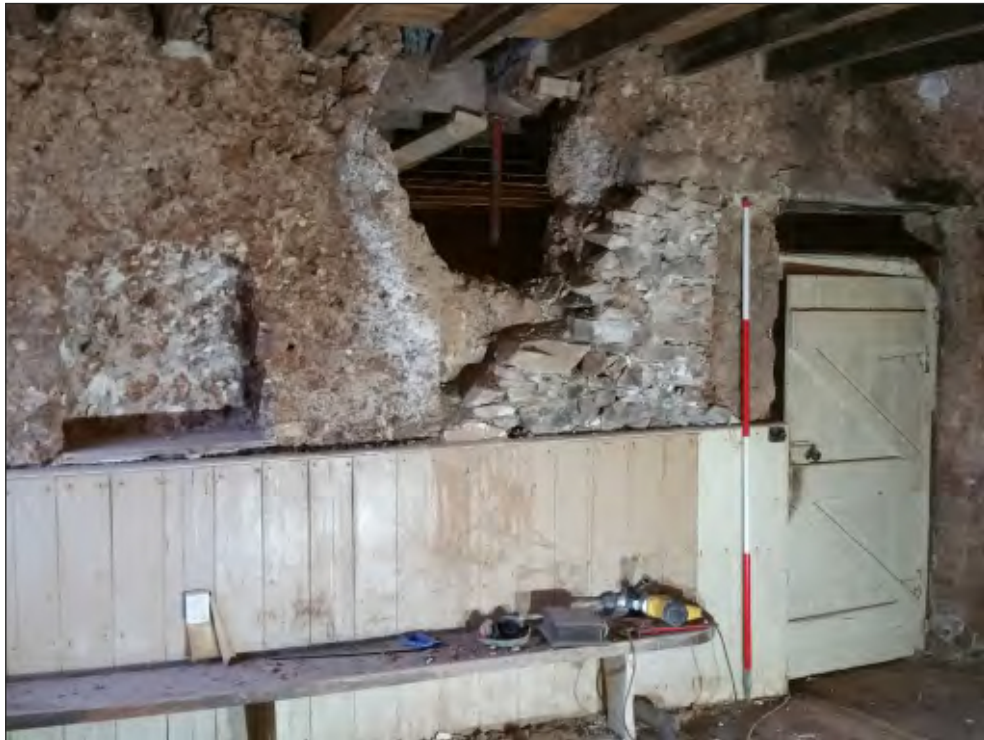
Pl. 13 General view of south elevation ground-floor room G06 showing doorway to room G03, infilled cupboard and later cupboard. 2m scale. Looking south.

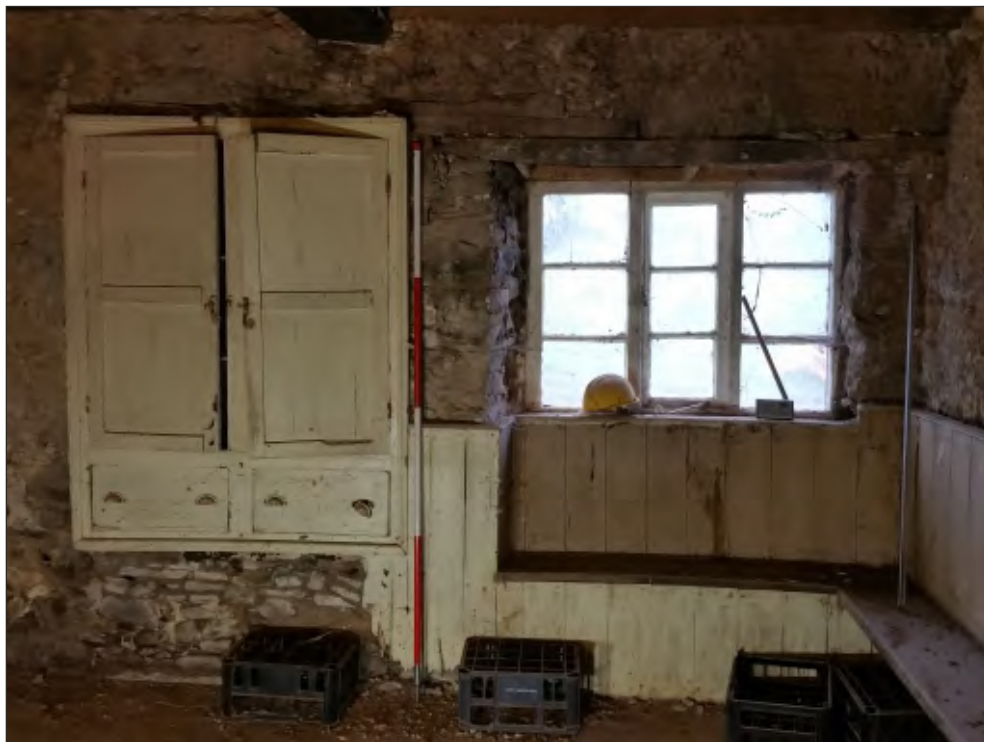
Pl. 14 General view of east elevation ground-floor room G06 showing cupboard inserted into blocked window, with current window inserted to right of blocking. 2m scale. Looking east.

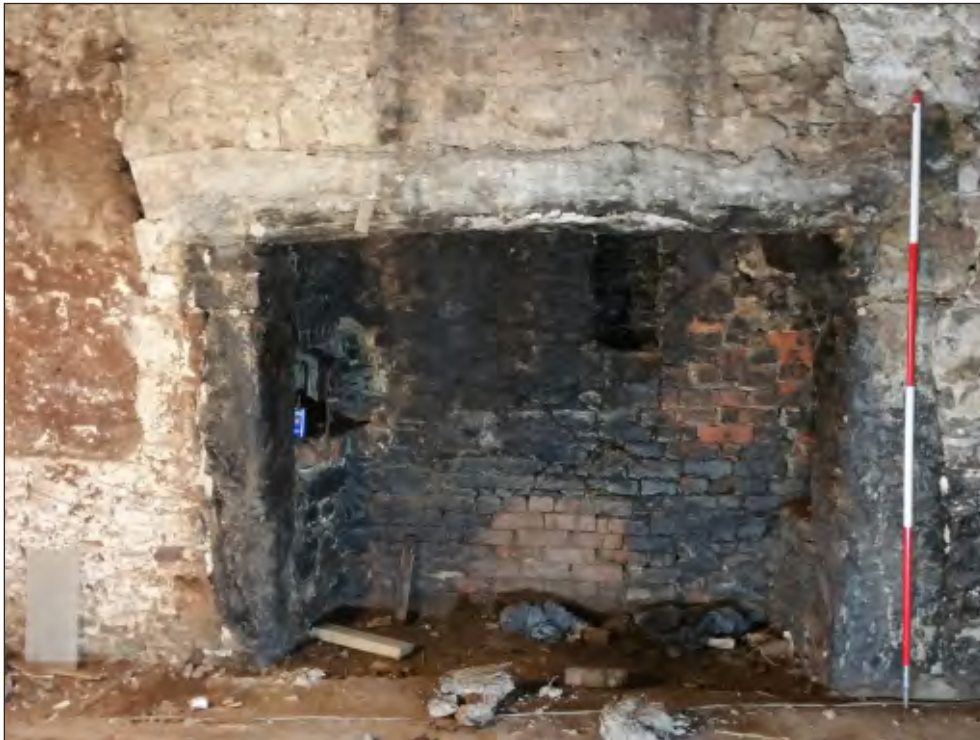
Pl. 15 General view of north elevation ground-floor room G06 showing large kitchen fireplace with bread oven. 2m scale. Looking north.

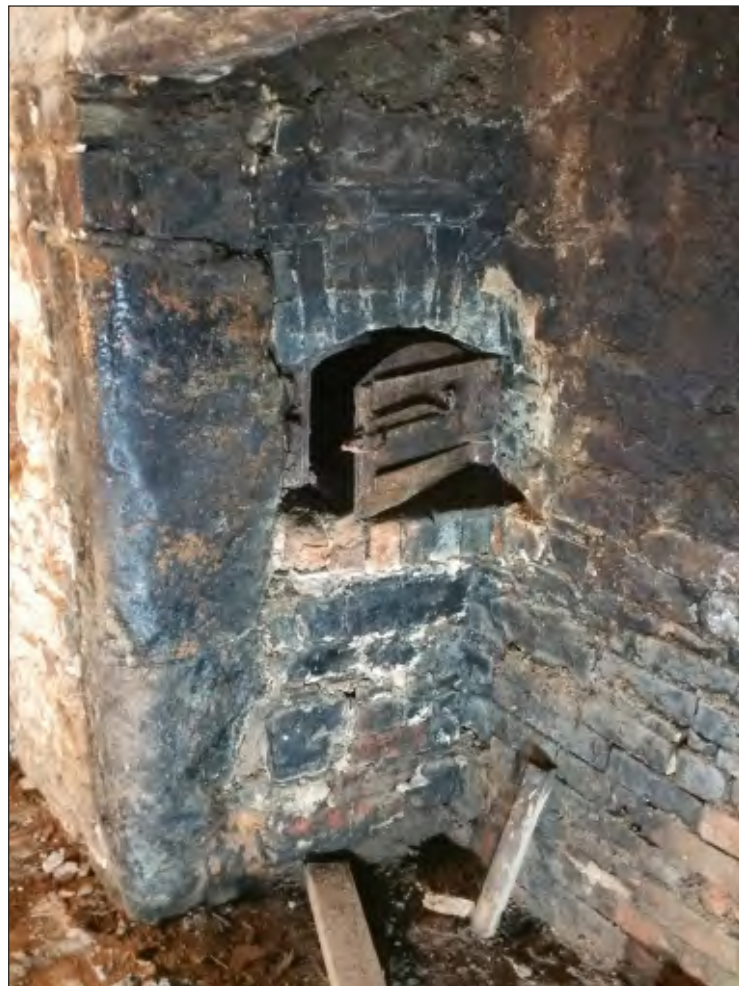
Pl. 16 Close-up of bread oven. Looking northwest.

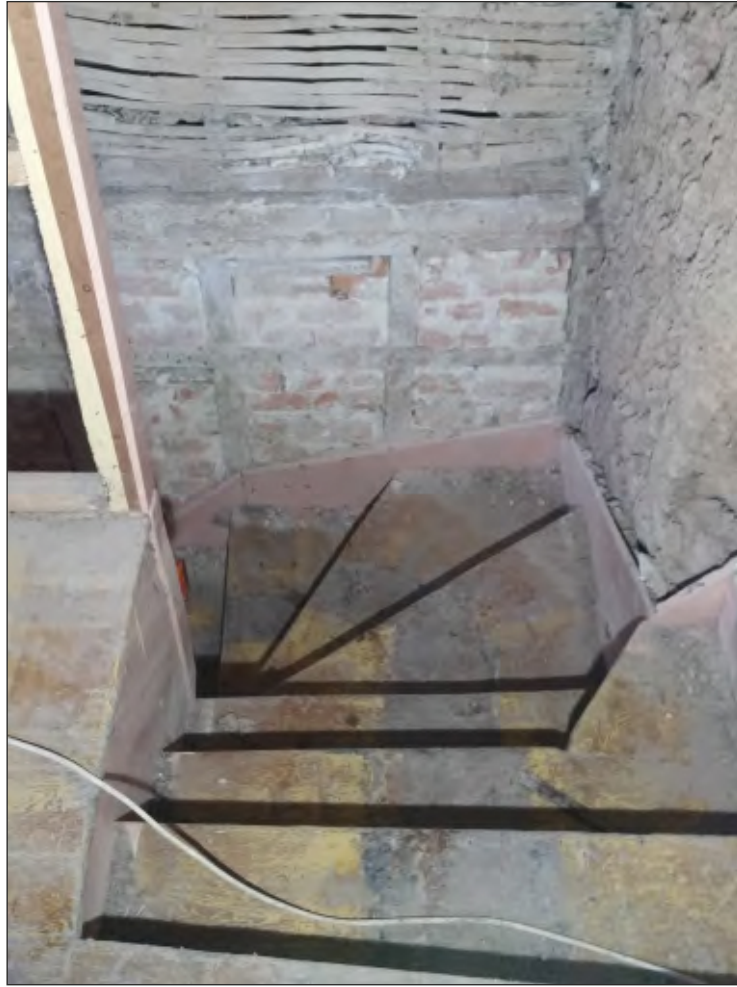
The first floor is accessed from the entrance lobby (G01) by the early 19th-century staircase (pl. 17) which terminates at a plain square newel post and two horizontal rails with stick balusters. This gives onto a small landing (F01) which provides access to all the rooms on the first floor. Originally much larger the landing has been subdivided in the late 19th or early 20th century by the insertion of a small room. This was subsequently converted to a bathroom. The room is lit by a single sash window in the south elevation, although the current window is a modern replacement and the landing, prior to its partition, was formerly lit by a sash window similar to the one in room G02.

Pl. 17 General view of main stair, landing F01. Looking west.

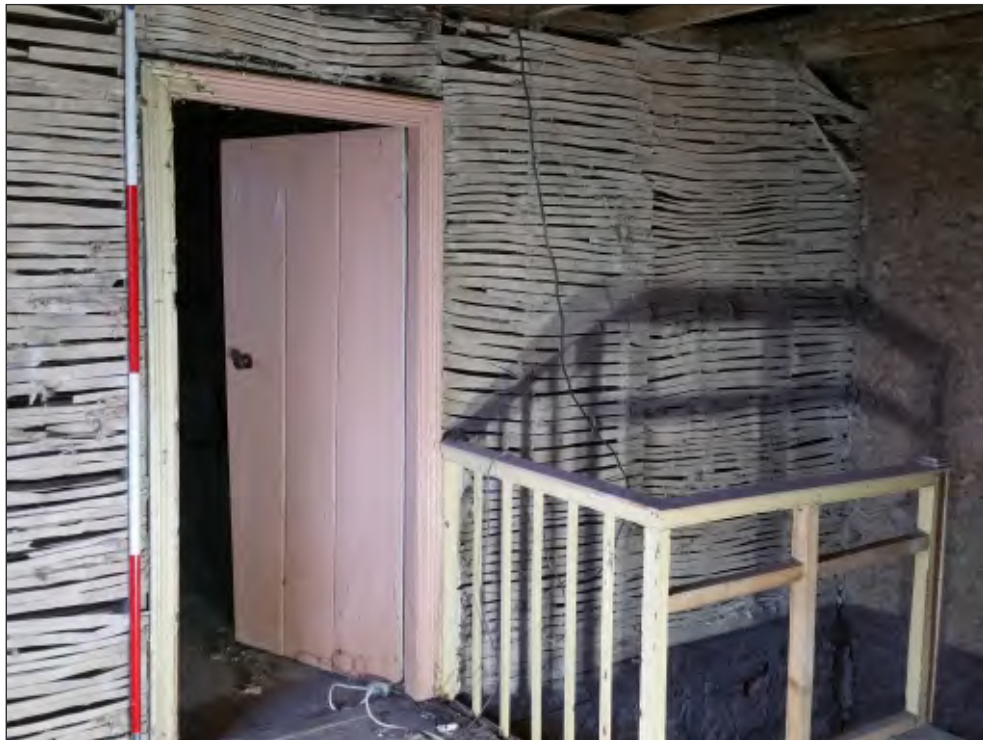
Pl. 18 General view of west elevation landing F01 showing doorway in partition. 2m scale. Looking northwest.

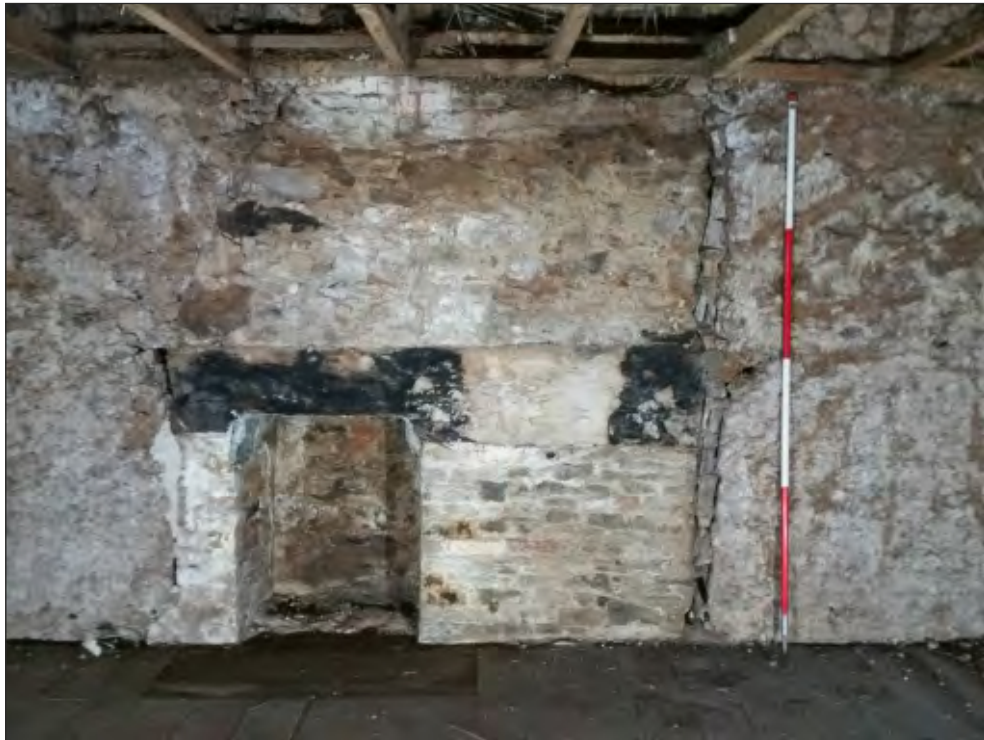
Pl. 19 General view of west elevation first-floor room F02 showing brickwork of small inserted fireplace. 2m scale. Looking west.

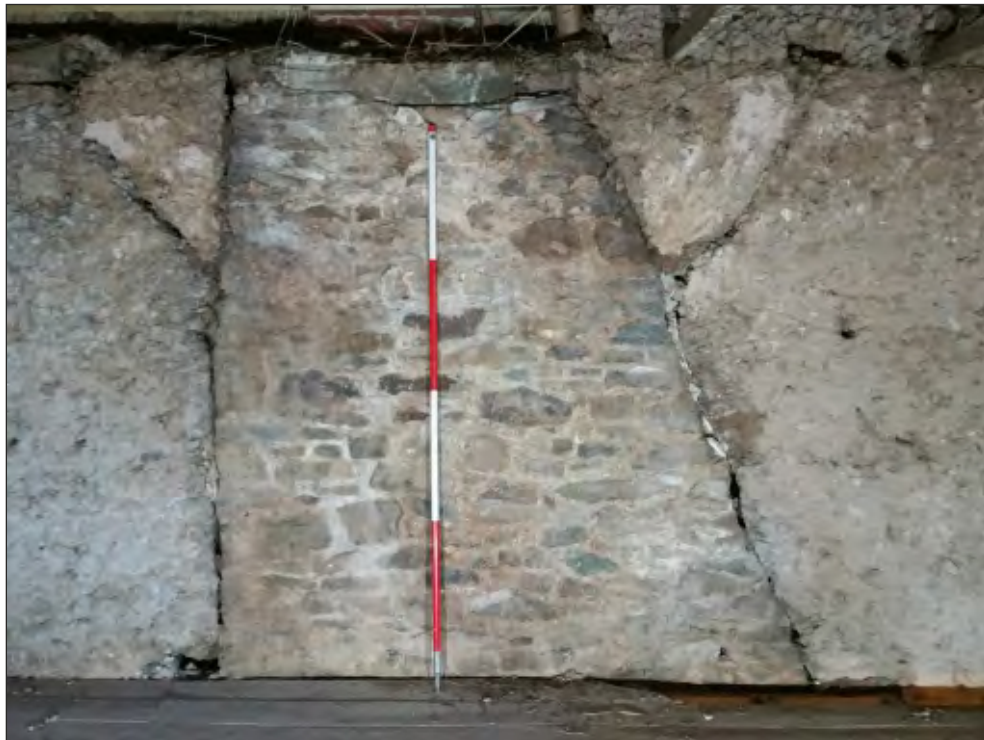
Pl. 20 General view of east elevation first-floor room F03 showing lack of fireplace. 2m scale. Looking east.

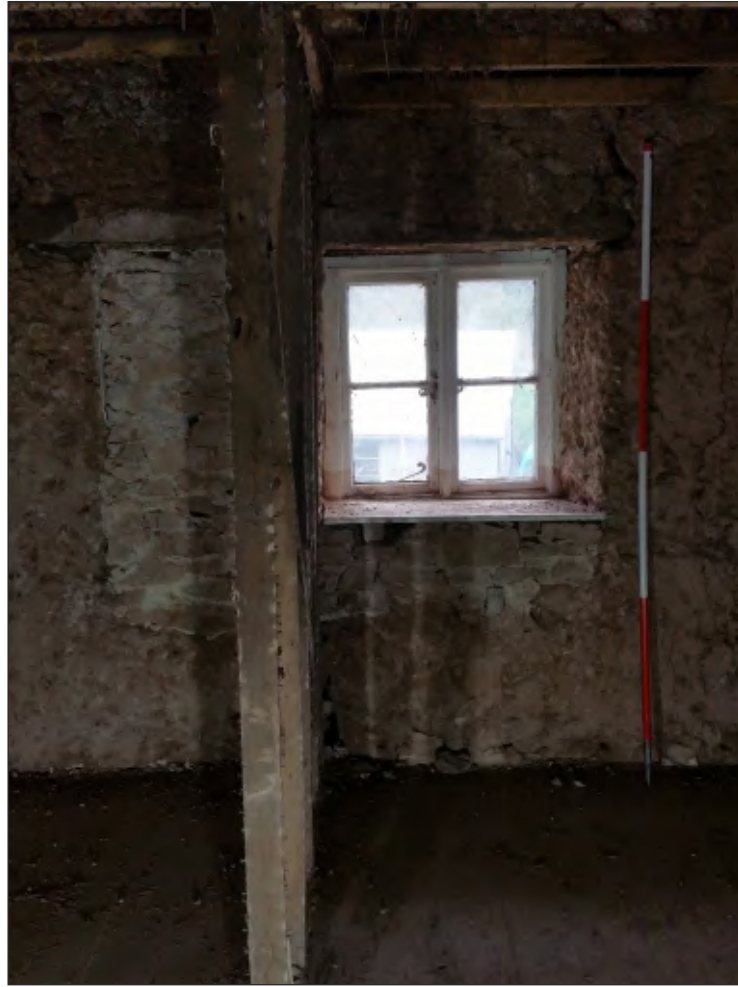
Pl. 21 General view of north elevation first-floor corridor F04 showing window insert through blocking contemporary with late 19th century partition. 2m scale. Looking north.

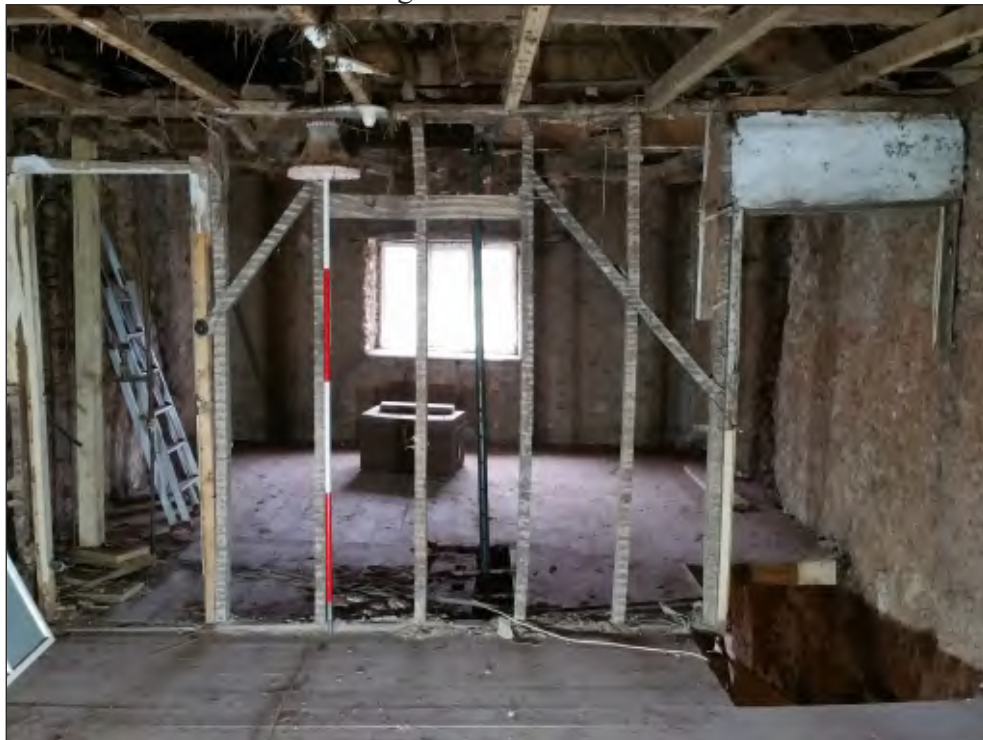
Pl. 22 General view of east elevation first-floor corridor F04. 2m scale. Looking east.

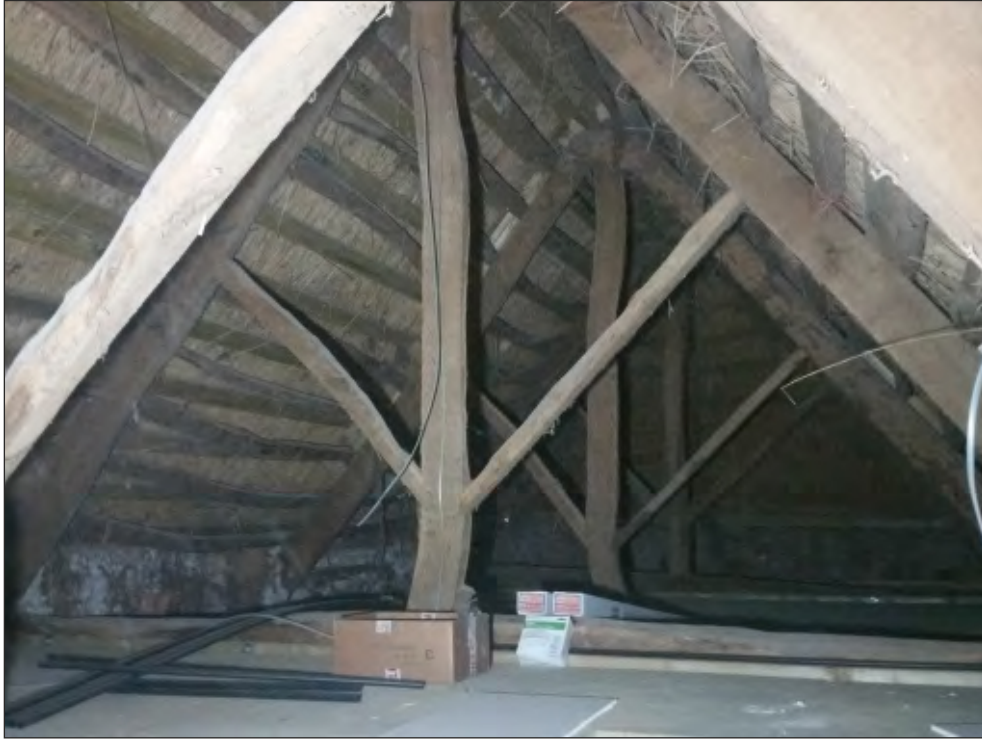
Pl. 23 General view of roof arrangement. Looking northeast.

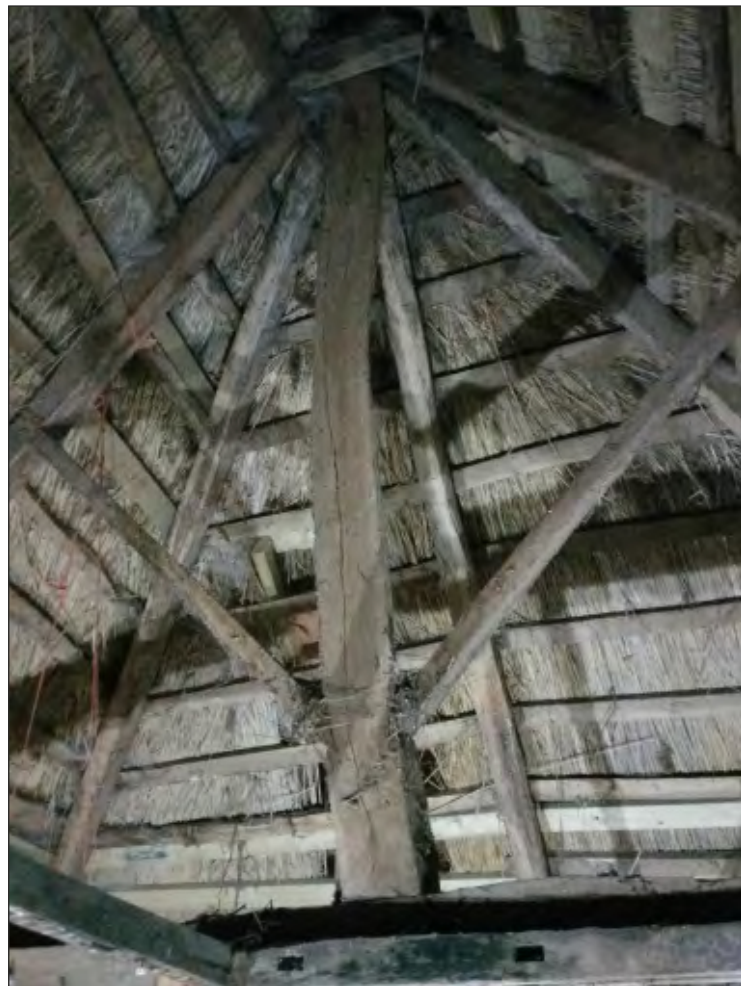
Pl. 24 General view of hip roof arrangement showing reused wall plate timber. Looking east.

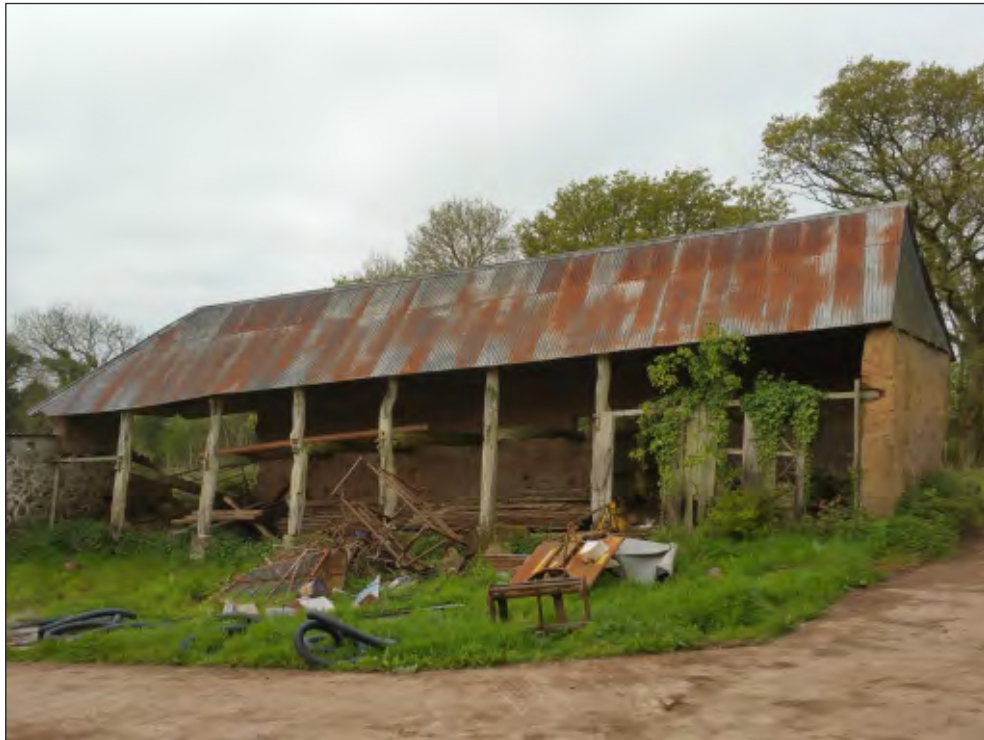
The absence of earlier building phases, the re-use of timber within the main house and the presence of burnt timbers within the linyhay to the north (pls. 25-26) supports the suggestion that the earlier building burnt down.

Pl. 25 General view of Linhay to north of Abbotsham House. Looking west.

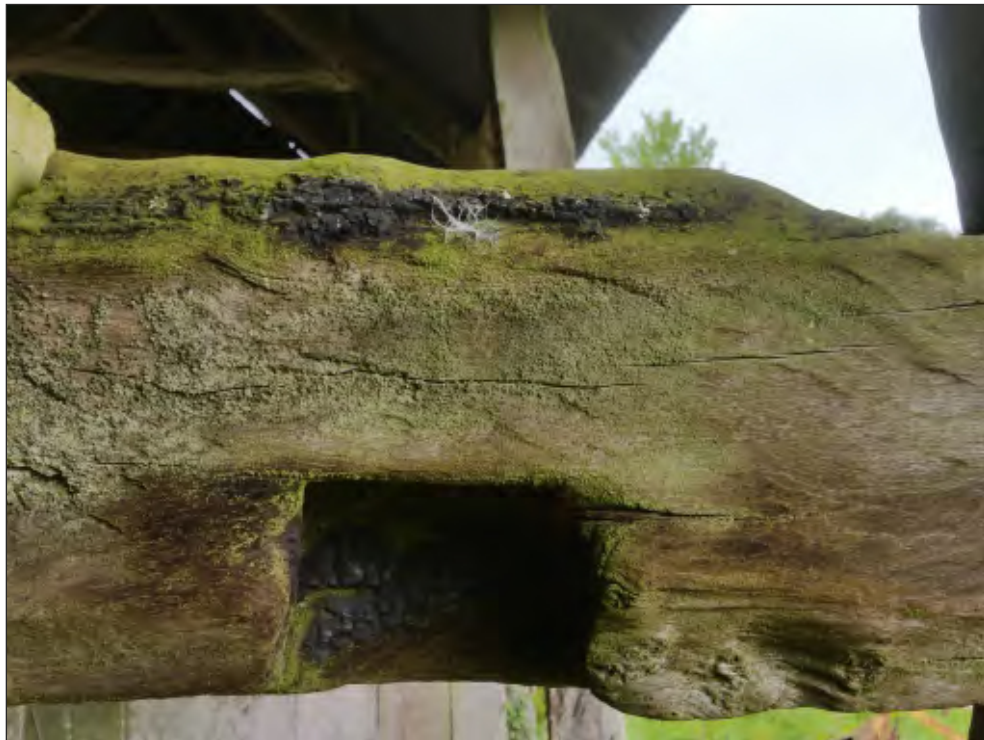
Pl. 26 Close-up of re-used timber within Linhay showing traces of burning. Looking north.
