## Dartmoor National Park Historic Environment Record

Civil Parish & District:  Holne, Dartmoor	Refer	nal Grid ence: 80 6916	Number:
Subject: Archaeological monitoring and recording Holne, Devon.			Photo attached:
Planning Application no: 0132/17		Recipient museu n/a	m:
OASIS ID: oakforda1-298533		Museum Accessi n/a	on no:
Contractor's reference number/code: OA1436		Dates fieldwork 28/09 and 02/10/2

An archaeological watching brief was undertaken by Oakford Archaeology between September and October 2017 during building work at Shuttaford Farm, Holne, Devon (SX 7180 6916). The site (Fig. 1) is located to the west of the Grade II Listed farmhouse. The layout of the building perpetuates that of an earlier house which was first constructed as a three room and cross-passage house in the 16<sup>th</sup> century, with a later 17<sup>th</sup> century parlour wing and porch, and 20<sup>th</sup> century alterations. The work therefore had the potential to expose and destroy archaeological and artefactual deposits associated with this activity and was therefore required by the Dartmoor National Park Authority (DNPA).

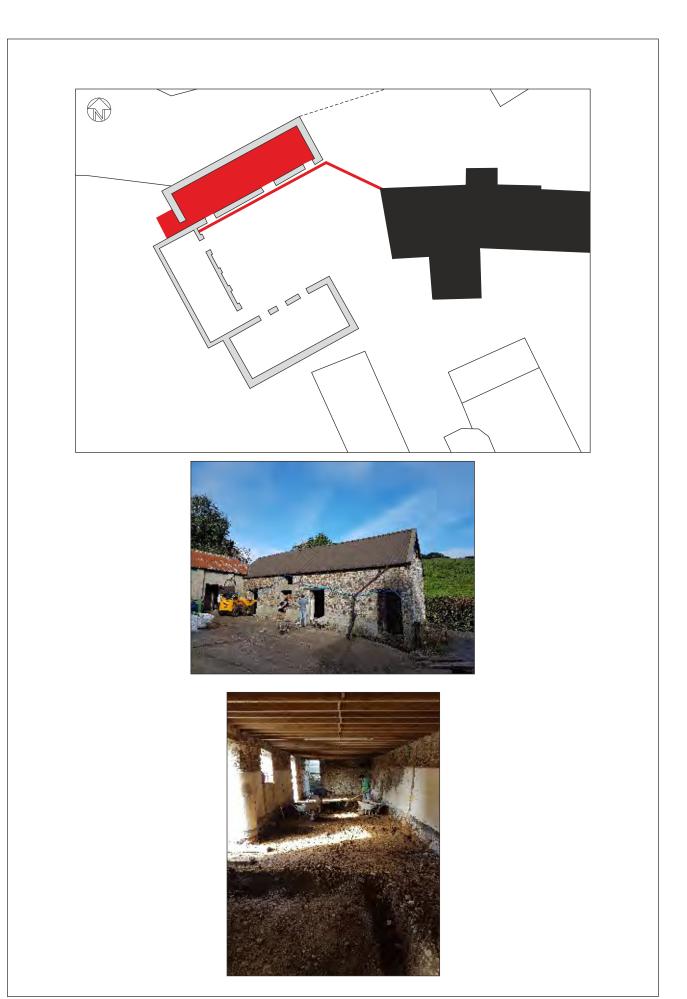
The removal of concrete floor exposed elements of an earlier cobbled surface (Fig. 2, pl. 1-2) inside the barn. Unfortunately, the modern concrete floor had been poured directly on top of the earlier surface resulting in its complete removal. The cobbled surface consisted of medium size worn stones on a bed of sand that overlay the natural subsoil. The barn is shown for the first time on the 1889 1<sup>st</sup> edition Ordnance Survey map and although no finds were recovered during the works it is likely that the floor is late 19<sup>th</sup> century in date.

Fig. 2 Plan showing location of observations and photos showing barn (top) and reduced area (bottom).
