Devon County Council Historic Environment Record

Civil Parish & District:	National Grid Reference:		Number:
Newton Poppleford and Harpford, East Devon	SY 0856 8971		
Subject: Archaeological monitoring and recording St Luke's Church, Newton Poppleford, D	_	borehole survey at	Photo attached:
Faculty no:		Recipient museu n/a	m:
OASIS ID: oakforda1-298635		Museum Accession no: n/a	
Contractor's reference number/code: OA1421		Dates fieldwork 06/07/2017	undertaken:

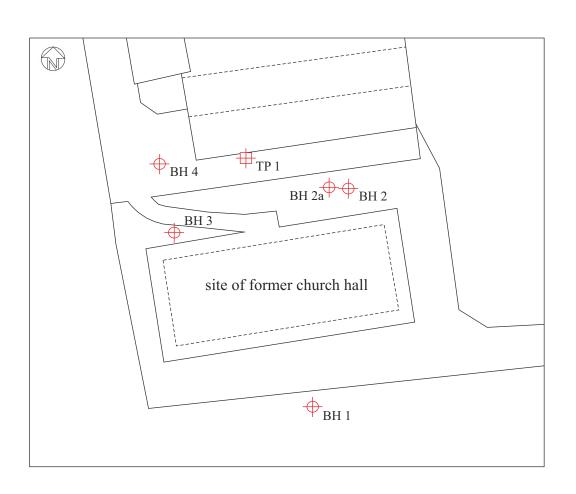
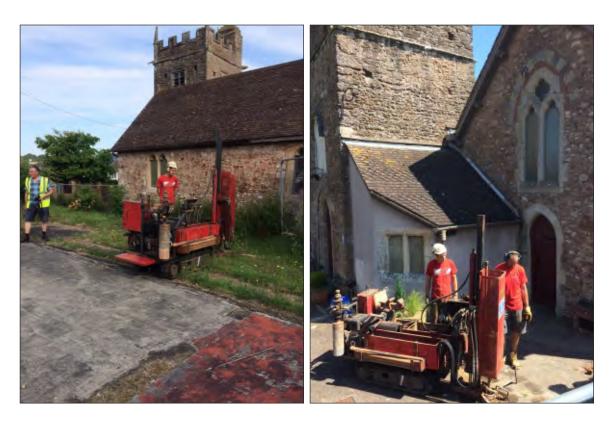
Fig. 2 Plan showing location of observations and photos showing drilling of borehole 2 (left) and borehole 4 (right).

A watching brief was maintained during the drilling of five boreholes, using a mini-tracked percussive auger rig, and a single test pit (Fig. 2, pl. 1-2). One (borehole 1) was located in the car park to the south of the site of the former church hall, three were located immediately to the north of the former church hall (boreholes 2-3) while one (borehole 4) was located to the southwest of the church. The single test pit was excavated against the south wall of the south aisle.
