OAKFORD
ARCHAEOLOGY

Archaeological monitoring and recording at St Alban's, Beaworthy, Devon

Report No. 17-16

November 2017

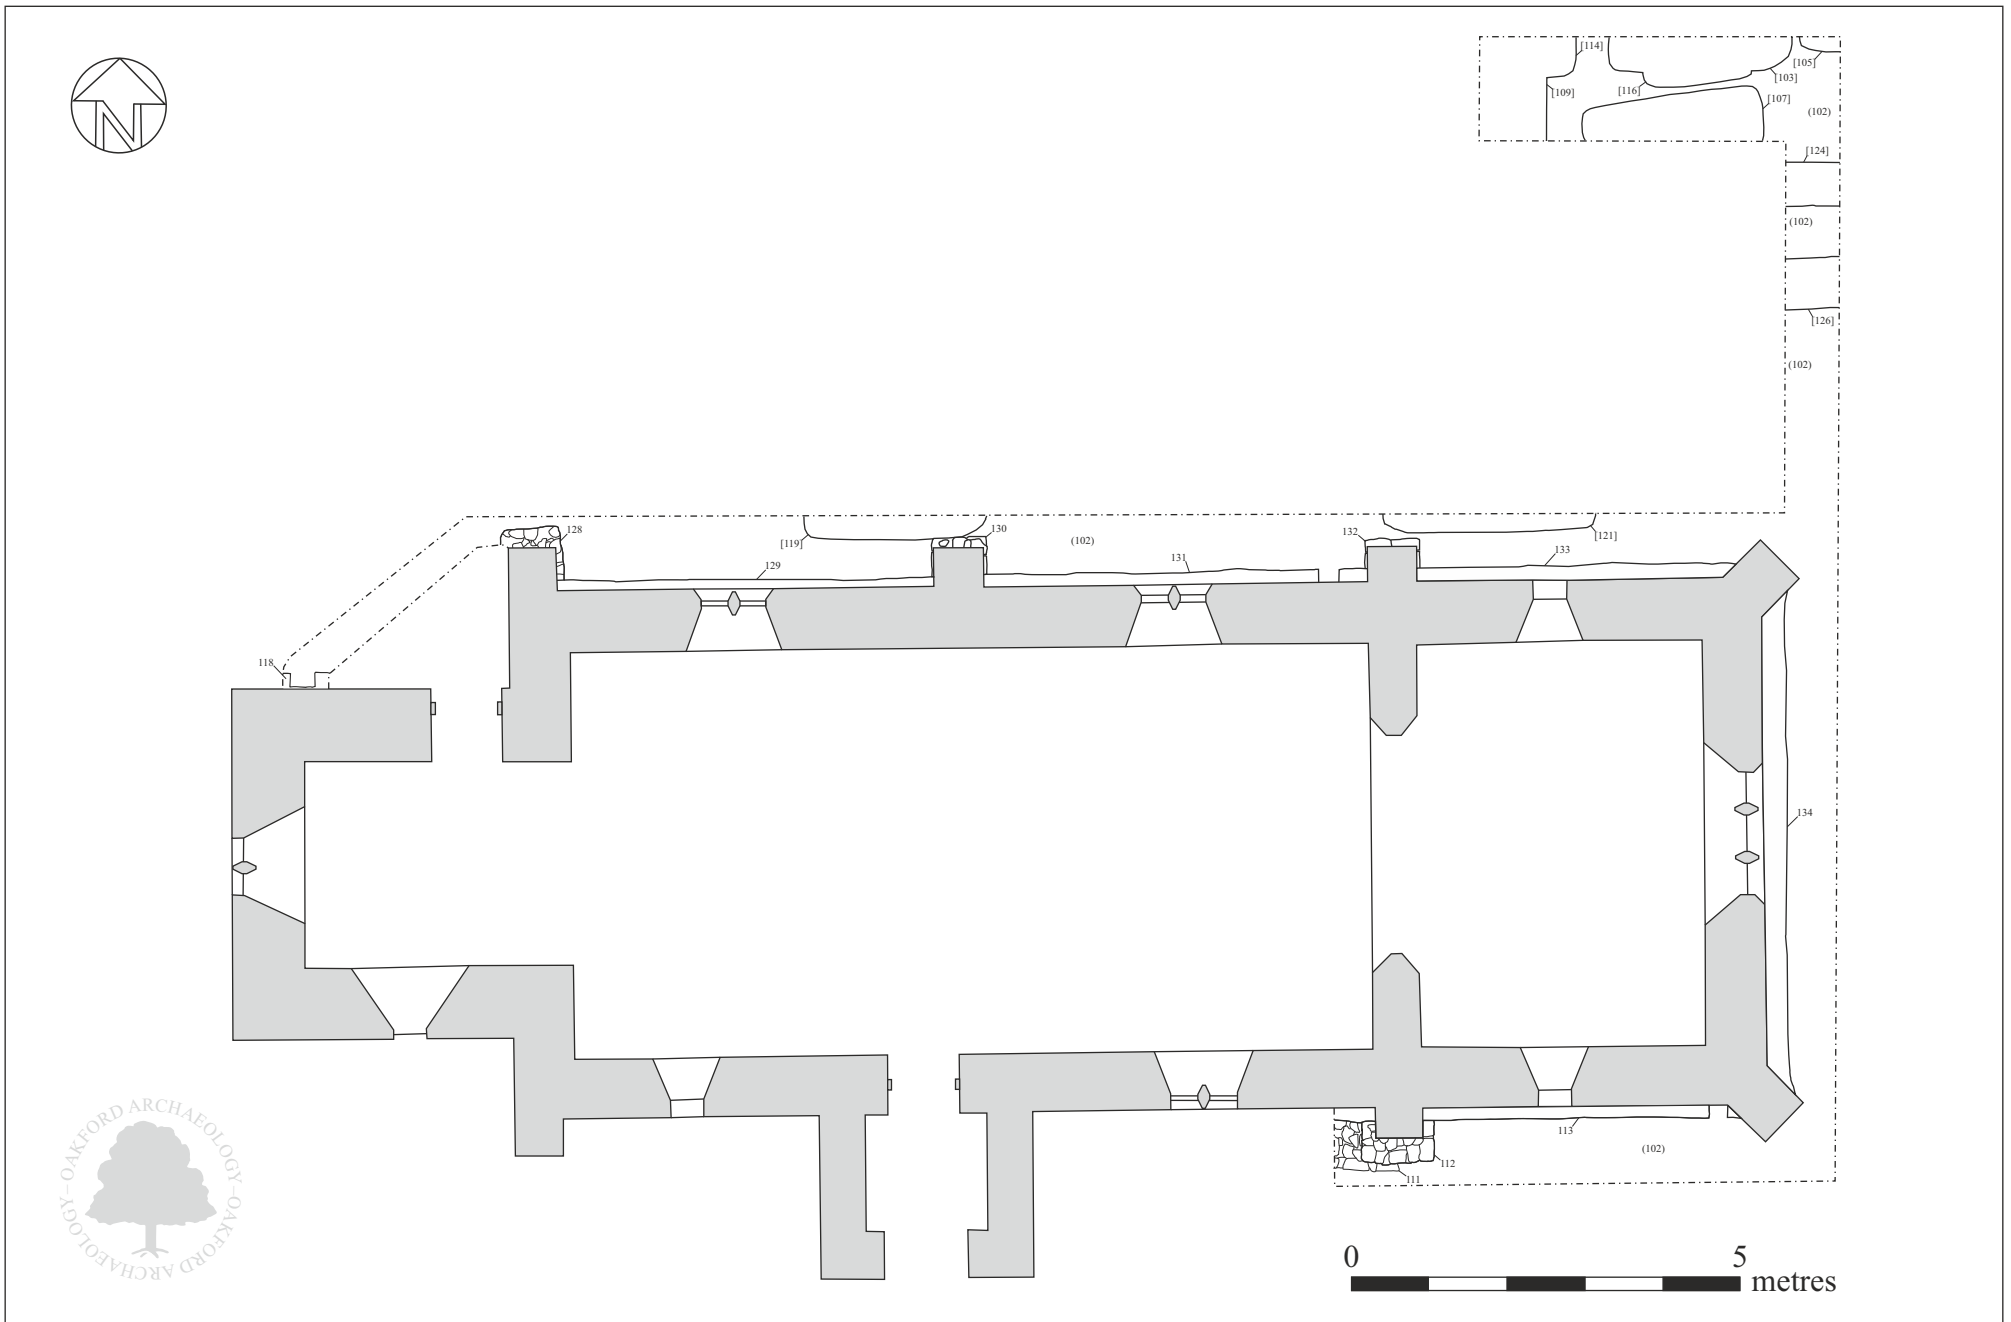
Fig. 5 Plan showing location of observations.

A watching brief was maintained during works to improve the drainage around the exterior of Beaworthy church (Fig. 5). The work involved ground reduction extending to a depth of between 0.5-1.5m in the graveyard.

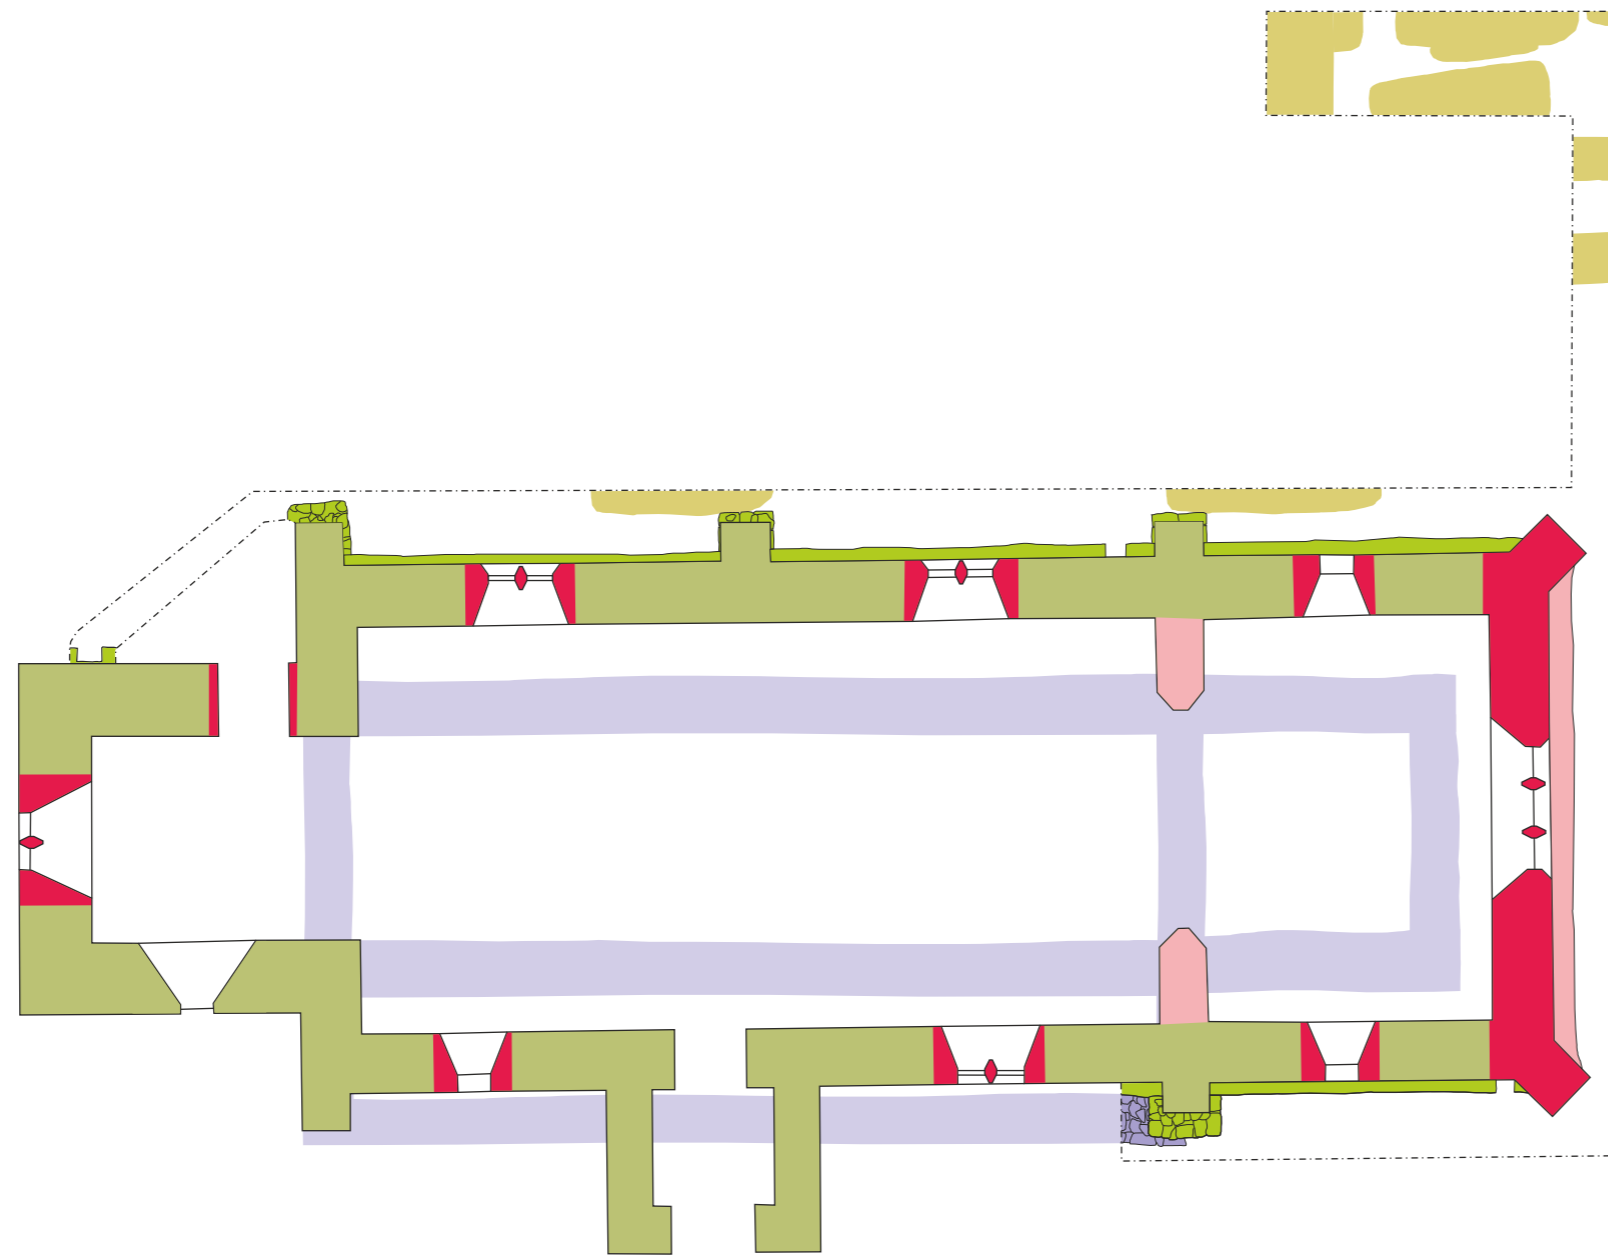
Fig. 6 Plan showing principal features identified and suggested phases of development.

Phase 1. No evidence of the Anglo-Saxon church was uncovered during the works, and the earliest building phase has been dated to the 12th-13th century on the basis of the architectural fragments re-used in the south door. The two imposts with heads and two fragmentary possible capital tops, decorated with squares with diagonals across and dots in the triangular cells between the diagonals, clearly date to the Norman period. With regards to the latter, similar decorative detail can still be seen on two capitals built into the wall of the aisle at the church of St James, Bondleigh (pl. 19).

Phase 2. The recent work suggests that the current church was completely rebuilt sometime in the 14th or early 15th century. The new parish church was planned on a great scale, with a large nave, a chancel and a large tower at the west end. The foundations of the new church were consistent throughout the excavations, consisting of clay-bonded stone rubble. Some Romanesque architectural elements, such as the two imposts and capital heads were reset within the new building, perhaps in order to display and affirm the antiquity and importance of the church.

Phase 3. By the late 19th century the most drastic alterations were undertaken. Close inspection of the external fabric of the building suggests that the works of 1871 included the rebuilding or raising of the nave and chancel wall heads, construction of a new roof, rebuilding of the east end of the church and the replacement of all the windows. Further alterations to the fabric of the building included the insertion of a new doorway in the north wall of the tower, while the window in the south elevation is probably contemporary with the construction of the tower in the 14th century. Although the current windows may be based on their medieval predecessors no original tracery survives and all the windows were re-glazed in the 19th century.

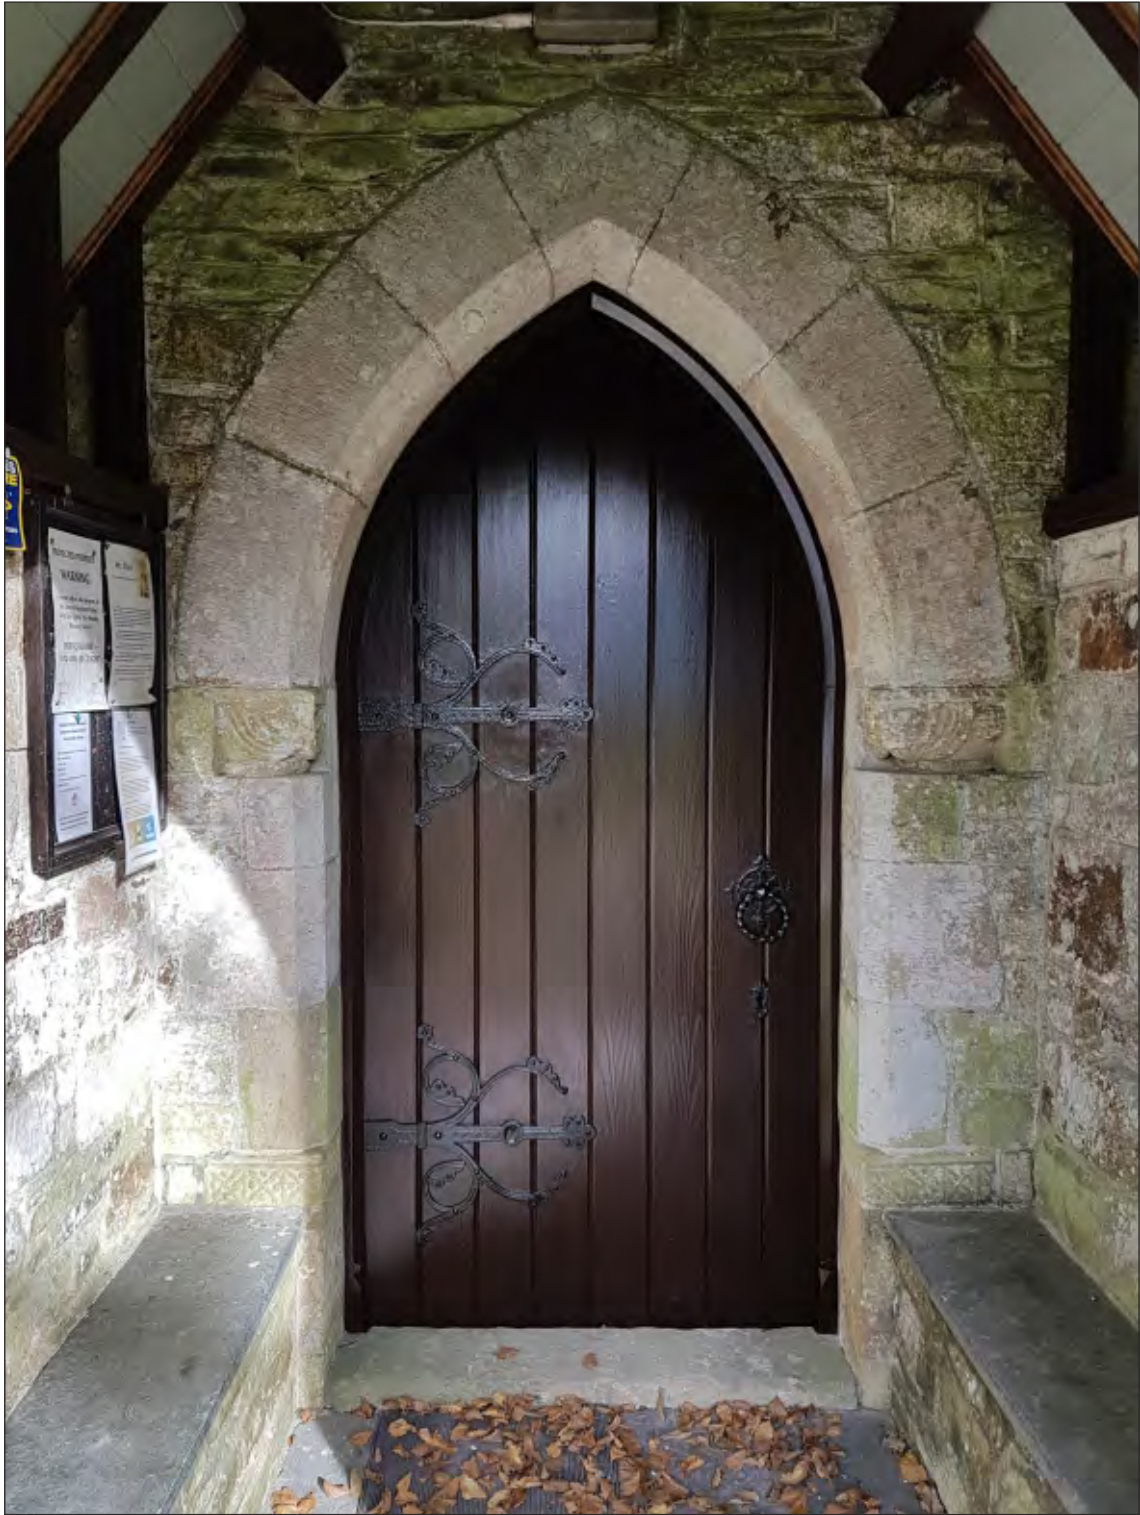
Pl. 3 General view of south doorway showing two Norman impost blocks (middle) and remains of capitals (bottom). Looking north.

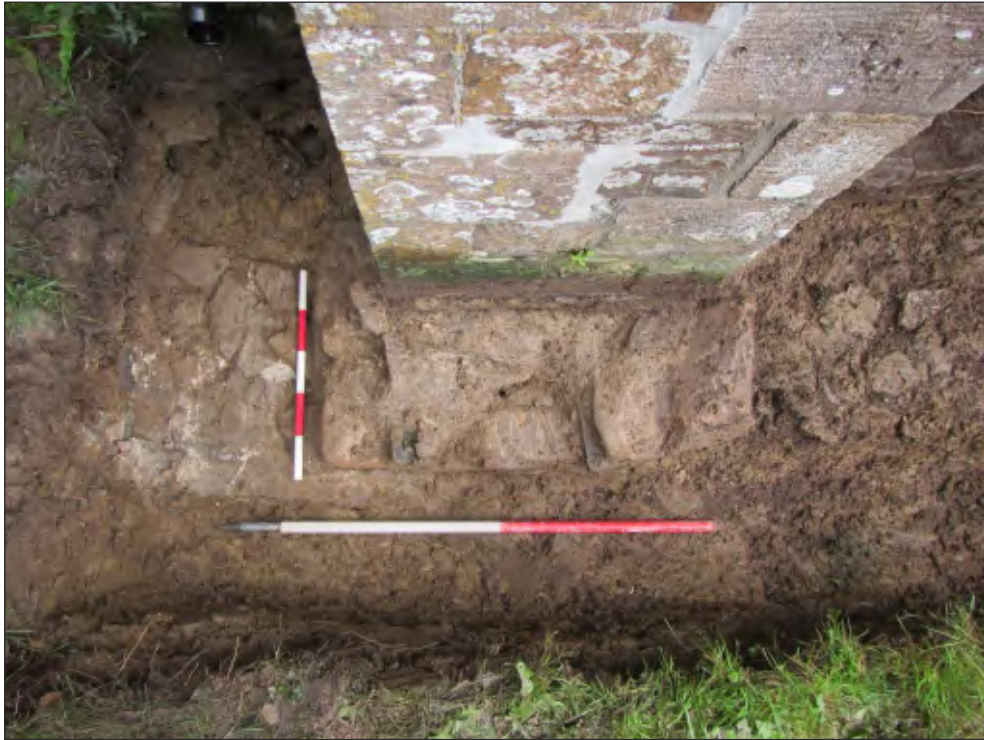
The excavations on the south side uncovered the remains of an E-W aligned foundation (111). Consisting of limestone rubble bonded with greyish white lime mortar this was approximately 0.59m wide, at least 0.45m high and had been cut into the underlying natural subsoil. This was in turn overlain by the foundation of a buttress (112). This consisted of sandstone and limestone rubble with occasional slate packing and bonded with light to mid-greyish yellow lime mortar. The footing butted up against the foundations of the south nave wall (113). These consisted of clay bonded limestone rubble.

Pl. 8 Close-up showing butters foundation (112) overlying early foundation (111). 0.5m and 1m scale. Looking north.

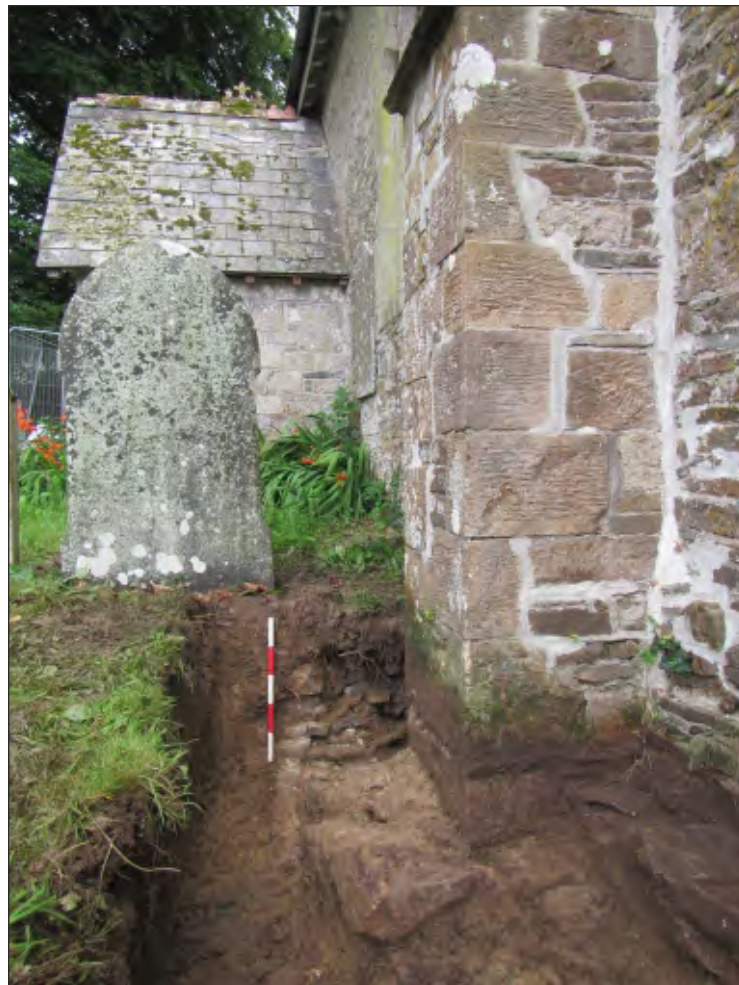
Pl. 9 General view of early foundation (111). 0.5m scale. Looking northwest.

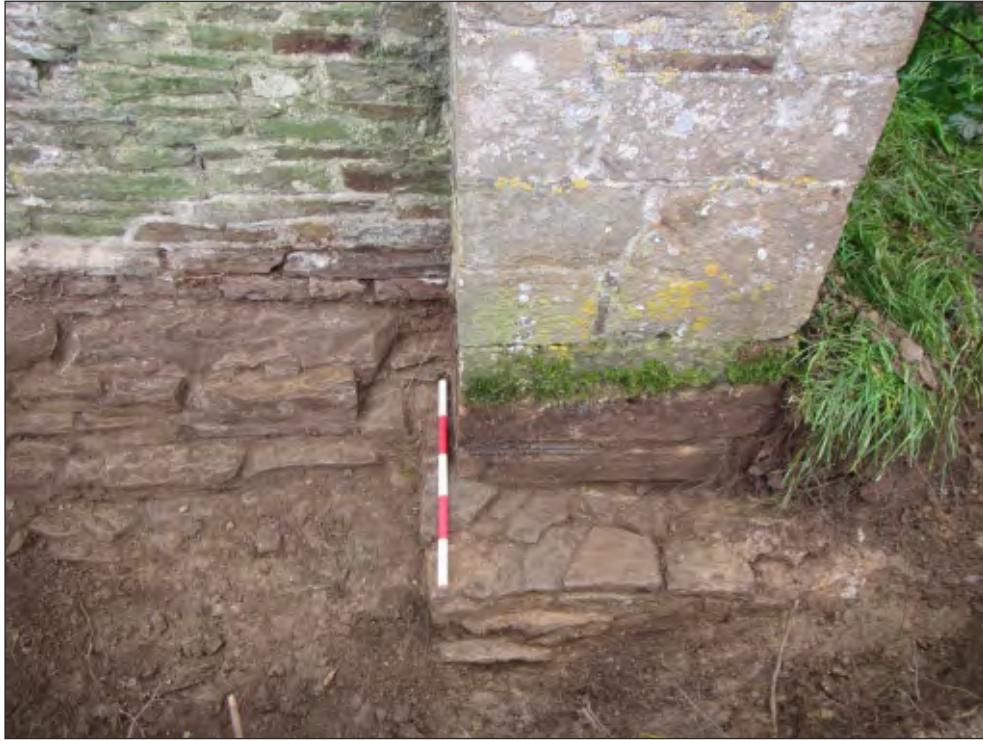
Work on the north side uncovered the foundation of the northern nave wall (129, 131 and 133). This consisted of clay bonded limestone rubble and was identical to the foundations of the tower (118). The foundations of the three buttresses, truncated to varying degrees by later graves, consisted of sandstone and limestone rubble with occasional slate packing and bonded with light to mid-greyish yellow lime mortar.

Pl. 10 General view of foundation of north wall and buttress. 0.5m scale. Looking south.

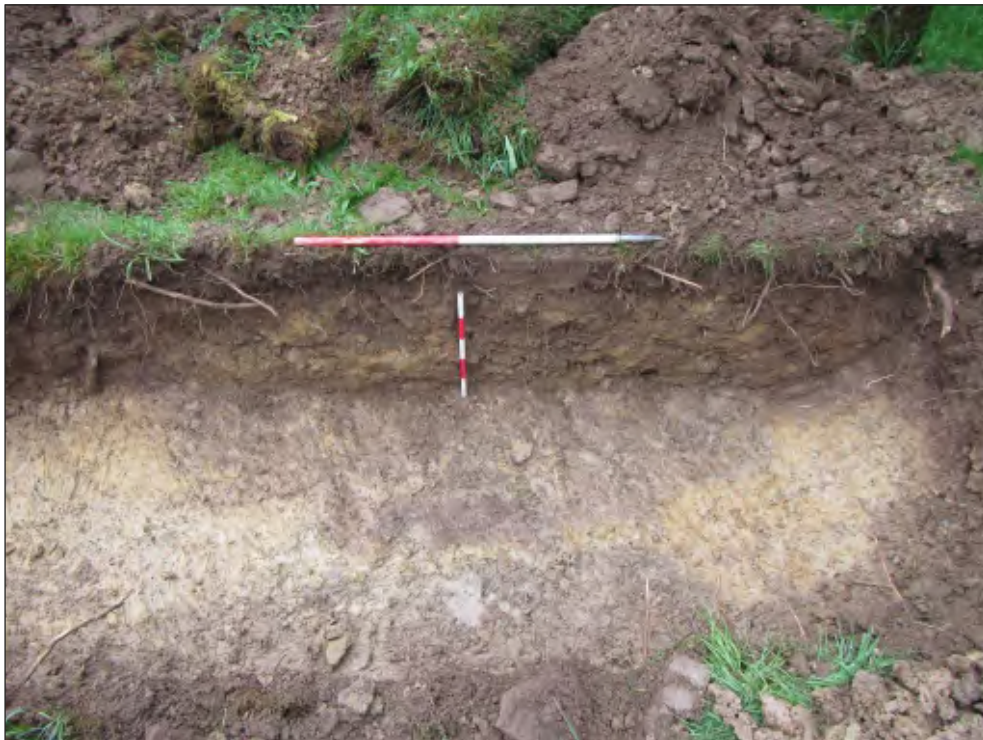
The trench for the new drainage was excavated over a distance of approximately 40m along the south, east and north side of the church. The work uncovered a generally uniform layer sequence of dark brown clay loam topsoil (100) overlying a light grey-brown clay loam (101) and light yellow silty clay natural subsoil (102). The former contained occasional fragments of disarticulated human bone and has been interpreted as a charnel soil. No distinct grave cuts were identified during the works on the south and east side of the church, while the partial outline of 10 graves were identified on the north side.

Pl. 11 General view of graves [103], [105], [107], [109], [114] and [116] in area of soakaway. 0.5m and 1m scales. Looking north.

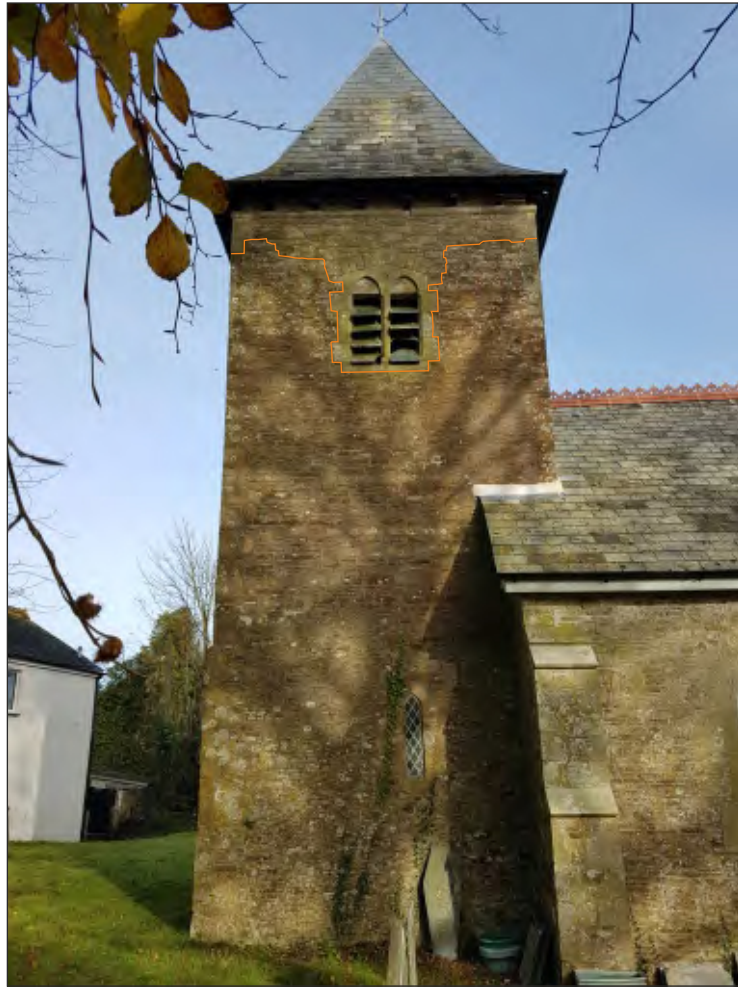
Pl. 12 General view of church tower showing 19th century rebuild (top). Looking north.

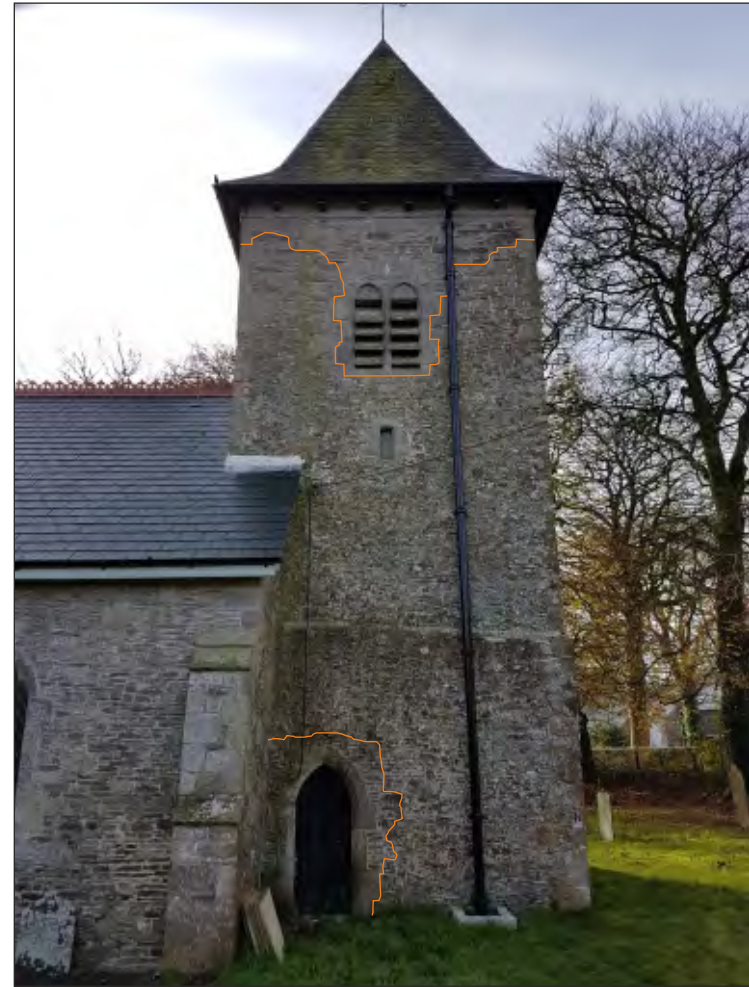
Pl. 13 General view of church tower showing 19th century rebuild (top) and door insert. Looking south.

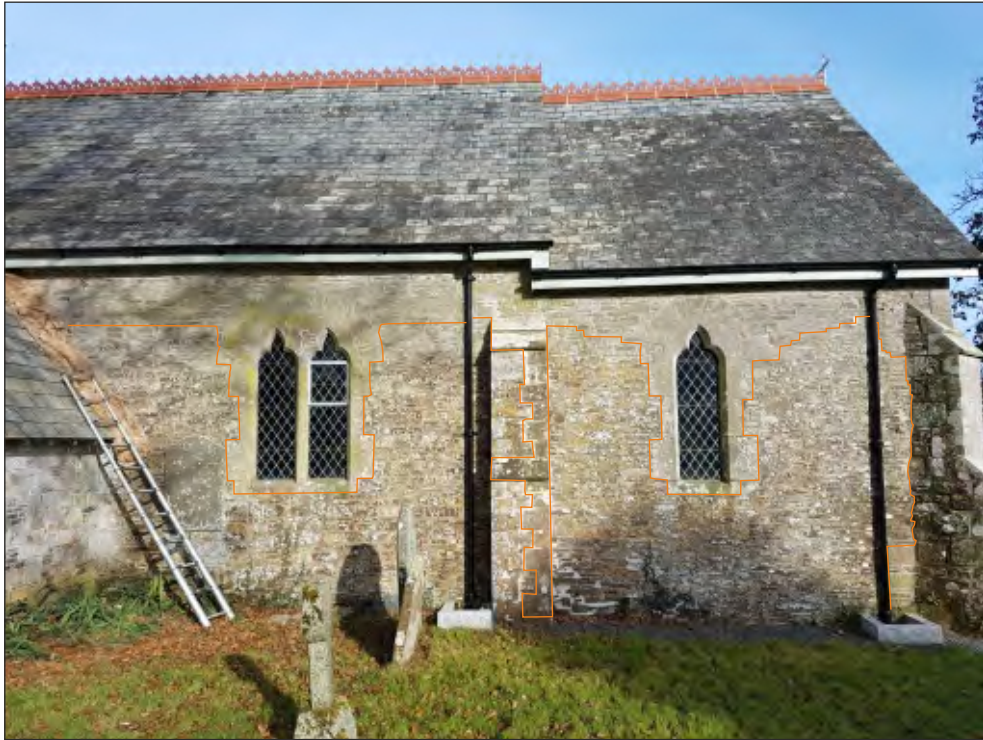
Pl. 14 General view of south elevation showing sections rebuilt in the late 19th century. Looking north.

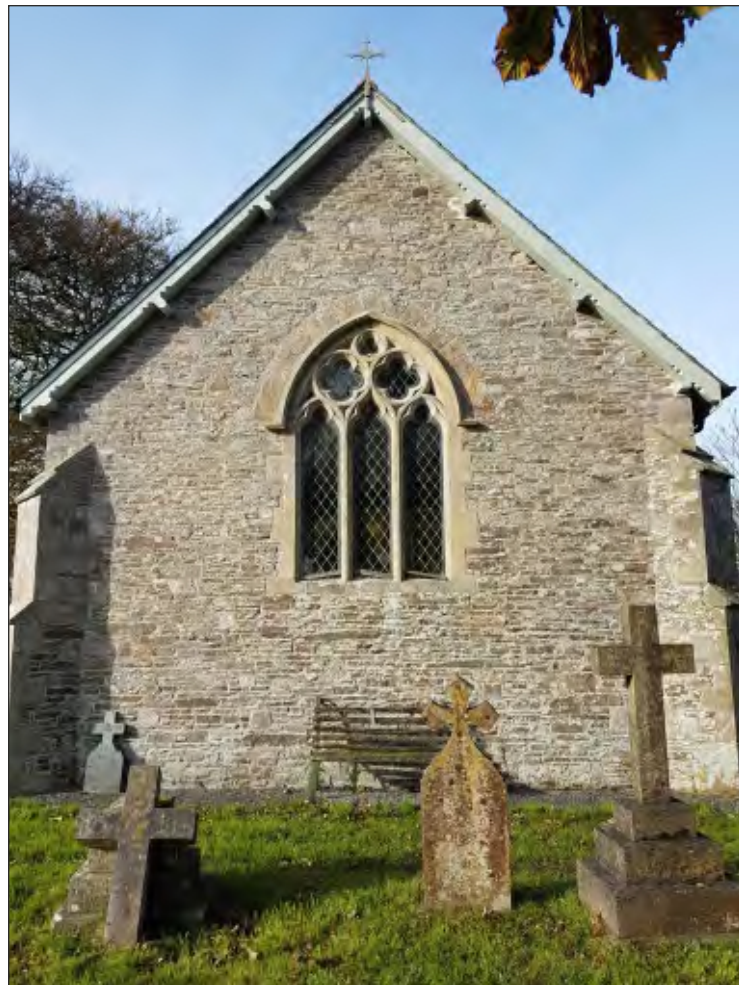
Pl. 15 General view of east end as rebuilt in 1871. Looking west.

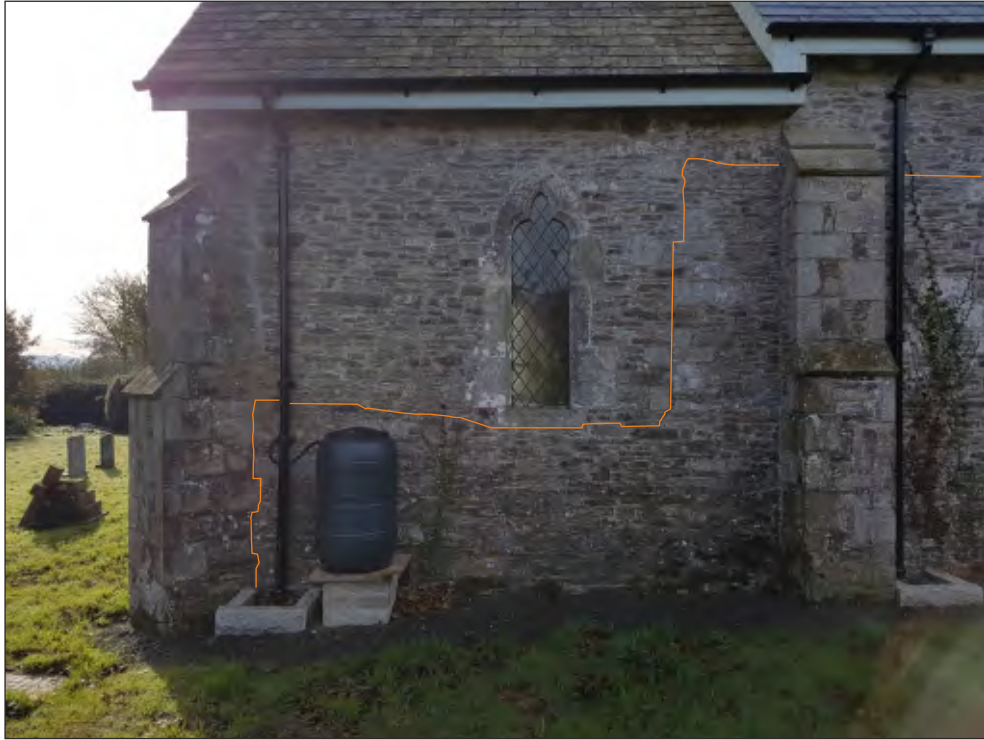
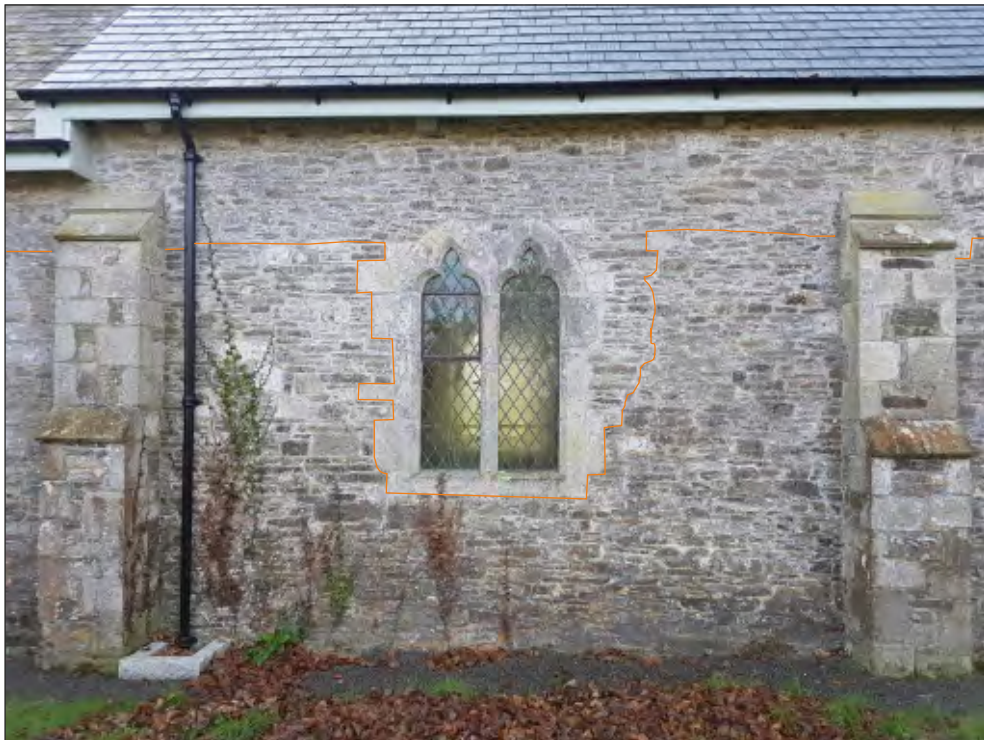
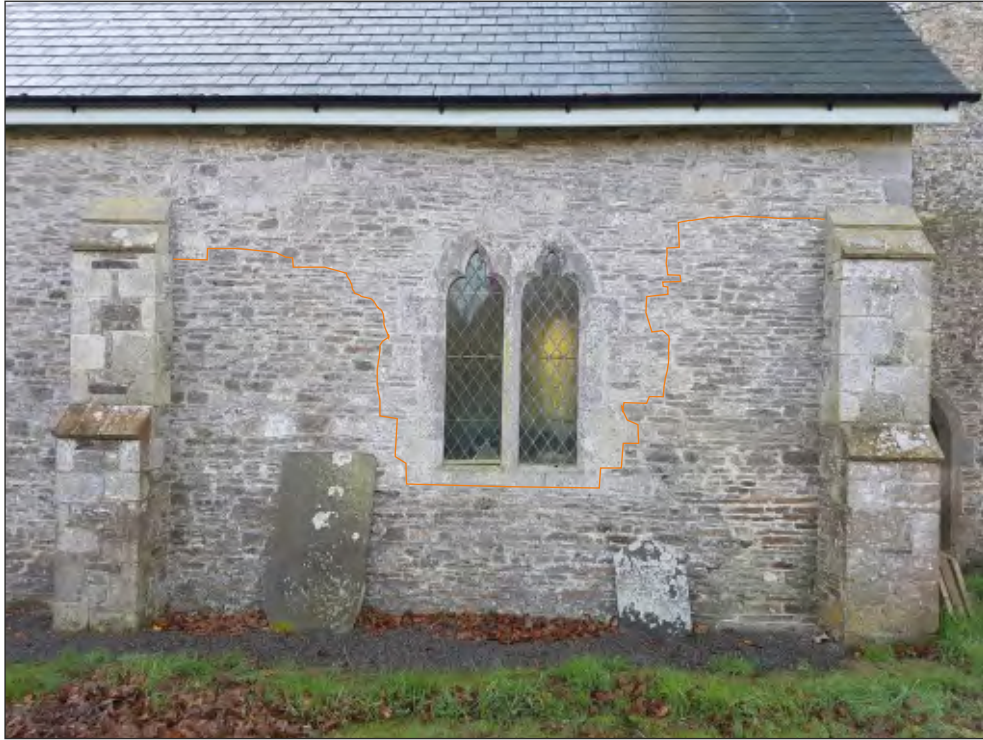
Pl. 16 General view of north elevation showing sections rebuilt in the late 19th century. Looking south.

Pl. 17 General view of north elevation showing sections rebuilt in the late 19th century. Looking south.

Pl. 18 General view of north elevation showing sections rebuilt in late 19th century. Looking south.

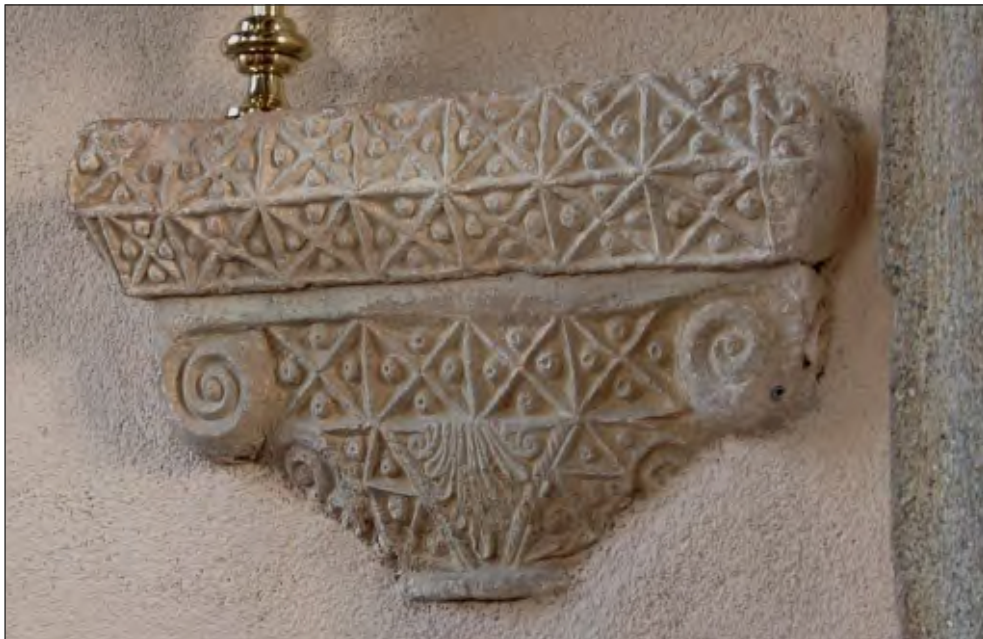
Pl. 19 Close-up of decorated Norman capital, St James the Apostle, Bondleigh.

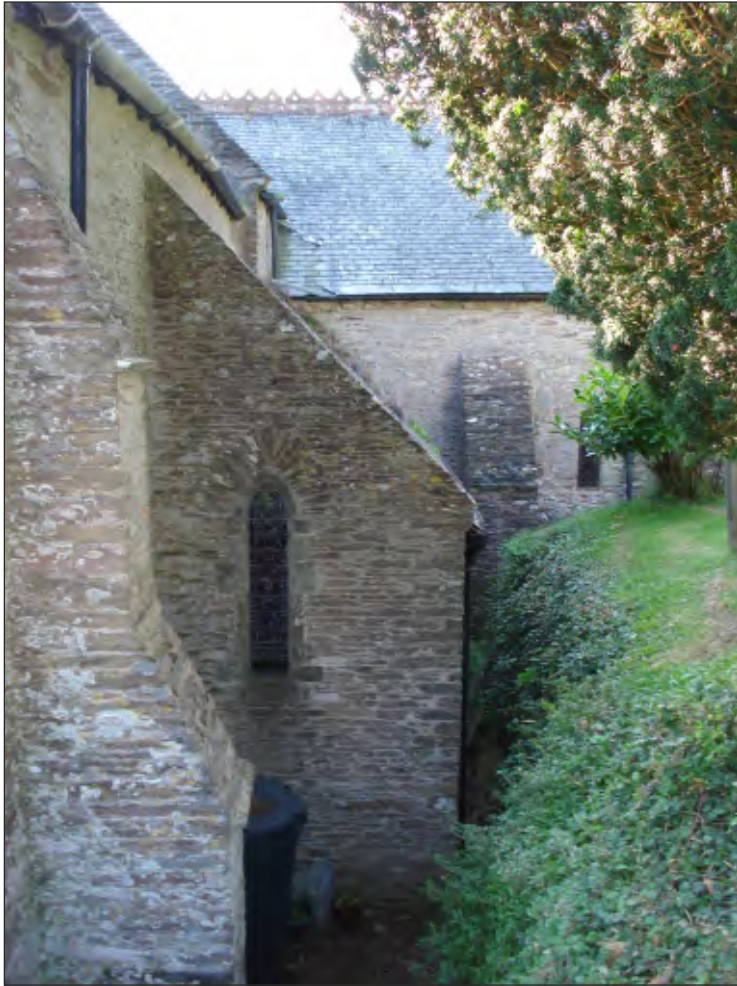
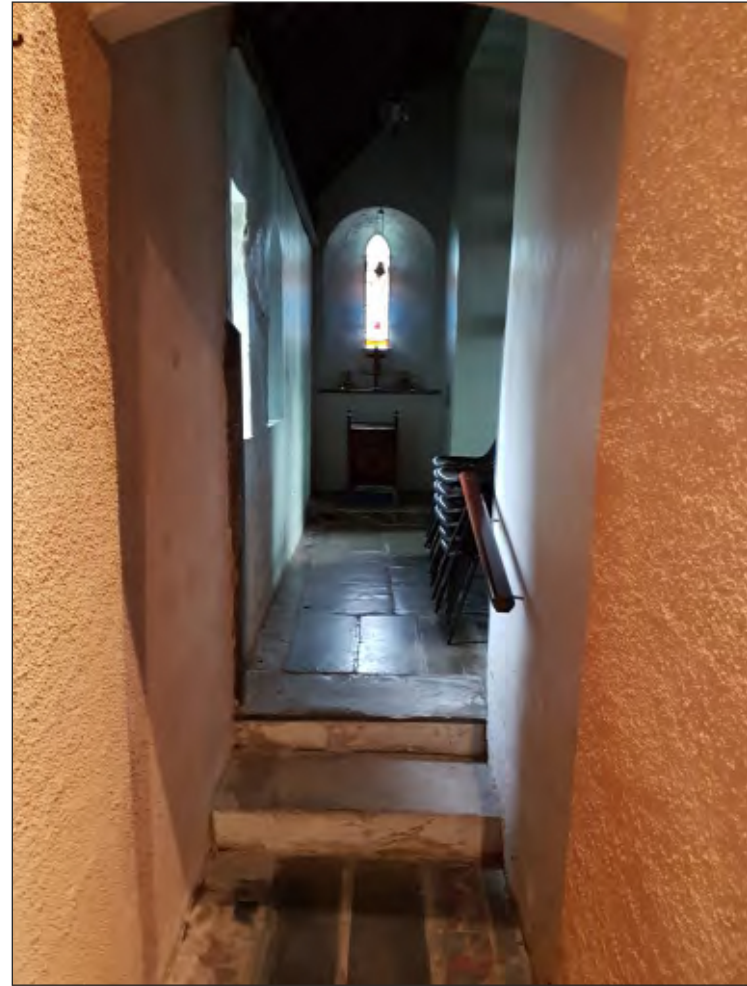
Evidence from the excavations suggests that the Norman church may have comprised a nave, south aisle and chancel. Norman parish churches were usually small simple structures containing no more than a nave and chancel, and the presence of a south aisle in the early church at Beaworthy perhaps indicates the aspirations of its founder. A narrow south aisle survives at All Hallows church at Ringmore in the South Hams, the aisle measuring no more than 1m in width (pls. 20-21).

Pl. 20 General view of narrow aisle, All Hallows, Ringmore. Looking west.

Pl. 21 General view of interior of narrow aisle, All Hallows, Ringmore. Looking east

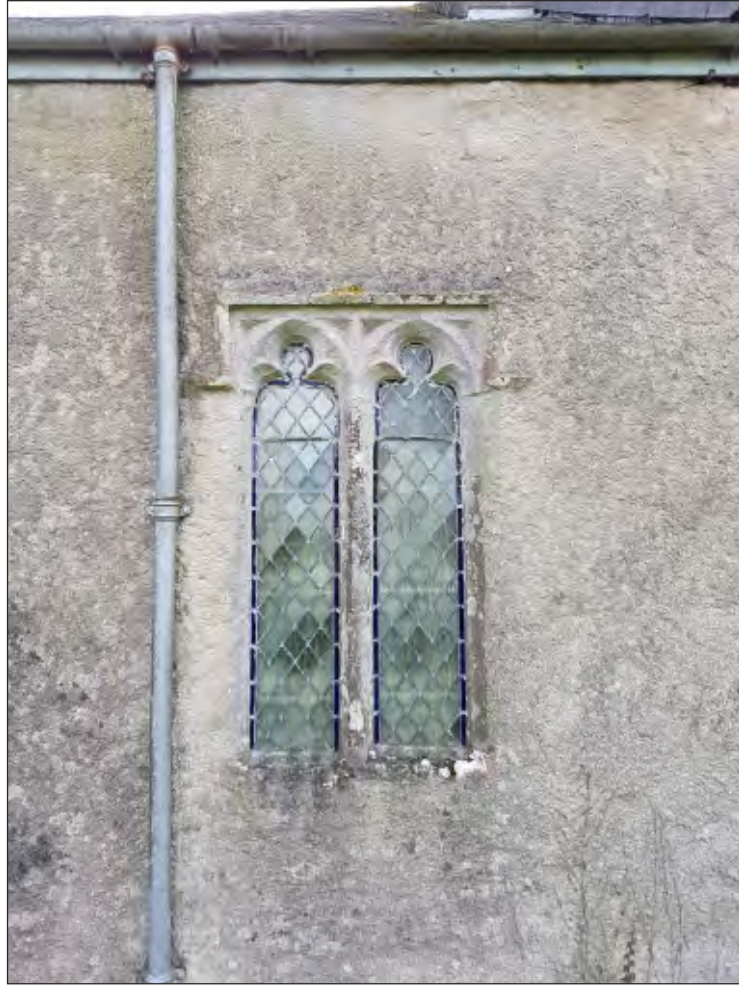
It is possible that the earlier openings originally contained windows with squared heads and hood moulds. A similar window is located in the south elevation of the church of St Mary in Rattery (pl. 22). These may have been replaced with sash windows in the 18th century, as was the case in the church of St James' at Luffincott in West Devon, and subsequently replaced with windows considered more appropriately 'Gothic' by the Victorians in the late 19th century.

Pl. 22 General view of 14th century window with squared head and hood mould, St Mary, Rattery.
