Devon County Council Historic Environment Record

Civil Parish & District: Barnstaple, North Devon	National Grid Reference: SS 5554 3335	Number:	
Subject: Archaeological monitoring and recording Barnstaple, Devon.	at Barnstaple Castle,	Photo attached: Y	
Scheduled Monument Consent No: S00197348	Recipient muse n/a	um:	
OASIS ID: oakforda1-339999	Museum Access n/a	Museum Accession no: n/a	
Contractor's reference number/code: OA1522	Dates fieldwork 08/10/2018	Dates fieldwork undertaken: 08/10/2018

An archaeological watching brief was undertaken by Oakford Archaeology in October 2018 during building work at Barnstaple Castle, Barnstaple, Devon (SS 5559 3330). The site (Fig. 1) lies in an area of high archaeological potential within Barnstaple Castle, a scheduled monument (SM 33062). The work was therefore required by English Heritage (EH) as part of scheduled monument consent.

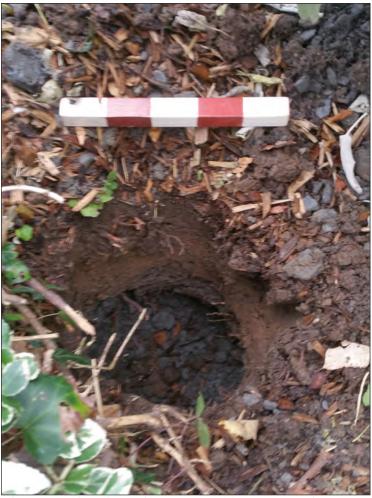
Point 1 (1): 100 0-0.15m mid brown silty clay (topsoil) 0.15-0.52m mid grey aggregate (modern made ground)

Pl. 2 Section through counter 1 (1). 0.25m scale. Looking northeast.

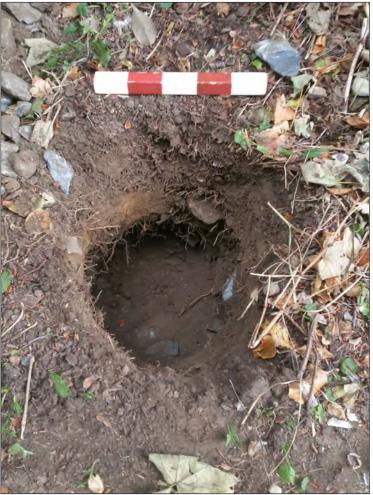
Point 4 (1): 400 0-0.2m dark brown humic soil (flowerbed) 401 0.2-0.28m mid reddish-brown silty clay 402 0.28-0.45m+ mid to dark reddish-brown silty clay shale flecks (2-3%), charcoal flecks (1%) Point 4 (2): 403 0-0.15m mid to dark brown silty clay (topsoil) 404 0.15-0.55m+ mid to dark yellowish-brown silty clay large limestone aggregate (10-15%)

Pl. 11 Section through counter 4 (2). 0.25m scale. Looking west

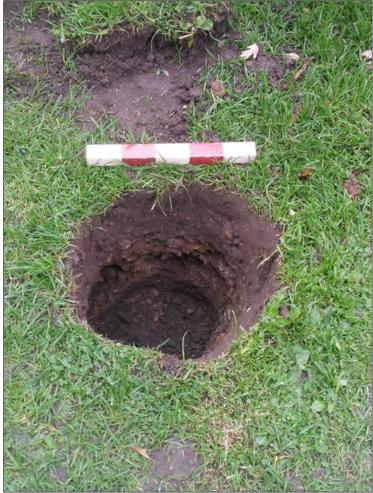
Point 5 (1): 500 0-0.2m mid brown silty clay (topsoil) 501 0.2-0.38m mid yellow silty clay shale flecks (10-15%) 502 0.38-0.45m+ mid brown silty clay

Pl. 14 Section through counter 5 (1). 0.25m scale. Looking south.

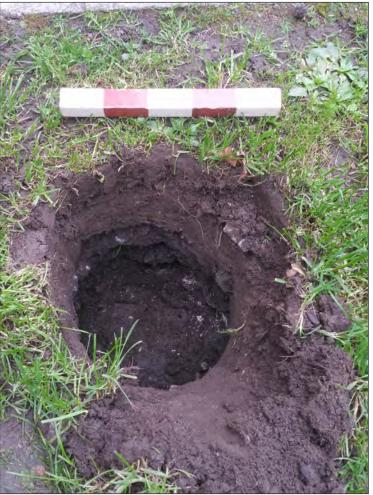
Point 5 (2): 500 0-0.3m mid brown silty clay (topsoil) 503 0.3-0.6m+ mid to dark brown silty clay lime flecks (5%), shale flecks (5-10%), charcoal flecks (1-2%)

Pl. 15 Section through counter 5 (2). 0.25m scale. Looking north.
