## Devon County Council Historic Environment Record

Civil Parish & District:  Ilfracombe, North Devon	National Grid Reference: SS 5307 4758		Number:
Subject: Archaeological monitoring and recording Ilfracombe, Devon.	on land at Hills	borough,	Photo attached: Y
<b>Scheduled Monument Consent No:</b>	Recipie n/a	nt museun	n:
OASIS ID: oakforda1-386145	Museur n/a	n Accessio	n no:
Contractor's reference number/code: OA1659	<b>Dates f</b> 01/07/2		ndertaken:

An archaeological watching brief was undertaken by Oakford Archaeology in July 2020 during hedge widening and the construction of a new gate on land at Hillsborough, Ilfracombe, Devon (SS 5307 4758). The site (Fig. 1) lies in an area of archaeological potential along the southern edge of Hillsborough promontory fort, a scheduled monument (SM 1002512). The work was therefore required by English Heritage (EH) as part of scheduled monument consent.

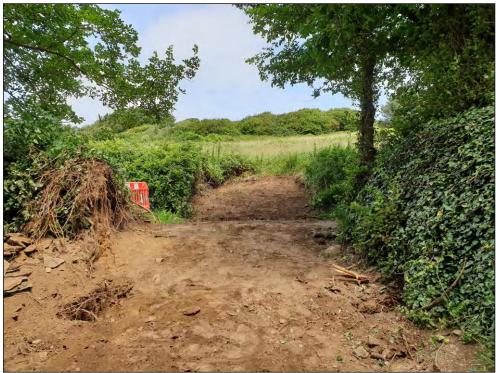
The initial excavations involved the removal of a mid-to-dark brown sandy loam topsoil across areas 1 (5.65m long and 3m wide) and 2 (3.25m long and 2.6m wide) to a maximum depth of 0.15m. This revealed a light-to-mid yellow brown sandy loam subsoil with frequent shillet inclusions. Excavation of two postholes (0.3m wide and 0.6m deep) for the new gate, revealed a shillet natural subsoil at a depth of 0.5m. This was in turn overlain by the 0.35m thick subsoil. A small collection of archaeological material was recovered from the topsoil, totalling 15 sherds and entirely post-medieval and modern in character. This consisted of 10 sherds of late 19<sup>th</sup> and early 20<sup>th</sup> century industrial whitewares including Staffordshire transfer printed ware. In addition three fragments of late 19<sup>th</sup> century bottle glass, including one inkwell and two 20<sup>th</sup> century glass bottle fragments were recovered.

Pl. 1 General view of the two areas showing shallow depth of ground reduction and position of the two post holes. Looking north.

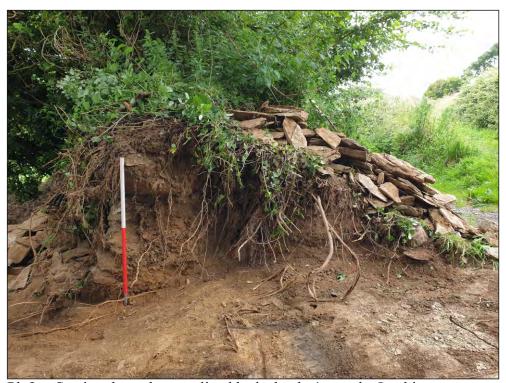
The hedgebank was 1.65m wide and 1.27m high and consisted of a mixed bank core deposit of mid yellow brown sandy loam with frequent shillet inclusions derived from the excavation of the underlying subsoil and natural subsoil. The bank was revetted on the both sides by a dry-stone wall of local slate stone, although this had been largely disturbed and survived only intermittently on the north side. The walls were footed at the base of the bank immediately on top of the subsoil. There was no evidence for a ditch on either side of the bank and the material for its construction was likely removed from its footprint. The bank was overlain by a dark brown silty loam and leafmould representing the result of organic growth and decay on the surface of the bank. Finally, the construction of a footpath sometime in

the mid-late 19<sup>th</sup> century on the up-slope (North) side of the bank had resulted in soil accumulating against this side of the bank. Although no finds were recovered from the hedgebank, its location equates with a boundary shown on the 1839 Ilfracombe Tithe map.

Pl. 2 Section through stone-lined hedgebank. 1m scale. Looking west.

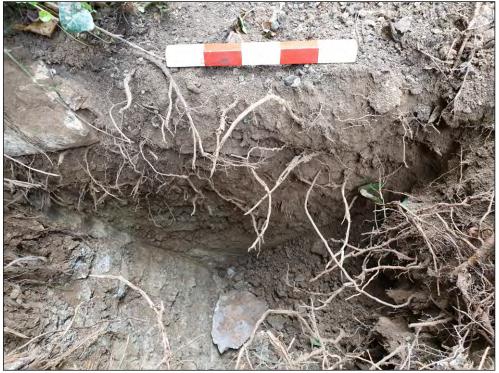
Pl. 3 General view of Posthole 1 showing depth of subsoil. 0.25m scale. Looking south.

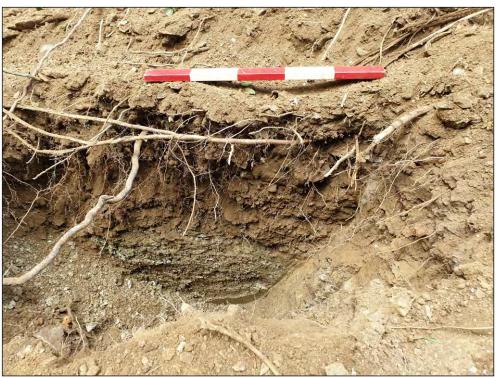
Pl. 4 General view of Posthole 2 showing depth of subsoil. 0.5m scale. Looking west.
