OAKFORD
ARCHAEOLOGY

Historic building recording on The Cyder Barn, Stancombe Farm, Devon

Report No. 20-12

September 2020

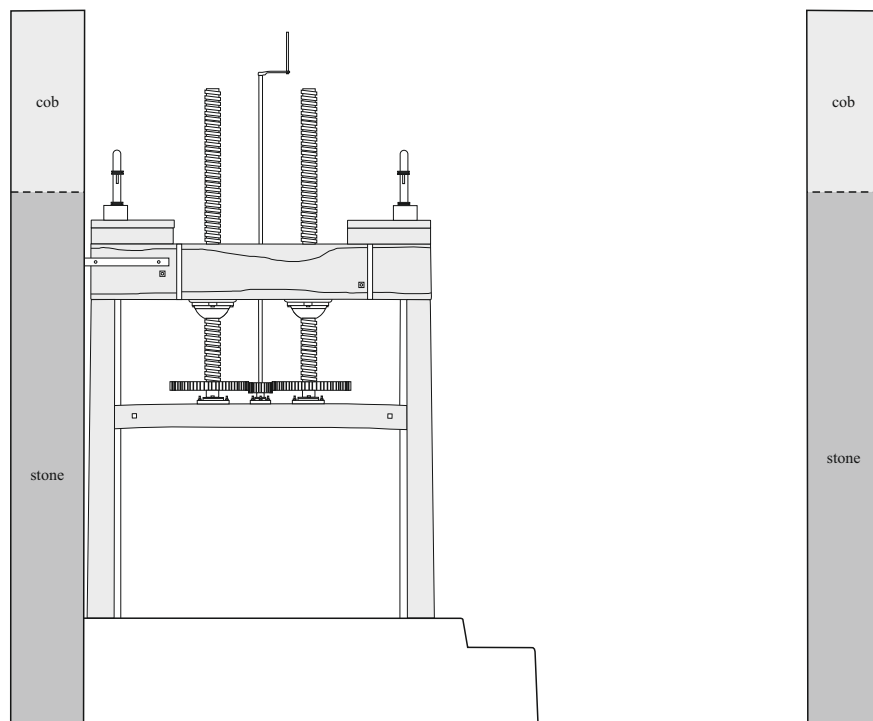
Fig. 6 South facing elevation of cider press.

The principal feature internally are the partial remains of an old cider press. Although this is relatively recent, it is an impressive piece of traditional farm machinery. A rectangular frame, formed with a large horizontal beam and a smaller crossbeam below, is linked by two square section vertical wrought iron posts which pass through holes in the upper beam. Additional support is provided by two timber uprights slotted into the beam above. Slots in the top of the wrought iron posts take simple straight metal cotter-pin plates; these are located some way above the crossbeam with two additional sections of timber wedged underneath the cotter-pins. The ends of the main beam have been sawn-off presumably to fit the press in its current position.

The screw mechanism consists of a pair of vertical wrought iron continuously threaded bolts with square-cut threads, which pass through the upper beam and work in threaded cast iron rings, bolted to its soffit. These bolts are fixed into half-globe housings bolted onto the underside of the beam and simple circular housings bolted to the upper side of the crossbeam below. The base of each bolt has a cast iron gear wheel fitted to it, which mesh with a small-diameter cog set between them. This cog is fitted to a narrow vertical shaft with a square lower section and round upper section which sits in a circular bearing on the upper face of the crossbeam and passes up through the upper beam of the press frame. The upper end of the rod is fitted with a lever, presumably to be turned by hand. Just above the cog is a cast iron four-pronged barring point, presumably to be turned on occasion with a spanner. In conjunction with the handle above this would presumably have enabled both the twin screws to be turned simultaneously, allowing the press deck to apply even pressure onto the stacked pulp, interleaved with straw layers, known as the 'mock'. The design of the press suggests a date after about 1830 and up to about 1890, when twin-screw presses were in common usage.

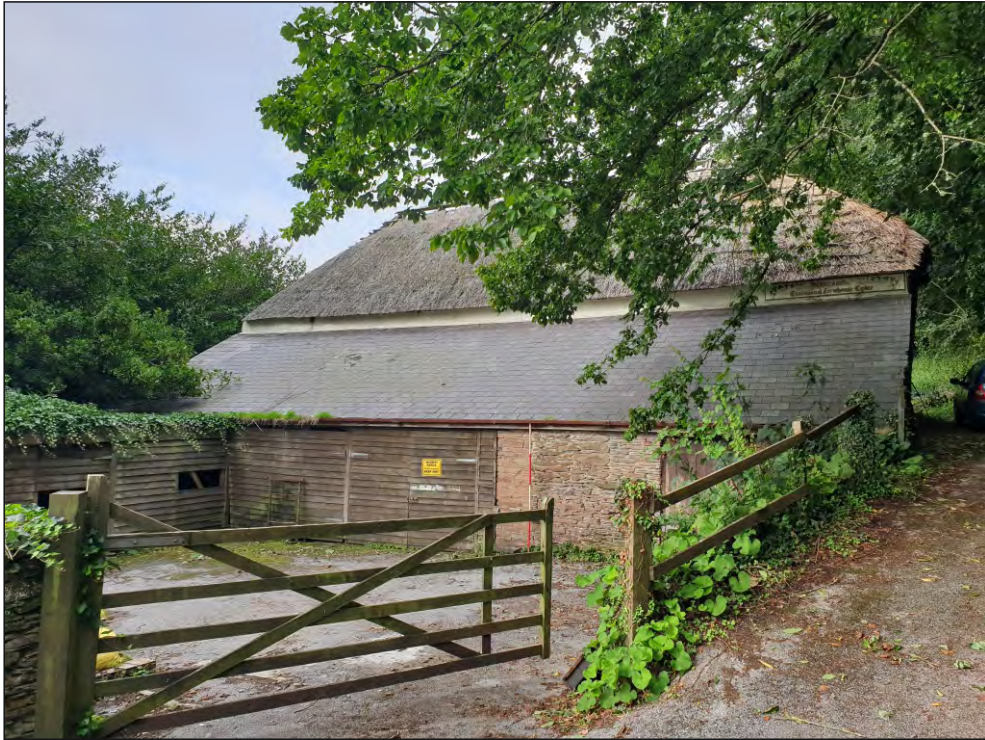
Pl. 1 General view of east elevation showing 19th and 20th century lean-to extensions. 2m scale. Looking west.

The main east elevation to the courtyard is obscured by a succession of later extensions (Pl. 1). To the north of the main door is a small outshut, built of stone rubble and originally accessed through a doorway in the south elevation (Pl. 2). The interior was formerly lit by a single window in the east elevation. This was subsequently blocked, and a doorway inserted in the modern period. Within the west elevation of the room the remains of an earlier roofline are visible (Pl. 3), showing that the original roof was lower. To the south the relatively modern timber lean-to structure incorporates an earlier stone rubble end wall. There is no evidence that the wall returned to the north, suggesting that the earlier extension was open-fronted. The remains of the former roofline and roof structure are preserved in the east elevation of the barn (Pl. 4) showing that the roof was again at a lower level. Finally, the south gable of the extension is partly tied into the existing masonry of the barn, with the string course providing a uniform façade towards the early 19th century farmhouse extension (Pl. 5).

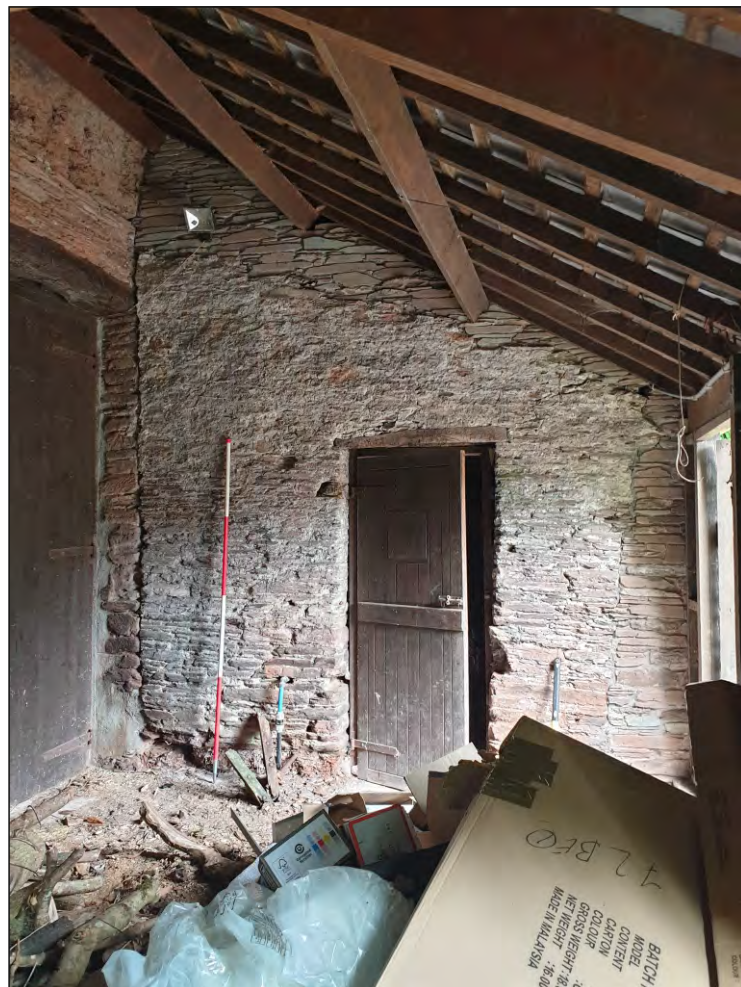
Pl. 2 General view of south elevation of lean-to showing original doorway into the extension with 20th century door. 2m scale. Looking northwest.

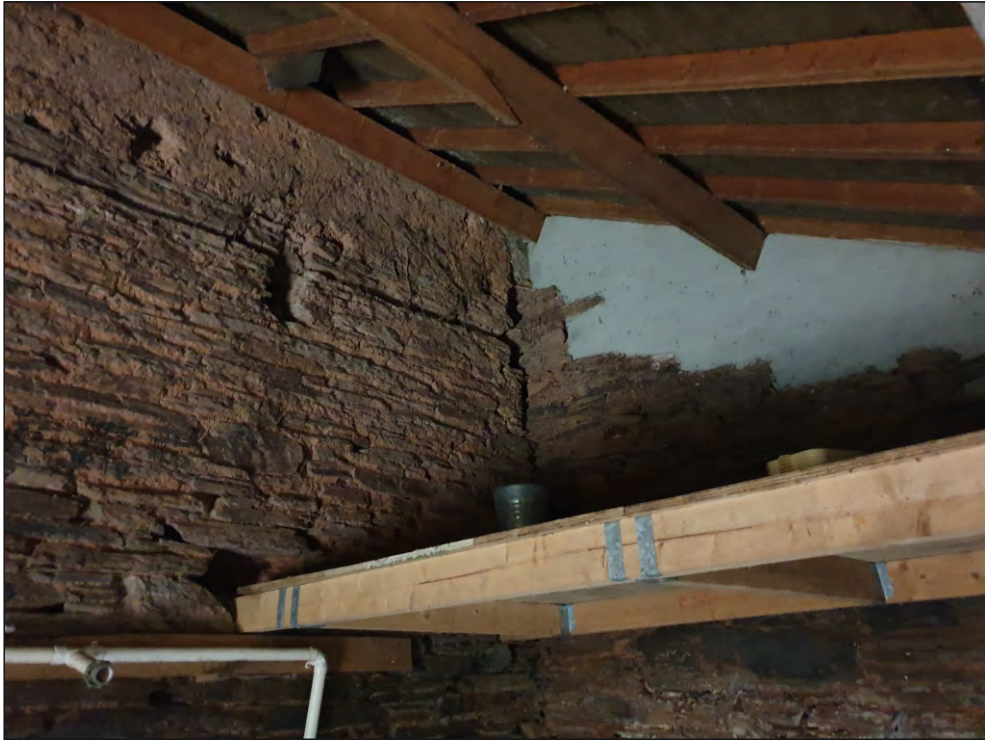
Pl. 3 General view of earlier roofline of extension below cob extension of barn and original height of north end wall. Looking northwest.

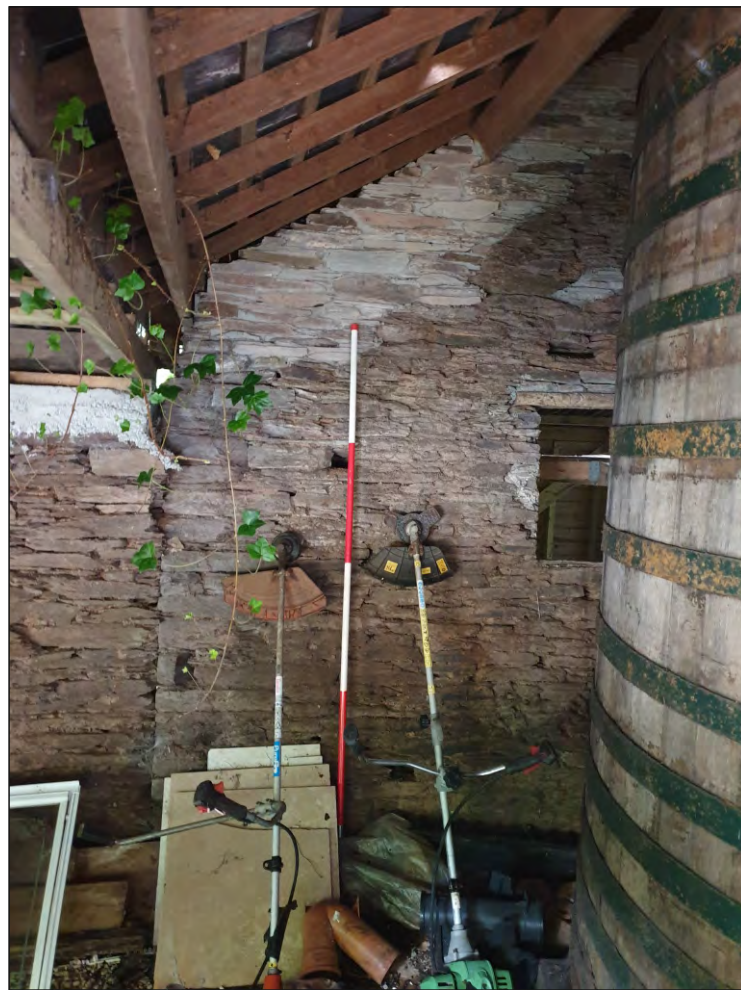
Pl. 4 General view of south end wall of lean-to extensions. 2m scale. Looking southeast.

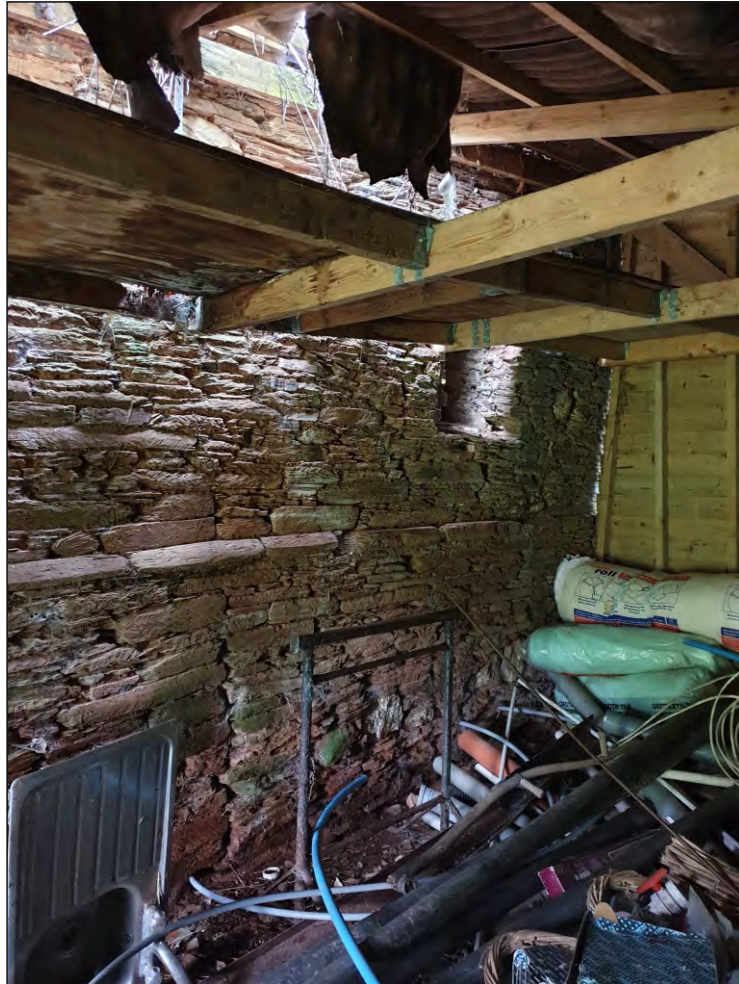
Fig. 5 General view of south elevation showing break between the barn and lean-to extension (below) and unifying string course. Looking northeast.

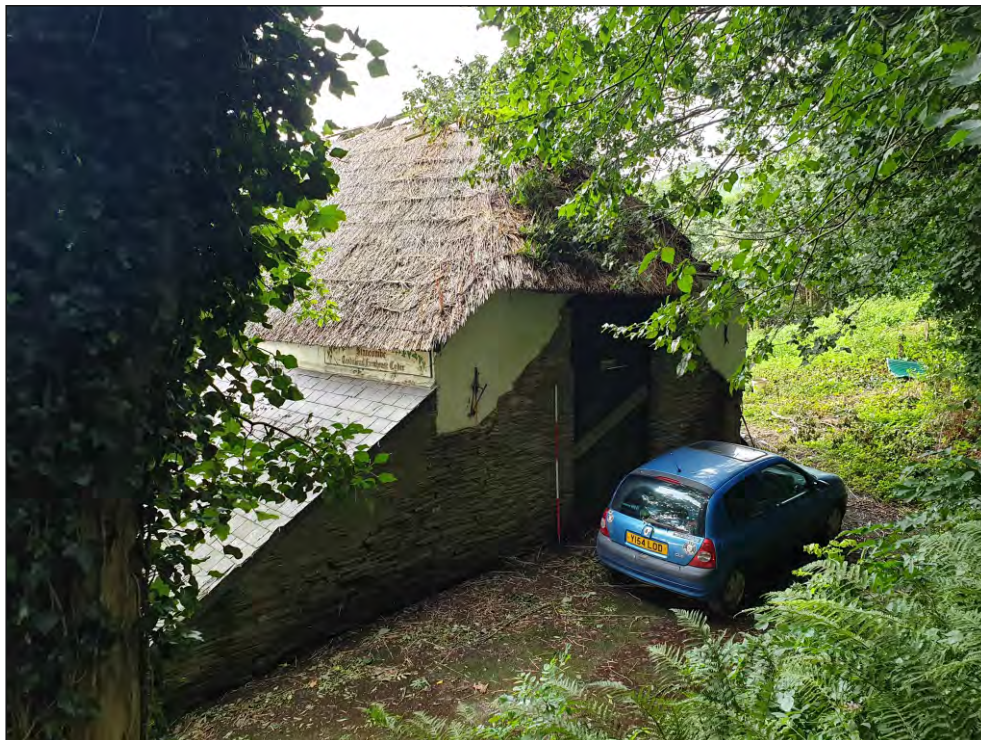
Fig. 6 General view of north elevation showing the original roof height of the lean-to extension and the barn and the subsequent raising of both walls. 2m scale. Looking southwest.

Evidence from the north elevation suggests that the earlier building was also hipped (Pl. 6), the west and east elevations coming in level and then rising to the height of the central doorway. Following the raising of the height of the barn the central door is extended with additional stonework, the new opening being slightly wider than the original doorway below, while the remainder of the elevation is made up in cob. Facing the fields to the west the barn elevation (Pl. 7) consists of stone rubble with cob above. The barn is accessed through a smaller centrally placed double doorway and a later doorway inserted at the south end of the elevation. Two slit windows to the north of the double door are largely covered by the current ground level. A modern timber lean-to shed is built against the south elevation.

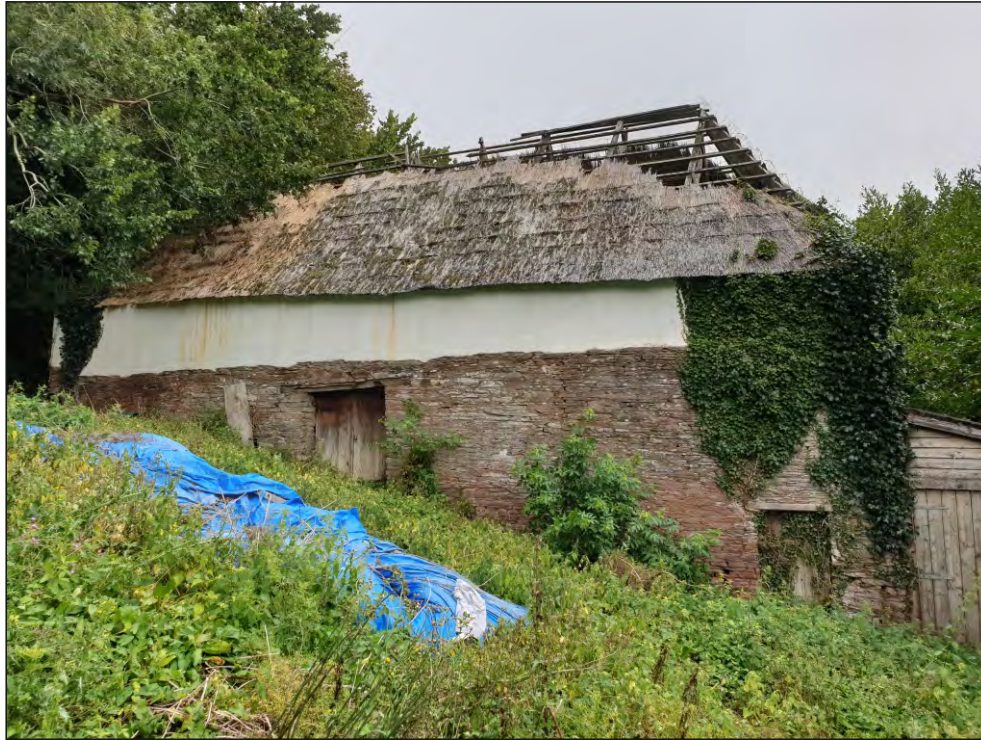
Pl. 7 General view of the west elevation showing the original roof height. Looking northeast.

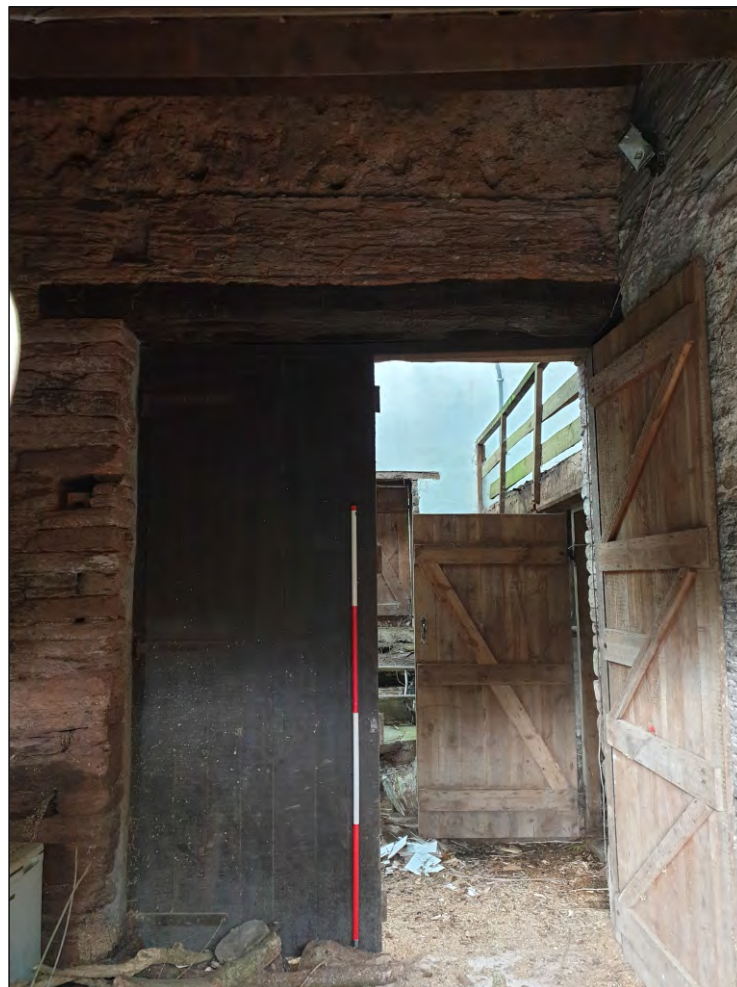
Pl. 8 General view of double door in east elevation showing cob walling above the original stone rubble. 2m scale. Looking southwest.

The barn is accessed from the courtyard through the lean-to extension by a set of large modern double doors, placed centrally within the east elevation (Pl. 8). This gives access to the ground-floor of the barn with the cider press on a raised brick and concrete platform in the centre of the former passage and immediately in front of the former west door of the barn (Pl. 9). The former west door opening is much reduced in size, presumably reflecting a change in the function of the barn after the construction of the new farm buildings to the east of the expanded farmhouse. To the south a low stone rubble wall divides the south end of the barn from the remainder of the structure (Pl. 10). Access is through an opening defined by concrete jambs, while the original floor structure above, consisting of pine logs, has been heavily repaired with modern joists. Access originally would have been through a small doorway in the west elevation placed against the south gable. Closer inspection shows that the opening has been cut through the existing masonry. This suggests that the doorway is a later insertion, its position suggesting that the intention was to maximise the space against the north side of the low partition, whether for storage or livestock is unclear.

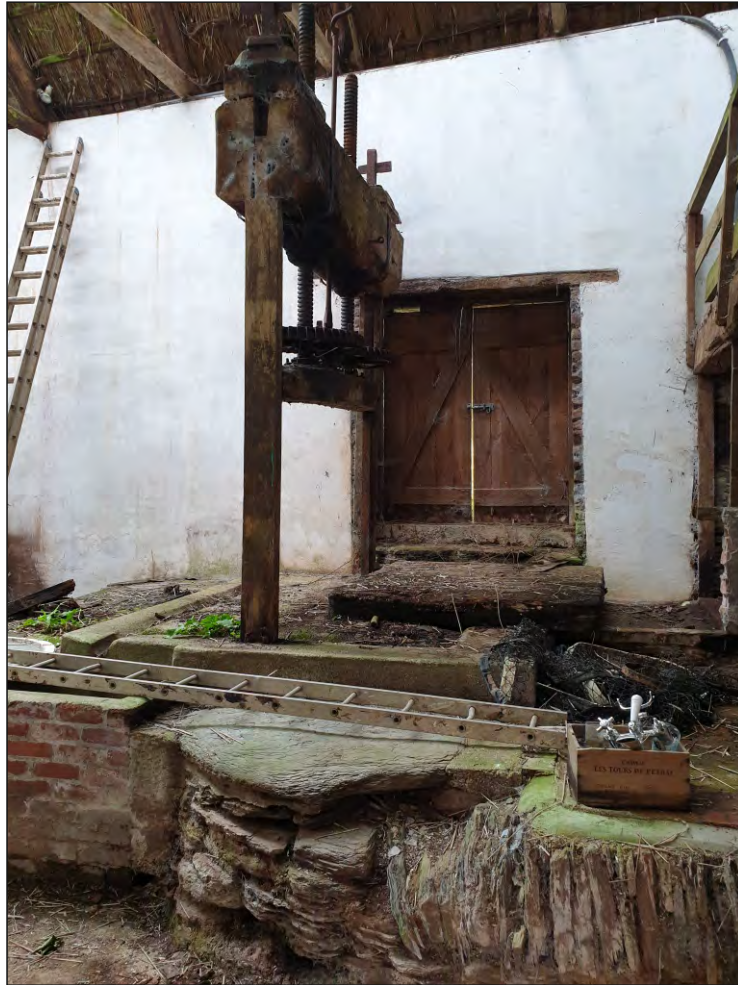
Fig. 9 General view of double door in west elevation with partly rebuilt stone platform in foreground. Looking southwest.

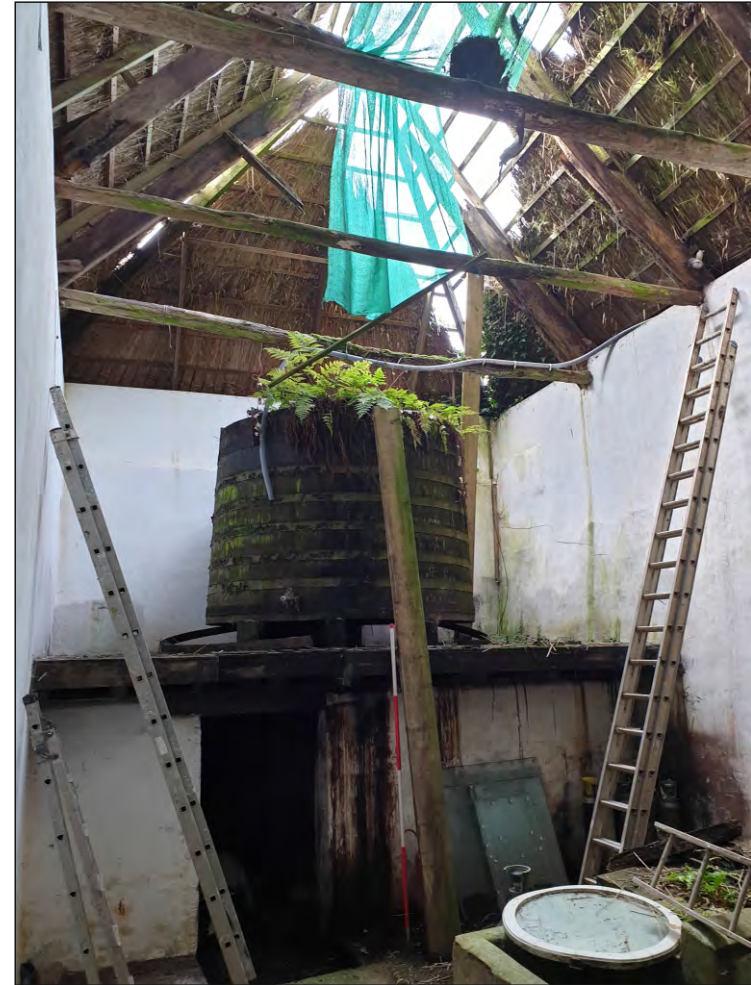
Fig. 10 General view of south end showing mid-late 19th century ground-floor partition with modern opening and heavily rebuilt floor structure. 2m scale. Looking south.

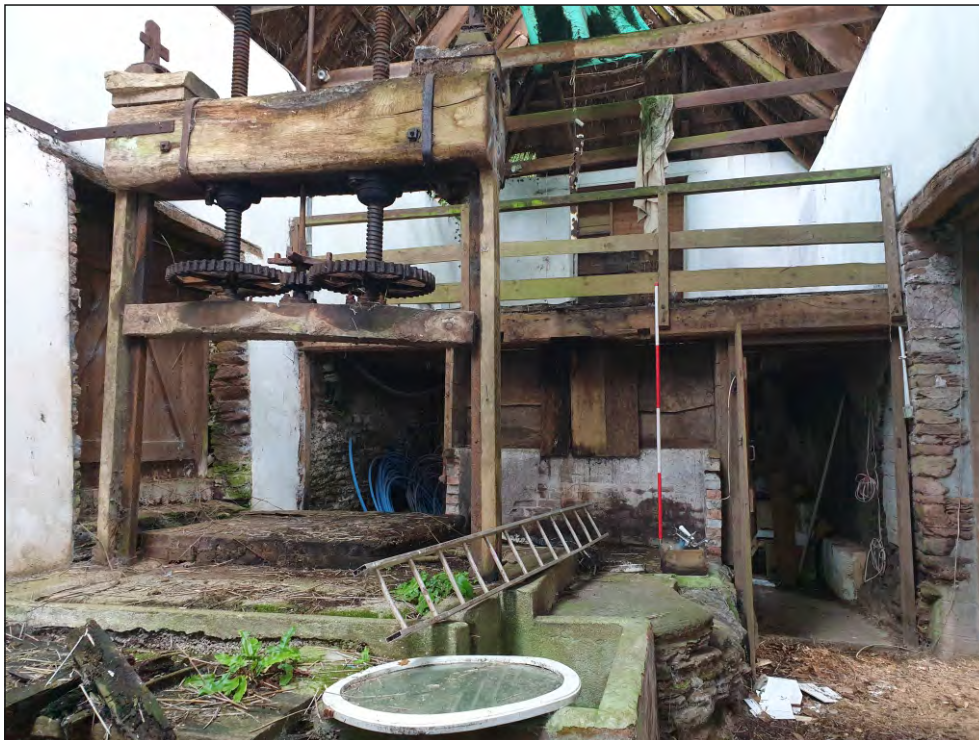
Fig. 11 General view of north end showing modern ground-floor partition with first floor above. 2m scale. Looking northwest.

At the opposite end the barn is partitioned immediately to the north of the two large facing double doors by a low ground-floor partition (Pl. 11). Consisting of modern brick with timber partition below the main beam. The latter contains two former joist sockets on the underside of the south side and has clearly been reused from elsewhere. Access to the northern bay is provided by a doorway at the east end of the partition. The use of timber identical to that used in the west door suggests both doors are modern. Two slit windows (Pl. 12-13) with splayed jambs provided additional light and ventilation to an otherwise unlit lower floor, suggesting perhaps that it was mainly used for the storage of processed straw and grain on the first floor above. The floor of the barn and the first-floor structure above has been extensively truncated in the modern period for the cider making machinery of the previous occupant.

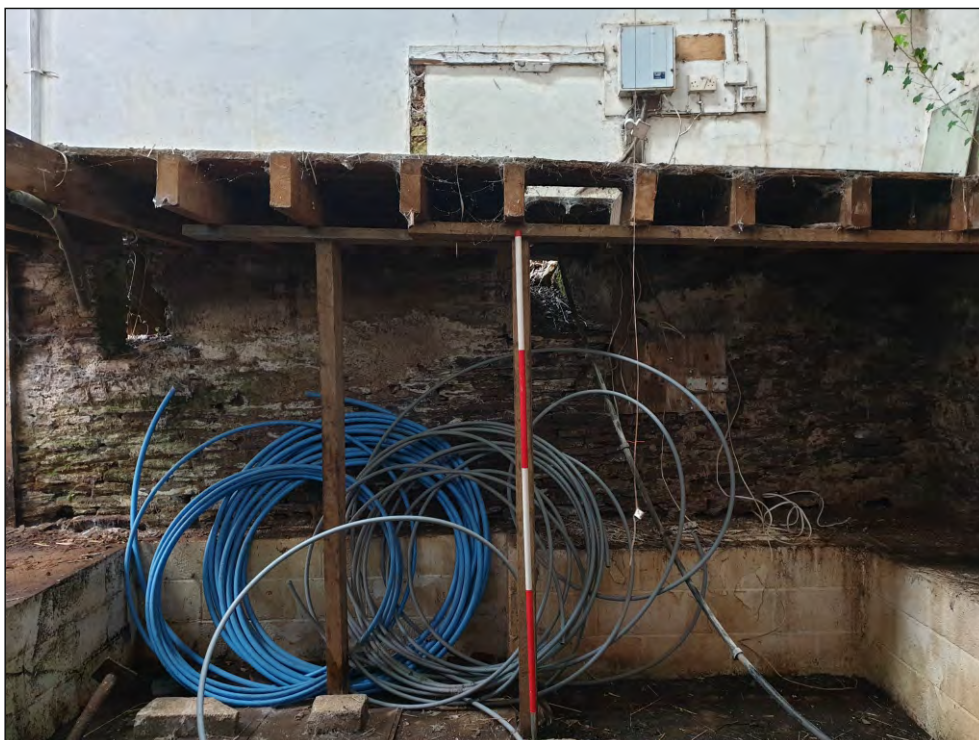
Fig. 12 General view of northern ground-floor bay showing two slit windows with splayed jambs in west elevation. 2m scale. Looking west.

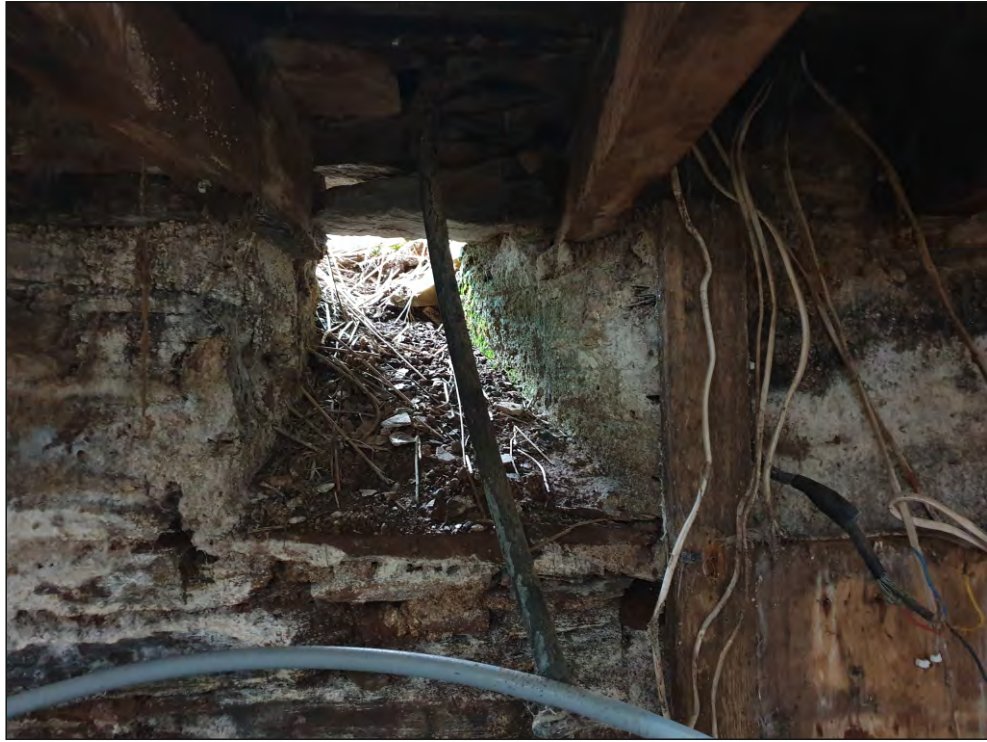
Pl. 13 Close-up of slit window. Looking west.

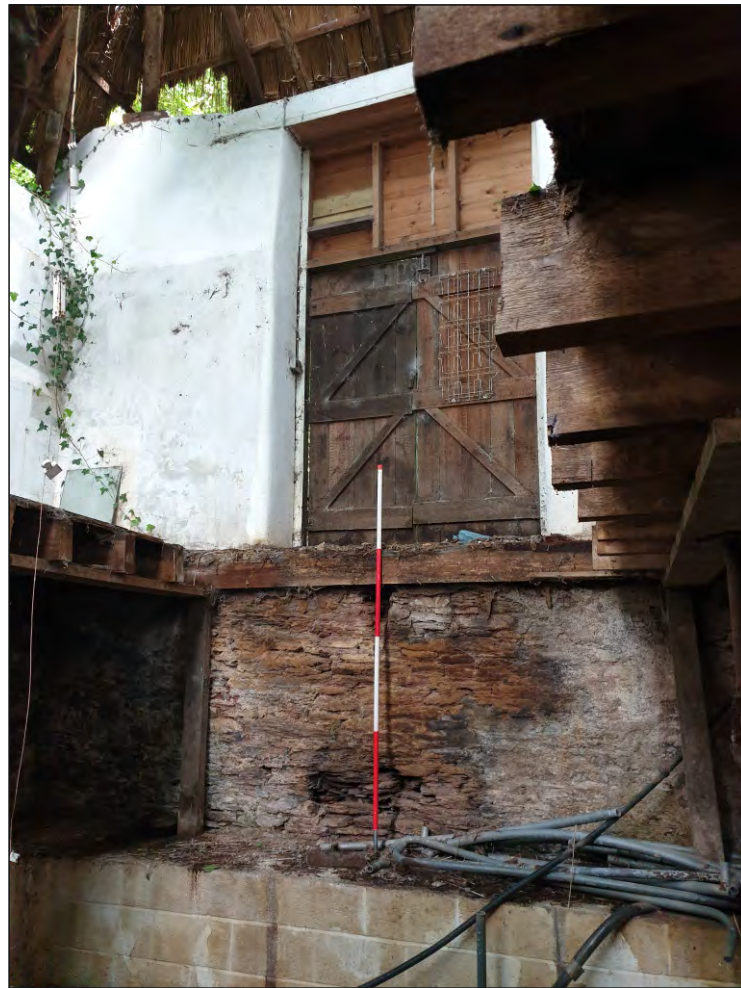
Pl. 14 General view of north bay showing extensive modern truncation of ground- and first floor. 2m scale. Looking northwest.

The first-floor structure consists of large diameter joists spanning the full width of the barn (Pl. 14). These are in part housed within earlier joist holes, while others have been cut into the earlier masonry, suggesting that the current floor is a complete rebuild of an earlier floor. There is no evidence for a permanent stair within the floor structure providing access from the floor below and this may originally simply have taken the form of a ladder. From the first-floor access to the lane is through a large modern double door (Pl. 15) set in the centre of the north elevation. The presence of this door opening suggests that the northern half of the barn contained a loft for storage. The original door opening was lower, being subsequently raised when the height of the barn was raised.

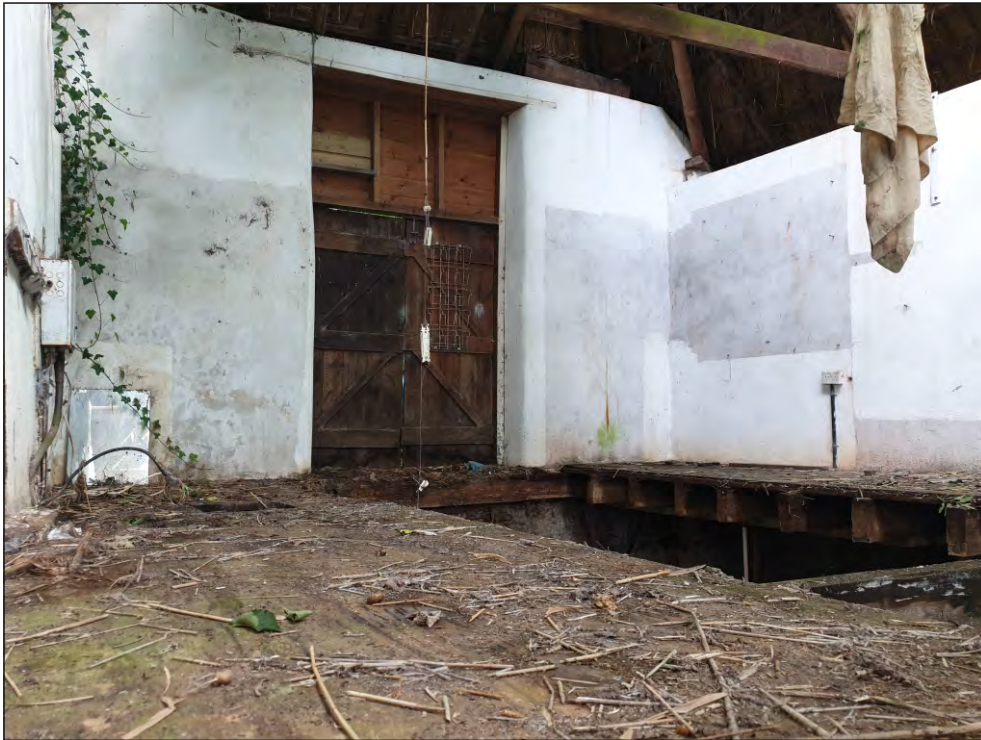
Fig. 15 General view of first floor showing former height of wall with extended double door in north elevation. Looking north.

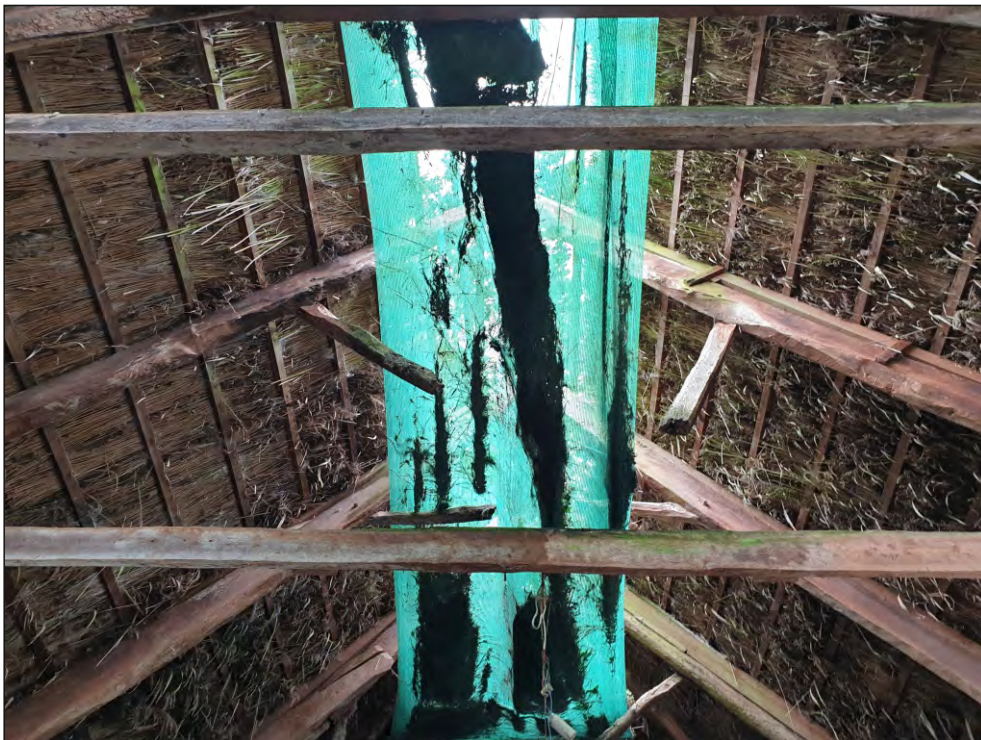
Fig. 16 General view of roof structure showing trusses with pegged collars, modern tie beams and thatching battens. Looking north.

The roof structure over the barn has been extensively altered and is currently in a terrible condition. A detailed inspection of the remaining sections shows that the surviving roof is a single-phase probably dating to the early 19th century. It is supported on eight main trusses,

lapped and pegged at the apex, dividing the roof space into seven irregular bays. The four northern trusses retain their original pegged collars although two have modern tie-beams bolted at their base, while the four southern trusses have modern collars bolted on. The feet of the two southern trusses at the eaves along with their tie-beams rest within the top of the cob walling of the long elevations, while the remainder of the trusses and tie-beams are located on top of the cob walling. The deliberate raising of the tie-beams within most of the barn was presumably done in order to maximise both the lighting and avoid obstructions during either flailing or other activities requiring additional height in these areas. The building is hipped at both ends, although nothing remains of the original construction of the north and south ends at the time of the site visit, both being relatively modern rebuilds. Finally all the thatching battens are modern.

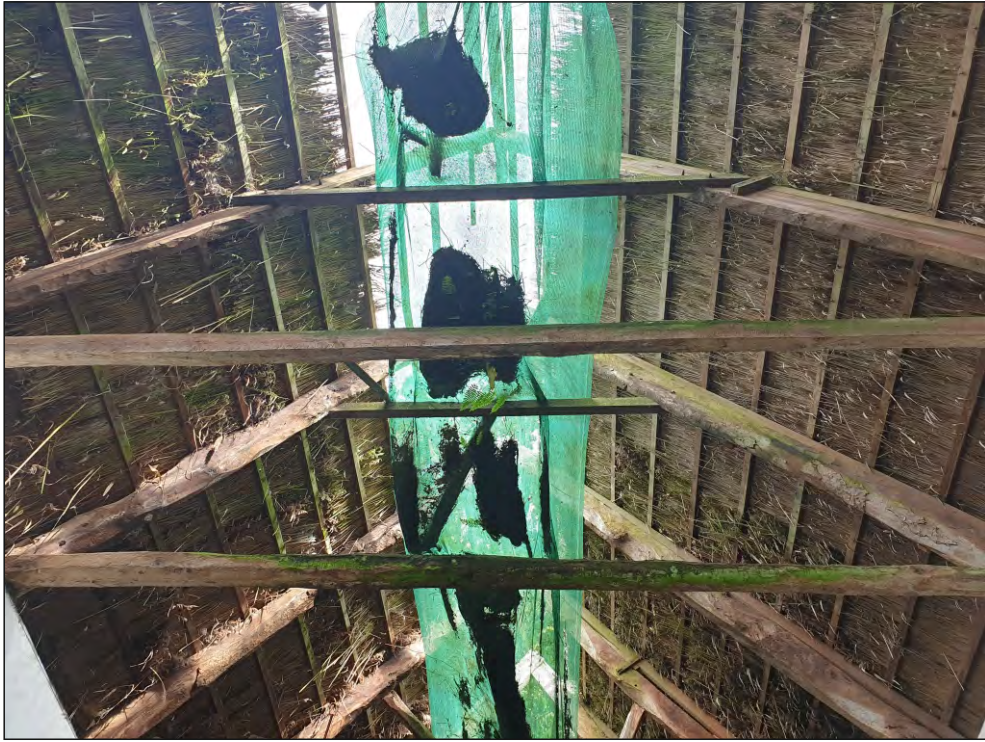
Pl. 17 General view of roof structure showing trusses with bolted modern collars and original pegged tie beams. Looking south.

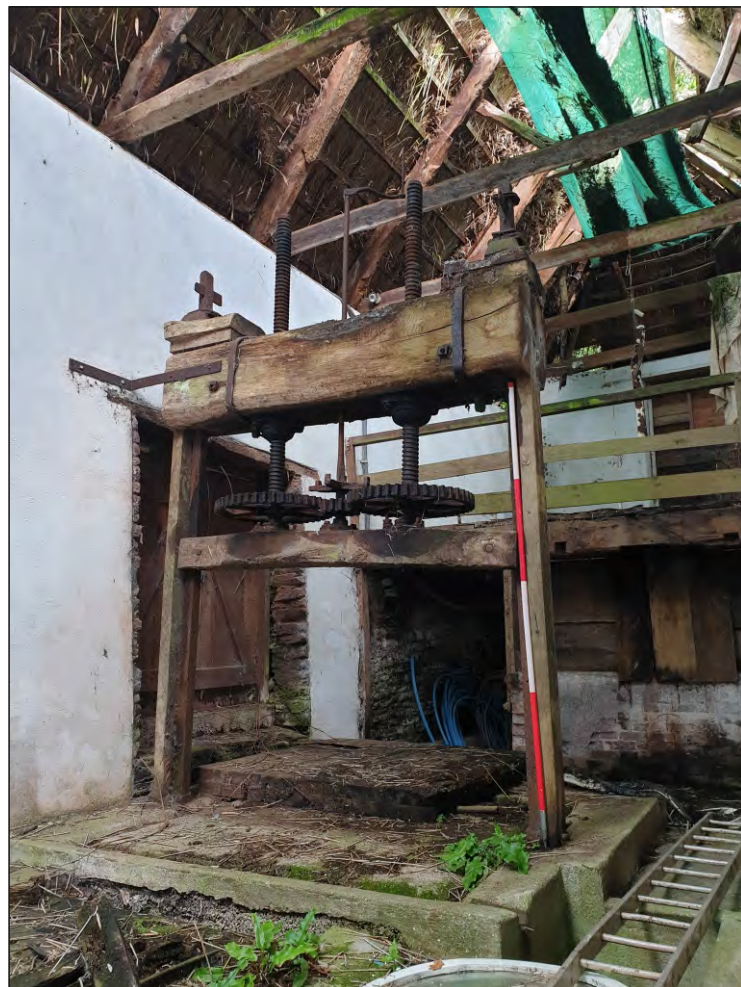
Pl. 18 General view of cider press. 2m scale. Looking northwest.
