Devon County Council Historic Environment Record

Civil Parish & District: Frogmore and Sherford, Devon	National Grid Reference: SX 7785 4424		Number:
Subject: Archaeological monitoring and recording Down, Sherford, Devon.	on land	l at Sherford	Photo attached: Y
Planning permission no: 0683/17/OPA		Recipient museu n/a	m:
OASIS ID: oakforda1-409676		Museum Accession no: n/a	
Contractor's reference number/code: OA1734		Date fieldwork u 02/09/2021	ndertaken:

Description of works:

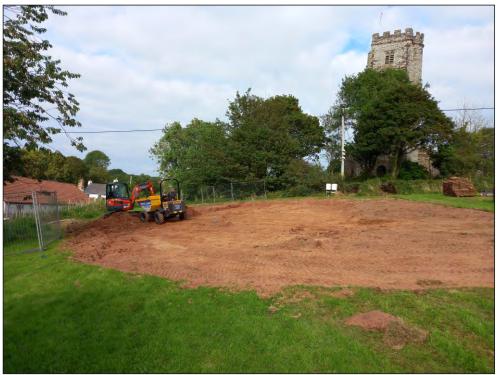
Pl. 1 General view of the access road soil strip with St Martin's Church in the background. Looking east.

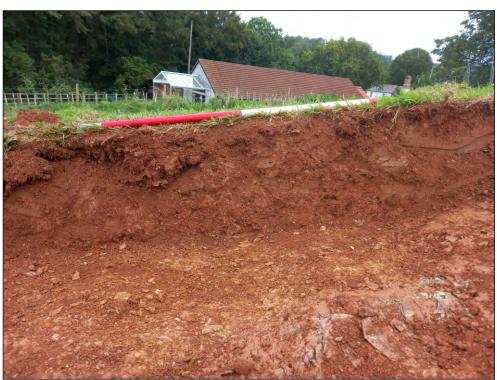
The work exposed a mid yellow clay with shillet (100), interpreted as a natural subsoil, at a depth of 0.4m below ground level. This was overlain by a mid reddish brown clayey silt (100) topsoil.

Pl. 2 Section through the access road showing a simple deposit sequence of topsoil (100) above shillet natural subsoil (101). 1m scale. Looking north.

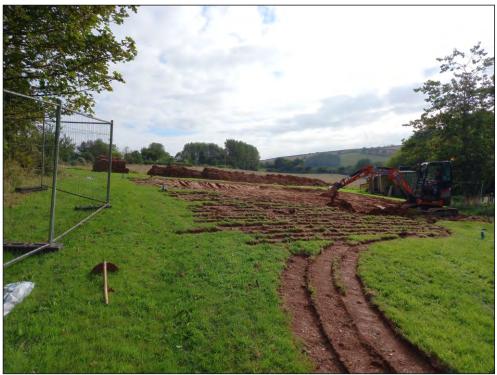
Pl. 3 General view of the house platform soil strip with Sherford Down in the background. Looking south.

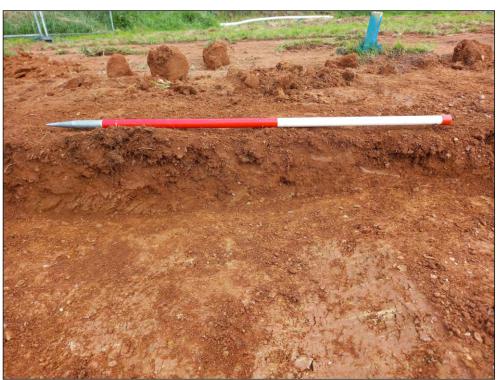
Pl. 4 Section through the house platform showing a simple deposit sequence of topsoil (100) above shillet natural subsoil (101). 1m scale. Looking north.
