**Historic building recording at No. 25 Southside
Street, The Barbican Plymouth, Devon**

Report No. 21-11

Project No. 1800

June 2021

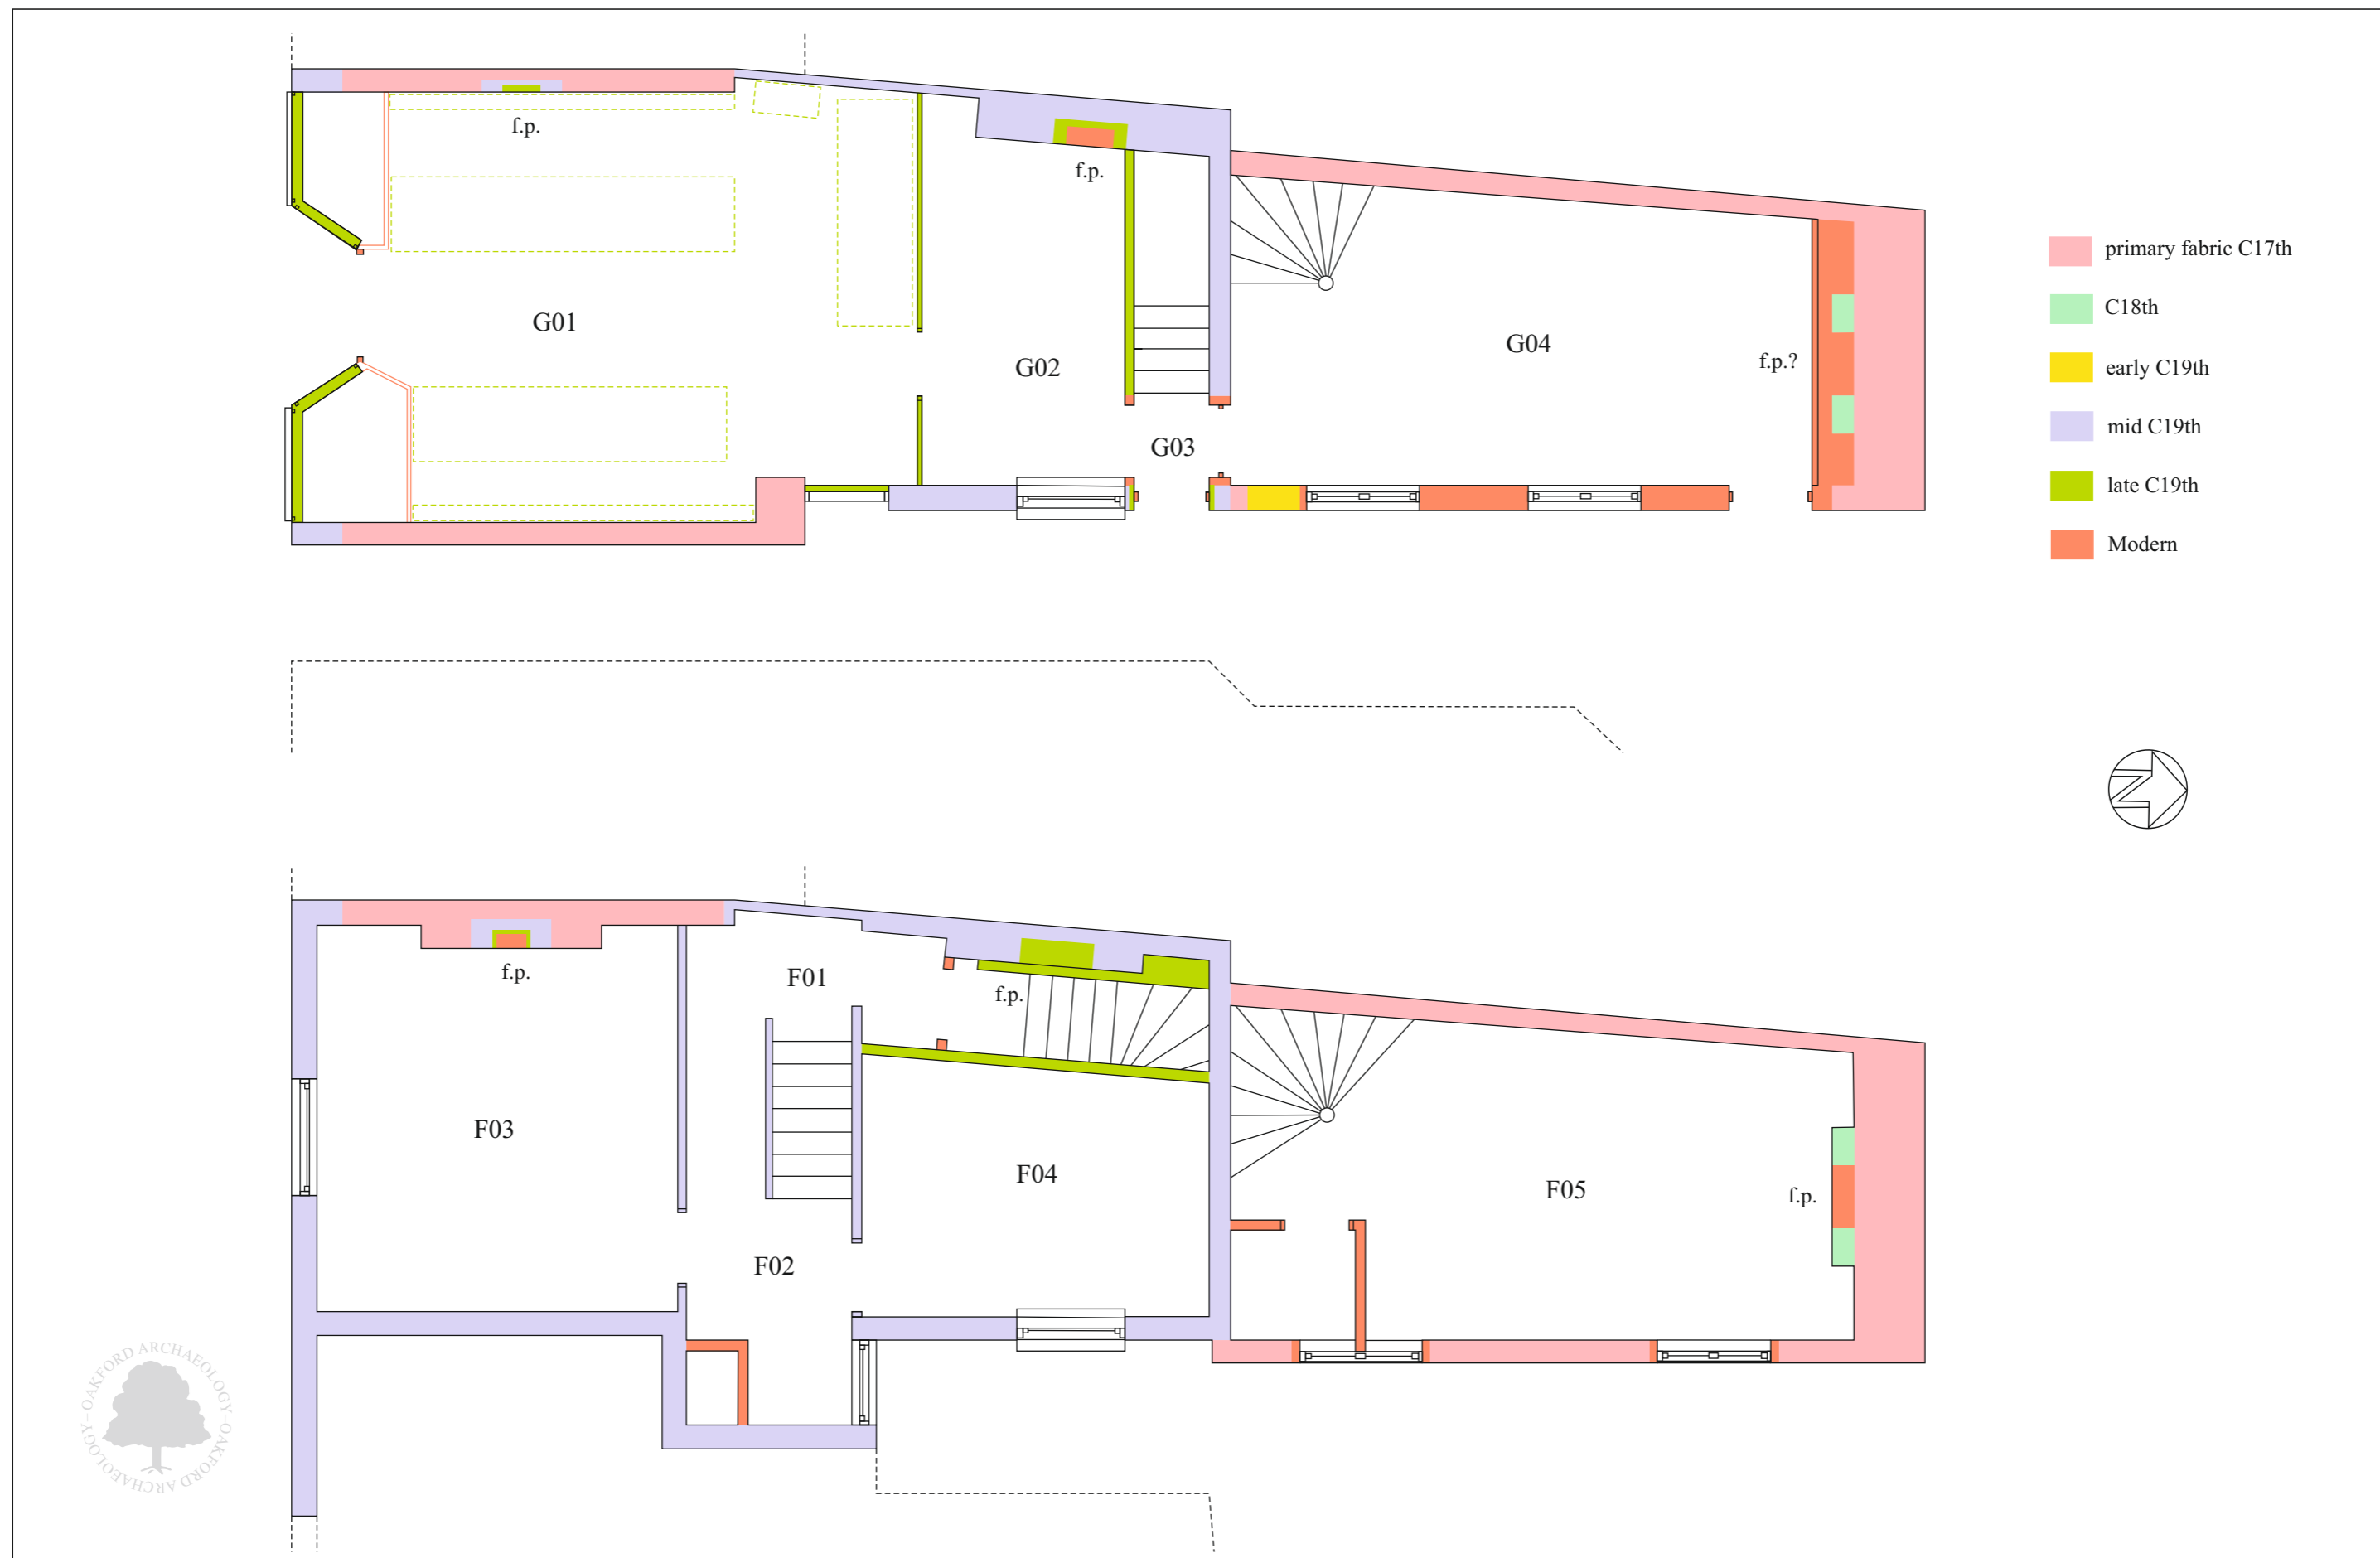
Fig. 10 Plan of ground- and first-floor showing location of observations and suggested phases of development.

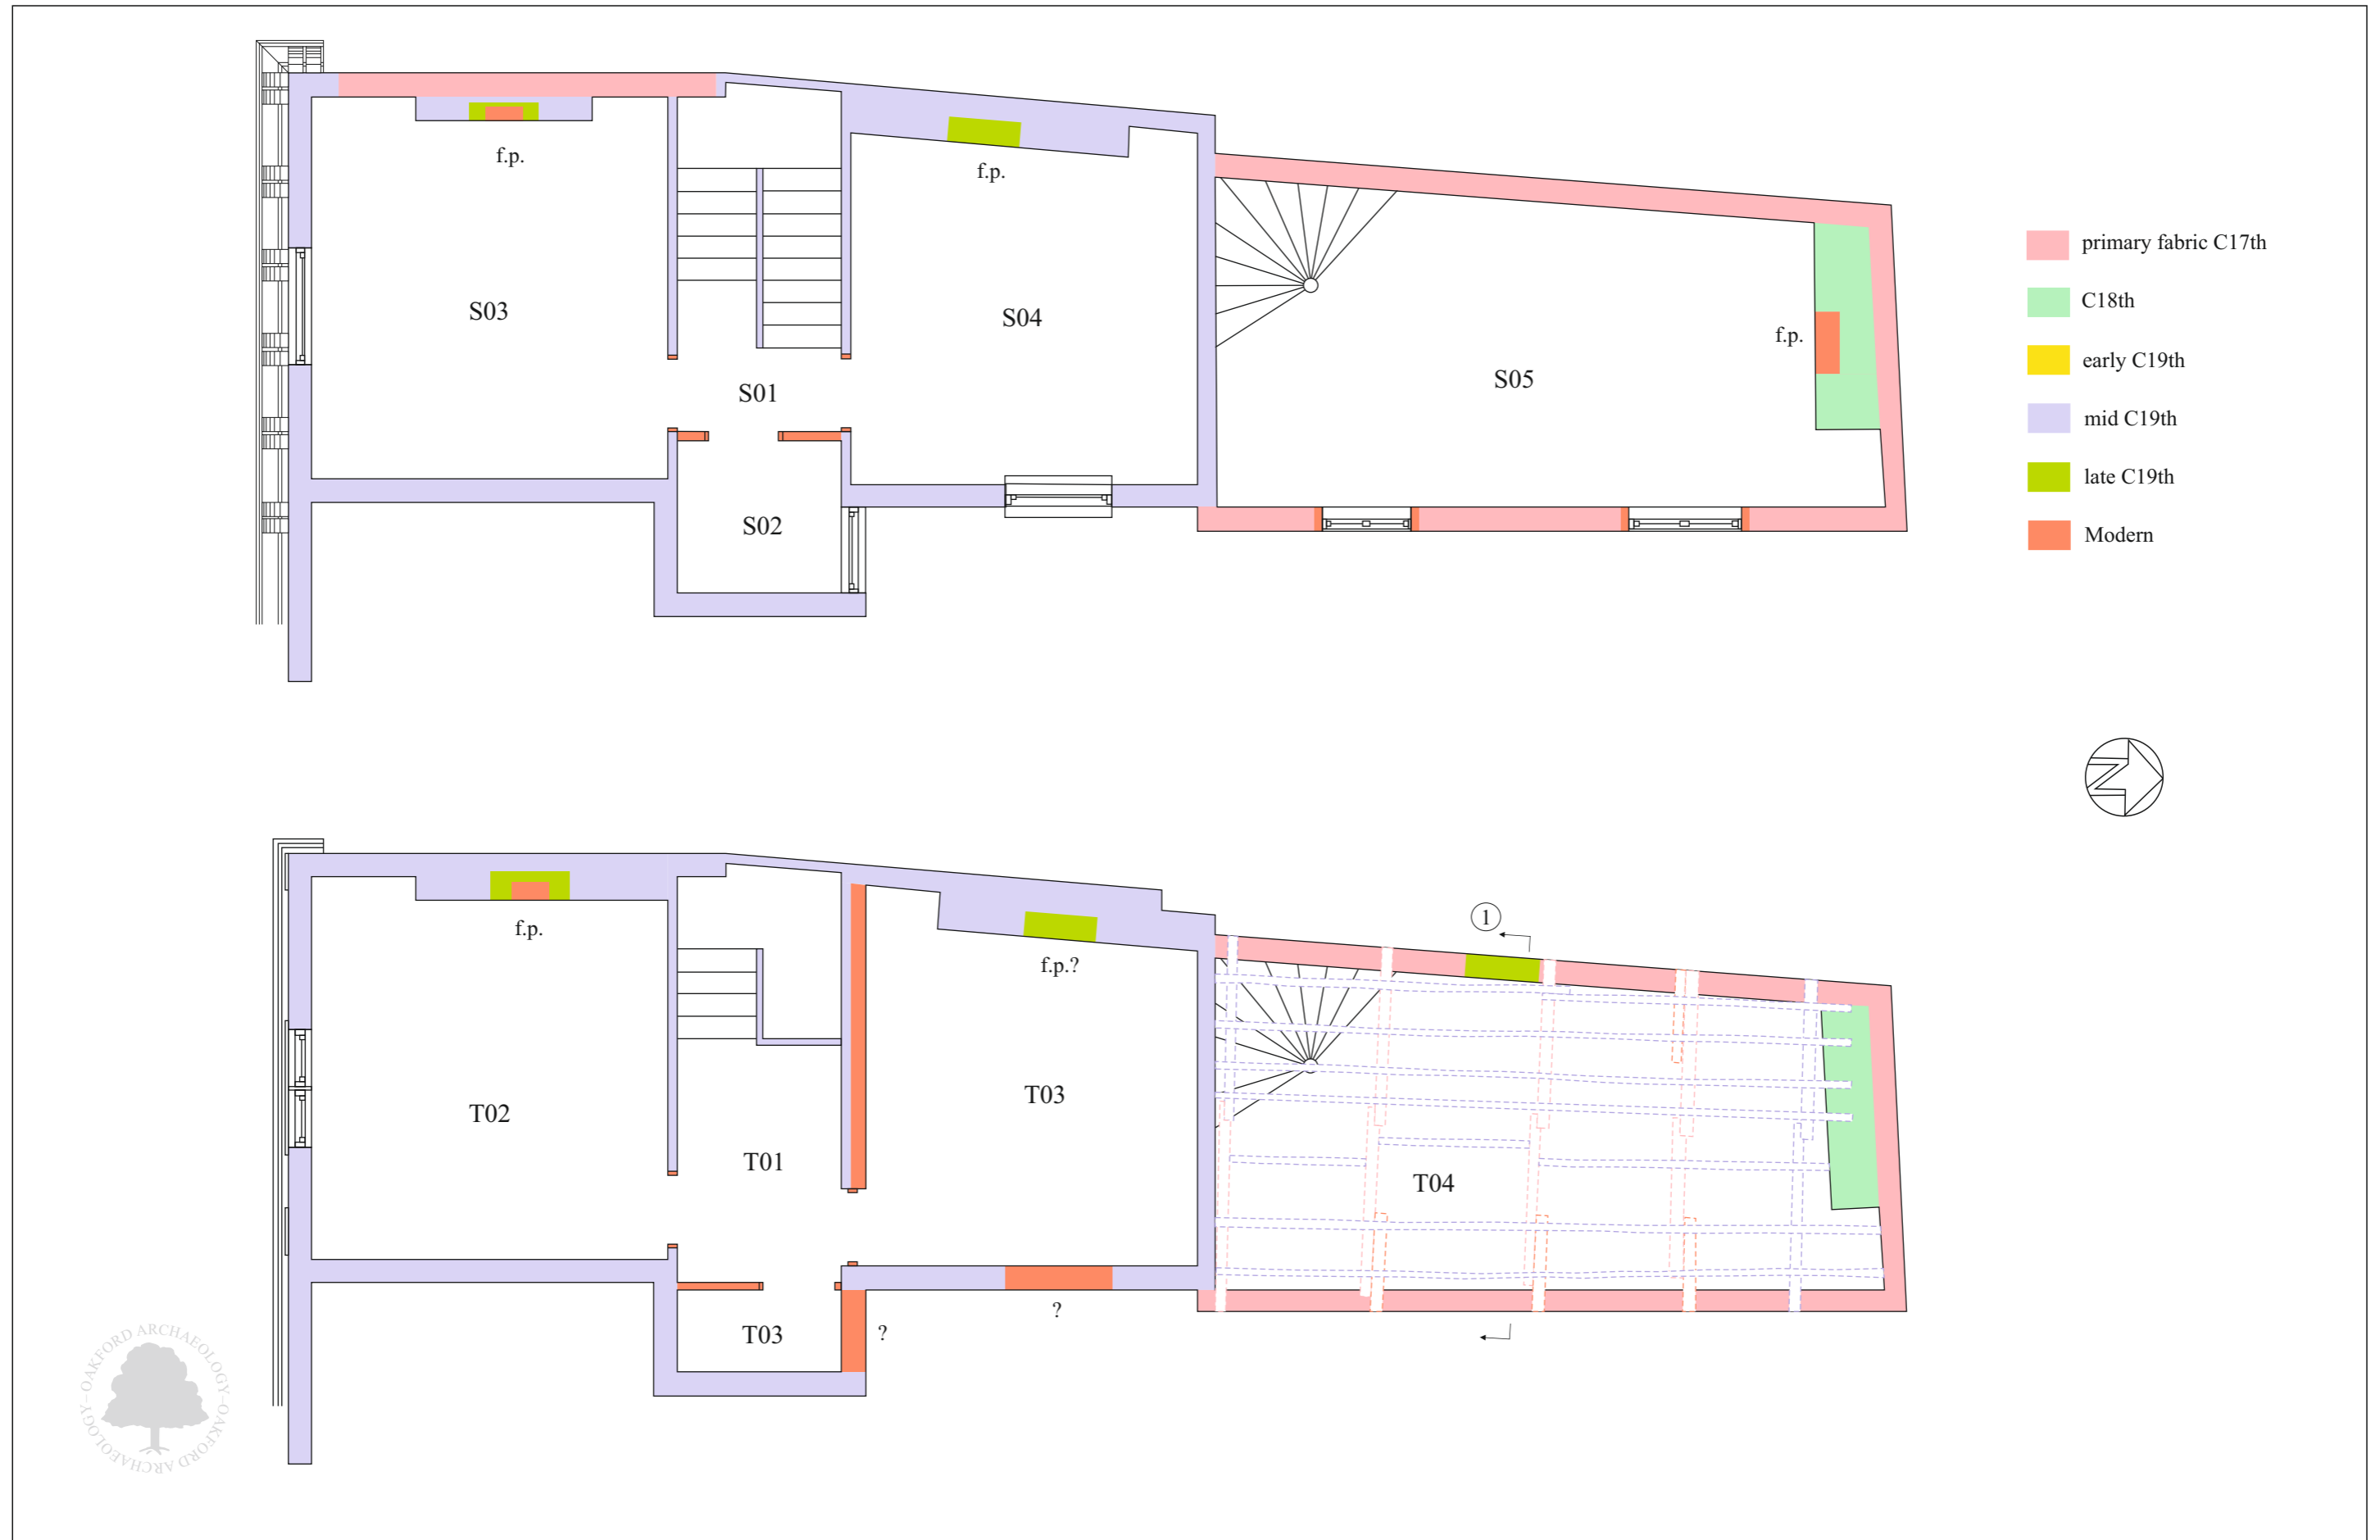
Fig. 11 Plan of second- and third-floor showing location of observations and suggested phases of development.

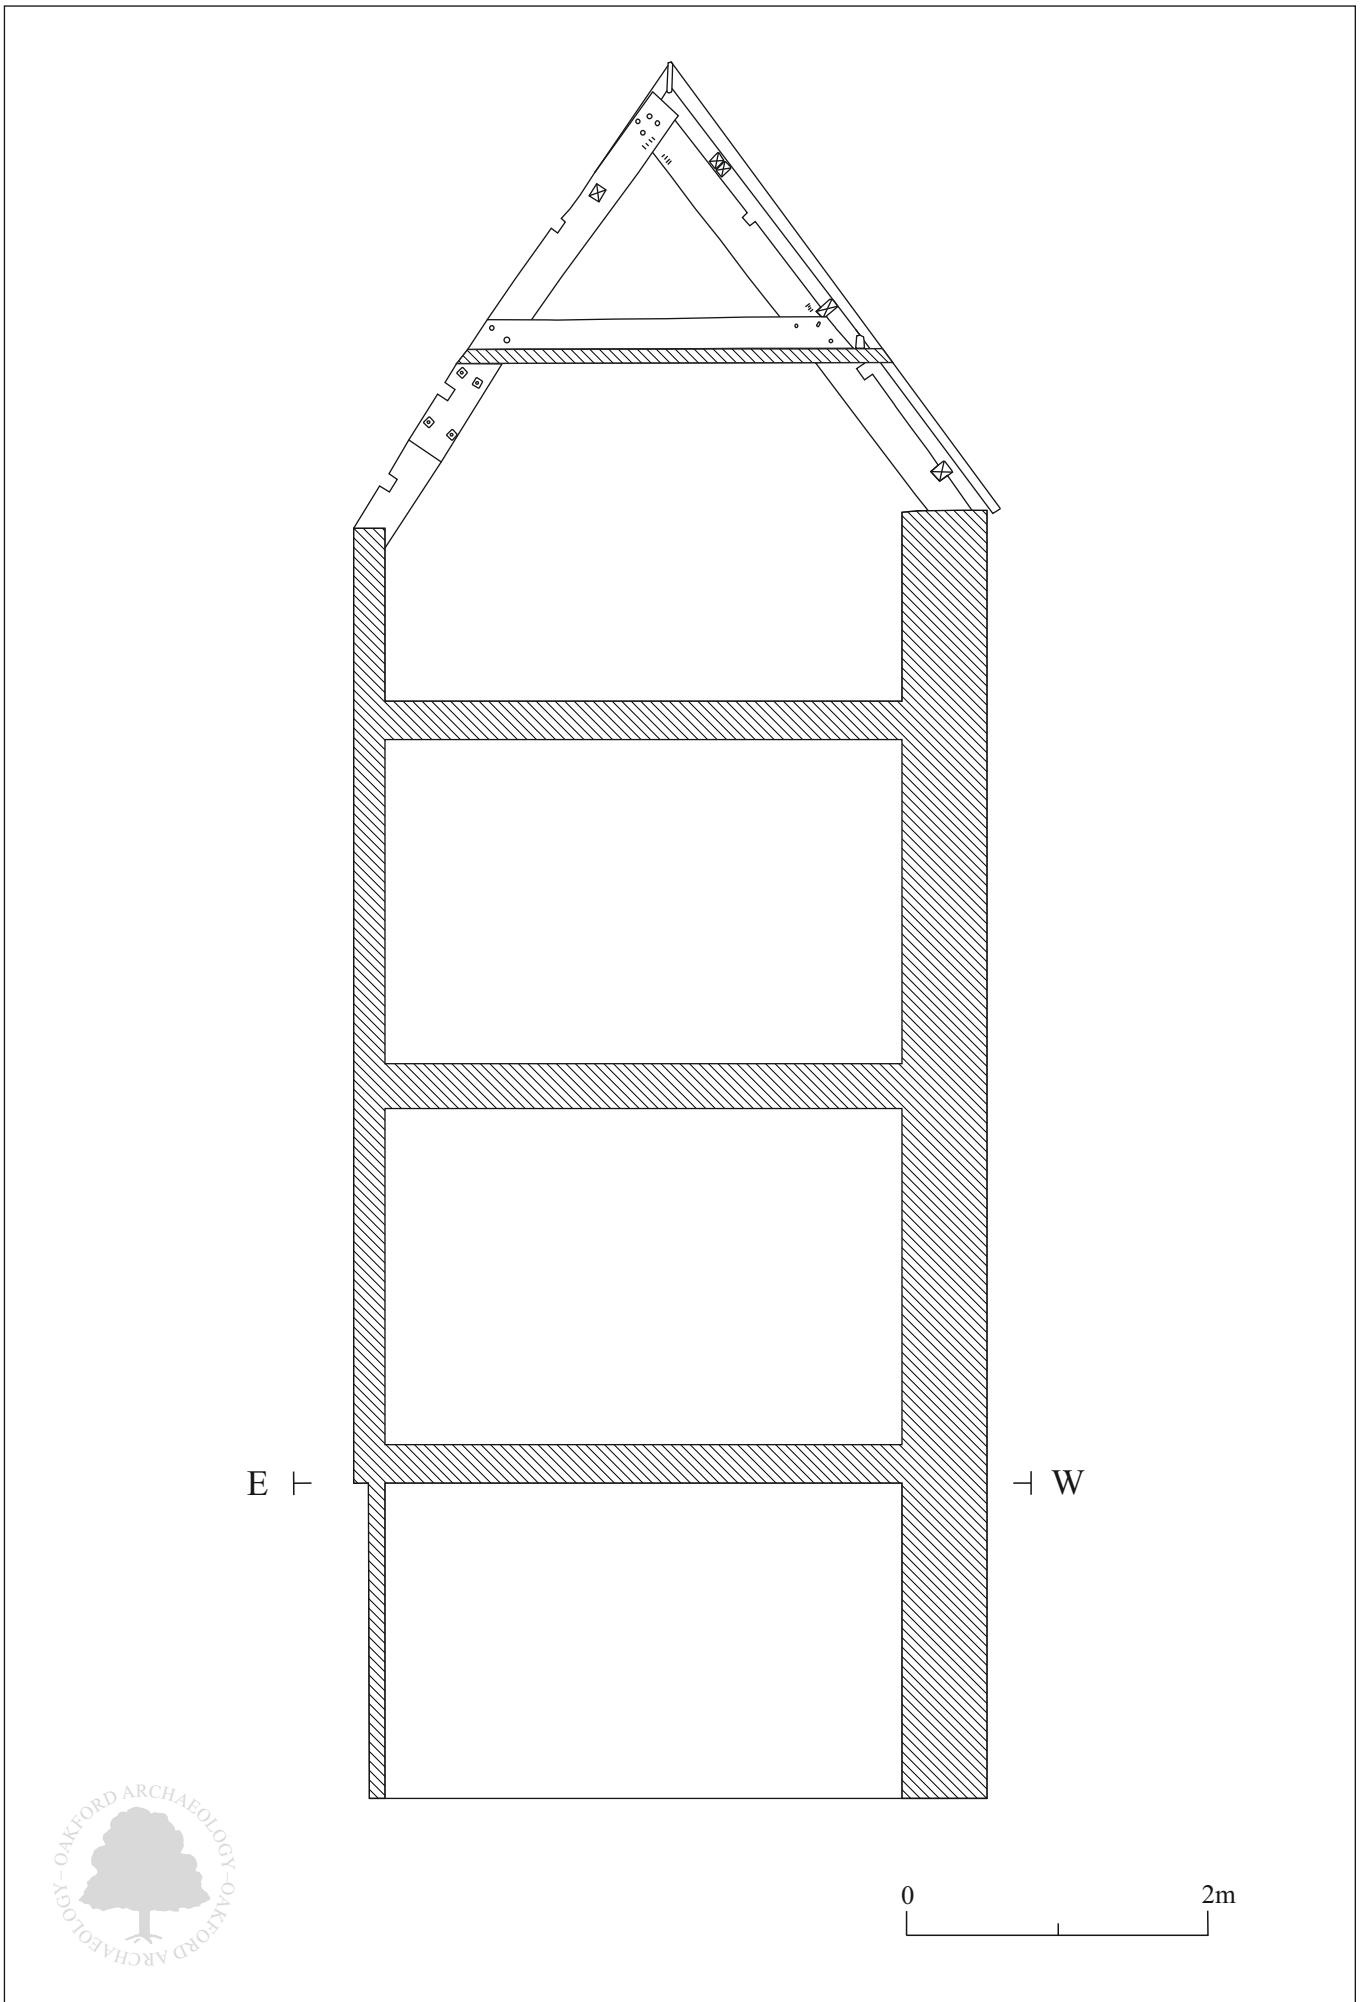
Fig. 12 Cross-section of rear range showing floor and roof construction.

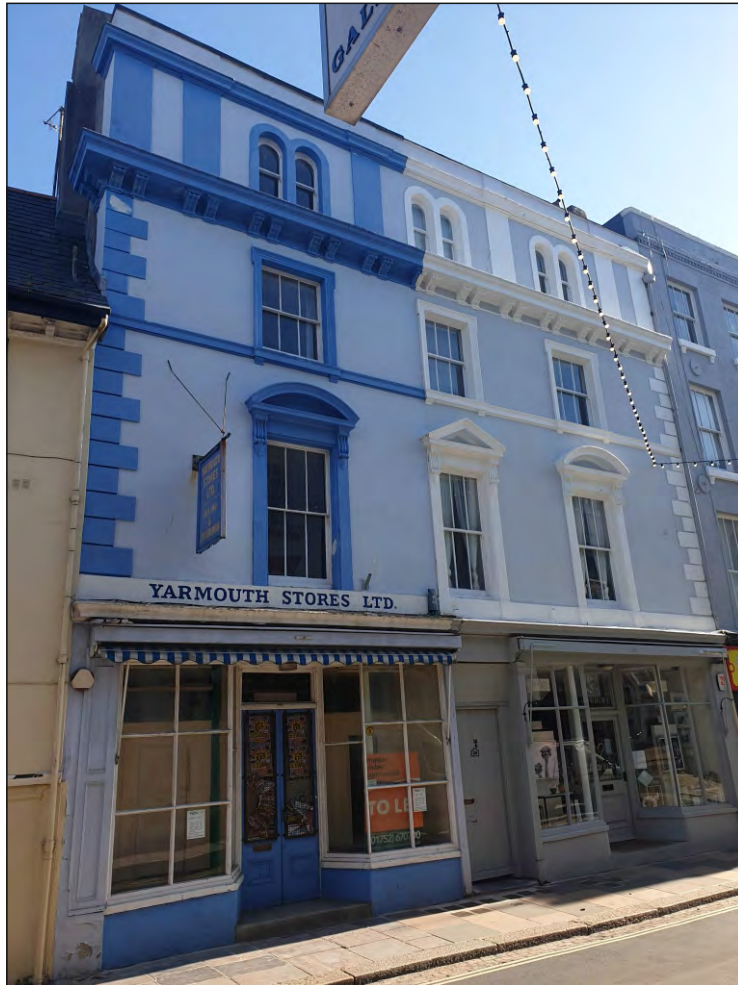
Pl. 1 General view of Nos. 25 and 26 showing mid-19th century stucco façade and originally symmetrical late 19th century ground-floor shop premises. Looking northeast.

The south elevation of the house is its principal façade (Pls. 1-2), presenting a four-storey elevation to the street under a gently pitched slate roof parallel with the street frontage. The façade was designed to be symmetrical with the adjoining property with the central ground floor doorway flanked by double shop fronts. The ground floor windows retain their original late 19th century arrangement, consisting of six large panes, while the horizontal glazing bars in the entrance splays have been replaced with a single bar and asymmetrical panes. In addition, the entrance doorway has been rebuilt, raising the height of the door and reducing the size of the light above, and the current door inserted sometime in the early 20th century. No. 26 retains the original late 19th century retractable awning with its delicate cast-iron arms and timber case, while the original retractable awning at No. 25 was replaced sometime in the late 20th century (Pls. 3-4). Above the level of the ground floor the main façade is decorated in stucco, consisting of rusticated plaster quoins to the level of the second floor. The first-floor window has classical pilastered surrounds with a curved pediment on consoles and a mid-19th century hornless sash. The quoins are interrupted on the second floor by a moulded sill string which breaks forward to form a bracketed sill. The window has moulded eared architraves and retains its mid-19th century hornless sash. The sill of the third floor consists of a heavily moulded cornice with paired modillions and, unlike the quoins on the lower storeys, returns to the west elevation. The third floor is lit by a pair of round-arched windows containing late 19th century horned sashes flanked by plain pilasters underneath a moulded cornice and low parapet. The gently pitched roof is gabled with a large chimney stack.

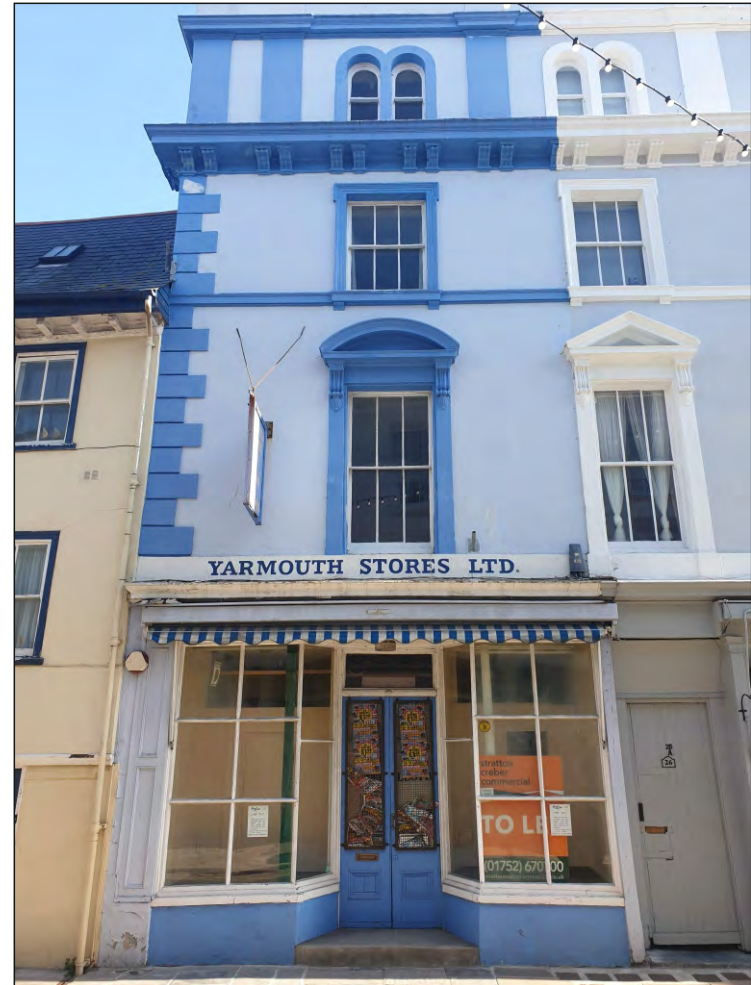
Pl. 2 Close-up of No. 25 showing 20th century replacement shop doorway and door, replacement single glazing bars on both shop window splays and modern awning. Looking north.

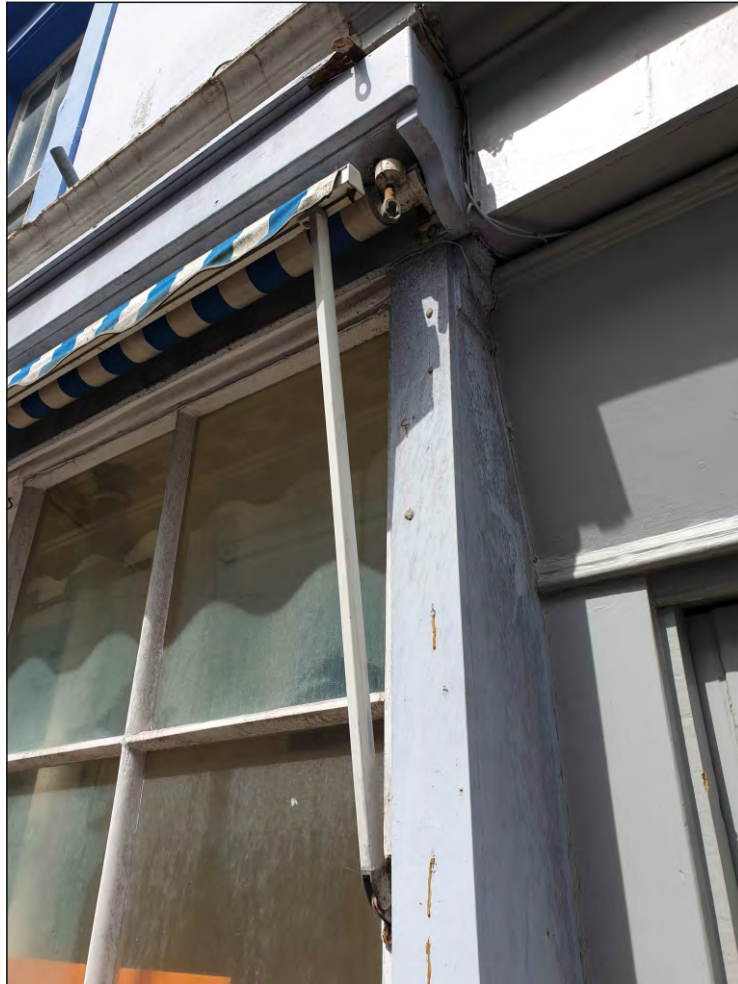
Pl. 3 Close-up of modern awning below original wooden container at No. 25. Looking northwest.

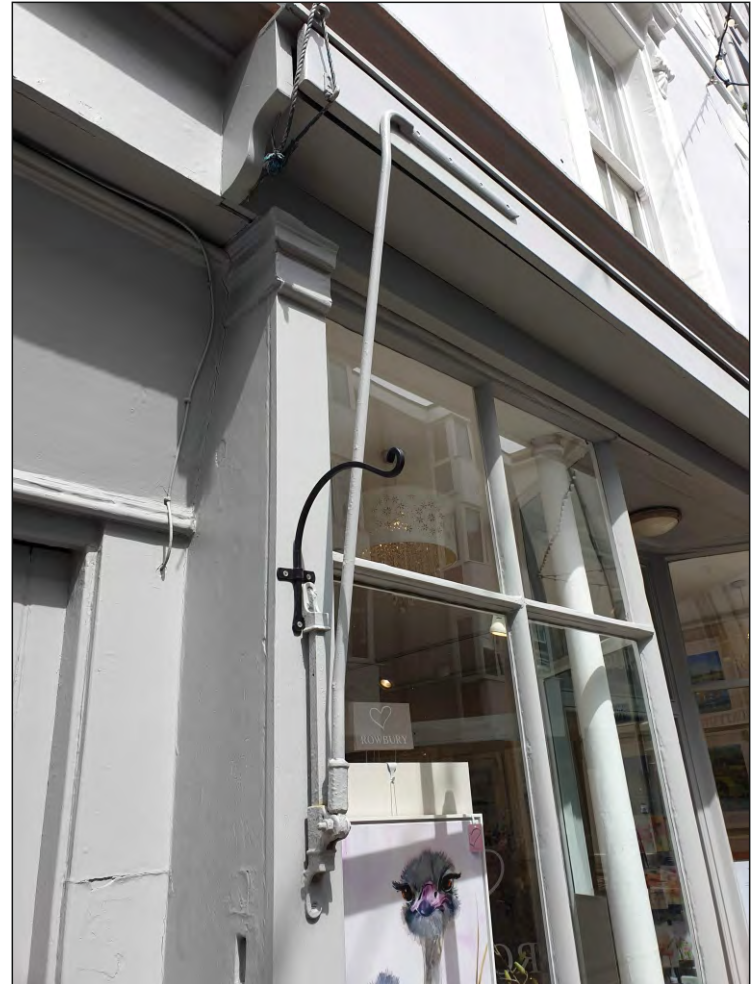
Pl. 4 Close-up of original awning mechanism and wooden container at No. 26. Looking northeast.

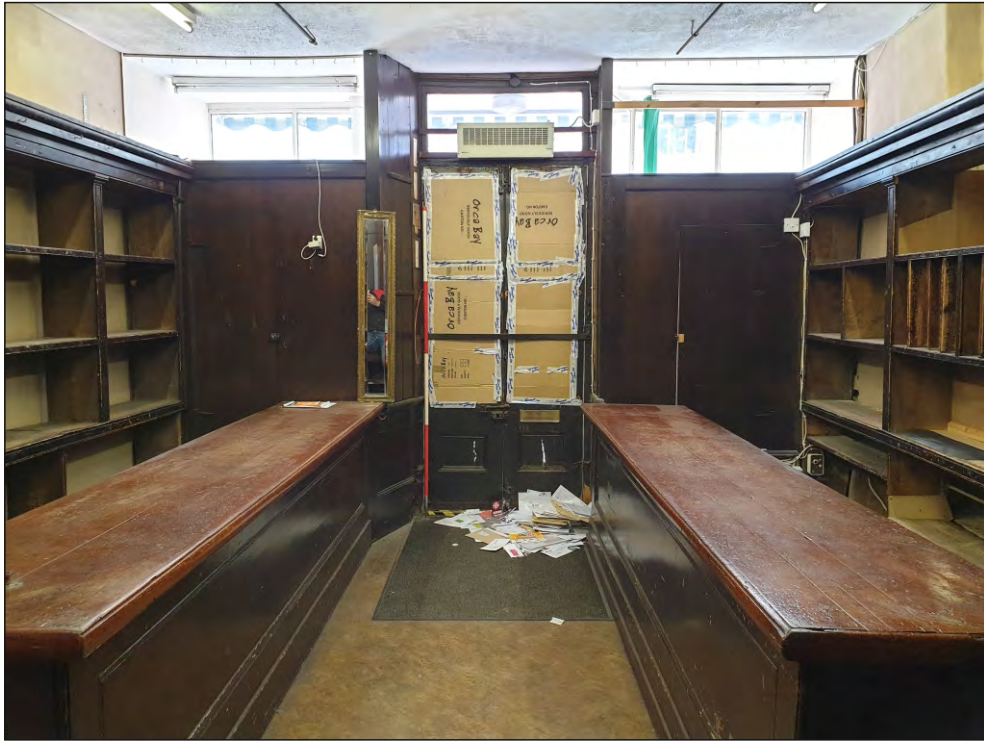
Pl. 5 General view of G01 showing 20th century doorway and modern shop window splays and backs, with late 19th century counters and shelves to left and right. 2m scale. Looking south.

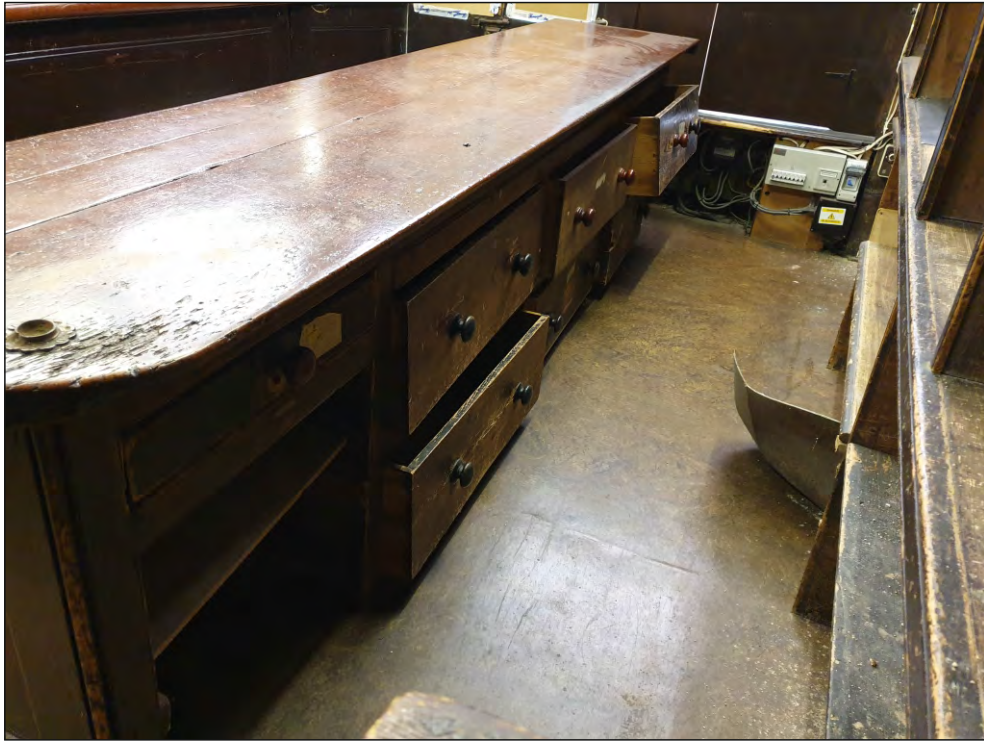
Pl. 7 Close-up of rear of western shop counter showing original drawer configuration and later alterations. Looking southeast.

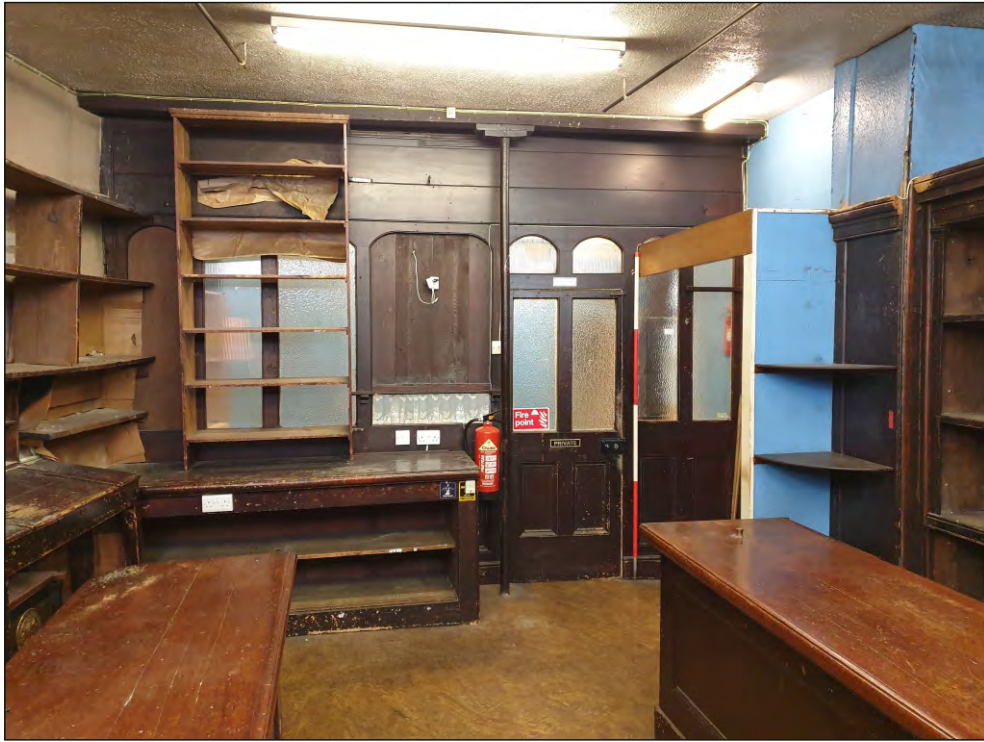
Pl. 9 General view of rear of G01 showing late 19th century partition and modern shelves, with late 19th century shop counter in foreground. 2m scale. Looking north.

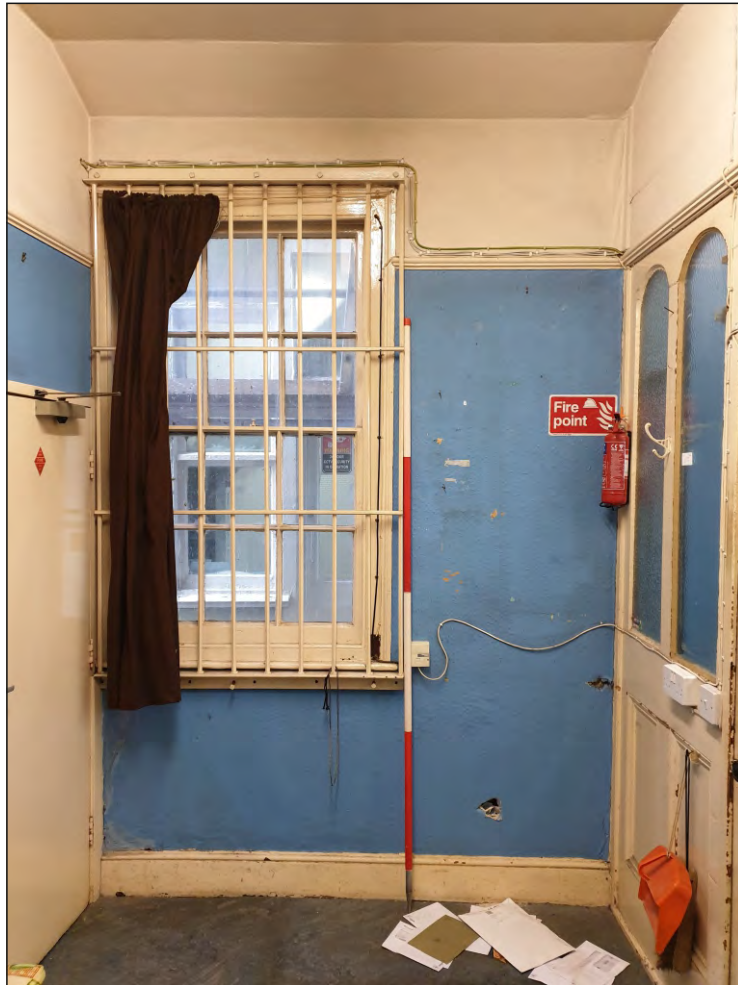
Pl. 11 General view of G02 showing mid-19th century window in east elevation with late 19th century partitions to right and modern door to left. 2m scale. Looking east.

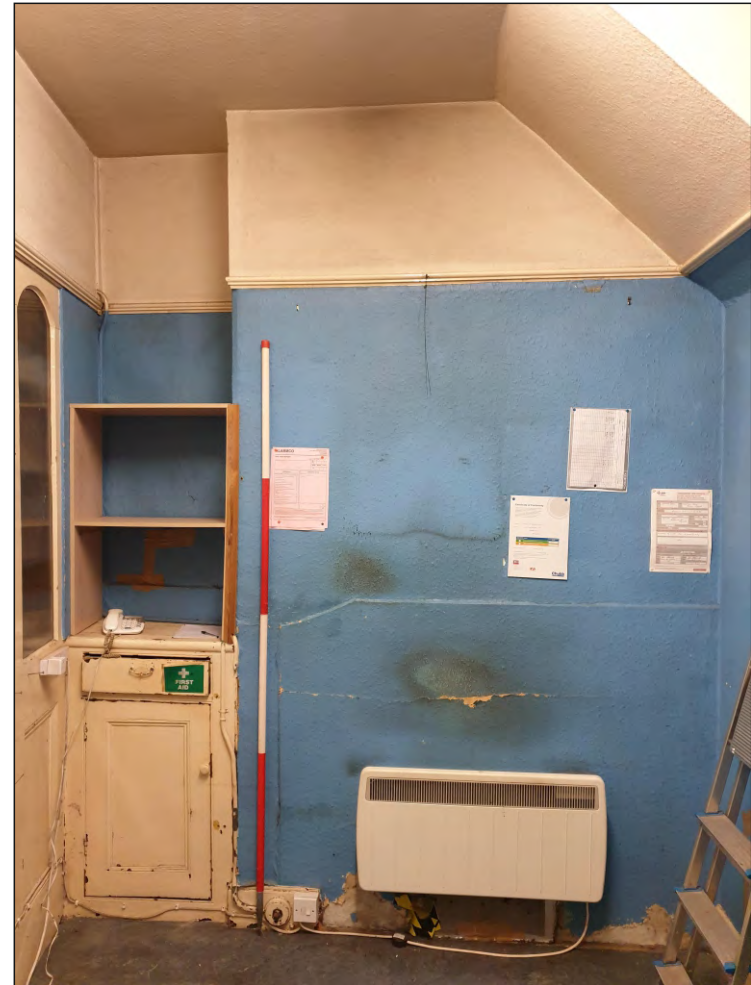
Pl. 12 General view of G02 showing position of former mid-19th century fireplace with low late 19th century cupboard to left. 2m scale. Looking west.

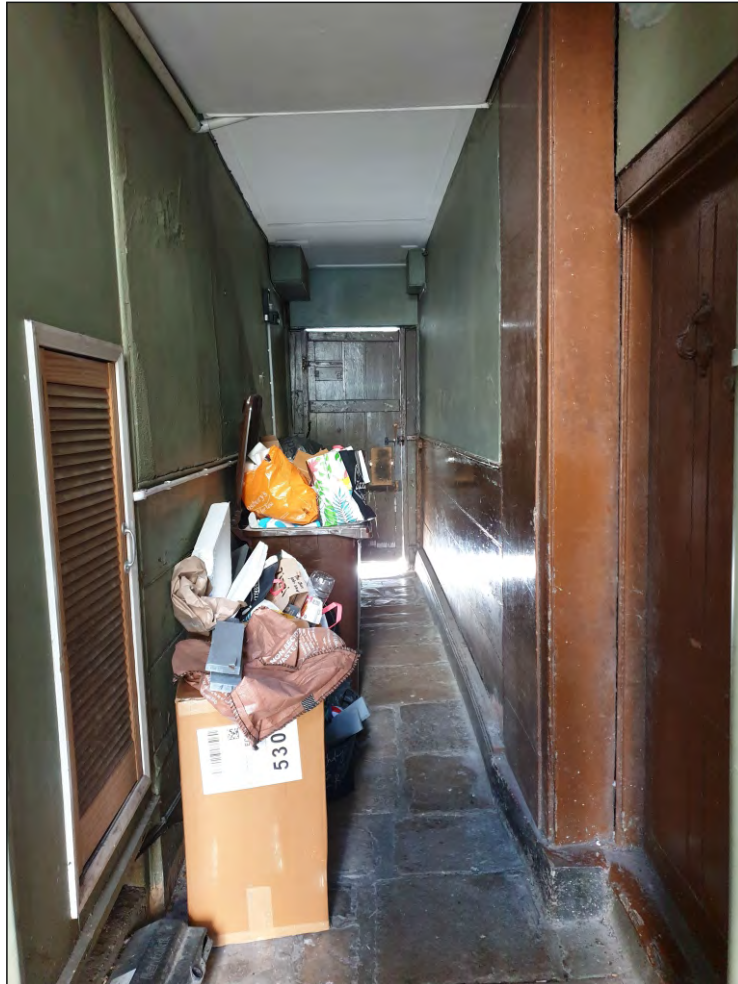
Pl. 13 General view of passage showing set-back mid-19th century doorway to original entrance hall and staircase in G01. Looking south.

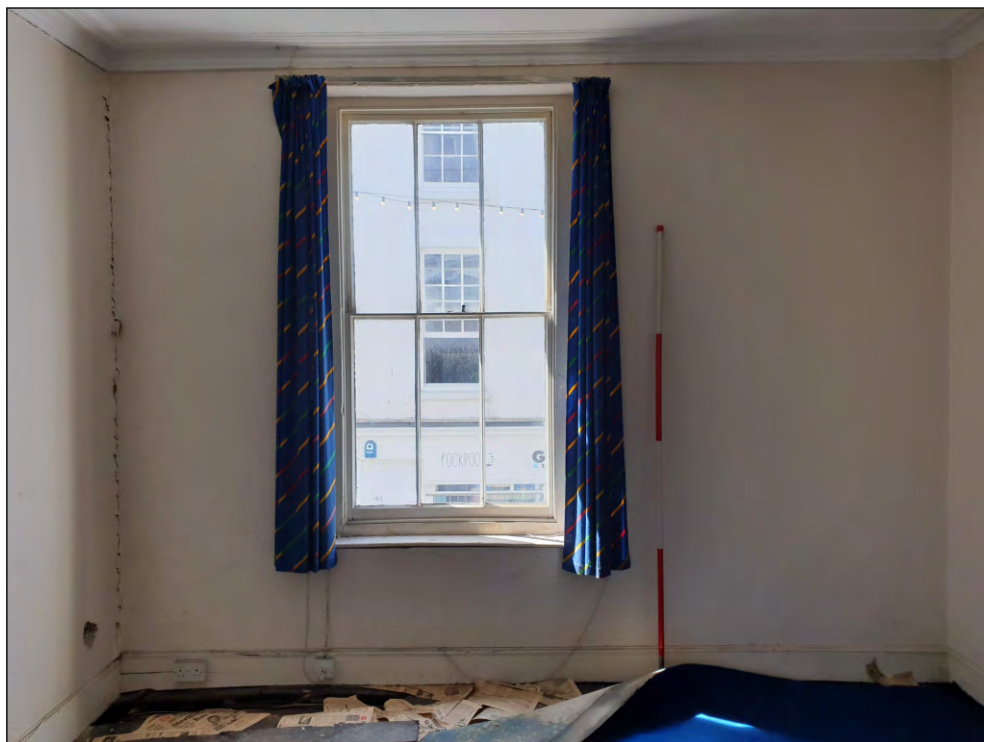
Pl. 20 General view of mid-19th century hornless sash window in F03. 2m scale. Looking south.

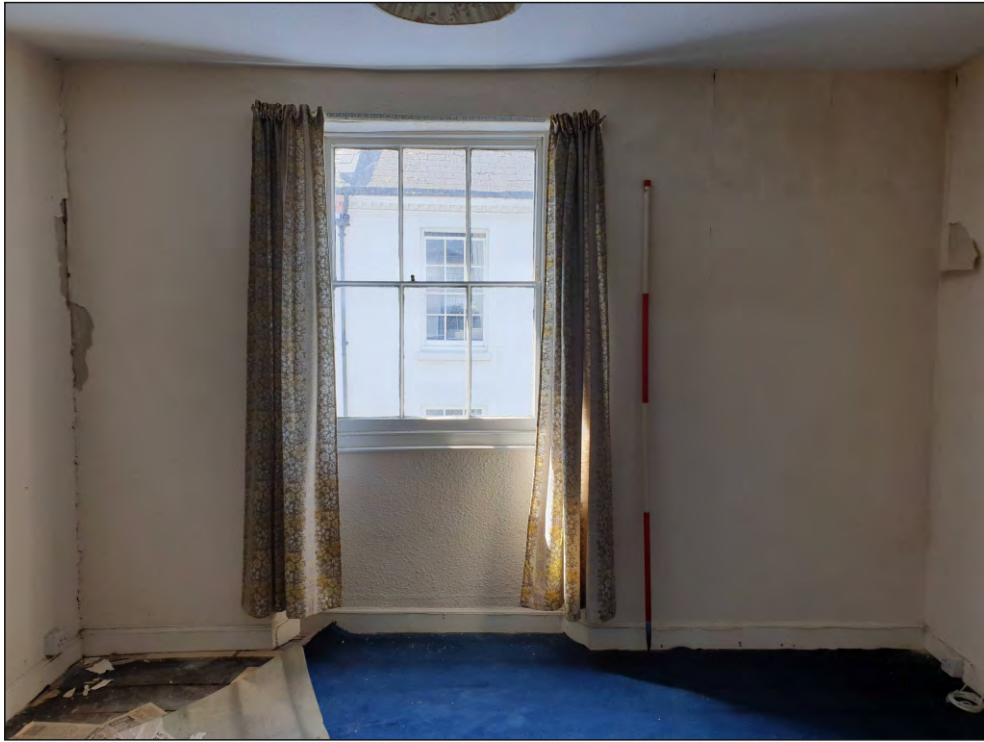
Pl. 27 General view of mid-19th century hornless sash window in S03. 2m scale. Looking south.

Identical doorways provide access to the rooms either side of the central stair. The room on the south side (S03) is lit by a single hornless sash window in the south elevation and was originally heated by a fireplace in the west elevation (Pls. 27-28). To the north of the landing room (S04) retains its original configuration although again the doorframe and door are modern replacements. The room was lit by a single hornless sash window in the east elevation (Pl. 30) while the blocked fireplace was located in the west elevation (Pl. 31).

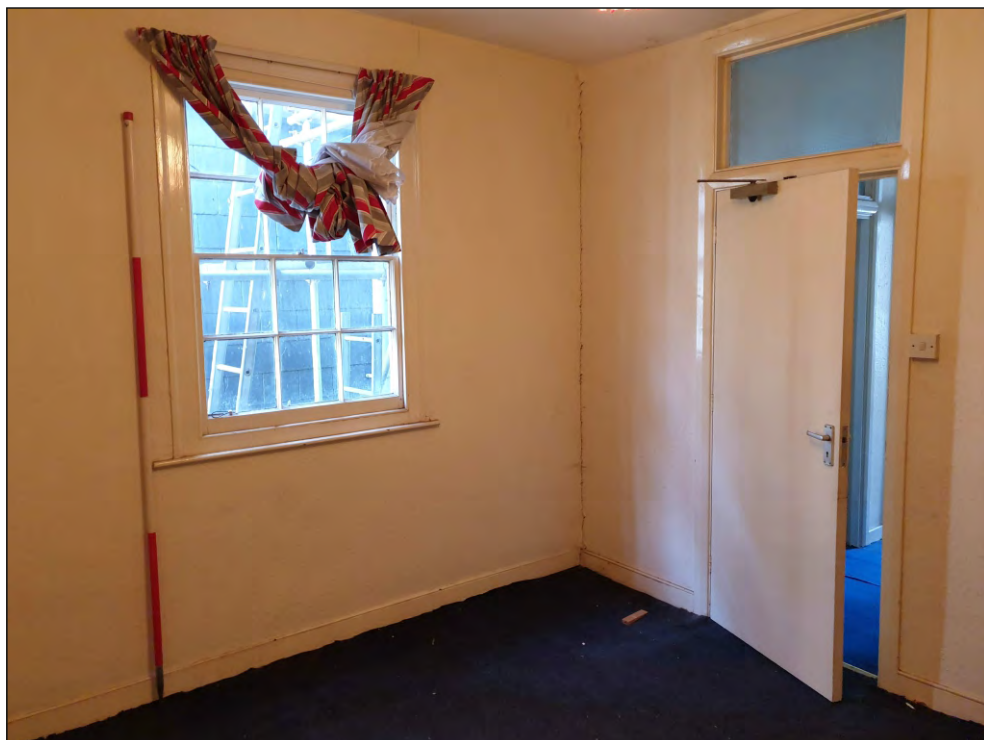
Pl. 30 General view of S04 showing original mid-19th century sash window in east elevation and modern doorway and door. 2m scale. Looking southeast.

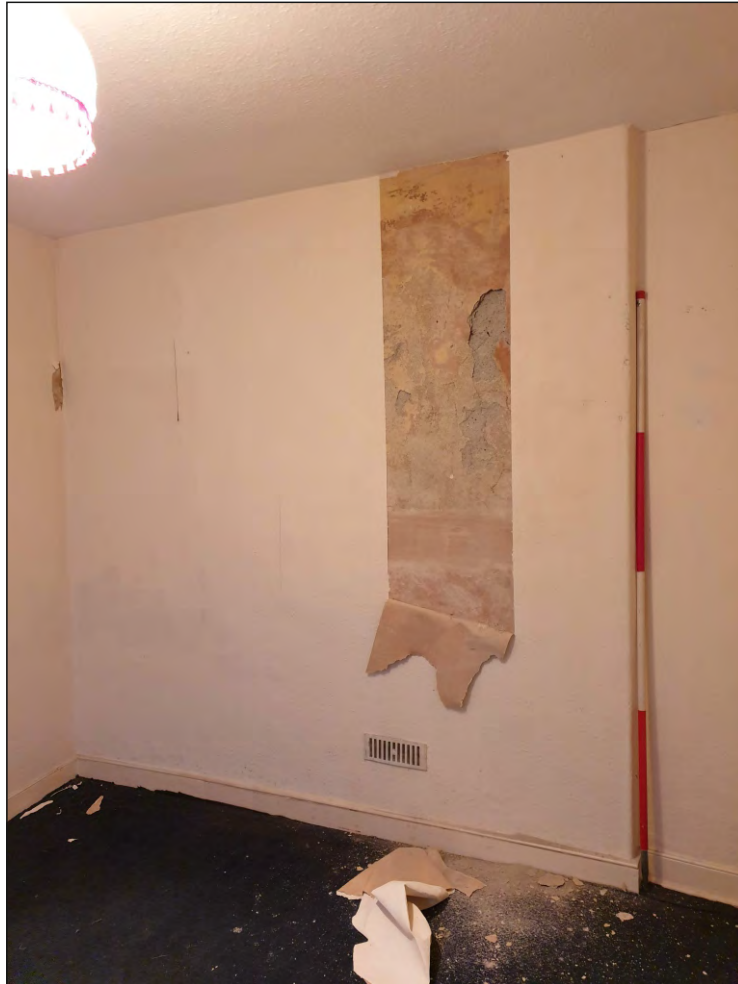
Pl. 31 General view of S04 showing position of former mid-19th century fireplace. 2m scale. Looking southwest.

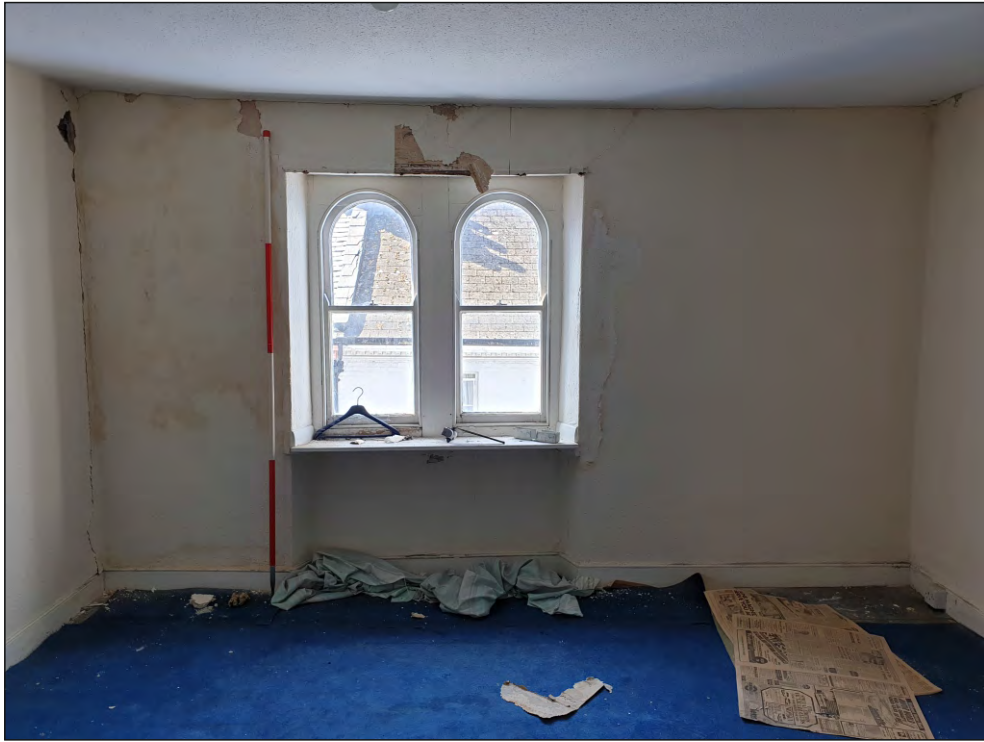
Pl. 35 General view of paired round-arched windows with horned sashes in T02. 2m scale. Looking south.

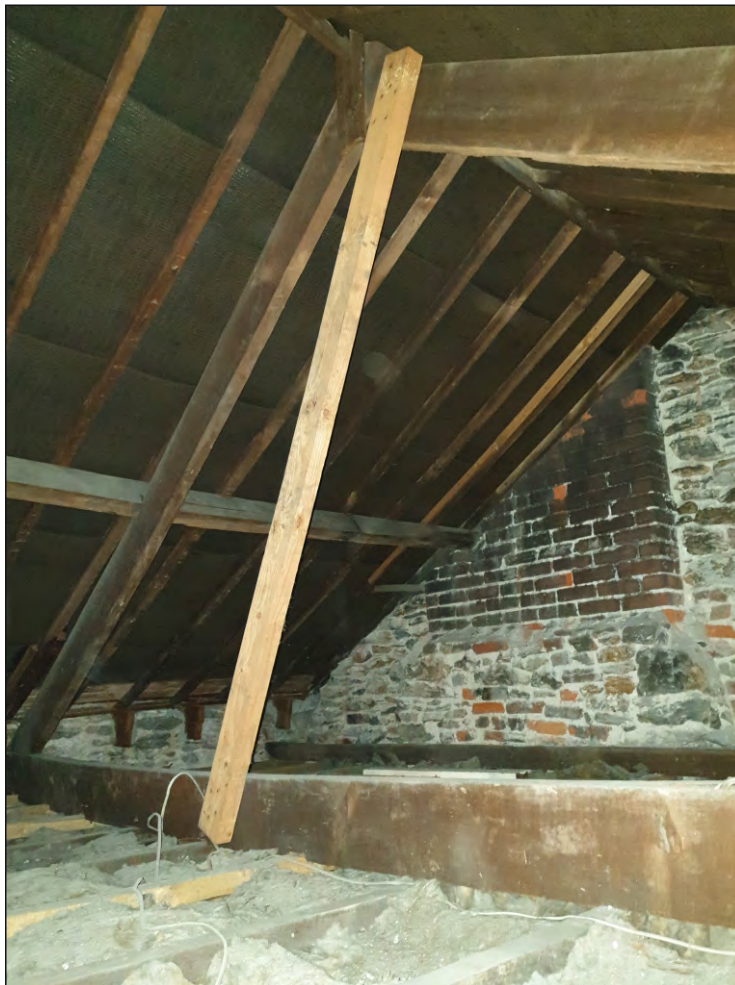
Pl. 38 General view of mid-19th century roof structure. Looking southwest.
