**Historic building recording at No. 25 Southside
Street, The Barbican Plymouth, Devon**

Report No. 21-11

Project No. 1800

June 2021

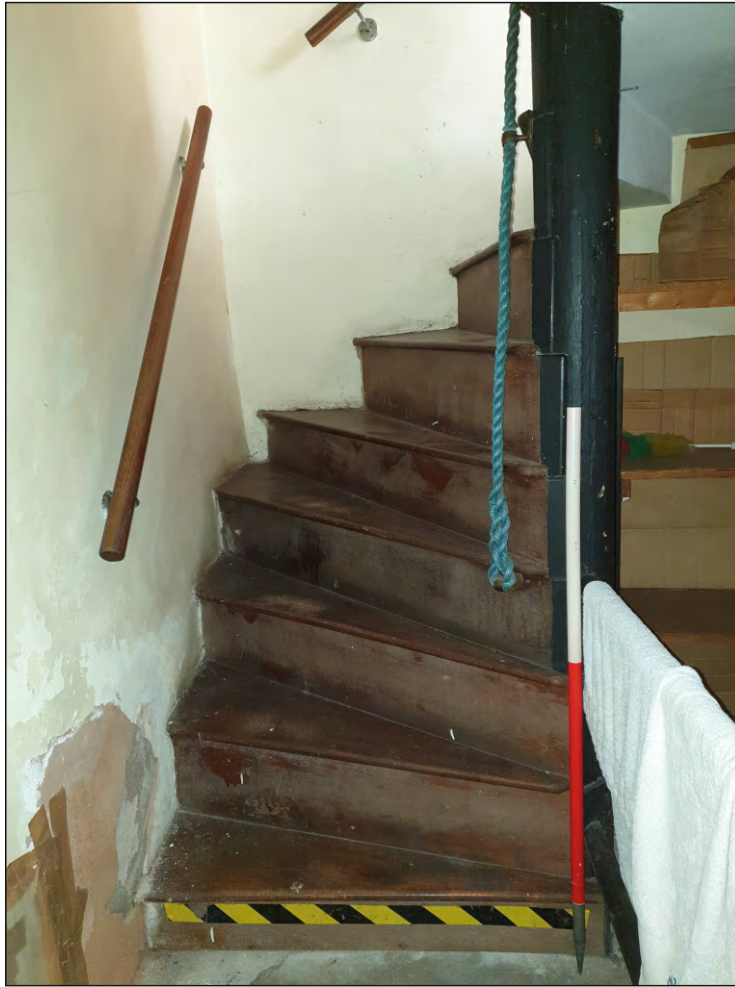
Pl. 43 Close-up of circular stair in G04 showing newel consisting of re-used mast and modern treads-and-risers. 1m scale. Looking west.

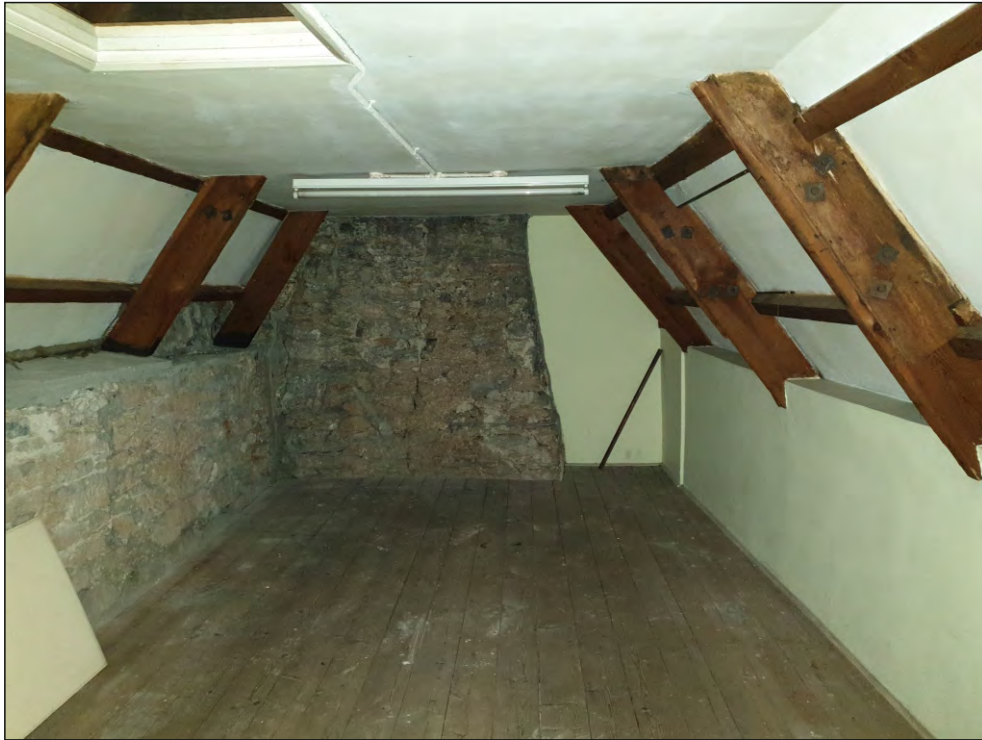
Pl. 47 General view of T04 showing multi-phase chimney in north elevation and feet of heavily repaired 17th century roof trusses. Looking north.

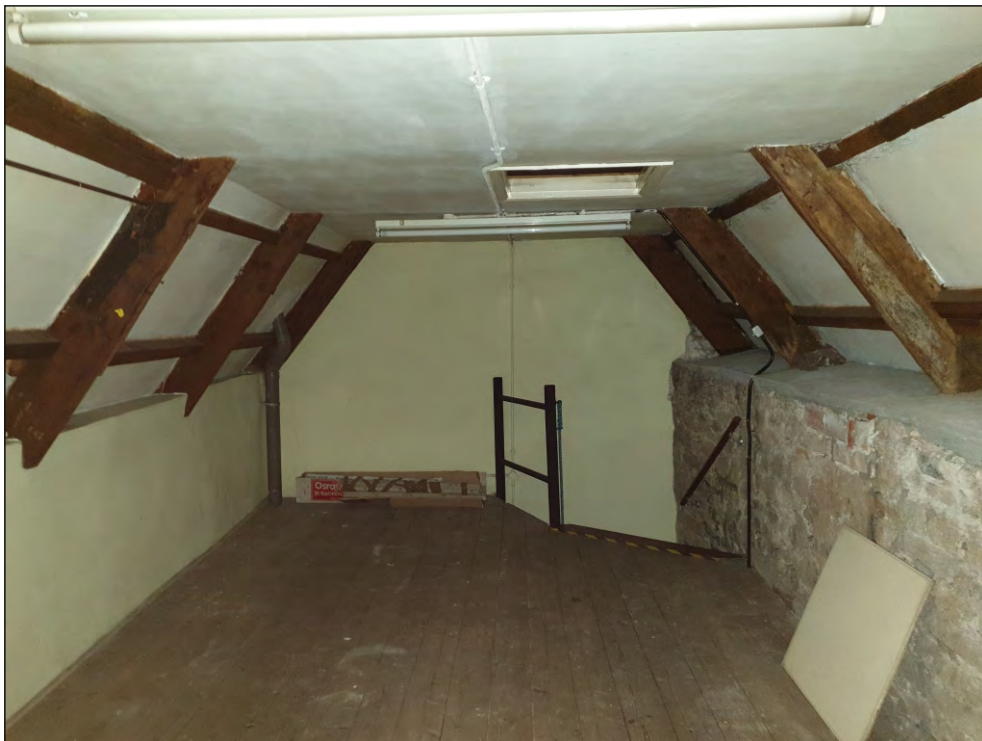
Pl. 48 General view of T04 showing blocking in west elevation of possible dormer window and feet of heavily repaired 17th century roof trusses. Looking north.

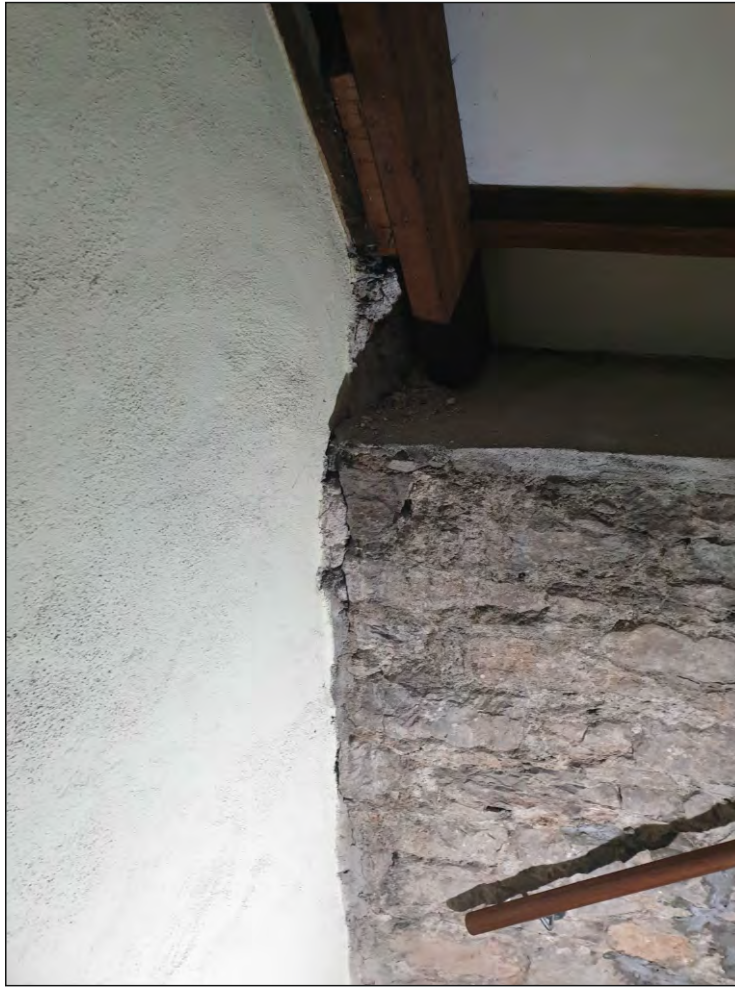
Pl. 49 Close-up showing a small gap between the north elevation of the central block and the rear range showing the former is a later rebuild. Looking southwest.

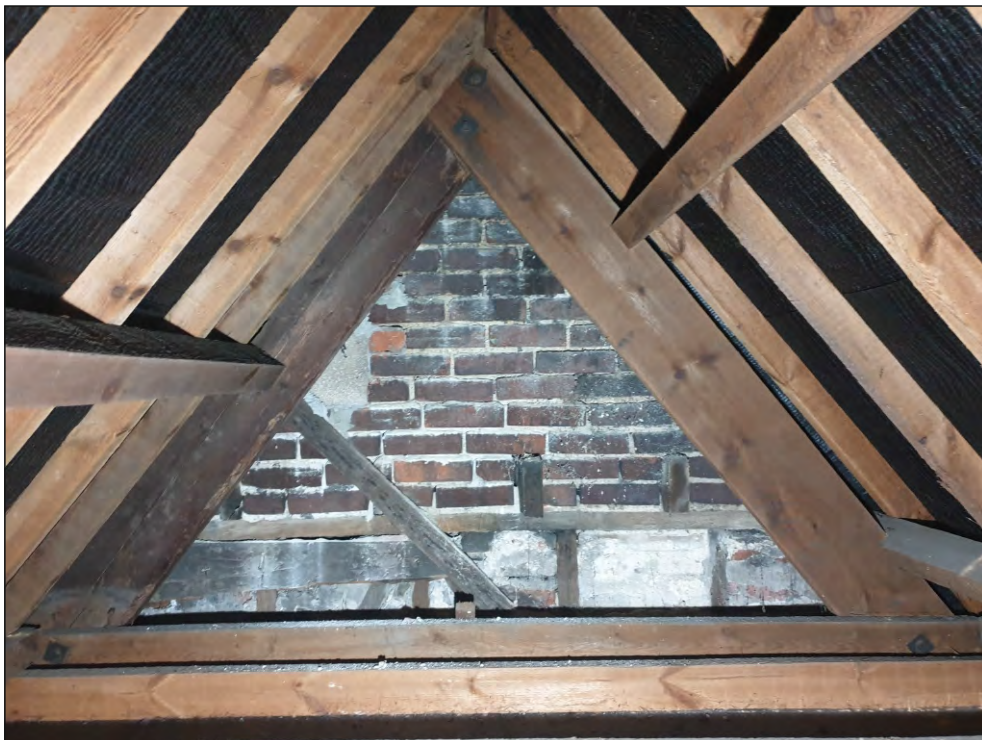
Pl. 50 General view of the roof structure showing original 17th century truss (left), 19th century replacement truss and purlins (right) and modern common rafters. In the background is the north elevation of the mid-19th century infill. Looking south.

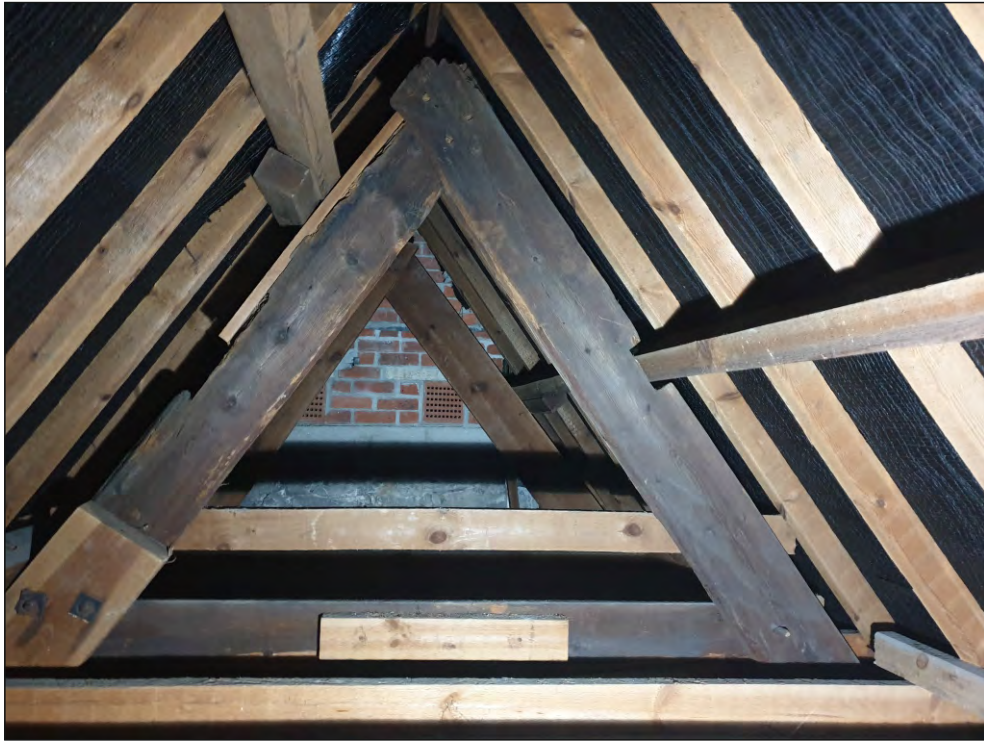
Pl. 51 General view of the roof structure showing original 17th century trusses (foreground) and 19th century replacement trusses (background) and purlins, and modern common rafters. Looking north.
