**Archaeological monitoring and recording at Milton  
Abbey, Milton Abbas, Dorset**

**Report No. 21-19**

**May 2021**

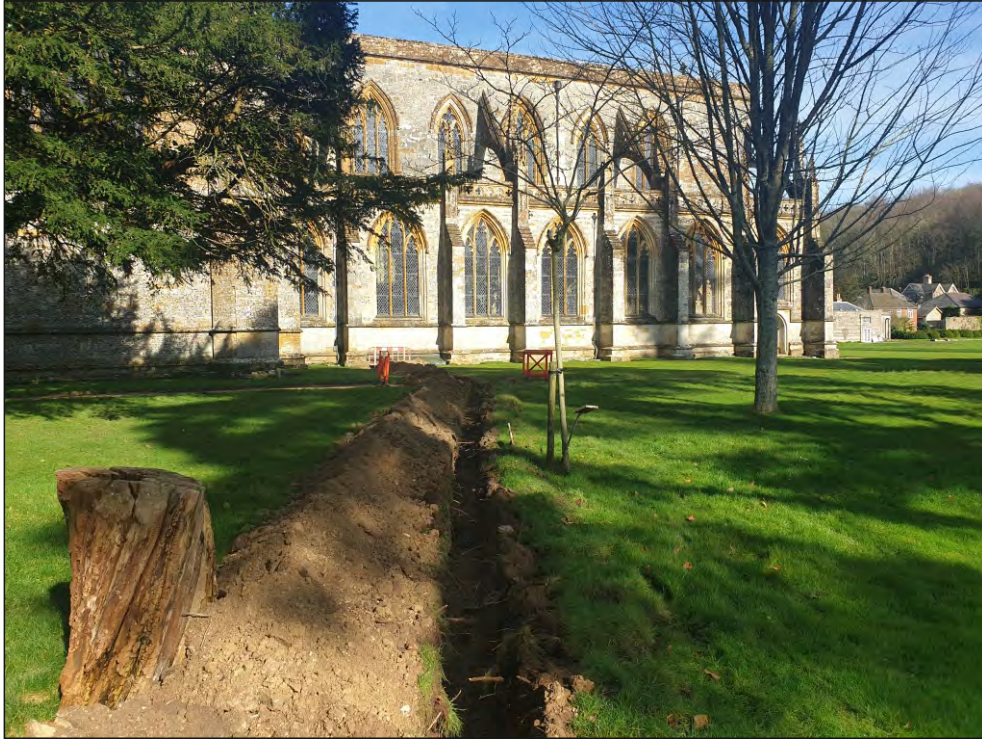
Pl. 1 General view of water trench to south of abbey. 2m scale. Looking northeast.

The trench for the new water main was excavated over a distance of approximately 45m from the boiler house on the south side of the south choir aisle. This area was part of the monastic graveyard during the medieval period and continued to serve as the town graveyard until the late 18<sup>th</sup> century. The trench was excavated to a maximum depth of 0.6m and uncovered a generally uniform layer sequence of light yellow sand and gravel (100) overlying a light yellowish-brown silty clay (101) with frequent inclusions of redeposited chalk. This

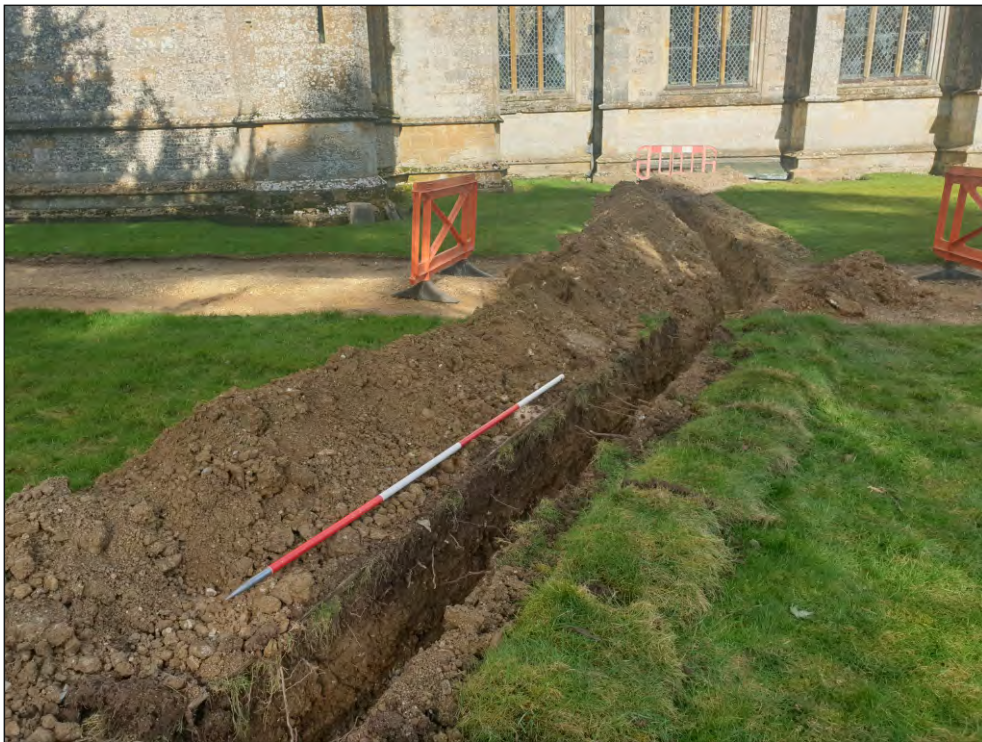
Pl. 2 General view of water trench showing 18th century landscaping (102) above charnel soil (101). 2m scale. Looking northwest.

Once the trench crossed the main path on the south side of the abbey church a 0.15-0.25m thick dark brown silty clay topsoil (102) overlay the charnel soil. This has been interpreted as 18<sup>th</sup> century landscaping following the demolition of the town and landscaping of the grounds.

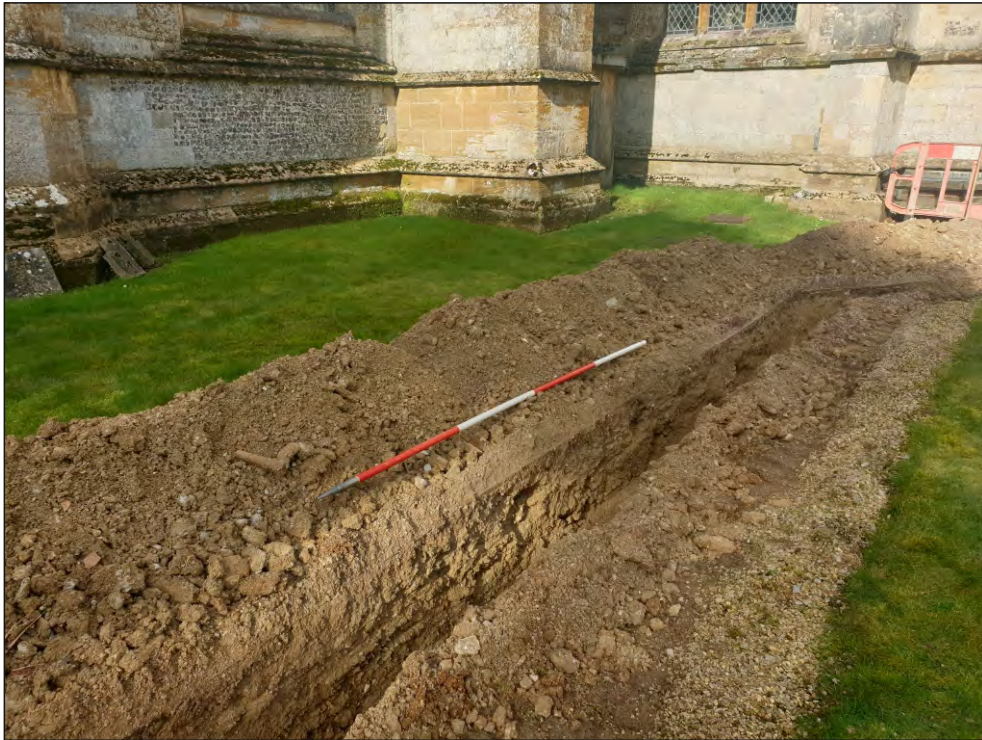
Pl. 3 General view of water trench showing path (100) above charnel soil (101). 2m scale. Looking northwest.

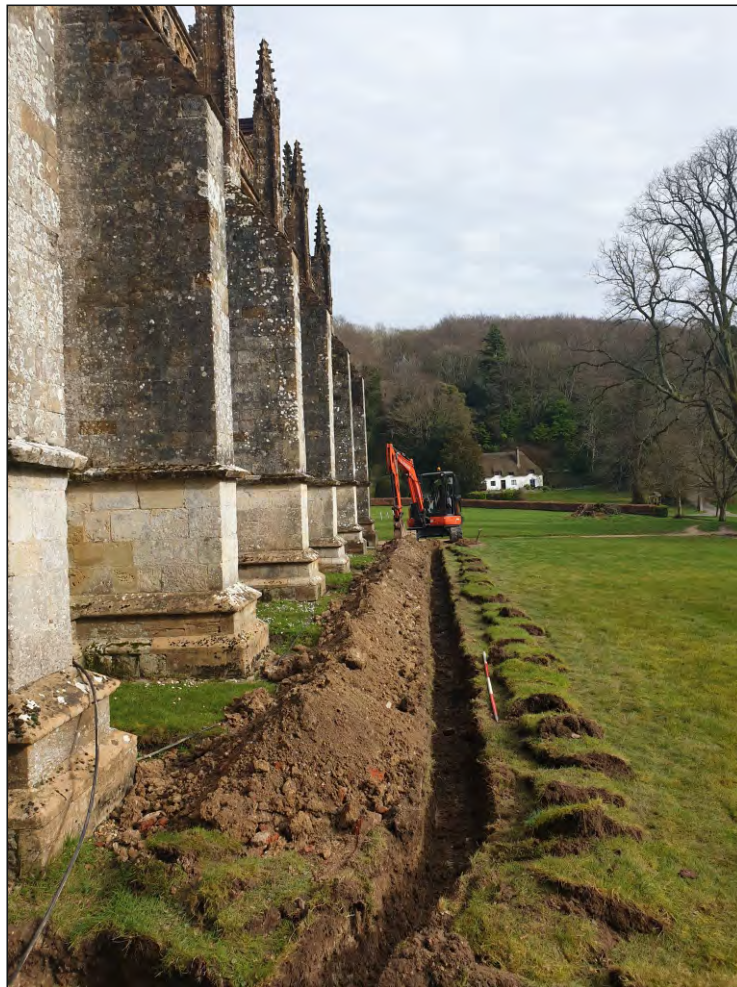
Pl. 4 General view of electric trench to south of abbey choir. 2m scale. Looking east.

The electric trench to the south of the choir was excavated to a maximum depth of 0.45m and uncovered a generally uniform layer sequence of dark brown silty clay topsoil (103) overlying a light yellowish-brown silty clay (101) with frequent inclusions of redeposited chalk. This contained occasional fragments of disarticulated human bone and has been interpreted as a charnel soil. No distinct grave cuts were identified during the works.

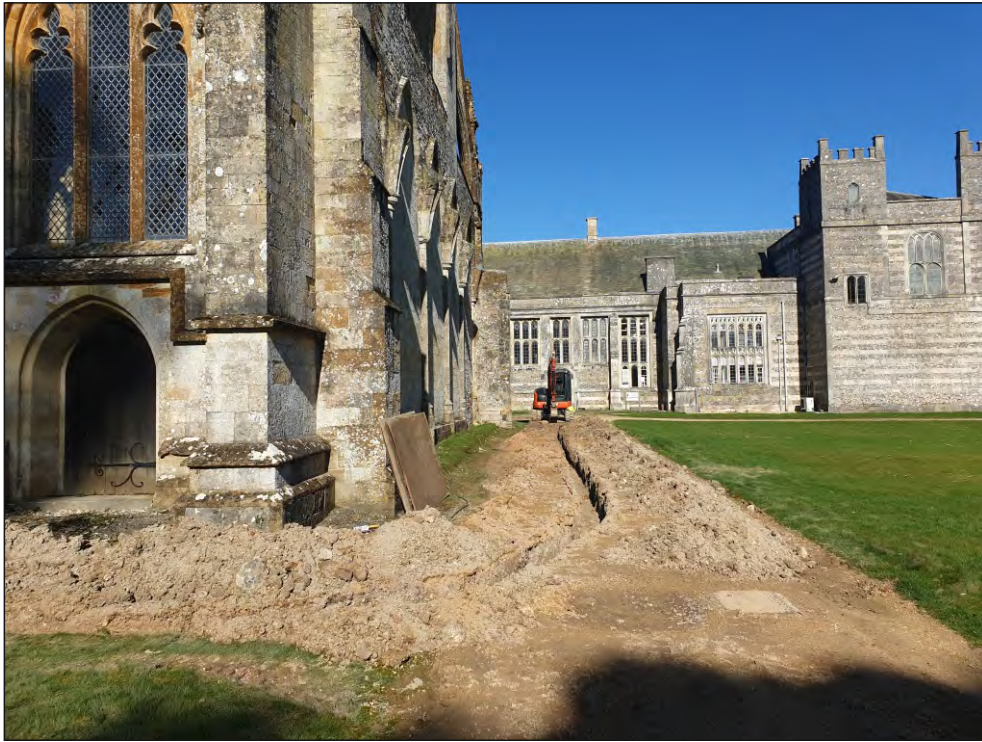
Pl. 5 General view of electric trench across east end of abbey church. Looking north.

The trench crossed the former east end of the church with its ambulatory and three chapels, although due to the shallow nature of the works and its location within the line of an earlier drainage trench excavated in 2017, no further archaeological deposits or features were uncovered.

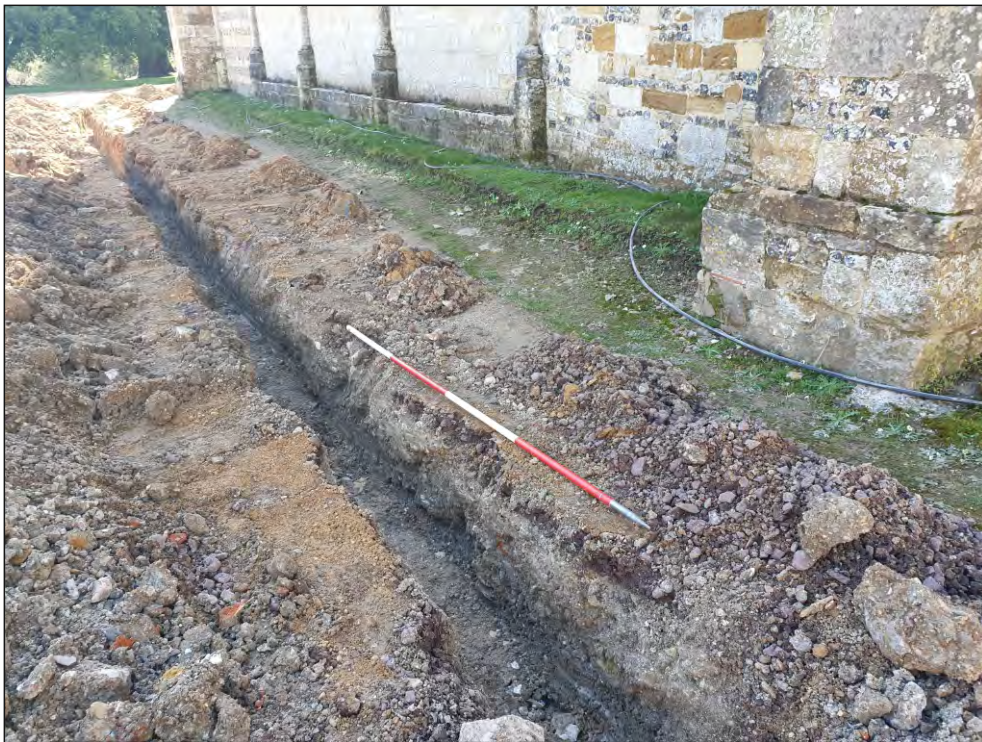
Pl. 6 General view of electric trench across east end of abbey church showing backfill of 2017 trench. 2m scale. Looking southwest.

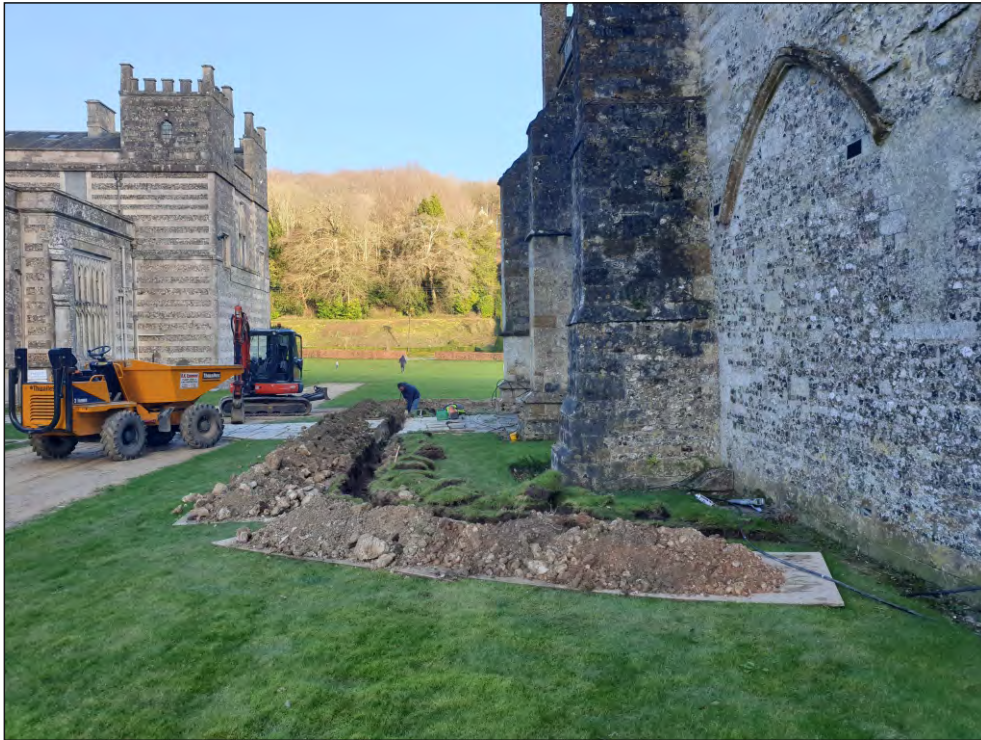
Pl. 7 General view of electric trench on north side of abbey church with the position of the former sacristy in the foreground. 2m scale. Looking east.

The excavations on the north side of the abbey exposed an extensive rubble deposit (104) which is likely associated with the demolition of the sacristy in the 1730s and the subsequent landscaping of this area following the construction of the house in the 1770s.

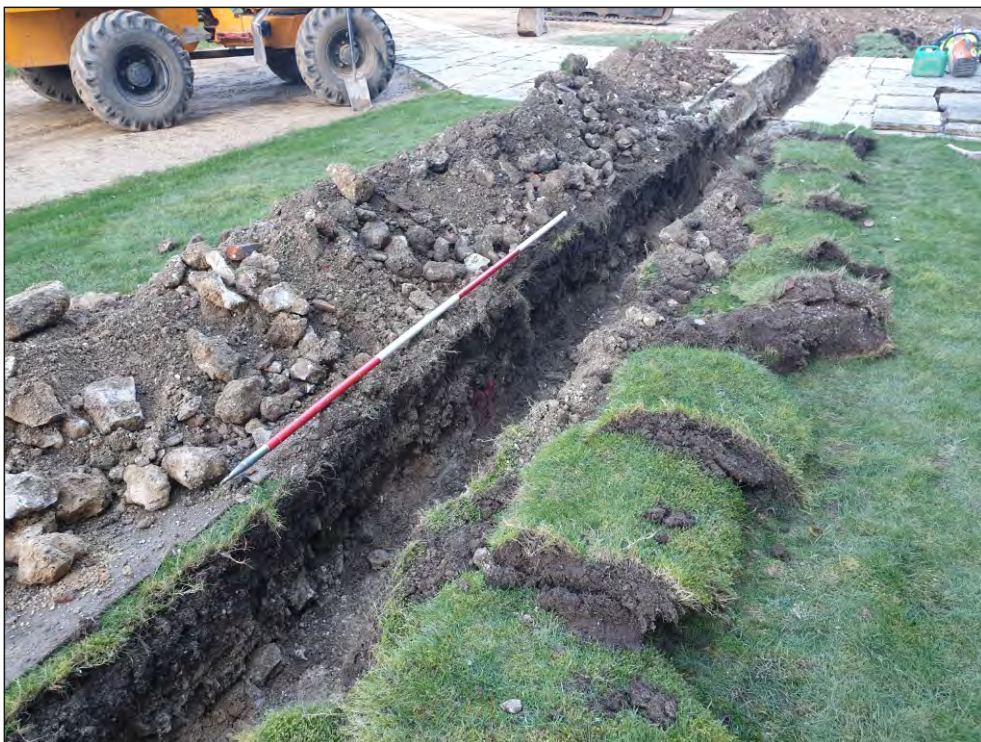
Pl. 8 General view of the trench showing extensive 18th century disturbance (104) underneath the landscaping. 2m scale. Looking northeast.
