## **Archaeological evaluation in the choir, presbytery and aisles of Exeter Cathedral, Exeter**

*on behalf of*  
**Exeter Cathedral**

**Report No. 21-05**

**July 2021**

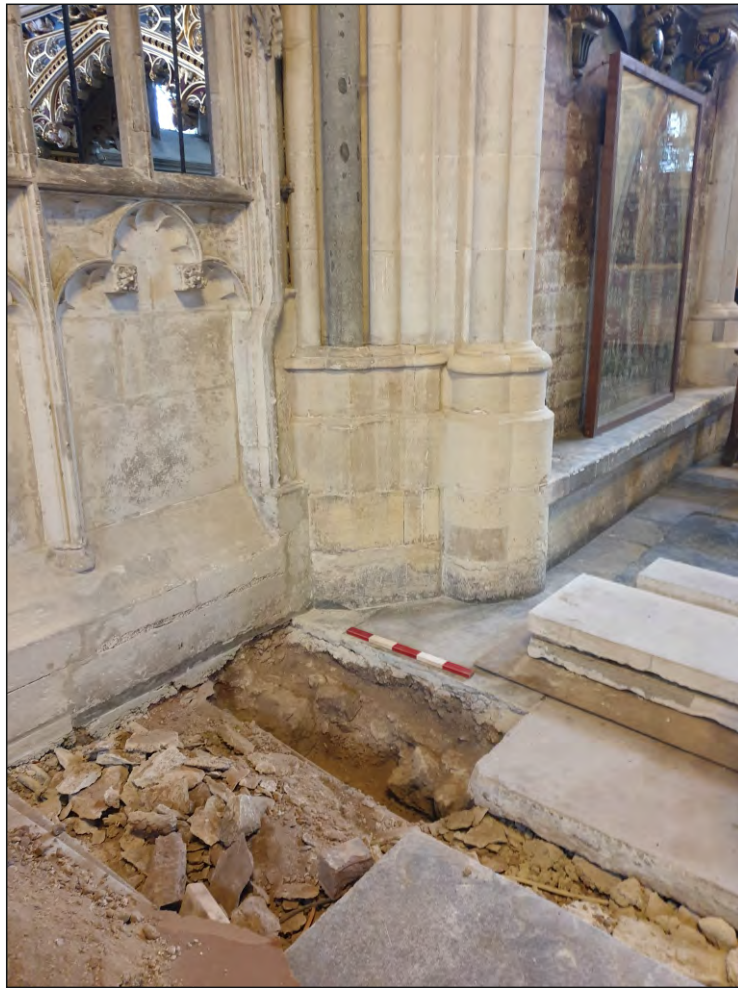
Pl. 5 General view of Trench 1 showing pier foundation (103). 0.5m scale. Looking southeast.

The work exposed the top of the adjacent pier foundation (103) at a depth of 0.15m below current ground level (38.37mAOD). It consisted of volcanic trap rubble bonded with white lime mortar and was overlain by a charnel soil (102) up to 0.26m thick containing frequent slate and cbm fragments, and rare inclusions of Beer stone and Salcombe fragments. This layer was in turn sealed by a 0.03m thick layer of light yellowish white lime mortar, interpreted as a post-medieval (early 19<sup>th</sup> century?) floor bedding and located underneath 0.07m thick stone floor slabs.

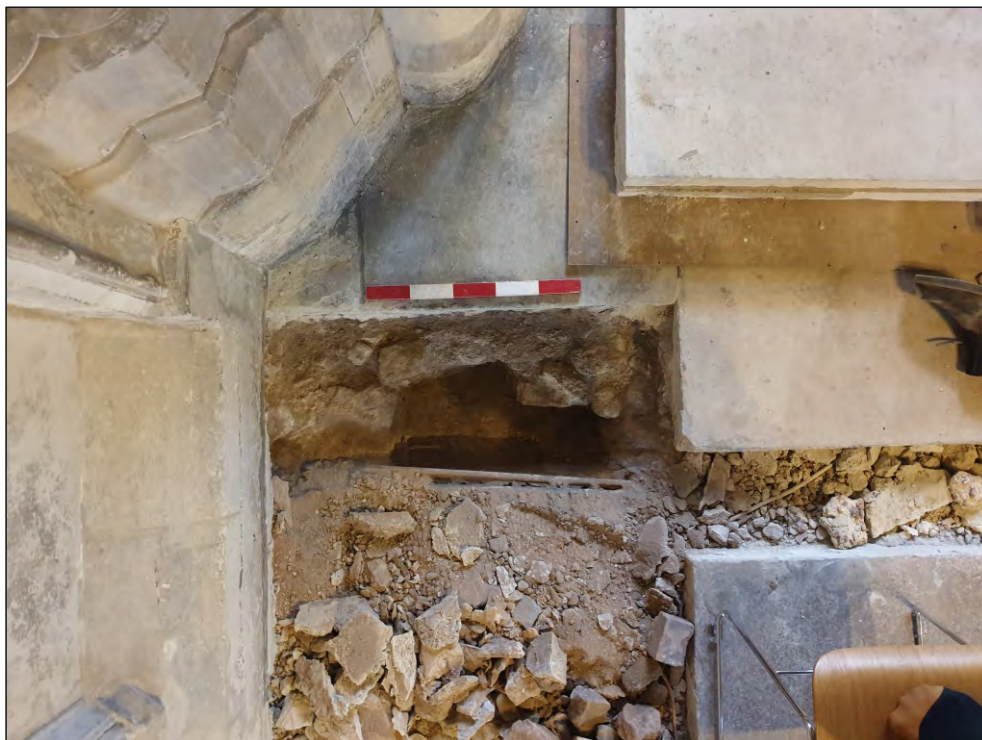
Pl. 6 Close-up of Trench 1 showing pier foundation (103). 0.5m scale. Looking south.

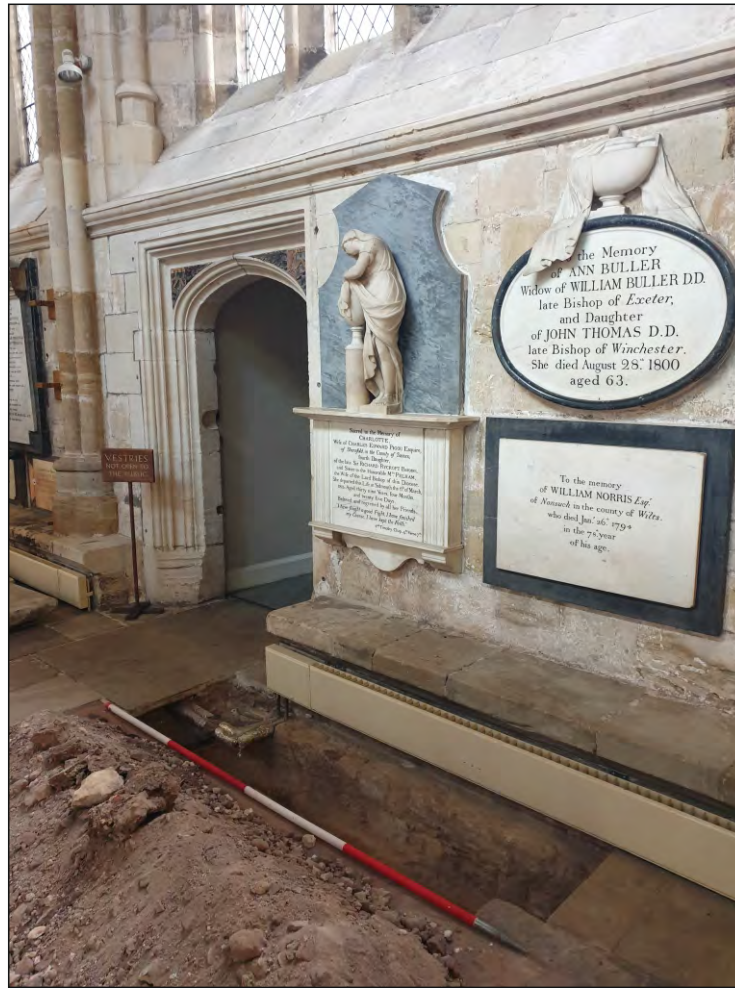
Pl. 7 General view of Trench 2 showing the stepped foundation for the south wall and bench (204). 2m scale, Looking southeast.

The work exposed the stepped foundation of the southern side of the south presbytery arcade wall and wall-bench (204) at a height of 38.22mAOD). This consisted of volcanic trap ashlar bonded and covered with a light yellowish white lime mortar. The upper footing projected 0.12m beyond the line of the bench, while the lower foundation projected c.0.5m beyond the

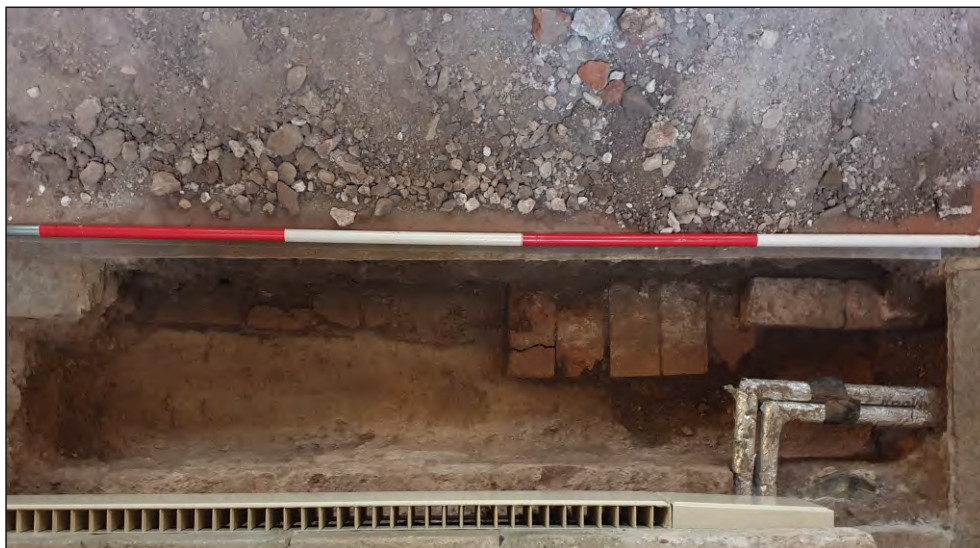
Pl. 8 Close-up of Trench 2 showing the stepped foundation for the south wall and bench (204) and brick grave lining (206). 2m scale. Looking north.

line of the wall-seat above. At the eastern end the lower projection of the foundation was in part truncated by a possible grave (207). This extended below the formation level of the works and was not excavated. The uppermost fill (208) consisted of a light to mid brown silty clay with frequent volcanic trap and mortar fragments. Butting up against the northern face of the foundation was the brick lining (206) of grave (205), whose bricks were 18<sup>th</sup>-19<sup>th</sup> century in appearance. The grave extended north beyond the limit of the trench and was not further investigated. These features were overlain by a 0.19m thick dark brown silty clay (202) with rare inclusions of cbm flecks.

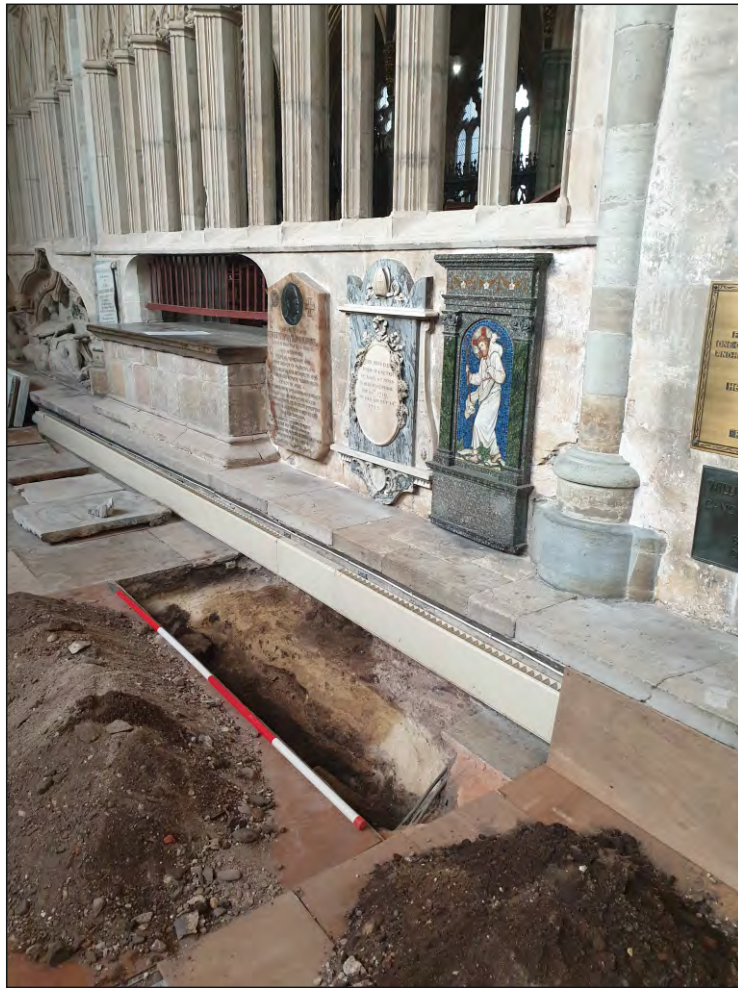
Pl. 9 General view of Trench 3 showing the stepped foundation for the choir screen and bench (303). 2m scale, Looking northwest.

The projecting foundation of the wall-seat (303), consisting of volcanic trap ashlar bonded with light yellowish white lime mortar, was exposed at a height of 38.44mAOD. This was uninterrupted for the whole length of the trench, with the remains of a former lined grave (304) exposed immediately to the south. The grave fill (306), containing frequent volcanic trap rubble and stone floor slab fragments, and rare fragments of cbm fragments, was partially excavated to a depth of 0.4m below floor level. The presence of a large quantity of rubble suggests that a former void, perhaps a burial vault, had been deliberately infilled, perhaps in the mid- to late 19<sup>th</sup> century.

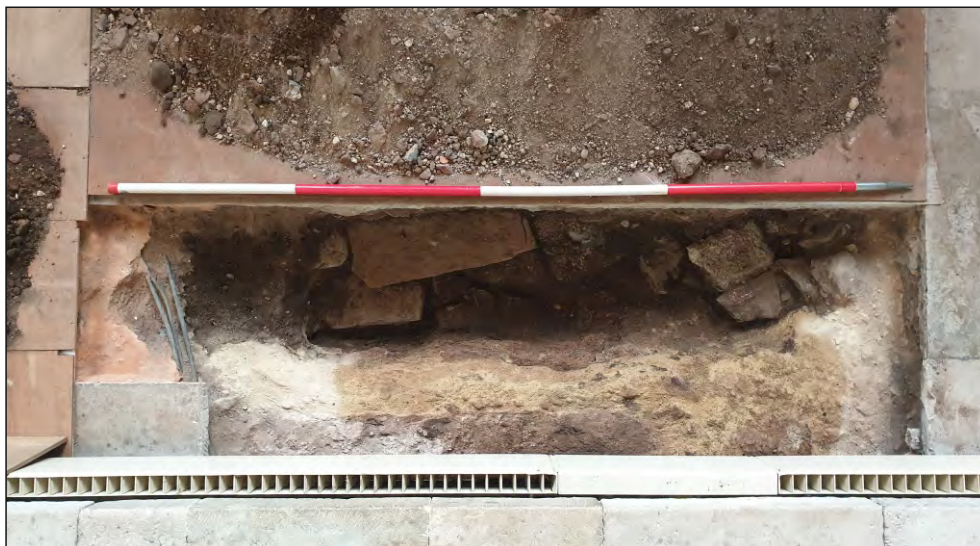
Pl. 10 Close-up of Trench 2 showing the stepped foundation for the choir screen and bench (303) and possible mortar grave lining (305). 2m scale. Looking south.

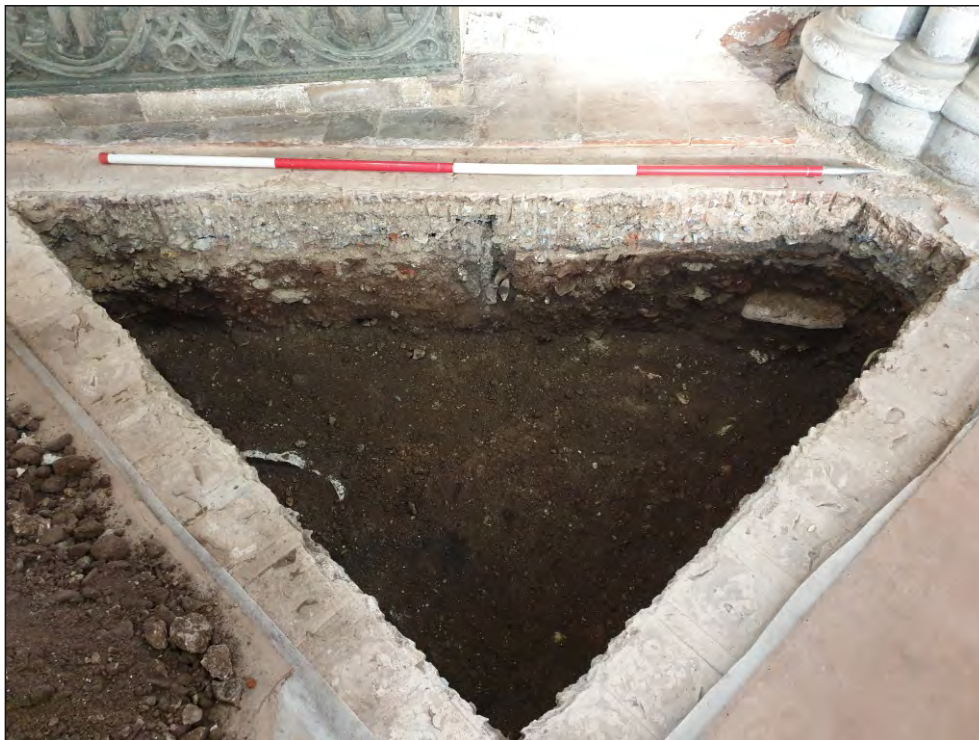
Pl. 11 General view of Trench 4 showing the extensive late 19th century sub-floor (402) above the heavily truncated 18th century floor make-up (416) and the late 13th century construction debris (408). 2m scale. Looking north.

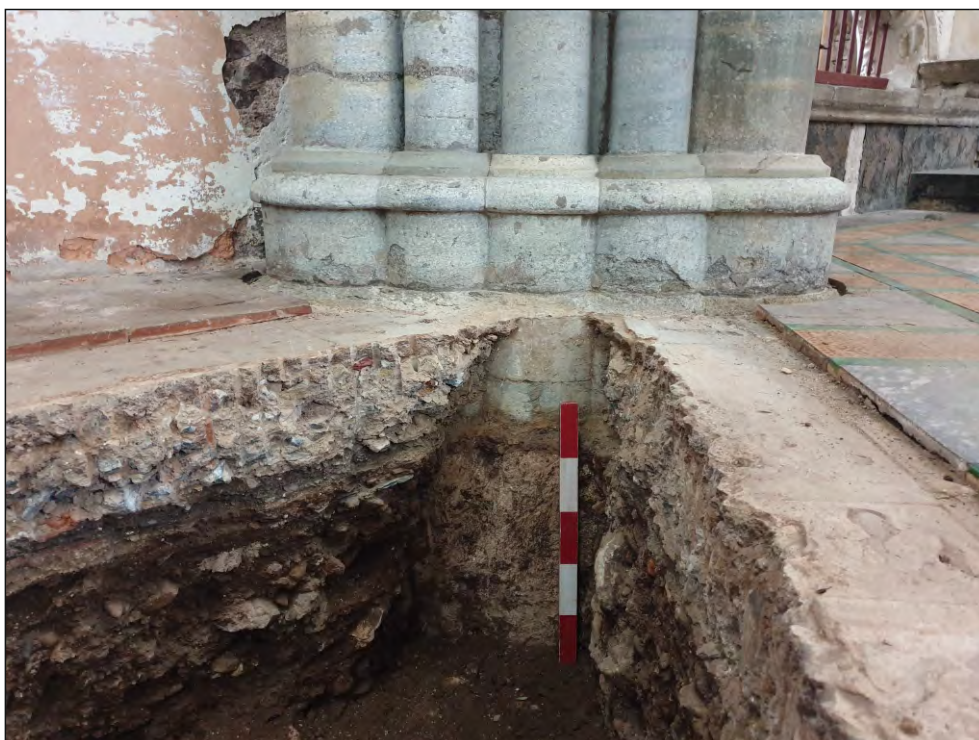
Pl. 12 Close-up of pier (419) and pier foundation (421) showing the original level of the 18th and late 13th century floors. 0.5m scale. Looking northeast.

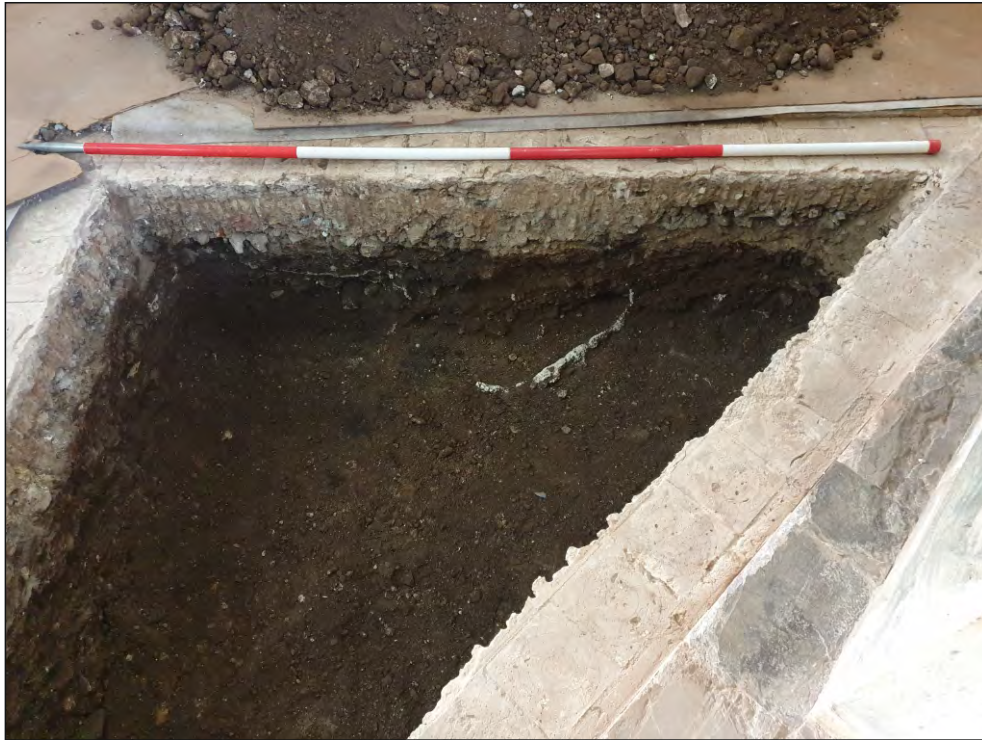
Pl. 13 General view of Trench 4 showing mortar lined grave (420) underneath possible late 13th century construction debris (408), and later grave (412). 2m scale. Looking west.

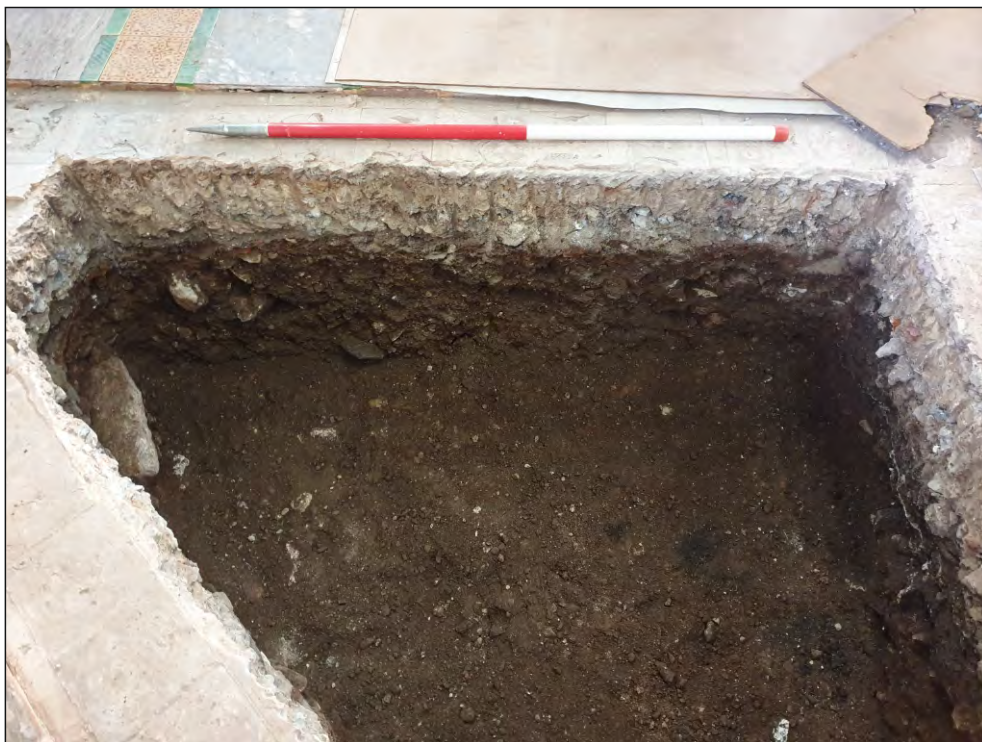
Pl. 14 General view of Trench 4 showing charnel soil (403) truncated by grave (412). 1m scale. Looking southeast.

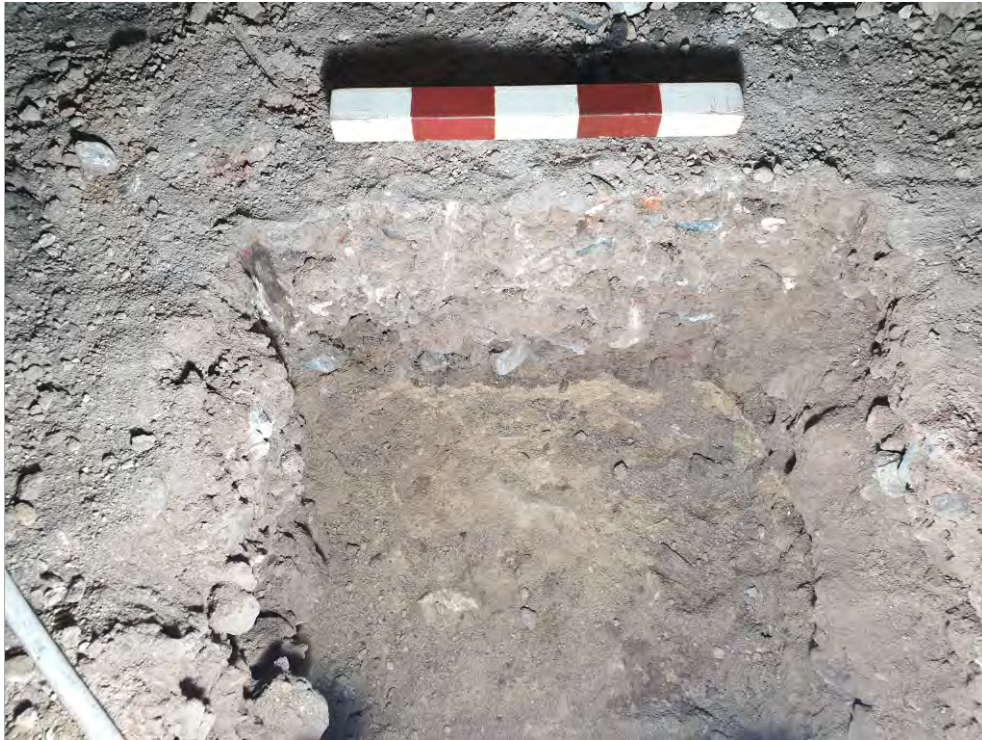
Pl. 15 General view of Trench 5 showing the late 19th century sub-floor (500) above the heavily truncated early 14th century construction debris (501) and charnel soil (502). 0.25m scale. Looking south.

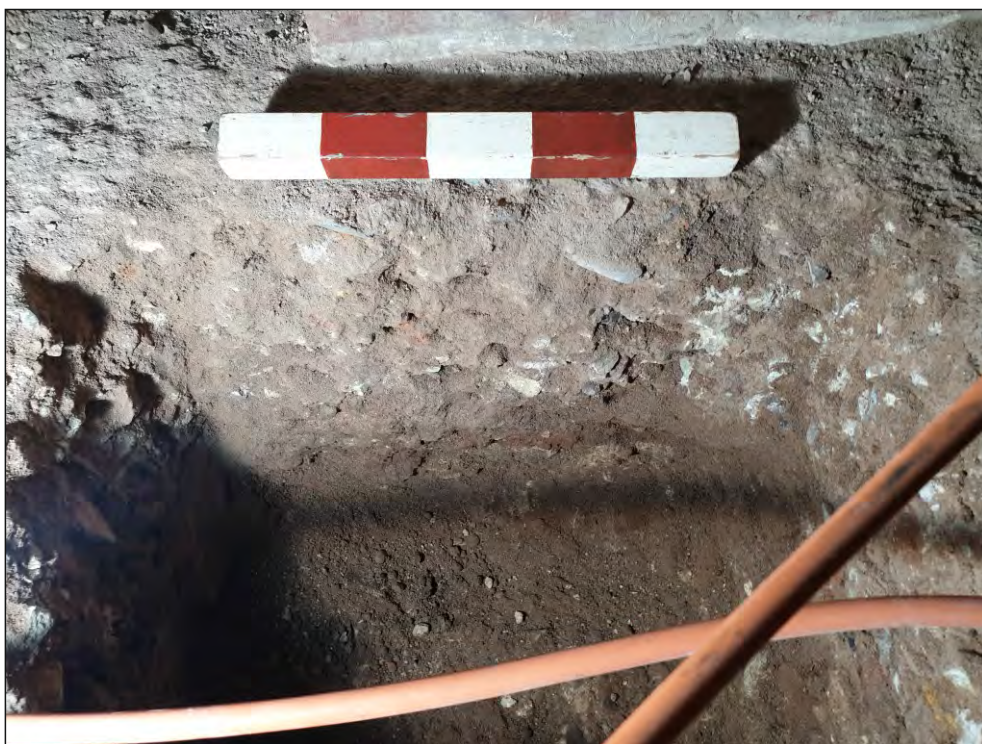
Pl. 16 General view of Trench 6 showing the late 19th century sub-floor (600) above the charnel soil (601). 0.25m scale. Looking south.

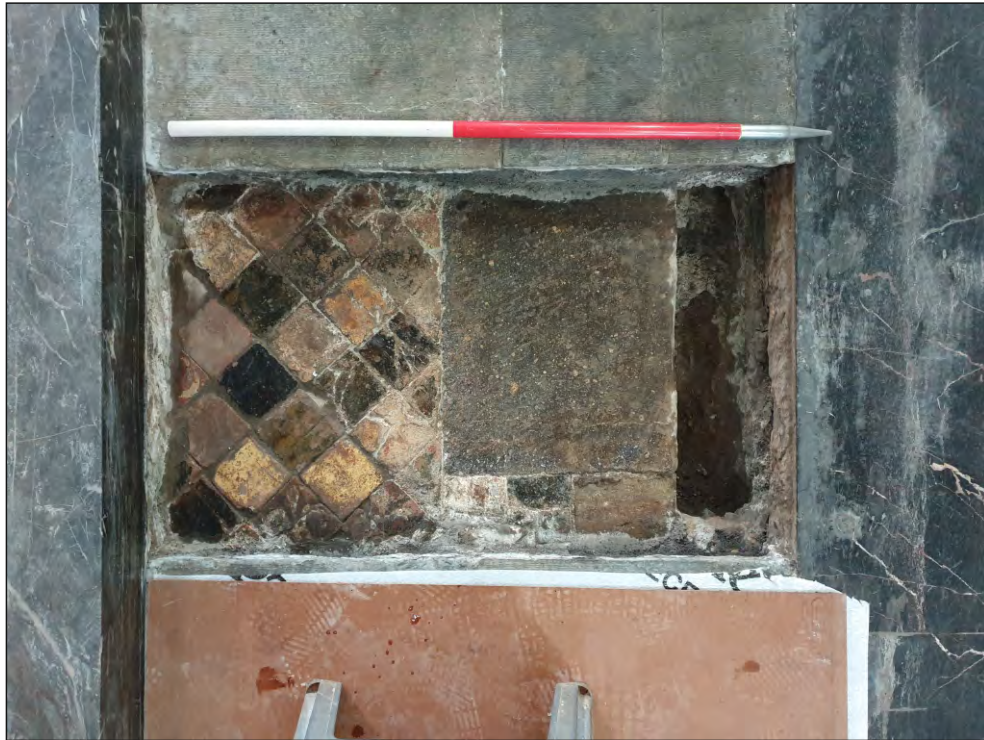
Pl. 17 General view of Trench 5 showing the late medieval pavement and Purbeck steps surviving underneath the late 19th century floor. The mortar bedding (704) of the original lower level is visible to the right. 1m scale. Looking south.

On the lower level, at the foot of the step, the edges of a 0.02m-thick layer of white lime mortar (704) was noted, overlying a mid to dark brown silty clay (705). The former is interpreted as the mortar bedding for a tile pavement, overlying a former charnel soil. The lower floor butted up against the kerb of a step of volcanic trap blocks of varying width. The tiled paving in the east part of the trench abuts this step. This is the sole visible portion of a strip of small diagonally-set medieval tiles exposed in 1939 when parts of Scott's presbytery floor were lifted and a plain new floor was installed on the upper platform around the high altar.<sup>3</sup> Fortunately a careful account of the discovery was made by the local antiquary Percy Morris, who studied the changes in the positions of the floors of the presbytery and choir and published his findings in one of the wartime issues of the *Antiquaries Journal*.<sup>4</sup> He noted that the southern end of the strip of tiles was then undisturbed, showing a pattern of tiles glazed alternately dark green and 'buff'; most of the glaze on the latter, he noted, had worn away.

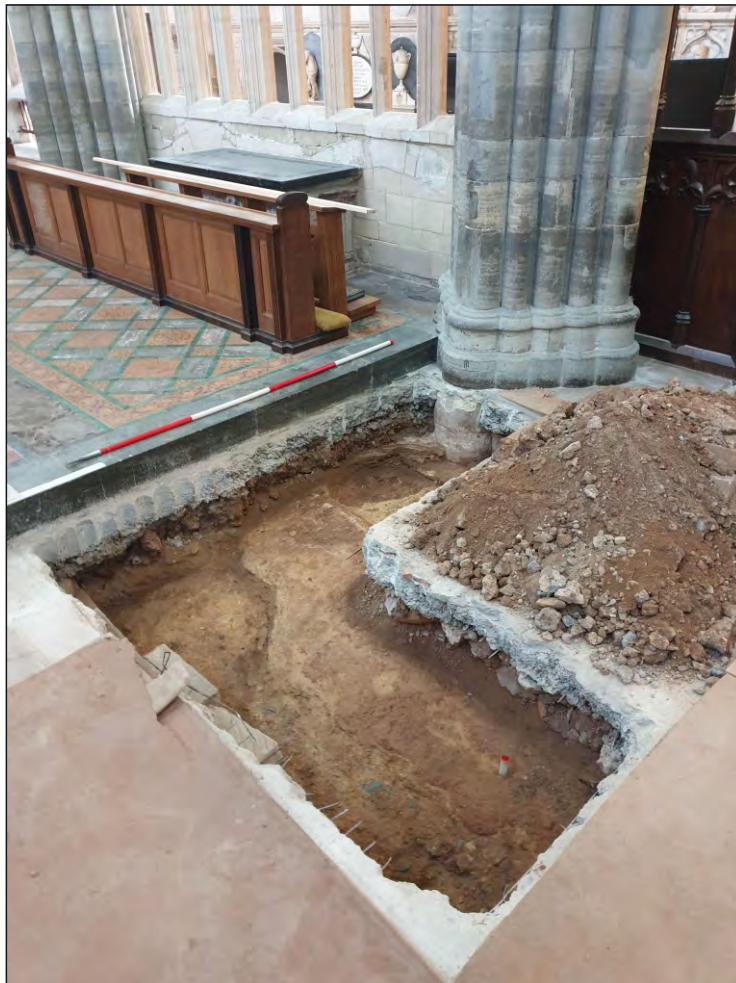
Pl. 18 General view of Trench 8 showing stone working and mortar deposits associated with the reconstruction of the east end in the late 13th and early 14th century truncated by the late 19th and 1960s flooring. 2m scale. Looking southeast.

The tops of the medieval deposits had been extensively disturbed by the construction of the floors of 1763, 1871–6 and 1963, and no medieval floor-tile pavement or even the underlying tile bedding was found. Nothing survived of the chequered ‘marble’ floor of 1763, whose slabs had also been lifted and their bedding removed. Neither did anything survive from Scott’s elaborate floor of the 1870s, apart from some loose tiles. The floor of 1963 had been laid by breaking up of the late 19th-century sub-floor (804/7), represented by a 0.35m-thick layer of grey cementitious mortar, and pouring a 0.18m thick reinforced concrete sub-floor (803) over it. The concrete of 1963 was overlain by a 0.04m-thick layer of cement bedding (802) for the present Purbeck stone floor (800).

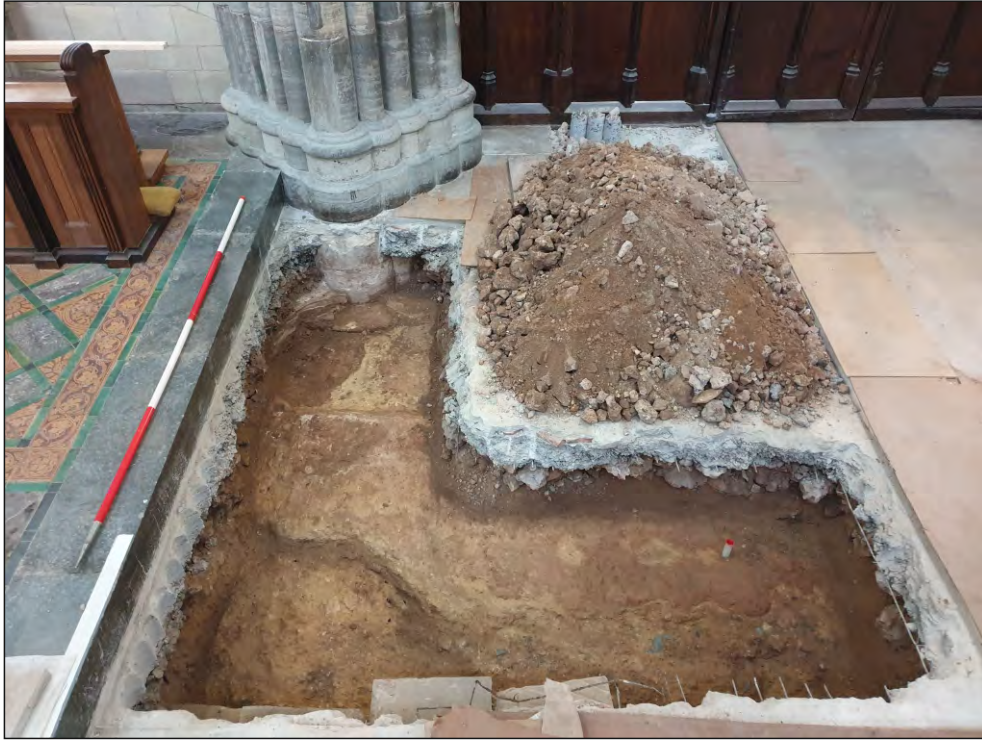
Pl. 19 General view of Trench 8 showing stone working and mortar deposits associated with the reconstruction of the east end in the late 13th and early 14th century truncated by the late 19th and 1960s flooring. 2m scale. Looking south.

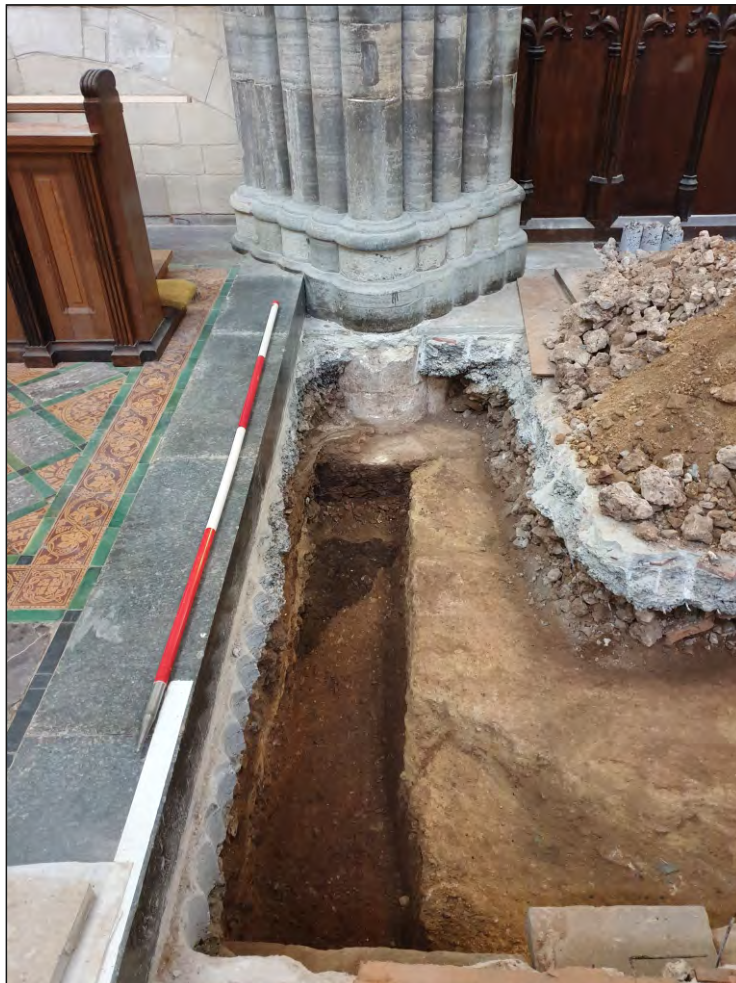
Pl. 20 General view of Trench 8 of trench through medieval construction deposits showing the pre-Norman soil (829) truncated by curved robber trench (830) and the choir arcade sleeper wall foundation (827). 2m scale. Looking south.

It was from above this level, post-dating the insertion of the foundation of the south presbytery arcade, that the feature interpreted as the Norman apse was robbed. The robbing cut (830) was almost vertical. The robber trench was backfilled with a homogeneous deposit (831) consisting of mixed silty clay and Salcombe stone with a few slate fragments (?from the roof of the Romanesque cathedral or attendant buildings). A single sherd of 10<sup>th</sup>-13<sup>th</sup> century coarseware ?Exeter fabric 20 was recovered from the backfill. Following the demolition of the Norman apse the robber trench was covered by two successive layers of Salcombe stone dust and chippings (820 and 823), overlain by a 0.05m thick layer of mid reddish brown silty clay (822), interpreted as trample. This was in turn overlain by a further succession of layers of Salcombe stone dust and chippings (818, 820-1, 825-6) interspersed with a single layer of white lime mortar deposits (819).

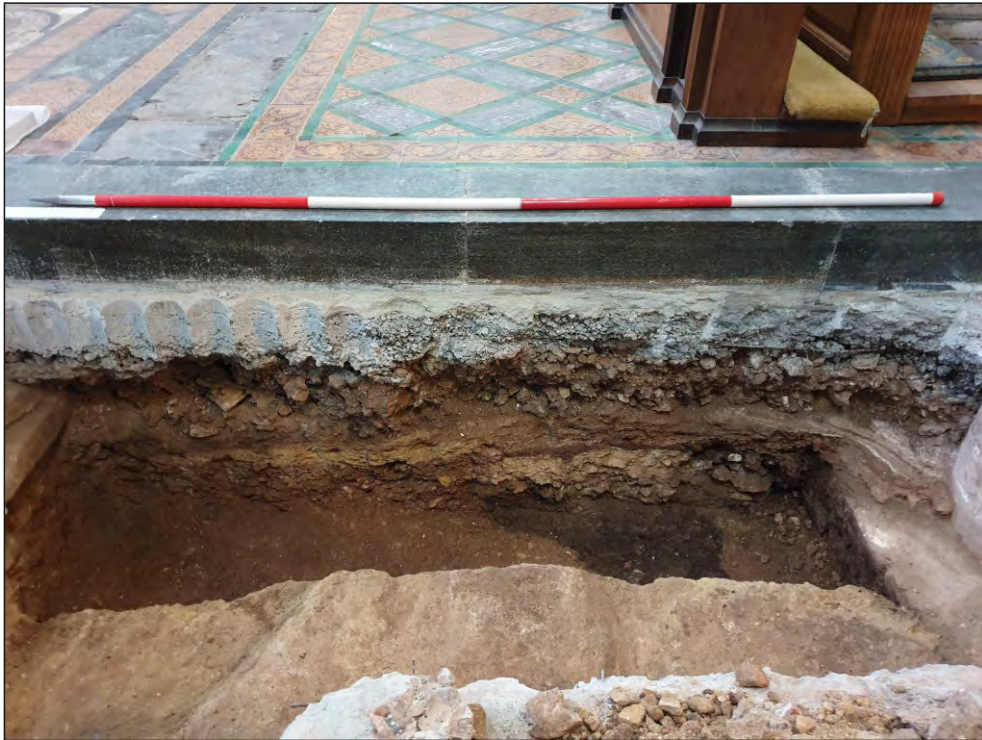
Pl. 21 Section through Trench 8 showing the pre-Norman soil (829) overlain by late 13th century construction deposits and truncated by the curved robber trench (830) and the choir arcade sleeper wall foundation (830). 2m scale. Looking east.

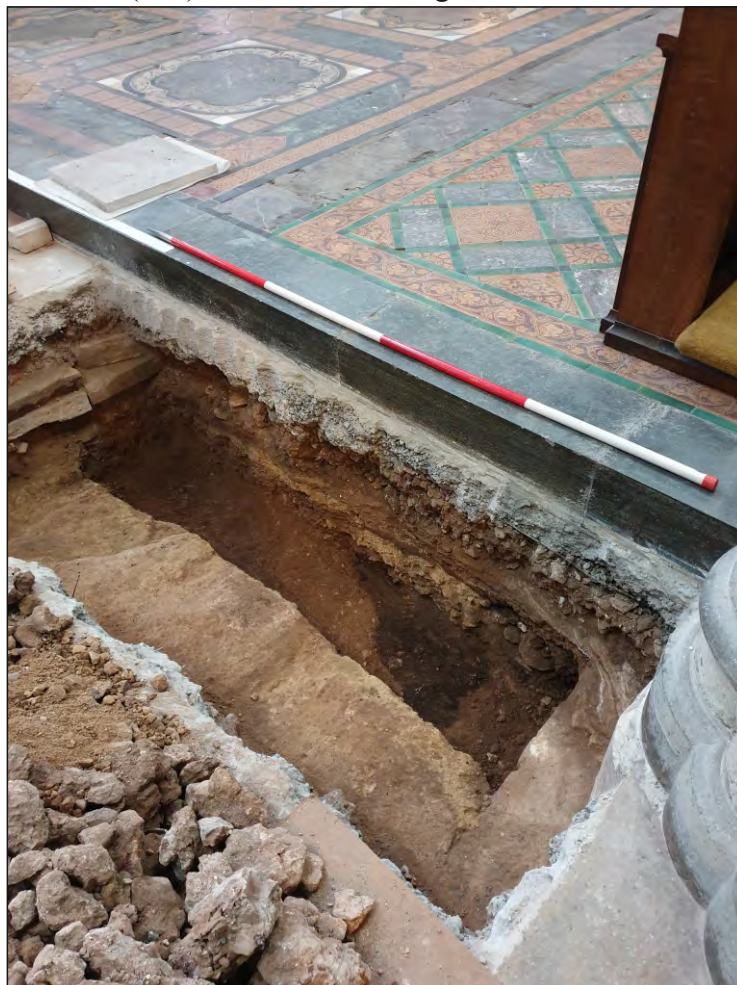
Pl. 22 Section through Trench 8 showing the pre-Norman soil (829) overlain by late 13th century construction deposits and truncated by the curved robber trench (830) and the choir arcade sleeper wall foundation (830). 2m scale. Looking east.

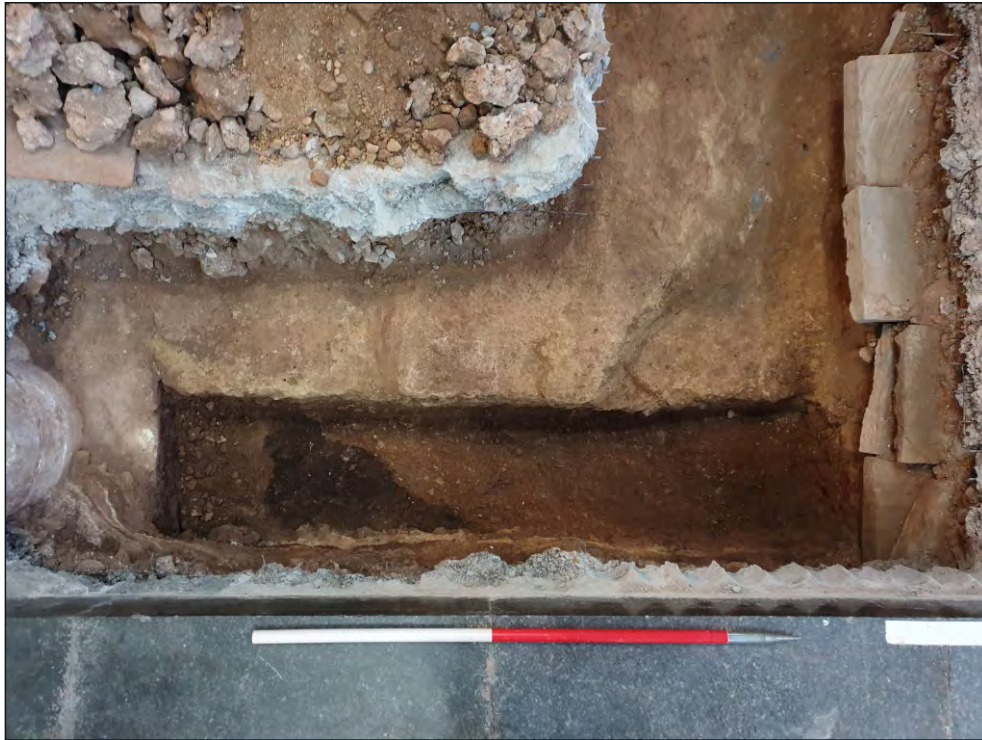
Pl. 23 General view of Trench 8 showing the pre-Norman soil (829) truncated by the curved robber trench (830) and the choir arcade sleeper wall foundation (830). 1m scale. Looking west

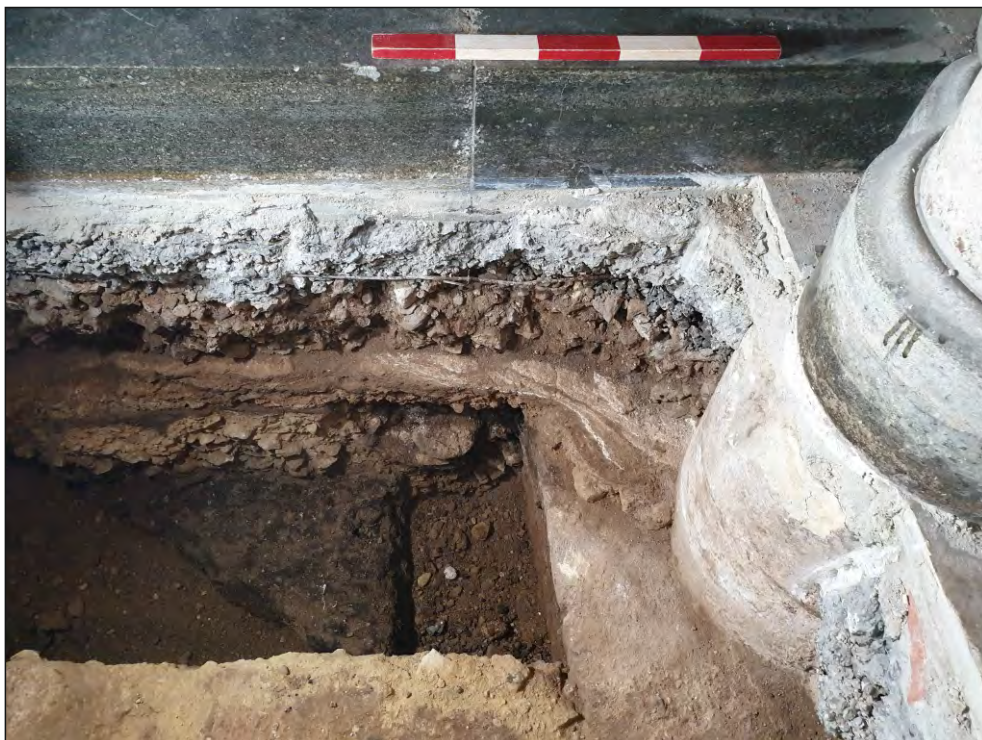
Pl. 24 Close-up of successive thin layers of lime mortar surviving against the arcade pier base and vertical truncation of pre-Norman soil below. 0.5m scale. Looking east.

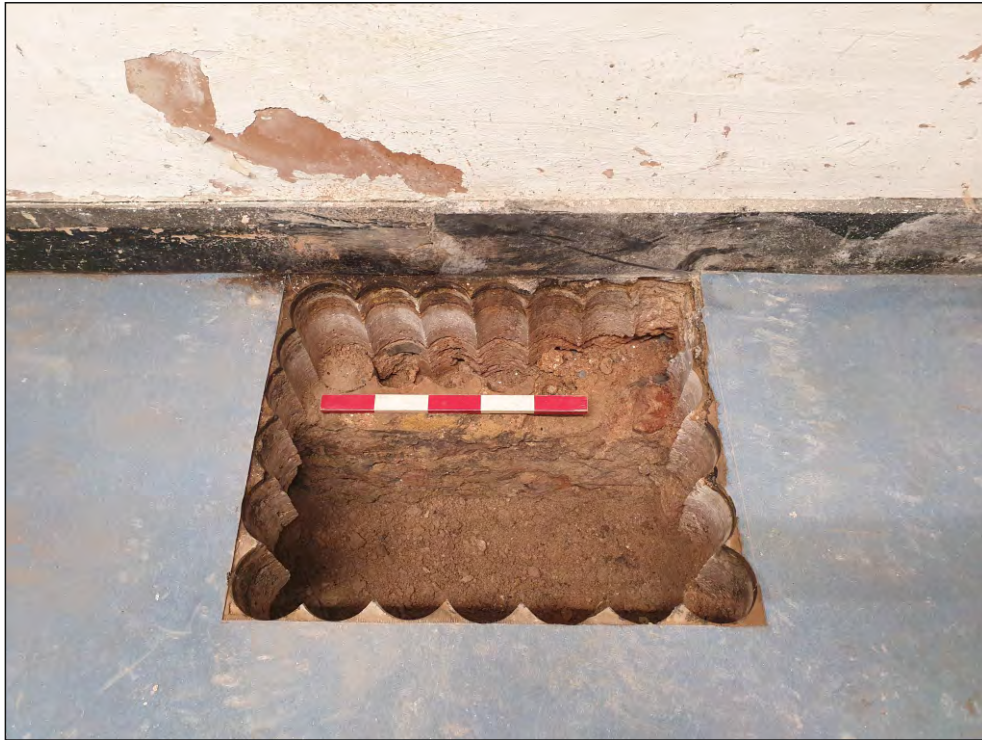
Pl. 25 General view of Trench 9 showing south wall (903) of vestry and infill above vaulting (902). 0.5m scale. Looking south.

of Salcombe stone and volcanic rubble (902) with mortar lumps identical to the lime mortar of the south wall foundation. This deposit is interpreted as undisturbed medieval rubble forming the sub-floor of the room. No medieval floor was found overlying this deposit; judging by the level of doorways and sills in the room, this must have been more-or-less at present floor level.

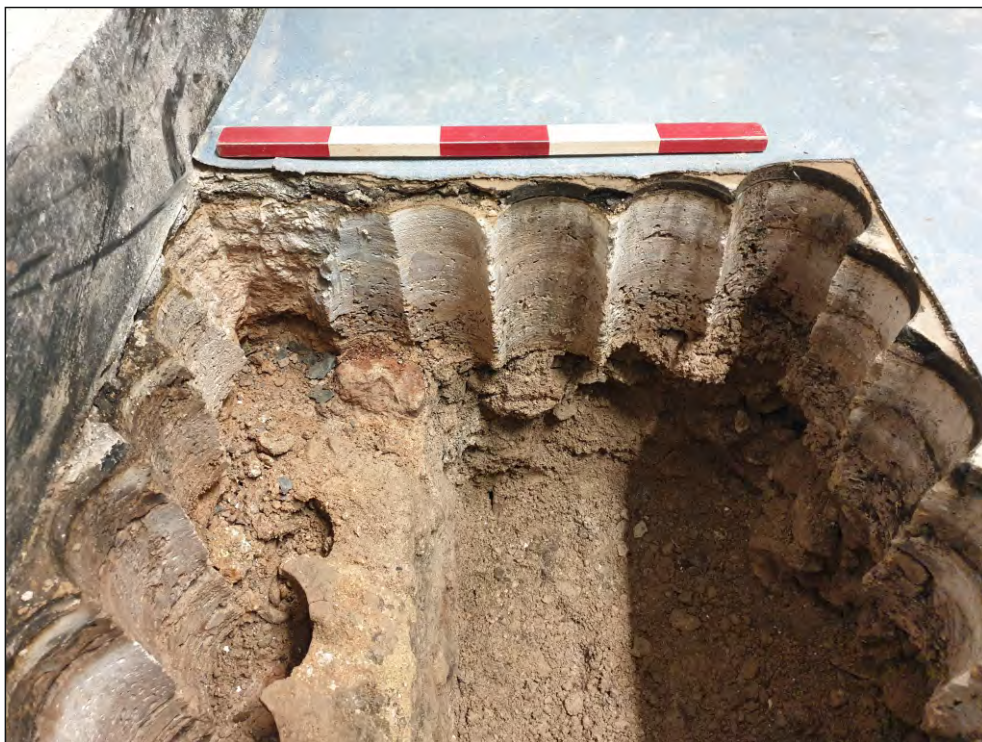
Pl. 26 Section through Trench 9 showing depth of concrete (900), south wall of vestry (903) and infill above vaulting (902). 0.5m scale. Looking west.

Both the foundation and the infill were sealed by a 0.2m-thick modern (post-1950?) concrete sub-floor (901) and a 0.02m thick layer of bitumen, topped with linoleum (900).

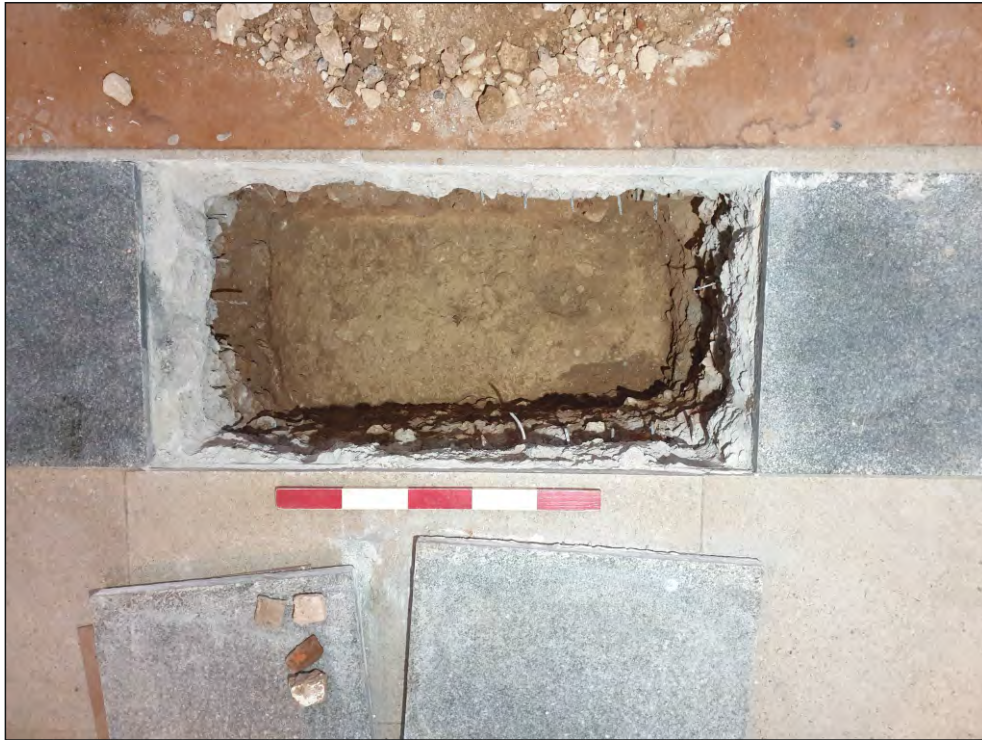
Pl. 27 General view of Trench 10 showing late 13th or early 14th century construction debris (1008) truncated by later grave (1009). 0.5m scale. Looking south.

The tops of this grave and of deposit 1005 were truncated (1004) by the insertion of the current floor in 1963. Broken-up and reused portions of Scott's floor of the 1870s formed a 0.17m-thick sub-base (1003) for the 20<sup>th</sup>-century flooring; this was sealed below a 0.16m-thick reinforced concrete slab (1002) overlain by the current Purbeck stone pavements (1001). A single fragment of Roman *tegula* was recovered from (1003).

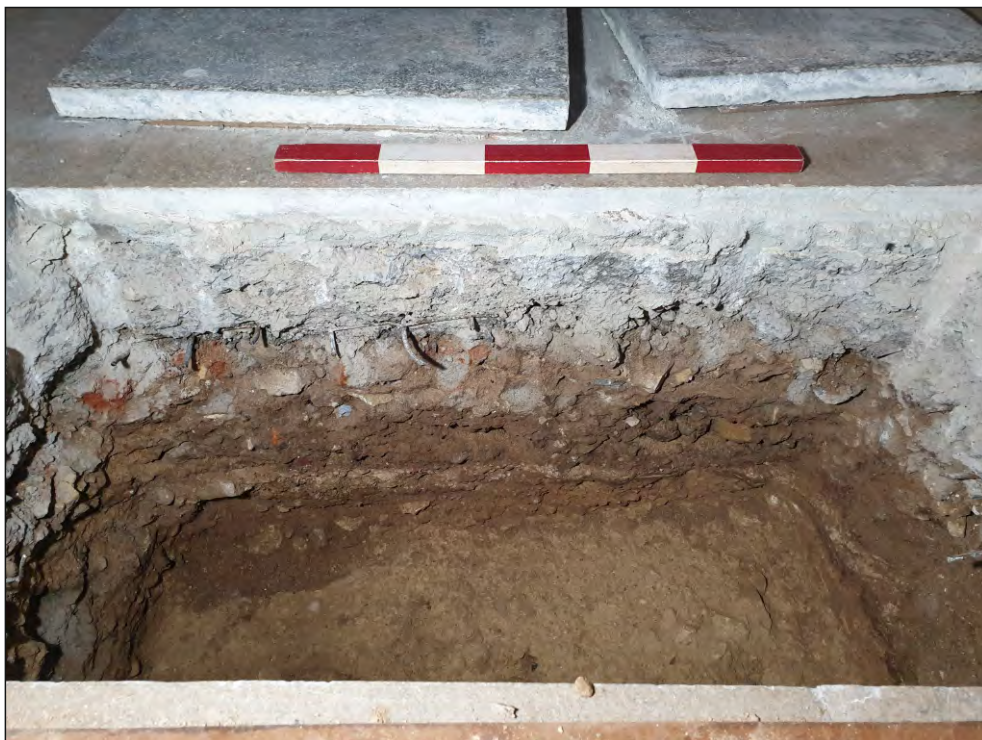
Pl. 28 Section through Trench 10 showing successive late 13th or early 14th century construction deposits. 0.5m scale. Looking north.

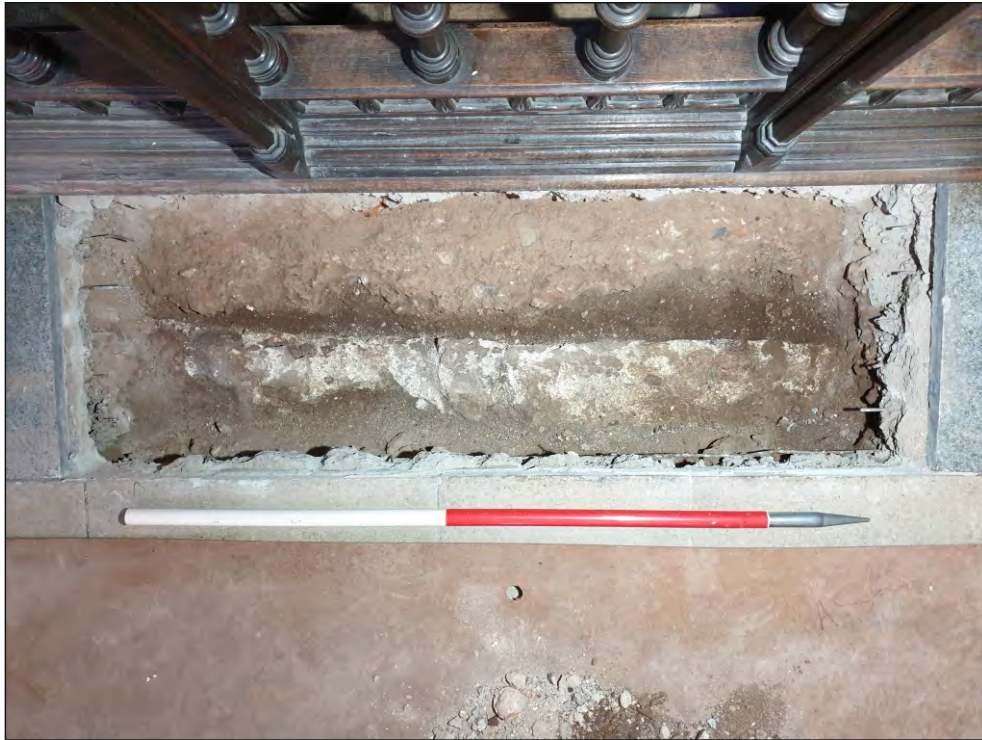
Pl. 29 General view of Trench 11 showing stone lined grave (1105) and a remnant of the late 19th century sub-floor (1103). 1m scale. Looking north.

Underneath the choir stalls the burial was overlain by the 0.05m-thick layer of cementitious mortar which represents the bedding of Scott's tile pavement (1103). Outside the stalls this had been broken up and reused in 1963 to form part of the 0.12m-thick sub-base (1102) on which a 0.1m-thick reinforced concrete slab (1101) had been poured and the current stone floor (1100) laid.

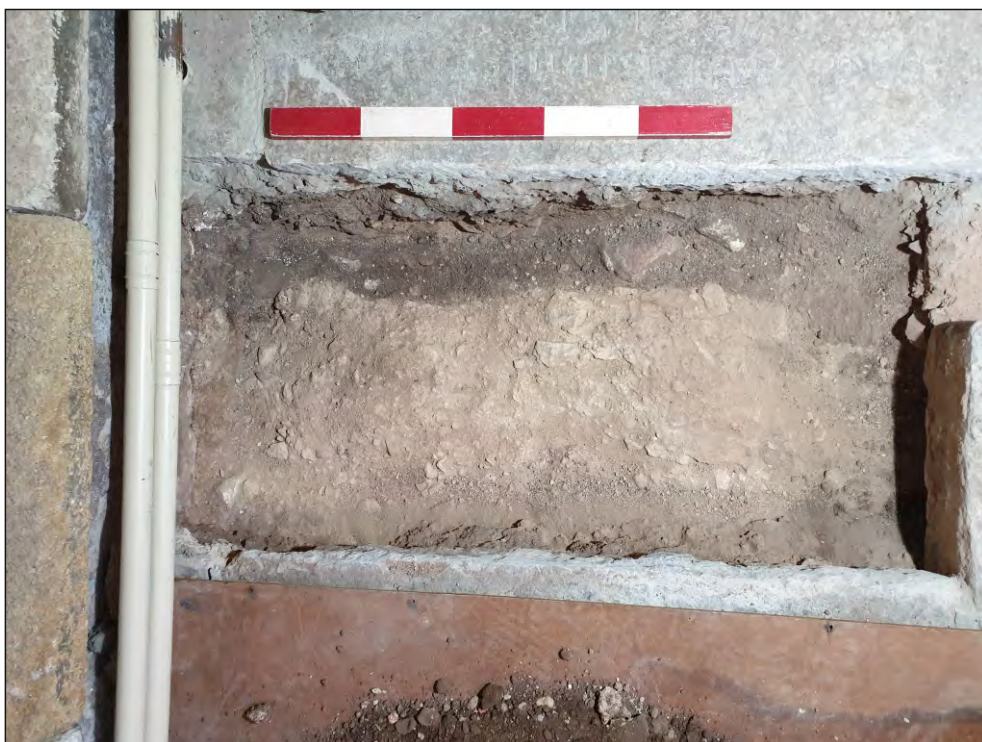
Pl. 30 General view of Trench 12 showing late 13th or early 14th century construction debris truncated by graves (1203) and (1205). 0.5m scale. Looking east.

The foundation of the sleeper wall (1208), consisting of volcanic trap ashlar bonded with lime mortar, was abutted by a layer of Salcombe stone dust and chippings (1207), the remains perhaps of a construction raft like the one seen in the choir. This was overlain by a charnel soil (1202), cut to the east and south by graves (1203) and (1205) respectively. The fills of these (1204 and 1206) were similar to the surrounding charnel soil. The recovery of a fragment of 18th-century English green bottle glass from (1206) shows that this context dates from after 1700.

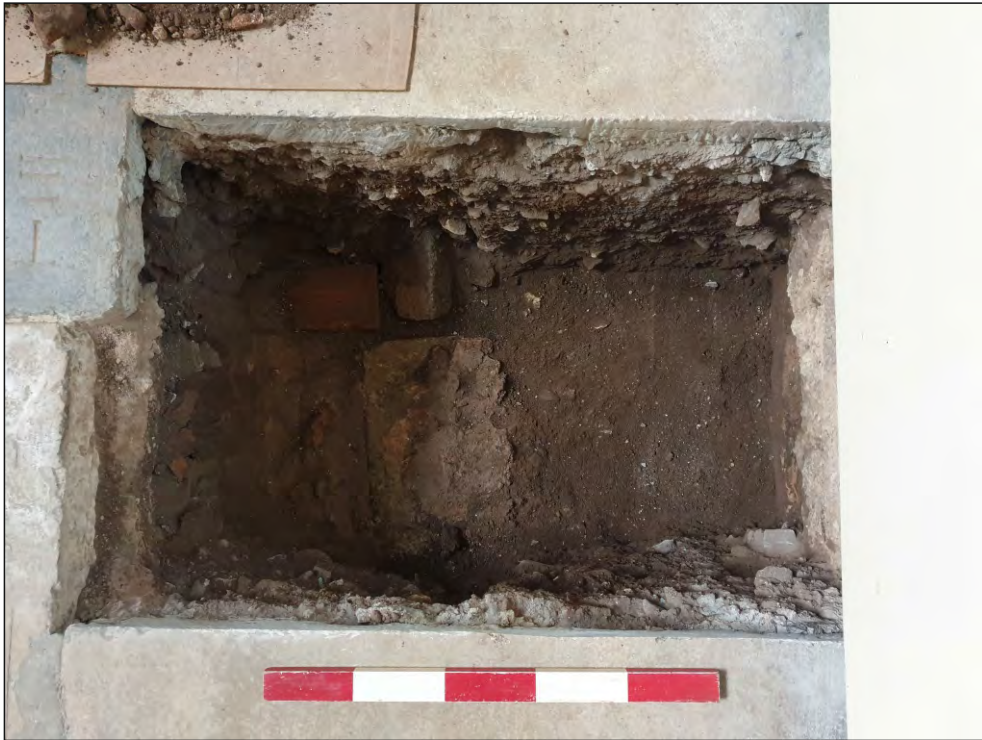
Pl. 31 General view of Trench 13 showing graves (1303) and (1305). 0.5m scale. Looking west.

The trench exposed the lower foundation (1308) of the sleeper wall of the south choir arcade. This consisted of volcanic trap rubble bonded with lime mortar, below the ashlar of the raised bench (1307), which seems to be largely of Beer stone. The foundation was abutted by a charnel soil (1306). This was cut along its southern edge by grave (1305) whose fill (1304) was excavated down to formation level. It contained bricks including one salt-glazed header, datable after *c.* 1700. Ten medieval floor-tile fragments including three of Normandy tiles with green glaze were also recovered, confirming the evidence from Trenches 2 and 3 that the early 14<sup>th</sup>-century floor had been patched or repaired in the late 15<sup>th</sup> or early 16<sup>th</sup> century.
