## **Archaeological evaluation in the choir, presbytery and aisles of Exeter Cathedral, Exeter**

*on behalf of*  
**Exeter Cathedral**

**Report No. 21-05**

**July 2021**

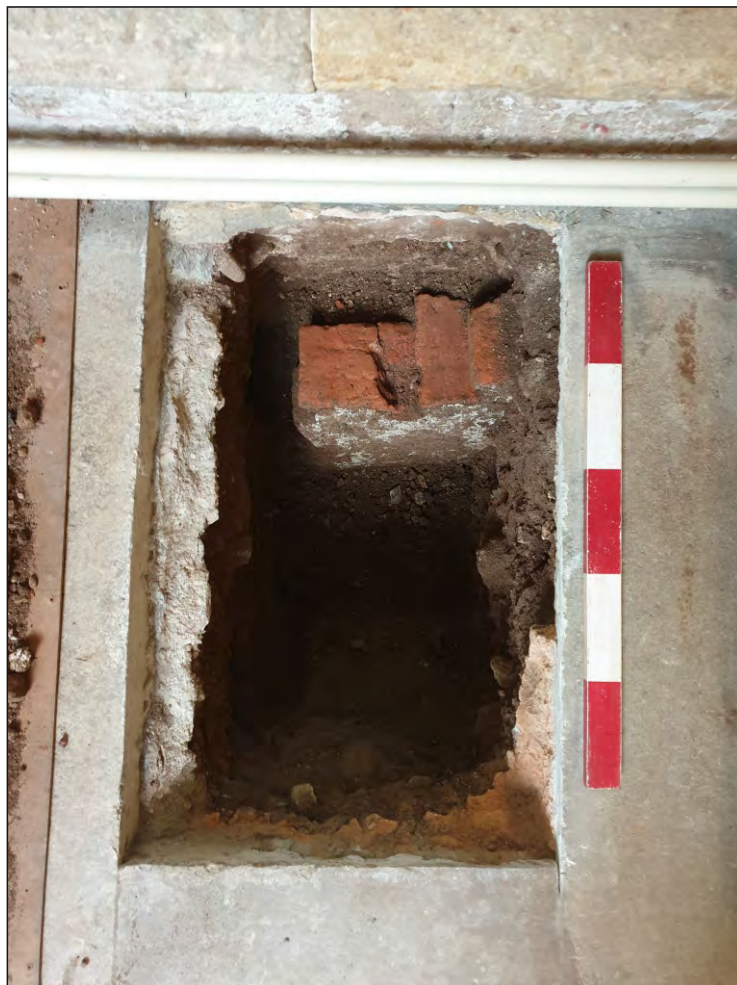
Pl. 32 General view of Trench 14 showing brick lined grave (1404). 0.5m scale. Looking south.

The excavation uncovered the remains of a single brick-lined grave (1404, the lining 1402), built against the north face of the wall-seat foundation. White mortar or plaster lined its internal face. The remains of a socket, cut into the wall-seat foundation and partly visible within the brickwork of the lining survived, although partly truncated by later activity. This may originally have held either a wooden or metal prop to support the ledger. The dark reddish brown fill of the grave (1403) was excavated to formation level. Two medieval floor tile fragments were recovered from the grave fill.

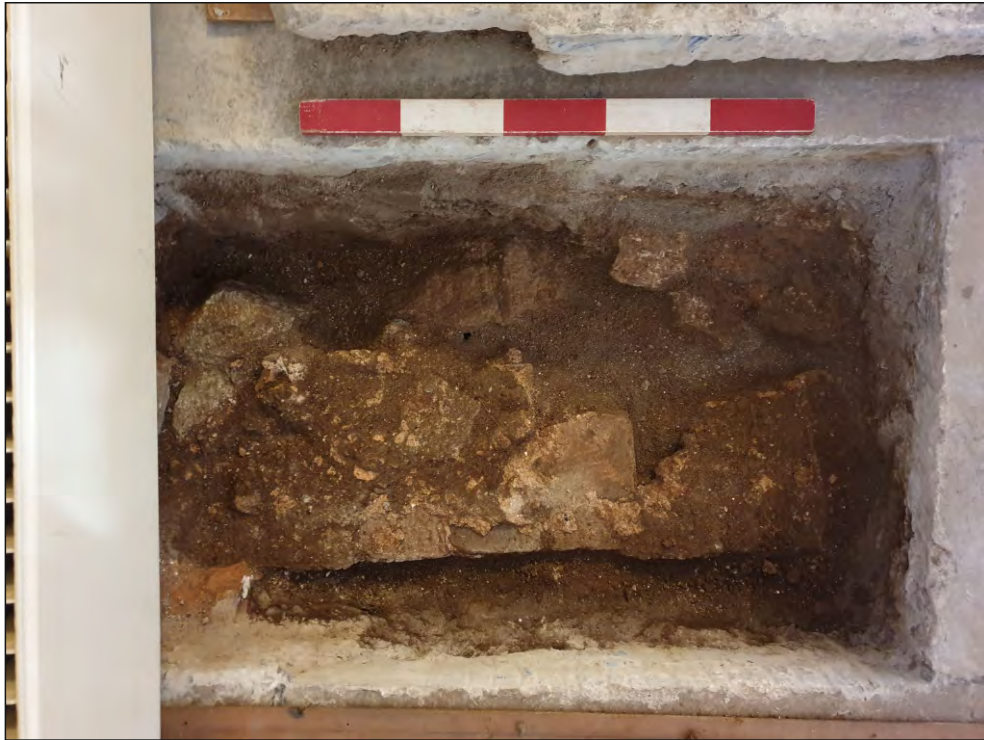
Pl. 33 General view of Trench 15 showing stone rubble and clay tile lining (1503). 0.5m scale. Looking east.

The excavation exposed the eastern end of a grave (1505) dug against the wall-seat foundation (1506). Its lining (1503) was built of rubble and earthenware tiles bonded in lime mortar. The inside face of the grave wall was rendered with lime plaster and the grave was filled with silty clays (1504, 1502). Three thin medieval floor-tile fragments of the late 13th or early 14th century, one with a scrap of inlay, were retrieved from the fill.

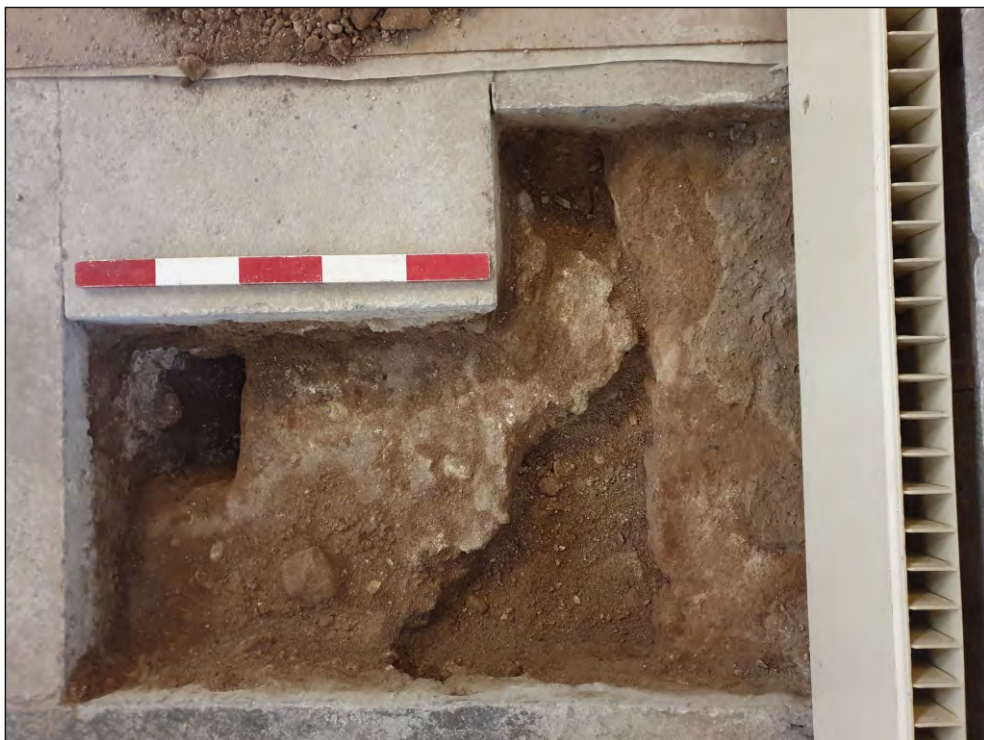
Pl. 34 General view of Trench 16 showing stone lined grave (1603) and projecting stepped north wall and wall bench foundation (1607). 0.5m scale. Looking west.

At this point the projecting foundation of the aisle wall-seat (1607), which consisted of volcanic trap rubble, was bonded with light to mid red lime mortar, different from typical white medieval mortars and perhaps indicating a post-medieval repair. It was abutted by a probable charnel soil (1602) whose southern edge was cut by a stone-lined grave (1603, the fill 1606). The inside face of the grave's stone lining (1604) retained evidence of lime plaster.

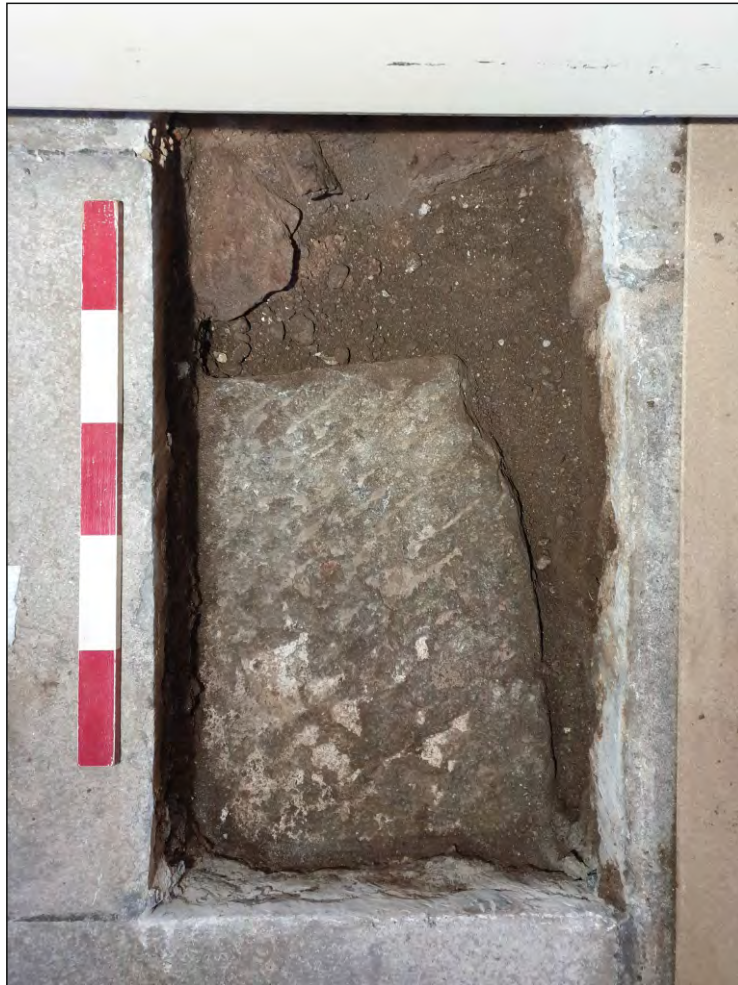
Pl. 35 General view of Trench 17 showing Purbeck ledger stone with tooled surface. 0.5m scale. Looking south.

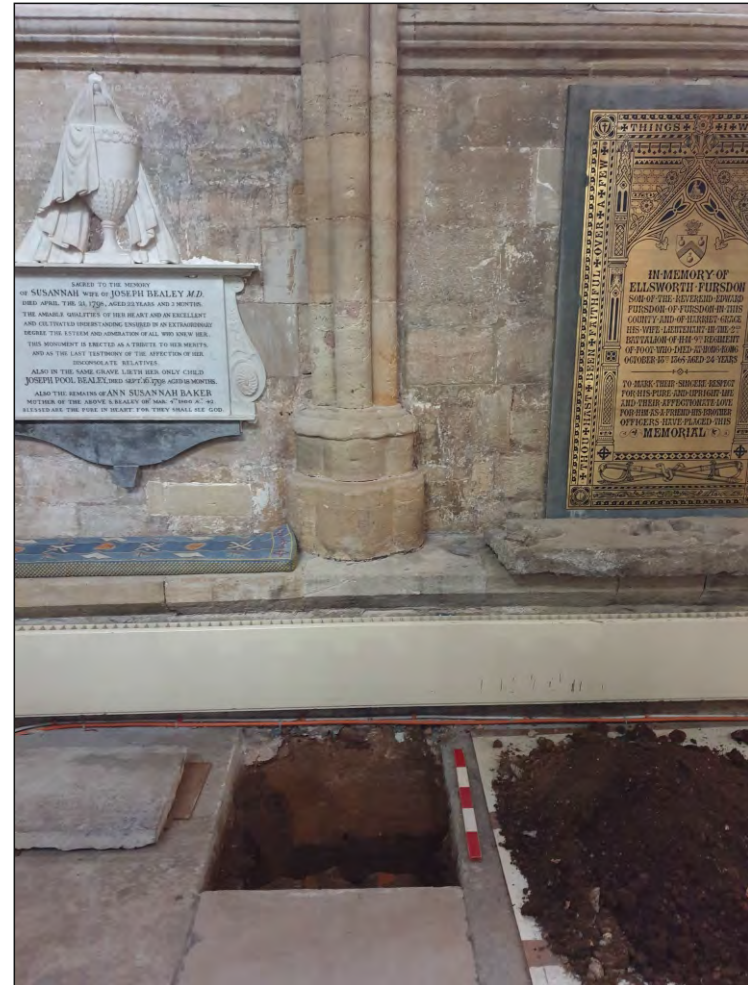
Pl. 36 General view of Trench 18 showing projecting foundation (1807) of possible Norman north wall pier. 0.5m scale. Looking north.

The foundation of the Norman north choir wall was built of volcanic trap rubble bonded with reddish-brown lime mortar. Its edge ran parallel with the aisle wall at the western end of the trench before stepping southward in the centre and eastern end of the trench, below the western side of the early 14<sup>th</sup>-century pier at the junction of Bays 10 and 11. Since this is also the expected position of the Norman respond between the two eastern bays of the eastern limb, it seems probable that the projection was the foundation of the respond at the junction of the eastern bays of the Norman church. The mortar colour may be noted; brown mortars are characteristic of late Saxon and early Norman building work elsewhere in Exeter, but it is possible that the mortar here has been discoloured since it has been buried.

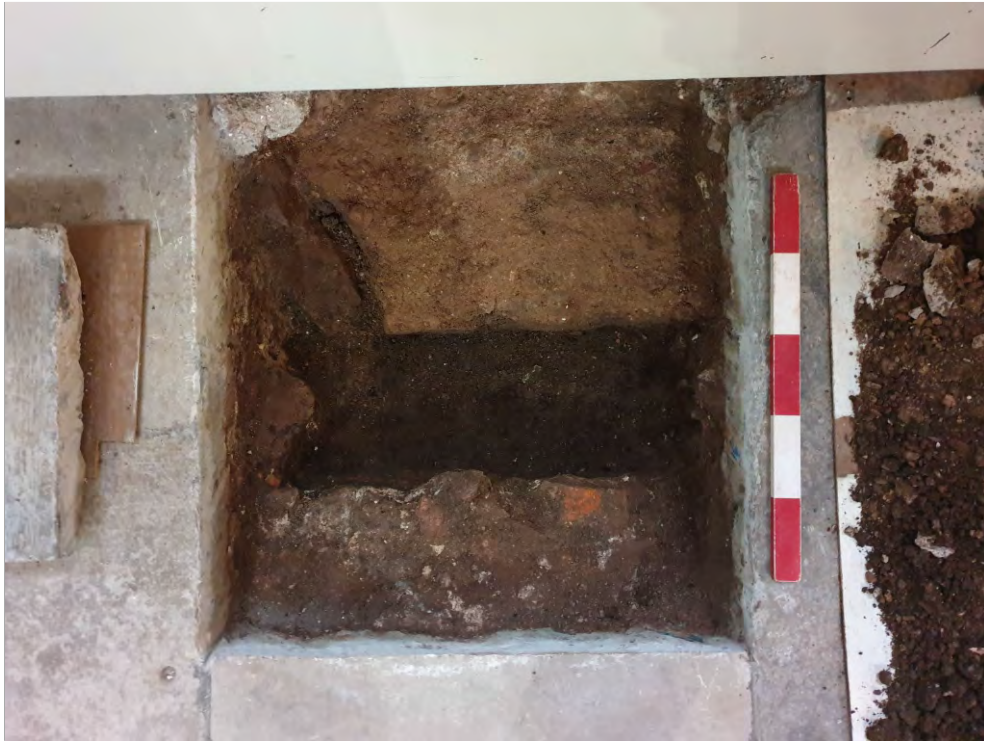
Pl. 37 General view of Trench 18 showing pre-Norman soil (1809) truncated by the projecting foundation (1807) of possible Norman north wall pier, stone lined grave (1803) and grave (1805). 0.5m scale. Looking north.

The earliest deposit was a small area of dark brown black silty clay (1809), cut along its northern edge by the foundation of the Norman north wall (1807). It contained single sherds of samian ware and amphora, both residual finds of the late 1<sup>st</sup>/2<sup>nd</sup> century. This layer's composition is typical of post-Roman dark soils; the fact that it is cut by the Norman east end indicates a date before AD 1114.
