**Archaeological excavation and historic building
recording in the Chapter House and the Chapel of
the Holy Spirit, Exeter Cathedral**

on behalf of
the Dean and Chapter of Exeter Cathedral

Report No. 21-24

August 2021

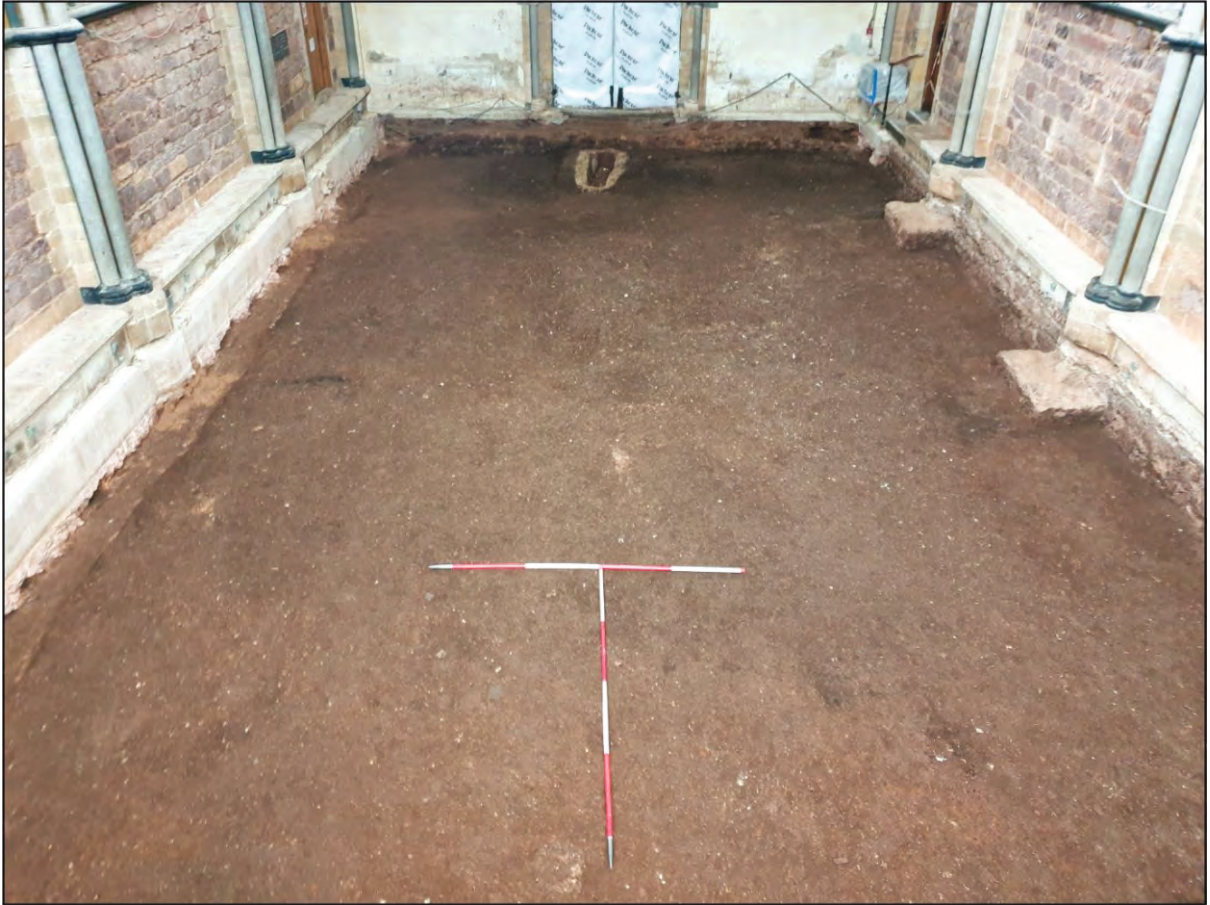
Fig. 2. The Chapter House after completion of excavation (*photo: M. Steinmetzer*).

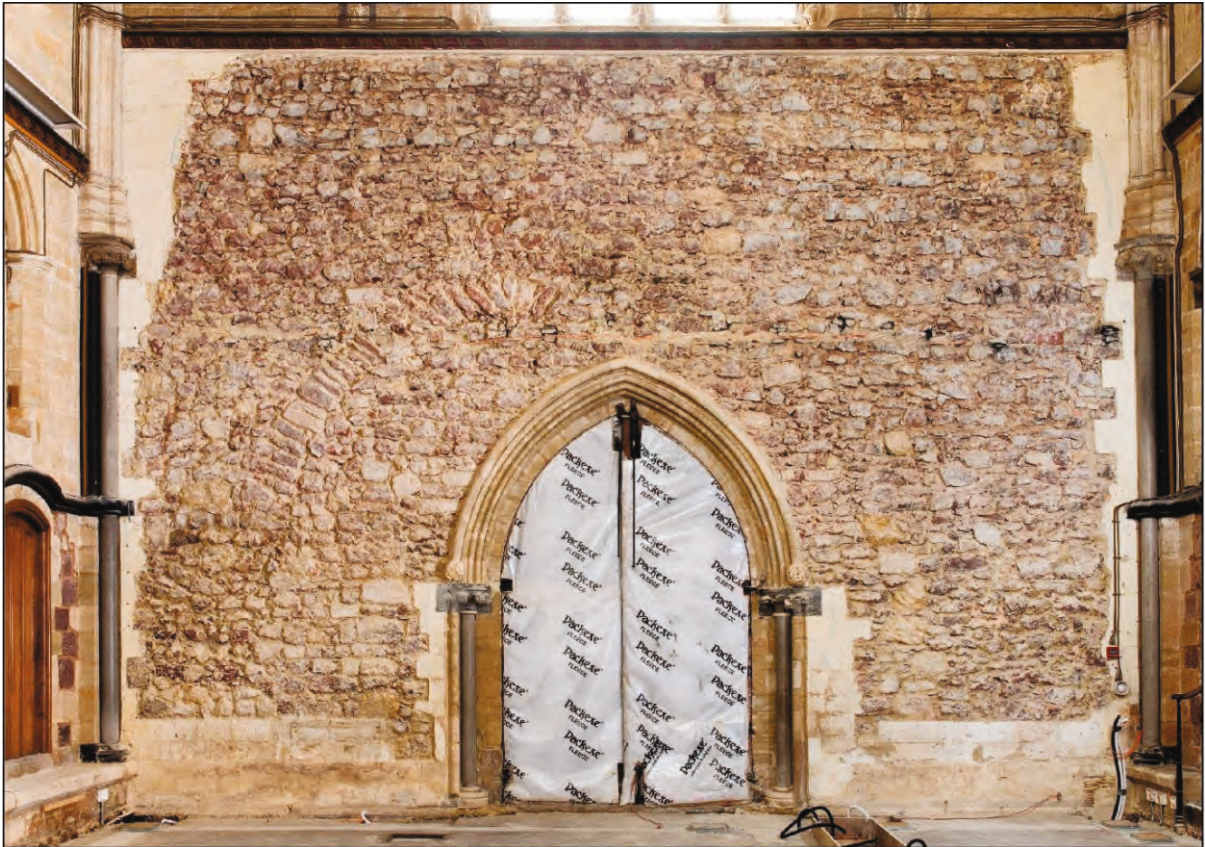
Fig. 4a. The Chapter House: internal face of the west wall after removal of modern render, 1 April 2021 (photo: Gary Young).

The internal face of the west wall had been recorded rather hurriedly in 1996, when it was stripped of cementitious render and re-rendered in lime mortar in preparation for the arrival of Dean Jones. By 2021 much of the render applied on that occasion had failed, so it was stripped once more and re-rendered. On this occasion a photographic record was made without intervening scaffolding (Fig. 4a) and the survey drawings of 1996 were re-examined.

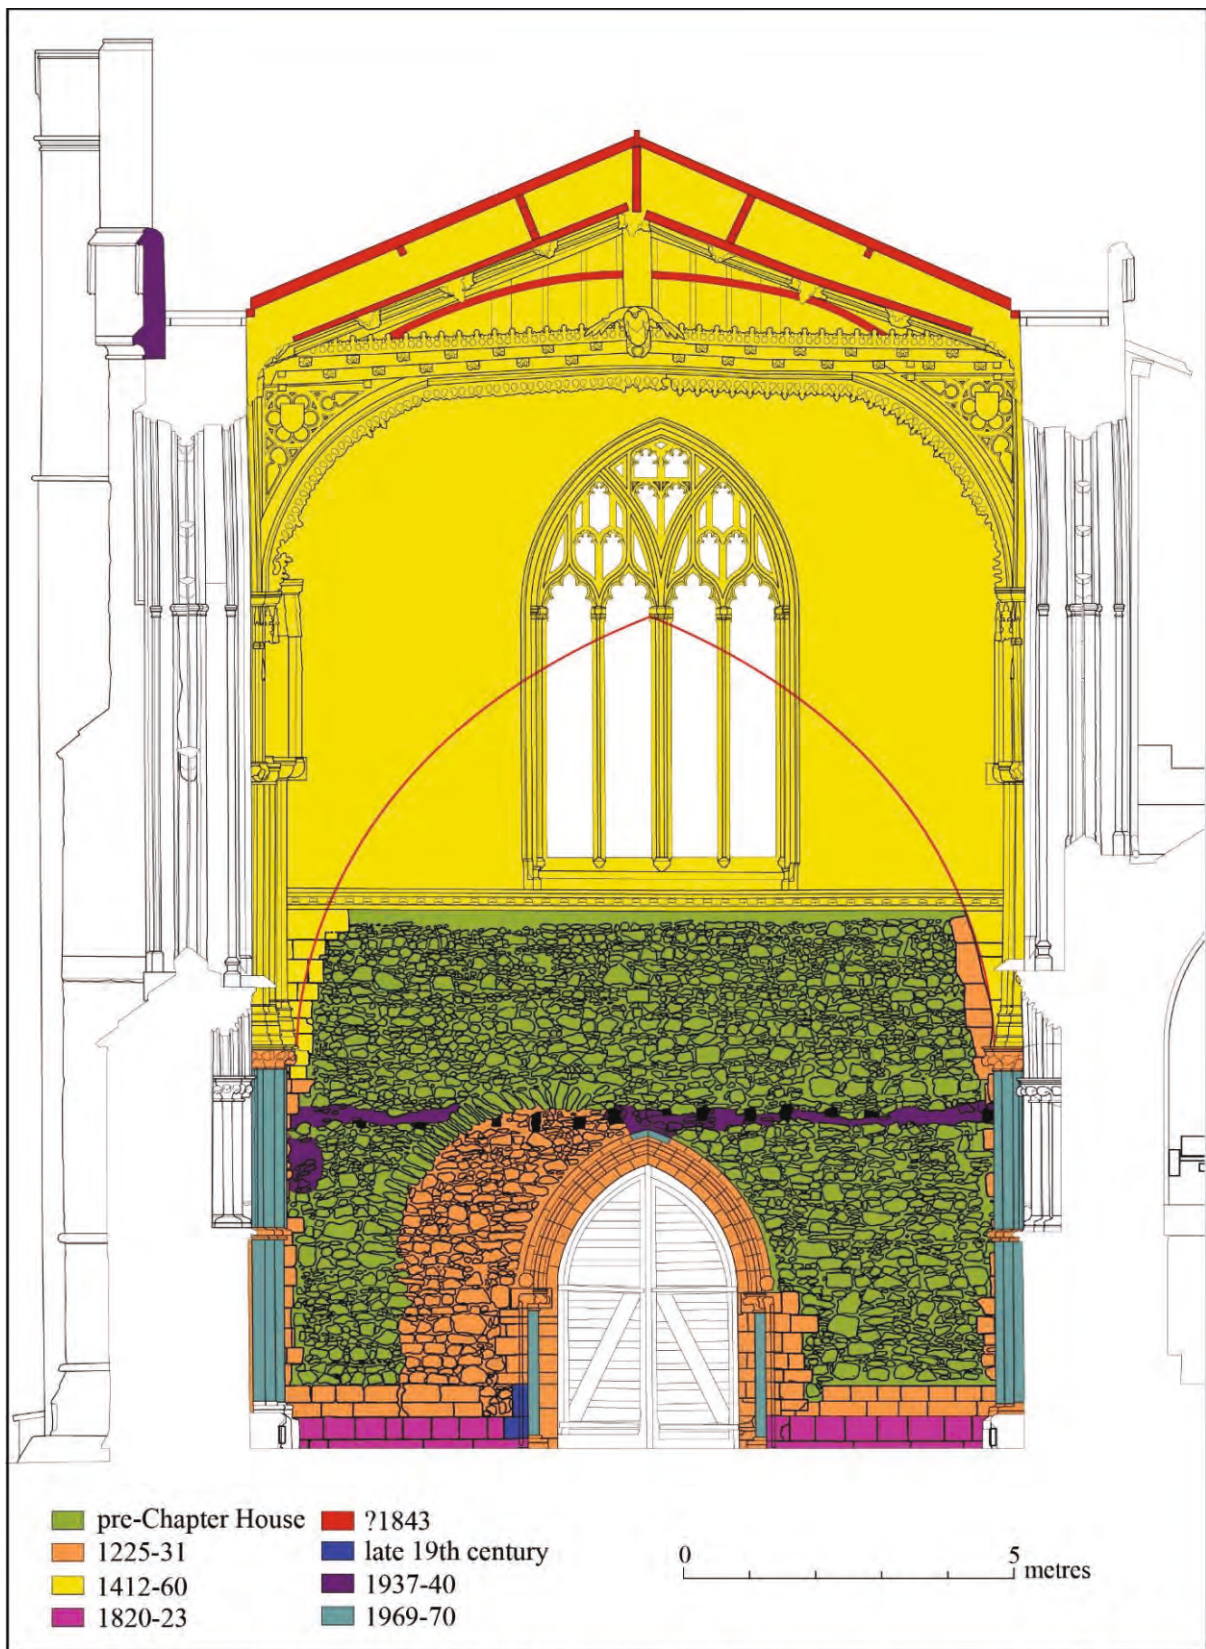
Fig. 4c. The Chapter House, internal face of the west wall: phasing with reconstruction of primary wooden vault (*J. Allan & J. Sampson 1996, with corrections/additions, J. Allan 2020 and 2021*).

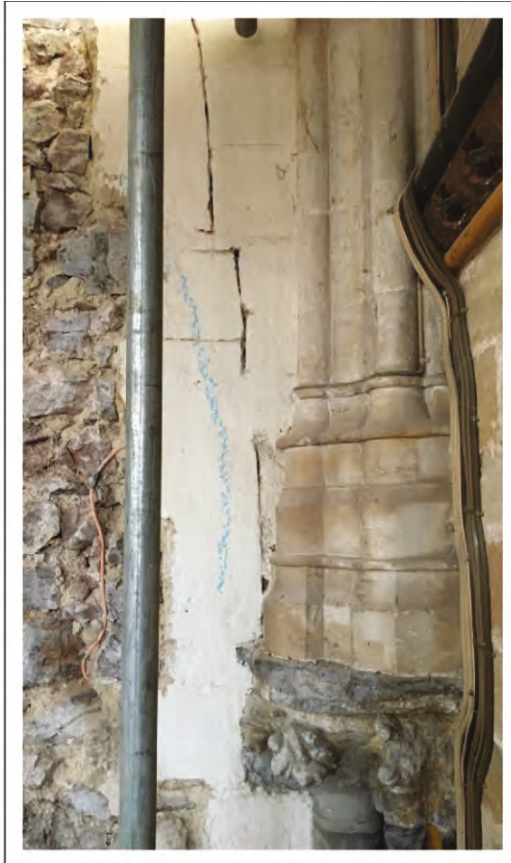
Fig. 4d. Chapter House, west wall: building break above 13th-century capital on north side providing evidence for early vault (*photo: J. Allan*).

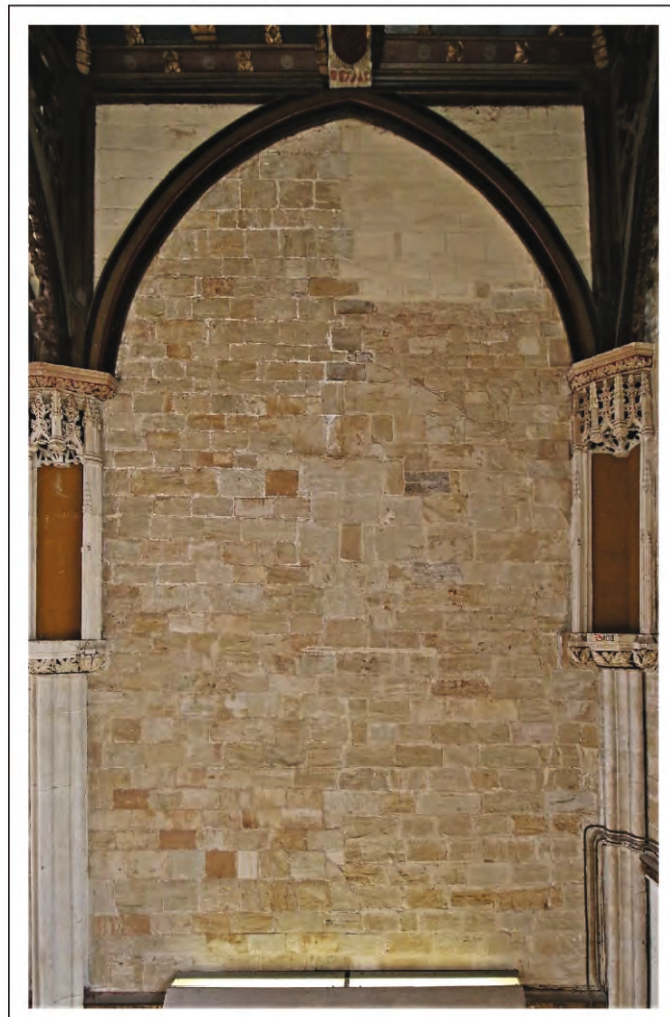
Fig. 5e. Chapter House, south wall: the upper part of Bay 4, showing two periods of masonry (*photo: Hugh Harrison, 20 Oct 2020*).

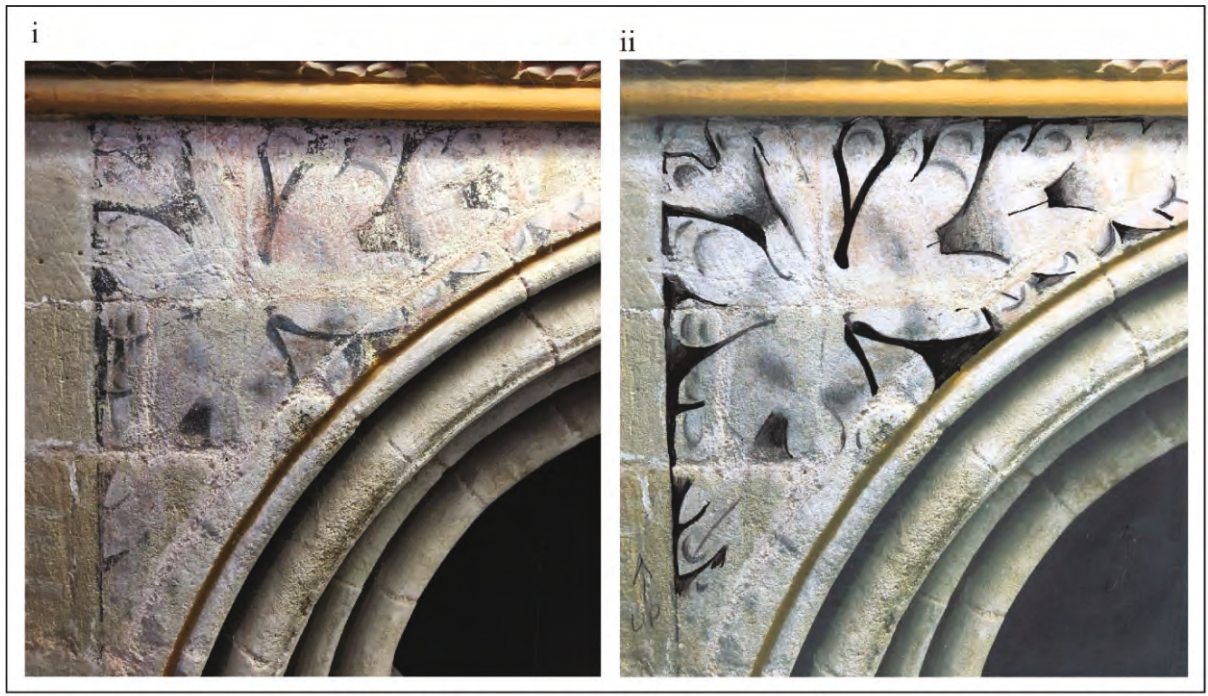
Fig. 5f. Chapter House, south wall, Bay 4: spandrel of wall-painting in arcade, enhanced in (ii) (photo: J. Allan).

It has not been noted hitherto that a near-vertical straight joint rises through the middle of Bay 4, marking the break between the 13th- and 15th-century masonry (Fig. 5f); a substantial fragment of the primary build rises above the arcade on the west side of the break, and this contains significant evidence about the primary form of the building. This corresponds to the position of the edge of the stair turret projecting from the external face, showing that this feature was retained in the 15th-century remodelling. The earlier masonry consists principally of Salcombe blocks but with a little Caen stone and a scatter of flat slabs of grey lias, the material used for capitals and shafts in the 13th-century work. The top edge of this masonry forms a low arch, rising towards the centre of the bay.

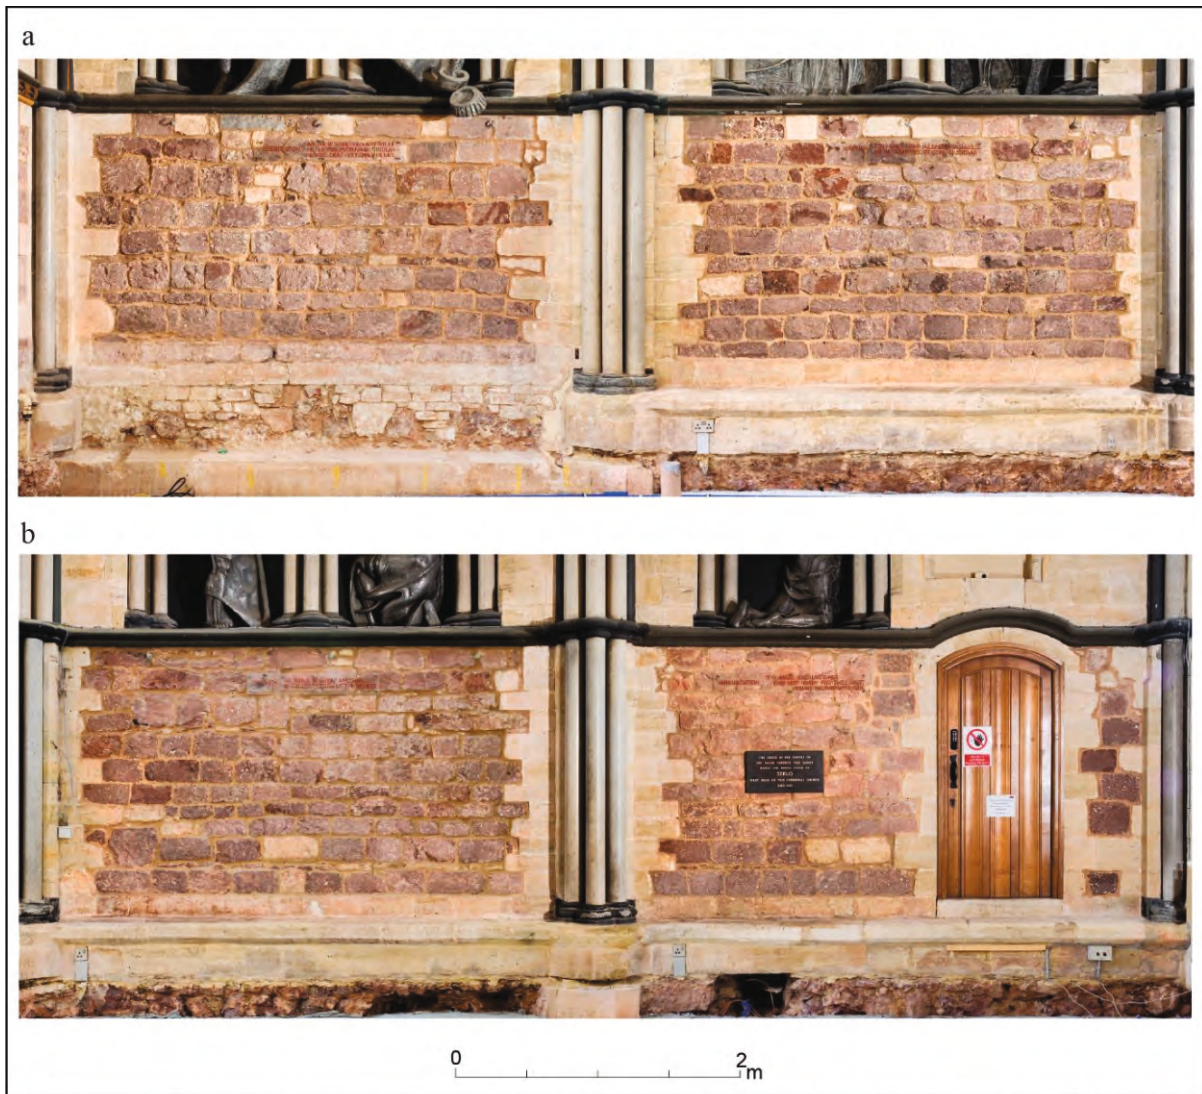
Fig. 6a-b. The Chapter House: internal face of the south wall, March 2021. (a) Bays 1 and 2. (b) Bays 3 and 4. The plain masonry was replastered subsequently (photos: Gary Young).

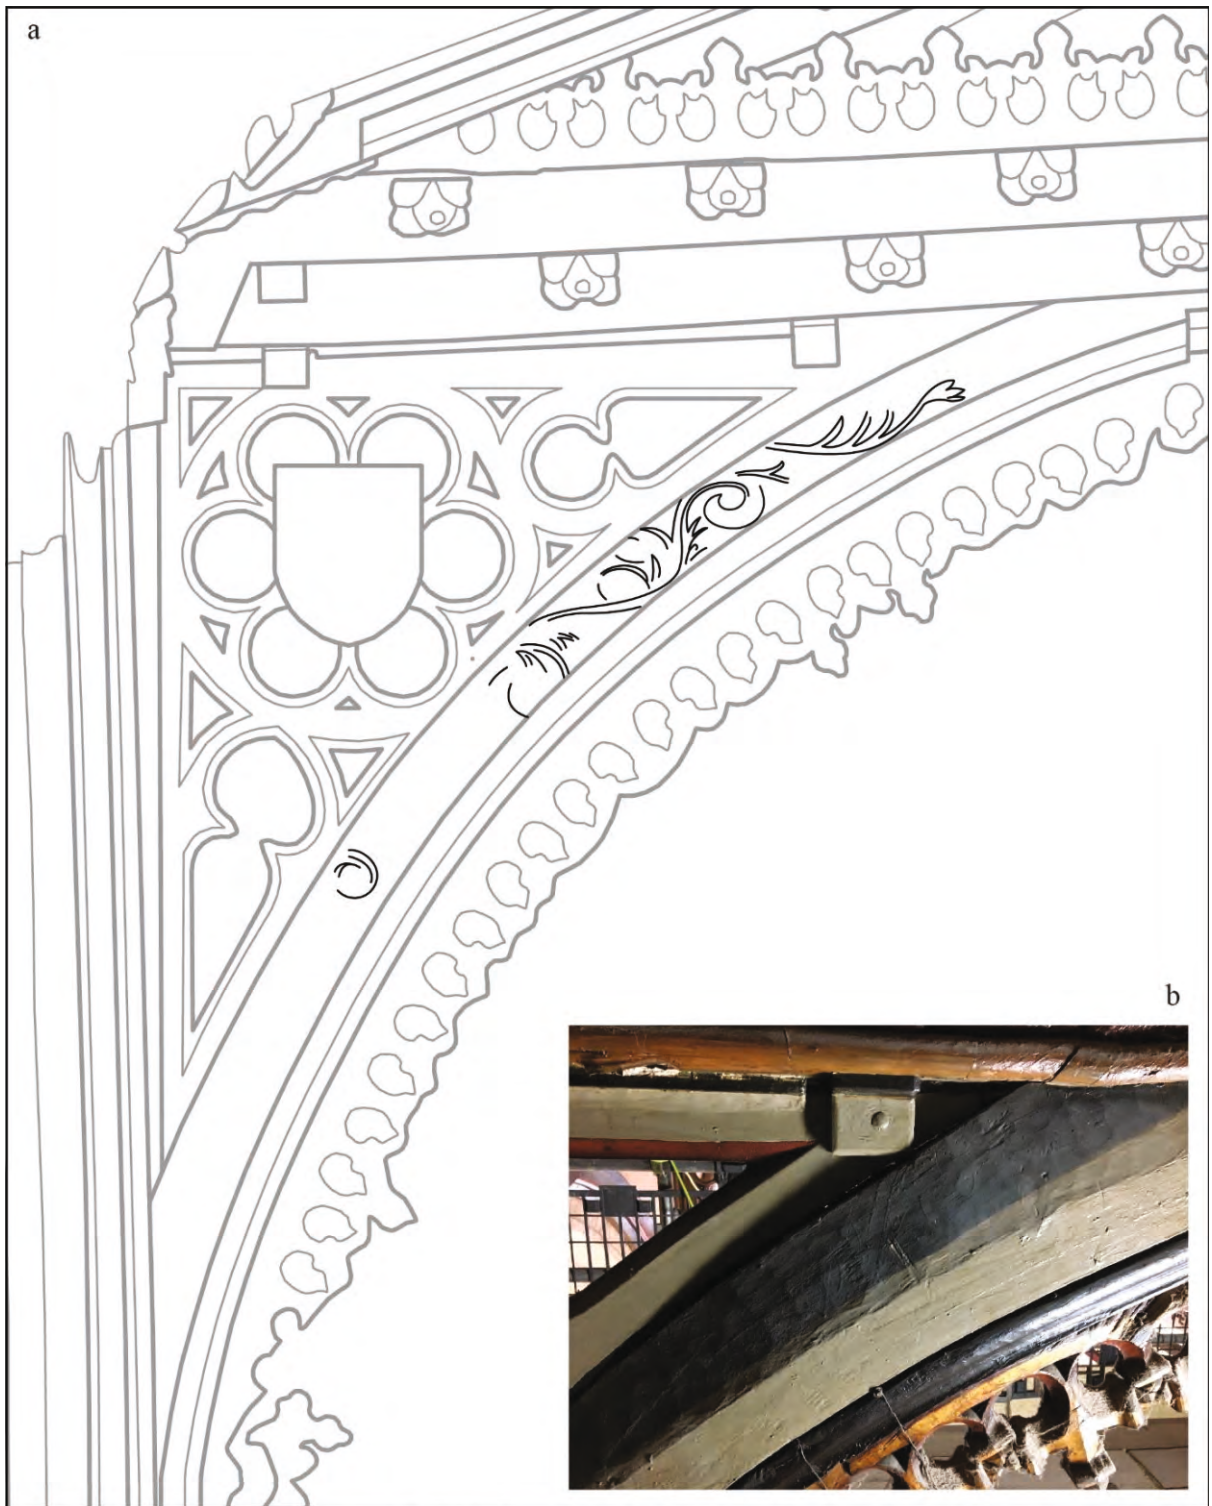
Fig. 9. Outline of a painted scroll, seen below modern brown paint, on the west side of truss 3/4. (a) Drawn record. (b) photograph (*J. Allan & A. Steinmetzer/D. Gould*).

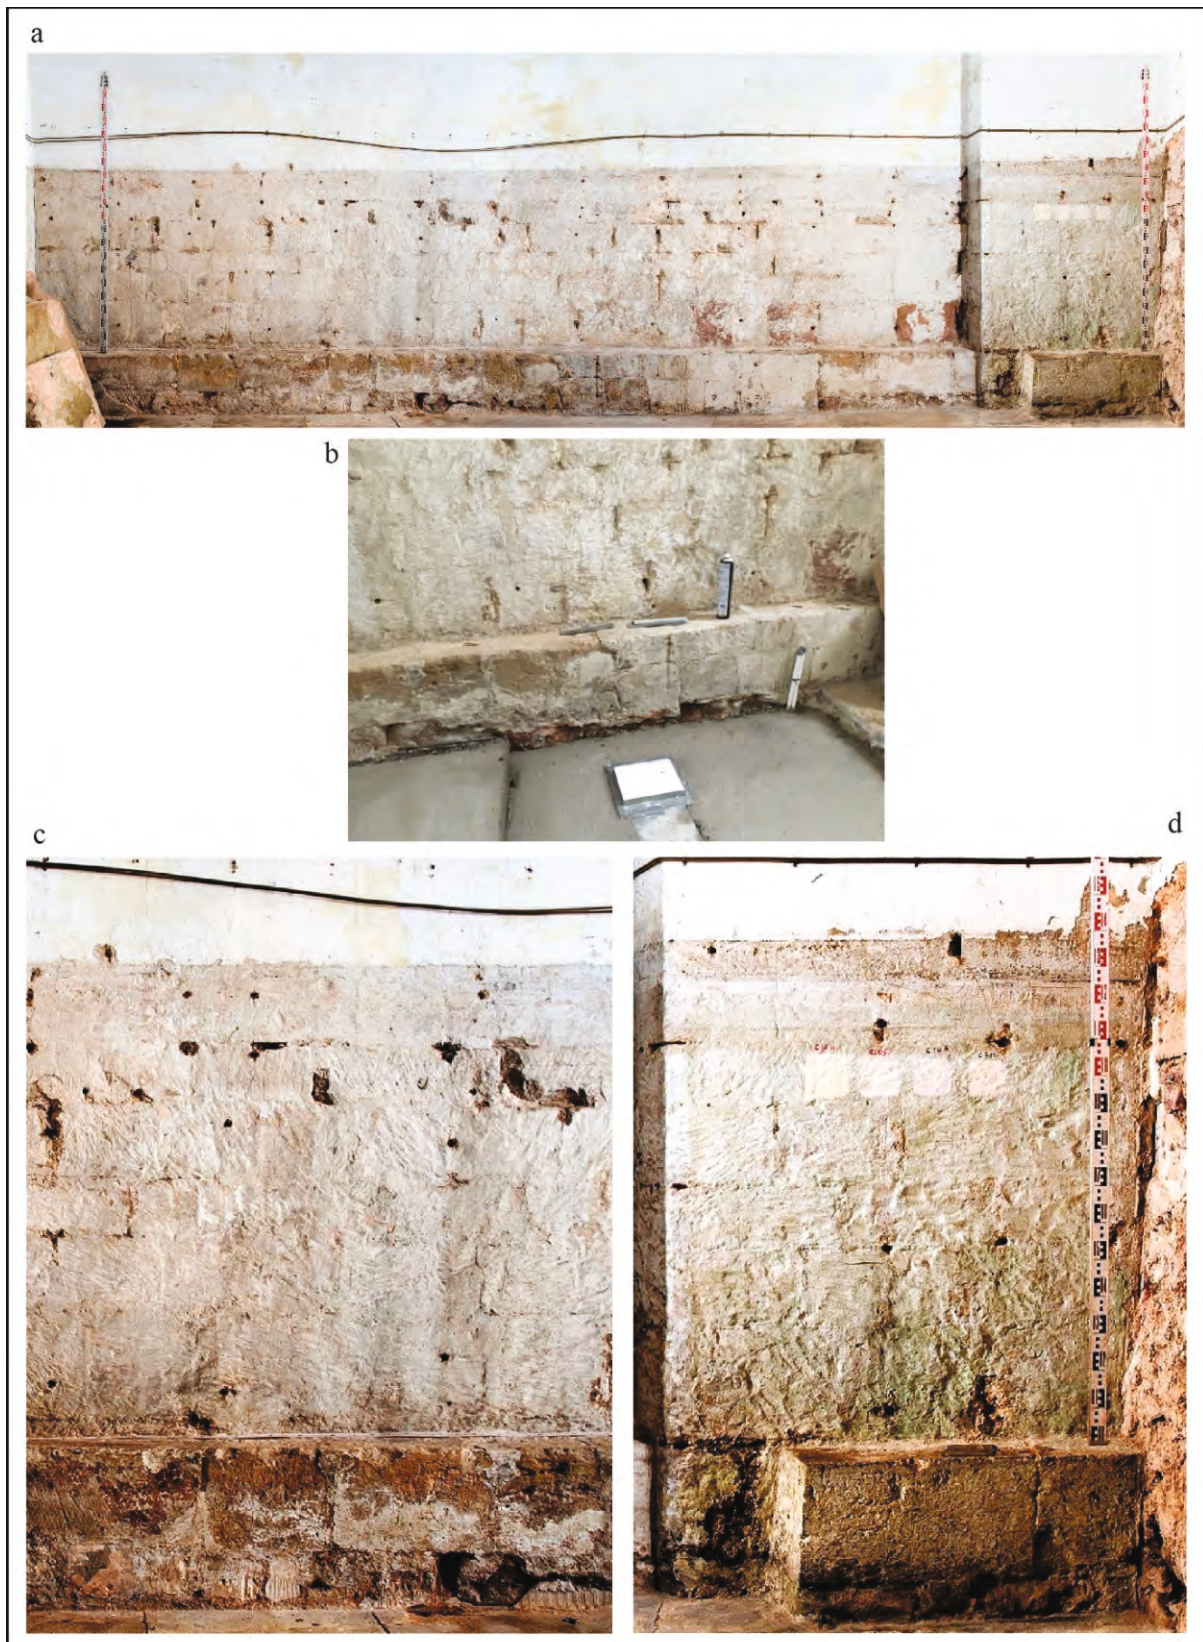
Fig. 12. The Chapel of the Holy Spirit: the north wall (external face of the south tower). (a) Photogrammetric record. (b) Footing exposed by lifting of paving slabs. (c–d) Details showing rough dressing, indicating that the face has been cut back (photo: a, c–d Gary Young, 8 Feb. 2021; (b) J. Allan, 9 March 2021).

2. The north wall of the chapel (Figs 12–13), which is the external face of the south wall of the Norman cathedral's south tower, is the oldest standing element, dating from *c.* 1114–33. A small excavation at its foot showed that the bottom of the wall visible today is in fact the bottom course of Norman ashlar; small rubble forming part of the foundation was visible below it. The old ground surface here was therefore *c.* 0.7m higher than its recorded position in the south-eastern corner of the room; the ground must have sloped markedly. The bottom course of the tower (which is deeper than most) contains alternating blocks of Salcombe sandstone and Red Rock sandstone (from the Paignton area/lower Dart valley) with a few blocks of volcanic trap, carrying on the pattern visible at the bottom of the west face of the tower. Above this level the facework consists of Salcombe stone ashlar courses of variable width, some of them readily recognisable on the internal face of the tower and on the west side of the exterior. The original face of the lowest 1.5m of this face of the tower have been crudely cut back (see below); above that level chisel-dressing parallel to the block faces, typical of early Norman masonry, is evident on some stones.

floor level (Fig. 12, c–d). No firm dating of this modification was found, except that it precedes Kendall’s western stone screen of 1825 (described below). It seems likely, however, that this feature is contemporary with the corresponding bench on the south wall, and thus is part of the conversion of the space to a chapel.

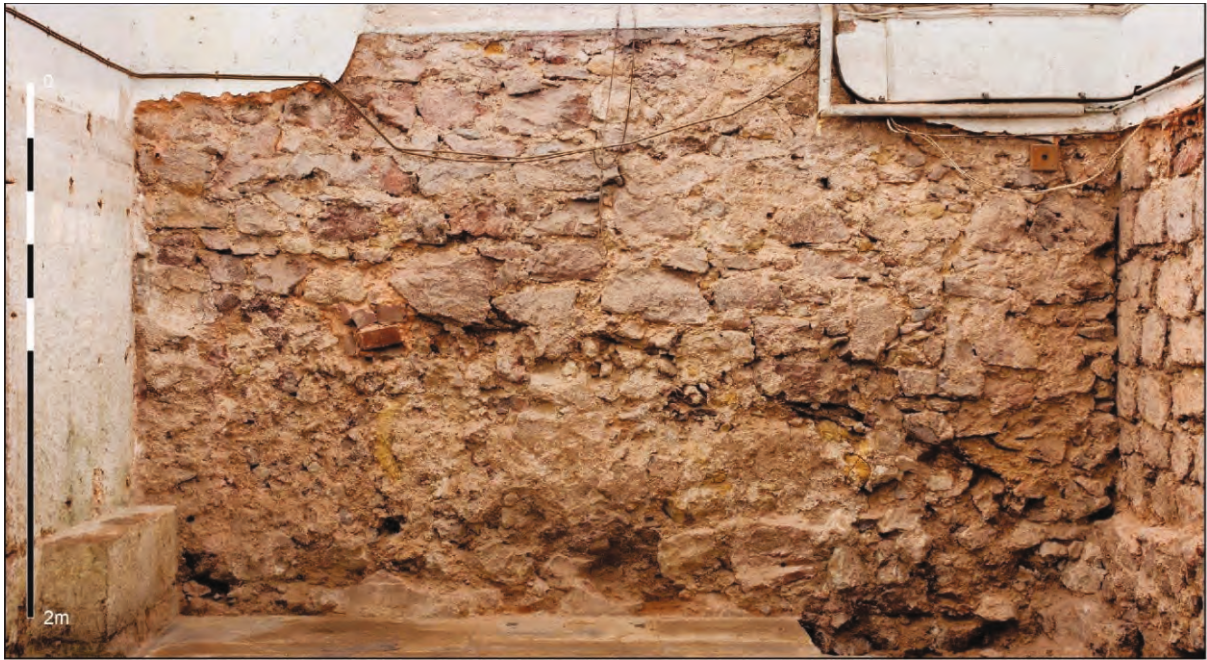
Fig. 15. The Chapel of the Holy Spirit: rectified photographic record of the east wall after removal of cement render (*photo: Gary Young, 8 Feb. 2021*).

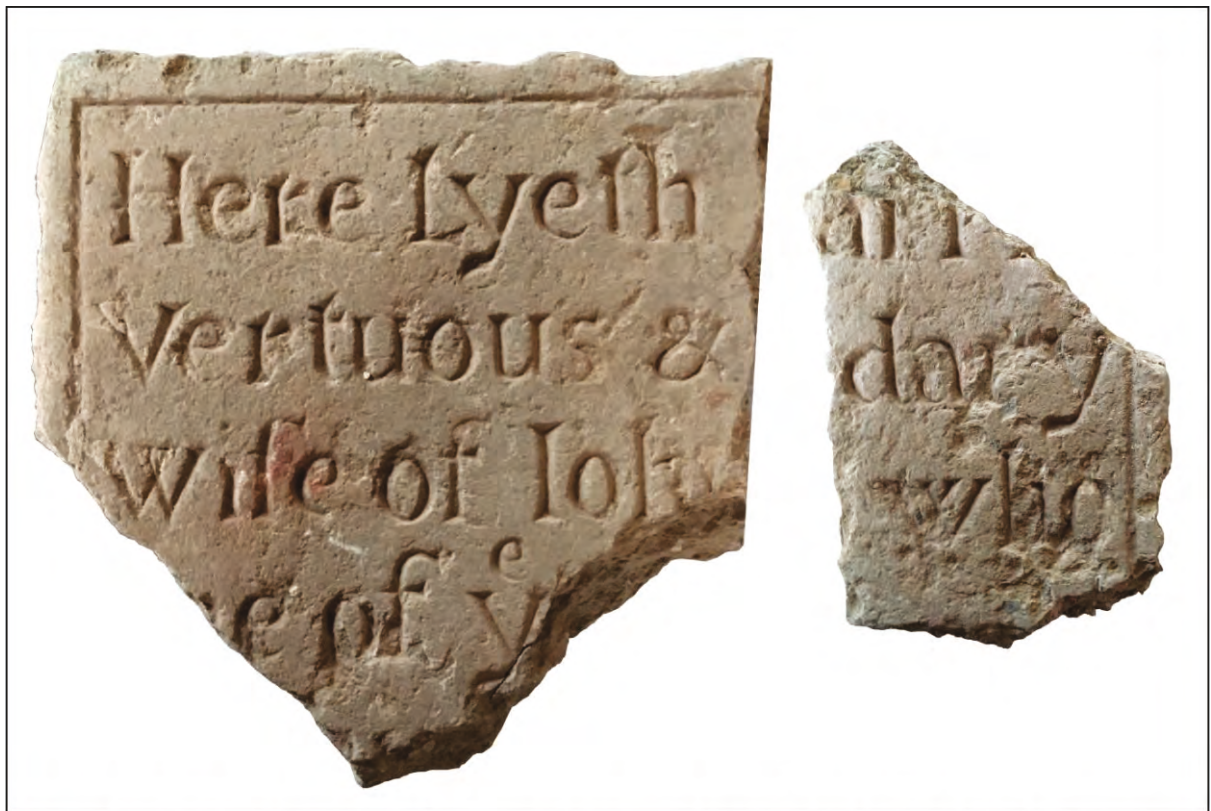
Fig. 19. Fragments of ledger stone from 19th-century make-up in the Chapel of the Holy Spirit.

The secondary floor may have dated from the 17th or 18th century or may have been the floor of Purbeck stone installed in October 1822, when Chapter ‘ordered part of the Holy Ghost Chapel to be paved with Purbeck stone’.¹⁶ Fragments of a late 17th-century ledger stone were found in the make-up layer below the 19th-century floor (Fig. 18).
