WIGHTWICK MANOR, WOLVERHAMPTON

STABLE BLOCK AND COACH HOUSE RANGE

Historic Building Report

5th July 2011

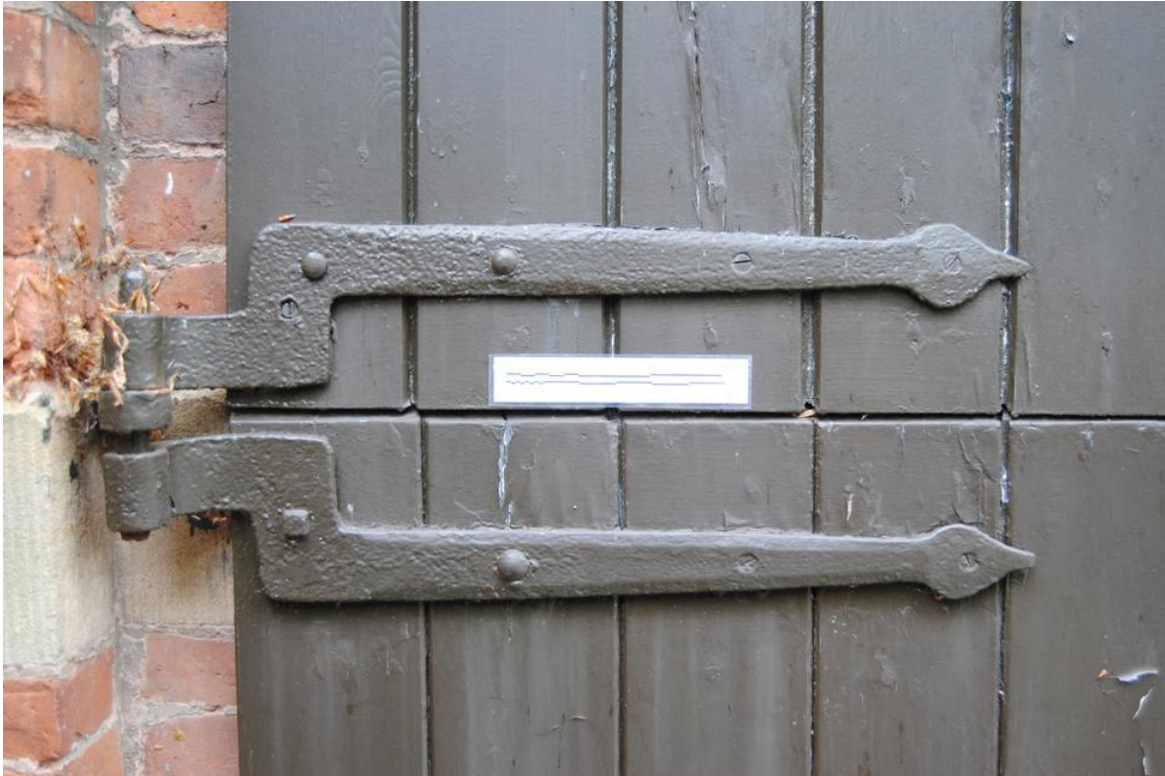
Plate 7: Distinctive strap hinges and sandstone pintle-blocks at [d3] (similar to Blocks C and D).

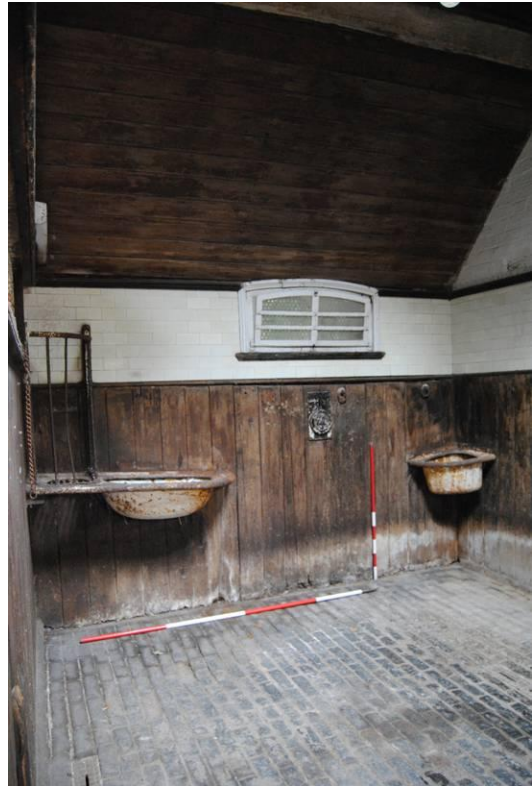
Plate 11: Loose-box [ST14] looking north.

- 6.1.7 The loose boxes are defined by partitions of substantial timber supporting screens of vertically set iron bars (@ 3in. centres) which extend to eaves level (Figure 12; Plate 10), and are accessed via sliding doors of similar construction.¹² Loose-box [ST12] extends across the full width of the range, boxes [ST13] and [ST14] being somewhat shorter, so as to accommodate access passage [ST12a] to the south. All loose boxes retain good 19th-century fittings;¹³ lower walls are clad in vertically set tongue-and-groove boarding with upper walls of white glazed tiles; [ST13] and [ST14] retain iron feeding stations and water troughs (Plates 11-13)¹⁴

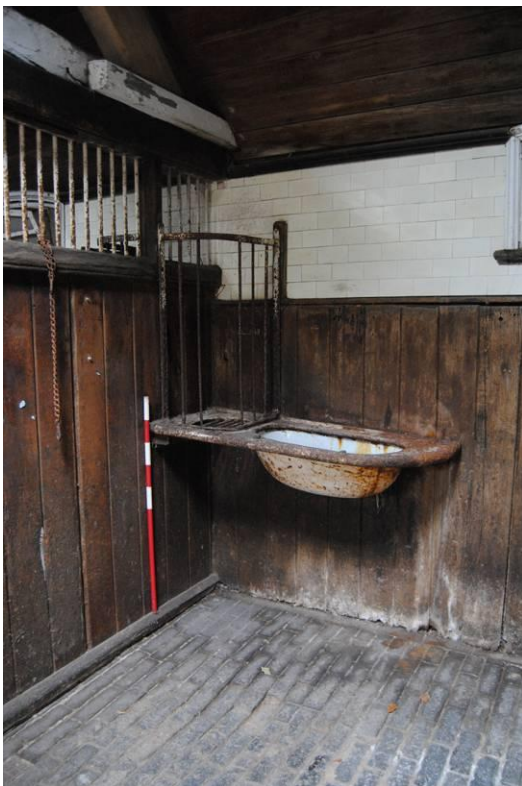
Plate 12: Feeding station within loose-box [ST14].

---	fitting	north wall	Iron drinking trough to north-west corner of loose-box (as per Plate 13)
	---	fitting	north wall	Opening mechanism located below (poss. related to) ventilation window [w11] (Plate 16)
	---	roof	---	see [ST12a]; KP truss forms upper east wall of loose-box
[ST13] Loose Box	[w10]	window	north wall	Segmental headed ventilation window (as per Plate 14) with iron grille to exterior elevation (as per Plate 20)
	---	door	south wall	Timber sliding door of stout vertical boarding with grille of iron bars @ 3in. centres over. Slides to east giving access to passage [ST12a] to south.
	---	floor	throughout	Edge-laid blue brick including inset iron drainage gulley (x1 transverse feeding into longitudinal)
	---	walling	north walls	T&G boarding to lower wall surface, white glazed tiles to upper walls.
	---	feeding station	north wall	Iron feeding station to north-east corner of loose-box (as per Plate 12)

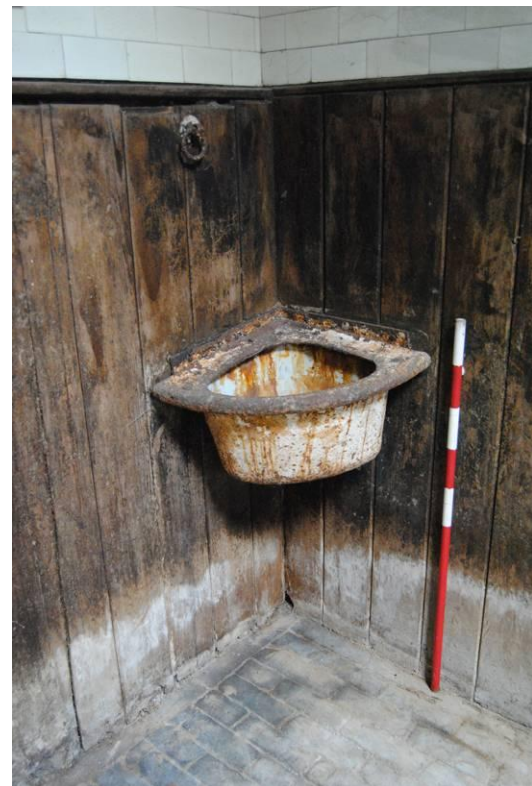
Plate 13: Water trough within loose box [ST14].

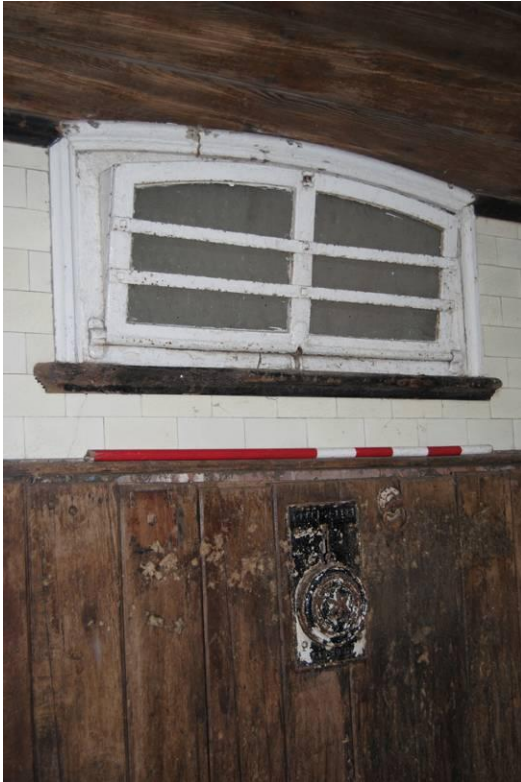
Plate 14: Ventilation window within loose-box [ST12] (north wall); see also Plate 20.

while each loose-box is furnished with a segmental headed, 'hopper'-type ventilation window within the north wall ([w9]-[w11]; see Plate 14). Tethering rings survive to varying degrees (Plate 17), up to four per loose-box, while an unusual iron opening mechanism (Plate 16) was recorded in each of the boxes, possibly related to the vent windows of the north elevation.

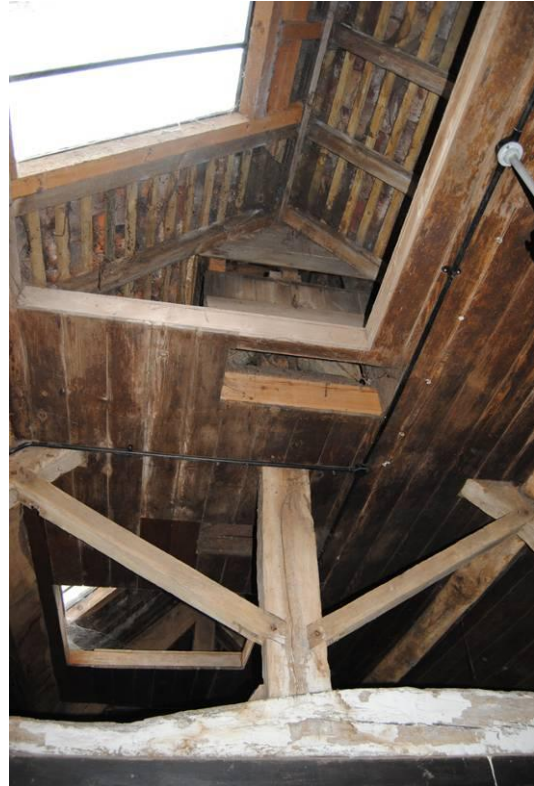
Plate 15: Stable Block A, king-post roof (from [ST14]).

- 6.1.8 The roof over the loose box range is of three bays, defined by two softwood, king-post trusses (Figure 12; Plate 15) with raking struts supporting principals at the level of a single tier of through purlins. Ties are evidently re-used, of uneven scantling and displaying a thick coating of limewash; likewise the heavy purlins show signs of re-use in the form of redundant mortices and peg-holes. The room is ceiled over at purlin level with a cladding of horizontally set tongue and groove boarding which extends onto the lower slope of the roof. The central bay includes a ridge vent, formerly served by small ventilation ducts rising from voids within the ceiling (Plate 15);¹⁵ large openings have been subsequently made within the boarded ceiling, coincident with a series of three inserted skylights to the southern roof slope providing generous natural lighting to the interior of the range. Additional ventilation was originally provided by three tall, timber box-vents against the south wall of the range, two of which survive (Plate 18), serving low level ventilation grilles within the exterior wall and furnished with a distinctive 'hand grip' turn-handle motif (Plate 19).

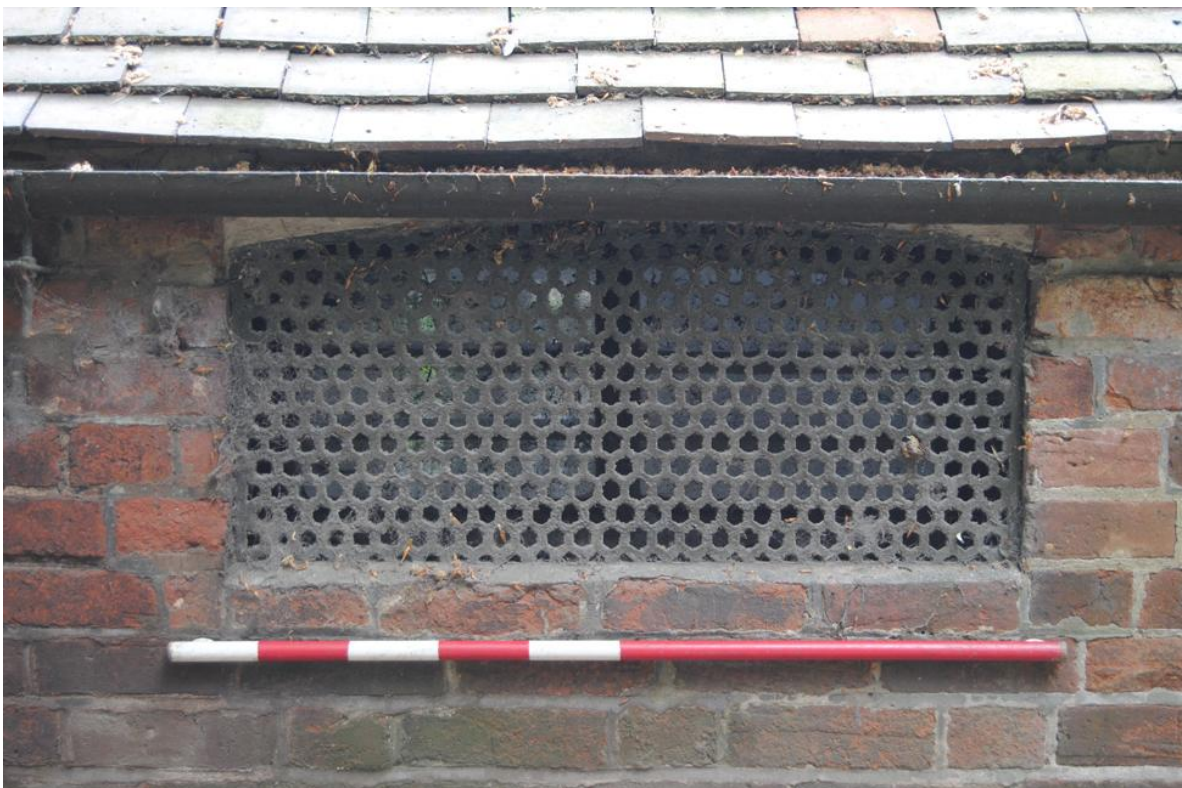
Plate 20: Stables Range, Block A, north elevation; exterior grille to ventillation window (see Plate 14).

- 6.1.5 The **north elevation** (Figure 11b) is essentially plain, terminating in straight joints to both east and west at the junctions with Blocks **B** and **E** respectively. Three iron ventilation grilles [w9-11] with low segmental heads (Plate 20) serve the interior loose-boxes.

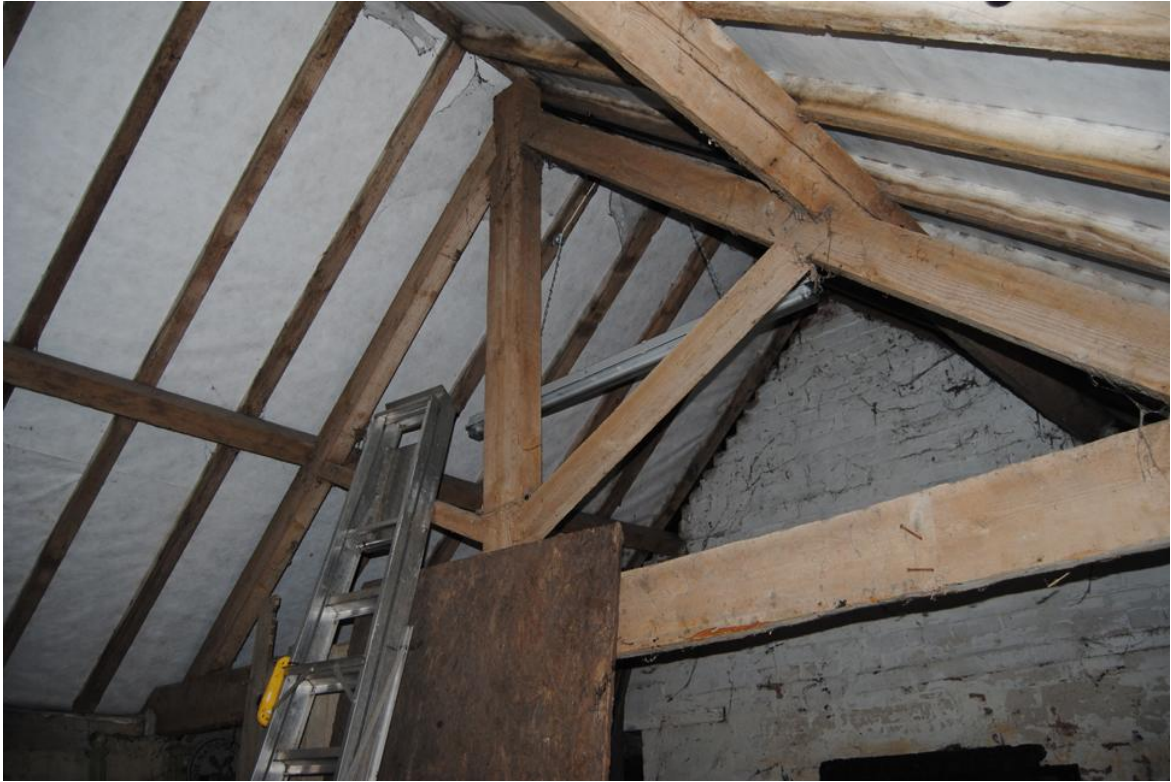
Plate 28: Stables Range, Block C; king-post roof structure.

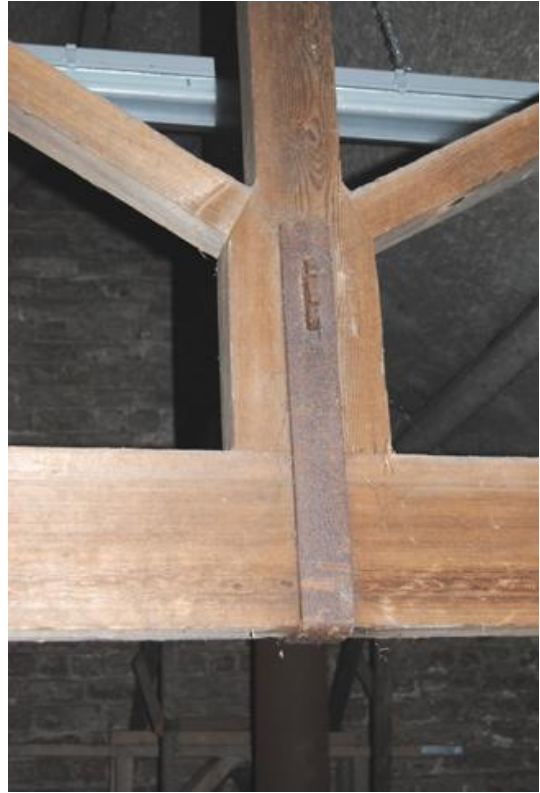
Plate 33: Gib-and-cottered stirrup to base of K-P.

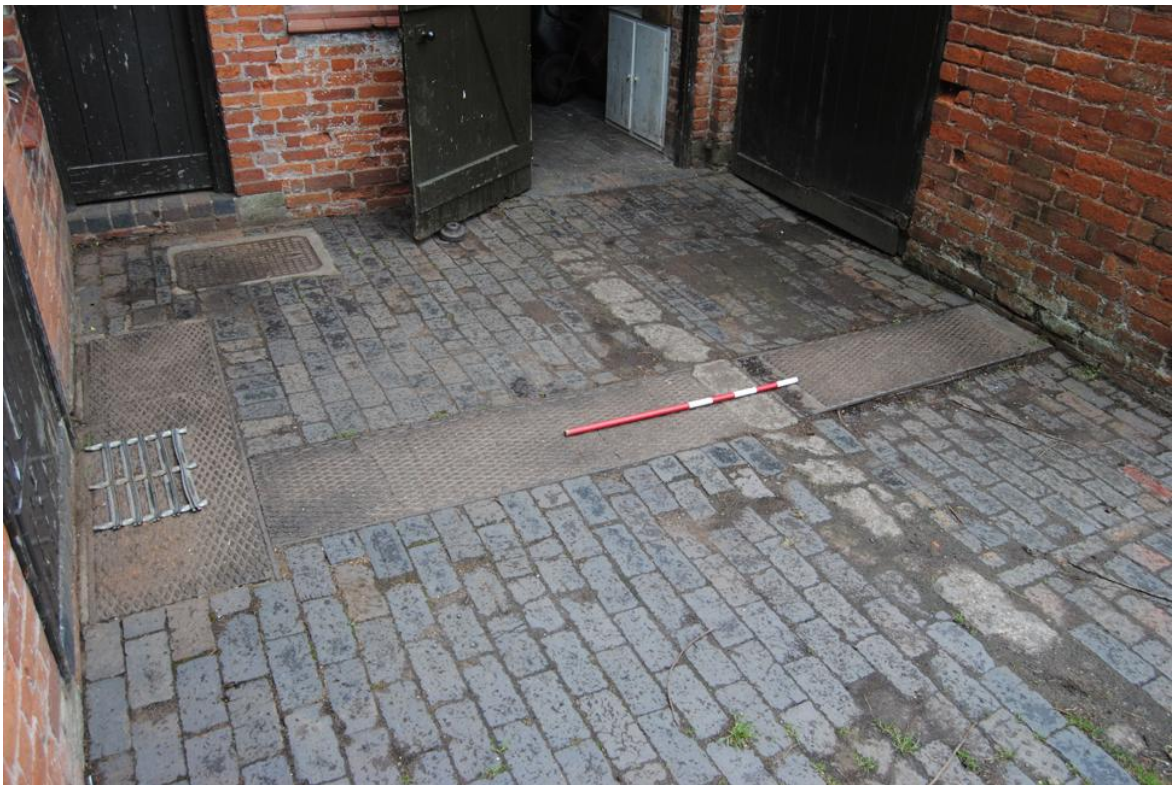
Plate 43: Coach House range, area of blue-brick paving to west of range with iron duct covers.

- 6.2.5 The **west elevation** (Figure 16b; Plate 39) presents a less homogenous aspect and holds more evidence as to the origin and development of the building, though successive phases of alteration make this evidence problematic to read with any degree of confidence. To the north and centre of the range, the elevation is obscured by later additions (Blocks **G** and **H** respectively). Where accessible, the lower wall was noted to be of narrow, 2¼ in. brick, though this changes to 3in. brick from c.1.6m above exterior ground level suggesting a significant programme of rebuilding; the two Mander phase windows to the south end of the range ([w19/20]; Plate 44) are set within the latter brickwork with no obvious sign of insertion. To the north of the range, between Blocks **G** and **H**, a single pedestrian doorway [d24] and window [w16] serving [ST10] have been inserted into a former wide gateway opening, iron pintles for gates survive to both north and southern jambs, supported on sandstone blocks. The upper brickwork of this section of the elevation displays several areas of patching presumably related to the former abutting structure indicated on early OS maps (Figure 6) and associated with the area of blue-brick paving which extends to the west of Block **E** at this point which includes a series of iron covers relating to a network of former heating ducts (Plate 43).²⁰

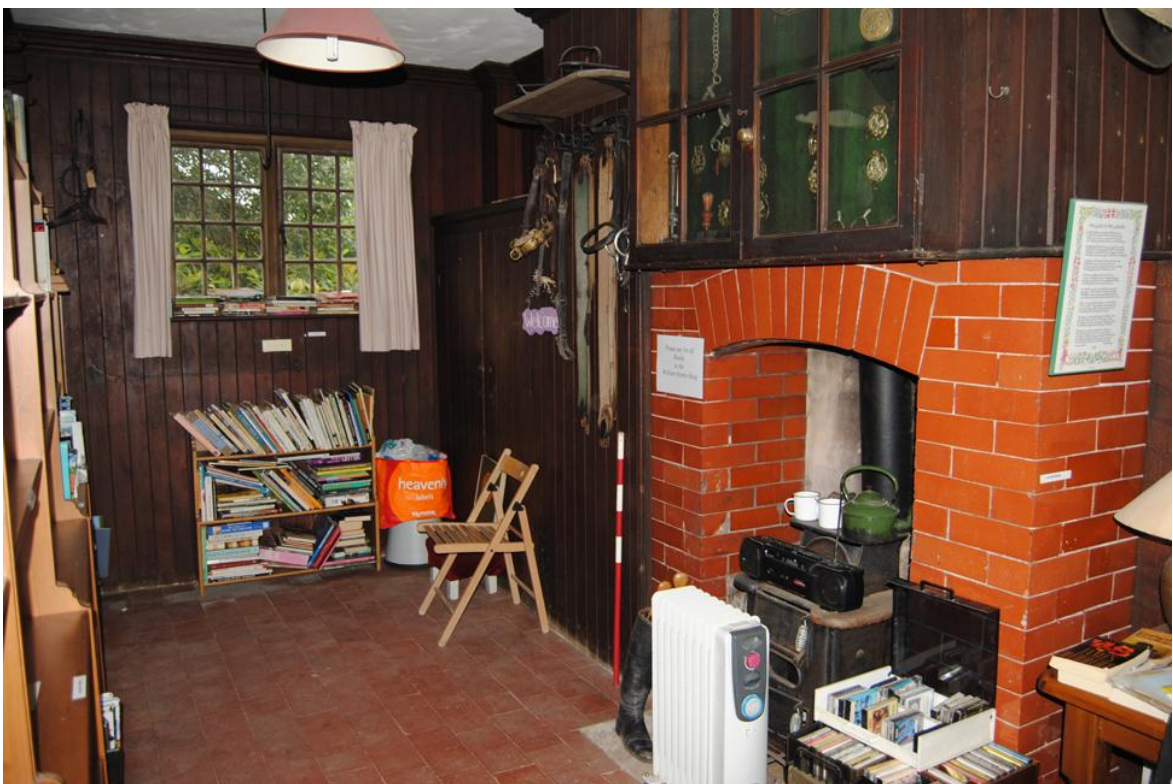
Plate 49: Coach house range, Block E; Tack Room [ST4] looking west.

- 6.2.10 Bay 5 is occupied by a tack room [ST4] (Plate 49), accessed from the exterior via doorway [d29], previously described, and from the stables [ST3] to the south via door [d30] at the east end of the south wall. The room lit by a single double-light timber casement in the west wall and via the margin lights of door [d29]; it is well detailed with flooring of 6 in. red quarry tiles, tongue and groove clad walls and a glazed brick chimney-breast, the latter with segmental-arched fireplace housing a cast-iron burner. The walls include a number of harness and saddle brackets of 19th-century date while a ladder access rises at the north-east corner (Plate 50) via a simple hatch to Loft Bay 5 over. The room is currently used, together with [ST3] to the south as informal retail facilities (second-hand book shop).

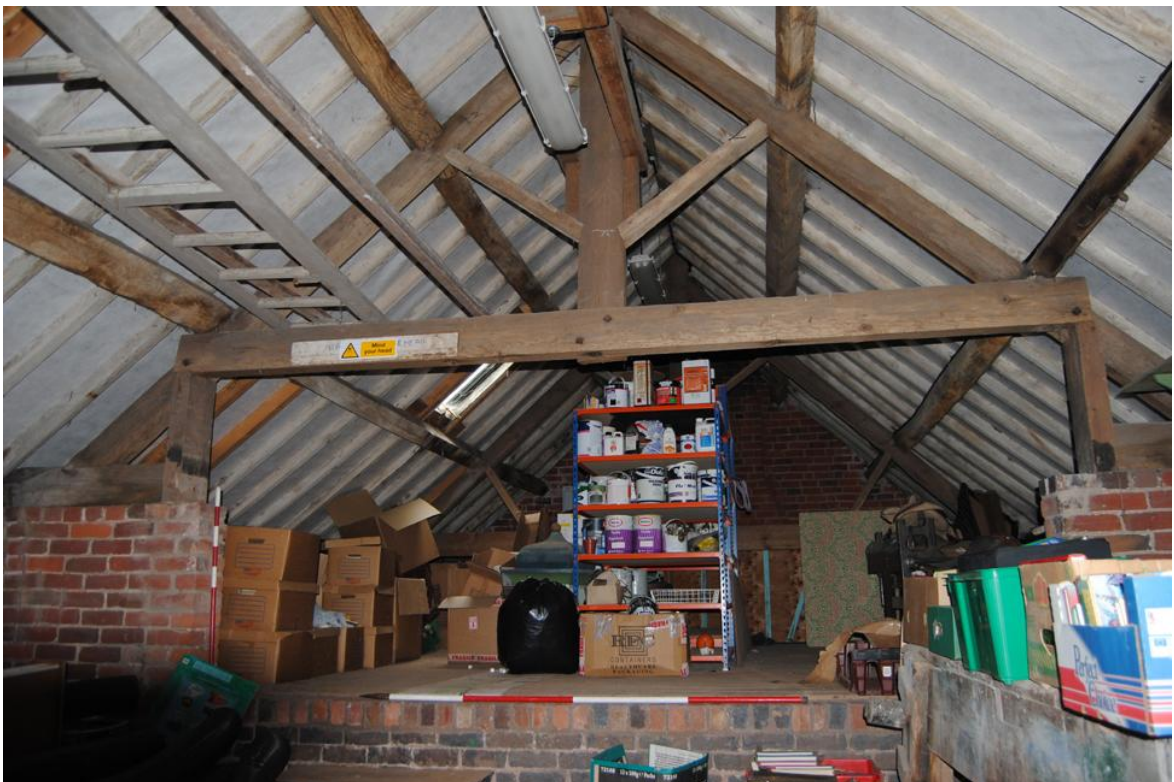
Plate 52: Coach house range, Block E; roof structure. Note truncated tie to near truss (T2).

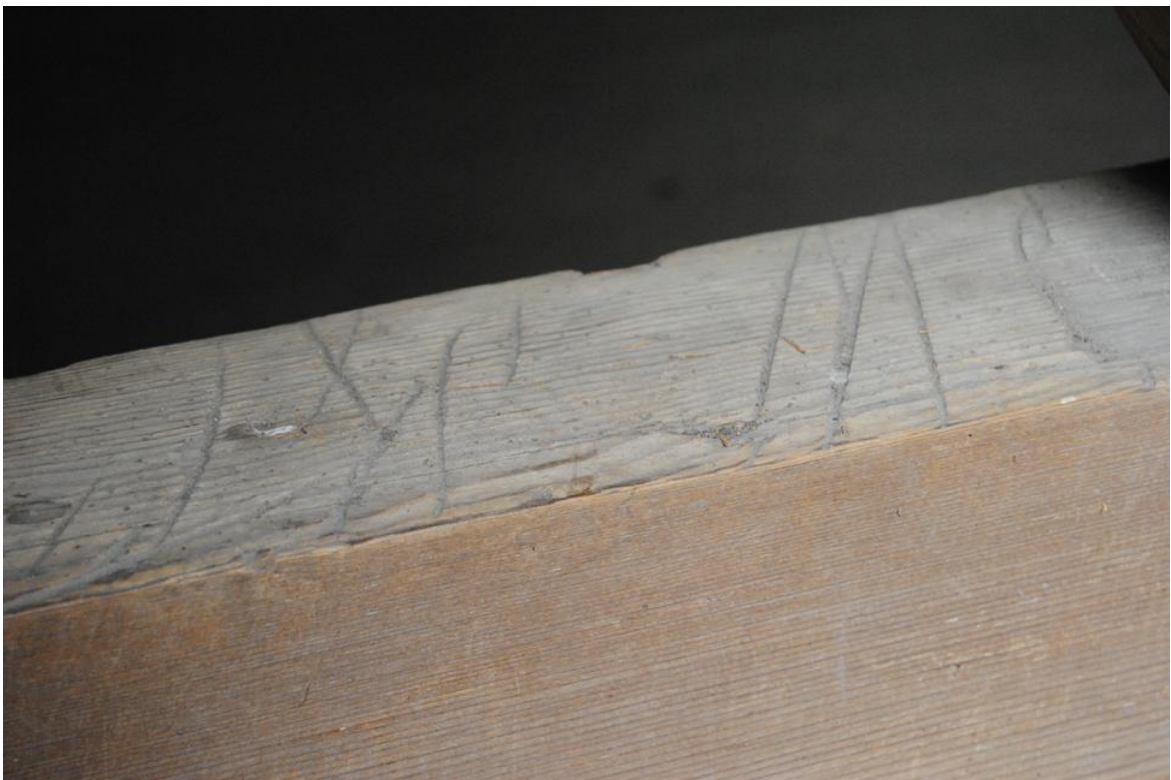
Plate 55: Distinctive Baltic importers marks to top side of tie, Truss T3.

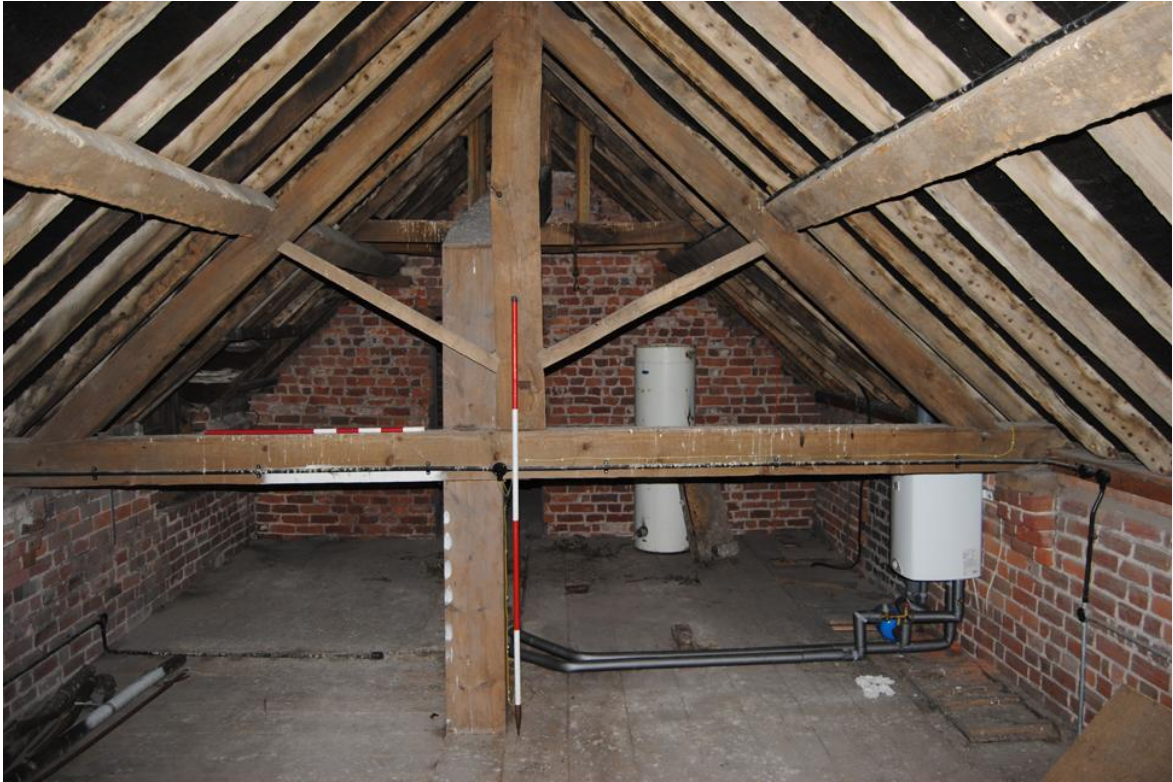
Plate 69: Coach house range, Block E; king-post roof structure looking south.

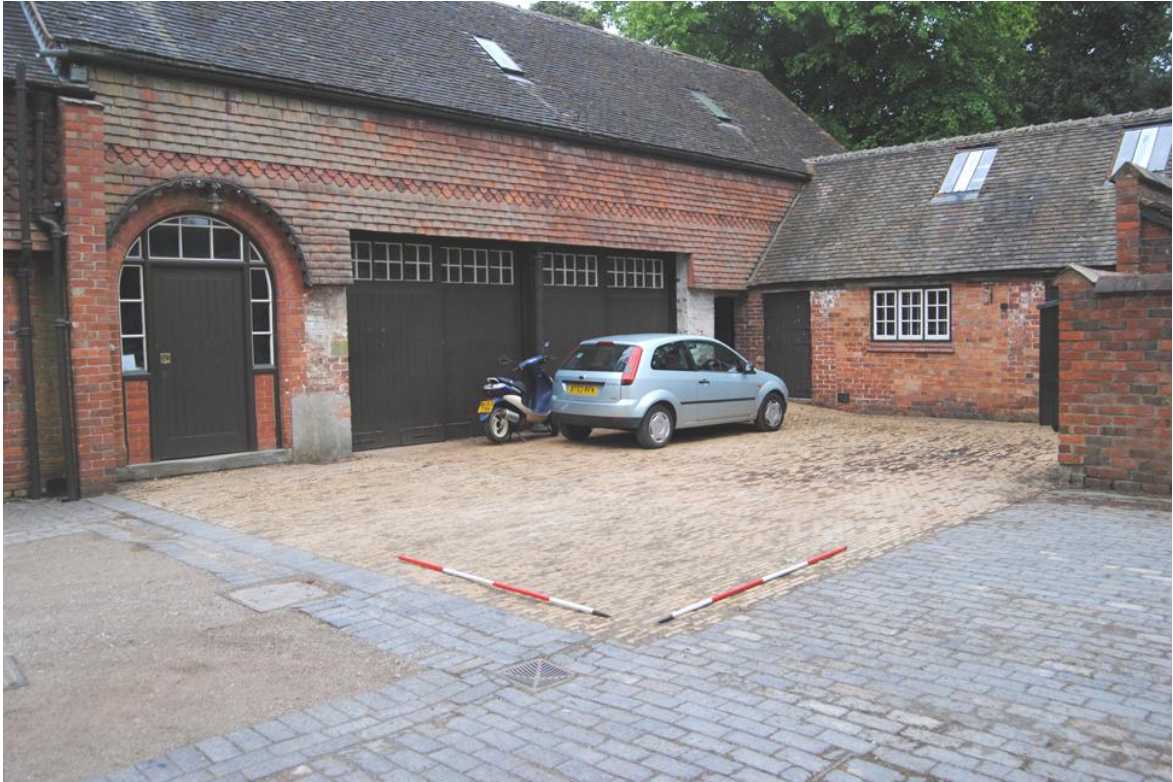
Plate 73: Yellow-brick paved area in angle of Coach House and Stables denotes extent of former port-cochère (see Figure 8).

- 5.5.2 The port-cochère is indicated on the Ould's drawing of 1888 (Figure 7) and thus formed an integral part of the refurbishment of the stables and coach house ranges undertaken for Theodore Mander. By the early 1960s concerns were being raised about the condition and safety of the port-cochère, referred to in correspondence as the 'covered wash' or 'car wash'. An outline specification for repairs to the garage and stables was drawn up and issued on 23rd March 1961 and the architect Anthony Sandford of Quatford retained, using JR Thorneycroft and Sons of Compton as contractors. The specification stipulated, amongst other works, the following:
