GUEST HOSPITAL

Tipton Road, Dudley
West Midlands

Historic Building Record and Ornamental Audit

31st March 2011

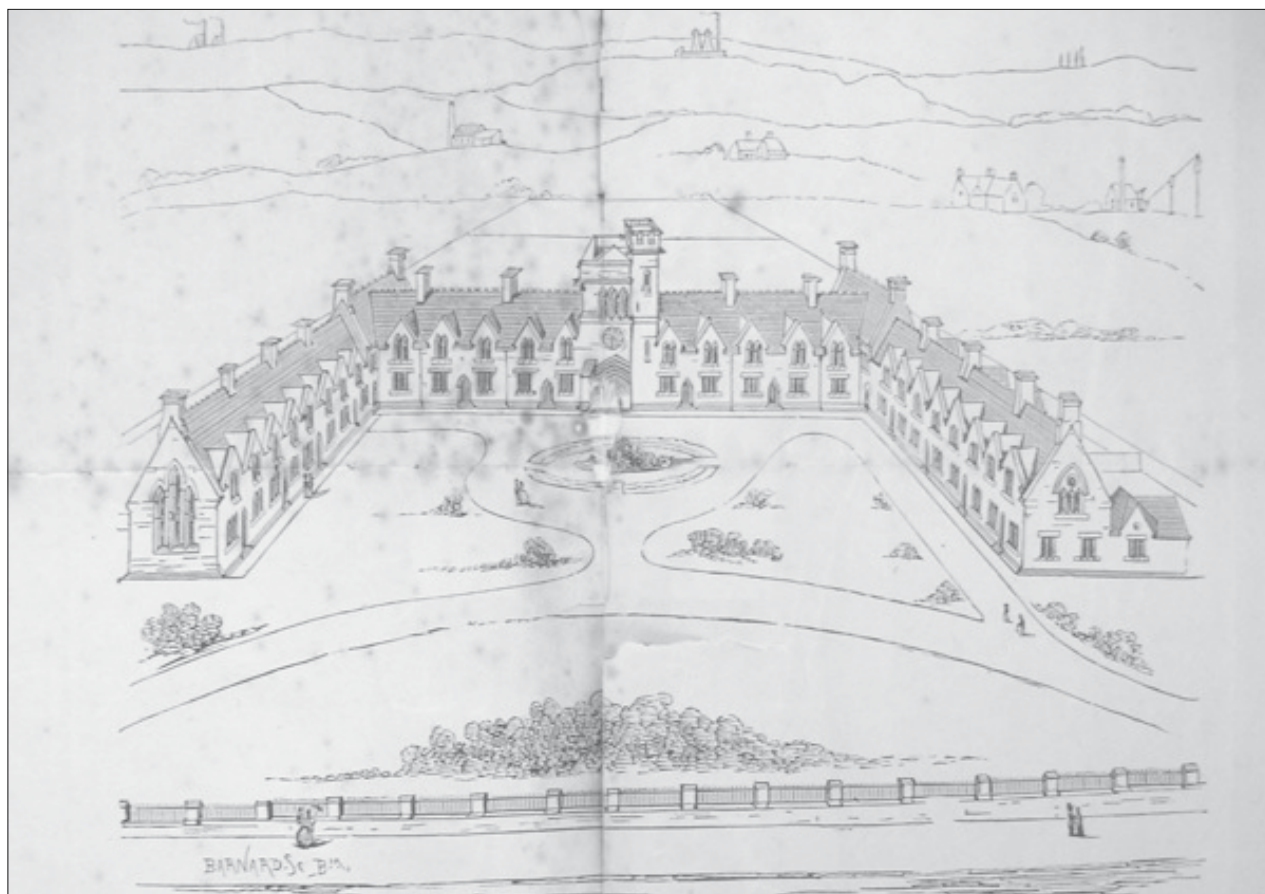
(a) Bird's eye view of asylum ranges after conversion to general hospital (from *Supplement to Dudley Guardian*, 28th October 1871)
DALHS ref. DGU/5/70

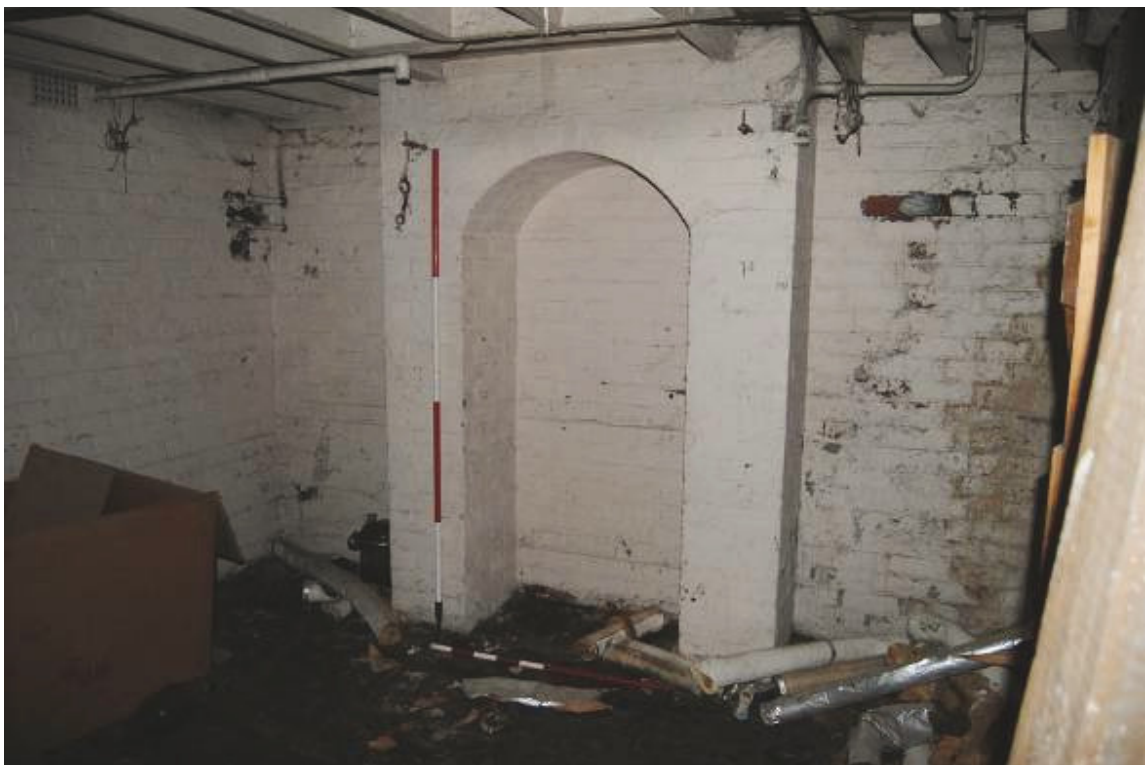
Plate 78: Building [03b]; stack support within cellar room [B02].

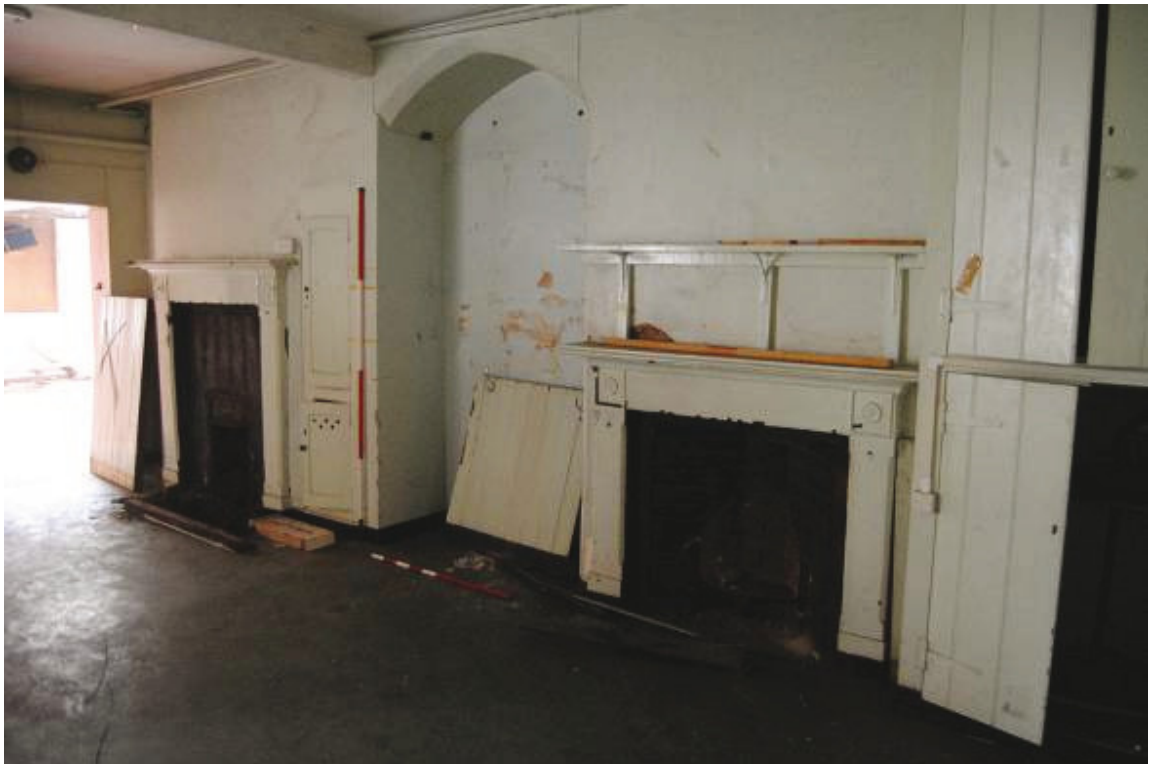
Plate 84: Building [03b]; primary, asylum-era fireplaces in south wall of Room [GF11]. **NB.** central arch dates to 1869/71 hospital conversion.

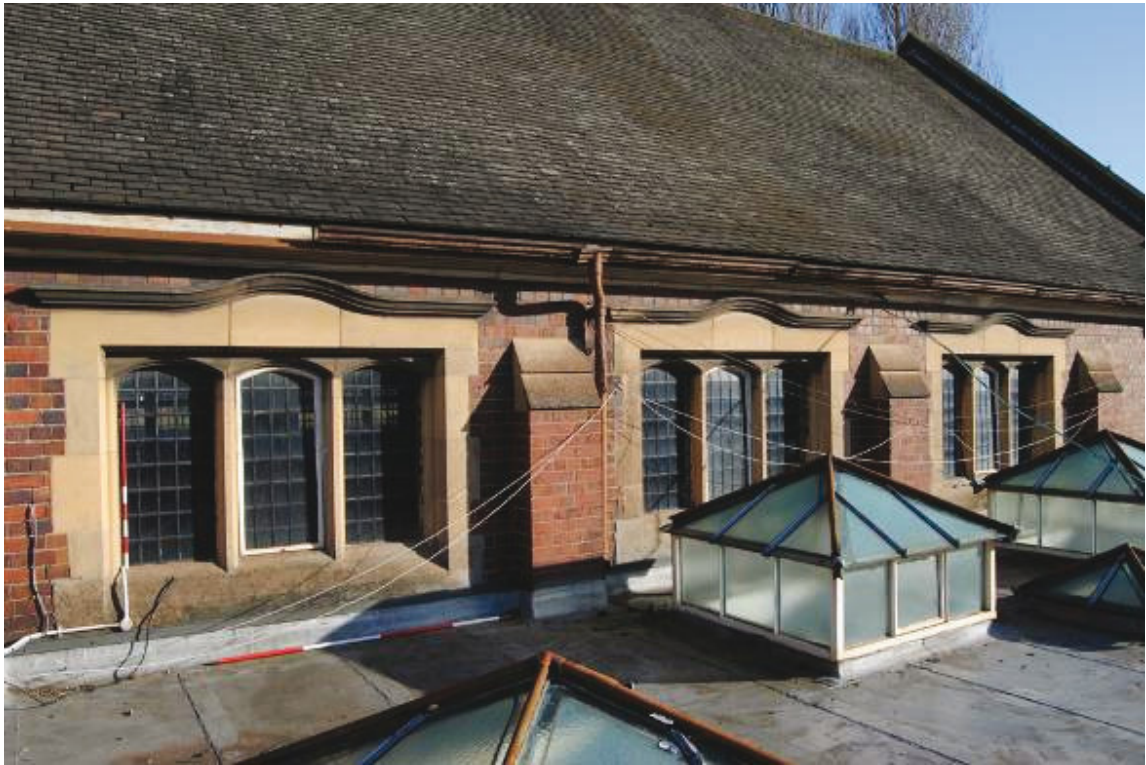
Plate 101: Building [06]; high level windows in west wall formerly lighting waiting hall. NB. skylights serve 1938 extension.

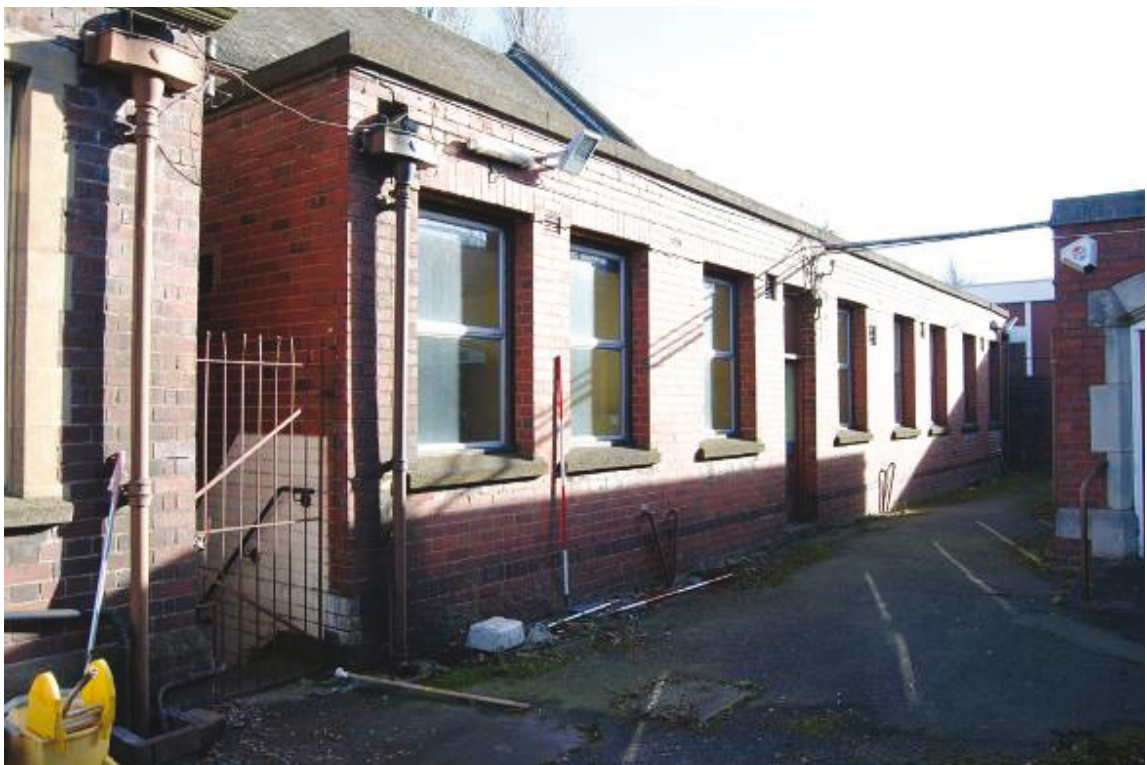
Plate 106: Building [06]; 1930s extension at south-west corner.

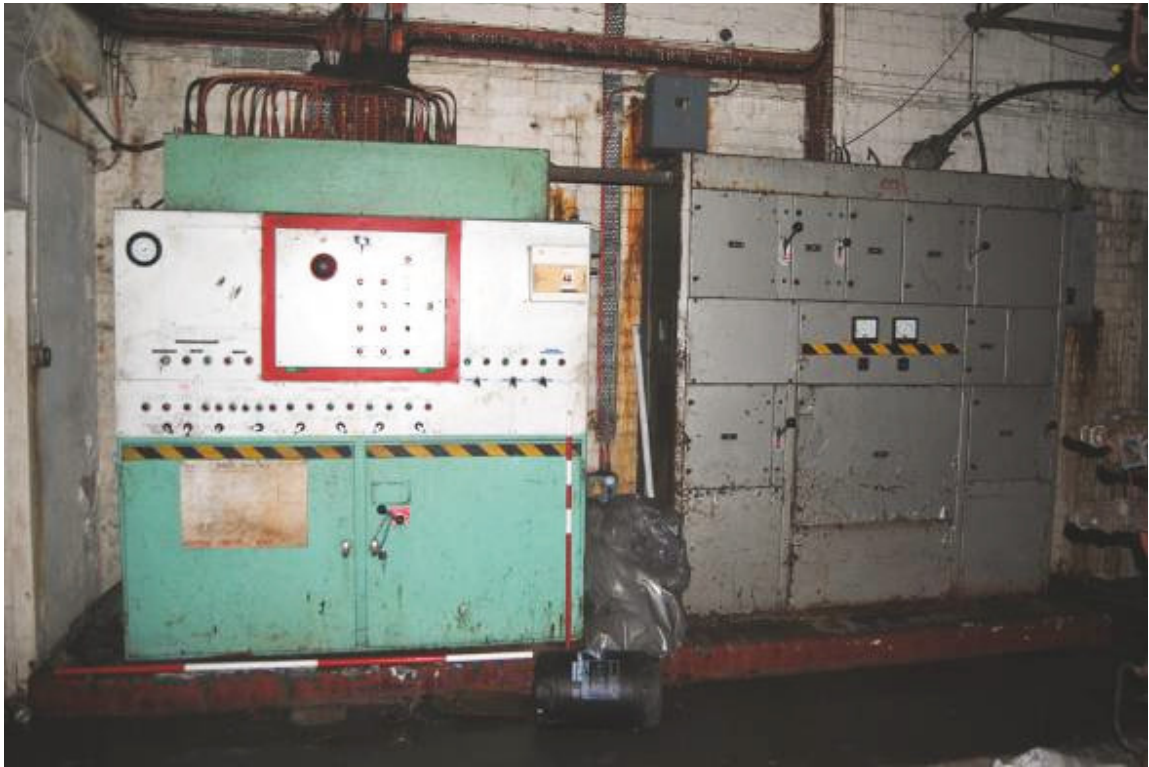
Plate 162: Building [09]; switch gear against west wall of main chamber.

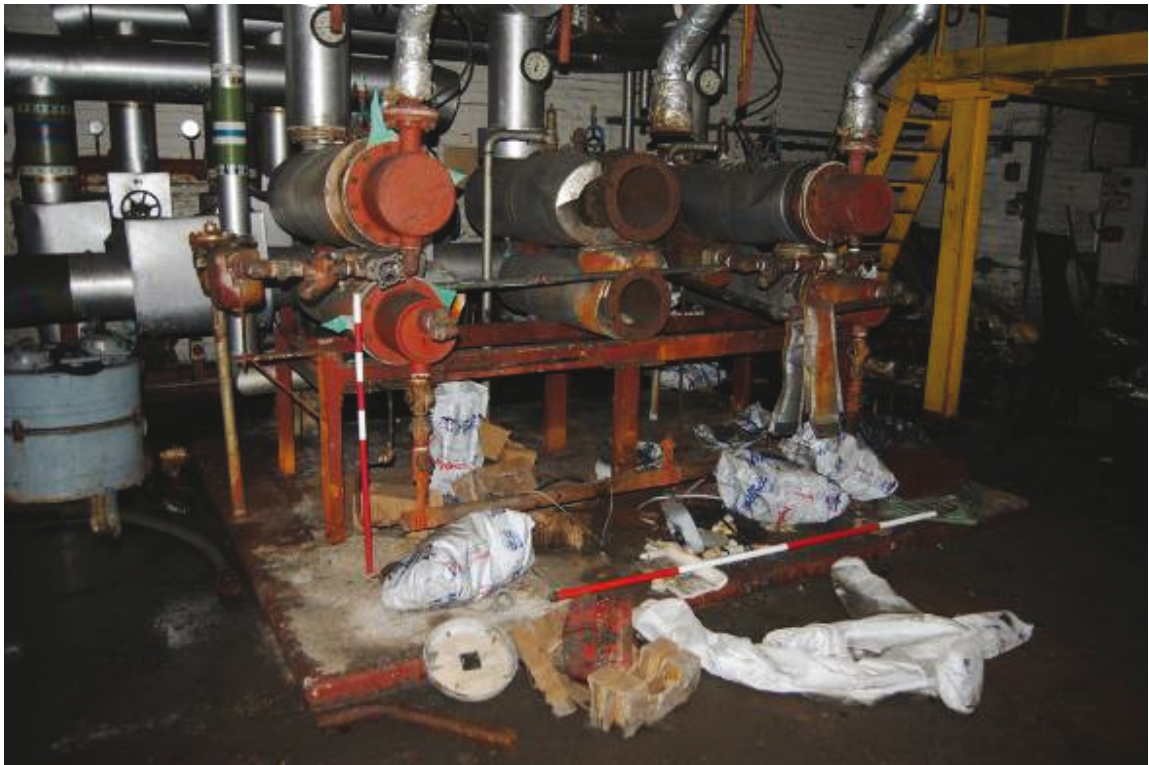
Plate 163: Building [09]; outlet pipework at north-west corner.

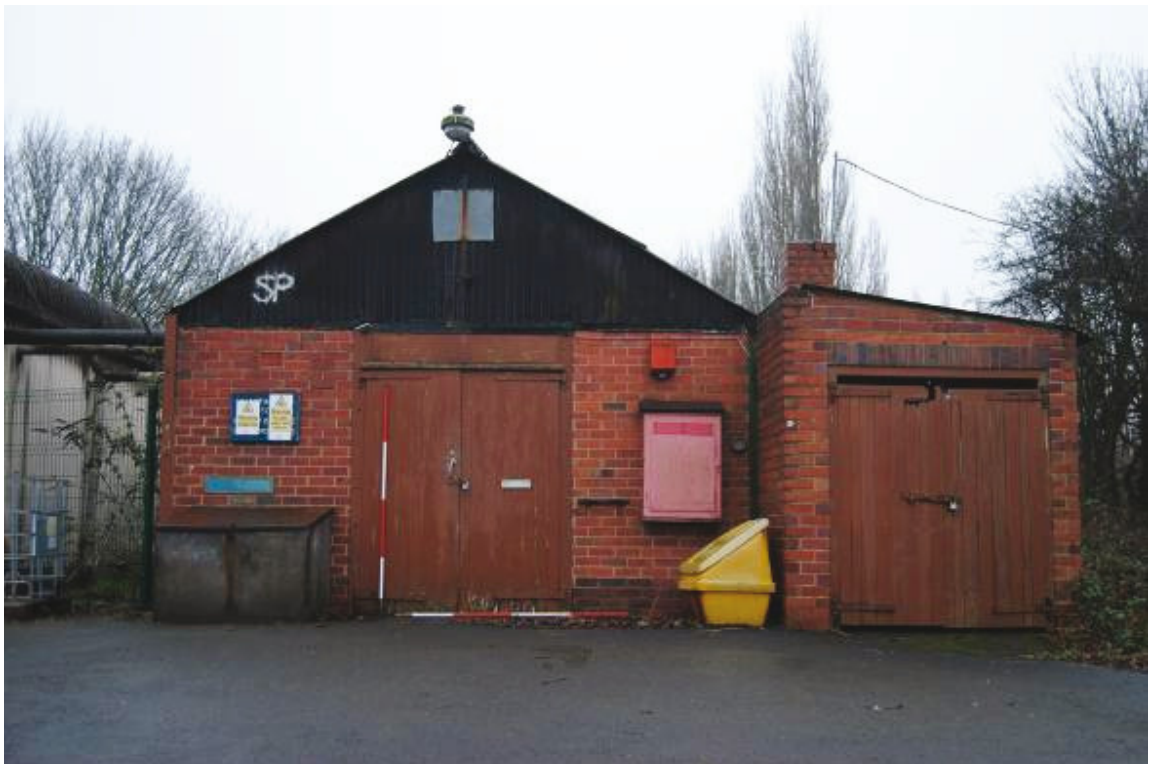
- 13.2.1 The north elevation of Building [10] (Plate 165) presents a simple gabled elevation, brick built to eaves level in red brick laid to stretcher bond (single skin), with a central, double doorway and corrugated-iron clad gable. The exterior angles and door jambs are strengthened by vertically set RSAs. To the north-western corner is appended a small, brick-built garage with sloping roof and again with a centrally located double-door. Above the pitched roof of the main block, two blocked windows were noted within the northern wall of the tall garage block.

Plate 165: Building [10], north elevation.
