OUTBUILDINGS AT DUDMASTON HALL

QUATT, nr. BRIDGNORTH, SHROPSHIRE

Historic Building Recording and Analysis

FINAL REPORT

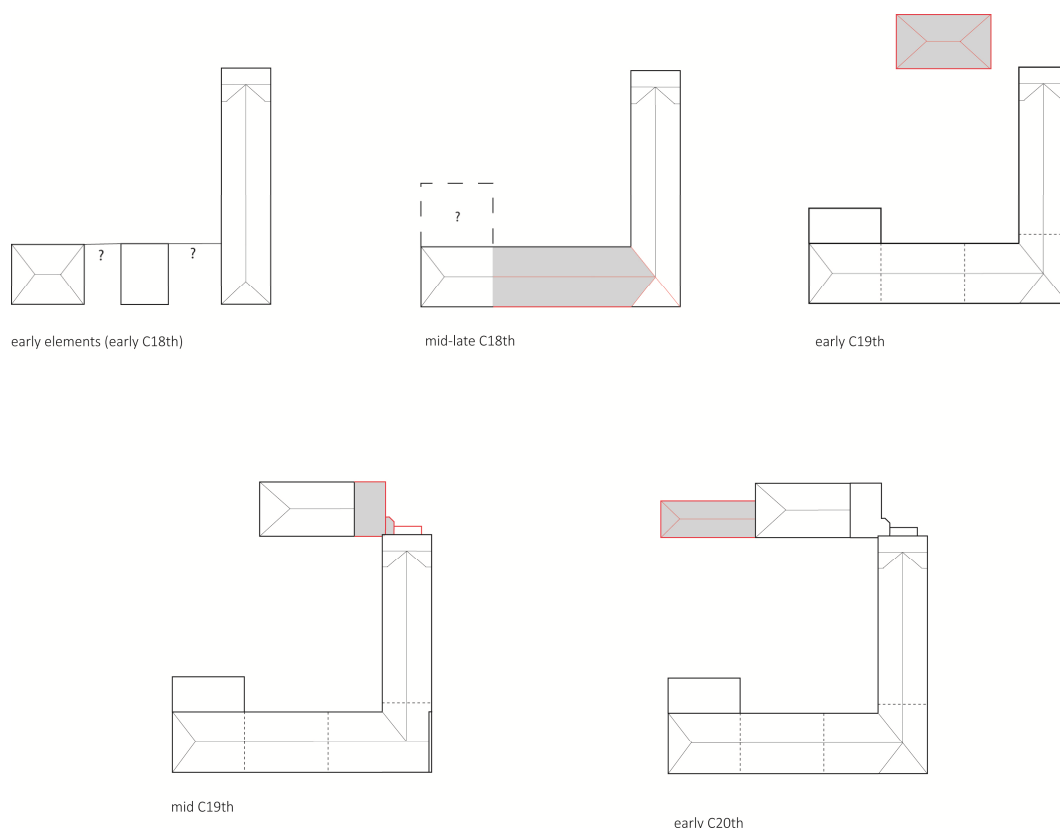
Principal phases of development of outbuildings
(new work highlighted at each phase)

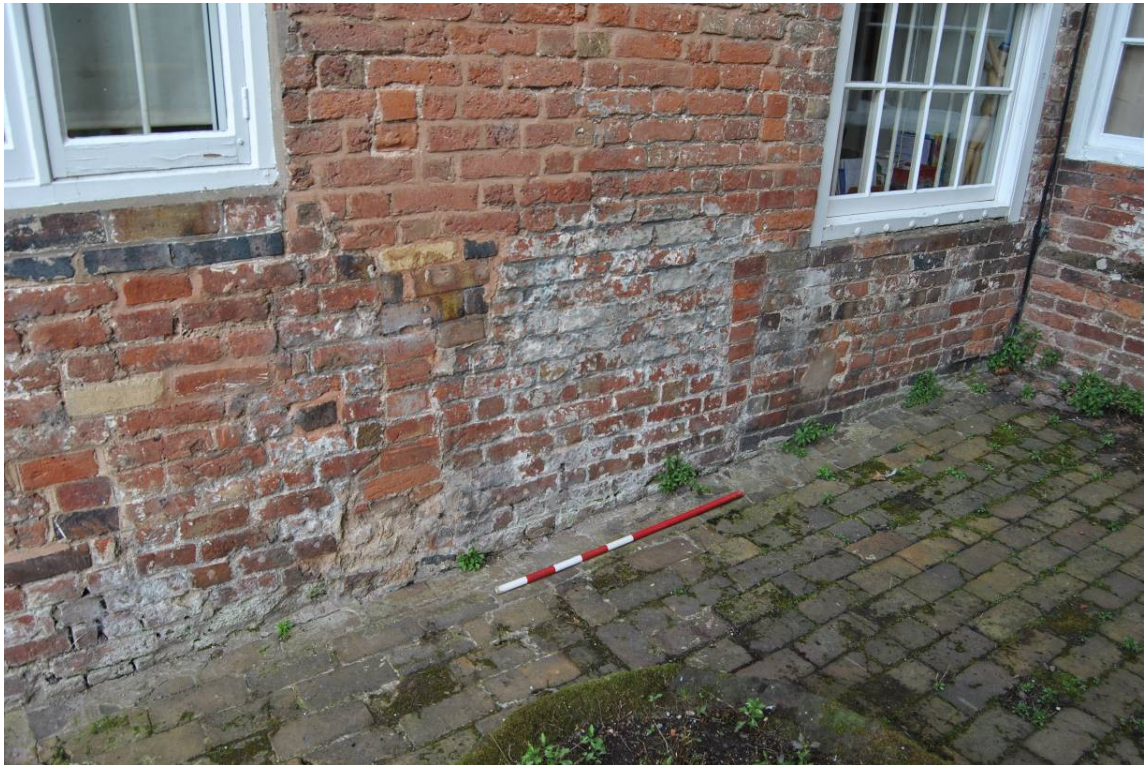
Plate 13: Low area of infill brickwork between [w6/7] defined by opposing straight-joints; function unclear.

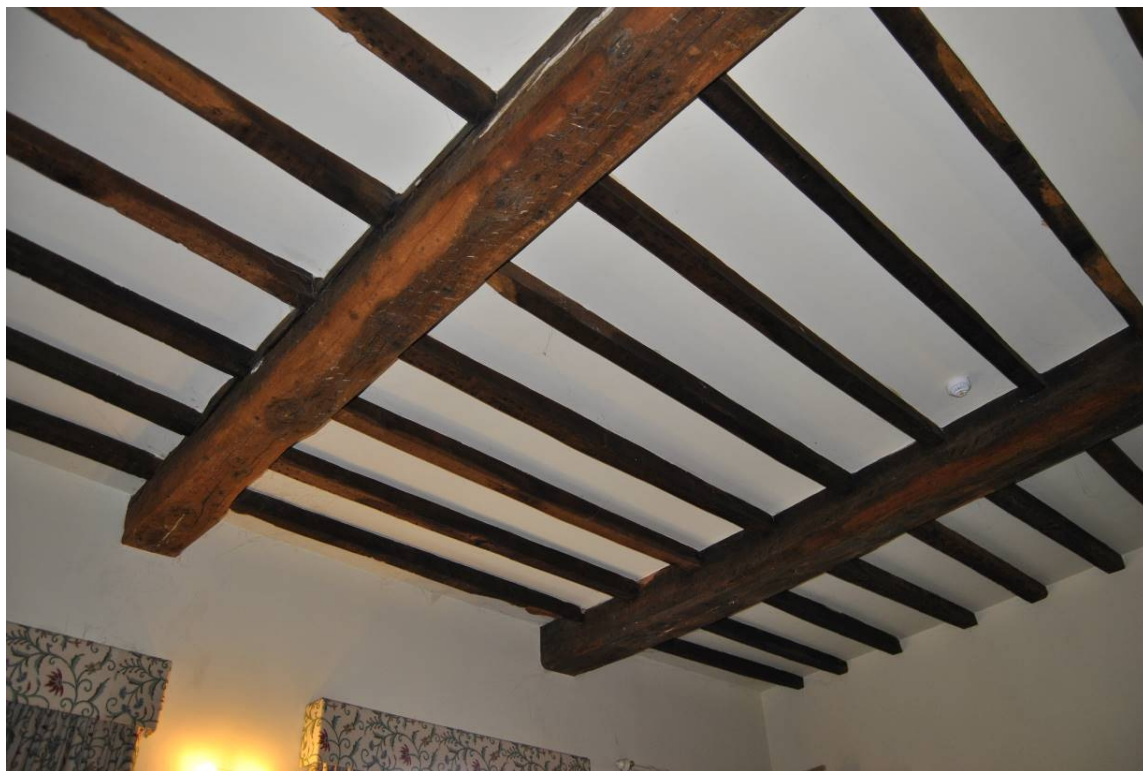
Plate 29: Substantial ceiling structure over living room [LG4].

- 7.1.11 Sitting Room [LG4] (Plate 28) opens off the south side of stair-hall [LG5] and occupies three bays; it measures 22ft (N/S) x 17½ft. (E/W). The ceiling is spanned by two transverse, chamfer-stopped beams⁷³ supporting longitudinal joists (Plate 29); beams are 'hacked' to receive a plaster coat while joists display tack holes for a former underdrawn ceiling;⁷⁴ both retain differential traces of smoke blackening / fire damage. The room is lit by two large, 6/6 sash windows [w17/18] (Plate 30) and a part-glazed door [d5] to the garden elevation, all of which represent secondary features inserted into pre-existing openings during the 1976 refurbishment (see Figures 19/20), and by two three-light stone transom and mullion windows [w3/4] to the east. The room is heated by a wide fireplace located centrally to the south wall,⁷⁵ served by a brick stack which projects to the south (visible within [LG3]); to the east of the fireplace, an arched recess reflects the location of a blocked door formerly communicating with the southern extension (see Figure 12).

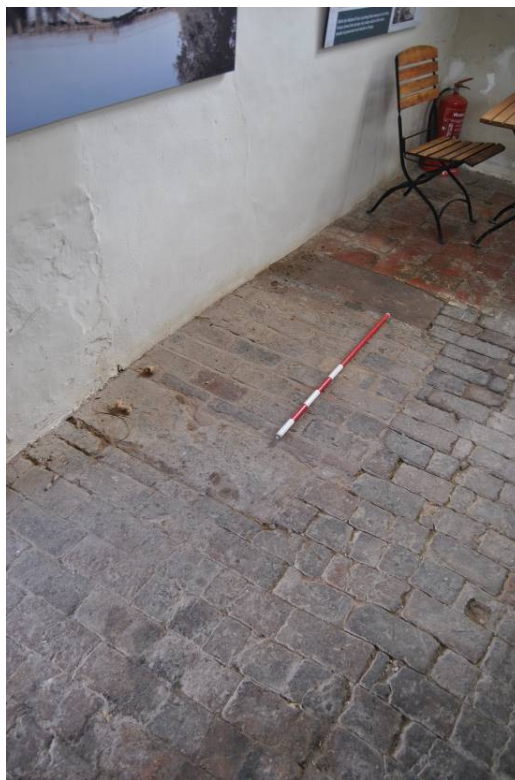
Plate 47: Variant paving around blocked doorway between [LG1/2] (infill of former steps).

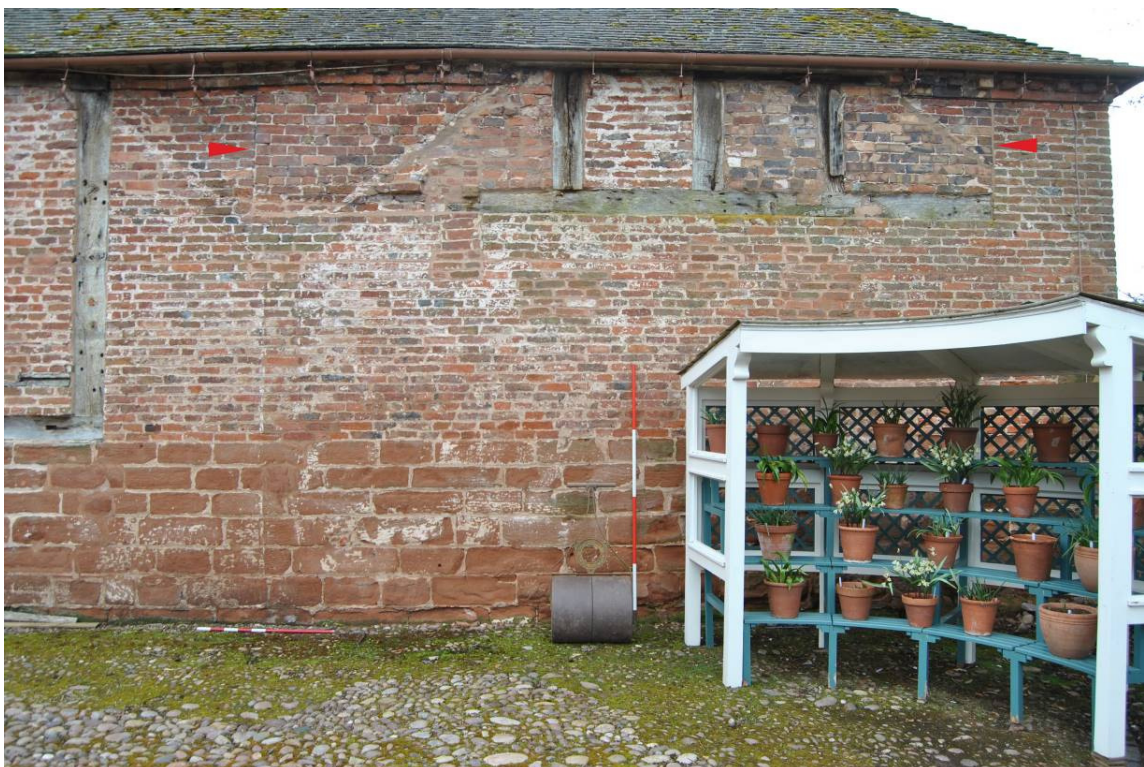
Plate 60: Raised section of timber-framing to west end of elevation. **NB.** symmetrically opposed vertical SJs (marked with arrows) plus roof scars of former pitch-roofed abutting ranges.

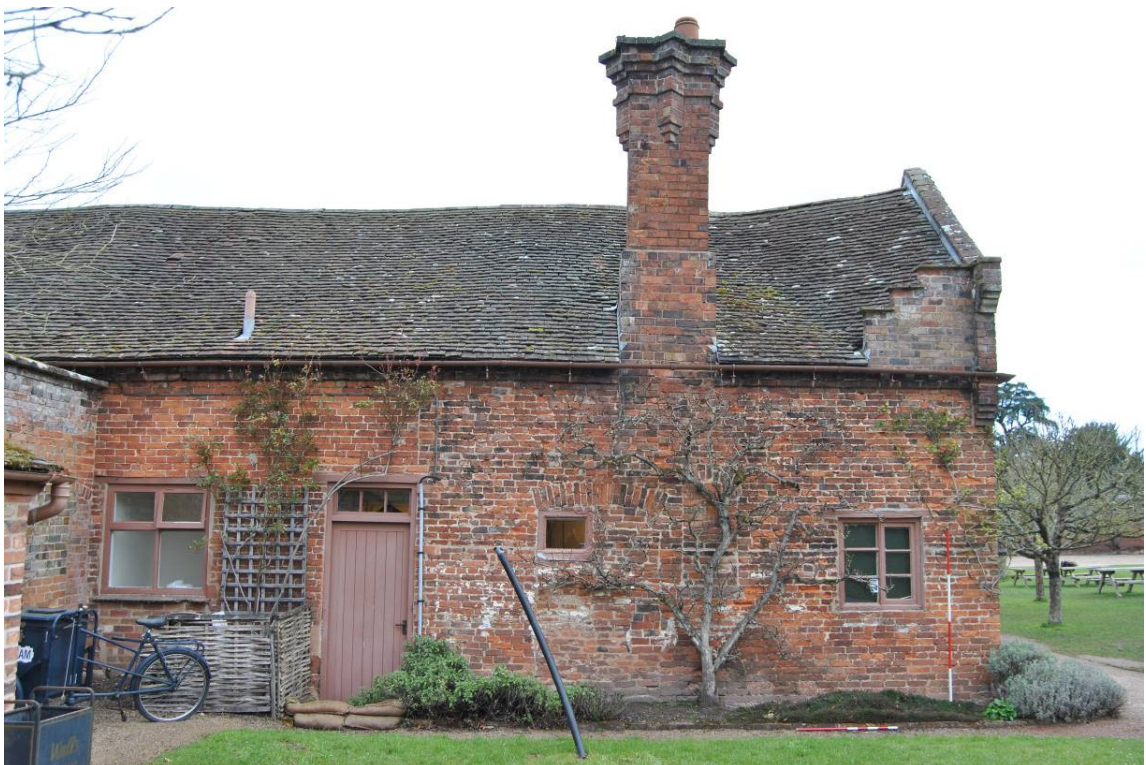
Plate 66: Garden Cottage range; south elevation, east end; **NB.** secondary stack and blocked door/window.

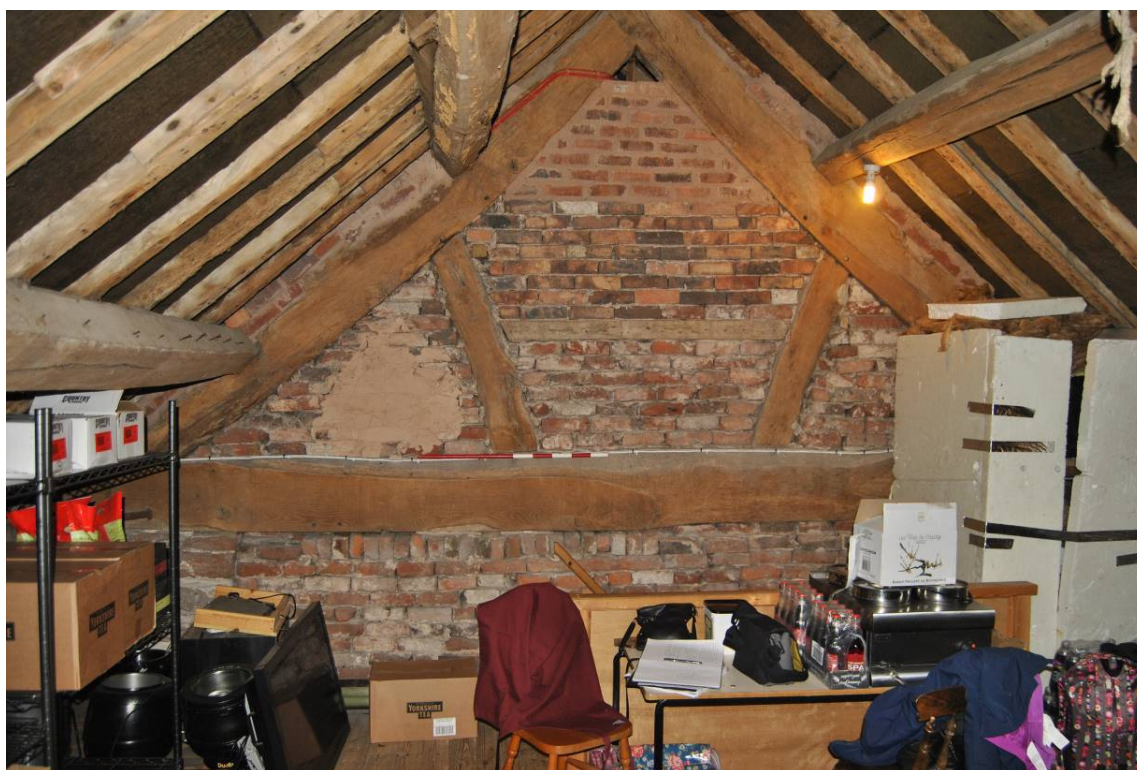
Plate 88: Massive timber truss forming west side of [F7]; shows clear evidence of re-use.

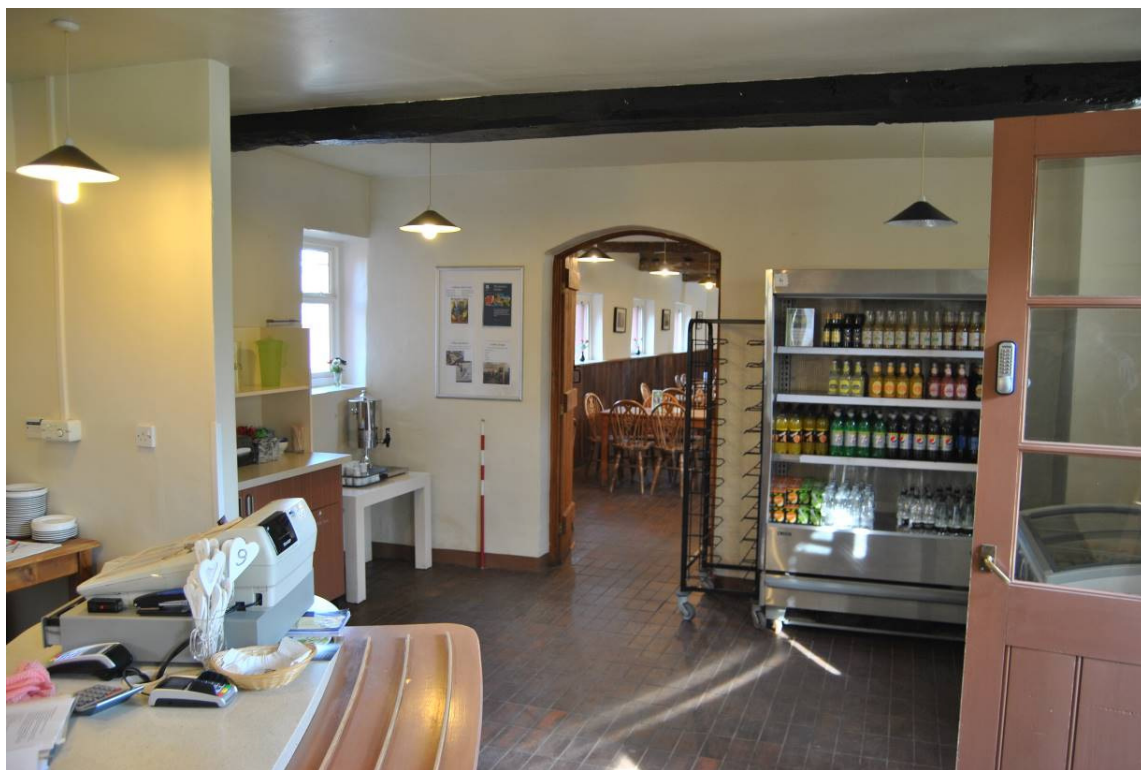
Plate 105: Servery [G16] looking north towards seating area [G17]; site of former stair to left hand side of image (behind till).

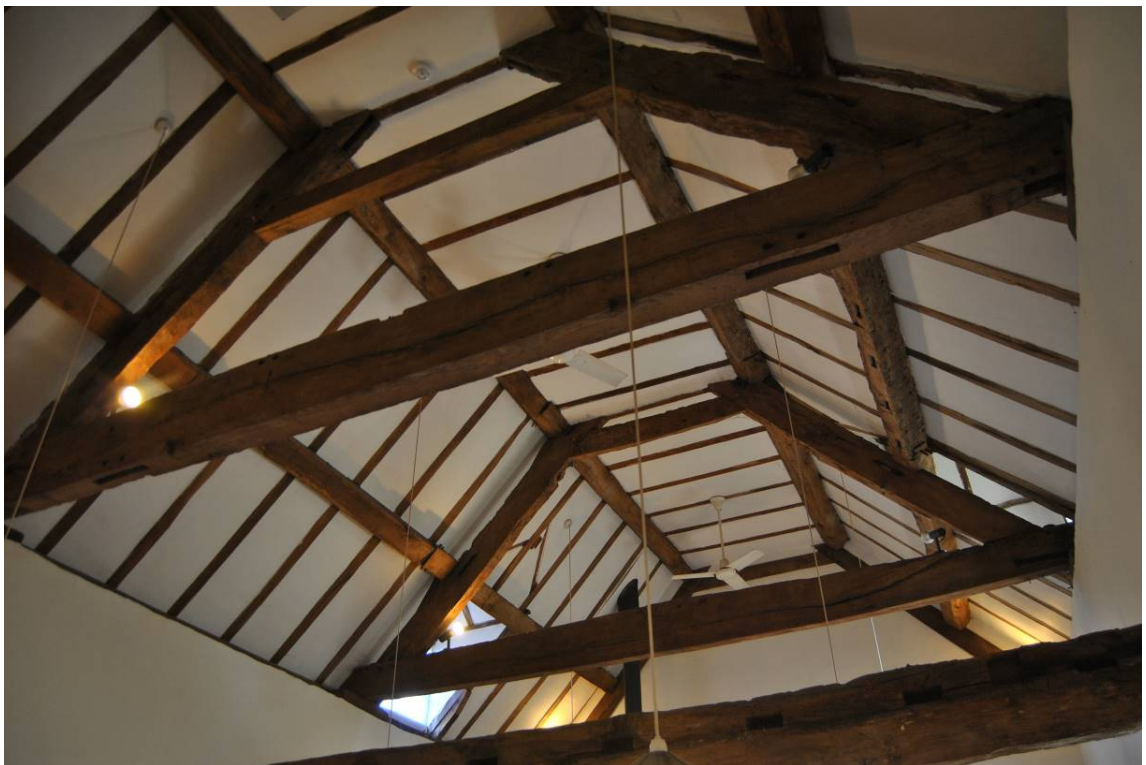
Plate 108: Roof trusses over café [G17]; note mortices for former timber-framing (wall-posts and braces to tie; former higher collar and longitudinal braces to principal rafters), indicating re-use.

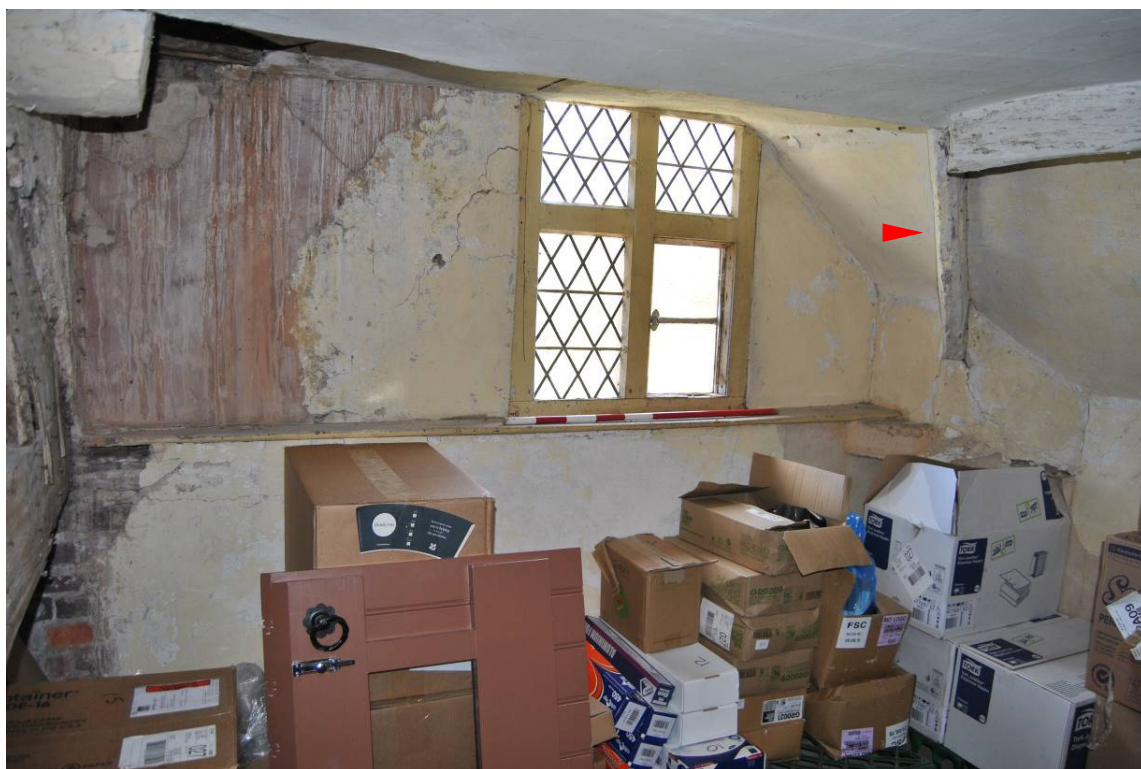
Plate 113: Room [F8] looking east; secondary gable end; NB. relic hip rafter (arrowed).

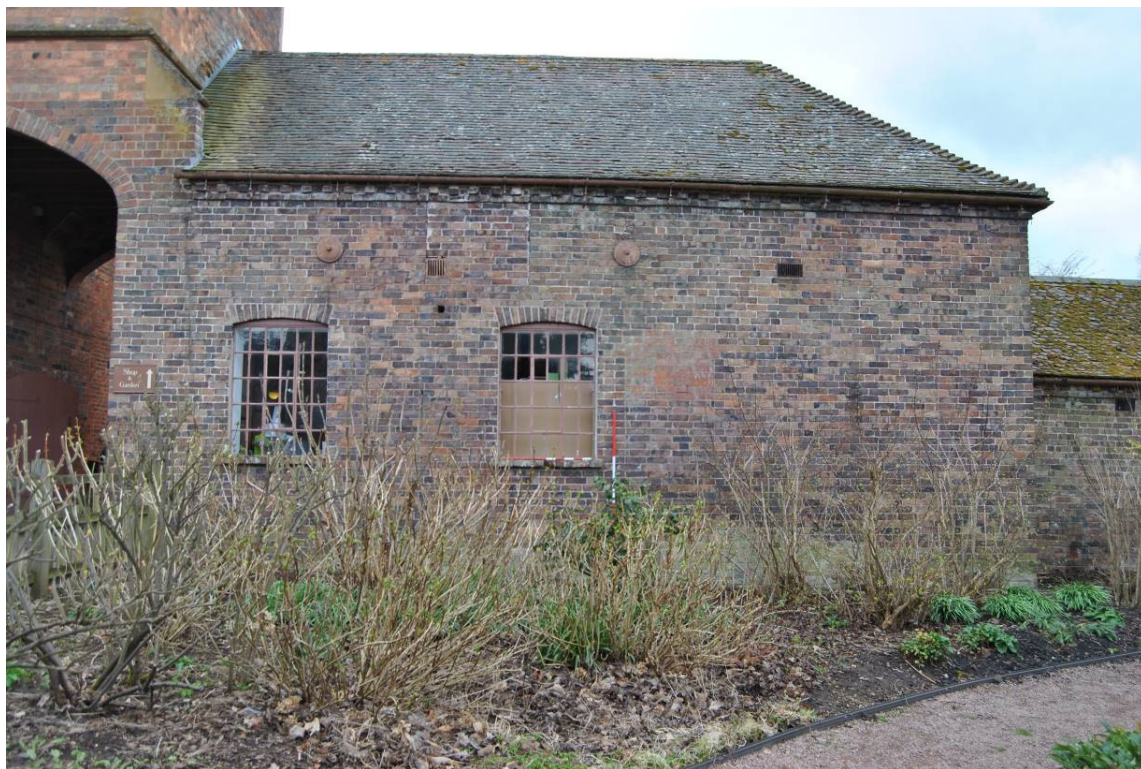
Plate 119: Coach House / Garages range (C); north elevation. **NB.** blocked upper window extends across present floor level (as indicated by tie end plates).

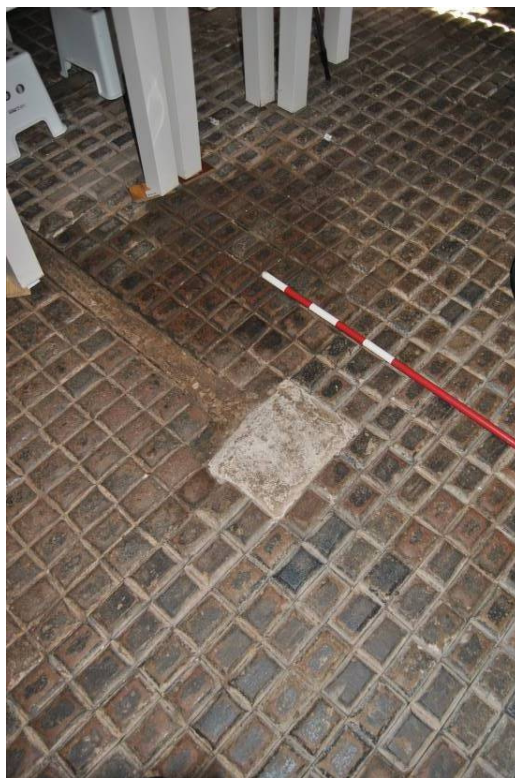
Plate 127: Staffs. blue-brick paviour flooring incorporating iron drainage channel.

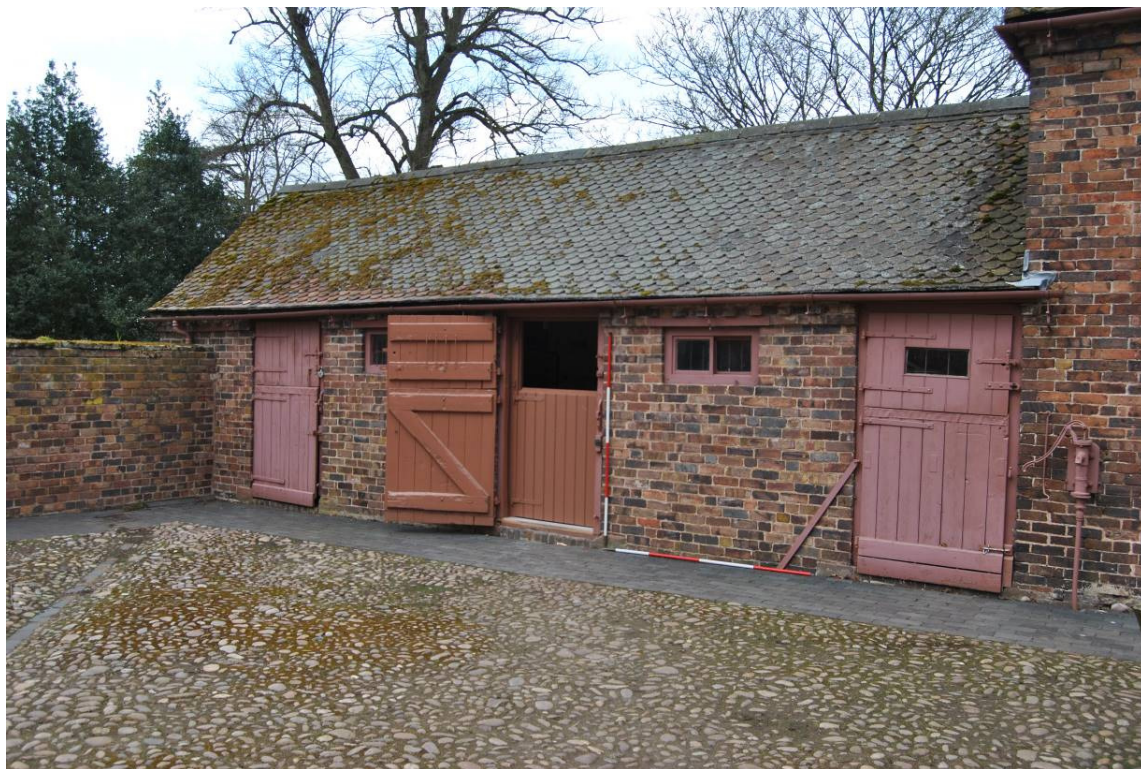
Plate 132: Loose-boxed (D); south elevation to yard.

- 7.2.29 The range of three **loose boxes** (**D**) forms a low, single-storey extension abutting the western end of coach house (Plate 132). The building is rectangular in plan aligned east-west, measuring 34½ft. (E/W) x 13½ft. (N/S) and oriented to the south, onto the stable yard. It is brick-built in 'Broseley' brick laid to Flemish stretcher bond, rising c.6½ft to a three-course eaves band comprising ¼-brick oversail and dentil course beneath a pitched roof clad in distinctive 'fish-scale' tiling. The roof is gabled to the west and abuts the end wall of the coach house block to the east. The **south elevation** (Figure 38; Plate 132) faces onto the stable yard and is furnished with three matching, bi-partite 'stable' doors [**d15-17**], one per loose-box, opening on strap hinges, pin-hung to the western jamb in each case. The eastern two loose-boxes are lit by horizontal sliding-sashes [**w21/22**] beneath timber lintels at eaves level though the corresponding window opening to the westernmost loose-box has been blocked.¹³² The **north elevation** (Figure 39; Plate 133) is plain with three high-level iron vents, hard beneath the oversail eaves band, while the **west elevation** (Plate 134) is blind, gabled with plain verges.

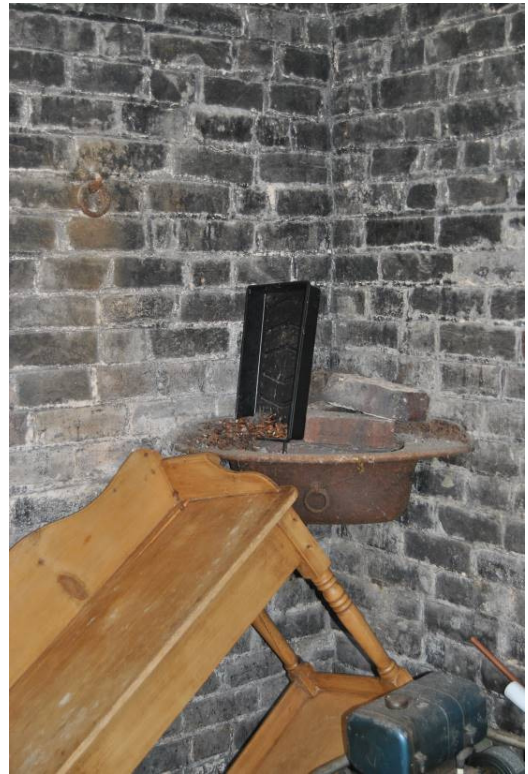
Plate 136: Cast-iron water trough to north-west angle of western loose-box.

¹³⁶ Assumed original; troughs have been renewed by brick-built troughs with tile tops within the eastern two loose-boxes.

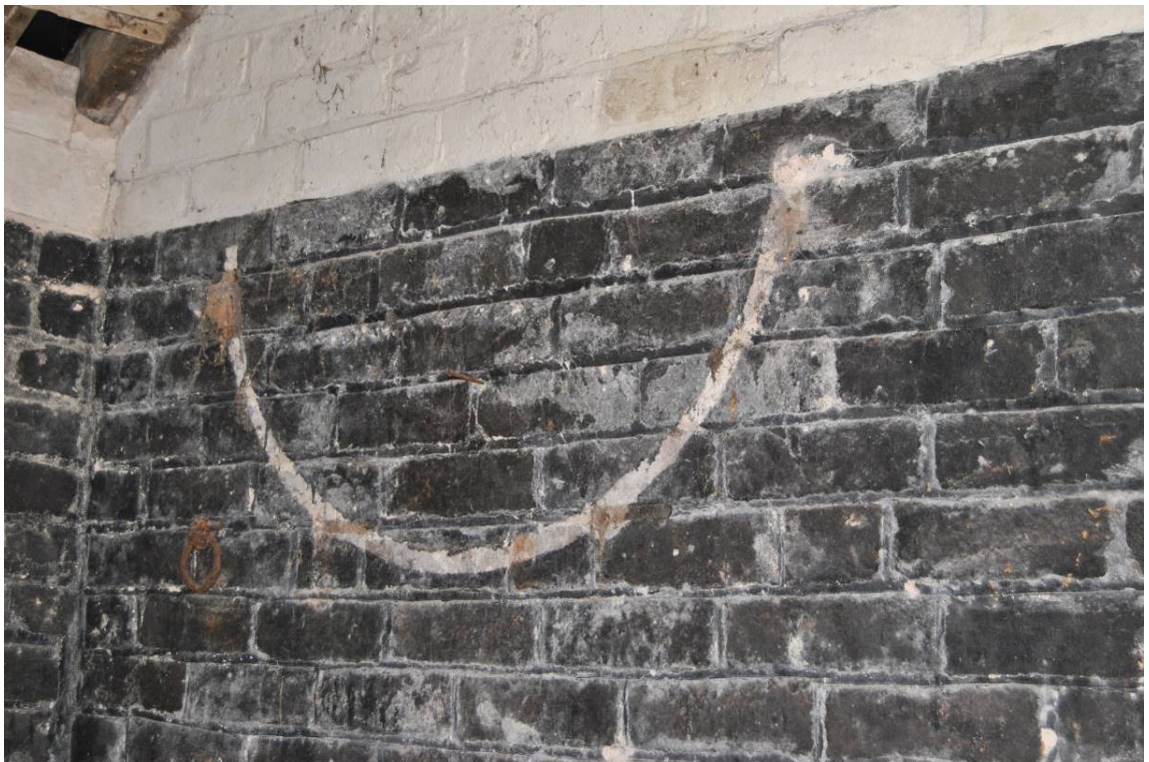
Plate 137: 'Ghost' of hay-rack to east wall of western loose-box.

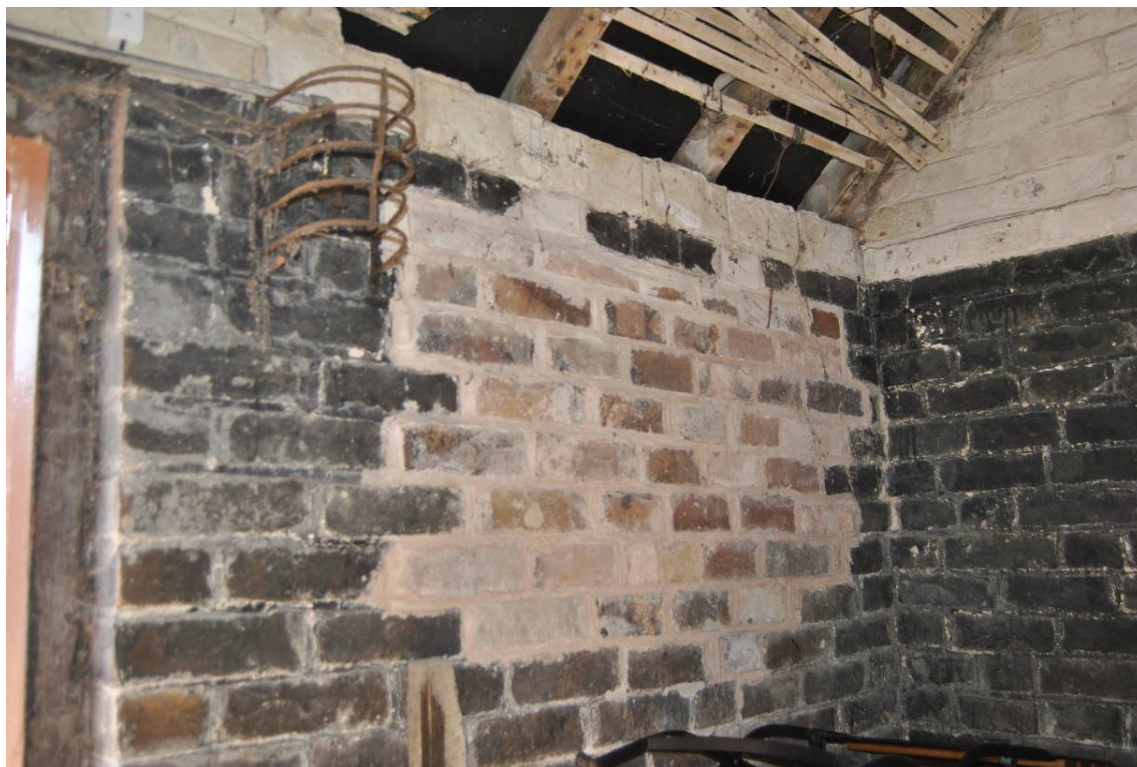
Plate 138: Former gas-light fitting adjacent to door [d15] with blocking of window to right.

- 7.2.30 Internally, the range is sub-divided on a tri-partite plan to form three loose-boxes of essentially similar size and original arrangements ([**G22-24**] from east to west);¹³³ of these, the westernmost [**G24**] (Plate 135) is the most unaltered (save the blocking of the window to the south elevation) and will be described in detail.¹³⁴ The room is approximately square in plan, measuring c.10ft (E/W) x 12ft (N/S), and is accessed via stable door [**d15**] to the south elevation. Flooring is in hard, face-laid brick throughout, sloping inwards in four quadrants to a central drain,¹³⁵ while walls are of exposed brick with a single, iron vent high in the north wall; the plain rafter roof is ceiled by lath and plaster render (Plate 135). Original fittings include a cast-iron water trough at the north-west angle (Plate 136),¹³⁶ while the east wall retains the 'ghost' of a former hay-rack (Plate 137); a number of tethering rings survive within the walls. A gas-light fitting within protective grille is located adjacent to the door to the west (Plate 138), similar to those within the adjacent coach house block.¹³⁷

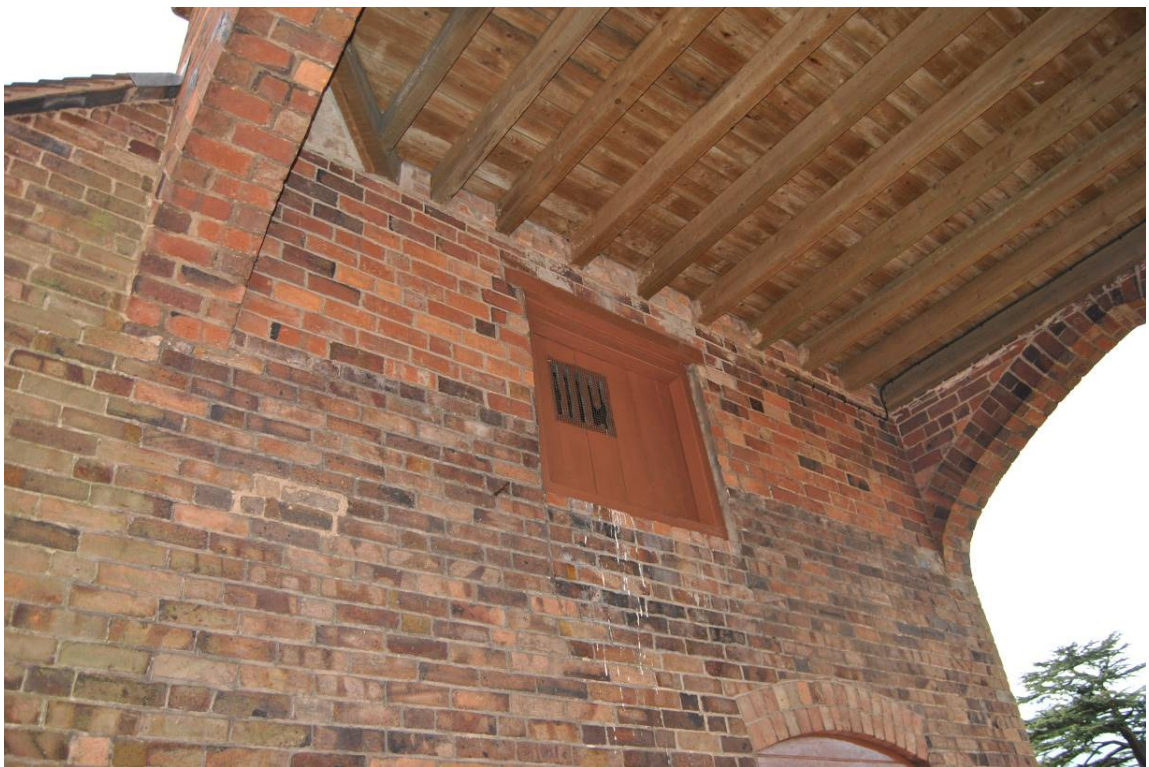
Plate 146: Distinction in brickwork of upper wall flanking west side of through-passage indicating raising of former hip-roofed coach-house. (NB. trimmer for 1F fireplace to SW angle).
