# MANOR HOUSE FARM BARN

Park Lane, Ashley, Staffordshire

## Historic Building Record, 2021

Newcastle-under-Lyme Borough Council  
Planning Refs. 19/00895/FUL & 19/00896/LBC

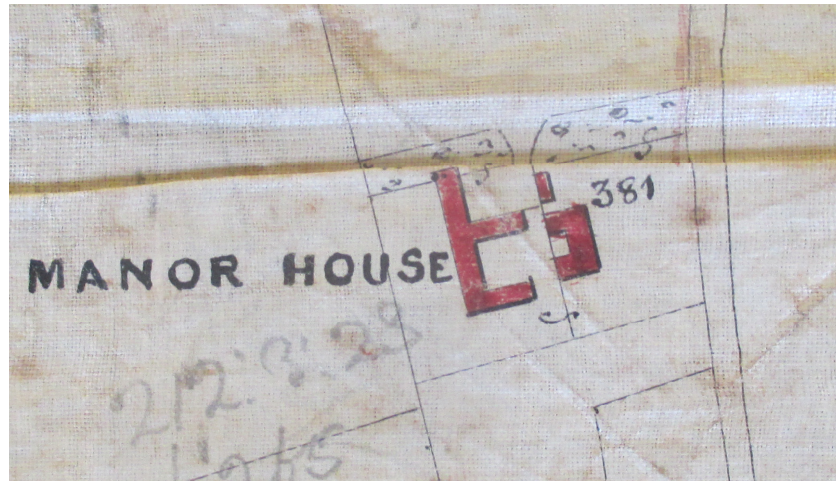
Manor House Farm as depicted on survey of Wm. Davenport's Estates at Maer and Ashley (detail)  
(SCRO: D1213/2/2; reproduced with permission, courtesy of Staffordshire Record Office)

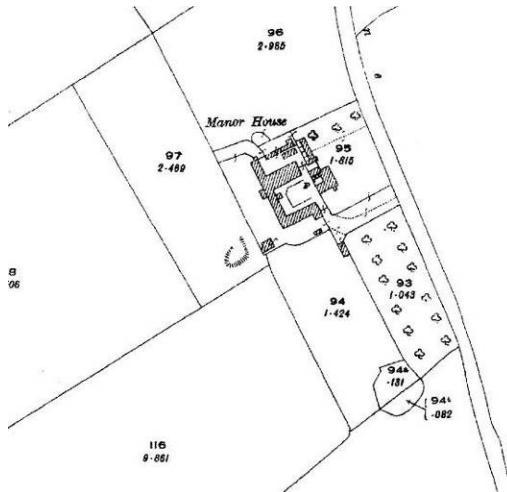
Ordnance Survey 1:2500 map of 1924 (extract).

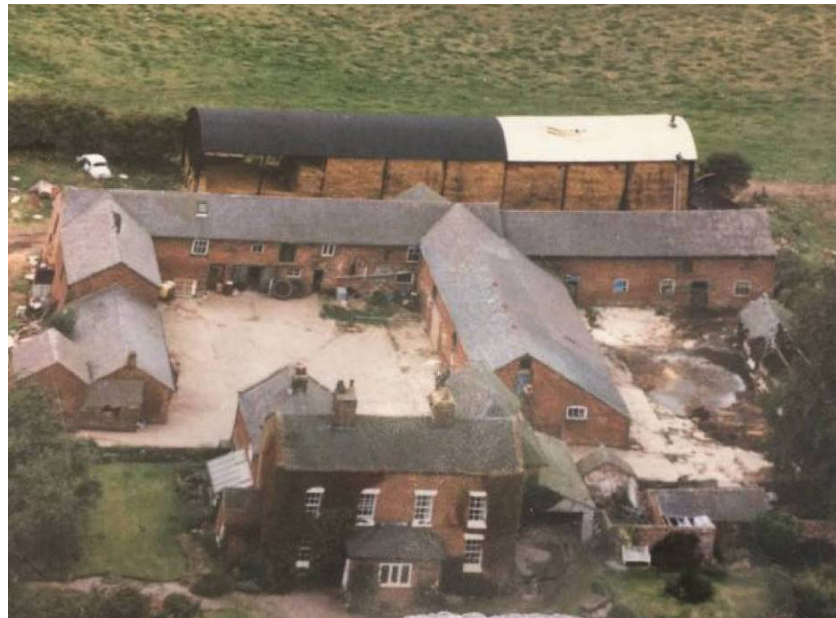
Bird's eye view of Manor Farm house and associated agricultural ranges, 1979.  
(reproduced from Tarpey Woodfine Architects 'Heritage Statement', 2019)

- 4.2.14 A 'bird's eye' oblique aerial photograph of 1979 (inset below) illustrates the agricultural ranges as seen from the east, looking over the farmhouse in the foreground into the southern foldyard.

- 4.2.15 Beyond the main north-south aligned range, the open-sided Dutch barn, first depicted on the Ordnance Survey map of 1960/61 can be seen, extending to eight bays, though roofed in two sections, three to the north and five to the south, suggesting either a partial re-roofing or perhaps suggesting a two-phase development. A number of detail discrepancies are evident when comparison is made with the main ranges as survive today; these will be addressed in the building descriptions at §.6 below. The remnants of the northern arm of the original 'E'-plan survived at this time, though in a derelict or semi-ruinous state (visible to the right-hand side of

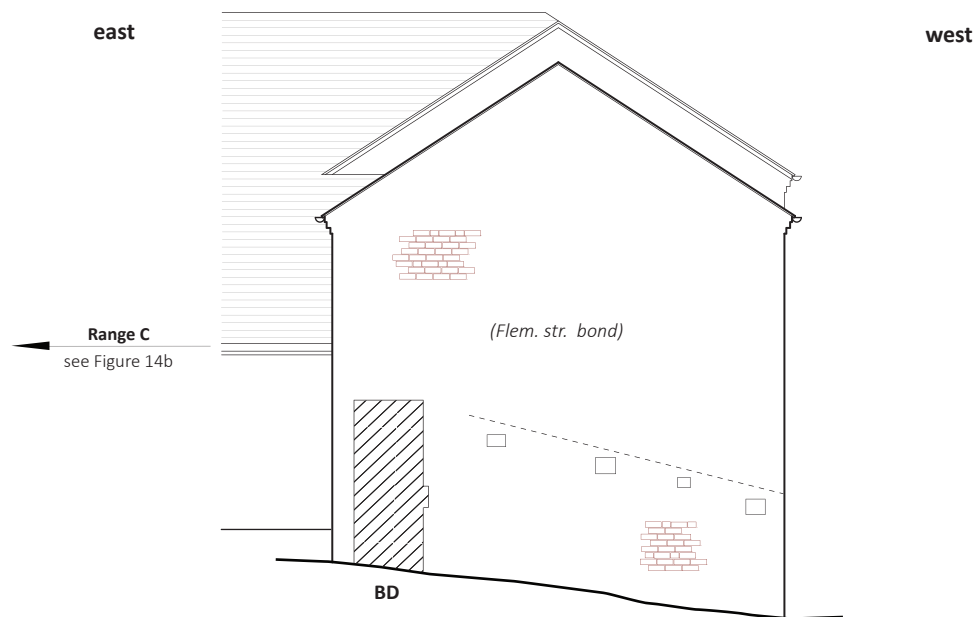
(a) eastern gable end

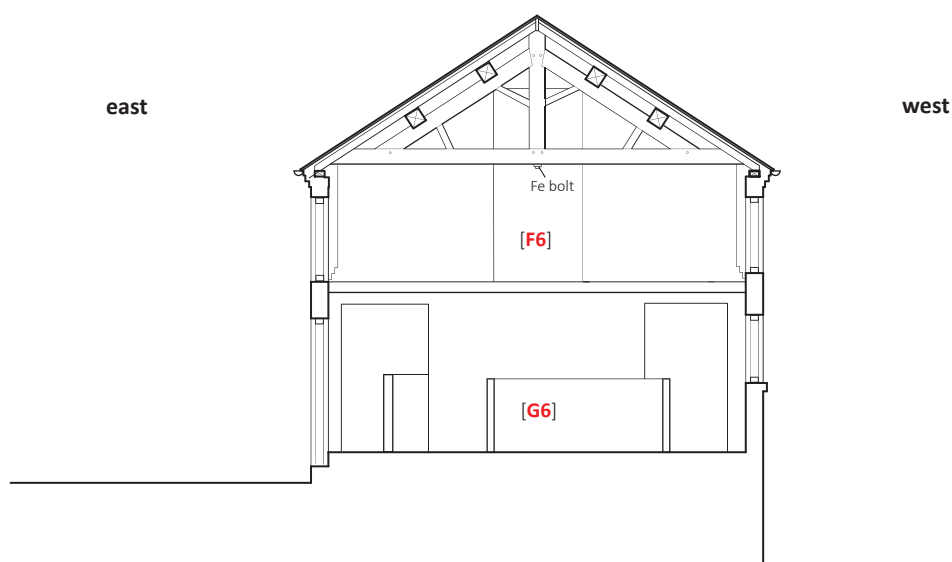
(b) transverse cross-section B-B looking south

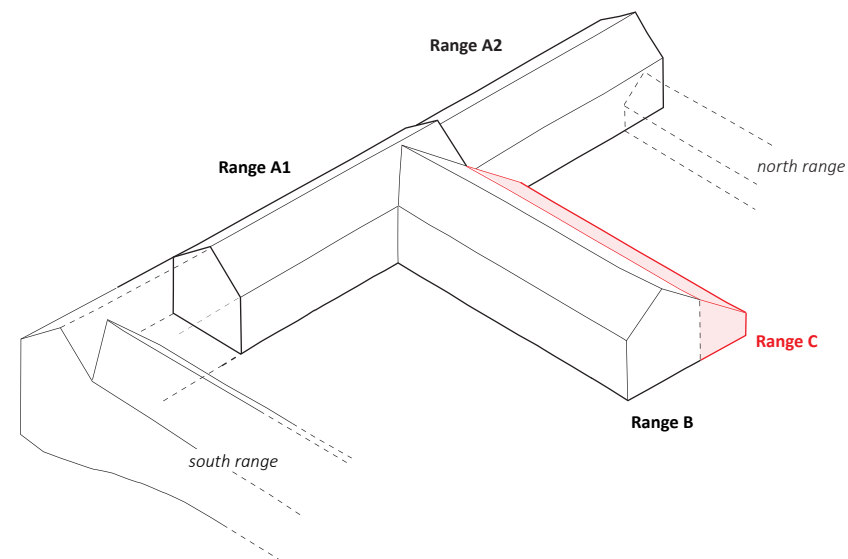
(d) Phase IIIb (range C added 1880-1901)

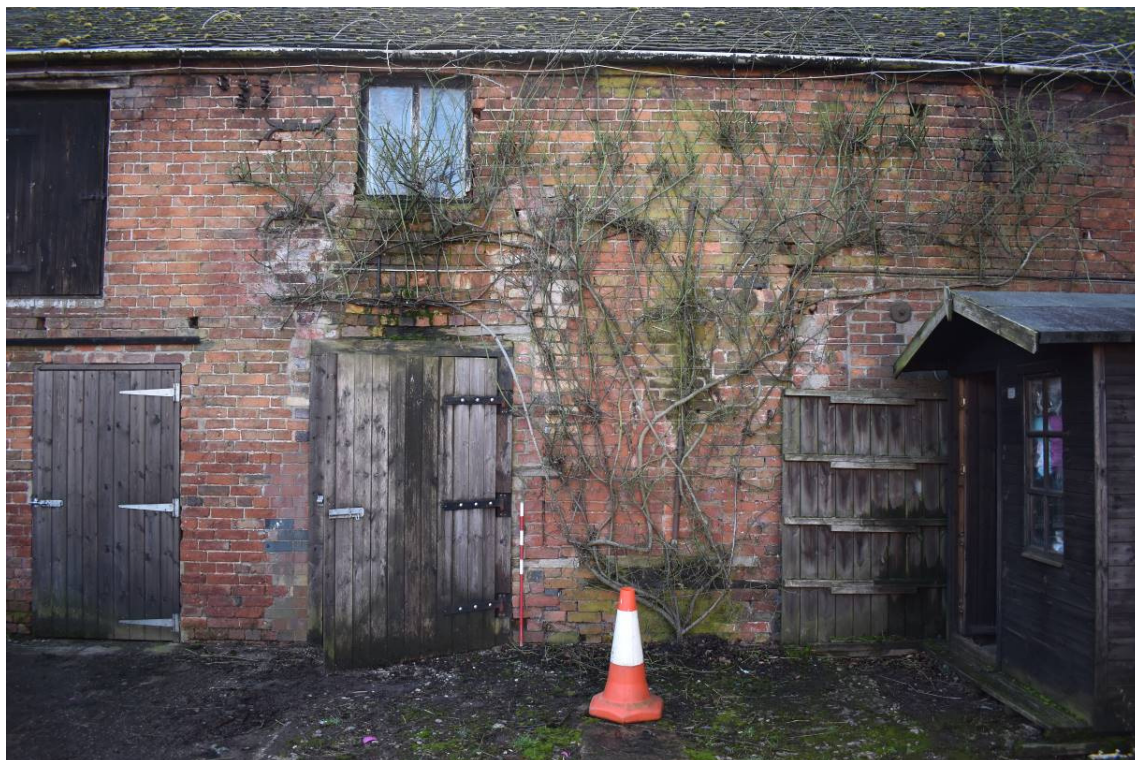
Plate 19: Range A1, east elevation to yard, north end with complex pattern of GF brickwork north of door [d3].

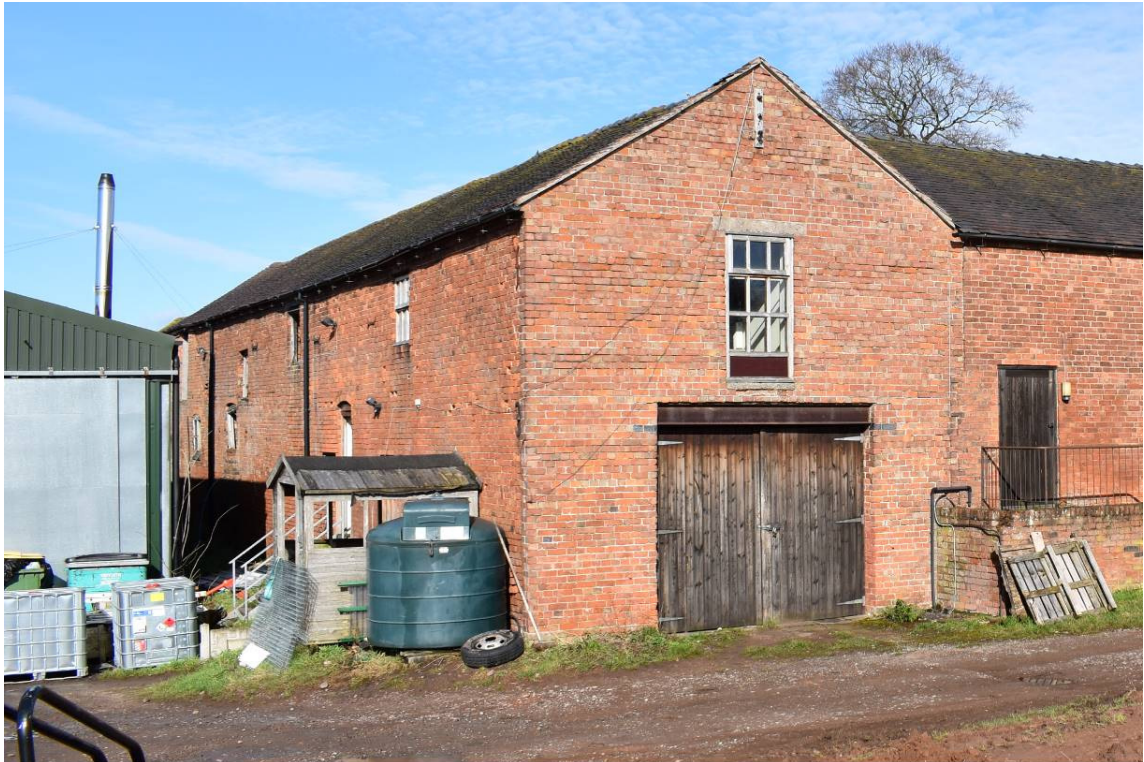
**Plate 22:** South end of main range (incorp. **A1**) looking north-east (**NB.** south gable end entirely rebuilt)

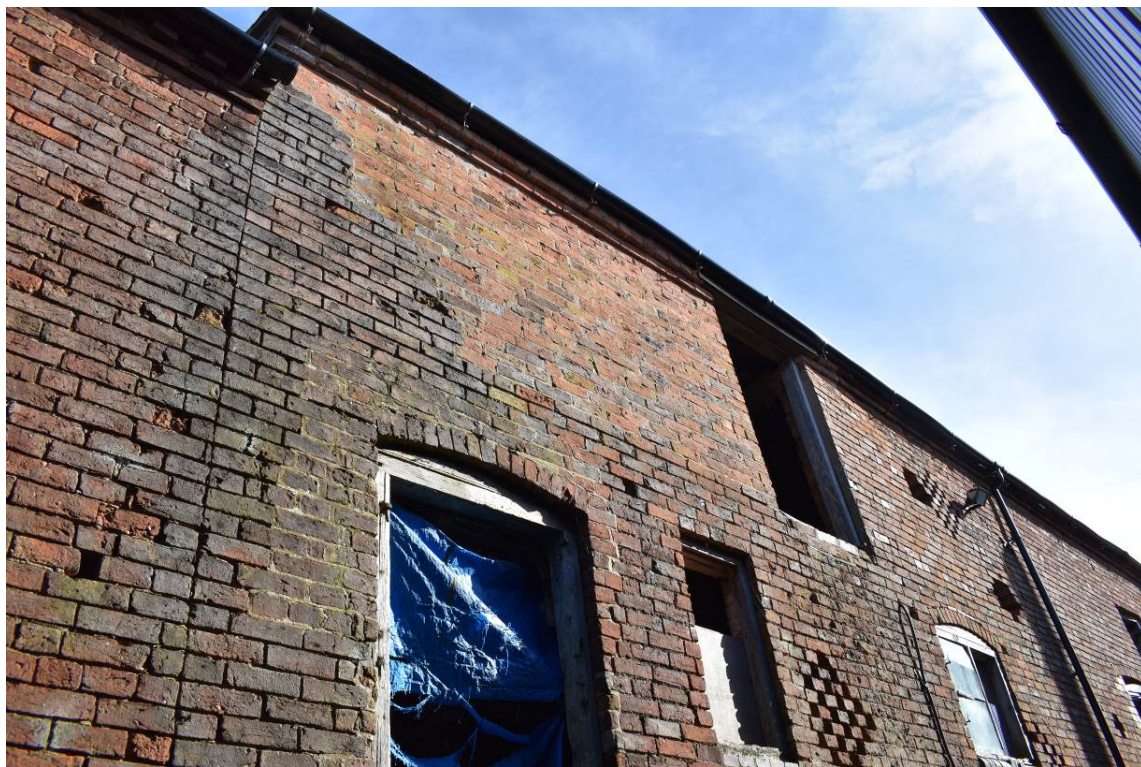
**Plate 27:** Rebuilt walling around 1F [d16], presumed to relate to removal of former projecting winch-bay.

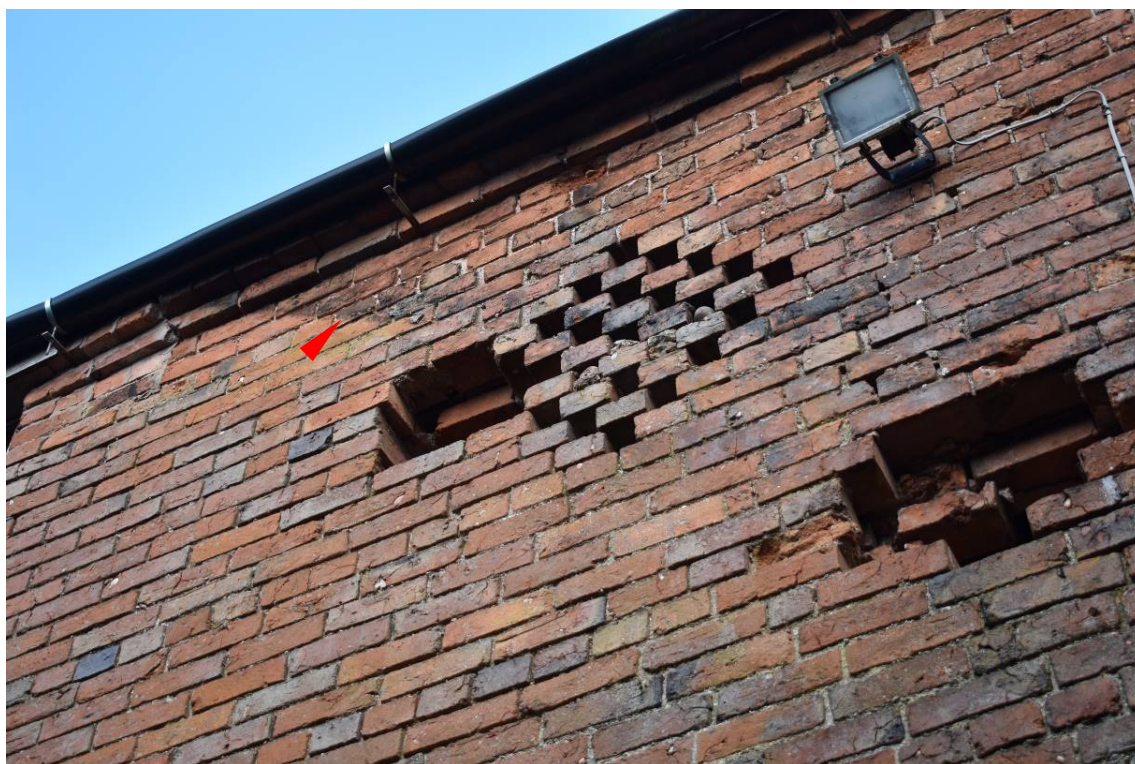
Plate 28: 'Ghost' of roofslope of former projecting winch bay.

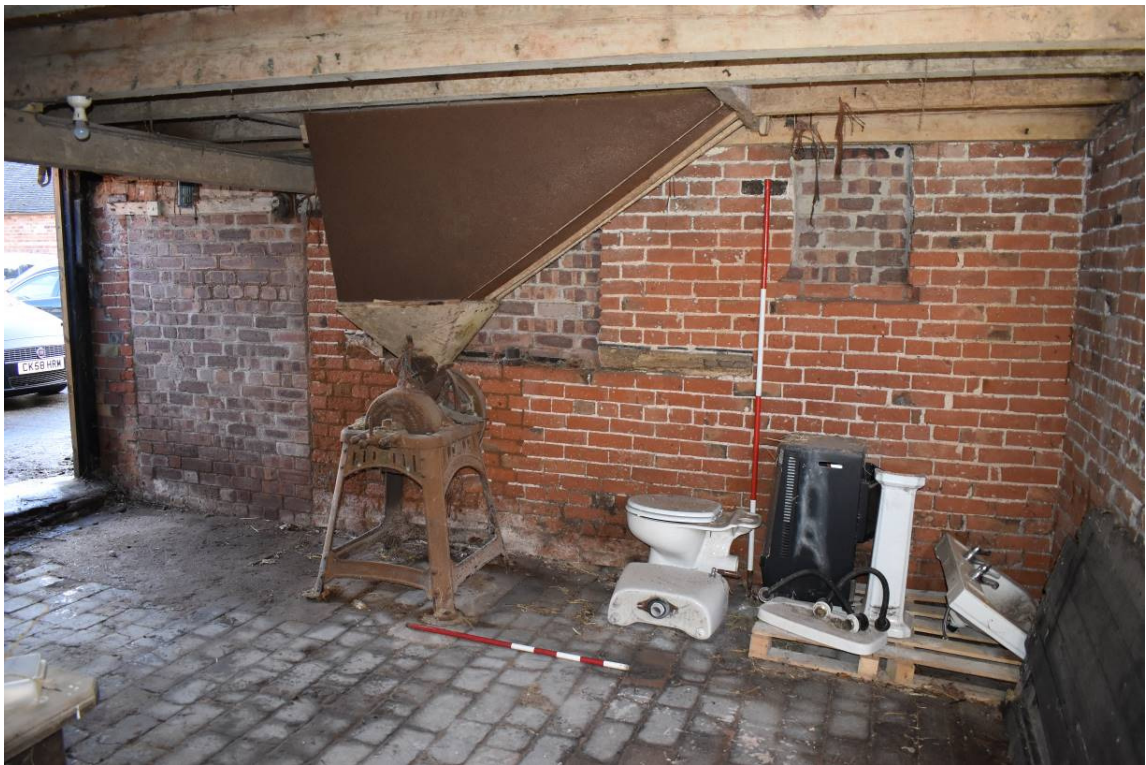
**Plate 34:** South wall of [G2] showing blocked openings and location of grinding mill with hopper chute.

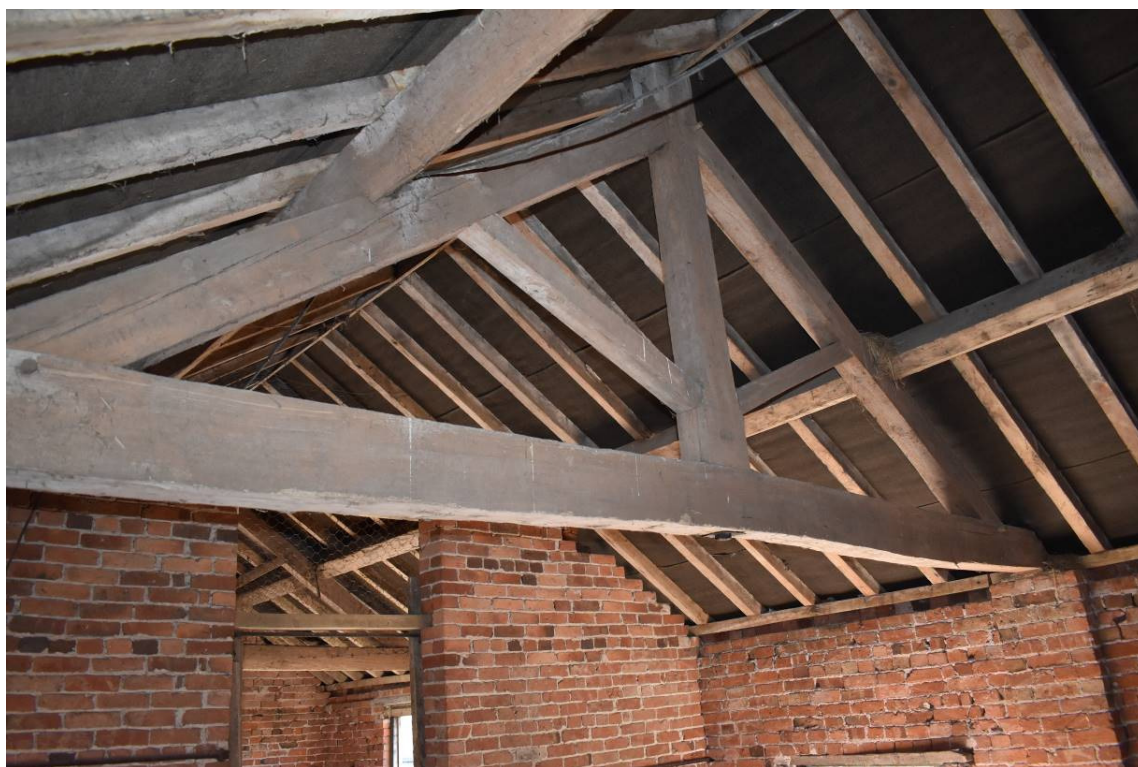
Plate 49: Roof truss T2 over [F2] looking south-west.

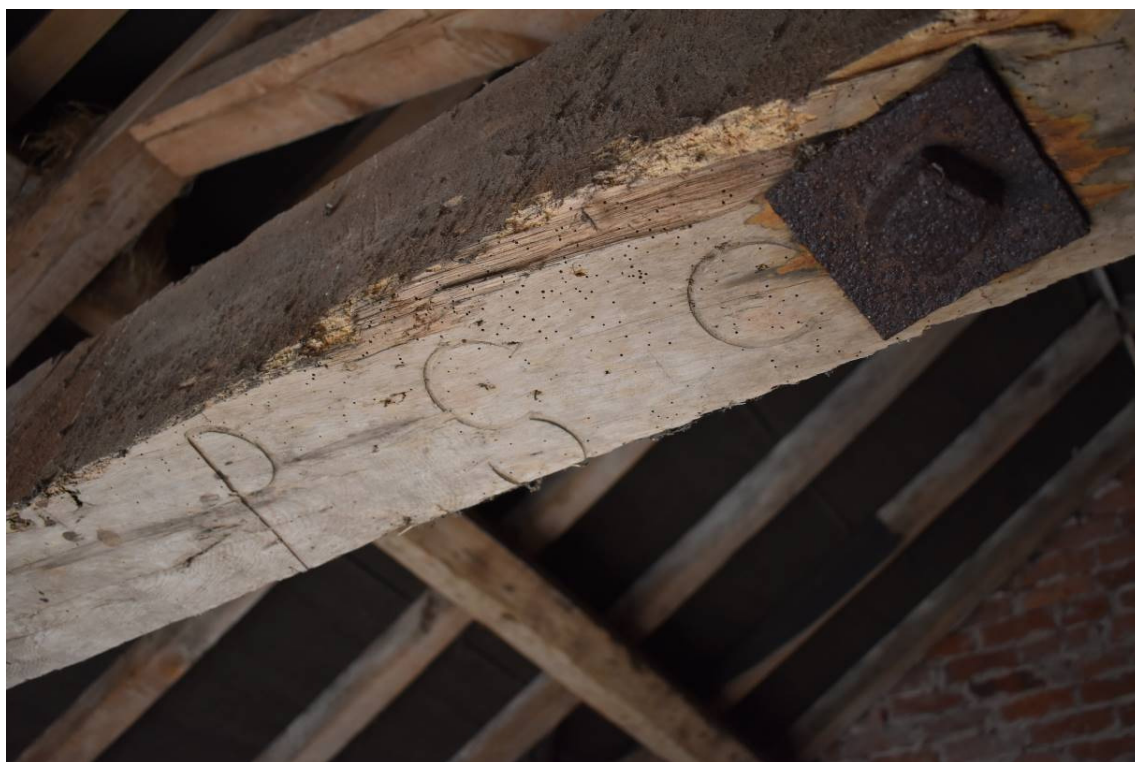
**Plate 52:** Initials 'PSC' to soffit of tie beam truss **T2**, formed with race-knife.

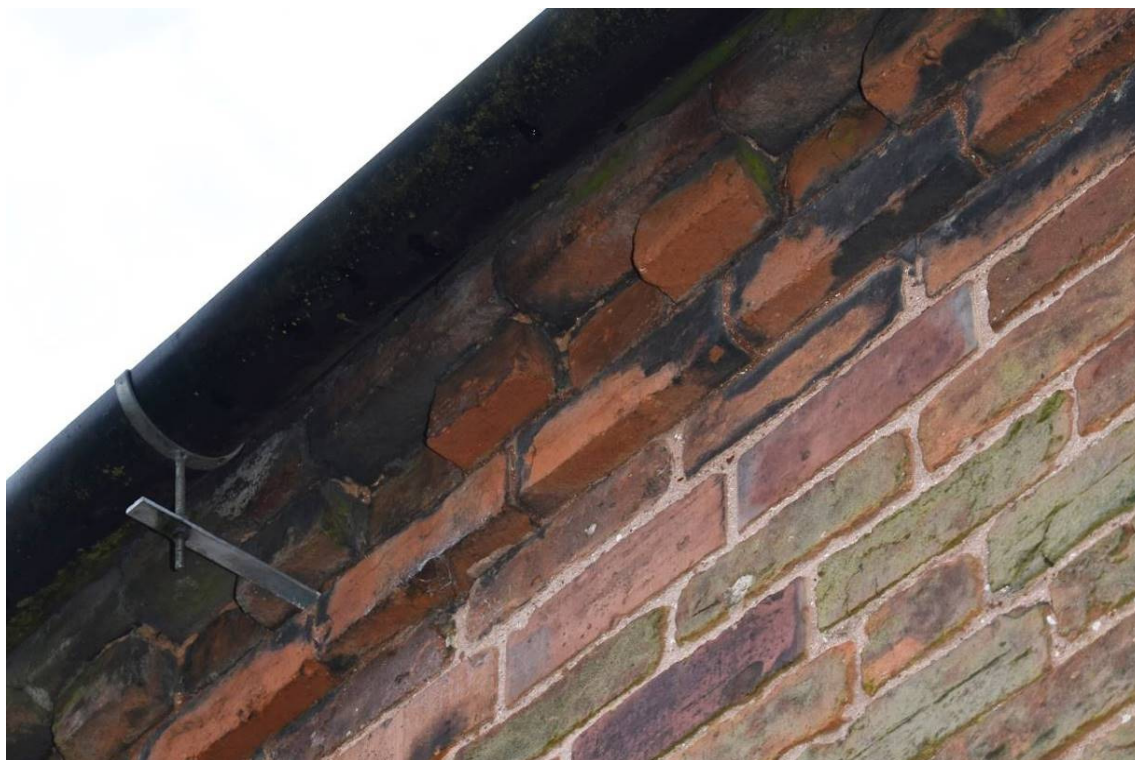
Plate 58: Range A2, detail of dentil-course eaves band.

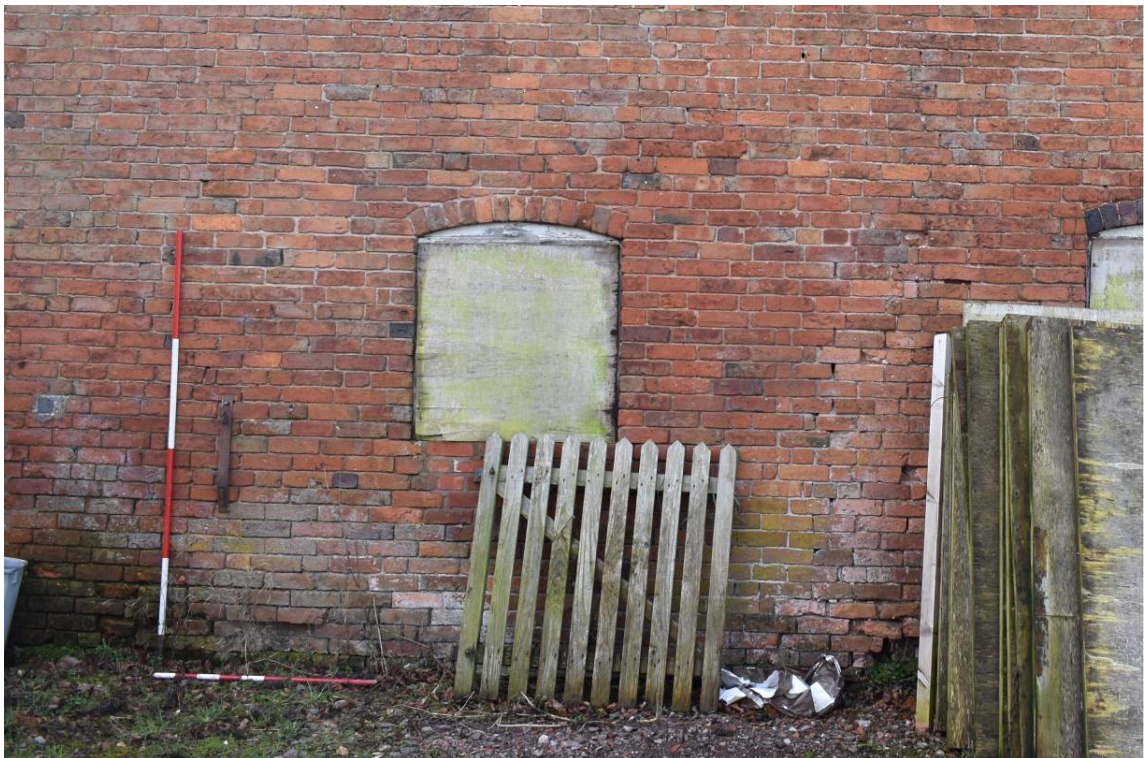
**Plate 63:** Uneven brickwork (colour/bond) around window [w2] suggestive of former, wide doorway.

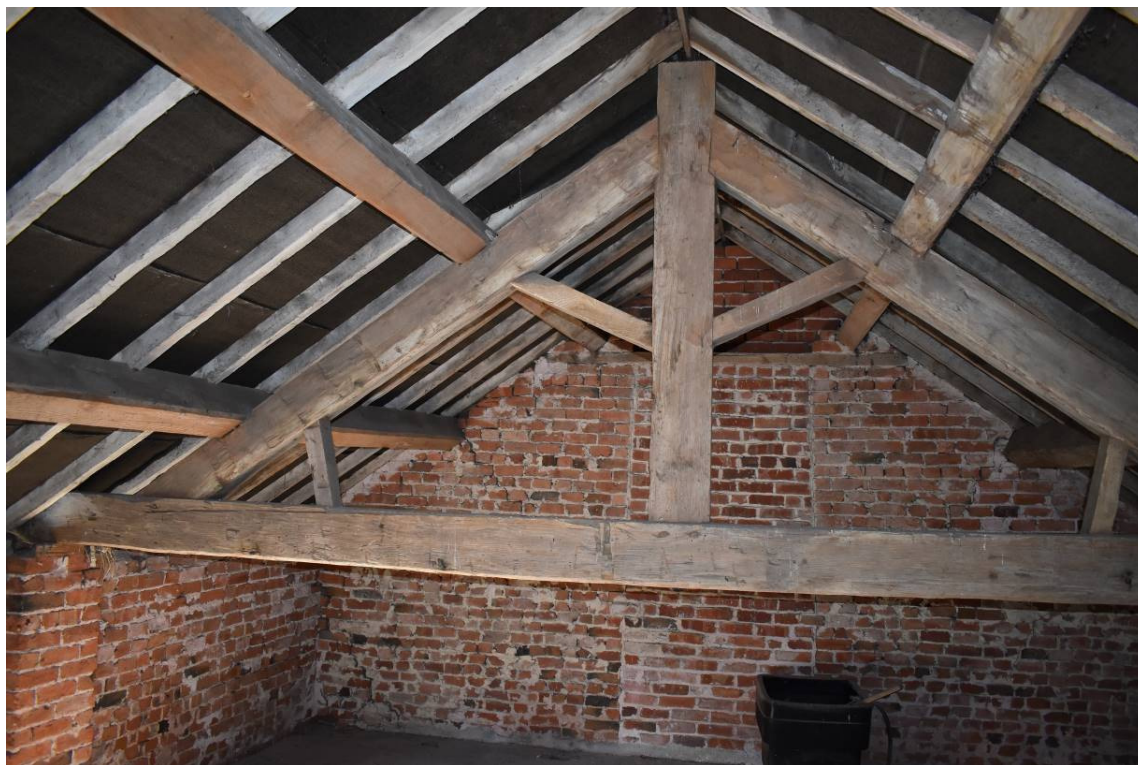
Plate 79: Variant roof truss over range A2 (truss T4 looking north).

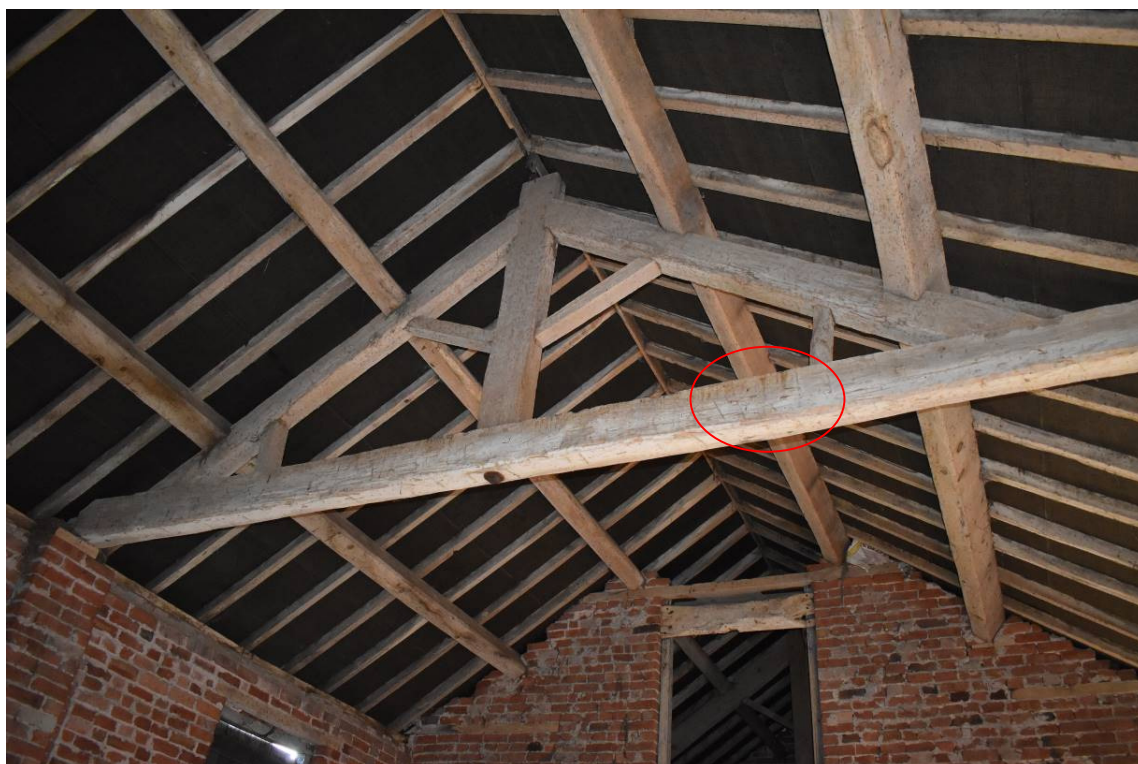
**Plate 82:** Truss T6 over [G6] with location of carpenter's marks highlighted.

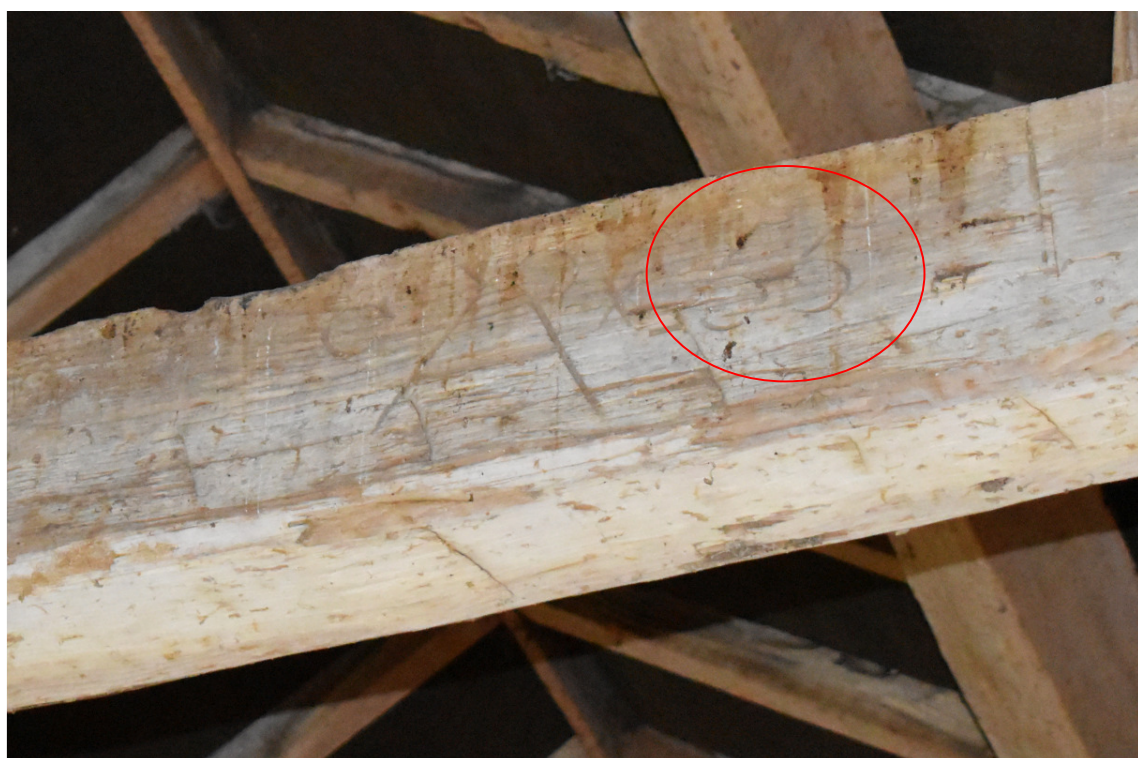
**Plate 83:** Detail of carpenter's marks; (?) '55' (circled) to tie beam of truss T6.

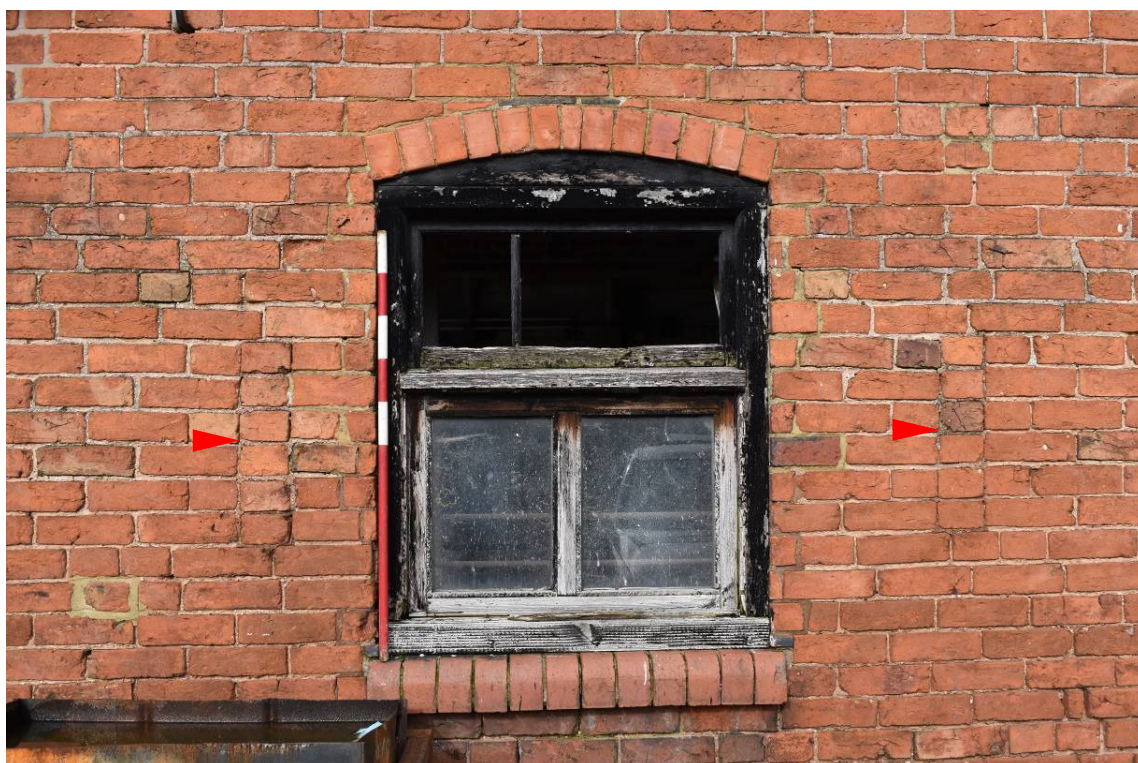
Plate 89: Range B, detail of window [w12] flanked by vertical vent slots (blocked, marked with arrows).

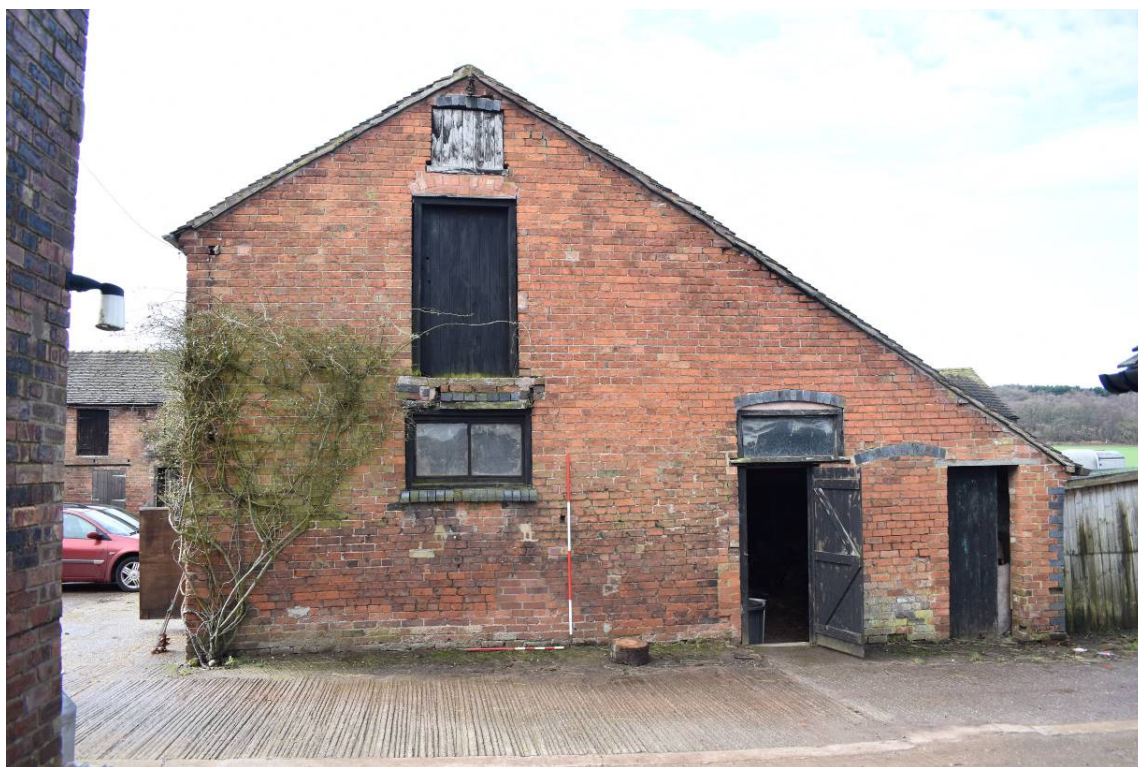
**Plate 92:** Range B/C; east gable end; NB. consistent brick coursing to upper wall.

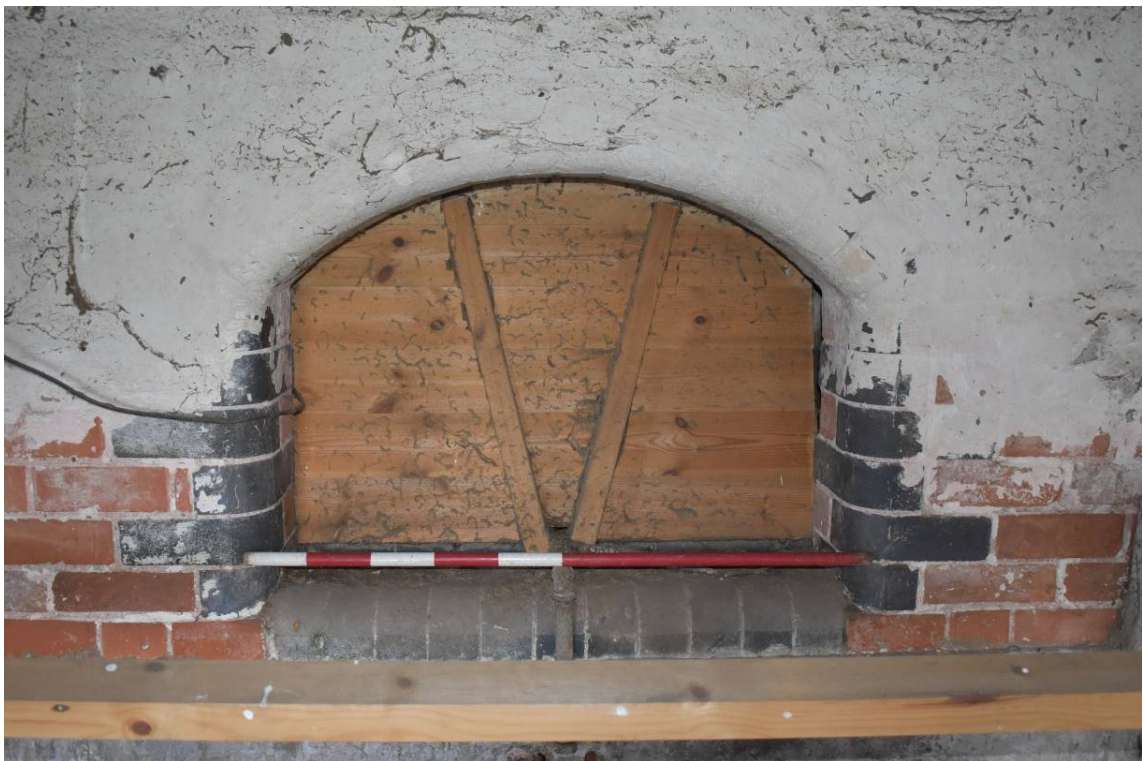
**Plate 97:** Feed hatch in north wall of Range B (see plate 88), as seen from building C.

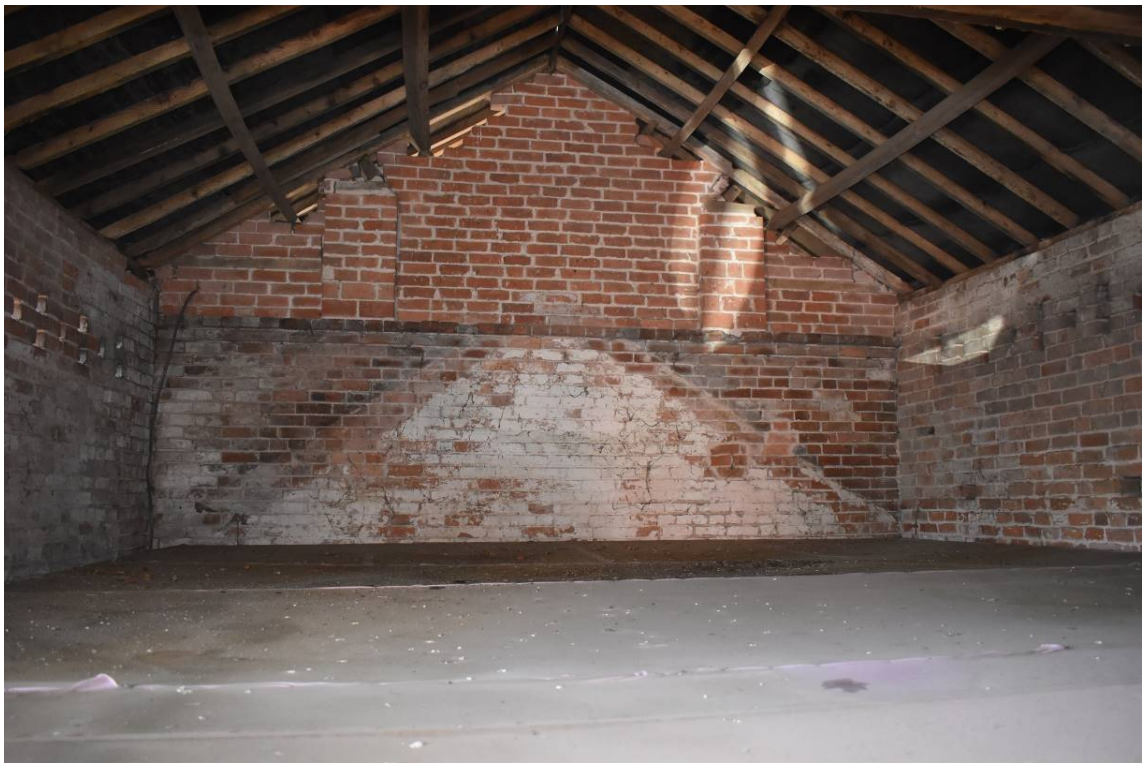
**Plate 98:** 'Ghost' of former, lower roof-line visible to west of Range **B** above inserted spray booth. **NB.** secondary stretcher-bond brickwork above level of Range **A1** eaves band with brick piers formerly supporting single tier of side-purlins.

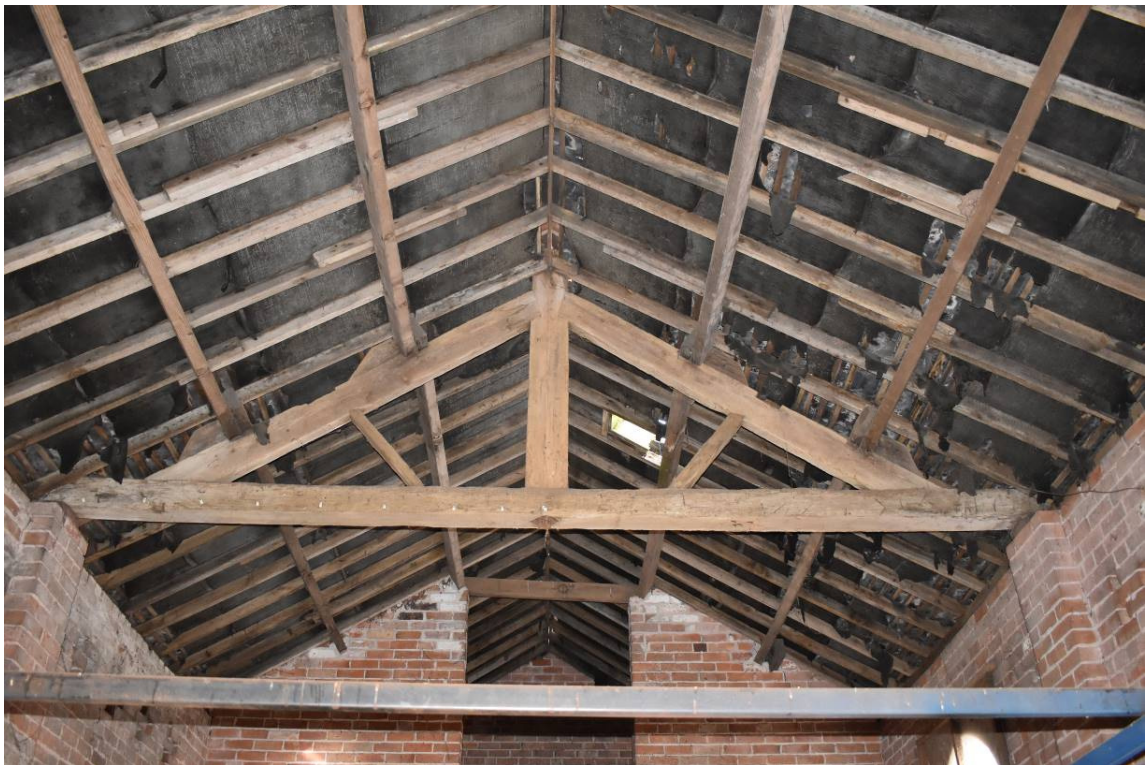
**Plate 101:** King-post roof truss over Range B (T9 looking east); NB. redundant trenches for former single side-purlins.

are again of king-post form (Figure 15b; Plate 101), the un-joggled KPs bolted at the tie, with raking struts rising from the tie to principal rafters at the level of an original single tier of shallowly-trenched side purlins. The latter have been removed, however, and replaced by two tiers of 'plank' section purlins, cut in bay lengths and supported at trusses on timber cleats. As noted above, the roof of range **B** has been historically raised, though the character of the roof carpentry and the similarity of pitch evident at the west end of the range (Plate 98) reasonably suggests that the original trusses were simply re-used in the heightened building, supported to north and south on projecting piers of brick, corbelled out at first floor level (Plate 102).

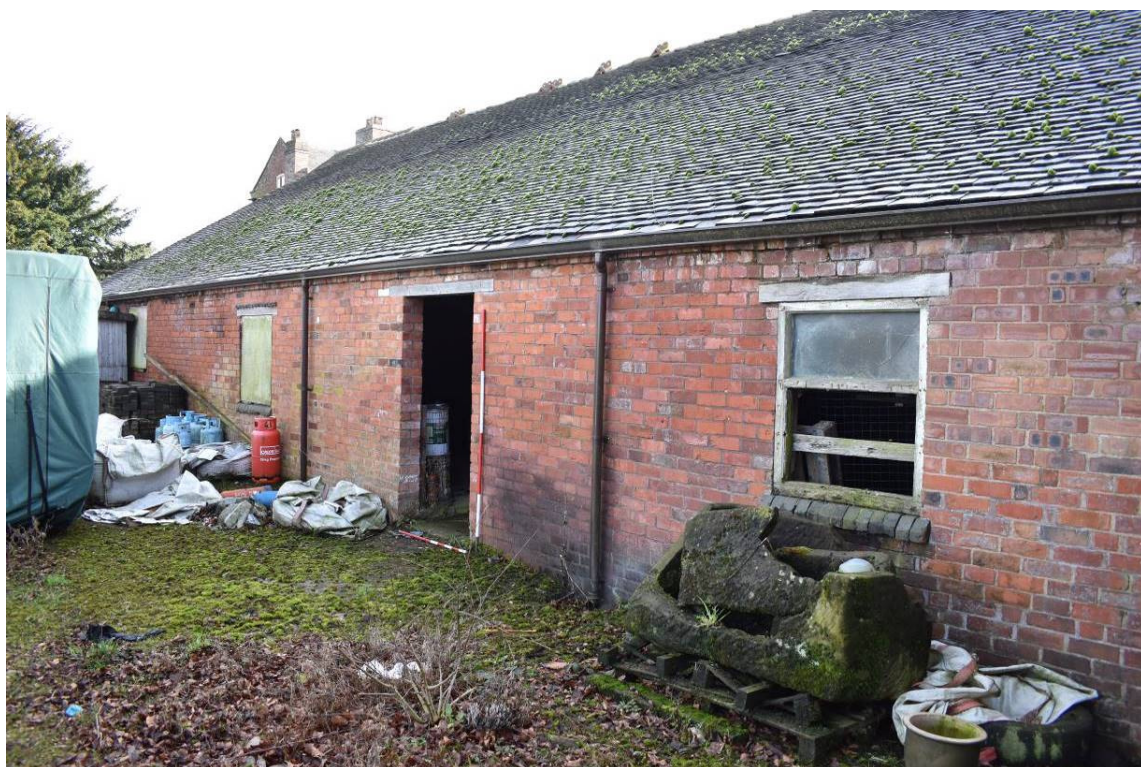
Plate 104: Range C, north elevation; largely rebuilt.

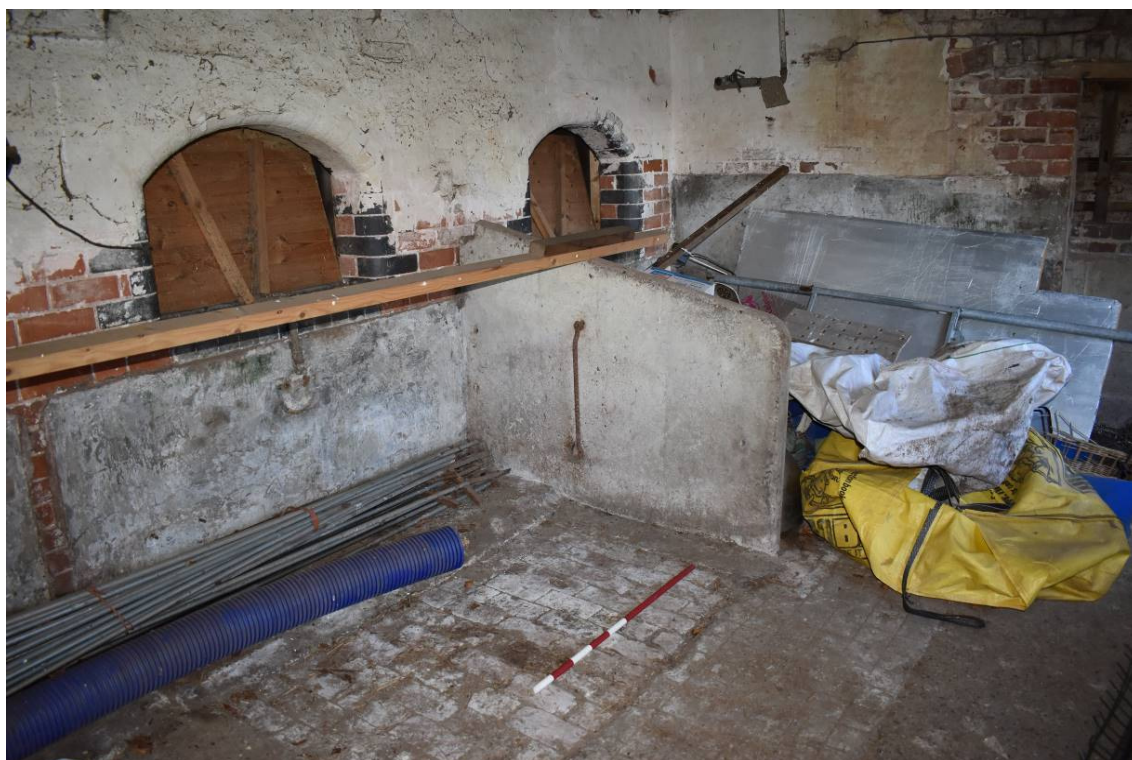
Plate 107: Interior of range C, room [G10]; detail of stalling.

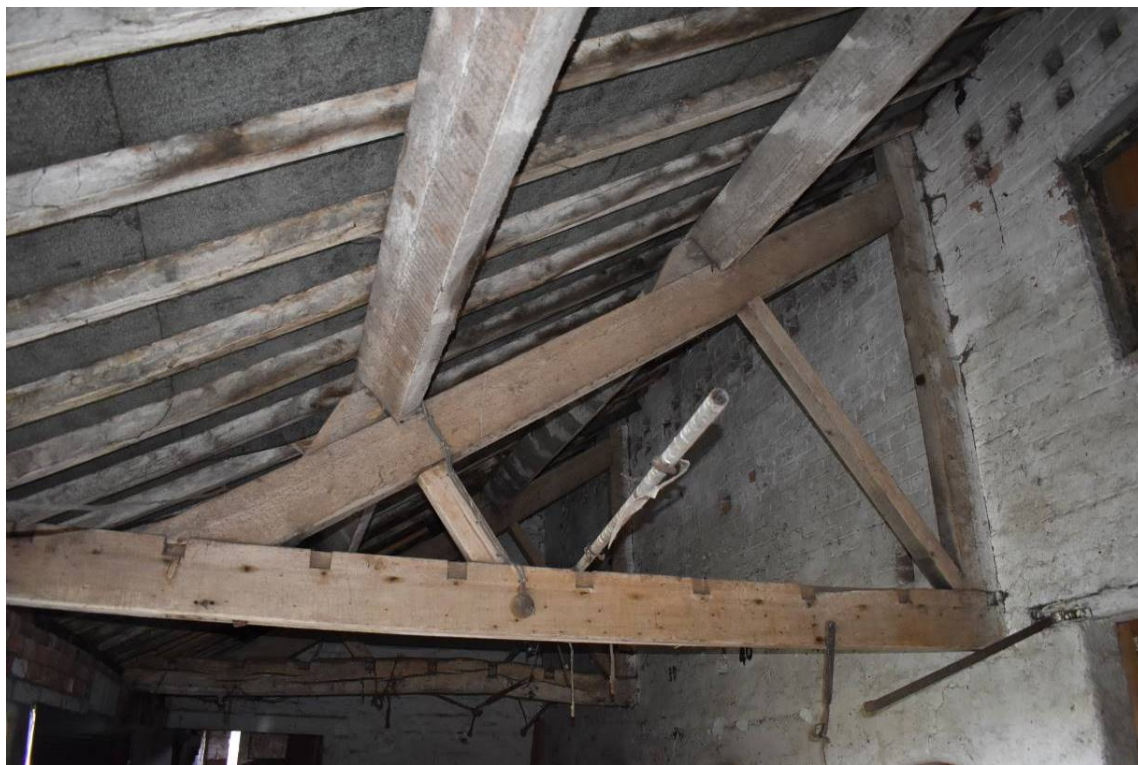
Plate 109: Roof truss T12 over [G10] (Range C), looking east.
