## Frickley Colliery

Archaeological Salvage Record

**RENAISSANCE SOUTH YORKSHIRE**  
**FRICKLEY COLLIERY AIR RAID SHELTER**  
**ARCHAEOLOGICAL SALVAGE RECORD**

**January 2008**

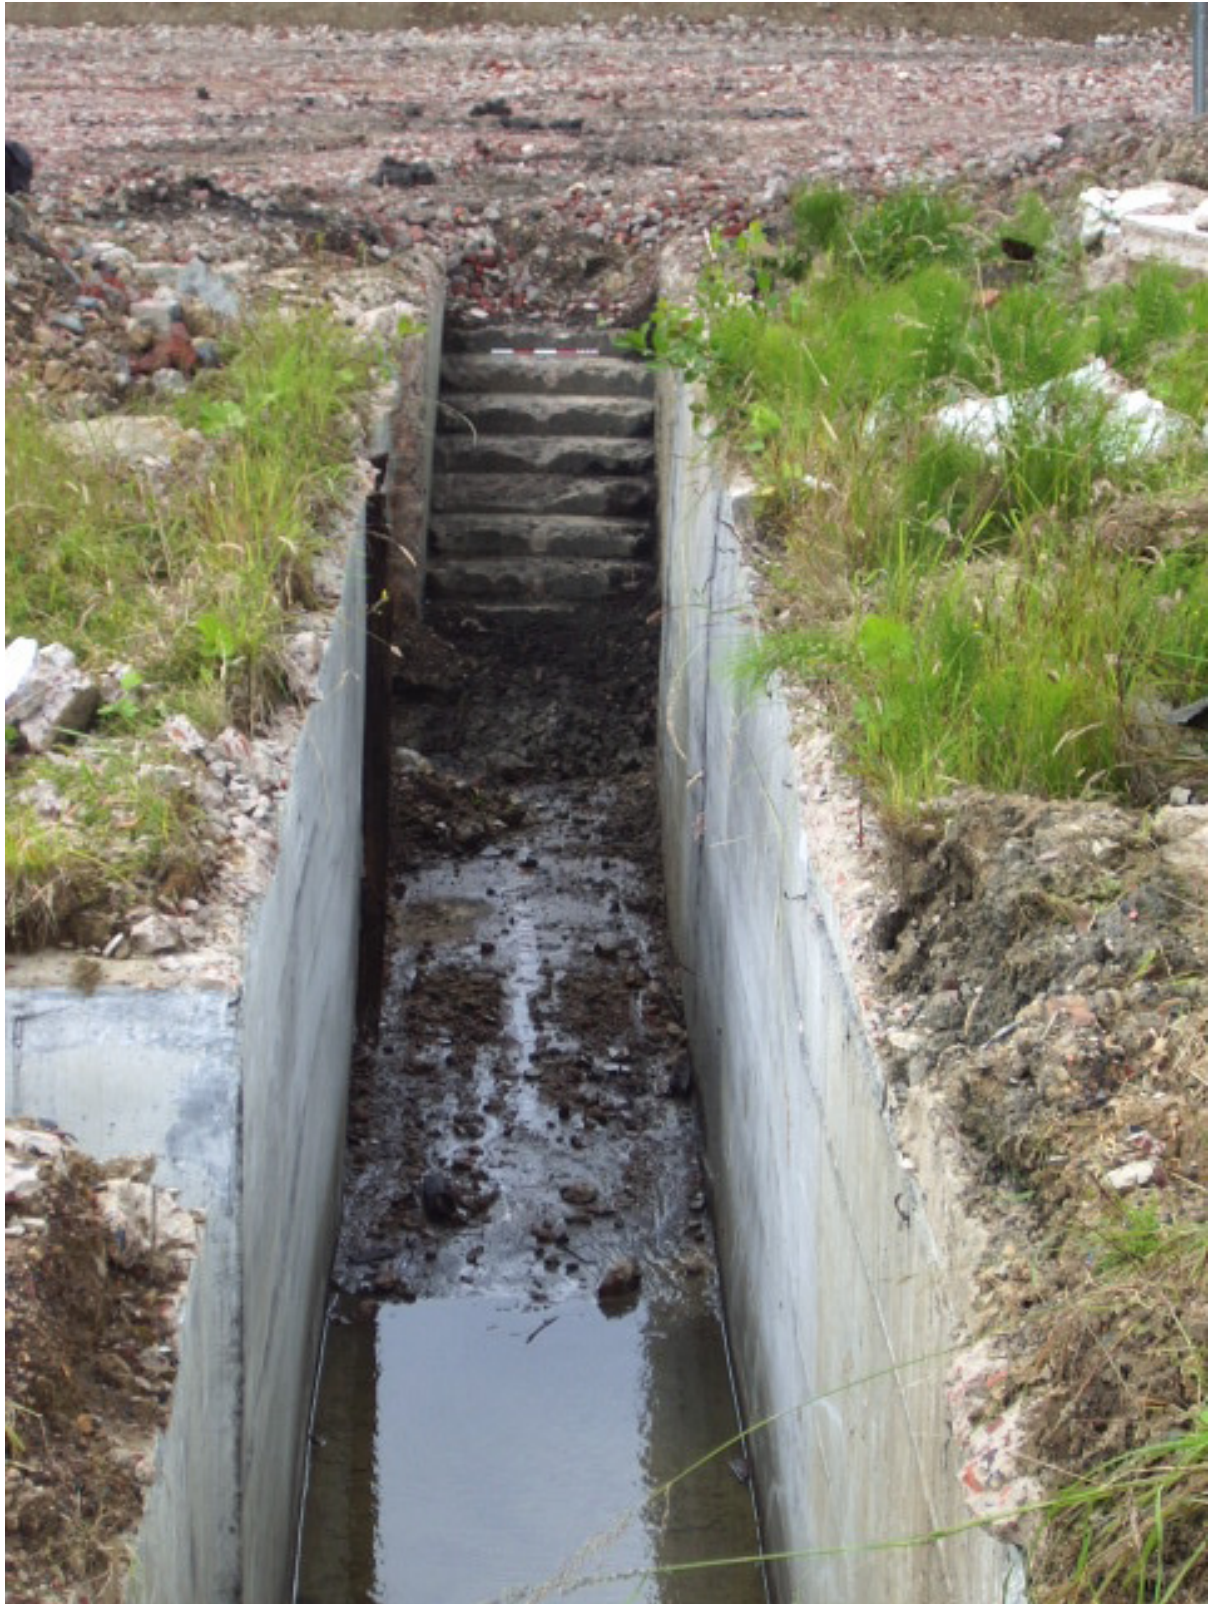
**Plate A Entrance 1 with remains of door seal identified to the left.**

Two pairs of doors were observed in close proximity to Entrance 1 (Plate A), with a further pair of doors observed near to Entrance 2 (Plate B). These appear to be associated with an air-lock procedure, to stop gas from the surface entering the tunnels. An in situ ladder found in one of the alcoves seems to have served as an emergency exit. Two toilet seats with the remains of buckets were observed within two alcoves suggesting the presence of two toilet areas, one located at the south west end of the structure, the other located at the south east end of the structure (Plate C). A possible conveyor pan was observed in Tunnel B, with a series of roof level hooks and a possible lamp bracket observed in Tunnels E1 and E2 (Plate D).

The main entrance to the structure was located at its northwest end and also at the end of Tunnel A had a series of concrete steps leading down into the structure, these steps also led directly onto an entrance lobby, approximately 2.2m<sup>2</sup> in size. There was no surviving evidence of a door located between the steps and the entrance lobby; however, the shelter may have been fitted with an iron blast proof door at the time of its construction (Wild & Bates 2004). The two tunnels leading off from the entrance lobby (Tunnel A and B) each had a wooden doorway at the entrance and a further doorway 2.75m into the Tunnel (in the case of Tunnel A) and 2.5m in the case of Tunnel B. It is thought that the voids between the two pairs of internal doors would have served as airlocks in the event of a possible gas attack. The frames of these doors were still visible attached to the sides of the structure, with shuttering to the arch crowns above. The secondary entrance to the shelter, located at the south western end of the shelter and leading into Tunnel D2 was less elaborate and did not have an entrance lobby. Remains of a pair of wooden doors were, however, observed close to the entrance way. The first doorway in this case being approximately 2m from the steps with the further doorways another 1.5m into the tunnel. Again it is thought that these doors acted as airlocks.

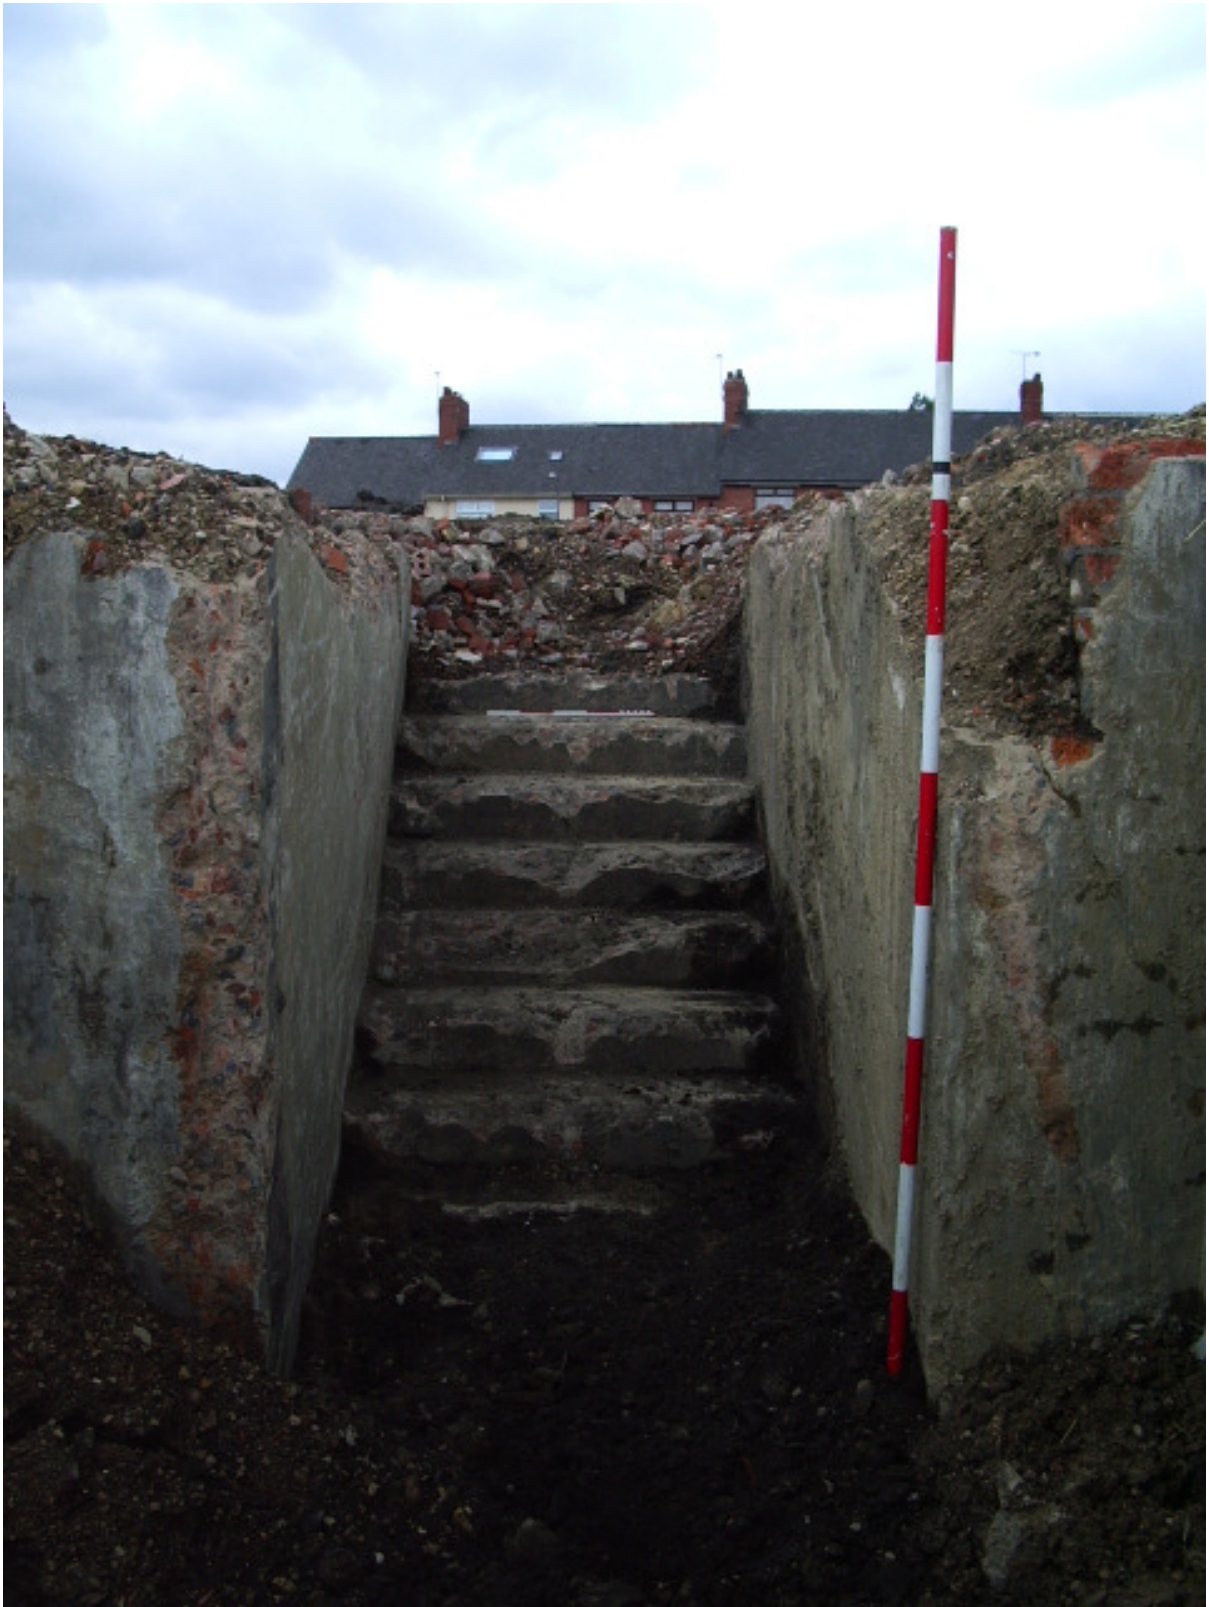
**Plate B Entrance 2.**

The complex was initially thought to have only one entrance, at the northwest end of the structure, however, the salvage recording exposed a further entrance at the south west corner both with steps leading down to the base and a series of wooden double doors (the frames still visible) close to these sets of steps. An escape tower was also present complete with metal ladder and capped with concrete at the surface. This was located at the mid point of Tunnel E3 and towards the south eastern end of the structure. A further ladder was located in an alcove in Tunnel C and this may have served as a further escape tower, however, there was no above ground evidence to support this theory. A total of 33 alcoves were located within the tunnels, all tunnels contained at least one alcove, with Tunnel C containing 5 alcoves and Tunnel B containing 4 alcoves. Tunnels A, A2, D2, E1 and E3 contained three alcoves, with Tunnels A1 and B3 containing two. All the alcoves were of a similar design and typically had a width of 1.02m. There was no apparent pattern to their distribution, neither in terms of their location within tunnels nor as to which side of the tunnels they located. Two of the alcoves acted as toilet cubicles and contained metal buckets with the remains of wooden toilet seats on top. These were located in the alcove located on the eastern side of Tunnel D2 and the south eastern most alcove of Tunnel B. It was not possible to retrieve these as they were washed away during the severe weather on June 25<sup>th</sup> and 26<sup>th</sup>.

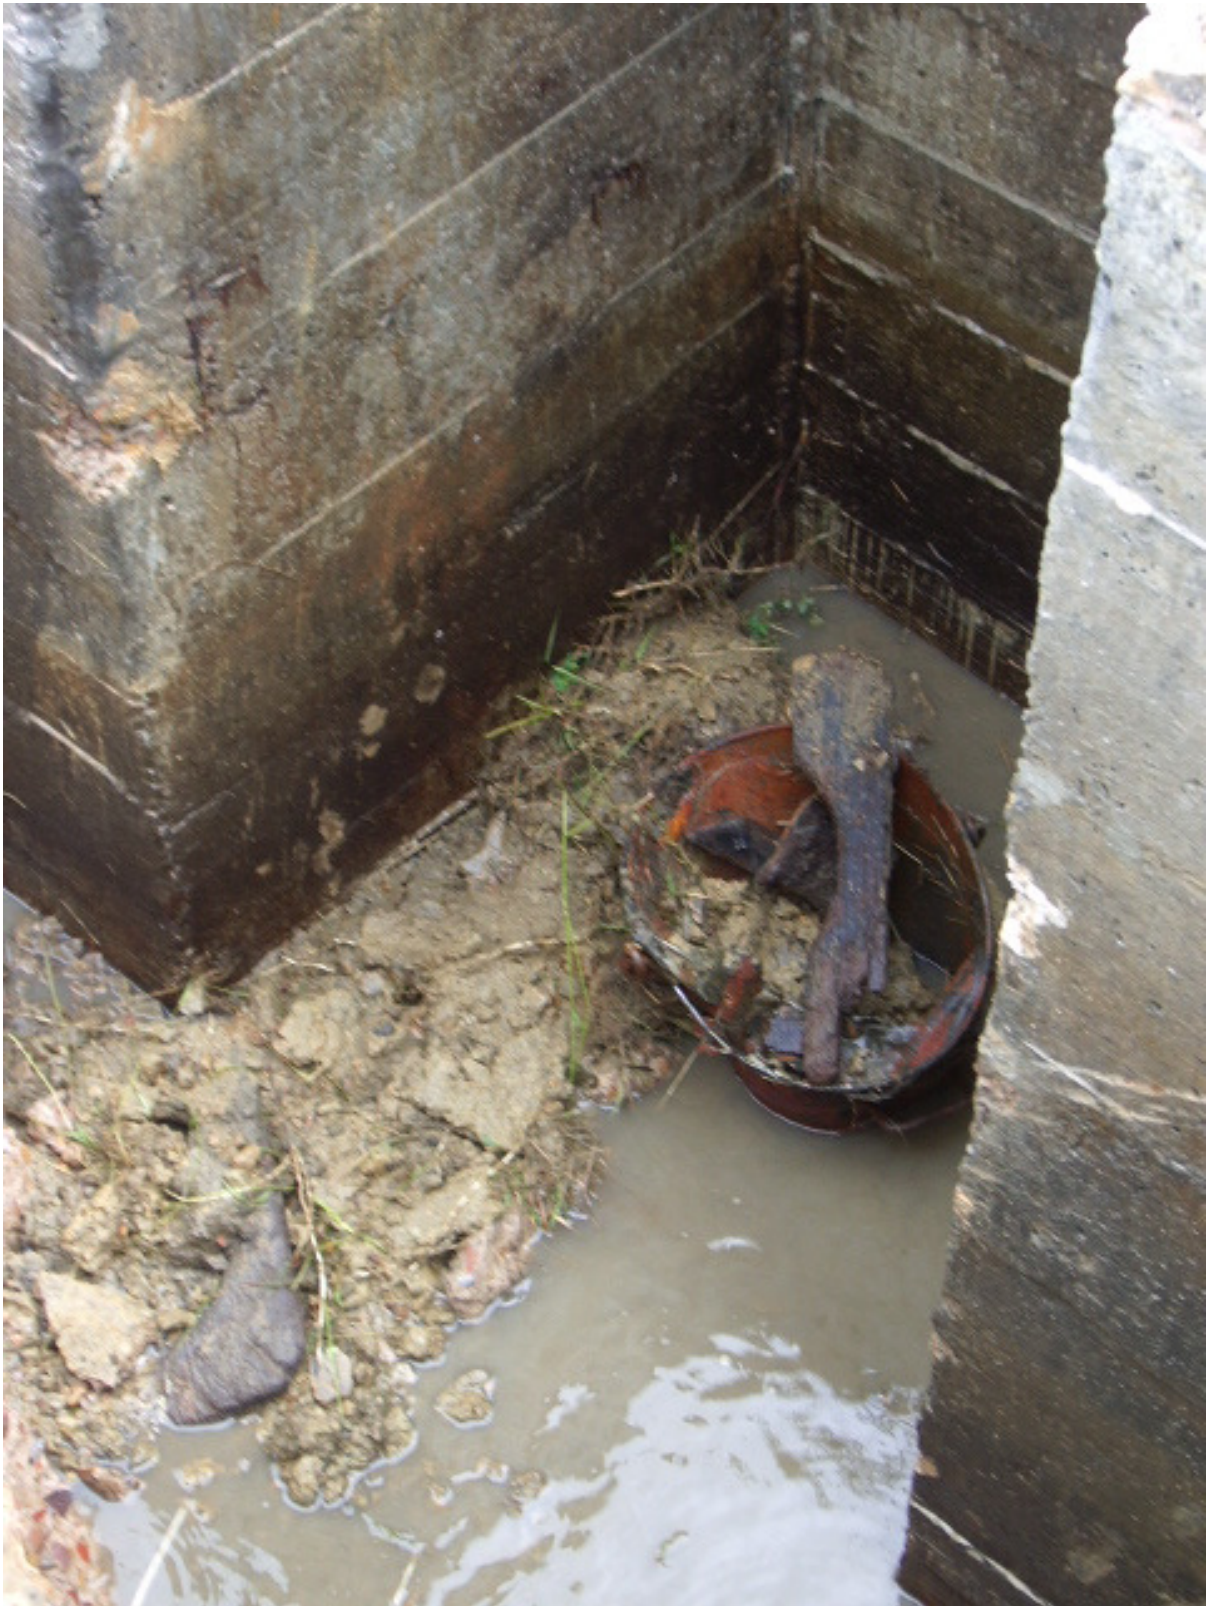
**Plate C Remains of Toilet Seat and Bucket**

General photographs were taken to show the extent of the various tunnels and more detailed photographs were taken of a number of the alcoves, an in situ toilet seat (Plate C), the stairs leading to Entrance 1 (Plate A) and details such as the metal hooks found at roof height in Tunnels E1 and E2 (Plate D). Where possible photographs were taken perpendicular to the line of the tunnels, however in a number of cases this was not possible.

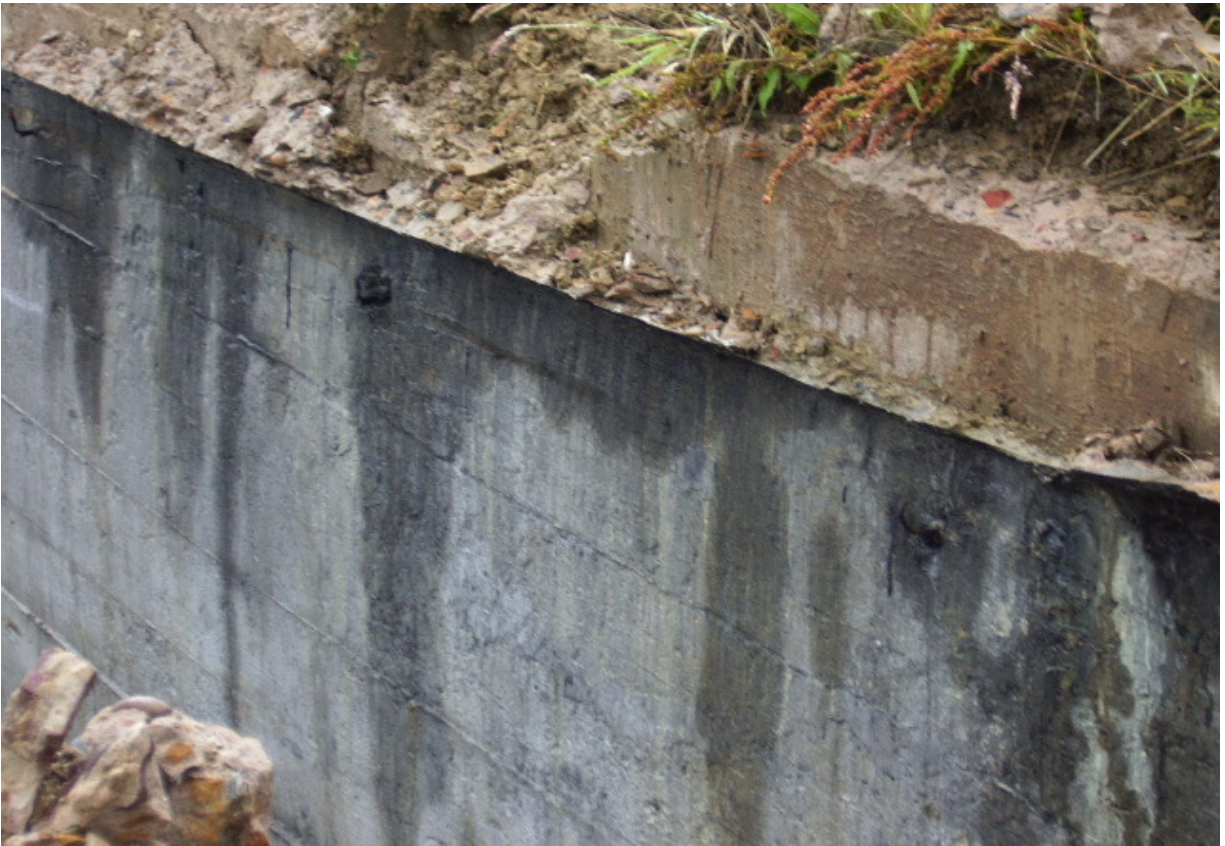
**Plate D Remains of Probable Electrical Trunking Anchors.**

A number of fittings were found towards the roof in Tunnels D1, E2 and F2. These comprised a number of small metal hooks probably employed to carry festoon lighting near the tops of the tunnel walls (Plate D). It is thought that the tunnels would have had a row of electric lights down one side supported on metal hooks, hammered into wooden dowels and inserted into holes drilled into the concrete walls, however, this is purely conjecture for the majority of the shelter and no evidence was apparent from the majority of the structures tunnels.
