Sainsbury's Supermarkets Ltd

Sainsbury's Development, Erdington

Watching Brief for Utilities Works

August 2015

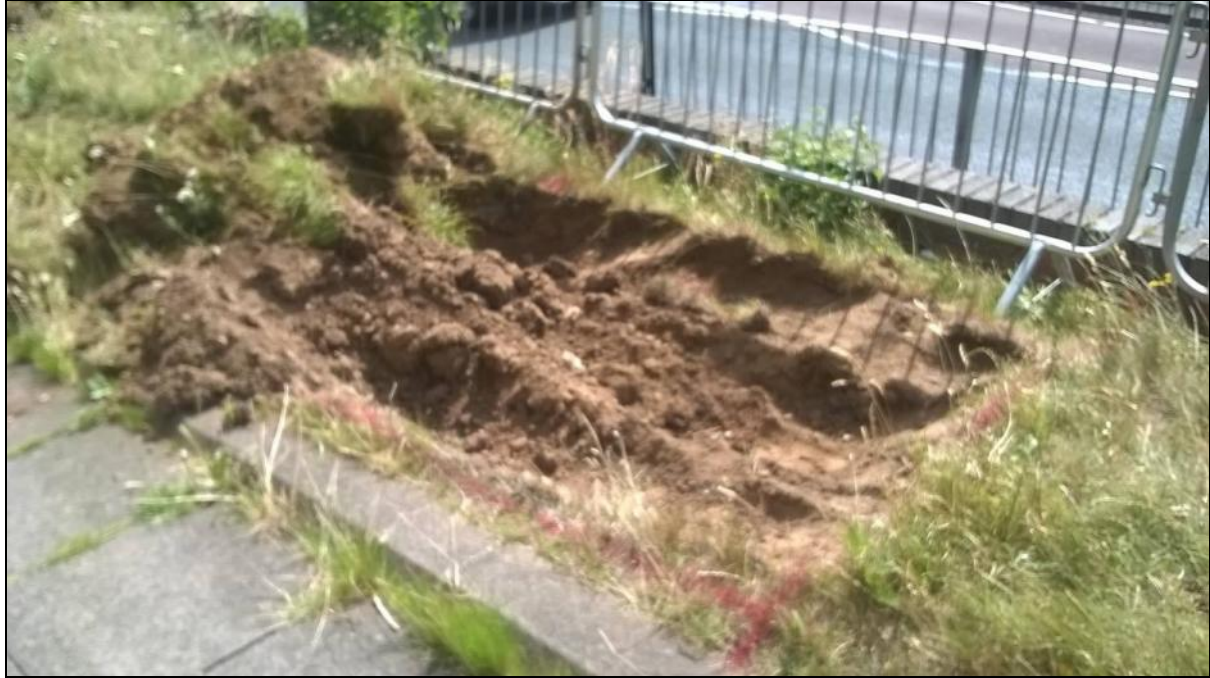
Picture 1: General view of the excavation area seen from the north-west showing ground conditions at the commencement of works.

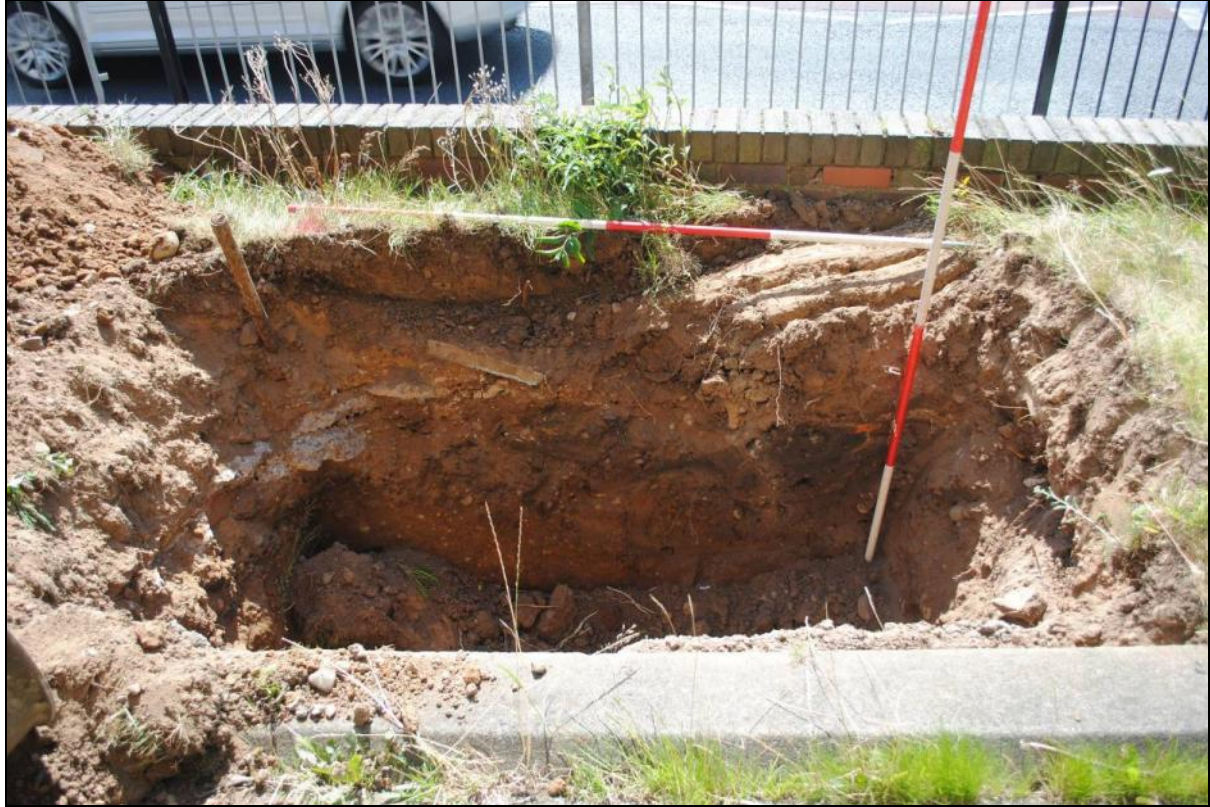
Picture 2: View of the works from the north during excavation.

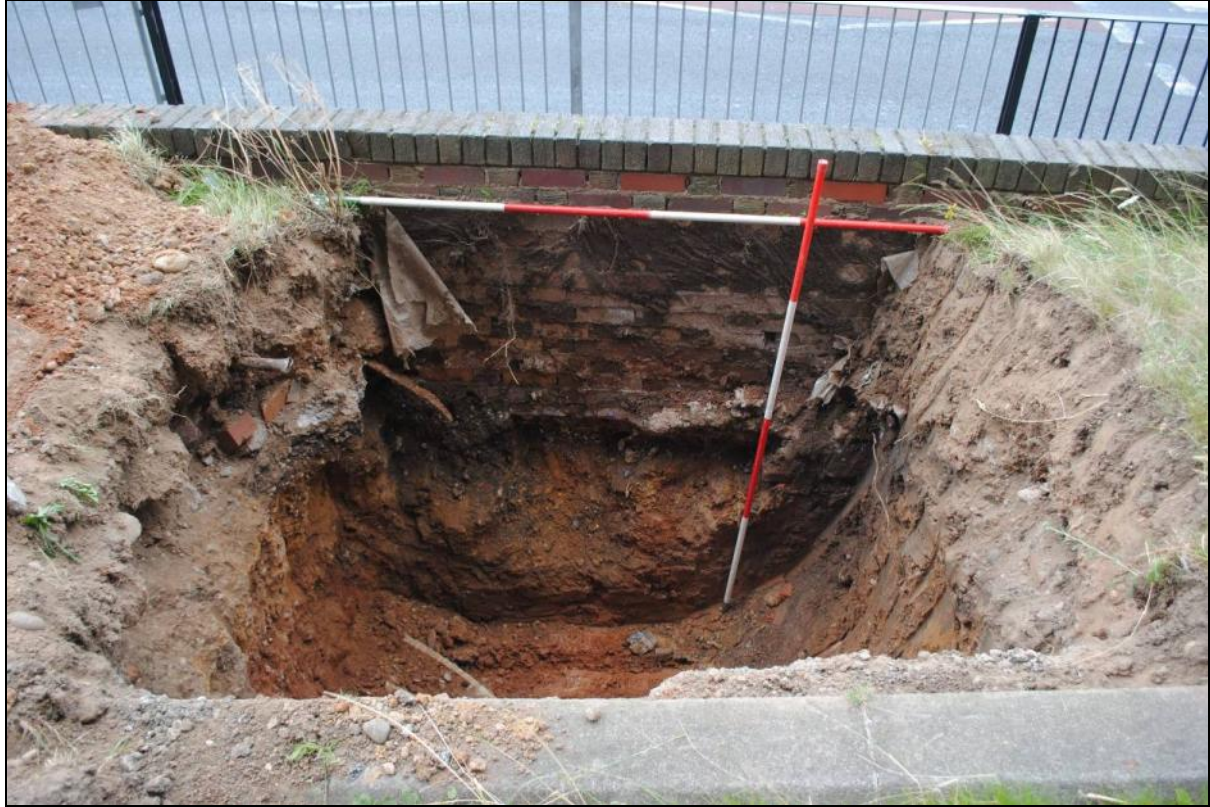
Layer (003) lay beneath (002) and was up to 0.50m thick. It was composed of a mottled orange-grey-brown clay-sand mix and included occasional to moderate water rounded gravel pebbles. This deposit is considered to be natural subsoil. The layer covered clean red-brown sands with occasional water rounded gravel pebbles which differed from (003) only in colour. This layer (006) is considered to be natural subsoil.

The southern boundary of the excavation was formed by the modern boundary wall of the site (005). This wall was constructed of modern red bricks, with a dark grey course forming a coping. The wall was 1.20m deep and to the north was abutted by layers (+), (001) and (002), while to the south it formed a boundary 1m high between the pavement on the north side of Orphanage Road and the site. As bricks of very similar form and appearance to those in (005) were identified within (003) the wall is considered to have been constructed at the same time as the remodelling of the site when the office block was constructed.

Picture 3: North-facing section of the excavation, showing brick wall (005) and layer (003) and Natural subsoil (006) beneath.

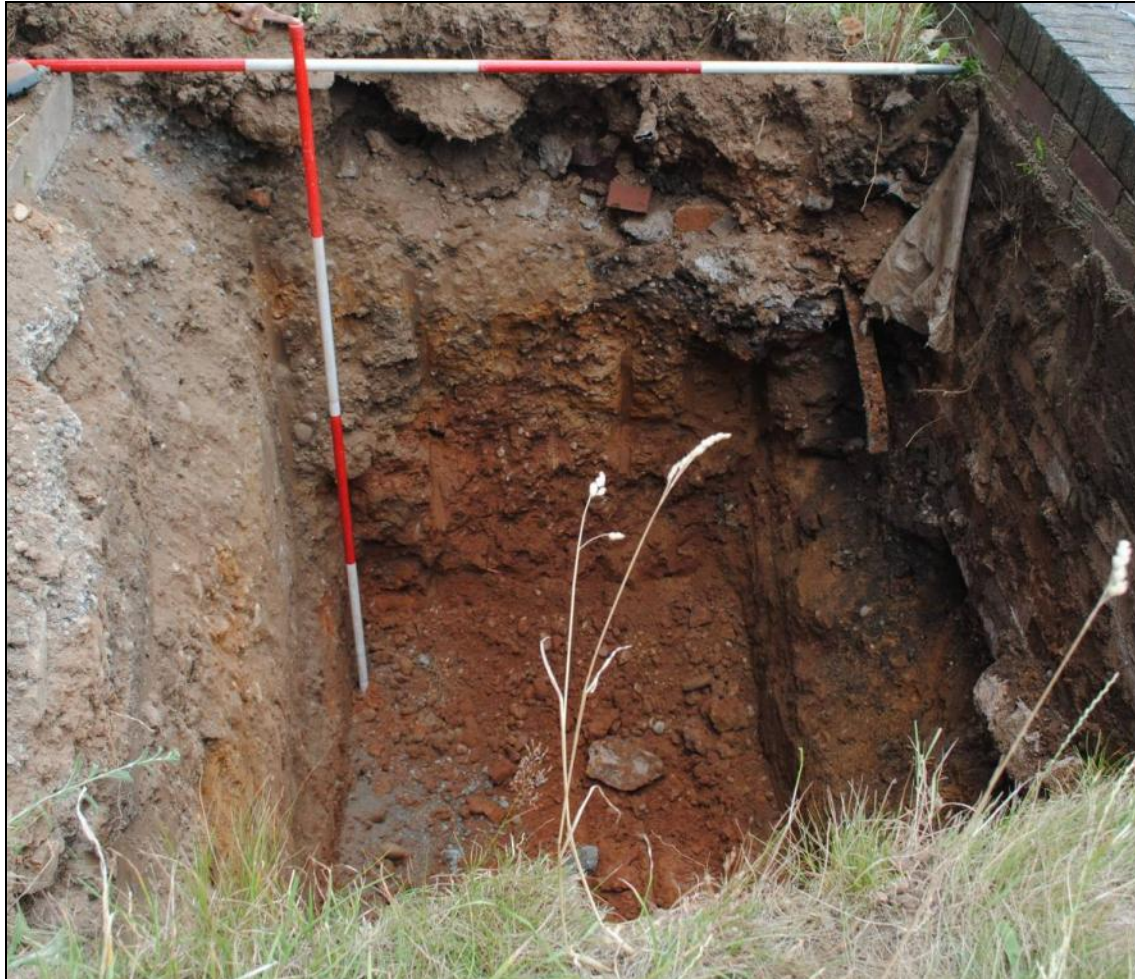
Deposit (001) lay immediately below the unstratified turf and topsoil (+) that was 0.10m thick. It included a loosely compacted mid yellow-brown sandy clay with occasional fragments of ceramic building material, builders aggregate and grey concrete chippings and was 0.40m thick. This deposit was above (002), a loosely compacted, light grey brown sand and mortar layer up to 0.55m thick. This layer included heavy concentrations of ceramic building material, concrete chippings, set mortar and fragments of paving slabs. The ceramic building material included fragments from bricks of identical form to those visible in the wall of the office block to the north and the boundary wall onto Orphanage Road to the south. Meanwhile, the fragments of paving slab recovered very closely resembled slabs in the paved path immediately north of the works between the excavation and the office building. This layer also included a corroded iron head of a pickaxe, metal strapping, the corroded lid of a paint tin and a length of lead piping. An aluminium ring pull was also recovered from this layer. This layer appeared to extend beneath structure (004), the paved pathway. The artefacts identified in this layer, as well as its general composition strongly suggest that this represents a dumped layer corresponding to the construction of the office block where surplus and waste material was deposited before its concealment beneath (001) and the turf of the landscaping.

Picture 4: West-facing section, showing topsoil (+), sandy deposit layer (001), dumped layer (002) and sands (003) and (006).

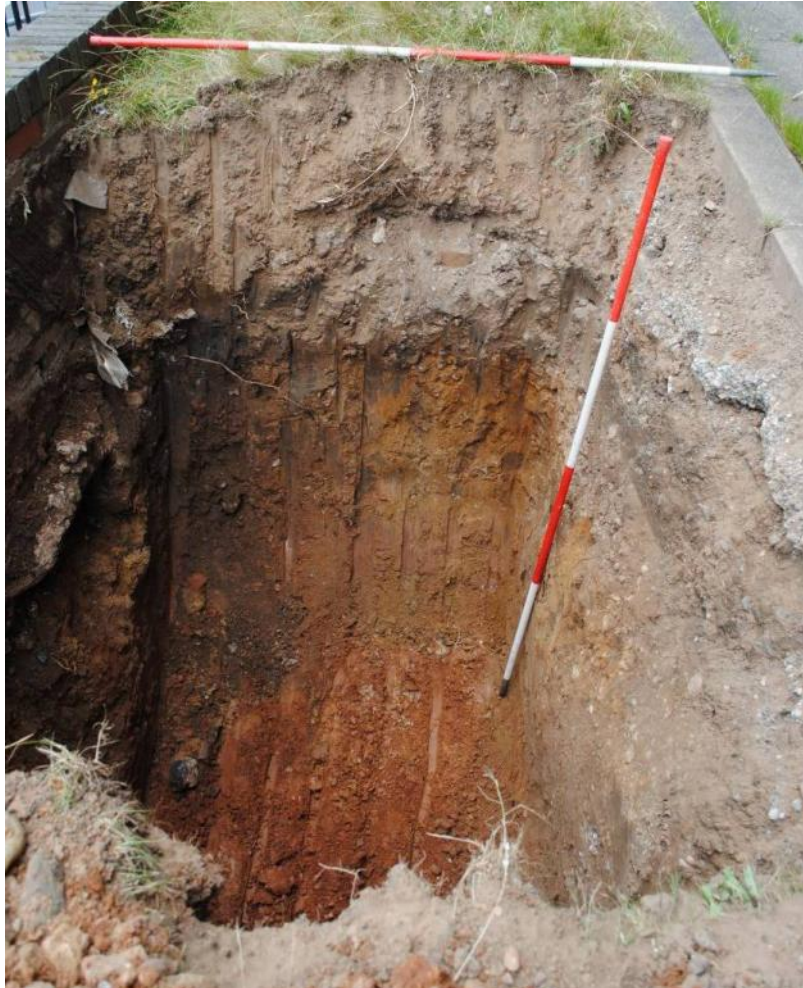
Structure (004) is the concrete path. It includes concrete paving slabs with a concrete kerb along its south edge. Both kerb and slabs are bedded on a bed of heavily aggregated concrete. The topsoil and turf (+) and layer (001) abut the kerb on its south side while it is bounded to the north by the south wall of the office block. Deposits (002) and (003) both appear to extend beneath (004).

Picture 5: East-facing section showing the sequence of layers identified as well as structures of the paved pathway (004) and the boundary and retaining wall (005).

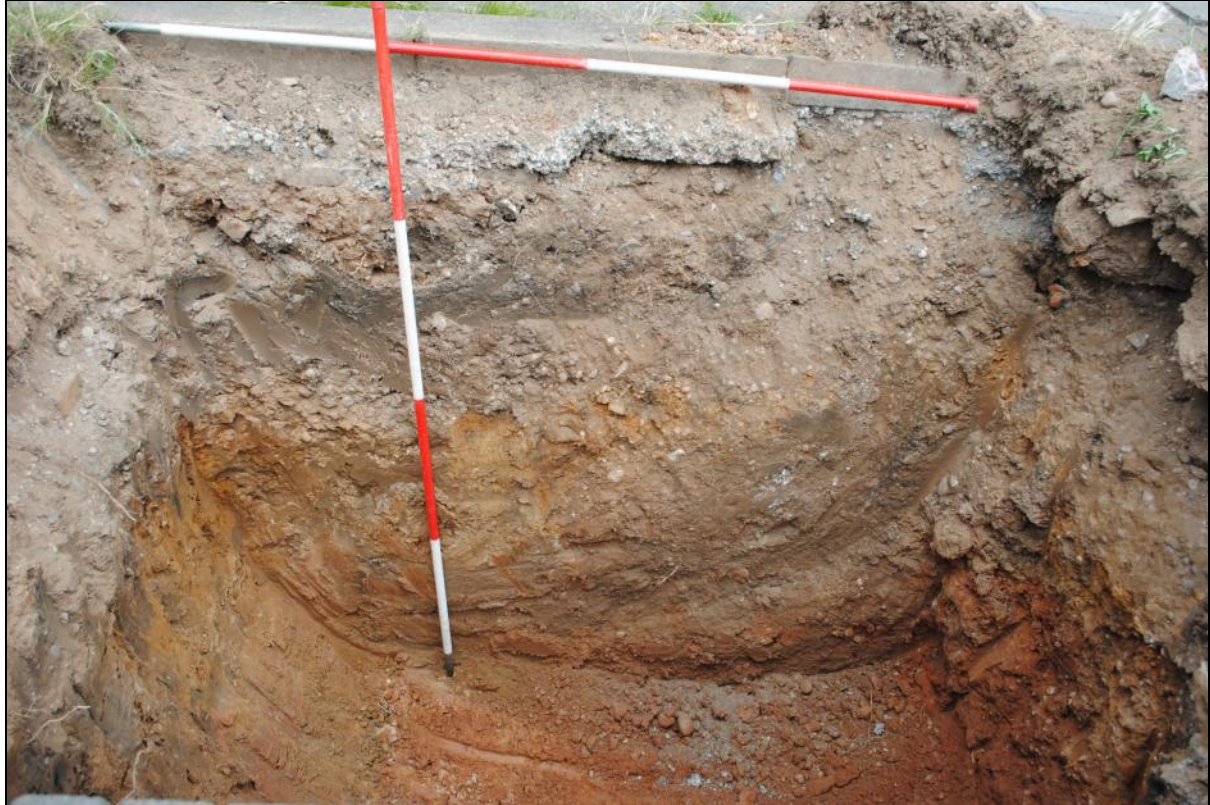
Picture 6: South-facing section showing pathway structure (004) overlying dumped layer (002) and sands (003) and (006).

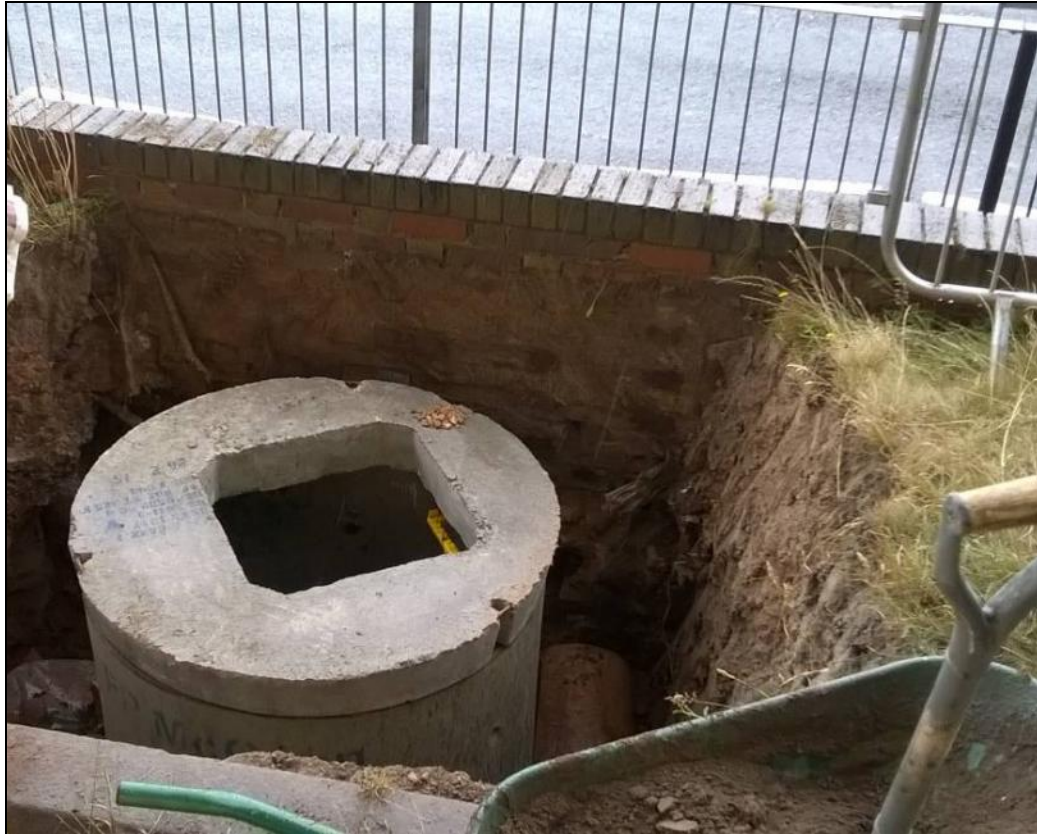
Picture 7: View south into the excavation showing the installed inspection chamber (prior to the installation of the hatch).
