Horsemarket, Kelso, Scottish Borders
Archaeological Watching Brief
Data Structure Report
Project 3393

Horsemarket, Kelso, Scottish Borders
Archaeological Watching Brief
Data Structure Report

Project Number: 3393

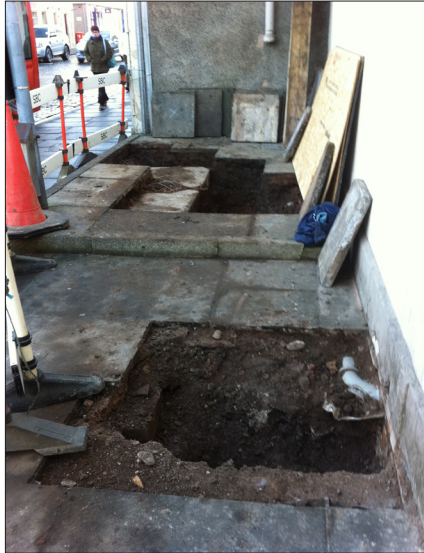
Plate 1.

- 7.3 The pavement slabs (001) in all trenches were underlain by a thin layer of sand and whindust (002). This was itself underlain by the base of a British Telecom junction box and a 0.25 m deep layer of sandy clay (003) on the north-west side, cut by modern service pipes, which was underlain by a layer of sandy gravel (004) at least 0.45 m deep, which was also cut by modern service pipes (Plate 1). Beneath the slabs (001) and sand and whindust foundation (002) to the south-east of the public toilets was a 0.37 m deep layer of sandy clay (003), which overlay a rough surface of mortared brick (005) that sloped down from the base of the public toilets to the adjacent pavement of Woodmarket between depths of 0.32 m and 0.50 m below the present ground surface (Plate 2).

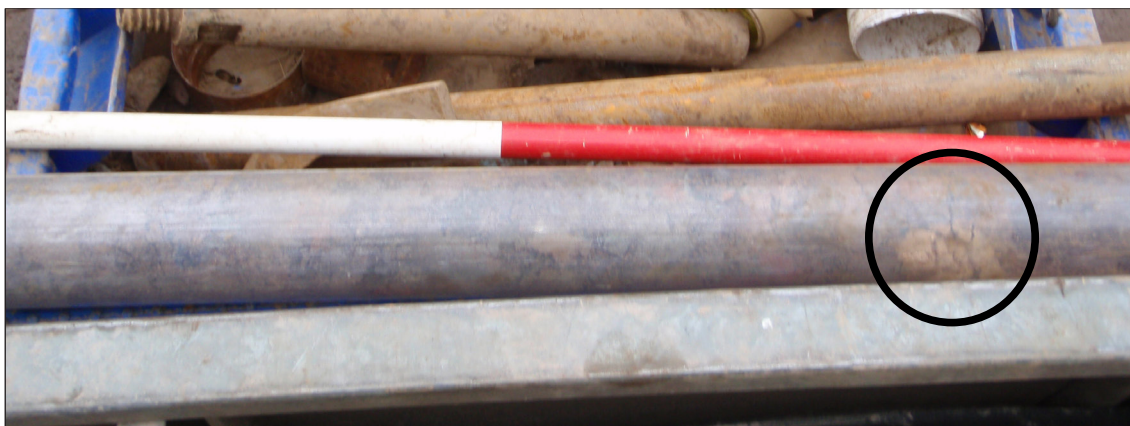
Plate 3: Window sampler 1 m - 2 m, BH2.

- 7.6 On the north-western side (Horsemarket) the trenches had been left open to allow the geotechnical team to note the location of services within the immediate area such as a sewage pipe and electricity cable. Borehole 2 (BH2) was located near the north-western corner of the public toilets in Area NW2. At a depth of about 0.5 m an obstruction was encountered and an inspection pit was hand-excavated to remove a medium sized rounded stone. Shortly after, another stone was encountered that became wedged into the casing. This stone was removed but because it had lodged in the mouth of the casing, it had compromised the sample by preventing any soil from being collected within the window sampler up to a depth of 1 m. The sample taken from 1 m to 2 m was very mixed, comprising predominately sand with stone inclusions and what appeared to a possible fragment of blonde sandstone at a depth of 1.30 m (Plate 3). BH2 was abandoned at 2 m depth after hitting another hard object.
