**17 Friar's Lane, Lanark
Data Structure Report
Project 3458**

17 Friar's Lane, Lanark
Data Structure Report

Project Number: 3458

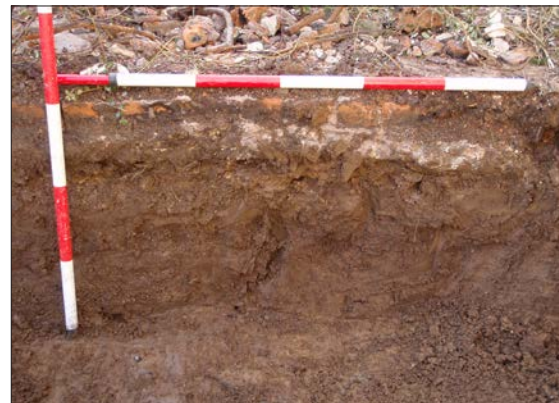
- 7.2 The foundation trench was L-shaped and abutted the rear of the present house. It measured in total 9.14 metres in length and 700 mm in width. Prior to stripping a patio was present on site. The upper deposit consisted of a mid-brown silt sand (001) measuring 100 mm in depth and represents the foundation layer of the modern patio. Immediately below this a linear sandstone foundation wall (003) with mortar bonding was located in the north-south foundation trench (plate 1). One course was truncated for the insertion of two cast-iron pipes. This probably represents the foundation of the previous house which occupied the site until its demolition in the 1960's. The wall measured 700 mm in width and was in alignment with the known foundation of the previous house. Excavation of the east-west foundation trench revealed a modern brick wall (007) with only two courses surviving above a relatively shallow mid-brown silt sand deposit (002) consisting of demolition debris including brick and stone fragments. Below this deposit was a beige/brown clay sand with inclusions of coal fragments (004) which measured 220 mm in depth and is presumed to be natural in origin. Below this was a natural beige/brown sand clay deposit (005; plate 2). The brick foundation of the present house (006) was also noted at the southern side.

Plate 2: Deposits in east-west trench at house extension.

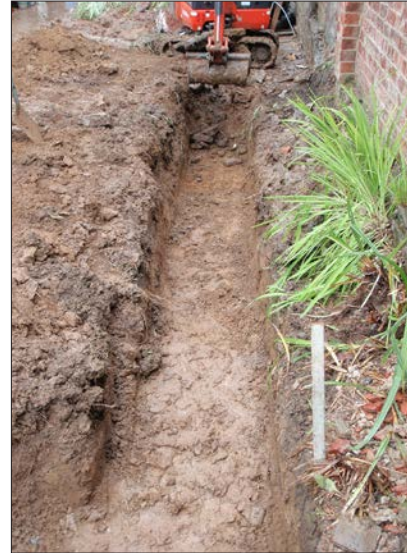
- 7.3 The garage foundation trench was rectangular in shape and measured 9 metres in length and 5.6 m in width (plate 3). It was orientated north-west/south-east with the north-western foundation wall only partly excavated at either side as this was the garage door location. The first deposit encountered was a grey concrete layer (008) 60 mm in depth. Below this was located a pebble hardcore deposit (009) which measured 80 mm in depth. Below these two deposits was found a dark brown coarse sand clay with a depth of 180 mm. It contained a few modern pot and glass fragments and represents made ground probably related to the garage which previously occupied this part of the site. Below this was found a mid-brown clay sand (011) which contained coal fragments, sandstone debris and brick and measured 190 mm in depth. This is probably demolition debris related to the previous house which was demolished in the 1960's. Below this was found the natural sand clay layer (005; plate 4).

Plate 4: Excavation of garage foundation trench at garden boundary wall.
