**Dumfries House  
Data Structure Report  
Project 3543**

## Dumfries House Data Structure Report

**On behalf of:** Hope Homes

**Project Number:** 3543

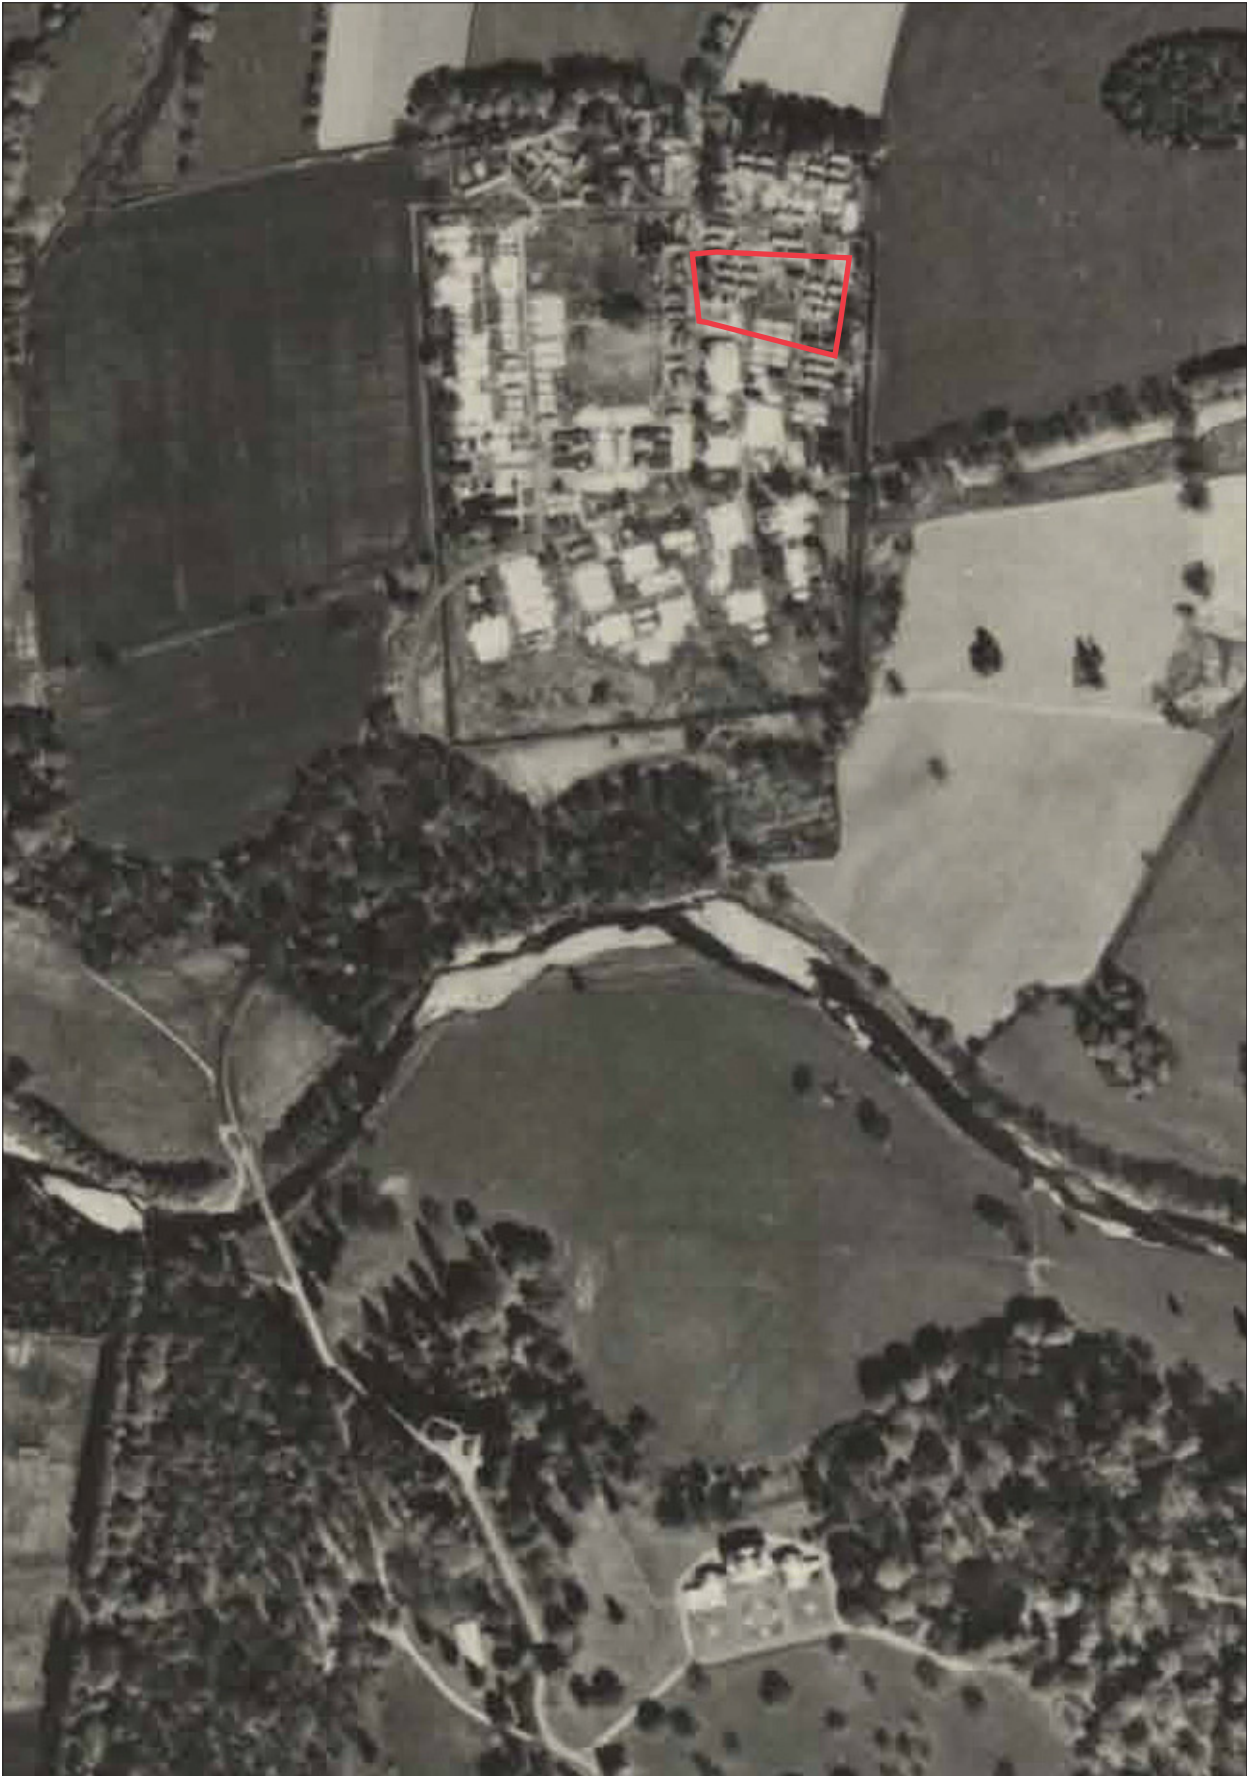
- 4.1 A review of desk-based sources undertaken in advance of the trenching revealed several known cultural heritage sites within the proposed development area. Prisoner of War Camp 22, known as Temple (NMRS: NS52SW 112; SMR: 46881), covers the whole extent of the proposed development area. It was identified on vertical air photographs (RAF 106G/UK/571, 3135-37, flown 1945), which showed a double fence-line enclosing the southern section of the camp. Immediately to the north are what may be the accommodation units for the camp guards. The sewage treatment plant, still depicted on the latest edition of the OS 1:10560 scale map (1968), to the south of the camp lies at NS 5415 2091. Examination of the air photographs reveals well over 100 huts within the compound, several of which have 'formal gardens' to the rear. In the central area of the camp is a group of larger huts, presumably the mess, kitchen and recreation buildings. The camp was still extant in November 1945, as it is still visible on a later sortie of vertical air photographs (RAF 106G/UK986, 3297-8, flown 1945). By 1951, however, the camp had been almost totally demolished, with only a few huts surviving at the north end (Ordnance Survey, Air Photo Mosaics, 1: 10,560, Ayrshire NS52SW, flown 1950) (Figure 2).

*Figure 2:  
1950's aerial photograph of  
POW camp.*

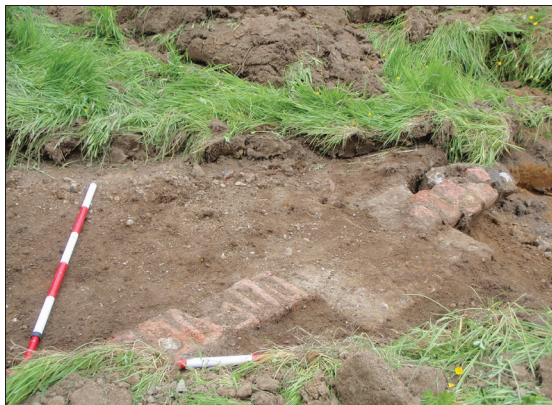
Plate 1: Brickwall and concrete on T2.

7.3 Two brick walls 2003 and 2004 were encountered in Trench 2. Both of them were made of bonded bricks two courses (c. 0.22-0.23 m) wide and orientated north-east/south-west. Wall 2004 was centred and overlaying a concrete block (2005). This rectangular platform measuring 0.85 by 0.6 m seemed to be a possible doorway step (Plate 1).

- 8.3 Most of the trenches showed the remains of concrete foundations with some of the surviving brick walls. They were similarly constructed and probably part of the structural walls of the camp huts. In trenches 6 and 10, more substantial remains of these buildings, comprising the bonded brick corners, were recorded. Within Trench 2 was also recorded a possible doorway step. A possible internal partition wall and concrete floors were exposed in Trench 11.

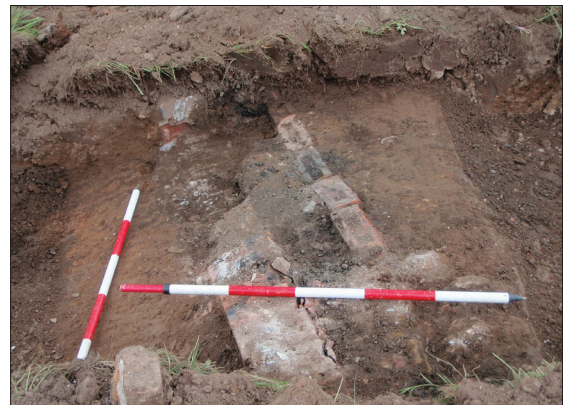
Plate 2: Post-ex of wall 5005.

- 7.5 Trench 5 revealed two other brick walls (5004) and (5005) running east/west. Wall 5004 was three brick courses in height (0.3 m) by a single brick width (0.45 m) across the top of a concrete block foundation. Wall 5005 on the other hand was made of two brick walls with a central hollow. One of the walls had the bricks arranged horizontally while the other north-west wall had been constructed by vertically arranged bricks and overlaid a concrete foundation (Plate 2).

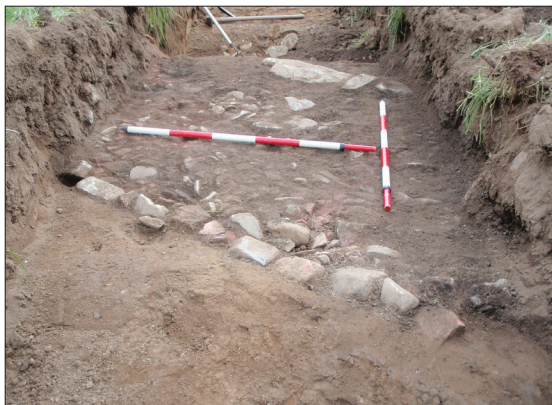
- 7.7 Several structures were found in Trench 7, comprising two brick walls located on the south-west corner (7004) and (7005) and a footpath made of rough cobbled stones (7006) (Plate 3). Wall 7004 was two courses wide and deep constructed by vertically arranged bricks and orientated north/south. Wall 7005 was built using brick and red sandstone, bonding was not apparent, and it measured 0.2 m height by 0.29 m width. It ran north/south although at the east section a possible corner was seen turning towards wall 7004. Grey sandy silt mixed with different cobbles and some brick fragments (7006) measuring 1.65 m width and 0.08-0.1 m deep was discovered at centre of the trench. It was flanked by drystone rectangular walls (7007) and (7008). Wall 7008, which seemed to be a kerb, was truncated by a field drain at its south-south-west/north-north-east side at the south side. A linear stone structure bonded by mortar (7009) was revealed underneath wall 7008. It had some rounded shaped mortar on top of it, suggesting a possible drain print.

Plate 3: Post-ex of brick-stone surface.

- 8.4 Other structures observed and recorded include the cobbled footpath in Trench 7 and possible concrete paths in Trenches 1 and 12.

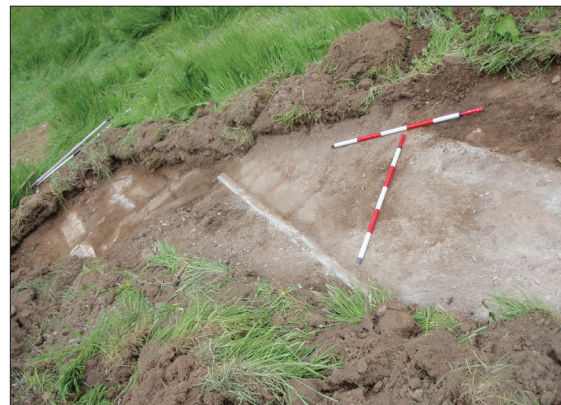
Plate 4: Post-ex detail of 11007 and other features in T11.

- 7.9 There were several remains of structures in Trench 11. Two concrete floors (11004 & 11006) with a smooth finish and 0.05 m thick were recorded with a line of bricks arranged mostly in a horizontal pattern and arranged across the top of a concrete foundation through the centre

(11005). An additional brick line (11008), a possible foundation, was exposed underneath 11004, at its north side. Further south-east another concrete floor was found (11007). It measured 1.15 m wide and 0.15 m deep and it presented a concrete kerb measuring 0.07 m in width and height at its east side (Plate 4). It had two rectangular shaped concrete slabs at either side of it: 11009 and 11010. Both of them were made of a much smoother concrete than the concrete used in 11007. 11009 measured 0.93 m in length by 0.38 m in width and 0.04 m in depth while 11010 was 1.25 m wide and 0.04 m thick. Another concrete floor (11011) was recorded south of 11010. It was made of a rougher material similar to the one used in 11007 and it was 0.08 m thick. Finally a brick wall running south-south-east/north-north-west was visible at the south-east corner of the trench. Bonded by sandy mortar and laying on top of a concrete foundation it was 0.48 m height by 0.22 m width.

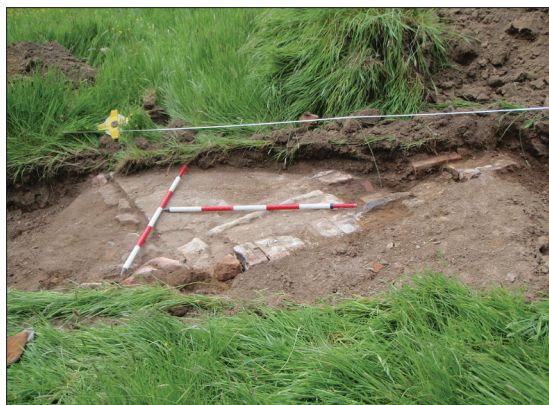
- 7.10 In Trench 12 a brick wall orientated east-south-east/west-north-west was observed at its south-west corner (12003). Constructed in bricks bounded by sandy mortar it laid on top of a concrete foundation. It was five courses height (0.55 m) by 0.2 m wide, with the bricks arranged vertically. Another brick wall, 12004, orientated north-north-west/south-south-east was observed south of 12003. It measured four courses in height (0.4 m) and 0.22 in width and it had a metal pipe running alongside of it. Adjoining this wall a rough rectangular concrete slab (12005) measuring one metre in width was located (Plate 5). It showed a rectangular shaped mortar on its east top surface, as if something which was bonded by mortar had left its imprint before it was demolished. It was limited by stones at its south and north side. On the south, the line of a roughly rectangular shaped drystone wall (12007) 0.1 m wide was located. On the north side, a rose sand stone drystone wall (12006) was recorded. It seemed to be disturbed at its north-east side possibly by the demolition process. Finally a possible drystone wall (12008) made of roughly rectangular rose sandstones lying on subsoil was observed north of 12005.

*Plate 5: Post-ex of 12004 and other features in T12.*
