**The Meadowhead and Stevenson Catchment -
Kilmarnock to Irvine storm relief sewer:
Archaeological Watching Brief on Areas 6.1, 6.2 & 6.3
Project 3635**

On behalf of: MBV joint venture

Project Number: 3635

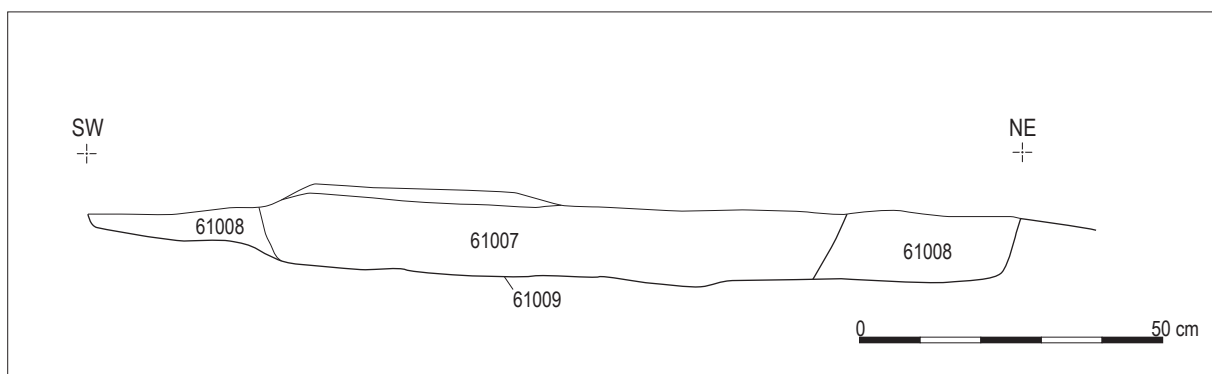
Figure 3: South facing section of pit 61009.

- 7.2 At the western end of Holmes Road, in the field adjacent to the North lodge for Caprington Castle, three negative-cut pits were uncovered. Excavation of a shallow sub-circular pit 61009 (2.05m by 1.56m by 0.12m) revealed that the main fill, clay deposit 61008, which contained pieces of coal and charcoal, lined the edges of the pit, while interior silt deposit 61007 contained fragments of partially burnt bone. The presence of charcoal and burnt bone, taken in conjunction with the discolouration often associated with *in-situ* burning noted at the base of the pit, suggests that this may have been a fire pit. Circular pit 61010 (0.86m by 0.85m by 0.16m), which was filled with orange silt, contained no material which might suggest its function. Oval pit 61013 (1.11m by 0.83m by 0.2m) contained a compact fill of red clay mixed with orange silt (61012). No artefacts were recovered from the fill or evidence that might suggest its function.

- 8.1 The 1st Edition Ordnance Survey map of 1860 records only wells and a road or track crossing the River Irvine in the vicinity of pits 61009, 61010 and 61013. No datable artefacts were retrieved from any of these pits, although datable botanical evidence may be recovered through analysis of their fills although the presence of coal may indicate that the deposits are relatively recent. No other archaeological remains were found in this area.

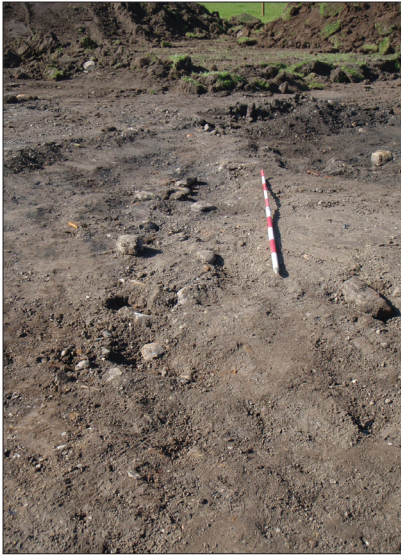
Plate 1: Robbed-out walls 017 from SE.

- 7.6 Two robbed-out drystone walls and a cundy drain were revealed in the field to the south of Rose Cottage. The walls (context 017) were found to be in a poor state of preservation and, as they are not noted on the 1st Edition Ordnance Survey map, are believed to be of relatively modern date. The cundy drain (context 019) was 4 m long, 0.49 m wide and 0.16 m deep, had sandstone walls and had a sandstone capping. The drain lay below a spread of coal debris, which also comprised the drain fill. A second drain 020 lay at the northern end of the cundy drain, and was filled with the same coal debris.

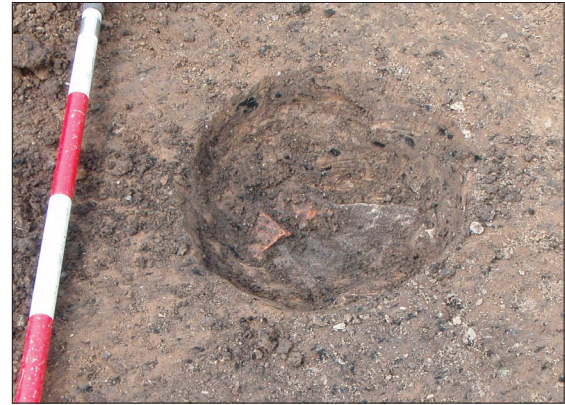
Plate 2: Mid-excavation view of posthole 026.

- 7.7 Two possible postholes were uncovered in the field between Old Rome cottage and the River Irvine. Postholes 026 (0.45m in diameter and 0.21m deep) and 027 (0.42m in diameter and 0.14m deep) were filled with black silt 024, similar to the overlaying topsoil, that contained frequent pieces of coal along with 19th or 20th century ceramics. The lower fill of posthole 026 contained fragments of bricks and concrete 025. Also within this field was possible drainage ditch 028 that was over 9 m long and filled with coal-rich orange clay.

- 8.2 The 1st Edition Ordnance Survey map of 1860 denotes an old coal pit to the south-west of Old Rome farm. The fills of postholes 026 and 027 found in this location were rich in coal fragments, suggesting that they may be related to the nearby coal pit, and the presence of concrete building material and 19th or 20th century ceramics within the fill indicates that these are of relatively modern date. The abundance of coal within the fill of ditch 028 also suggests an association with the coal pit, and indicates a relatively modern date for this feature.

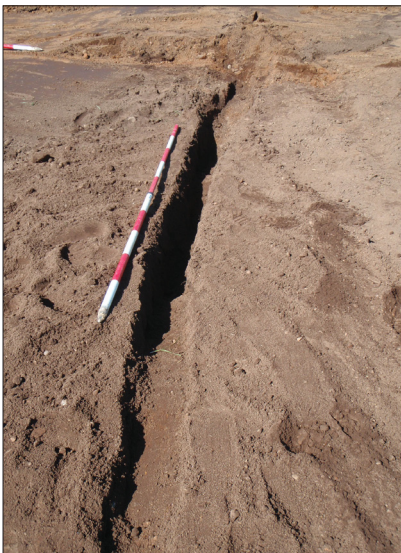
Plate 3: Slot through cultivation rig 004.

- 7.9 An area of rig & furrow cultivation was noted in the fields between Dundonald Burn and Oldhall Roundabout. Two small circular pits visible in the topsoil were cut into the rig. Pit 042 (fill 043) was 0.56m in diameter and 0.11m deep, while pit 044 (fill 045) was 0.55m by 0.36m and 0.03m deep. Both pits were filled with black silt that contained frequent inclusions of coal and small pebbles.

- 8.5 The rig & furrow cultivation method, remains of which were found at Harperland and to the east of Oldhall Roundabout, was used in the Medieval and post-Medieval periods. It involved digging channels (furrows) and piling spoil between the furrows to create raised strips (rigs) on which crops were grown. Roy's map depicts the fields to the east and north-east of Meadowhead Farm and those surrounding Harperlands as rig & furrow, indicating that the cultivation method was in use in the mid-eighteenth century. However, no datable evidence was recovered from either of these areas of rig & furrow.
