## Happendon to Carluke Water Mains Rehabilitation Data Structure Report Project 3696

## **Happendon to Carluke Water Mains Rehabilitation Data Structure Report**

**On behalf of:** Scottish Water

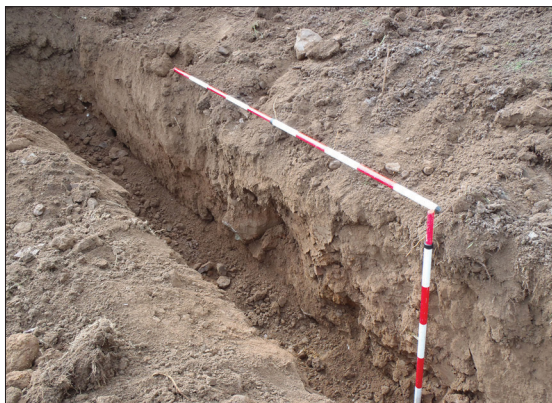
- 7.3 At the extreme south of the northern field is a field bank where ground surface is about 0.4 m higher than that to the immediate north. As this is at about the location of the Roman Road, as mapped on the Royal Commission on the Ancient and Historic Monuments (RCAHMS) on-line database, excavations were monitored extremely closely. None of the characteristic indications of a Roman Road were noted in this area, although boulders were found at a depth of about 0.9 m.

Plate 1: East facing section of pipe trench at field bank.

- 8.1 The boulders deep in the subsoil at the supposed location of the Peebles - Castledyke - Loudon Hill - Irvine Roman Road are most likely to be natural. There was no structure to these stones, and none of the features that help define Roman Roads (drainage cuts, metalled surface and camber) were present. In addition, this location is about midway down a fairly steep ridge, which seems an unusual location for a Roman Road, especially when the summit of the ridge is only about 80 m to the south.

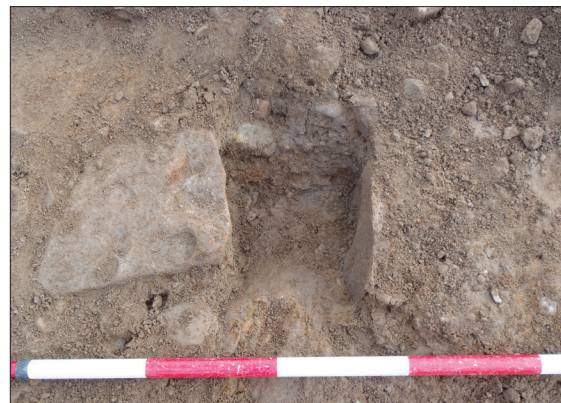
- 7.4 A spread of stones was uncovered at the northern end of the southern field, close to the field boundary. On investigation, this was found to be a stone lined and capped drain (Context 004) running approximately east to west.

Plate 2: Post-excavation view of stone field drain.

- 8.4 The watching brief identified a stone field drain relating to the use of the site during the post-medieval period. This feature was constructed in part using flattish capping stones that were unlike the rounded cobbles and boulders seen elsewhere on the Site.

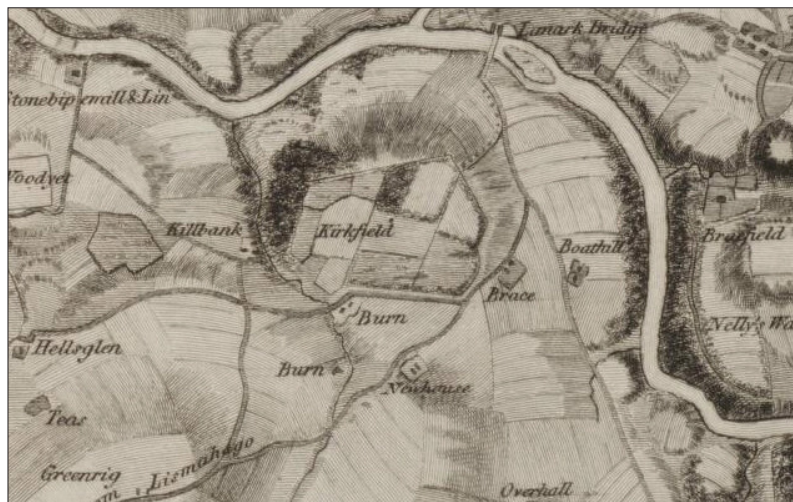
Figure 2

- 8.3 A second possibility is that the road was indeed located in the area of the watching brief, but its remains have been destroyed by agricultural activity. A brief observation in the 1834-45 account of the parish, which could be viewed as confirmation of this interpretation, states that “an old roman road which passed through a corner of the parish, has been obliterated by the plough” (Hamilton and Wilson 1834-45, 33). No date is given for the destruction of the Roman road, but it is worth noting that Roy’s late eighteenth century map of Roman remains in the vicinity of Lanark, which includes the Site, does not record any road at this location, suggesting that the road may have been destroyed before 1793 (Figure 2).
