**Gartmore Village Hall  
Data Structure Report  
Project 3569**

## **Gartmore Village Hall**

### **Data Structure Report**

**Project Number:** 3569

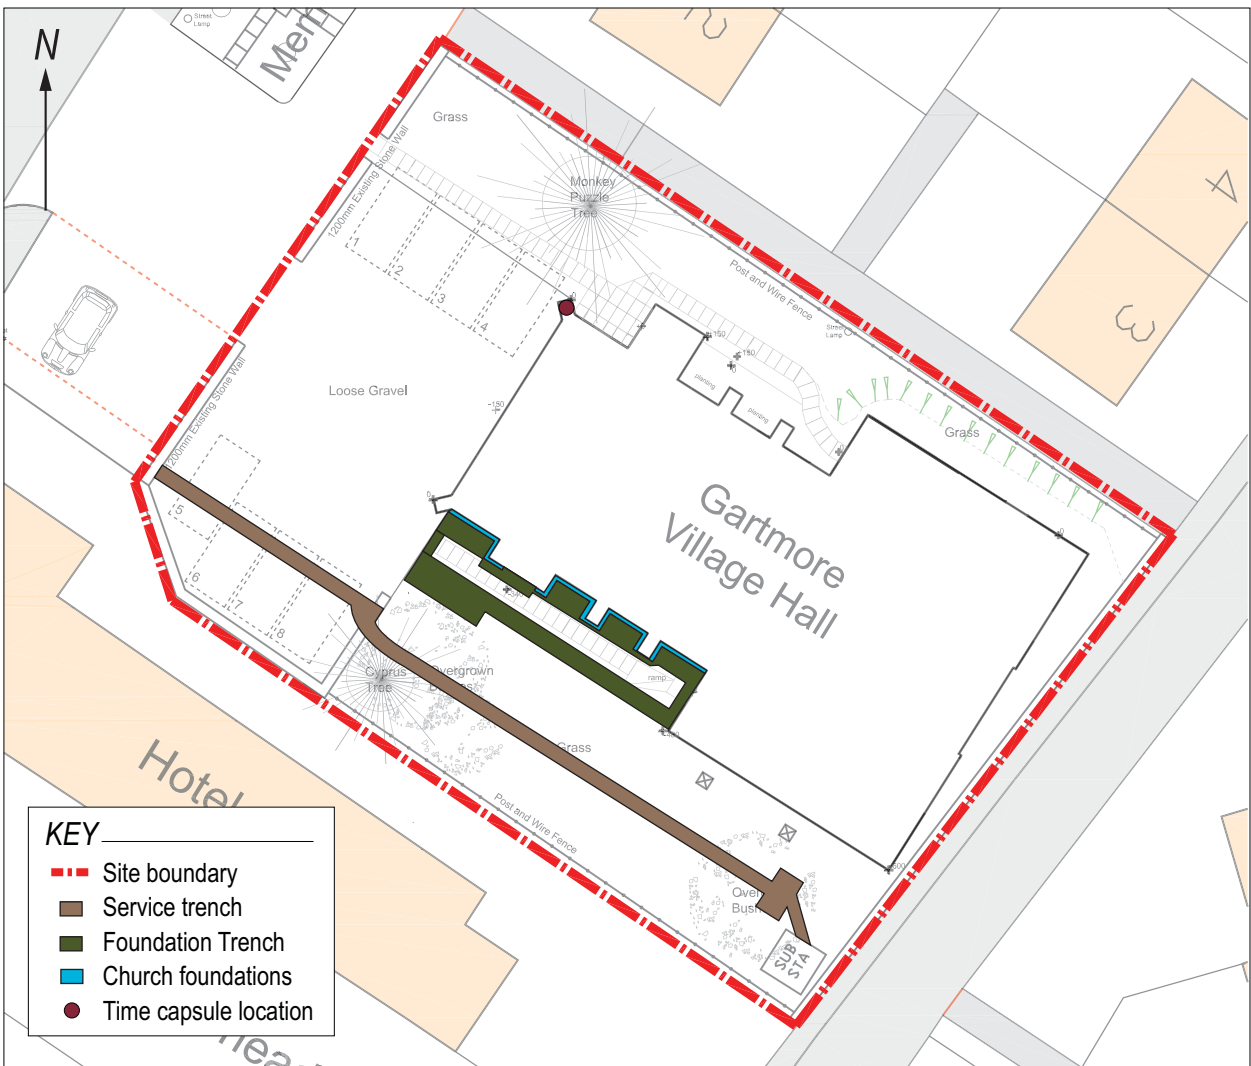
Figure 1:  
Site location.

- 3.1 The development site lies on the south side of Gartmore Village Hall, within the boundary wall of this former Free Church (NGR: NS 5225 9719; Figure 1).
- 3.2 The site is bounded by the Main Street to the west, a lane to the south and housing to the north and east. The south side of the village hall is fairly flat and may have been landscaped; the south-west of the site had previously been used for car parking.
- 3.3 The bedrock at this location is Cromlix Mudstone Formation, a sedimentary bedrock found in association with ancient rivers; the drift geology has not been recorded. ([www.bgs.ac.uk](http://www.bgs.ac.uk)).

6.1 The watching brief methodology was agreed in advance of fieldwork (see Appendix E). The watching brief comprised the monitoring of service and foundation trenches (Figure 1), in order to evaluate the underlying deposits for their archaeological potential and ensure that significant archaeological remains were recorded. The made ground that composed the top surface was stripped using a mechanical excavator, fitted with a flat-bladed ditching bucket, under close archaeological supervision. It was removed in spits to the required depth of the foundations and water service trench. Exposed surfaces were recorded by written description, measured drawings and by digital photography.

- 7.7 However, a time capsule was recovered by the contractor from the basal stone of the front left buttress (Figure 1) which was removed from the church building early in 2013. The time capsule consisted of a glass bottle with a degraded cork stopper set into a rectangular cavity in the buttress foundation stone. The contents included two coins, a William IV 'four pence (groat)' dated 1836 and a Victorian 'sixpence' dated 1844 (Plate 3), both roughly contemporary with the construction of the church in 1847. The contents also included a piece of paper with writing (Plate 4), though very few words were discernible and the paper is in a poor state of preservation. The time capsule and contents at the time of writing are in the care of Eleanor Hamilton of Gartmore Community Trust Ltd.

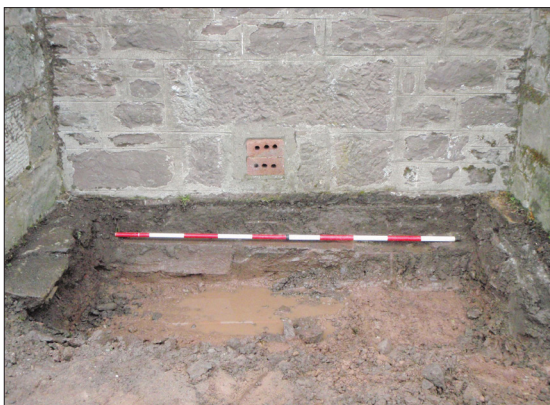
Plate 1: Church foundations.

7.3 The stone foundations of the former church were exposed along the southern side of the building (Plate 1). The foundations were found to be 0.3 to 0.35 m deep and to jut out from the base of the walls by about 0.1 m. Made ground (Context 003) was found throughout the site, and overlay subsoil 006.

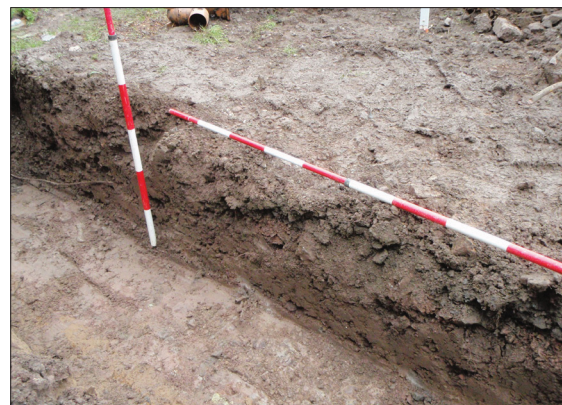
Plate 2: Section of foundation trench showing made ground deposits.

- 7.4 The foundation trench largely followed an existing service trench where the fills were made ground 003 and a deposit of sand that had surrounded electricity cables (Plate 2).
