**Dalmusternock Farm, Fenwick
Data Structure Report
Project 3735**

Dalmusternock Farm, Fenwick
Data Structure Report

On behalf of: Hope Homes

Project Number: 3735

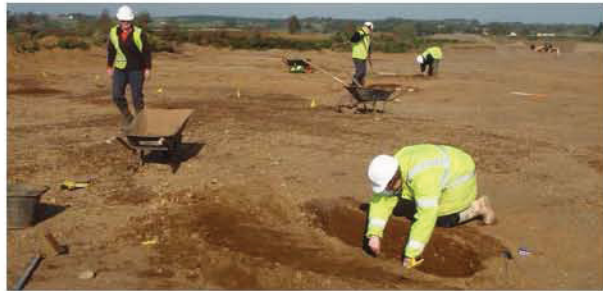
Plate 1: Foundation trench.

7.1 The area to the immediate east of the steading where the foundations of the new house were being constructed was initially cleaned of vegetation to expose a mid-brown sand silt deposit 001 which contained modern detritus including stone and brick fragments. It ranged in depth between 300–600 mm. Six foundation trenches (1-6) were excavated three along the eastern wall of the steading and the other three positioned on the edge of the slope towards the water course. They ranged in size between 1.2–5 m in length, 2 - 2.4 m in width and a depth between 0.90 - 1.7 m. The topsoil 001 overlay a weathered sandstone bedrock deposit of 600 mm – 1.0 m in depth which fractured easily during machining. Below was found a firm sandstone bedrock (rock head) 003 (plate 1). A further linear foundation trench was excavated parallel to the steading and positioned 1.8 m from its eastern wall. It measured 19 m in length and 600 mm in width and ranged in depth between 300–600 mm. The overlying deposit of this trench was topsoil deposit 001 with an orange/brown sand gravel deposit with occasional cobbles 004 exposed below. This deposit was found in the southern half of the site only. No archaeological deposits or structures were found in this area (plate 2).

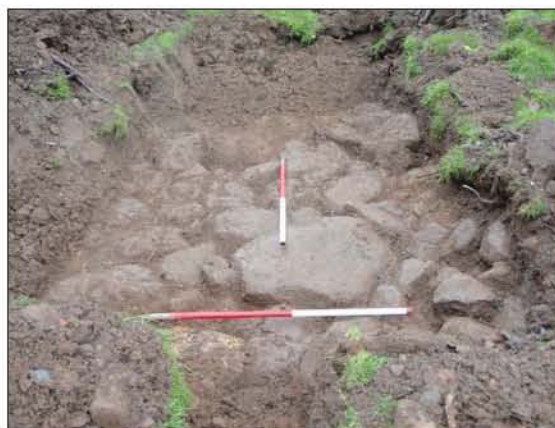
Plate 3: Cobble and boulder spread at proposed septic tank site.

7.2 A linear service trench was also excavated from the south-west corner of the present steading building. It measured 26 m in length and 600 mm in width. It consisted of a topsoil deposit consisting of mid-brown silt 005. It measured 400 mm in depth and was located above natural light brown sand silt 007 which appeared very disturbed at several locations and contained several cobble sized stones. It was intercut with four service trenches, containing one salt ash ceramic drain, two plastic drains and one unused cable, which were positioned perpendicular to the trench. The septic tank which was positioned at the southern end of this trench and located on the front lawn of the farmhouse building and measured 2 x 3.5 m and was rectangular in shape. The topsoil was similar to 005 and measured 300 mm in depth. Below was found a spread of sub-rounded cobbles and boulders 006 which formed a fairly flat surface (plate 3). The spread appeared to be orientated NE/SW across the trench and measured 3 m in width and only one

stone course in depth. It was found above the natural brown silt deposit 007. Tree roots had infiltrated the natural subsoil and the stone spread. According to the farmhouse owners the tree had been cut down at least five years ago. In between the stones were found two sherds of modern glass and one small body sherd of late nineteenth century white earthenware with a sponge pattern ware (Bob Will pers comm).

- 8.1 The archaeological watching brief at Dalmusternock Farm encountered no finds or features of archaeological significance. The stone spread, of unknown use, at the septic tank location is

presumed to be of modern date due to the associated finds. During excavation work elsewhere on site a number of large cobbles and boulders were excavated from the natural subsoil deposits, which could suggest that the make-up of the stone spread is derived from locally sourced material. This could suggest that the stone spread is clearance material which was later flattened during the landscaping of the front garden area or that it could represent a possible hard standing associated with the farm buildings.

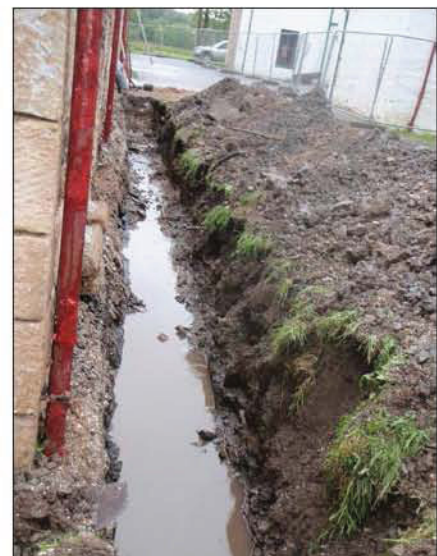
Plate 4: Drainage trench to west of steading.

- 7.3 A further service trench was excavated parallel to the western elevation of the steading at its north-west end and across the waste ground to its north. It measured 46 m in length, 600 mm in width and ranged in depth from 600 – 1 m in depth. Most of the overburden 008 removed was very disturbed containing initially a tar surface with a mid brown silt below containing a large amount of stone, brick, broken tile drains and other building detritus. It measured between 500 mm 800 mm in depth. Below was found a natural mid-brown silt clay deposit 009. No archaeological finds or features were observed (plate 4).
