**Robroyston, Glasgow City Council  
Data Structure Report  
Project 3528**

## **Robroyston, Glasgow City Council**

### **Data Structure Report**

**Project Number:** 3528

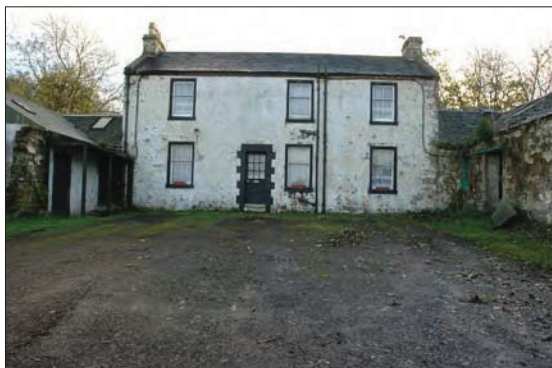
Plate 1: Auchinleck farmhouse north elevation.

7.2.3 The north elevation (Plate 1) has one doorway with two stone steps and six windows with block stone lintels. Windows have wooden sash frames, and are possibly original. Cast iron piping is present at the east side and towards the centre at the west. To the west, the walls continue into what becomes the eastern side of the stables building, and although the stonework is continuous showing that these are of contemporary construction, this is marked with slightly raised stonework at the extent of the farmhouse building. To the east a quoin in the stonework marks the extent of the farmhouse, although slightly inset stonework continues to the northern entrance to the outbuilding, suggesting that this was also of contemporary construction.

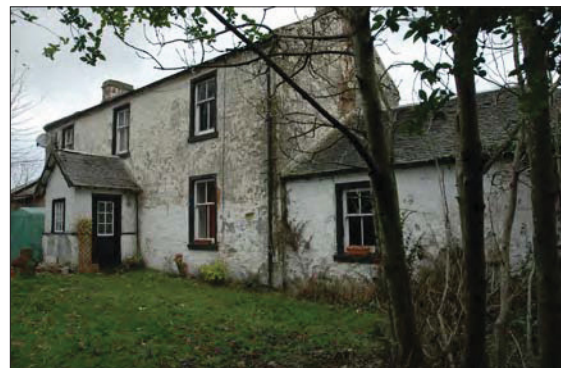
Plate 2: Auchinleck farmhouse south elevation.

7.2.4 The south elevation (Plate 2) has five windows with block stone surrounds and wooden sash window frames. A brick and wood porch has been added at the entrance on this side, likely a later addition; this has a sloping ridged slate roof, with the slates arranged in a decorative manner to either side, and the doorway is located on the east side, with a window to the south

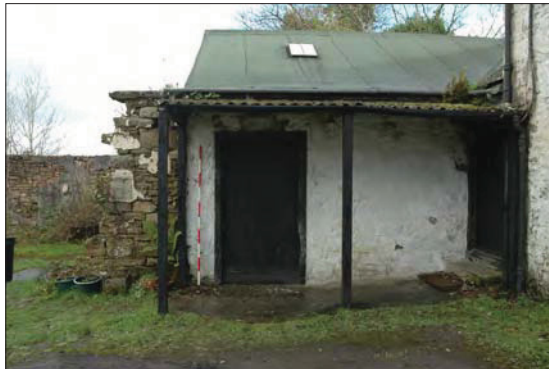
*Plate 3: Eastern outbuilding west elevation.*

7.2.9 The western elevation (Plate 3) shows similar stonework to the house and south elevation, indicating that it is likely that the structure was originally constructed extending to the north. The roof over this section is also of a sloping ridge construction, however is missing the original slate-work being covered only with asphaltic sheeting. The western elevation clearly shows modification of the building, as the original wall has been partially demolished to the north ending in rough brickwork, and it is possible that the slatework was removed during these later extensions; it is unclear how far this wall originally extended. A later skylight is visible in the roof here. A wooden framed lean-to structure with corrugated iron roof had been added to the western elevation, creating a sheltered porch structure over the doorway in the northern corner.

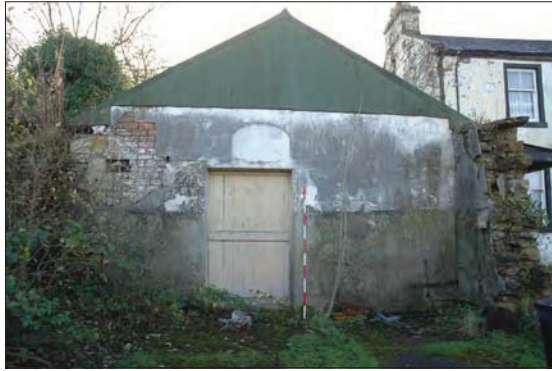
Plate 4: Eastern outbuilding north elevation.

7.2.10 The existing northern elevation (Plate 4) of the outbuilding has been heavily modified and is a later addition to the original structure, replacing the original northern wall. It appears to be of brick construction, although is mostly cement rendered. A doorway has been incorporated into the wall, and fading in the cement work indicates that a sign was likely screwed over this at some point. At the east side sandstone blocking marks the extent of the original structure, although this seems unlikely to be part of the original wall as the stone work is different from that to the west, and has possibly been added for support when modifications were made (Plate 5). Extending slightly beyond this to the east is a small section of the same walling described below extending at the side of the courtyard to the north; this small section expands this later extension to the original building slightly out to the east. It appears as if the brickwork has been completed as a later blocking off of this first extension, in effect creating an internal wall between the original outbuilding and the later extension.

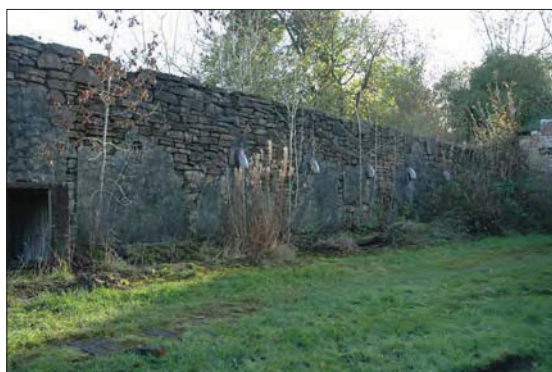
Plate 6: West elevation of extension wall remains.

7.2.11 At the northern end of the original outbuilding structure, a wall of bonded stonework extends towards the north; this seems likely a later nineteenth or early twentieth century addition, which would have been the eastern wall of a barn extension. It incorporates eight ventilation shafts along its extent, visible as grates on the east elevation and as ceramic pipe ends on the west 'internal' elevation, which appear to be later additions. The western 'internal' elevation (Plate 6) is cement rendered; the pattern of wear in the cement suggests that internal partitions were added to this wall possibly at the same time as the ventilation shafts, creating storage or livestock stalls around the ceramic ventilation pipe ends. The corner and return of the wall are still partially upstanding at the northern end, showing the extent of the structure. It would appear then that this structure has been added as an extension to the original outbuilding, and likely later internally modified to update the conditions for storage or livestock with the addition of ventilation and stalls (a similar arrangement can be seen in one of the more modern outbuildings to the west of the farmstead.).

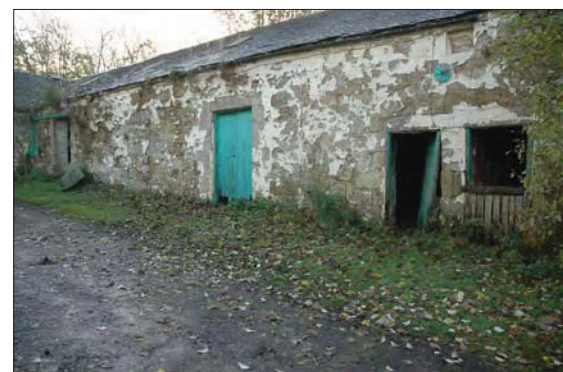
Plate 7: Stables east elevation.

7.2.15 Only the southern and eastern exterior elevations of the stables buildings were accessible, with later collapsing corrugated iron lean-to structures present at the north and west sides. However modifications are clearly visible in the eastern elevation. There are four existing doorways here, one leading to each room, and a window at the south and north ends (Plate 7). The windows have wooden sash frames and block stone lintels; the window at the north end leading into Room 1 was originally a doorway which has been blocked with similar block sandstone work to

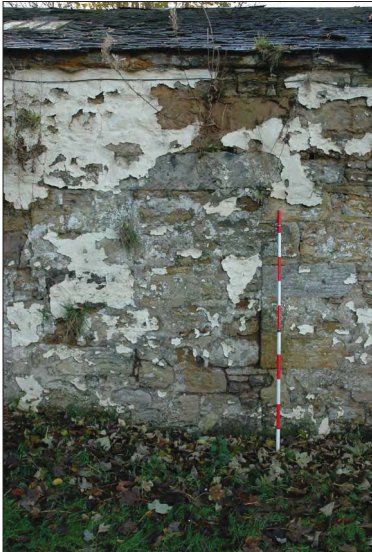
Plate 8: Blocked entrance in Stables east elevation.

form a window. In addition, there is a completely blocked entrance in the stonework at Room 2, also done in block sandstone (Plate 8); it is possible that this modification was carried out at the same time as the addition of the extension which forms Rooms 3 and 4. This extension is visible in the stonework where the quoin work can be seen at the corner of the original building (Plate 9); the extension appears to have been added as a completely separate wall, in effect built against the original structure, though bonded together (this is also visible internally). A modified cart arch entrance is visible in this extension, which has been blocked off with sandstone blocking and converted into two doorways leading to Rooms 3 and 4 (Plate 10), indicating that these were originally a single room internally. There is an inset in the stonework located centrally above this arch which may have contained a plaque or additional stonework.

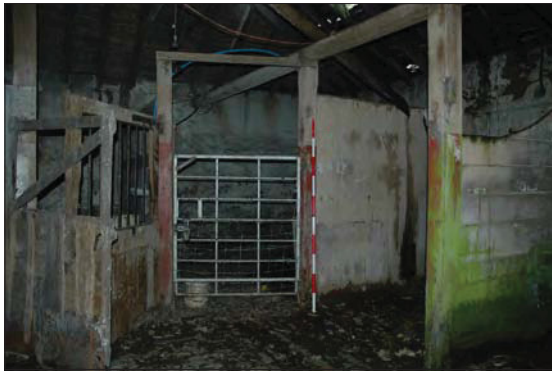
Plate 11: Room 1 interior stalls.

7.2.18 Room 1 appears to have served as stables most recently, and has wooden partitions dividing the room into five stalls and one smaller compartment (Plate 11); these look likely twentieth century in date, and may replace older partitions. The original floor is cobbled, with a drainage channel incorporated along the centre (Plate 12). The walls are lime plastered, although the plaster is discoloured and in a bad state of repair. There is an internal doorway in the northern wall leading to Room 2, with a stone block surround and wooden lintel. Both the exterior window and entrance in the east wall have a wooden lintel. The slate roof is supported by a system of wooden beams and wood panelling and incorporates two later windows, however the roofing is in a state of partial collapse over this room at the northern end. Various modern pipes and cables are visible, particularly along the eastern wall.

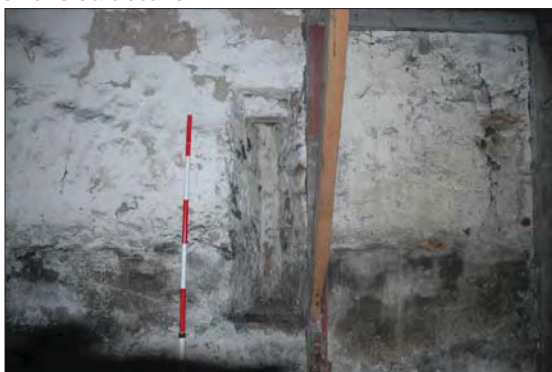
Plate 13: Detail of blocked window slit.

7.2.19 The walls in Room 2 have been partially cement rendered at the lower level, but the lime plastered exposed stonework is still visible further up. The floor has been cemented over so that the original flooring is no longer visible, although there is an original stone step exposed at the doorway in the south wall shared with Room 1. As in Room 1 the slate work of the roof is supported by a system of wooden beams, but is in a better state of repair. The room seems to have been recently used for storage and as a workshop, with a modern metal partition at the north end. There are external doorways in the western and eastern wall, both of which have wooden lintels. The northern wall shows evidence of the buildings extension, with two window slits present (Plate 13) both of which have been subsequently blocked by the addition of the extension forming Rooms 3 and 4, which has been constructed abutting the original building. These are narrow, and may originally have been for the purpose of ventilation. A wooden staircase has been added at the northern wall, leading to an upper doorway which leads to an upper level stretching over Rooms 3 and 4 (Plate 14) access to this was judged unsafe and subsequently the upper space was not surveyed; it is possible that this was modified at the same time the cart entrance was blocked and two separate rooms created in the extended part of the structure.

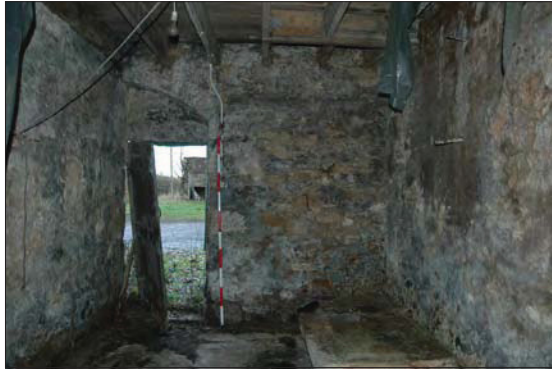
Plate 15: Room 3 interior.

7.2.20 Rooms 3 and 4 are smaller internally and both have cement-rendered floors and walls (Plates 15); this may have been modified at the time of conversion of this part of the structure. The ceilings are wooden boards, which presumably form the flooring of the space above. Both rooms have evidence of modern electric cables and lighting, no longer in use. The internal wall which divides the rooms is inset slightly into Room 3 at the west side, creating a slight alcove in Room 4, possibly to contain the feeding trough this currently holds. Only Room 3 was accessible internally. The blocked off cart arch was visible as an inset above the existing doorway, and above this the wooden beams forming the ceiling appear to be set into the original splayed stonework around the cart entrance (Plate 16), suggesting that the upper space is likely to have been created during the later modifications, rather than as an original feature. The walls of Room 4 were painted red internally, although this was largely flaking off, and the room looked as if it formerly housed livestock as there was straw on the floor and a feeding trough.

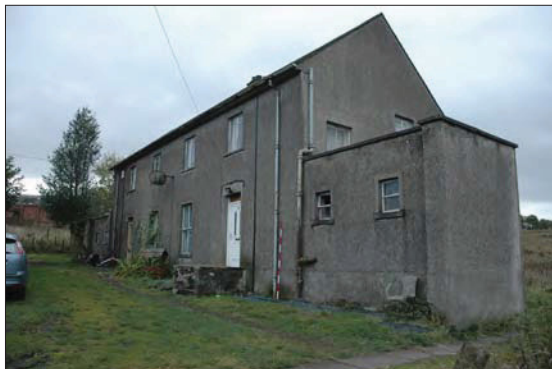
Plate 17: Auchinleck cottages east elevation.

- 7.5 On the eastern elevation of the building each cottage has a doorway, a single ground floor window, two upper floor windows and two small windows in each extension (Plate 17). The windows have thin stone surrounds and wooden frames, possibly original. On the western elevation each cottage has three windows at the ground and upper floor, and three wooden doorways entering each extension. At the southern and northern elevations (Plate 18) there are a doorway and two windows on the lower level, a window at a mid level, presumably for an internal staircase, and a window at the upper level.
- 7.6 No major modifications to the cottages are apparent and they are generally in a good state of repair, with only some wear on rendering and some discolouration around piping.

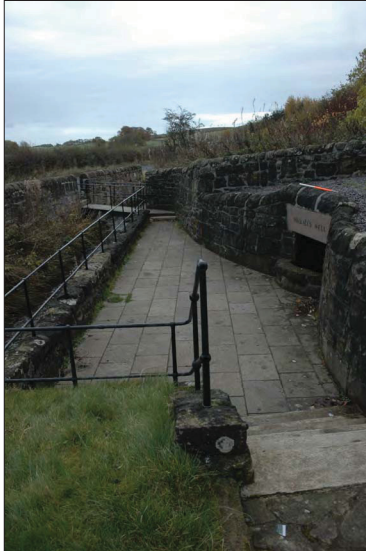
Plate 19: Wallace's Well setting.

- 7.7 The existing monument, said to have been used by William Wallace whilst hiding in the area, is located at the very north-east extent of the area proposed for development at the end of Robroyston Road, set back from the road within a purpose-built setting of a curvilinear bonded stone wall edging a turfed bank which continues upslope behind. Signage at the site of the monument indicates that the well has been set in this current form since the early twentieth century. A pathway and steps run from the road at either side to form a modern paved viewing area next to the burn (Plate 19).

- 9.5 In addition to the above, it should be noted that although the site of Wallace's Well and its setting lie on the boundary of the development area, care should be taken during any construction works within the vicinity not to damage the structure.

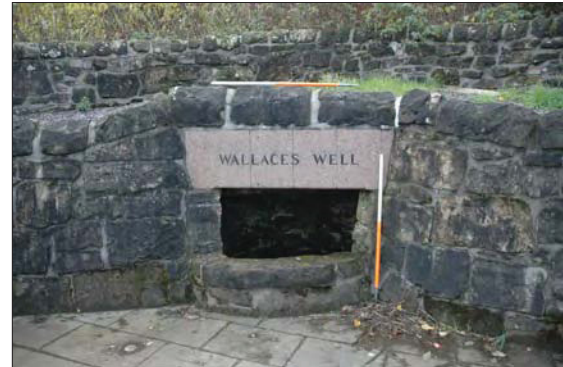
Plate 20: Wallace's Well.

- 7.8 The well itself is set into a lower bonded stone wall of around five to six courses of stonework, so that only part of the curvature protrudes out (Plate 20). The original well wall is only two courses of stonework high, around 0.40 m in height, and the wall appears to have been constructed around it. The stonework appears to have been relatively recently re-rendered, and is in fairly good condition, although there is some moss growing on the upper well ledge and some graffiti has been carved into the stonework along the lower wall. Internally the well appears to have been built-up within the lower wall and bank creating a rounded cavity.

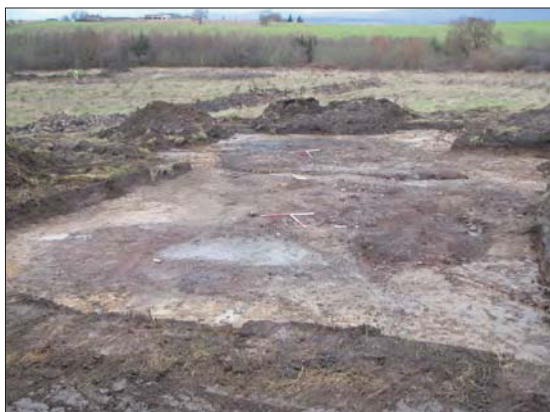
Plate 21: Structural feature (154004-017) in Trench 154.

7.15.1 Stripping and subsequent expansion of an area around Trench 154 revealed what appeared to be the disturbed foundation and demolition remains of a structure (154004-154017), measuring 17 m in length by 7 m in width and 0.29 m in maximum depth (Plate 21). This was irregular in shape, although appeared to form a sub-angular 'C' shape, and was orientated north-west/south-east. The 'interior' of the structure comprised of various deposits of sandy gravelly shale, debris and rubble like material, which may represent foundations or collapse material, and generally contained occasional to frequent fragments of brick and stone (154005-007, 154011, 154017).

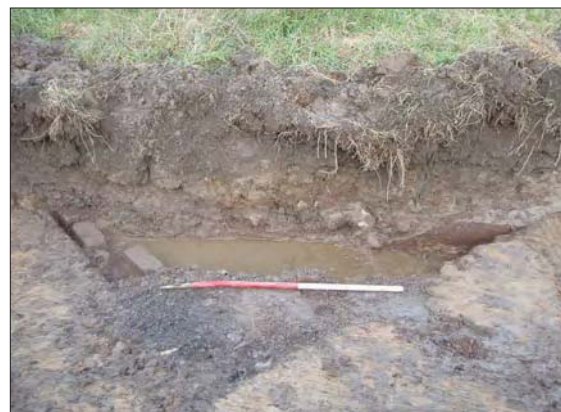
Plate 22: South facing section of slot through feature showing possibly wall (154008-010) at west extent.

7.15.2 A slot was taken through the centre of the feature, revealing the remains of a possible brick wall (Plate 22) at the west side of the feature (154008-154010), which appeared to survive for at least two courses and was approximately 2.2 m in length, although became more disturbed beyond this point. The bricks (154008) were arranged lengthways; no bonding was apparent, but this may have degraded as the surrounding clay was very waterlogged. A loose rubble-like material (154010) filled the wall slot (154009) around the bricks, which appeared to consist of re-used crushed industrial material. Another possible area of walling (Plate 23) was revealed at the east side of the feature (154011, 154013), although this was more disturbed and consisted of a deposit of rubble material with frequent brick fragments, rather than more clearly arranged bricks. A curvilinear band of dark ash and shale material (154012) stretched around 5.8 m in length cutting into the structure (Plate 24); a small slot revealed this to be only around 40 mm in depth by 0.25 m width. This feature may be the remains of a drainage channel for the structure.

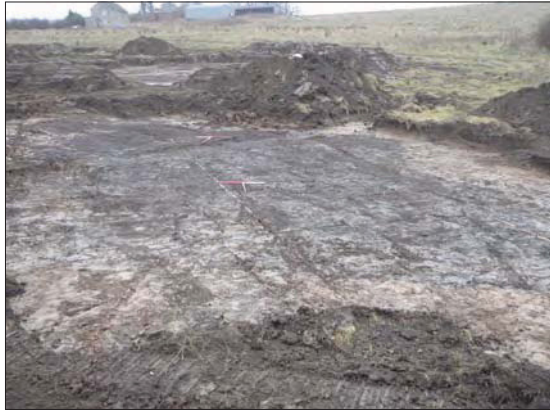
Plate 25: Pit feature (157005) from the north-west.

7.16.1 Stripping in trench 157 revealed a large pit feature (157004-005, 157010-013); an area around this was expanded to reveal the feature to be of an irregular sub-angular shape, and around 14.2 m in length by 13.05 m in width, with an apparent 'offshoot' to the east side (Plate 25). An initial hand dug slot into the main pit to a depth of 0.45 m revealed an upper deposit of dark gray-black degraded stone and shale like material (157004), above a deposit of rubble and small boulder stones (157009). Two subsequent machine excavated slots into the south-west and north-west (Plate 26) sides of the pit revealed the upper deposit (157004) which had a maximum depth of 0.67 m, overlying a lower re-deposited light grey clay subsoil deposit (157010), which was also visible around the edges of the pit feature in plan and was up to 0.64 m in maximum depth. These overlay a light brown-yellow-orange re-deposited clay (157012),

up to 0.25 m in maximum depth which was the lowest deposit revealed. The base of the feature (157005) was not revealed across the full extent, however appeared to be relatively flat at a depth of around 0.9 m as seen in the machine-excavated slot; the sides were quite gradually sloping. The machine excavated slots also revealed a lower natural subsoil fine clay (157013), which was mid blue-grey in colour and had virtually no inclusions. The pit appeared to cut at least 0.85 m into this clay, and it seems possible that the pit may have been used for quarrying this finer clay deposit.

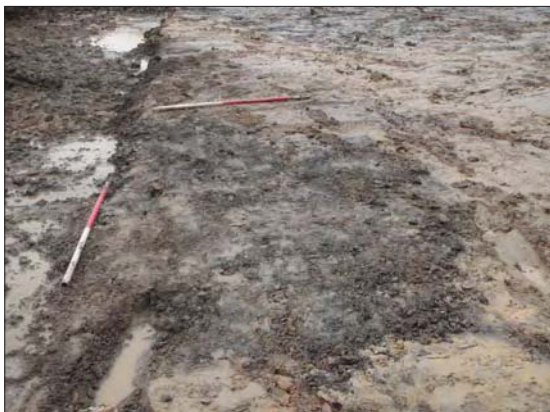
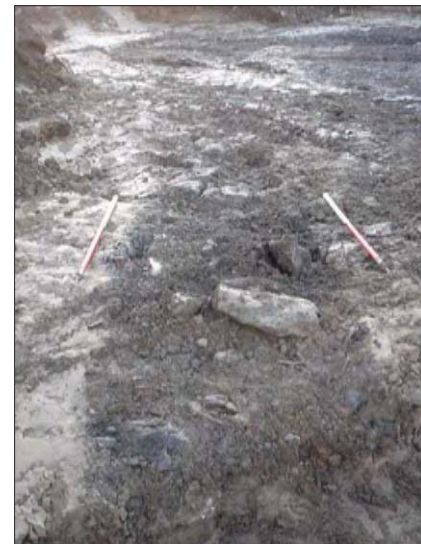
7.16.3 Expansion also revealed two further features (Plates 27 & 28), a shallow spread of material located to the north of the main pit (157008) and a linear ditch feature situated to the immediate north-east of the pit (157006-007). The spread of material was sub-circular in plan, measuring 2.52 m by 1.87 m, and revealed on excavation to be only 90 mm in depth. The material appeared to be a mixture of dark stony material similar to the fills 154004 of the main pit and 157006 of the nearby ditch feature, and re-deposited topsoil and subsoil. The material may represent the base of a more substantial pit which has been heavily disturbed by ploughing or other activity, or may simply be dragged or trapped material related to the nearby main pit feature (157005). The ditch feature was visible for 3.52 m in length and 0.89 m in width and was 0.15 m in depth. The fill (157006) was a silt sand clay with large stones and dark stones inclusions similar to

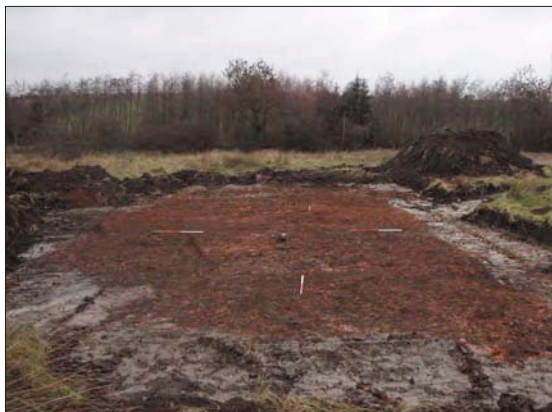
Plate 29: Pit feature (159003-007) from the south-east.

7.17.1 Stripping and subsequent expansion around trench 159 revealed a large pit feature (159003, 159006-007), irregular in shape and measuring around 18.8 m in length by 7.7 m in width (Plate 29). This was initially investigated with two hand excavated slots, then subsequently through a machine excavated slot through the full width of the feature (Plate 30). This revealed the depth of the pit to be 0.84 m at maximum, with the cut (159007) creating sharp then gradually sloping sides leading to a flat base. The pit was filled with a compact deposit of brick rubble, with the lower deposit (159006) made up of more substantial fragments, sometimes complete bricks, while the upper deposit (159003) consisted of compacted crushed brick; it is possible that more crushed compact material was intentionally laid to create a stable upper surface, however it is also possible that the upper layers of brick have simply been more disturbed by ploughing. The bricks appeared to be of the same type across the feature and appear to have been deposited as a dump of material to fill the pit; no structural elements were discernible.

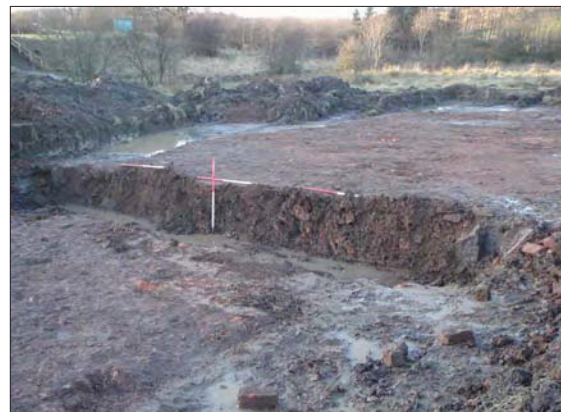
Plate 30: South-east facing section of machine-dug slot through pit (159007)

7.17.2 The pit was located below the topsoil (159001); no discernible intermediate deposit was present in this trench. The pit cut into grey-orange-yellow clay subsoil (159002), although the machine excavated slot revealed a mid blue-grey clay subsoil (159008) at the lower level with few inclusions and similar to that seen in trench 157 (157013). However the pit (159007) barely cuts into this clay at the lowest extent, so it seems unlikely that the pit was intended for the purposes of extracting this clay specifically. It is possible that the upper subsoil clay (159002) was extracted for local industrial use as this still contained relatively few inclusions, however the function of the pit could also have been for another industrial process which may further explain the use of dumped bricks as a fill, such as creating a hard standing for machinery or storage. The feature is cut by the same ceramic field drain system as seen in trenches 154 and 157. Material culture recovered from the upper fill (159003) includes glazed pottery sherds, a fragment of a small glass bottle base, and a clay pipe fragment, all potentially from the latter half of the nineteenth century and the bricks themselves are similar in form and date to those described from trench 154. This potentially adds to the suggestion that the function of the pit was connected to the same kind of local industrial quarrying activity as likely represented in trenches 154 and 157, although it is unclear if the feature represents contemporary activity.
