**Edinburgh Tram Scheme:
Tram construction phase investigation
Data Structure Report
Project 3405**

Edinburgh Tram Scheme Investigations Data Structure Report

On behalf of: Bilfinger Construction UK Ltd/Edinburgh Trams,
City of Edinburgh Council

Project Number: 3405

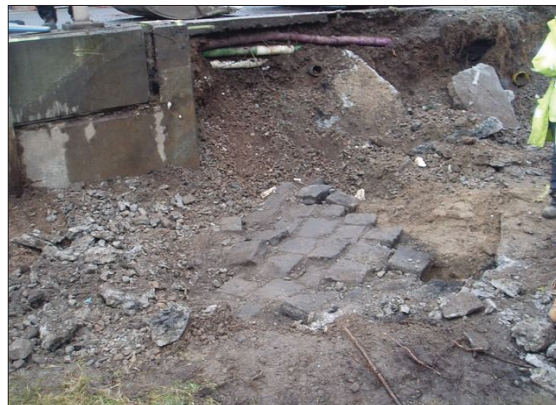
Plate 4: Cobbled surface at Victoria Swing Bridge

A foundation trench was machine-excavated on the south side of Victoria Swing Bridge, prior to the placement of a structural pile. A cobbled surface and part of a brick wall was uncovered at NGR: NT 7032 6861. The cobbles had been disturbed by the insertion of modern power cables. These were removed to uncover the solid stone foundation of the quayside below which was then used as a base for the new foundations. The original quayside was protected with geotextile before the new concrete was laid on top.

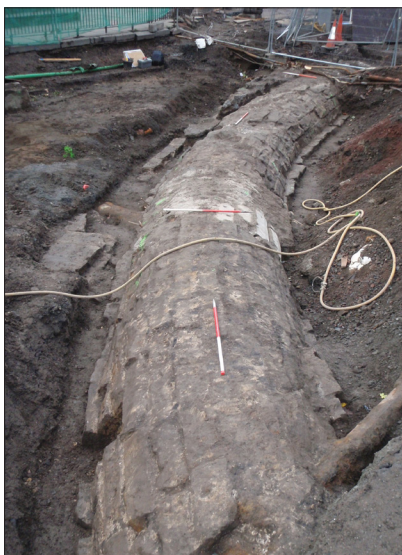
Plate 13: Crawley Tunnel exposed with arched roof

A 15 m long section of the Crawley Tunnel was exposed where it crosses Princes Street, the tunnel curves round from the foot of the Mound across Princes Street before continuing along the east side of Hannover Street. The roof and sides of the tunnel was cleaned and examined and several features were noted in the fabric including an area that had been damaged and patched with concrete and concrete kerb stones.

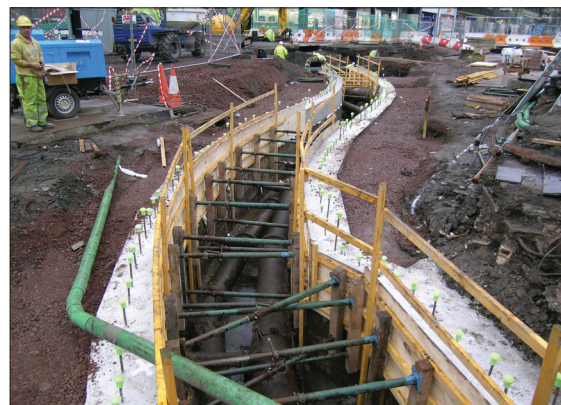
Plate 14 : Crawley Tunnel with roof removed and water pipes exposed

As the exposed section of the tunnel would carry the new tram lines on Princes Street, the existing tunnel structure was not suitable therefore once the tunnel was recorded the arched roof was removed and replaced with a reinforced concrete slab.

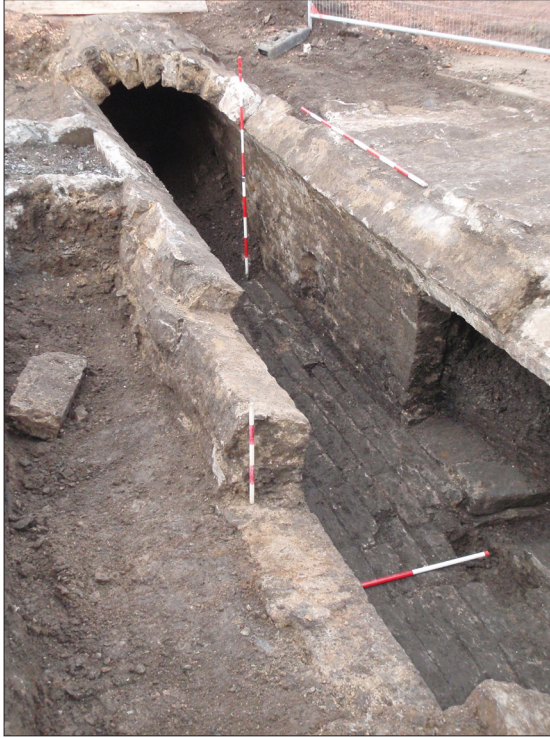
Plate 16: View of Second tunnel

The section of tunnel investigated was approximately 10 m long north-south, at some point in the past the stone roof had been partly removed and the tunnel completely filled in with earth and rubble. This material, was removed by machine under archaeological supervision, was sifted and investigated using a metal detector in order to retrieve any datable artefacts. Once the section of the tunnel had been emptied it was cleaned and recorded. The tunnel roof was 1.7 m high and 1.5 m wide (internally) with a small chamber off the east side. The north end was blocked by the insertion of a deep stone built manhole that connected with a sewer 5 m below that was still in use, another manhole this time made from concrete had been cut into the west wall of the tunnel. The floor, walls and roof of the tunnel were built of rectangular coursed sandstone masonry with an arched roof. The building stones were on average 0.9 m by 0.25 m by 0.3 m.

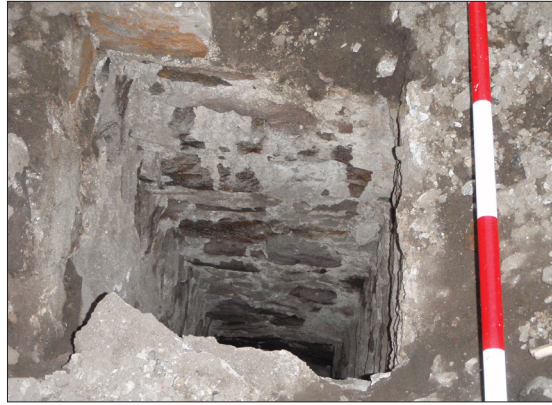
Plate 23: Stone manhole

This stone-built shaft was an entry-point to a sewer that ran east-west along Princes Street. The shaft measured 0.63 m by 0.63 m and was oriented NNE/SSW. Mortared stones were found to a depth of 2.65 m from current ground level; thereafter, the shaft opened out into a sewer with running water visible at the base. The depth from ground level to the water was about 6 m. The instability of the disturbed ground and the vertical nature of the sewer shaft were regarded as potential health and safety concerns. The sewer shaft was, therefore, only recorded by digital photography and written description.

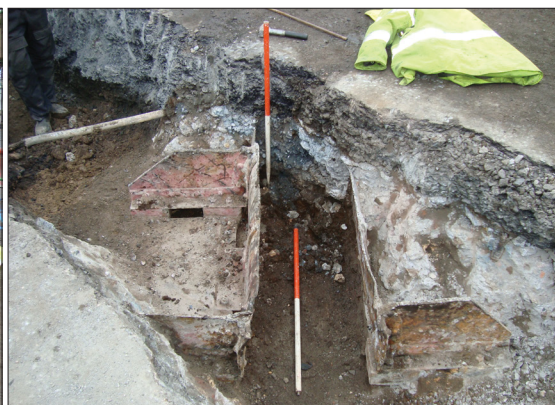
Plate 25: Detail of steel structure

During service diversion work on the corner of York Place and Broughton Street a steel box structure was uncovered immediately below the tarmac road surface. The service trench ran diagonally across the road and 1.34m of steel section was uncovered. The structure was made from steel plates bolted and riveted together and was 1.34m long by 0.7m wide and 0.4m high with a channel down the middle. The sides were set in concrete with some brickwork on the north side. The steel uprights were removed to lay the new service pipes but the lower structure was left in place. With the uprights removed it was possible to see the channel continue to the east in the trench edge. This channel and the steel structure may relate to the previous tram system which relied on cables to pull the trams. Similar steel work had been exposed during earlier service diversions in the area.

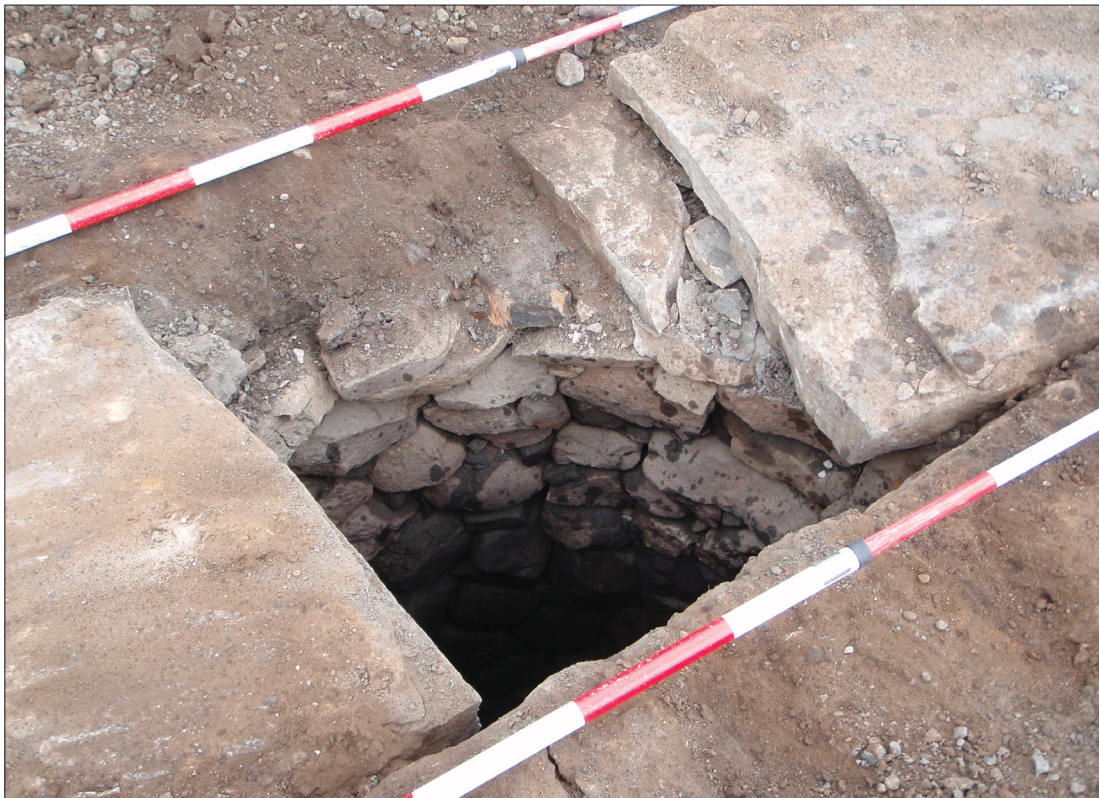
Plate 37: Stone well

3.20 During groundworks a well was uncovered at Balgreen. The circular well was a dry-stone construction with a diameter of 1.5 m and a depth of at least 4 m. A metal pipe protruding from the north-west edge of the well was probably a more recent addition. The top of the well was capped by sandstone blocks.

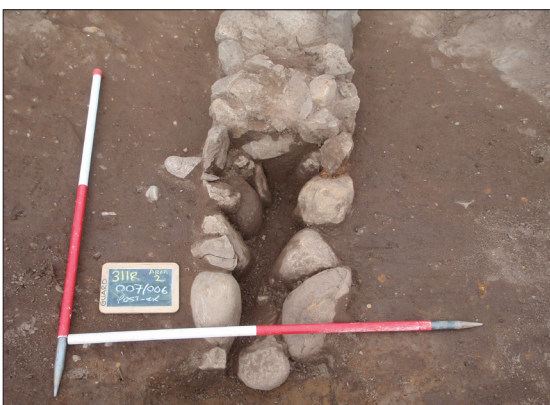
Plate 42: North-east facing section of stone drain

3.27 A stone field drain with capping stones was excavated, although no datable evidence was recovered. No other significant archaeological remains were observed.

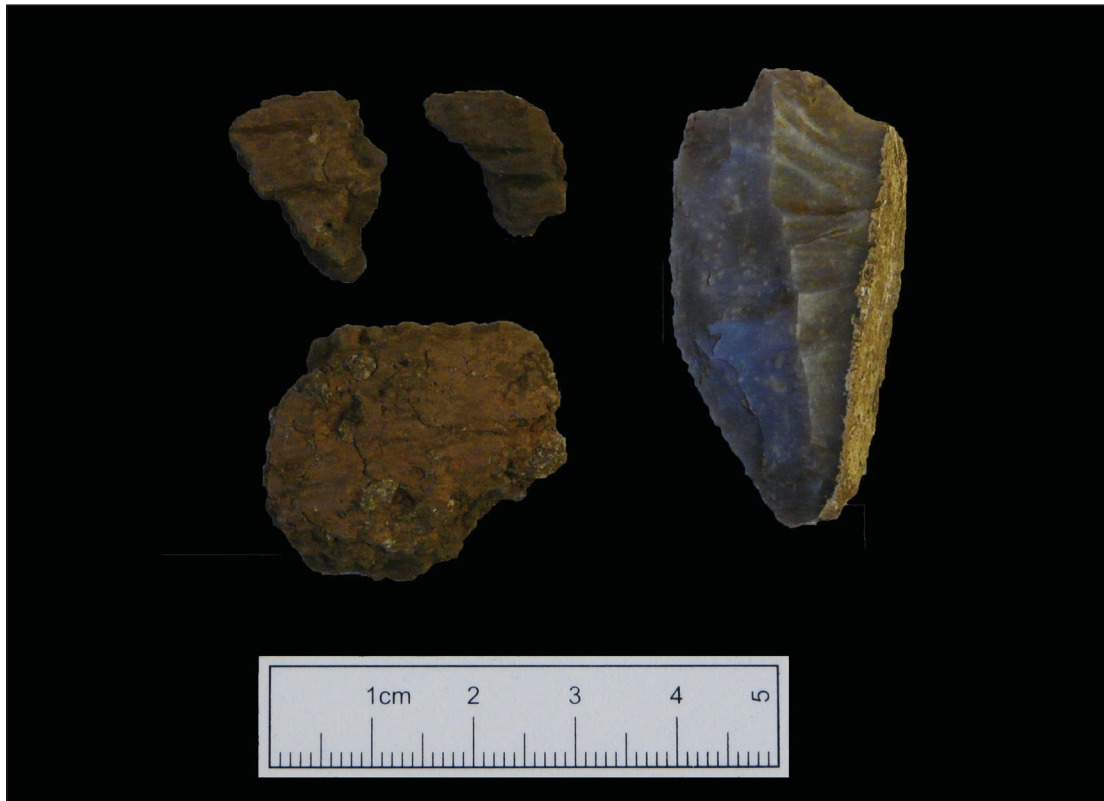
Plate 44: Beaker pot and flint blade

The flint recovered from the small pit or posthole (Catalogue no 2: 46 mm by 23 mm by 9 mm) is probably made from Yorkshire flint and represents the distal half of a scale-flaked knife, based on a stout blade. It is well-executed with semi-invasive retouch along its right lateral site, probably representing the knife's cutting-edge. Use-wear analysis of scale-flaked and plano-convex knives from Overhowden Henge in the Scottish Borders (Ballin 2011) suggests that these tool forms may be a form of sickles, fulfilling the same purpose as the curved single-piece sickles from southern England (Clark 1934). This type of blade and the use of Yorkshire flint would suggest a late Neolithic date.

This small group of sherds is probably from one Beaker vessel. The largest sherd measures 50.5 mm by 40.3 mm and is the majority of the base of the pot minus the basal edges where it joined the vessel walls. Its centre is slightly domed possibly as a result of deliberate action or because of finger moulding, which may have flattened the remainder of the base when the vessel wall
