## **Cambuskenneth Abbey Investigations Data Structure Report**

## **Cambuskenneth Abbey Investigation**

### **Project Design**

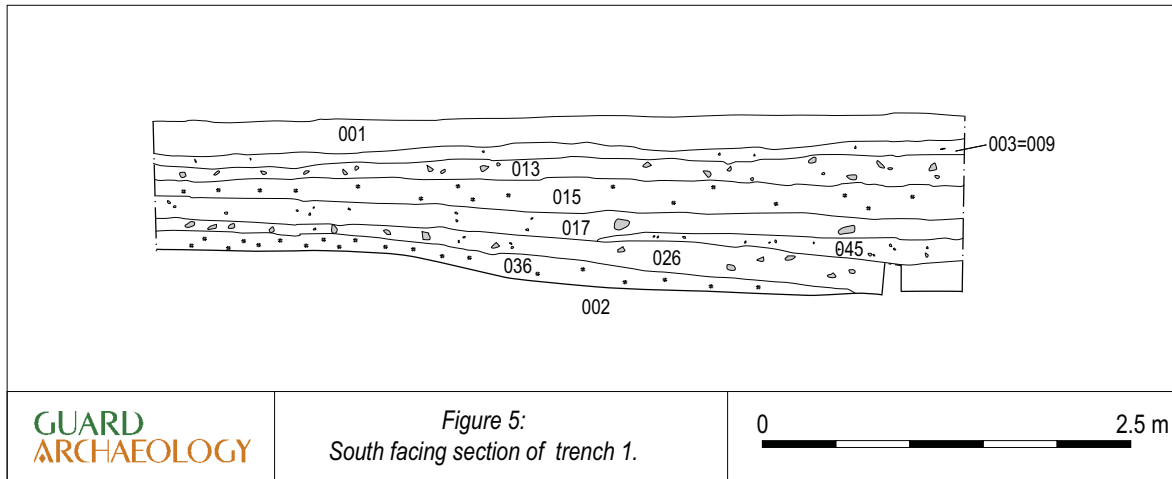
- 8.16 This trench measured 1.2 m by 5.6 m and was positioned over a square geophysical anomaly, which was located immediately west of the Abbey tower and graveyard (Figure 2 plan of trenches). The trench was orientated east to west and aimed to cross one side of the potential underlying feature. The trench revealed a series of eight layers in section, (including topsoil) before reaching the underlying sterile sandy clay subsoil 002 at 1.2 m below current ground level. These layers sloped gradually towards the Abbey grounds (Plate 4) (Figure 5)

- 8.17 Immediately overlying the subsoil 002, the earliest anthropogenic layer encountered in Trench 1 was a layer consisting of very dark grey silty clay (036) with occasional charcoal flecks. There were no finds recovered from this material and it measured between 0.1 m and 0.2 m thick, petering away on a slight incline towards the east. Sealing this was a layer of grey sandy clay (026) with occasional small rounded stones. This layer also inclined slightly to the east and measured between 60 mm and 0.2 m thick. Artefacts recovered from this layer included mortar (EX SF 50), floor tile fragments (EX SF 52), burnt clay (EX SF 53), animal bone (EX SFs 43 and 54) and numerous sherds of green glazed and unglazed pot sherds (EX SFs 44 to 49). Above this layer was very firm dark grey silty clay (045) with occasional charcoal flecks. This layer, only present towards the east, measured up to 0.18 m thick and was observed extending 2.5 m from the east end of the trench. One fragment of floor tile (EX SF 59) was recovered from this layer. Sealing this layer was possible rubble layer 017 which consisted of sandy clay with moderate inclusions of rounded and sub-angular stone fragments and occasional degraded sandstone pockets throughout. The colour of this layer varied between yellowish brown and greyish brown and the artefacts recovered included pottery sherds (EX SF 39 and 40), animal bone fragments (EX SF 38), iron fragments (EX SF 37) and a piece of carved stone (EX SF 41). Sealing this layer was a very compact rubble layer consisting of mid-grey brown clay (015) with occasional broken stone rubble with occasional charcoal and coal flecks. This measured between 0.16 m and 0.22 m thick in section and was present throughout the 5.6 m long trench. The finds included metal objects, animal bone and ceramic, including one sherd of possible white gritty ware (EX SF 33). The layer above this (013) consisted of moderately compact rubble with grey silt and finds recovered included animal bones, iron fragments and ceramic. Sealing this was a layer of firm

dark grey brown sandy silt (003) with very occasional stone rubble and mortar inclusions. This layer varied between 90 mm and 0.11 m thick and was present throughout the 5.6 m section length. Finds recovered from this layer included iron and lead objects, a flint flake (EX SF 19) and numerous pottery sherds. Topsoil (001) then completed the sequence of layers encountered in Trench 1.

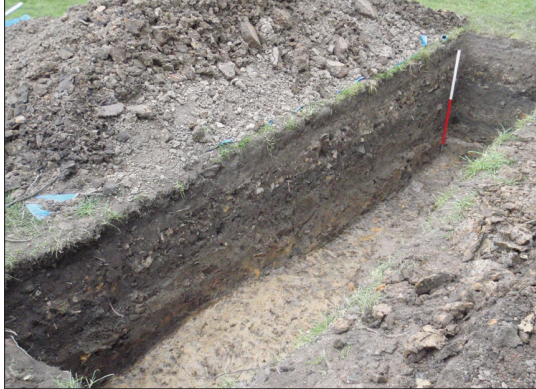
Plate 4: Trench 1 south facing section, note slope to east.

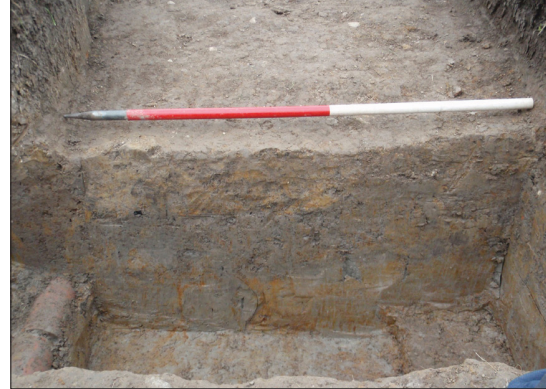
Plate 5: Trench 2, mole drain, drainage cut and later ceramic drain.

8.18 This trench was located to the south of the main track leading west across the site. Trench 2 was positioned over two perpendicular ridges which framed the south-east corner an obvious rectangular hollow to the west. These two ridges were seen as potential remnants of former buildings. The north/south arm of the trench measured 5.4 m and the east/west arm measured 4 m in length, both measured 1.2 m wide (Figure 6) . This trench revealed the presence of a drainage system which extended down slope to towards the apparent hollow. What appeared to be a cut for a mole drain (027) was observed two arms of Trench 2 coincided (Plate 5). This was cut into the subsoil (002), and extended east and was then truncated slightly by later drainage cut 028. The cut of the later drain measured 0.53 m deep and over 1.1 m wide as it extended south beyond the trench edge. The basal fill of this later drain was a layer of very compacted grey brown clay silt (016) with very occasional charcoal flecks, fragments of burnt animal bone (EX SF 65) were recovered from this fill. Above this lay (014) which consisted of a very compacted mix of yellow orange and grey brown clay. One sherd of green glazed pottery (EX SF 63) and an iron nail (EX SF 64) were recovered from this fill. The uppermost layer was very compacted pale yellow brown silty clay (011) with occasional rounded and angular stones; one sherd of green glazed pottery was recovered during excavation. Another orange ceramic drain cut (048) truncated the north edge of cut 028. This measured 0.48 m wide and up to 0.6 m deep and was filled by an orange ceramic drain surrounded by mid-grey silty clay. This drain extended west and east beyond the trench limits. In addition to the drainage features observed there was a deposit 010 observed on the lower slope of the north to south arm of Trench 2, this was found to be a natural silting layer of up to 20 mm thick at the base of the slope forming a transition between topsoil 001 and subsoil 002.

- 9.9 Trench 2 showed the presence of a succession of drainage features leading to a wide shallow rectangular hollow which extended parallel along the south edge of the current track across the site. The drains ranged from a mole drain which was succeeded by a wider drainage cut which in turn had silted up and was later replaced by a fairly recent orange ceramic drain on roughly the same original drainage line. It is not certain whether this drainage system relates to small scale industry once carried out or if it is a remnant of earlier land management. There is a channel depicted on Feuw Plan of Cambuskenneth 1813 (Stirling Council Archive Service, MP SB 70) which extends parallel to the current track and may offer an explanation for the successive

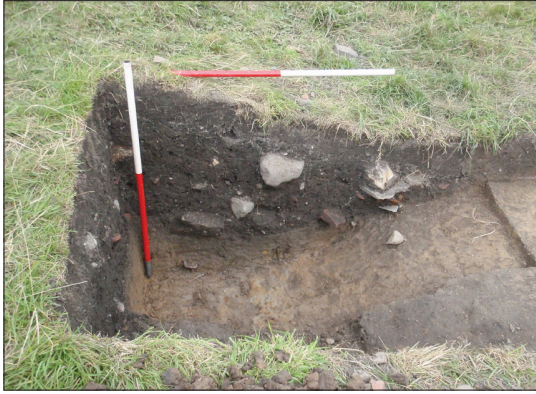
Plate 6: Trench 4, ditch 018 east facing section.

8.20 This trench measured 1.2 m by 5.65 m and was located over a geophysical anomaly and above ground feature which lay to the north of the main track leading across the site. The trench revealed that there was a ditch feature (018) extending parallel along the north side of the current track which leads west across the site (Figure 8). This ditch measured 0.75 m deep and 1.8 m in the trench section which was restricted to the south by a modern service trench and the track itself (Plate 6). The true width of the ditch is unknown although if the profile is uniform, based on the extent revealed in section, it could be up to 3 m wide. There were a total of five fills present; the basal fill consisted of very firm mid-grey silty clay (019) with occasional charcoal flecks. This measured between 60 mm and 0.11 m thick and lined the base of the ditch and the upper north edge of the cut, no artefacts were recovered from this fill. Above this lay a fill consisting of very firm dark grey brown silty clay with frequent charcoal flecks and occasional small angular stones. This fill measured between 60 mm and 0.14 m thick and 1.6 m wide within the limits of the section. Finds recovered from this fill included glass, pottery, animal bone with the remains of a leather shoe sole (EX SF 012) also found (Plate 7). The fill overlying this consisted of very dark brown silty clay (006) with occasional large rounded stones and red-brick fragments. This measured up to 0.4 m thick and extended 1.45 m across the section. Finds recovered included clay pipe fragments (EX SFs 096 to 098), a ceramic bottle stop (EX SF 093) and twentieth century pottery sherds (EX SF 092). This fill was sealed by mid-grey brown silty clay (005) with occasional charcoal flecks. This fill measured between 50 mm and 0.1 m thick and measured 1.4 m wide in the exposed section. Finds recovered included mixed refuse in the form of ceramic sherds, drain fragments, animal bone, glass, metal and slag. The uppermost fill of the ditch was dark grey brown silty clay (004) with occasional charcoal flecks. This measured between 40 mm and 80 mm thick and was 1.5 m wide in section. A mix of waste material was also recovered from this fill.

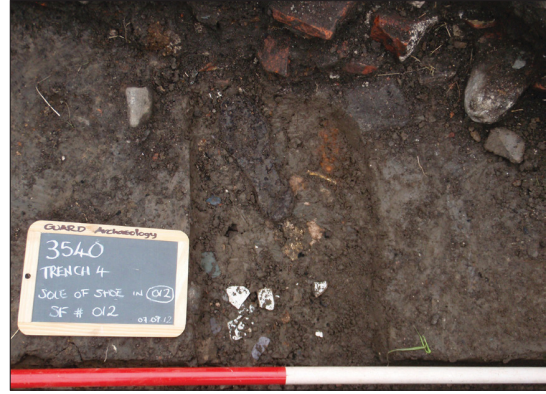
Plate 7: Trench 4 Shoe sole SF 012 in situ.

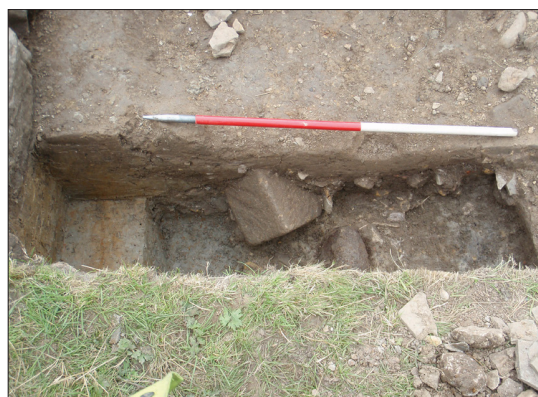
Plate 8: Trench 6, possible demolition layer extending below limits of trench.

Overlying this layer was a possible demolition layer (037) (Plate 8) which consisted of compact dark brownish grey silt with very frequent pebbles, cobbles and large angular dressed stones. This deposit measured between 0.74 m and 1.6 m north to south, extended beyond the 1.2 m wide trench to the east and west and measured up to 0.5 m thick in section. In the west facing section of the trench this demolition layer was abutted by blue grey clay (033) with orange mottling, although in the east facing section this same deposit appears to underlie the demolition layer. This may be down to nature of the limited investigations conducted here; it may be that the widening of the trench would resolve this stratigraphic relationship. Sealing layers 037, 033 and 029 was a layer of very compacted orange grey clay with occasional small pebble inclusions. This measured between 40 mm to 0.36 m thick and was present throughout the trench. The masonry that was visible at ground level, and which dictated the positioning of the trench initially, was stone wall 008, one course thick with no apparent bonding material (Plate 9). This wall extended beyond the trench to the west and east, measured approximately 0.8 m wide within the trench and up to 0.22 m deep. The stone was of sandstone and other unidentified fragments of various stone types. There was no uniformity in the elements used in this construction and no foundation cut. This was subsequently overlain by a thin topsoil and turf layer (001).

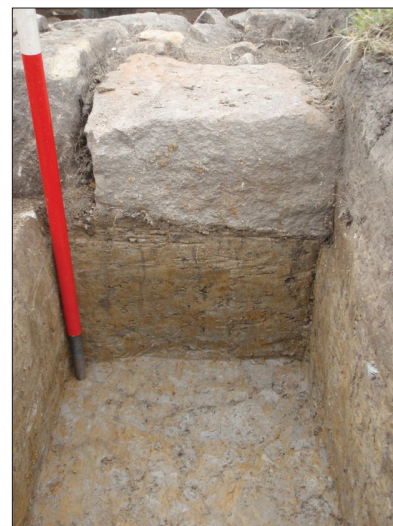
Plate 9: Trench 6, one course of sandstone.

- 9.13 The single coursing of sandstone and other stones, unbonded and with no foundation can be discounted as the footing for the former Watergate archway which was a substantial construction reaching at least the height of the nearby 2 storey farm buildings to the south of it in Slezer's drawing of 1693. The single course found may have been re-use of some of the stone from the arch for a less substantial surface or building. There is a track extending across this area and turning south along the bank of the Forth River on the Feuw Plan of Cambuskenneth 1813 (Stirling Council Archive Service, MP SB 70). Perhaps some of the stones from the arch were used as revetting for the track. The lower possible demolition layers encountered in the trench do however have the potential to be the remnants of the more substantial water gate construction. Time constraints negated further investigation during this phase of works.

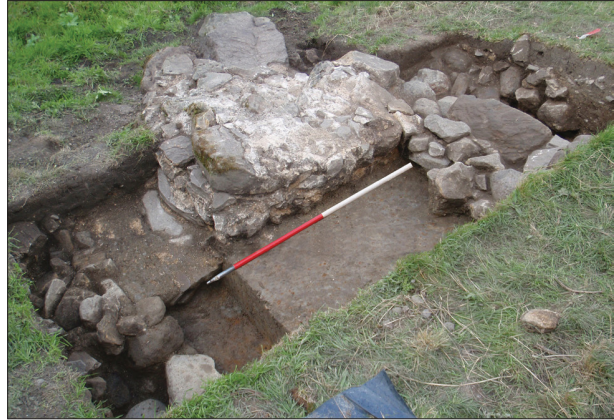
Plate 10: Trench 7 wall 038 (left) wall 021 (right) mortar footing 022 (centre).

8.25 This trench was positioned over what was initially observed as the possible collapse from the Watergate shown in Slezer's plan of 1693 (Pollard 2012). The trench measured 1.56 m by 3.2 m on plan with the long axis orientated north to south. The excavation of this trench revealed the presence of three separate constructs consisting of possibly contemporary wall (021 and 038), and a later mortar footing (022), which seems to have truncated wall 021 (Plate 10) (Figure 11).

8.26 The two walls which may be contemporary were both orientated east to west and were found in the north and south edges of the trench. The first of these (021) was built on top of a compacted yellowish brown grey sandy silty clay layer (039) with occasional sandstone fragments throughout. This is not a natural layer and may be the remnants of a former episode of demolition or construction trample layer. Wall 021 stood 0.55 m proud of this surface and extended partially intact across the width of the trench. The wall measured 0.25 m wide at the surface and tapered to approximately 0.5 m at its base. The stones were sub-angular partially dressed, irregularly coursed, un-bonded sandstone blocks. A series of layers had accumulated against the wall on the south and north sides. To the north were layers 030, 024 and 056, to the south were layers 031 and 023. The foundation cut 053 for the second wall (038) was cut into a natural orange grey clay layer (041) at the south end of the trench. This wall was built of roughly shaped un-coursed and un-bonded sandstone pieces and measured 0.53 m wide, extended east and west beyond the trench edges and the true height of the wall was not determined due to time constraints. Overlying the stones of this wall was a layer of brownish orange silty clay (046) with occasional sandstone fragments. Overlying this layer and abutting the south side of wall 021 was a layer of compact light yellowish brown silty clay (031). This was then overlain by rubble layers 023 and 025 before being sealed by topsoil 001. Truncating the northern wall (021) and the rubble layer 023 was the cut for a mortar footing (053), this was in-filled with a grey clay (055) with frequent sandstone and mortar fragment inclusions. The upper level of the footing consisted of rounded mortar footing 022 with occasional large stones set into the mortar for strength. This footing measured 0.2 m thick and approximately 1.4 m in diameter, extending beyond the trench limits to the west.

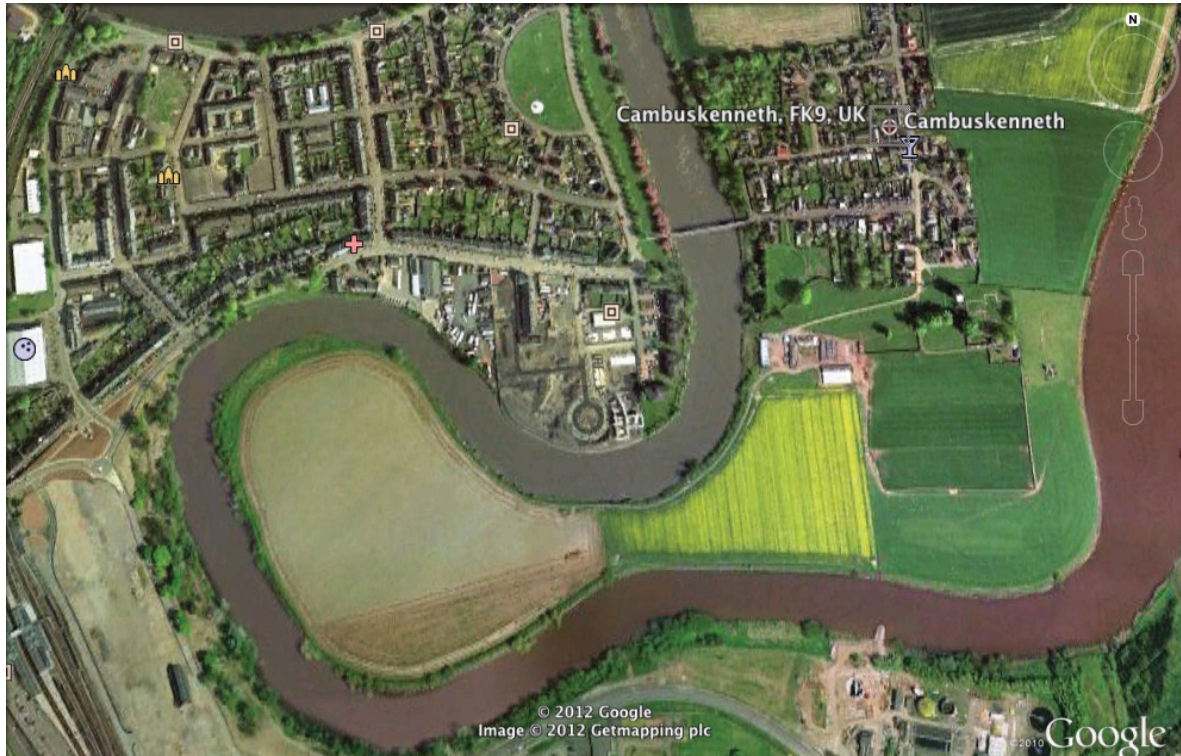
Fig. 1 Google image of meander – note western dog-leg with pinched neck

To the southwest of the Abbey, or more specifically to the west of the land to the south of the Abbey, the meander extends to the west, where a dog-legged salient of land exhibits a pinched neck, which with little difficulty could have been isolated from the eastern part of the meander occupied by the Abbey. There is no historical suggestion that this area was ever fortified in any way – a ditch across the neck would effectively create something akin to a promontory fort (it is however interesting that the narrowest point, where a barrier might be expected does correspond to a field boundary). Barrier or no, this area is likely to have appealed to Bruce when it came to placing his baggage in a safe location (his train is unlikely to have been placed within the precincts of the Abbey itself).

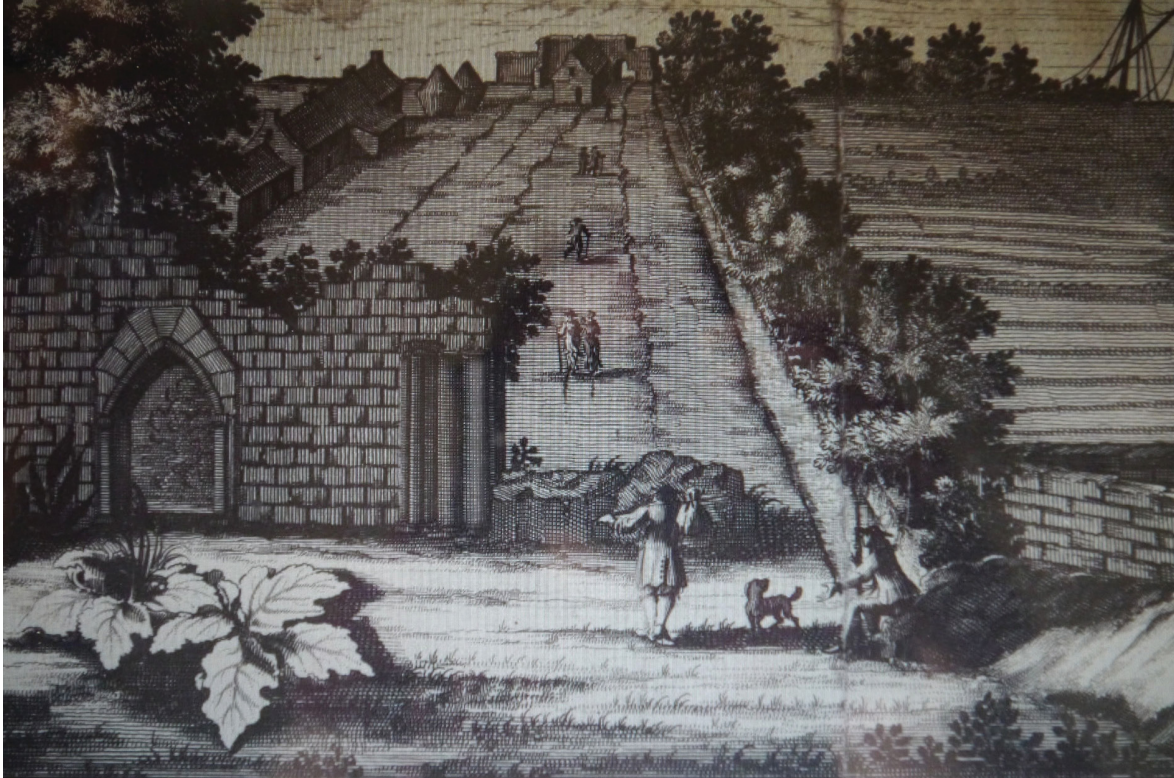
Fig. 2 Slezer print of 1693 showing track running west to river from Abbey ruins and water gate on river's edge (top off frame)

The Slezer drawing also shows some interesting details regarding the river itself (the tower is missing, probably due to artistic license as it would interrupt the vista). The western spur of the meander (the dog-leg) is visible to the left of frame, and has buildings on it (though given the previous comment about artistic license this should not be taken for granted). The river to the west of the water gate appears to be much wider than at present, which would certainly be in keeping with the 1529 report of a boat capsizing while undertaking the crossing. Stirling Bridge is visible to the right of frame and it would appear to be this that the Scots under Bruce were using to gain access to the Abbey at the time of the battle in 1314 – it seems highly unlikely that Athol mounted his assault on the baggage by boat (see below).

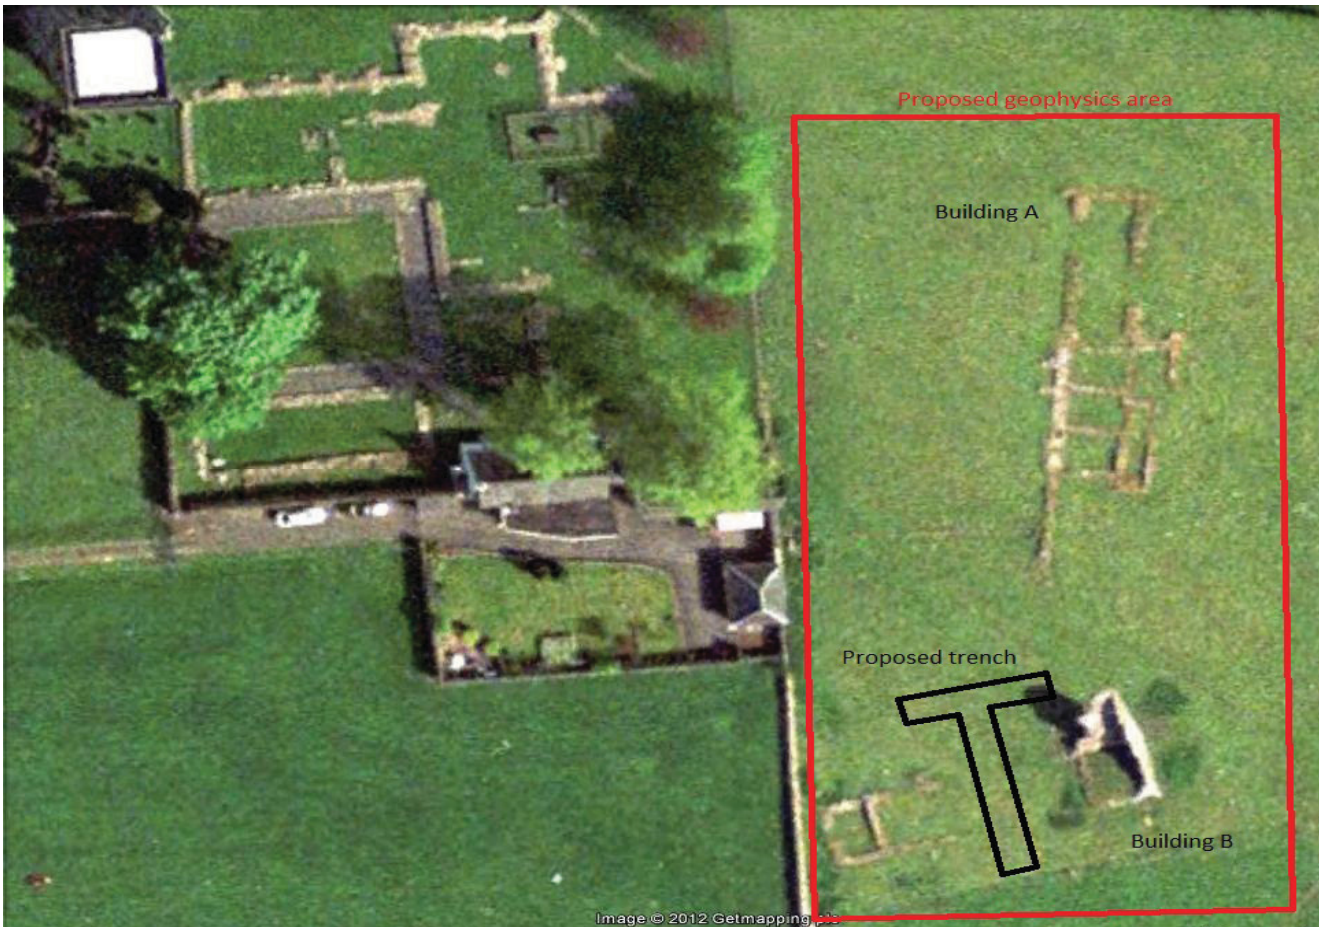
Fig. 3 Proposed geophysics survey area and prelim trench locations

It is proposed here to focus attention on the part of the Abbey complex, which sits on the river terrace to the east of the ecclesiastical heart of the Abbey (Fig.3). At present two buildings (A and B), or ranges of buildings, are visible here. In the main the remains relate to the lower courses of walls, which appear at least in part to have been reconstructed on the basis of remains first unearthed in the 1864 excavations. As the Canmore entry states: ‘The remainder of the Abbey buildings are now only foundations. The measures taken to preserve these foundations, revealed in 1864, have substantially altered their character and much of the masonry visible today is comparatively recent.’ One of the photographs from 1931 (Fig.4) shows the most northerly of the two buildings (A) in what looks like a state of fresh consolidation, with the mortar looking very new and reinstatement around the structure just finished. The building to the south (B), which has the dovecot attached to the eastern end, was also exposed/excavated in 1931, with a photograph showing the extent of the disturbance, probably with the aim of consolidating the outside walls (Fig. 5). Another shot, taken from the east, shows the exposed interior dividing walls and what looks to be a cobbled area, but possibly a further building, outside the building on the northern flank (Fig.6)

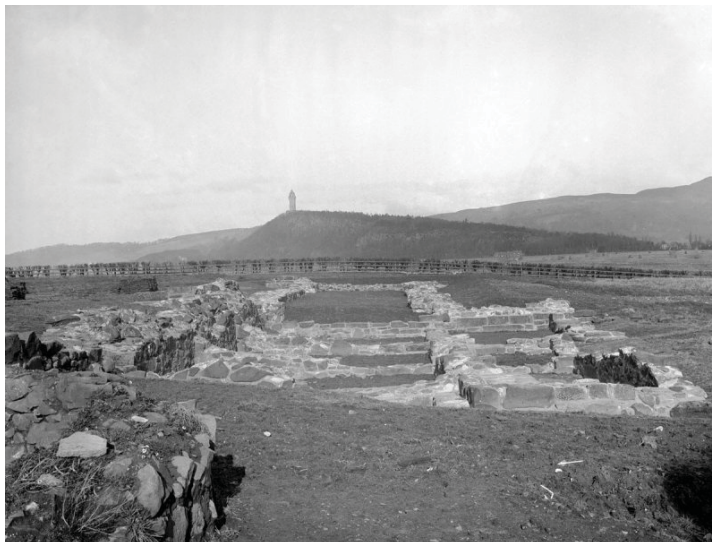
Fig. 4 Photo from 1931 (Canmore) Building A from south, presumably following consolidation

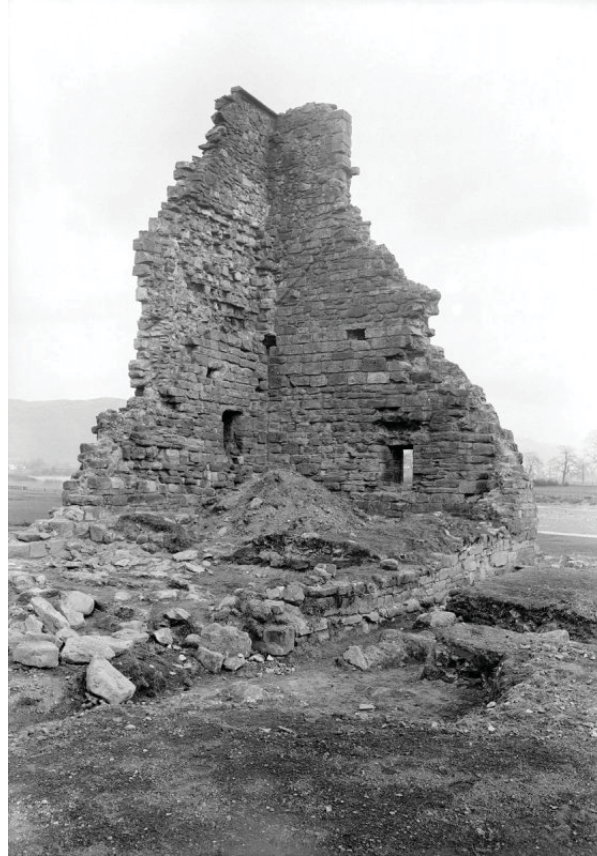
Fig. 5 Photo from 1931 (Canmore)  
Building B from south-west

The photo above (Fig. 5) appears to show that the ground level has been reduced to at least the subsoil, thus exposing several courses of the lower wall, possibly foundation courses. On the southern side of the building this disturbance appears to be limited to the edge of the wall footings, with some expansion away from the wall. This would bode well for undisturbed and unknown features to exist outside this area of disturbance.

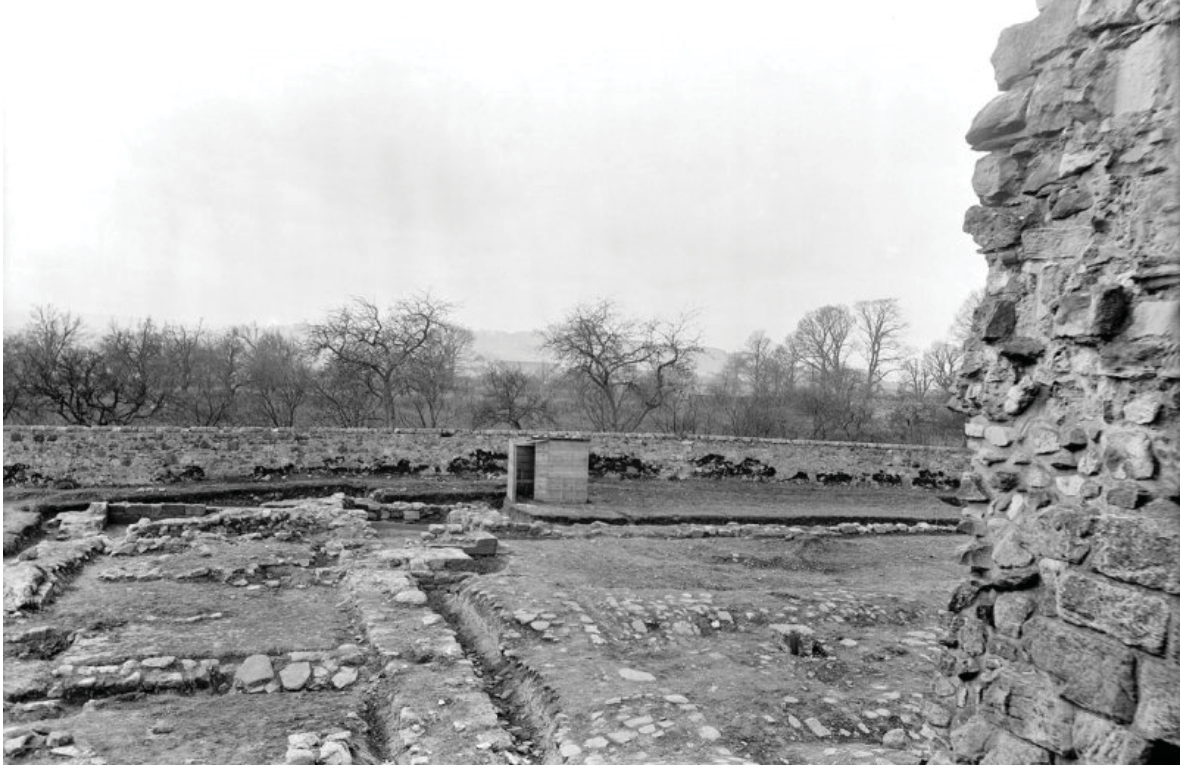
Fig. 6 Photo from 1931(Canmore) – Building B from east, showing exposed internal walls and cobbling or further building to north (right of frame)
