Dumfries House New Adventure Playground, Archaeological Watching Brief Data Structure Report Project 3717

Dumfries House New Adventure Playground, Archaeological Watching Brief Data Structure Report

Project Number: 3717

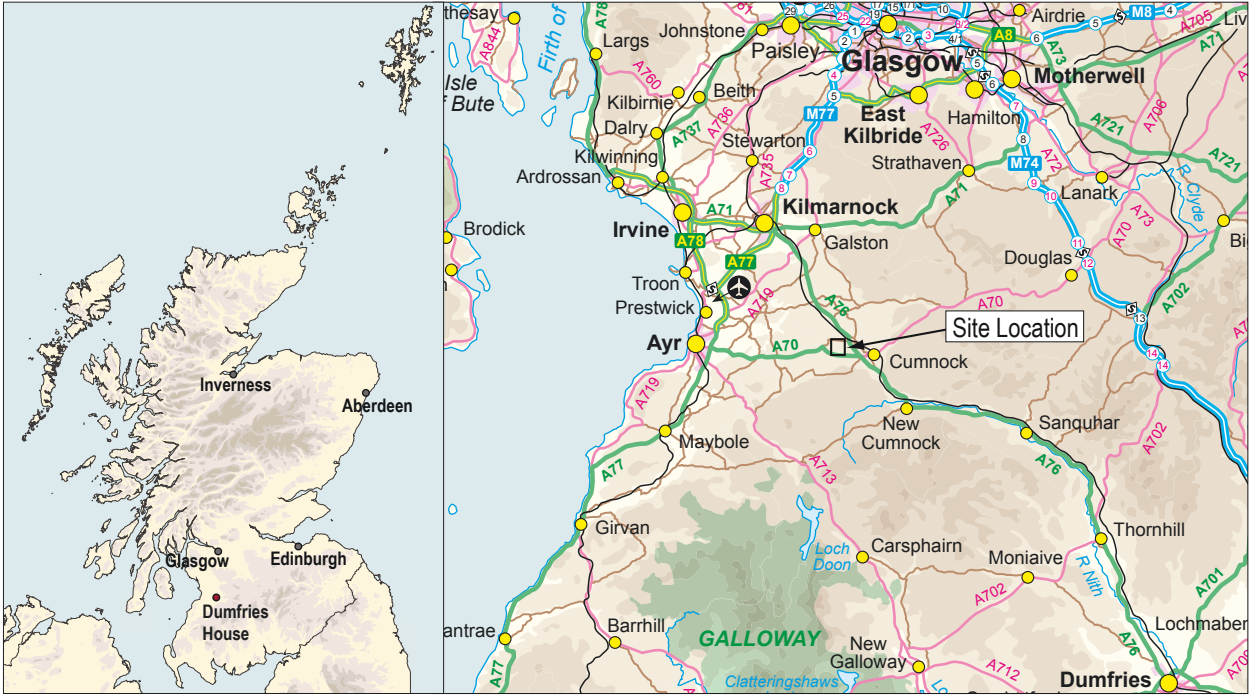
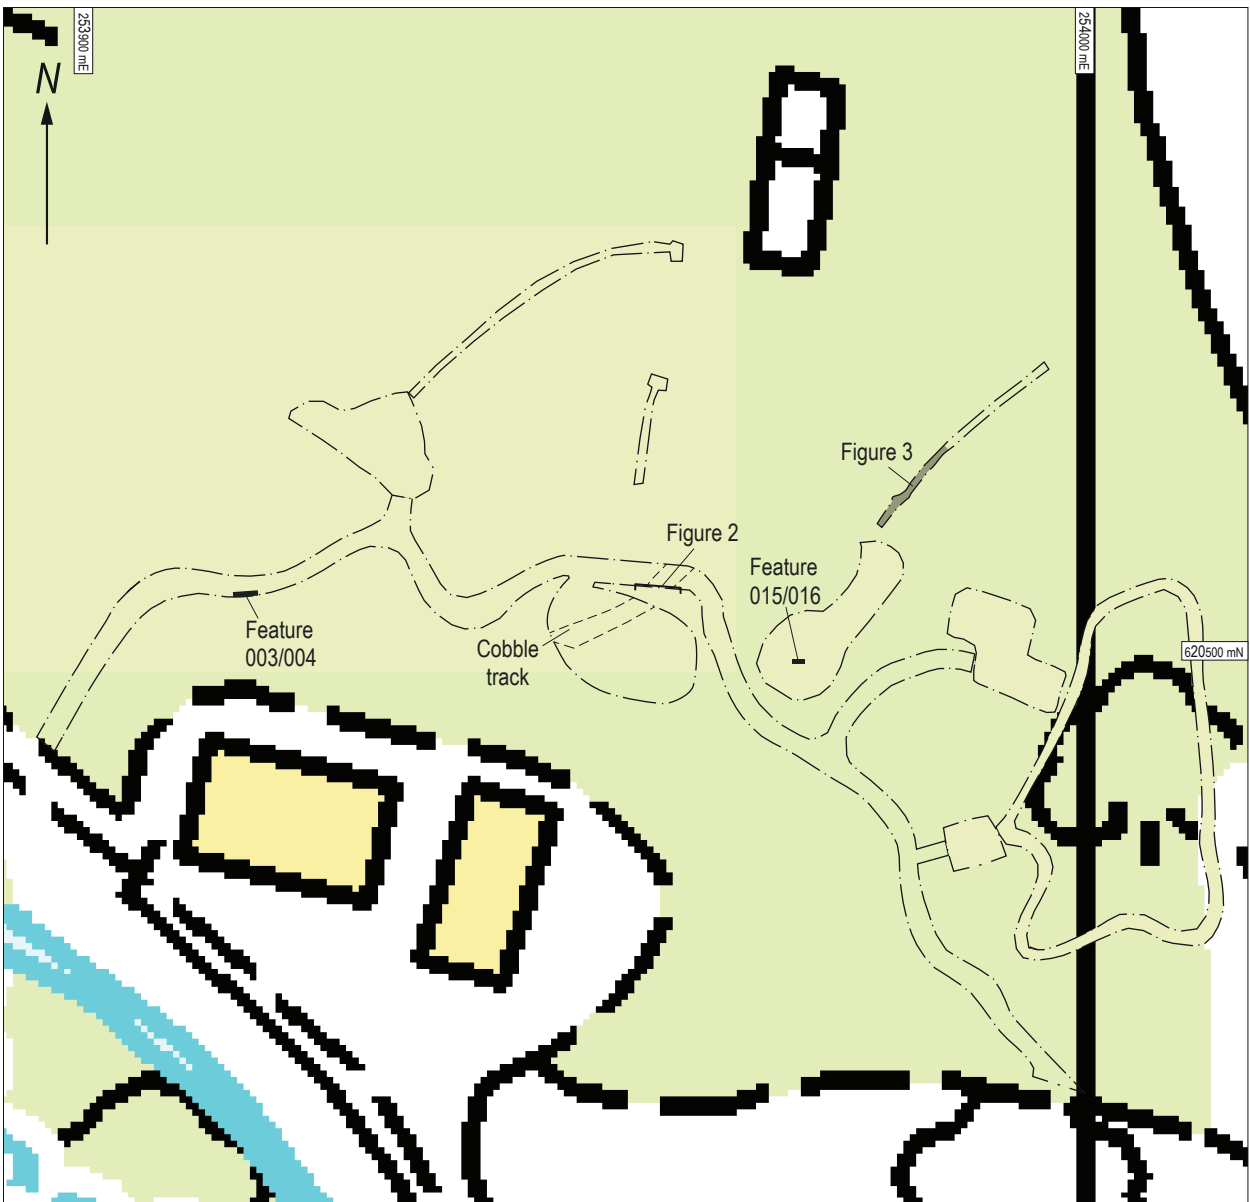
Figure 1:
Site location.

- 3.1 The development location lies to the north-east of the Stables House buildings which house the existing visitor café and shop, within the grounds of Dumfries House (NS 53961 20510). (Figure 1).

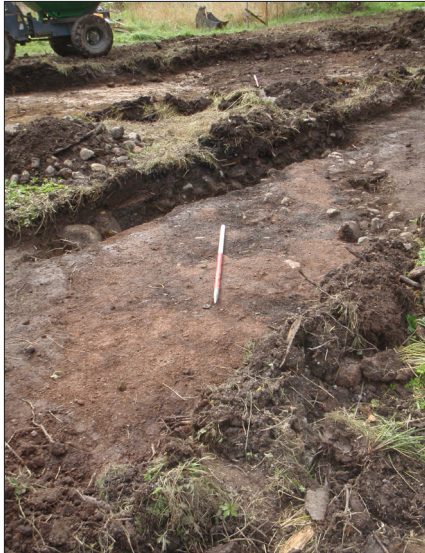
Plate 1: Trackway (005)-(007) from the north east.

- 7.3 005/006/007 Part of a track way aligned south-west to north-east was uncovered running across a section of the path and was also revealed further to the west where an area was stripped for part of the playground equipment. The track was 1.8m wide and could be traced for 14m (Plate 1). A section 0.4m wide was hand excavated across the track (Plate 2). The upper surface consisted of compact red gravel or grit (005) up to 0.05m thick. This sealed a more substantial layer of compacted grit and stone (006) that was up to 0.25m thick and overlay a foundation layer of larger stones and cobbles (007), the larger stones were up to 0.4m in size. The larger stones were placed at the edges of the track to form a rough kerb and this lower course of stones extended the width of the track to 2.2m (see Figure 2). At the south-west edge the track had been truncated by the insertion of a modern service trench. No artefacts were uncovered either within the excavated slot trench or on the exposed surface, although brick fragments were recovered from within (007) towards the south where the feature was more disturbed. The track was orientated east/west and appeared to run towards the north end of the stables building.

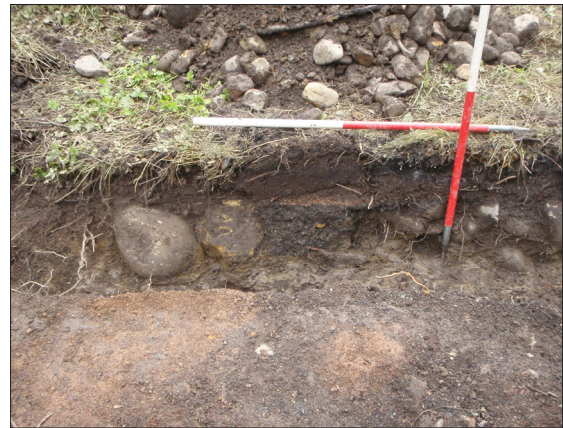
Plate 2: North-east facing section through (005)-(007)

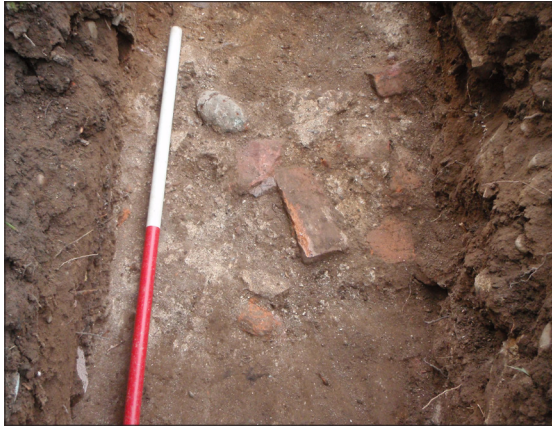
Plate 3: Mortar spread (010) with rubble, from the north east.

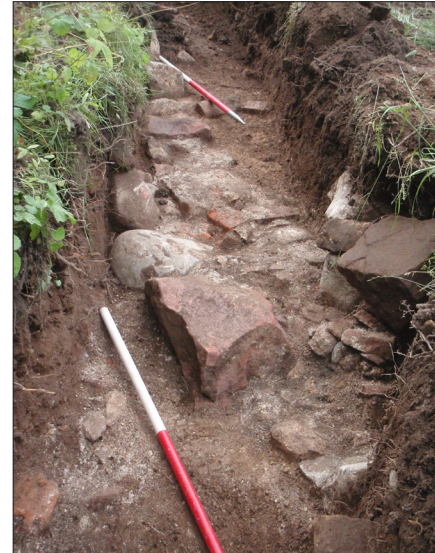
that was 0.7m wide and survived to three courses and a height of 0.53m. The wall was built from both angular and rounded stones, the largest being 0.5m by 0.5m by 0.4m and was bonded with white mortar. The larger stones were used to form an outer face for the wall with a rubble core. Orange/red coloured hand-made bricks were also used in the construction of the wall. At the base of the wall a cut for the foundations was visible the cut (013) was the same width as the wall and 0.23m deep. No artefacts were recovered from the wall or the immediate vicinity. In the area between the wall and the mortar spread the sand and gravel subsoil (012) was very compacted whether this was the result of building activity for the wall or a deliberate attempt to create a floor surface is uncertain.

Plate 4: Stone wall (011) from the north.
