Woodland & Farm Cottages, Dumfries House, Cumnock Data Structure Report Project 3877

Data Structure Report

NGR: NS 54085 21130

Project Number: 3877

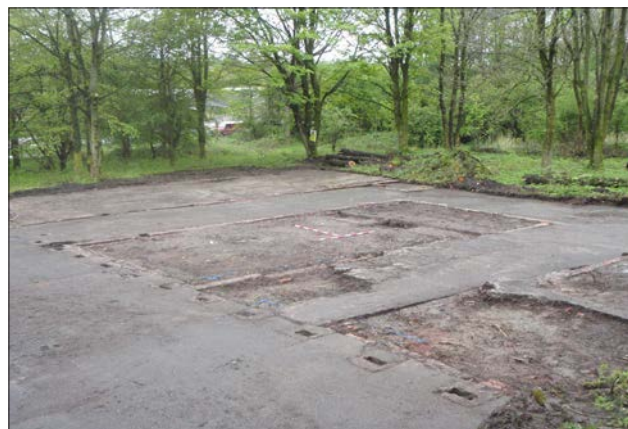
Plate 1: Shot of Woodland House area stripped.

7.2 The Woodland House location was the smaller of the areas to be stripped of topsoil. Due to the density of trees in the area and the requirement to keep them in situ, stripping was curtailed to the edge of the canopy to prevent tree damage. The topsoil itself was extremely shallow with only 0.2m cover before concrete and foundations appeared. The area stripped in entirety displayed three distinct brick structures with concrete surrounds.

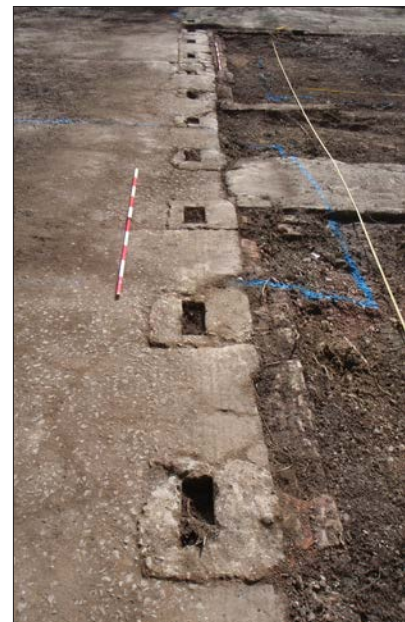
Plate 2: Shot of rectangular post holes.

7.5 Structure 3 was located in the southern portion of the site. The structure itself was a mirror image of that of Structure 1. It displayed the same red brick foundation wall [016] with the same type of brick seen in the previous two structures stamped with “littlemill” and “DICO”. The interior of this structure however had the concrete floor remaining in a high percentage of the internal area. It comprised of two distinct layers of concrete. A thicker lower layer (010), of a coarser finish 80mm in thickness across the full structure and directly above that (015) a fine finished thinner screed of concrete only 35mm in depth. This thin layer appeared very fragile compared to the lower levels of concrete and thus as a result was significantly fragmented and only visible in portions of the structures base. The remains of this thin concrete screed also displayed a shallow drainage channel [016] abutting the edge of the interior wall. This channel 0.13m in width and lined the full interior of the structure. The interior channels appeared to connect or feed into a series of pipes or drains located in either end of the structure on opposite sides.

7.6 The exterior of the three structures appeared to be fully concreted, possibly pathed, with a larger concrete yard directly to the east. Surrounding the three structures, a series of 11 rectangular post holes were visible running north-south and spaced a metre apart. They appeared to be concreted in situ at a later time than the yard itself was concreted and many of them displayed evidence of the wooden posts or sleeper still in situ at the base. A smaller post hole or possible gate post was located at the end of this line of post holes with another corresponding visible 3m away with a smaller directly in the centre of these two. This indicating the likely hood of a gateway into the structures area.

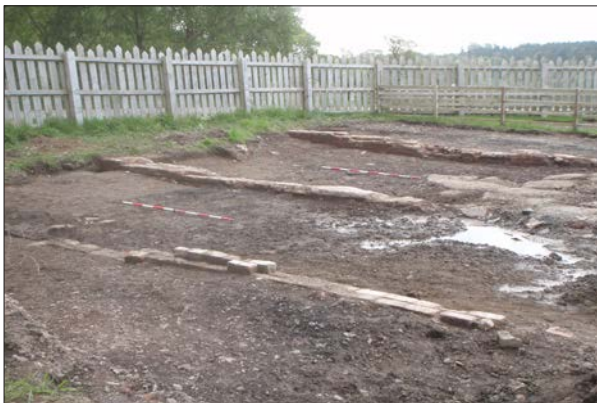
Plate 3: Shot of Farm House area stripped.

- 7.7 The Farm House location was larger than the area stripped for the woodland house, however the proposed area had a series of obstacles which did not allow complete stripping to subsoil deposits across the full area. A large well established tree located in the eastern portion of the site under an extensive canopy concealed a significant area of archaeology under it and was retained in order to preserve the tree and root system as part of the development. The western portion of the site was mostly covered by a relatively modern silage/slurry pit – still in use – which had destroyed much of the evidence of structural remains surviving elsewhere throughout this portion of the site.

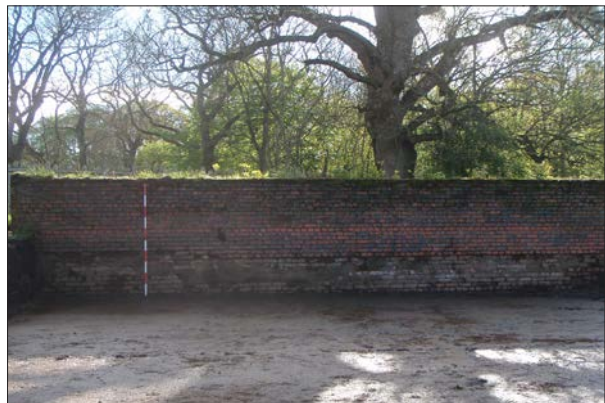
Plate 4 : Shot of wall of slurry pit [003] [004].

- 7.10 The north-west of the site was mostly taken up by the retaining wall of the slurry pit. This appeared to have been laid directly on the top of an existing red brick foundation – possibly relating to the structures nearby. It measured 10m in length possibly extending down slope in a north/south direction, however much of the area had been truncated by concrete from the base of the slurry pit. Standing at 2.1m in height, only the lower 0.7m of the wall being that of the existing wall foundations. The lower brick was of the same type seen in nearby structures 0.24m by 0.11m by 70mm in thickness but stamped with “DICO”. The lower original section of wall also appeared four courses in thickness with the upper later additions narrowing down to two courses in thickness. A visible joint between both portions of wall was visible with a running course added to allow the later addition to the wall.
