**Tigh Caol, Strathlachlan, Argyll
Data Structure Report
Project 3727**

Data Structure Report

Project Number: 3727

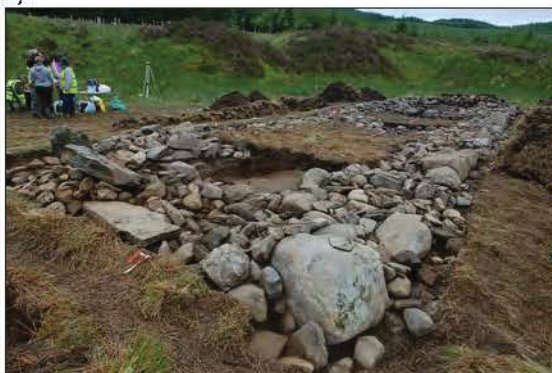
Plate 1: East Gable wall 014 with lintel stone left of centre.

- 8.2 There is evidence to suggest a possible window at the east gable end of the building, assuming the lintel stone is not coincidentally part of the collapse here. There was no evidence of a hearth or doorway which would have also accounted for the presence of the lintel here.

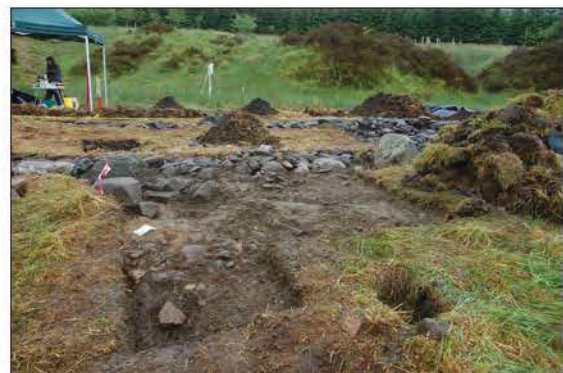
Plate 2: Trench 2 showing possible surface 047 external to north wall, from north.

7.3.1 This trench was opened over the central area of north wall 016 and extended northwards onto the terrace on which *Tigh Caol* is set covering an area of 2 m by 3 m (Figure 2). The north wall measured 0.7 m to 0.85 m wide and only one lower course survived. Similarly to the east gable wall the construction method appeared to consist of two roughly faced courses or kerbs with infill consisting of more irregular smaller stones of quartzite, schist and granite. The area out with the structure showed evidence of a rough surface consisting of grey silty clay 047 and mixed small stones (Plate 2). This surface was not fully investigated but it may represent an attempt at consolidating a passage of entry to the building. There was also a slight variation in the rough coursing of the wall 016 at this point with a concentration of large rounded smooth quartz stones flanking one possible entrance position on the north side of the building (Figure 2).

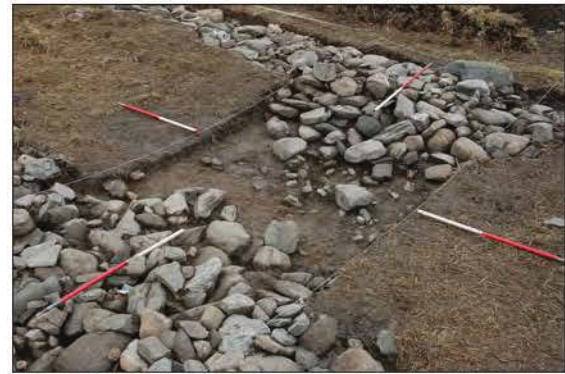
Plate 3: Central hearth 046 with some of collapse 006 in situ.

7.3.2 Trench 8 was opened in the centre of the structure to investigate the floor level and to determine if there was a central hearth present. Trench 8 was expanded across the central floor area to investigate an area measuring 2.2 m by 3.2 m, meeting Trench 2 to the north. The floor 002 which consisted of dark yellow grey silty clay sand. A central hearth feature 046 was discovered set in a hollow in the floor 002 (Figure 2) (Plate 3). This hearth was located almost perfectly in the centre of the building on the long and short axis. The hearth base and surround consisted of gravel and small pebbles with some larger irregular stones remaining in situ to form the partial upper perimeter of the hearth. The lower stones showed signs of reddening from burning. This circular hearth feature measured approximately 0.65 m in diameter. A floor deposit 032 had accumulated in the central floor area and around the hearth. This consisted of mid-brownish grey silty clay with occasional patches of burnt sediment, probably from raking out of the hearth. This floor deposit and the hearth were not fully investigated so it is not certain if there is a sequence of hearth use. Among finds of metal and glass from this area a coarse stone tool SF 080 was recovered close to the hearth position. No charcoal-rich deposits were observed in the hearth feature 046 as it was exposed.

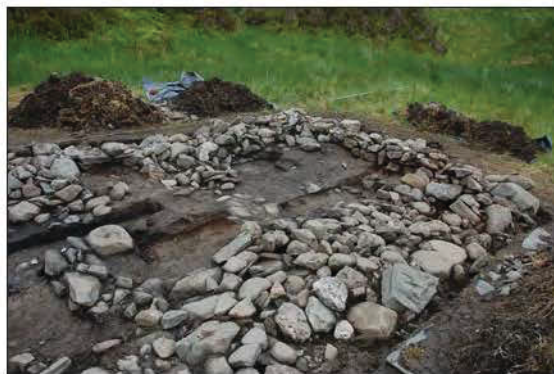
Plate 4: Hearth 012 in Room 1, centre of image.

7.4.2 Set on this floor within Room 1 and against the north wall 016 and west gable wall 013 was a dry-stone constructed low bench feature 011 (Figure 2). This rectangular feature measured 0.9 m wide and 4.7 m in length with a height of approximately 0.25 m above the floor level. A Copper alloy milled coin of probable eighteenth to nineteenth century date SF 090 was recovered below collapse 010 resting on the bench feature. A formal paved hearth feature 012 lay 0.5 m south of the bench and this was set into the floor level sitting just proud of the floor surface. The hearth was roughly oval in shape and consisted of a main central flat stone with longer, thinner flat stones framing it (Plates 4 and 5). This hearth feature measured 0.9 m by 1.2 m on plan and lay off centre at 2.4 m from the west gable wall 013 and 1.2 m from wall 004. This feature was not fully investigated so it is not certain how deep the hearth is set into the floor or if there is any sequence of hearth use below this extant setting.

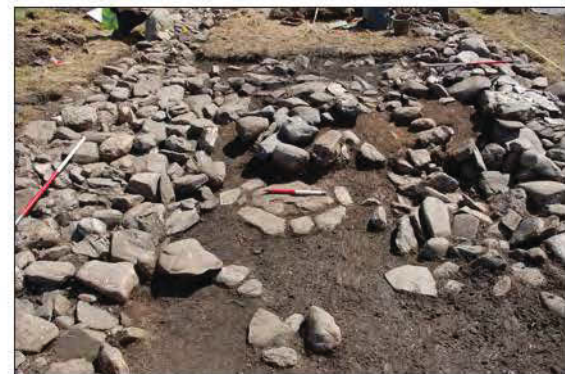
Plate 5: Hearth feature first exposed below collapse 010 in Room 1.

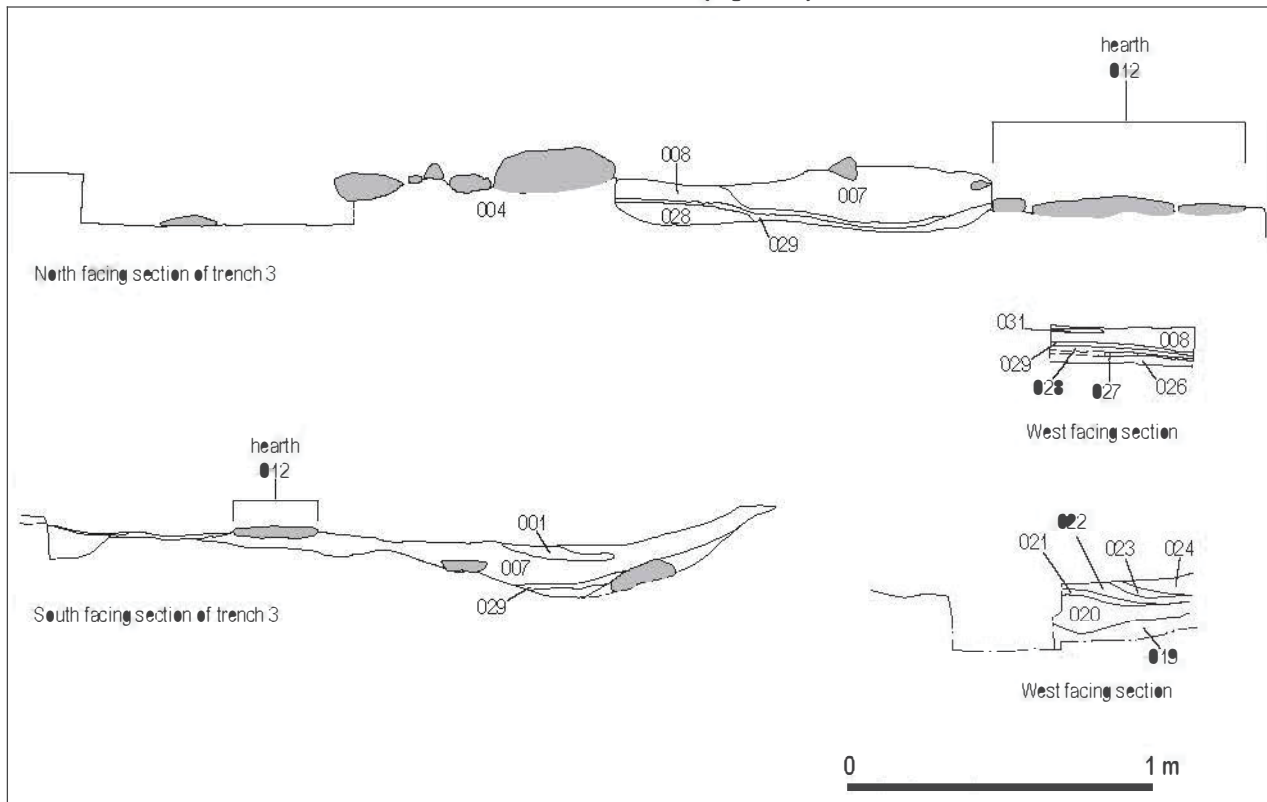
Figure 4: Sections across room 1 deposits.

7.4.3 Accumulation of floor and hearth deposits were observed within this area of the structure. Finer floor deposits were concentrated in the west side of Room 1 while the hearth rake out deposits were concentrated in the eastern side of Room 1 (Figure 4).

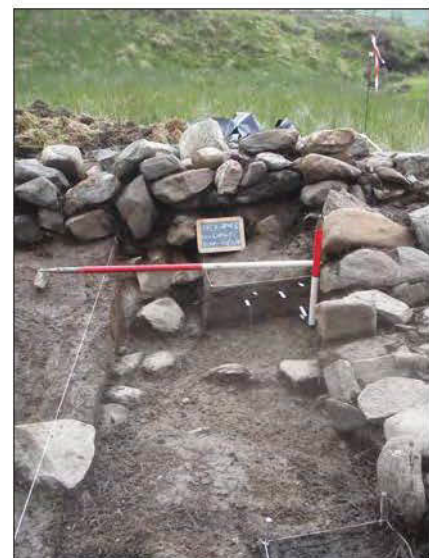
Plate 6: East facing section of floor deposits accumulated against bench feature 011 and west gable wall 013 Room 1.

7.4.4 The finer sediments of the floor deposits, possible from sweeping, were concentrated in the north-west corner between the bench feature 011 and the west gable wall 013, similar deposits were observed in section in the south-west corner of the structure, although not as well defined. The investigations did therefore show that these deposits are probably present all along the west gable wall (2.9 m north to south) but peter out before they reach the hearth feature 012 2.4 m to the east. From the exposed section in the north-west corner a total of six clear layers of deposition were observed (Plate 6) (Figure 4). The earliest of these floor deposits consisted of very dark brown charcoal-rich silty clay 019 measuring between 20 mm and 40 mm thick. Above this lay firm grey gravelly sandy clay 020 measuring between 40 mm and 110 mm thick. Overlying this was a dark brown silty clay 021 with moderate charcoal flecking measuring up to 20 mm thick. Next came a firm dark grey silty clay 022 measuring between 30 mm and 50 mm thick. The penultimate deposit consisted of grey gritty clay 023 with a maximum thickness of 20 mm. The upper deposit, and probably representing the last occupation level of *Tigh Caol*, was firm light grey brown sandy clay 024 measuring up to 70 mm in thickness. Two kubina tin samples were taken to capture the horizons observed in section and to permit potential higher resolution examination of the sediment accumulation through micromorphology techniques.

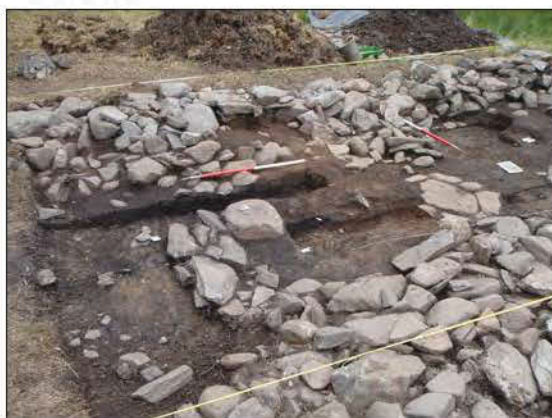
Plate 7: Hearth rake out extending beyond and below the line of wall 004, from north.

7.4.5 The hearth deposits observed in Room 1 were concentrated east of the hearth 012 and were observed extending up to a distance of 3 m east of the hearth, beyond and under the position

of wall 004. The layers were less well defined beyond the position of the wall probably due to trampling, the charcoal-rich accumulation here was therefore given a separate number 018. A Copper alloy taper SF091 was recovered from 018 just east of the entrance through wall 004. The layers were better preserved to the west below and just west of wall 004 (Figure 4) (Plate 7). The earliest deposit which lay over the floor 030 consisted of black charcoal-rich silty clay 026 with frequent charcoal chunks. This layer measured between 40 mm and 90 mm thick and was traced for at least 1.4 m east to west and below wall 004. Above this lay a red brown sandy clay layer 027 with moderate charcoal flecking and inclusions of burnt gravel and sand, this layer measured up to 20 mm thick and was traced for 1.1 m east to west and under wall 004. Overlying this was another black charcoal-rich silty clay layer 028 which measured between 30 mm and 40 mm thick and was traced for up to 1.2 m east to west and below wall 004. Next came another red brown silty sandy clay layer 029 with moderate charcoal content and frequent burnt gravel and sediment, this layer measured 20 mm to 30 mm thick and was traced for approximately 1 m east to west and below wall 004. Wall 004 was constructed over this layer and abuts the north wall 016 and is tied in to the lower courses of the south wall 015 (Figure 2). The wall measured 4.65 m in length, between 0.6 m and 0.85 m in width and up to 0.2 m in height. There was an apparent gap in wall 004 construction approximately 0.8 m north along the partition from the inner face of the south wall 015, this represents the entrance between the two rooms. Where wall 004 is tied into the south wall 015 there are two header stones which span the whole wall width, this is characteristic of an entrance position as it takes the load of the wall in an area where a structural weakness such as an entrance may be constructed. This is the only position in any part of the external walls where any header stones were observed, here the two header stones are set 0.85 m apart with notable wear and polish on, what would have been the exposed edge of the stone, the most westerly of the two header stones possibly suggesting entry from the south and west. The first layer to accumulate against wall 004 within Room 1 consisted of loose grey silty sandy clay 009 with frequent grit, this thin layer measured up to 10 mm thick and probably represent some trample associated with the insertion of wall 004. The next layer to accumulate against the internal partition consisted of very dark brown silty clay 008 with frequent charcoal flecks and chunks and occasional very small stone inclusions. This layer measured up to 0.1 m thick and was traced for 1.2 m east to west and up to 2 m north to south but was not fully excavated. Overlying this was a thin layer of red brown sandy clay 031 with moderate charcoal flecking measuring 10 mm to 20 mm thick, this layer was intermittent and may represent the last rake out of the hearth 012 before the collapse 010 of the walls 013, 015, 016 and 004, which was generally distributed across Room 1. The last layer in the sequence consisted of light brown silty sandy clay 007 and may represent a much later use of the space for temporary shelter. The turf layer 001 overlay this and the collapse 010 in Room 1 and beyond in to Room 2.

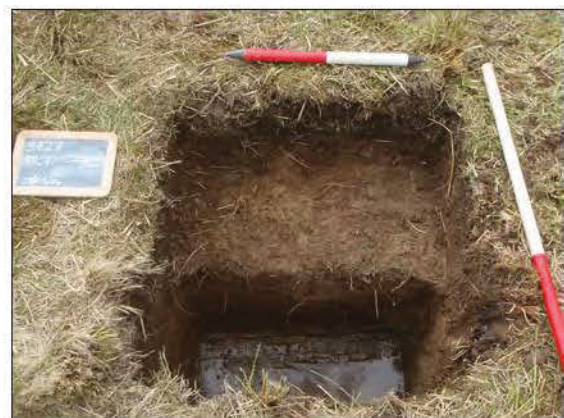
Plate 8: Trench 7 showing section through floor level 002 from east.

7.6.1 These trenches were opened along the central long axis of the structure to investigate any apparent changes in the floor deposits. Both trenches showed that floor 002 lay immediately below the turf level and was surprisingly sterile with only occasional small pockets of organic material borne of root intrusion into the floor. Some stone collapse 006 from the north 016 and south 015 walls was present. In Trench 7 the floor 002 was excavated in section into the underlying natural silt, sand and peat layers 003 by hand (Plate 8). This section revealed that the beaten floor measured between 30 mm and 150 mm thick, samples were taken of the floor in this position as it was shown to be relatively undisturbed.

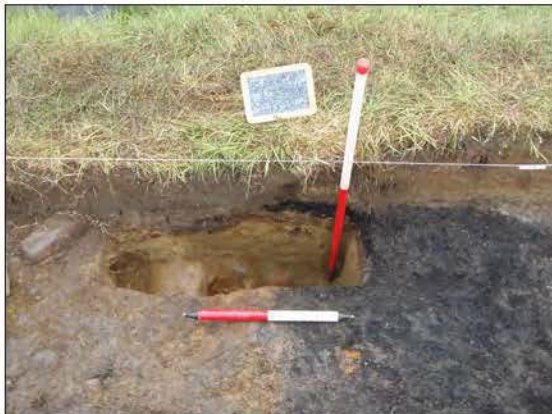
Plate 9: Burning in situ in Trench 4 from north above.

7.7.1 This trench was positioned across the drovers' track position and this confirmed the presence of the track as well as revealing evidence of activity pre-dating it. This included an area of extensive burning in situ (Plates 9 and 10). The trench was reduced down in layers and a small section was excavated by hand to determine the stratigraphic sequence of events in this trench and to facilitate sampling of the various layers.

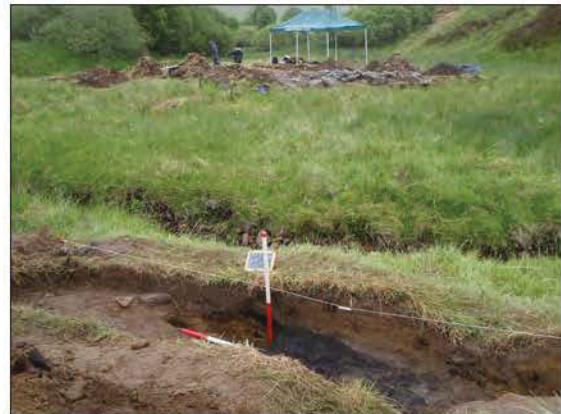
Plate 10: Showing Trench 4 in context of Tigh Caol building across burn, from north-west, dips for track line also clearly visible.

- 8.4 In Trench 4 across the supposed drovers' track position a surface was discovered and there was also some evidence of repair or consolidation. There were two dips in topography, indicative of a track or tracks, extending parallel to the north beyond the trench for approximately 20 m before disappearing into the vegetation and the weaving former meanders of the burn. This 20 m dimension is reflective of the scale of *Tigh Caol* and may suggest that the in situ burning is associated with a similar building that once stood here prior to the track. The deposits however have the appearance of sediment that has naturally compressed over a long period, perhaps suggesting a much earlier date for the burning activity, possibly a prehistoric date. The layers of what appear to be sterile naturally deposited sediments sealing the burning episode would also have taken a considerable amount of time to accumulate. There were no obvious tip lines or dump layers to suggest that these apparently natural deposits were placed here as a levelling layer for the track.

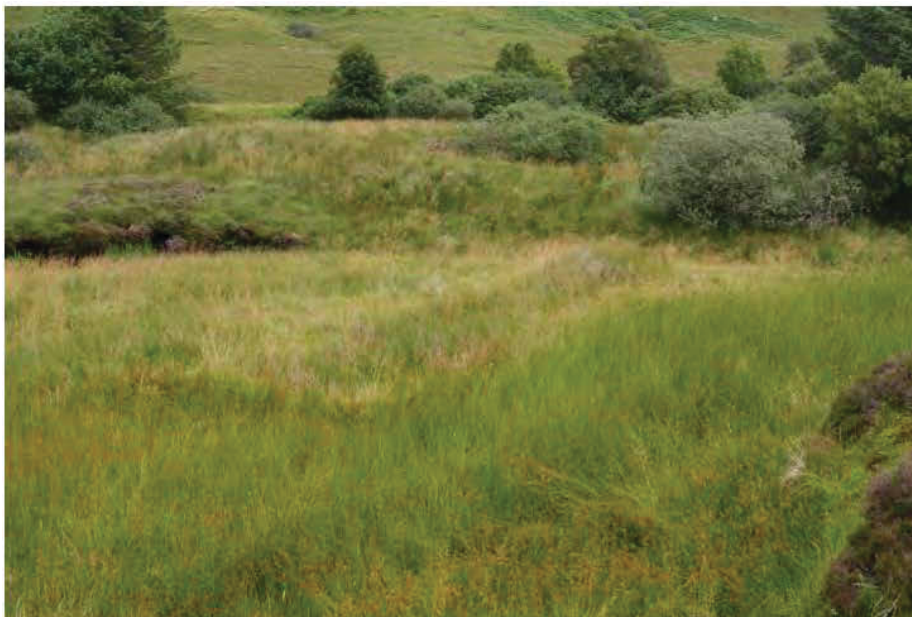
Plate 1: Overview of *Tigh Caol* from west, note darker, higher vegetation at east end
