## Huntly House Museum Courtyard, Edinburgh Archaeological Evaluation Data Structure Report Project 3840

**Huntly House Museum Courtyard, Edinburgh**  
**Archaeological Evaluation**  
**Data Structure Report**

**Project Number:** 3840

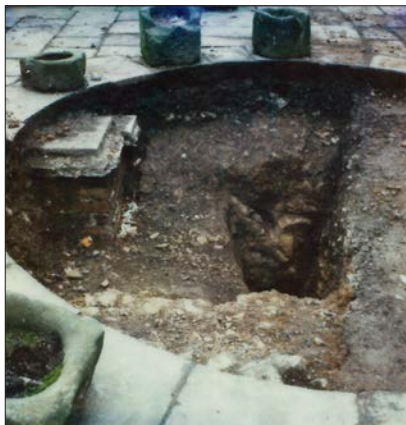
*Plate A: General view of the pit excavated during the 1986/1987 excavation.*

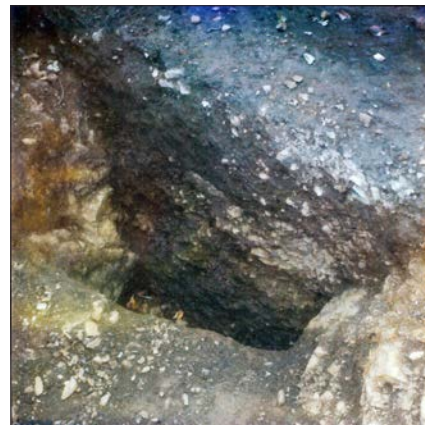
*Plate B: General view of the pit section excavated during the 1986/1987 excavation.*

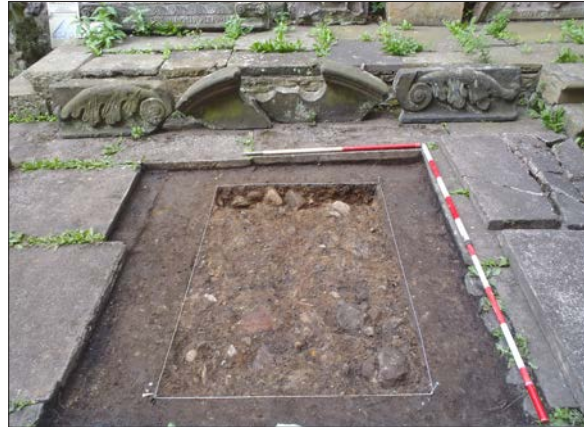
7.3 Trench 1 was located at the north end of the site, aligned north-east to south-west and measured 1.5 m long by 1 m wide. Paving, concrete slabs (001), forming part of the courtyard surface were removed and found to be overlying a layer of bedding sand (002). This overlay a thin dark trampled layer of natural clay (003), which overlay bright orange/brown natural clay (004). No archaeological features were seen. Concrete slabs may have been laid over areas formerly planted as garden, particularly noticeable in the area around Trench 1 as they appeared to form a square within an area of sandstone paving slabs.

Plate 1: Trench 1, from the north-east

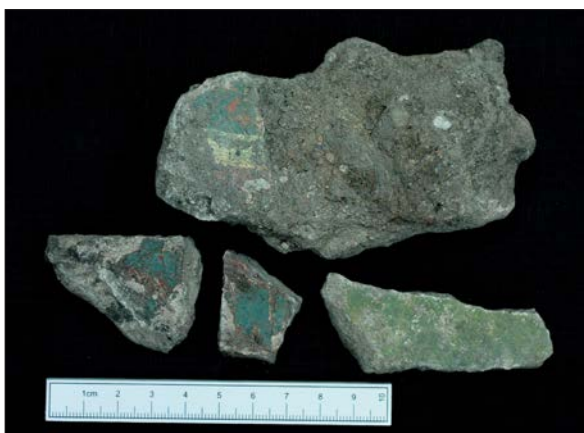
7.4 Trench 2 was located in the central part of the courtyard and was aligned north-west to south-east immediately north of a large Rosemary bush which formed the garden area excavated in 1986/1987 prior to planting. This measured 1.5 m long by 1 m wide but was extended northwards slightly to further investigate a putative kerb or paving remnant (205). Below the sandstone paving slabs (200) forming the current courtyard surface yellow bedding sand (201) with patches of ash and cinders was found to a depth of 30 mm. Below this a levelling layer (202) containing frequent small sandstone fragments, occasional slate and pantile fragments, moderate spreads of lime mortar and degraded mortar throughout. Fragments of painted lime mortar were recovered from this layer during excavation suggesting this material derived from demolition debris.

Plate 2: Painted plaster.

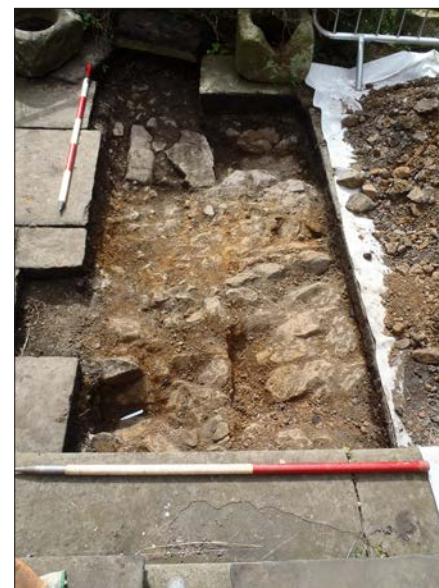
Plate 3: Trench 2, white arrow indicates position of post-hole (207) and putative paving/kerb (205) is visible top left rear of frame, from the north-west.

- 7.5 This overlay a very compact dark grey/brown silty sand (203) with moderate to frequent inclusions of small sub-angular stones, small fragments of slate and orange tile and occasional lumps of lime mortar, although this material (unlike layer 202) may be residual and have accumulated during a time of construction and development on the site during the eighteenth and nineteenth centuries. After removal of these overburden layers a putative kerb or remnant of paving (205) was recorded towards the north end of the trench, this comprised two sandstone rubble stones laid on bed set onto a brown clay. This measured 0.56 m long by 0.48 m wide and survived to a single course in height 90 mm. A pit cut (207) was recorded at the north end of trench 2 and contained a fill (206) of dark grey/brown sandy silt with frequent wood fragments probably the remains of a timber post.

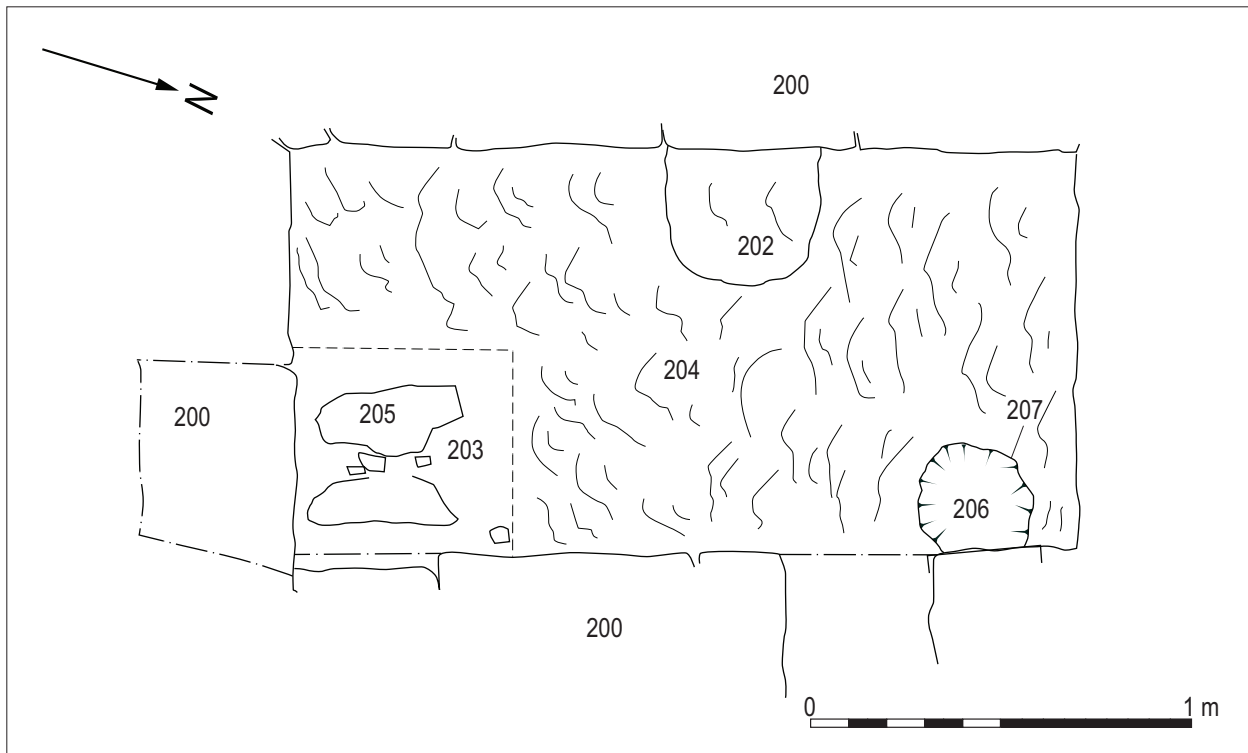
Figure 2: Plan of trench 2 showing putative paving/kerb 205 and pit cut 207.

| Context No. | Area | Description | Interpretation |
|---|---|--|--|
| 205 | Trench 2 | Structure: Possible kerb or paving remnant comprised two sandstone rubble stones possibly clay bonded laid onto brown clay. Stone size 500 mm x 260 mm x 90 mm. Measured 0.56 m long x 0.48 m wide and survived to a single course in height 0.09 m | Putative paving or kerb remnant laid onto a brown clay, built off natural 204 found below deposit 203 |
| 207 | Trench 2 | Cut: Semi-circular in plan, continued below trench edge to the east, U-shaped in profile. Sharp break of slope at top to steep sides which break abruptly to form a narrow V-shaped base. Measured 0.28 m long (excavated) x 0.28 m wide x 0.2 m deep | Pit cut probable post-hole, filled by 206 |

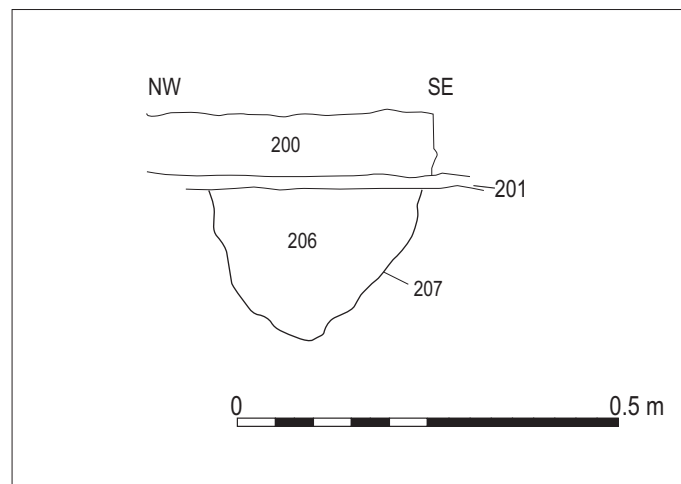
Figure 3: South West facing section of pit 207 in trench 2.

| Context No. | Area | Description | Interpretation |
|---|---|--|--|
| 206 | Trench 2 | Fill: A moist, loose dark grey/brown sandy silt with frequent small fragments of wood, moderate inclusions of small stones and sherp gravel. Measured 0.2 m deep | Fill of pit cut 207 found below deposit 201 |

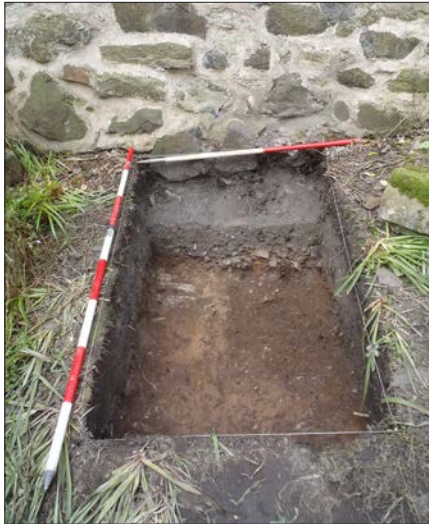
7.6 Trench 3 measured 1.5 m long by 1 m wide, aligned north-east to south-west and was located towards the southern end of the courtyard against the wall forming the present western property boundary wall. Topsoil (300) was found overlying a buried pale grey/brown garden soil horizon (301), which contained post-medieval pottery fragments. This overlay natural clay (302). After removal of the garden soil horizons (300 and 301) a pit cut (304) was found cut into natural clay (302). This measured 0.84 m long (visible), by 0.56 m wide (visible), by 0.3 m deep and continued below the trench edges to the south-west and north-west. The pit was filled with a dark brown silt and several fragments of glazed and unglazed thirteenth century White Gritty Ware pottery were recovered from this material during excavation. The pit appeared to extend beyond and below the existing wall forming the current property boundary and may relate to a time predating the existing property boundaries.

Plate 4: Pit cut 304 below existing west property boundary wall in Trench 3 pre-ex, from the south-east.

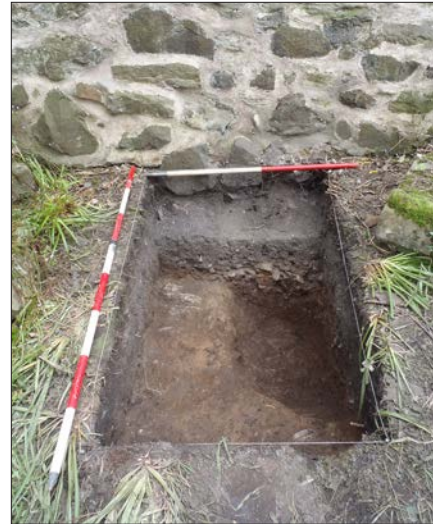
Plate 5: Pit cut 304 in Trench 3 post-ex, from the south-east.

| Context No. | Area | Description | Interpretation |
|---|---|--|---|
| 304 | Trench 3 | Cut: Sub-rectangular in plan (continues below trench edges to east and north), U-shaped in profile. Sharp break of slope at top to moderately sloping slightly concave sides which break gradually to form a rounded base. Measured 0.84 m long (visible) x 0.56 m wide (visible) x 0.3 m deep | Medieval midden pit cut |

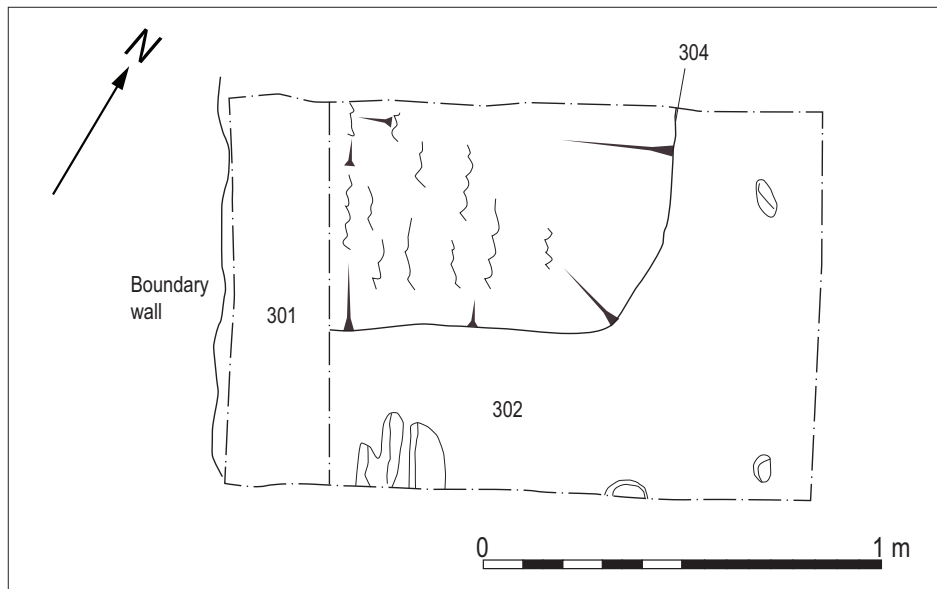
Figure 4: Plan of pit cut 304 in trench 3.

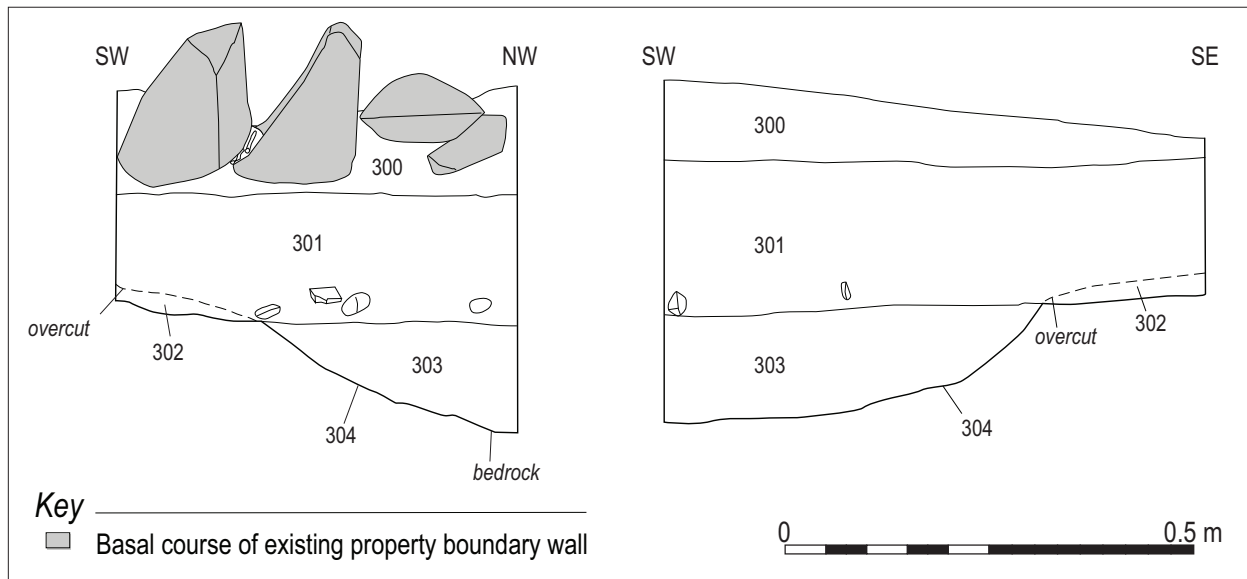
Figure 5: North East and South East facing sections through pit cut 304 in trench 3.

| Context No. | Area | Description | Interpretation |
|---|---|--|---|
| 303 | Trench 3 | Fill: A moist, firm dark brown silt with sub-angular stones and white grittyware pottery fragments, occasional charcoal flecks. Measured 0.27 m deep | Fill of pit cut 304 below garden soil layer 301 |
