**Royal Victoria Hospital, Edinburgh
Archaeological Watching Brief
Data Structure Report
Project 3943**

**Royal Victoria Hospital, Edinburgh
Archaeological Watching Brief
Data Structure Report**

Project Number: 3943

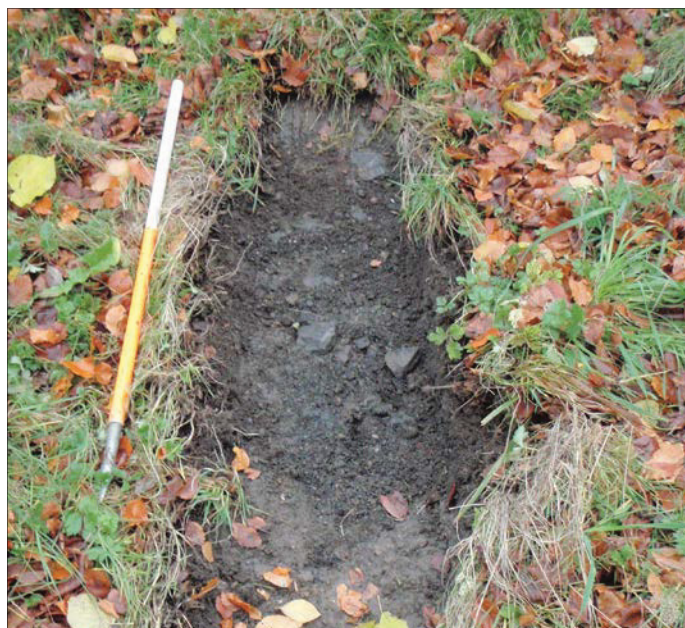
Plate 1: Deposit 005 at the south end of Test-pit 8, from the north.

- 7.3 Test-pit 08 was aligned north to south and measured 6 m long by 0.4 m wide by 0.5 m deep and located to the south-east of Craigleith House (Figure 2). At the southern end of the test-pit below topsoil (001) and above subsoil (002) a layer of sandstone fragments contained within an ashy matrix (005), possibly a path, was recorded, this measured 1.8 m long, by 0.44 m wide, the depth of this layer was undetermined and it continued below the trench edges to the south, east and west. Test-pit 8 was relocated 3 m to the north of the feature to avoid disturbance to it.

| Context No. | Area | Description | Interpretation |
|---|---|--|--|
| 005 | Test-pit 8 | Deposit: A moist, loose grey ash with frequent small angular sandstone fragments overlain by pea gravel at the northern limit of the deposit. Continued below trench edges to the south, west and east. Measured 1.8 m long (excavated) by 0.44 m wide (excavated) depth undetermined. | Remnant of garden path associated with Craighleith House or part of a hard-standing associated with later use of the grounds of Craighleith House as a nursery |

- 8.1 The watching brief recorded the remains of a possible path or hard standing in Test-pit 8 to the south east of the site of Craigleith House, the path may be associated with the gardens of Craigleith House or perhaps later use of the site as a nursery. On a site location plan supplied by Mason Evans the site of Craigleith House is marked towards the south-west part of the site but

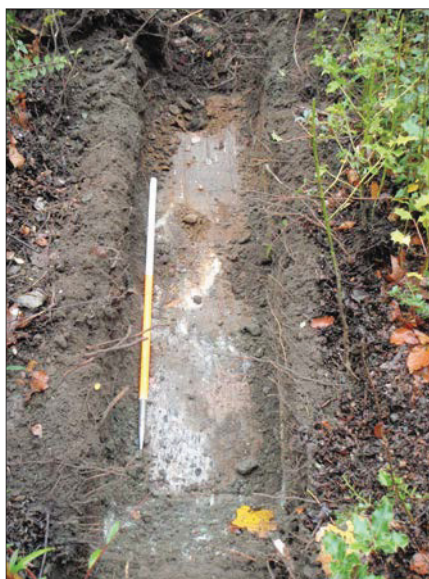
Plate 2: Concrete slab 008 in Test-pit 017,
from the east.

- 7.4 Test-pit 17 was aligned east to west and measured 3.2 m long by 0.6 m wide by 0.25 m deep. A layer of type 1 gravel (007) 0.1 m deep was visible below topsoil (001). After removal of the type 1 gravel part of a degraded concrete slab (008) was visible at the east end of the trench. The concrete measured 1.2 m long by 0.6 m wide by 60 mm deep. And continued below the trench edges to the east, north and south

| Context No. | Area | Description | Interpretation |
|---|---|--|--|
| 008 | Test-pit 17 | Degraded concrete slab at the east end of test-pit 17. Measured 1.2 m long by 0.6 m wide by 0.06 m deep. Continued below trench edges to the east, north and south | Concrete slab function uncertain. |

- 8.2 It is not clear what the concrete slab recorded in Test-pit 17 relates to or what period of development of the site it pertains to.
